## Expertise

Protocol number: 45969355  
Order No. / Reference: 26457248  
Inspection date: 16 Jun 2026

Manufacturer: Mercedes-Benz

Model: 317 CDI Sprinter Standard HA 9G-Tronic

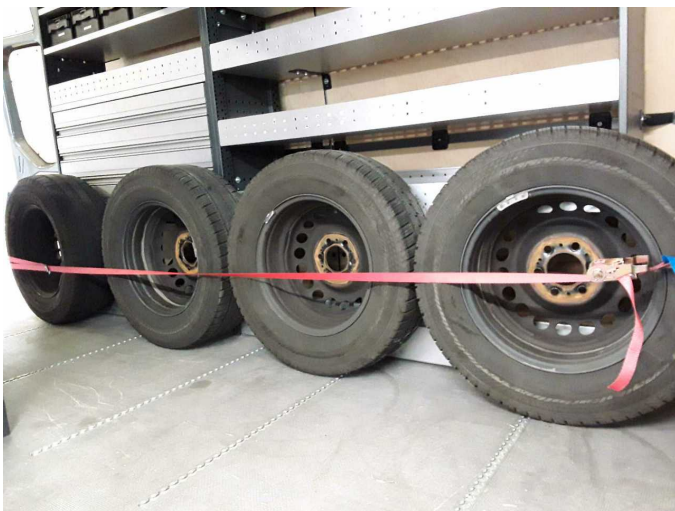
Figure 15: Additional tyres

#	Tyre size	Type of tyre	Manufacturer	Tread depth
1)	235/65 R16 119R	Winter tyres on Steel	Continental	0mm / 0mm
2)	235/65 R16 119R	Winter tyres on Steel	Continental	5mm / 5mm

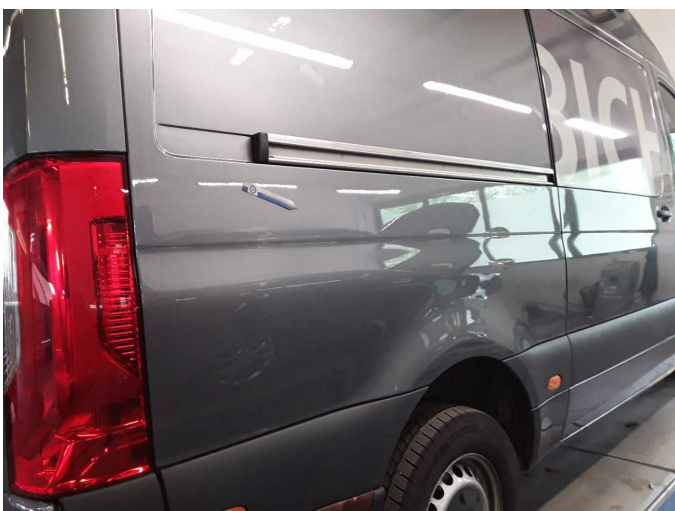
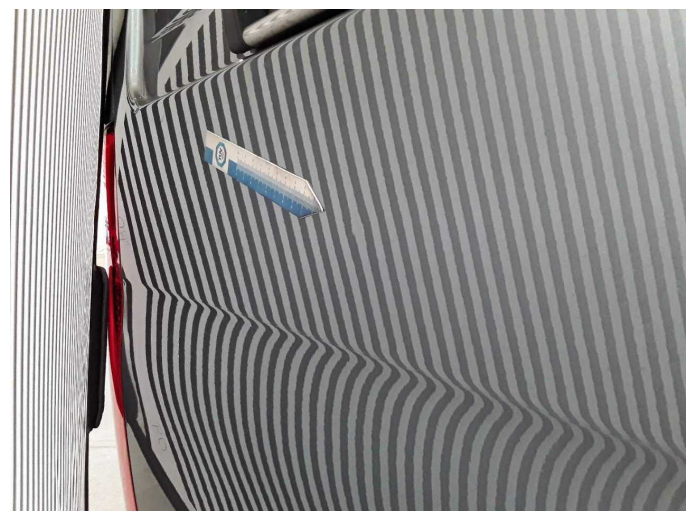
Damage 2: Side panel - rear right side: Side panel - dent(s) - Smooth repair work

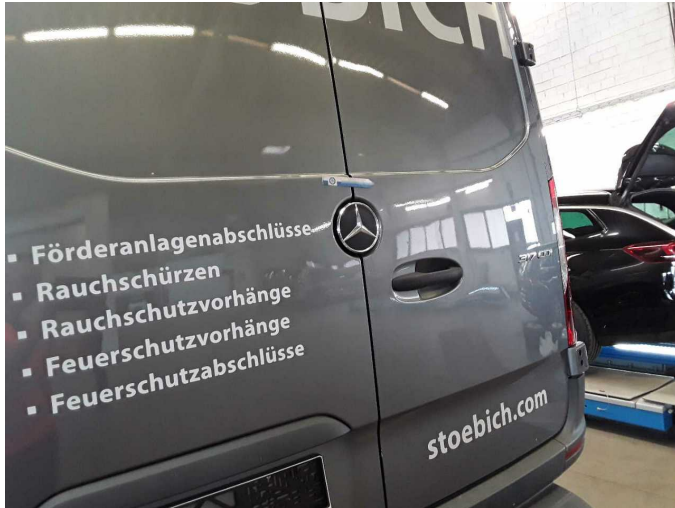
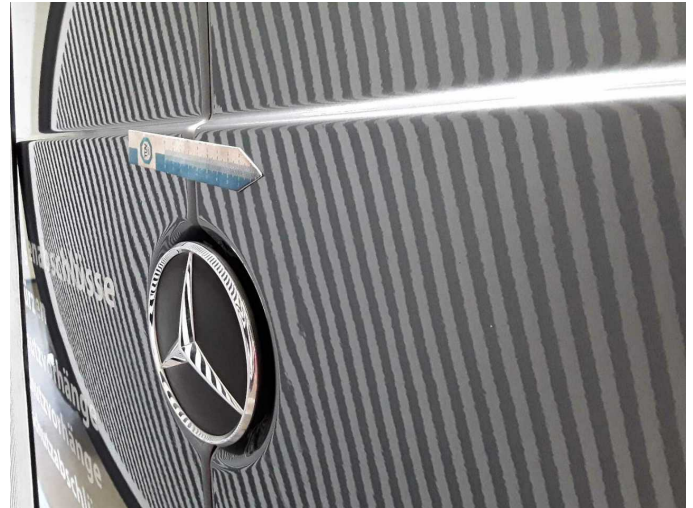
**Damage 3:** Boot lid / rear door: Rear door - right side - dent(s) - Smooth repair work

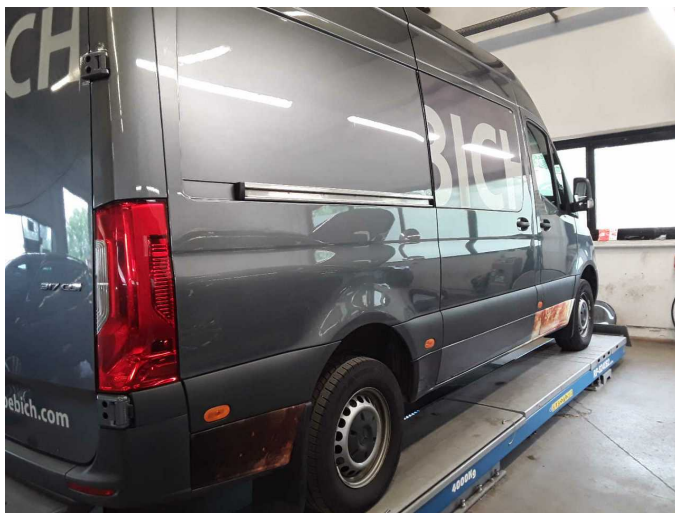
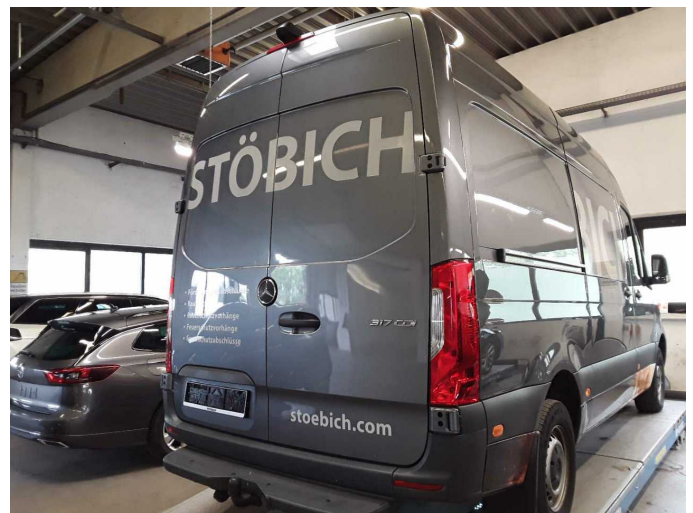
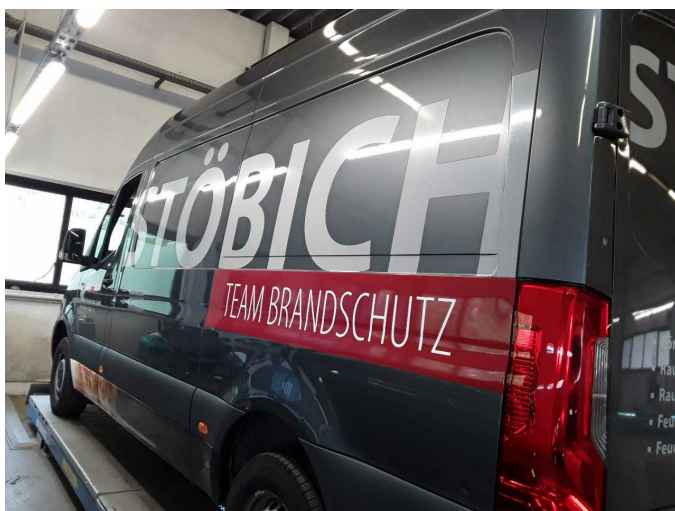
**Damage 4:** Body: Body - Glued / labelled - De-glue / neutralise

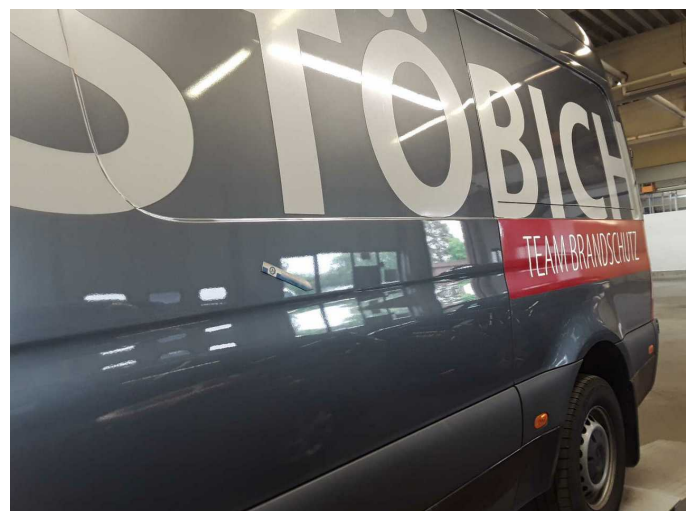
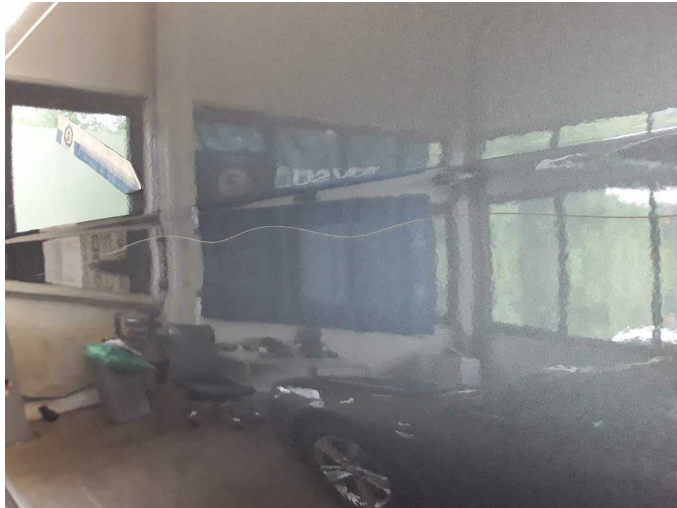
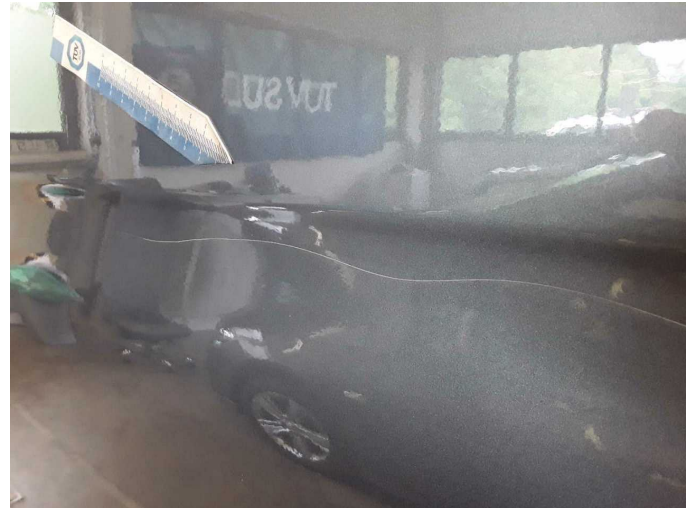
**Damage 5:** Side panel - rear left side: Side panel - Scratch(es) - Paint

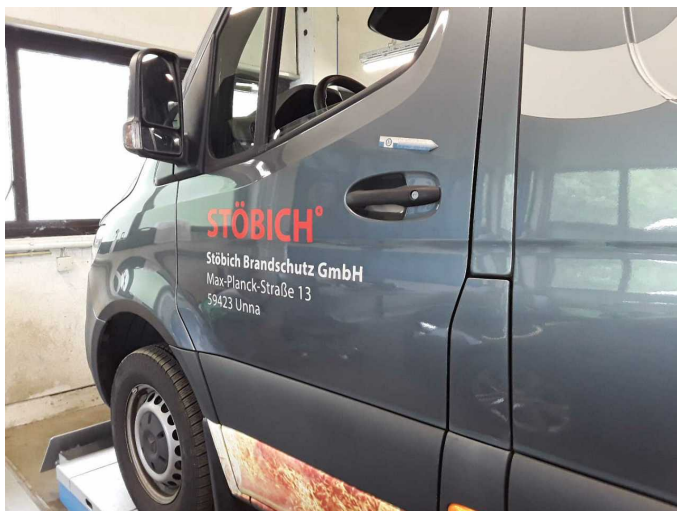
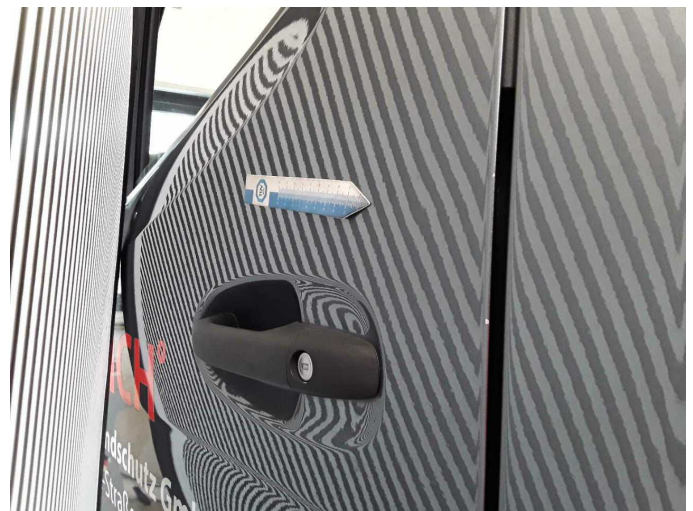
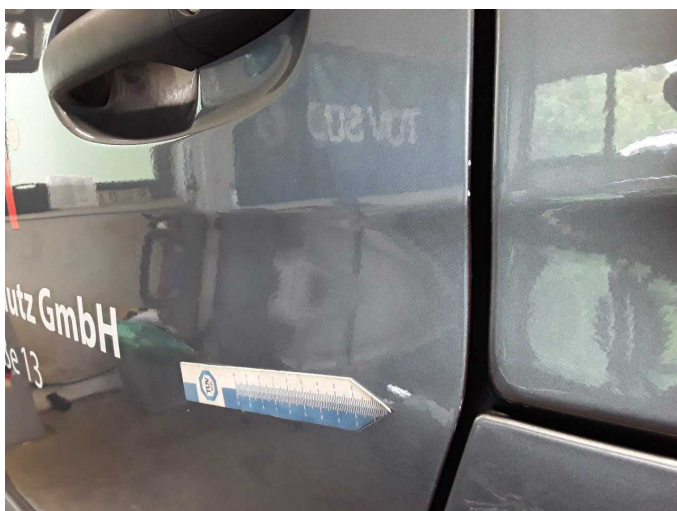
**Damage 6:** Door - front left side: Door - Dent / paintcoat damage - Repair and paint

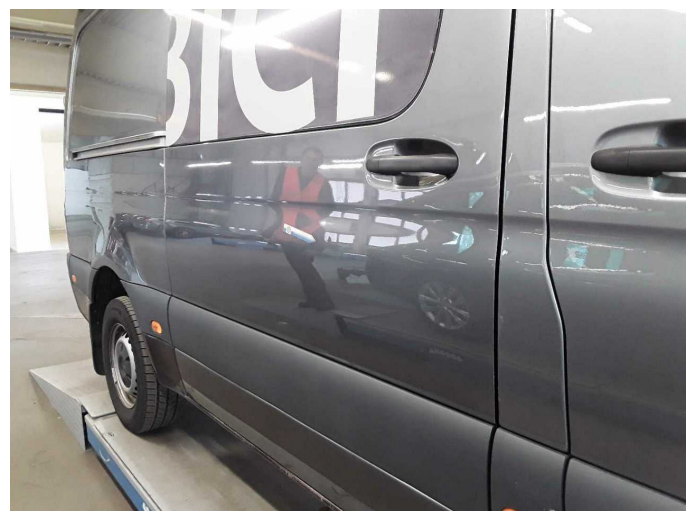
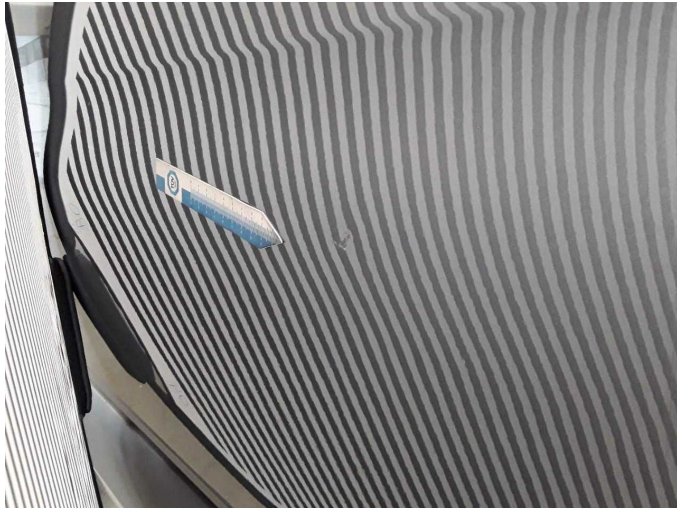
**Damage 7:** Door - rear right side: Door - Dent / paintcoat damage - Repair and paint

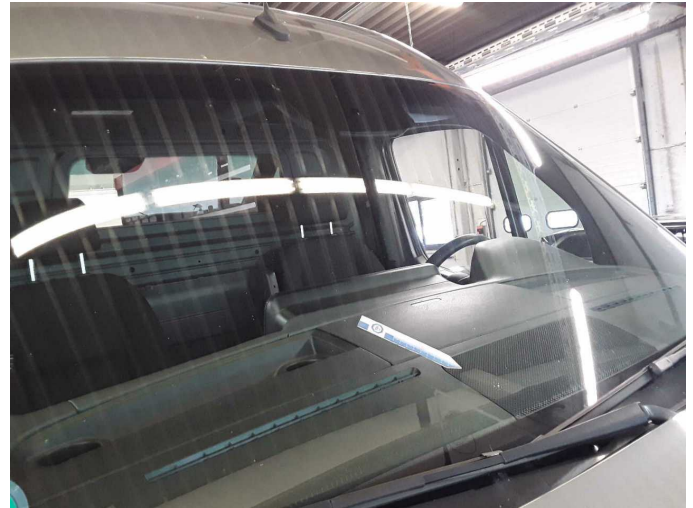
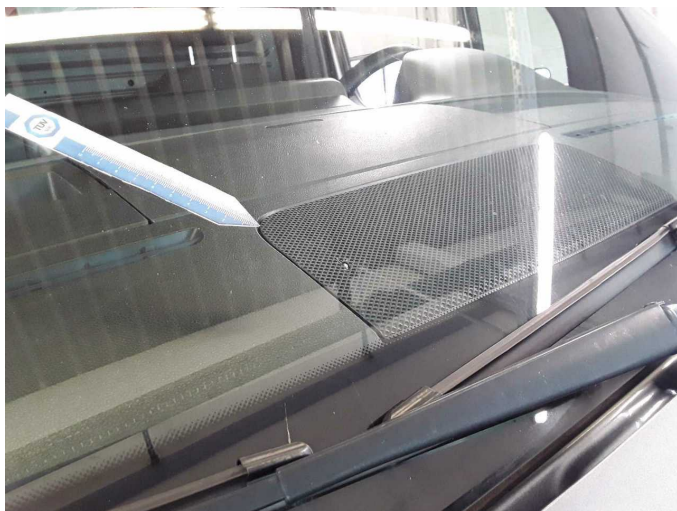
**Damage 8:** Vehicle glazing: Windscreen (Rissbildung) - Stone chips - Replace

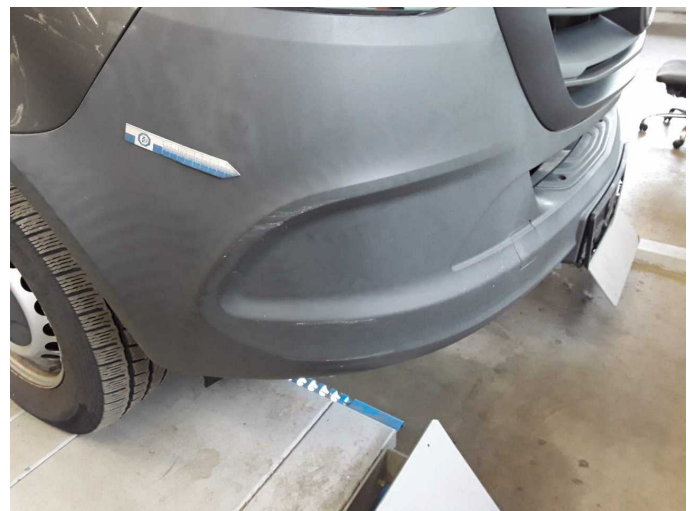
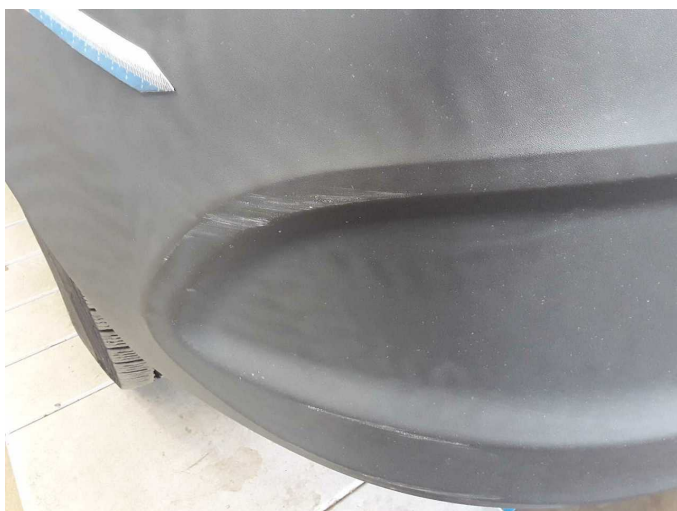
**Wear and tear 1:** Front bumper: Front bumper (unpainted) - Scratch(es) - No deduction

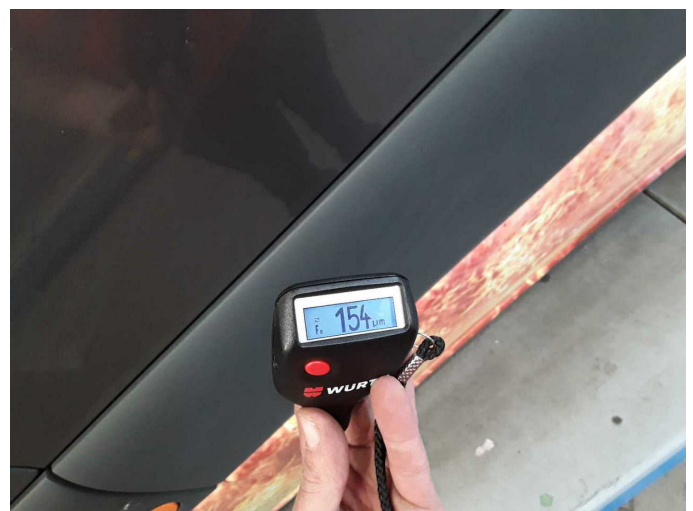
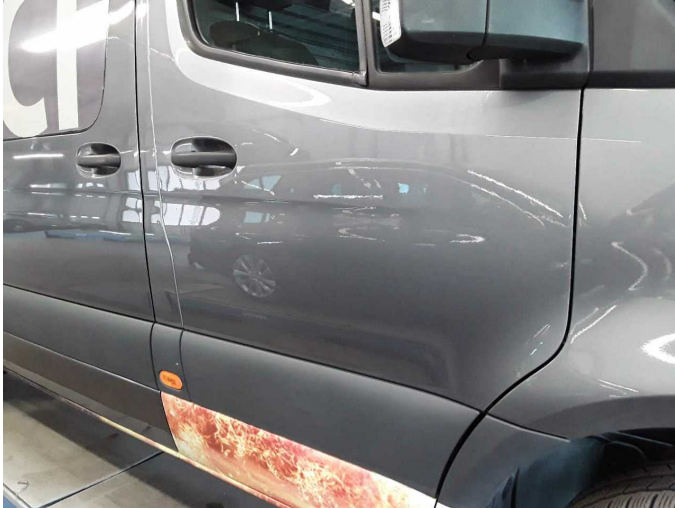
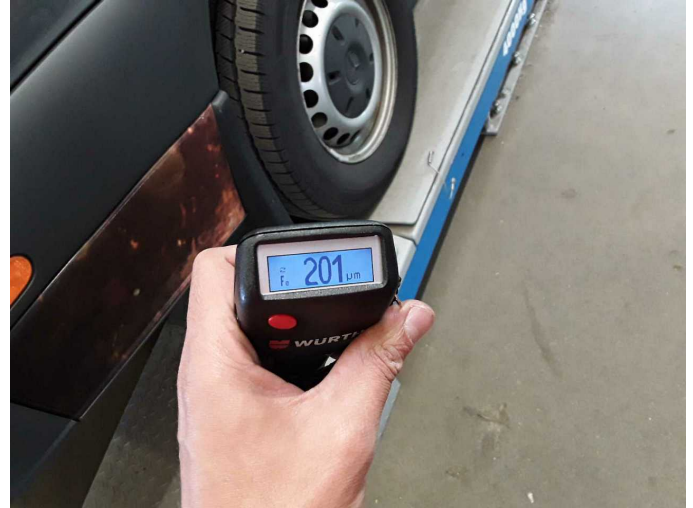
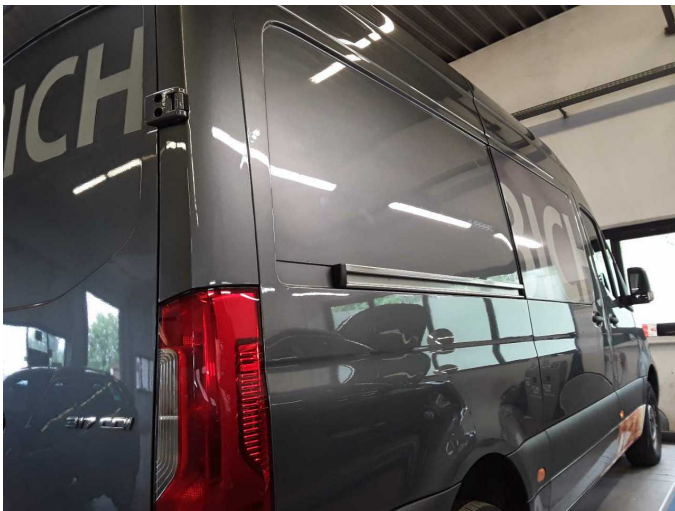
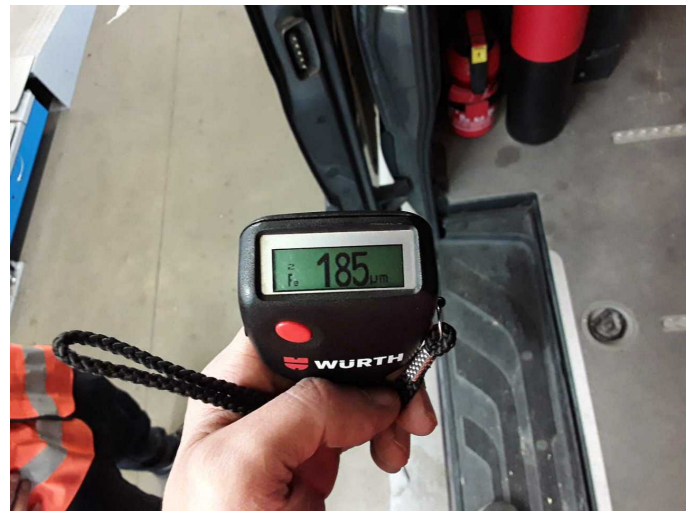
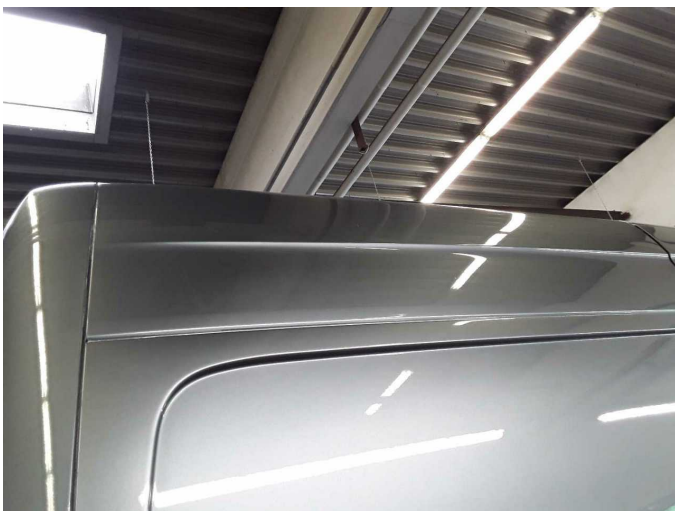
Roof	185 µm	Side panel - rear right side	201 µm
Door - front right side	154 µm

**Repainting 1:** Roof, Side panel - rear right side, Door - front right side

Repainting 1: Roof, Side panel - rear right side, Door - front right side
