Expertise

Protocol number: 45860200
Order No. / Reference: 26379565
Inspection date: 3 Jun 2026

Manufacturer: CUPRA

Model: Born 150kW/58kWh

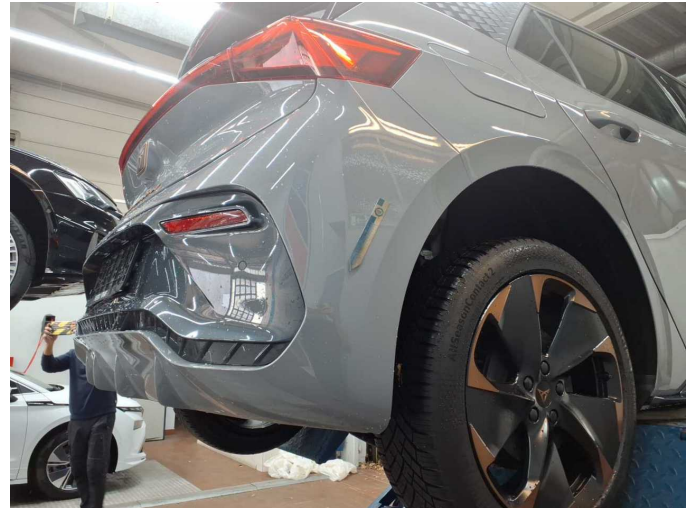
No.	Component group	Description
1	Rear bumper	Rear bumper - Scratch(es) - Smart repair
2	Multimedia system	Navigation system - Non-operational - Perform diagnosis
3	Misc.	Inspection / maintenance - Due - Perform

Damage 1: Rear bumper: Rear bumper - Scratch(es) - Smart repair

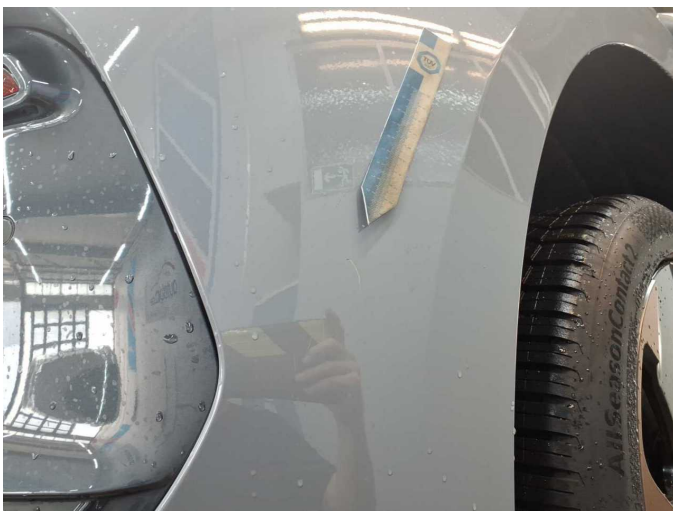
Damage 1: Rear bumper: Rear bumper - Scratch(es) - Smart repair

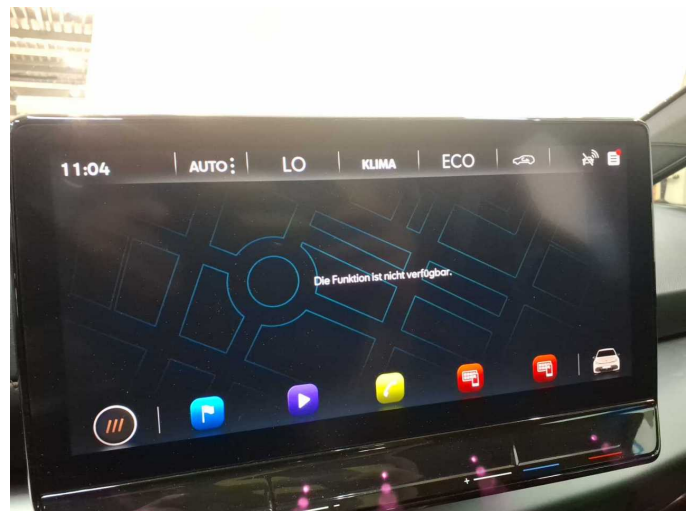
Damage 2: Multimedia system: Navigation system - Non-operational - Perform diagnosis

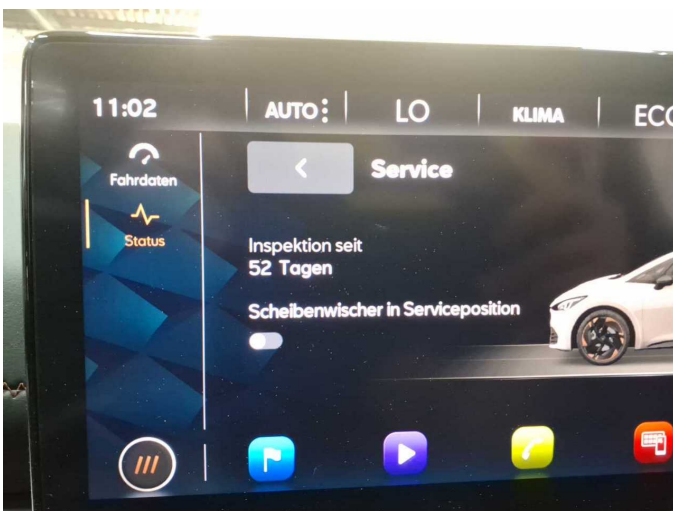
Damage 3: Misc.: Inspection / maintenance - Due - Perform
