Expertise

Protocol number: 46198163
Order No. / Reference: 26042711
Inspection date: 22 Jun 2026

Model: Vito 116 CDI Lang HA Aut. PRO

VIN: W1VVLBEZ7T4563567

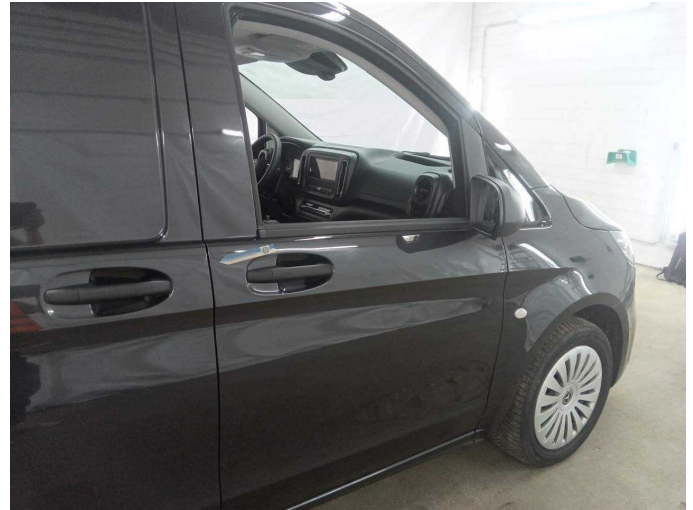
Damage 1: Door - front right side: Door edge - Scratch(es) - Smart repair

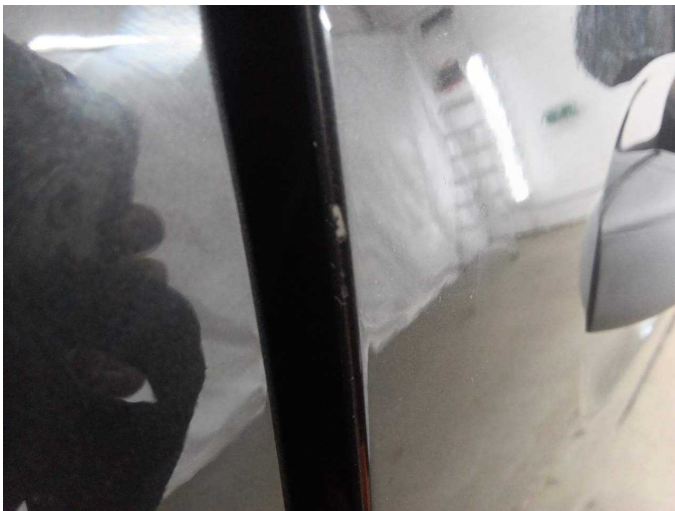
Damage 1: Door - front right side: Door edge - Scratch(es) - Smart repair

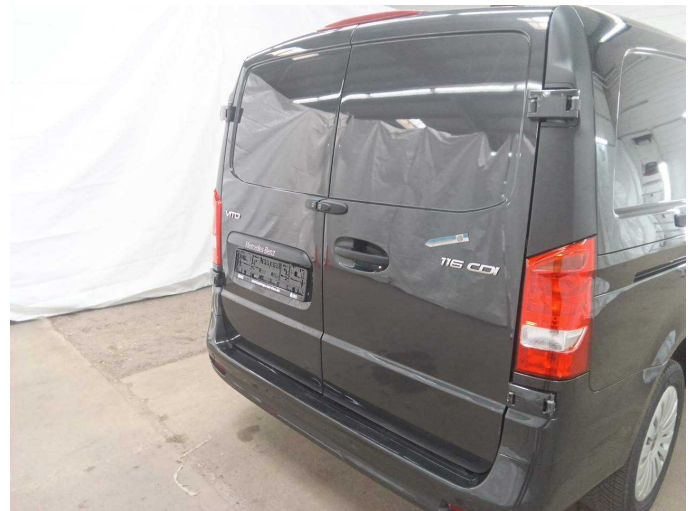
Damage 2: Boot lid / rear door: Rear door - right side - dent(s) - Smooth repair work

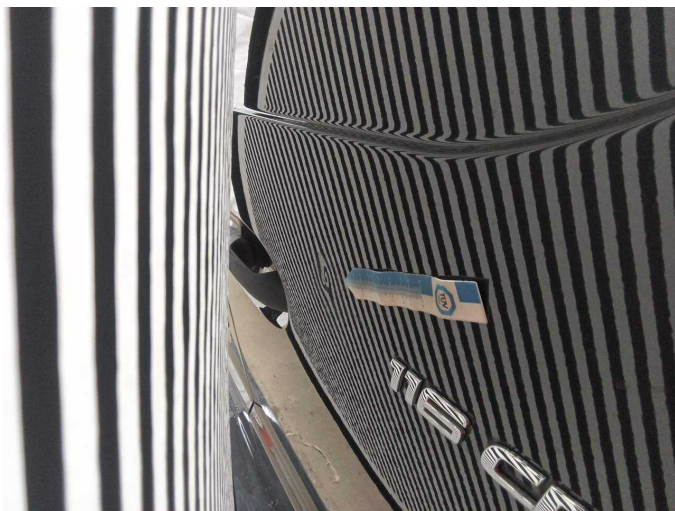
Damage 2: Boot lid / rear door: Rear door - right side - dent(s) - Smooth repair work

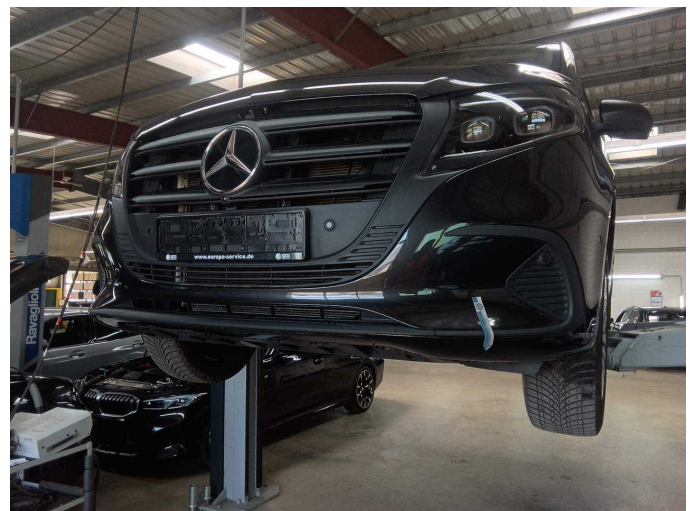
Damage 3: Front bumper: Front bumper - Scratch(es) - Smart repair

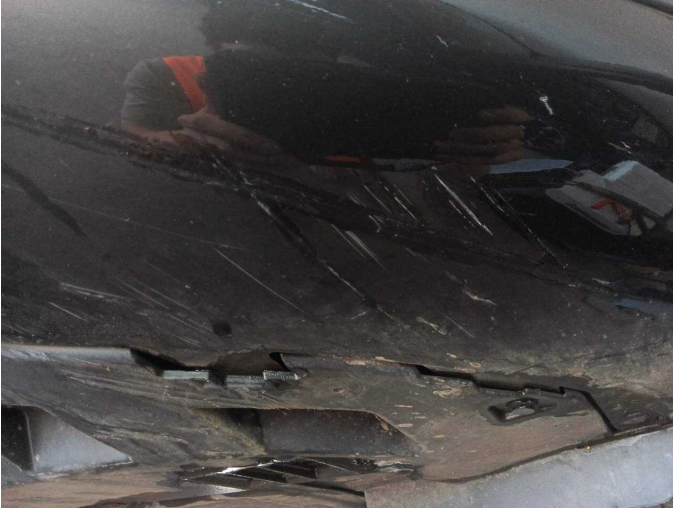
Damage 3: Front bumper: Front bumper - Scratch(es) - Smart repair

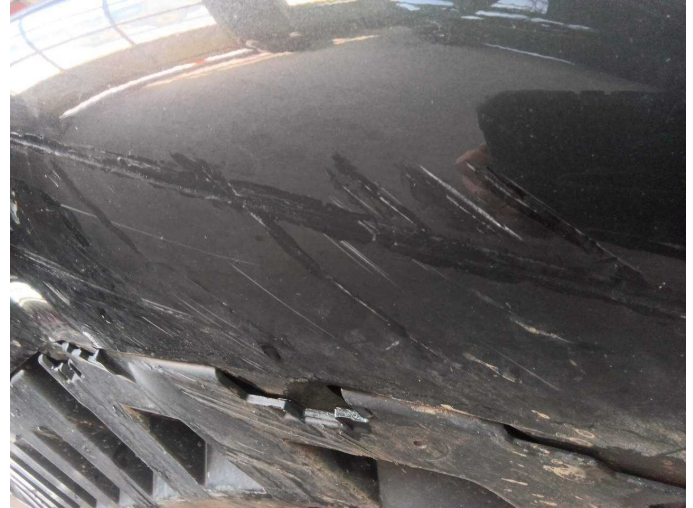
Damage 3: Front bumper: Front bumper - Scratch(es) - Smart repair

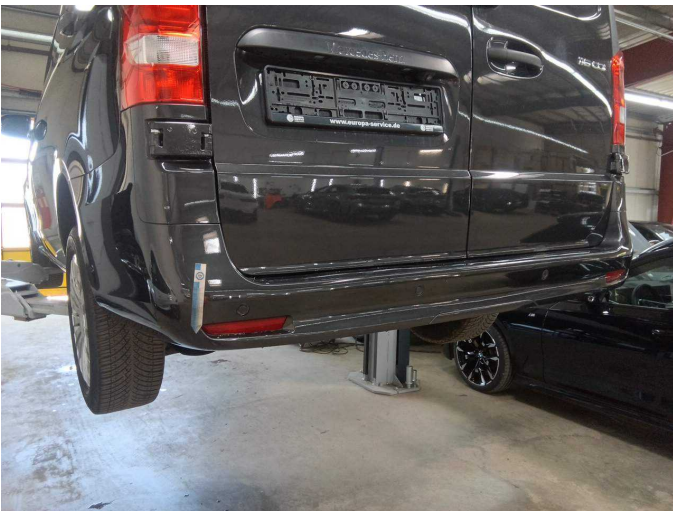
Damage 4: Rear bumper: Rear bumper - Scratch(es) - Paint

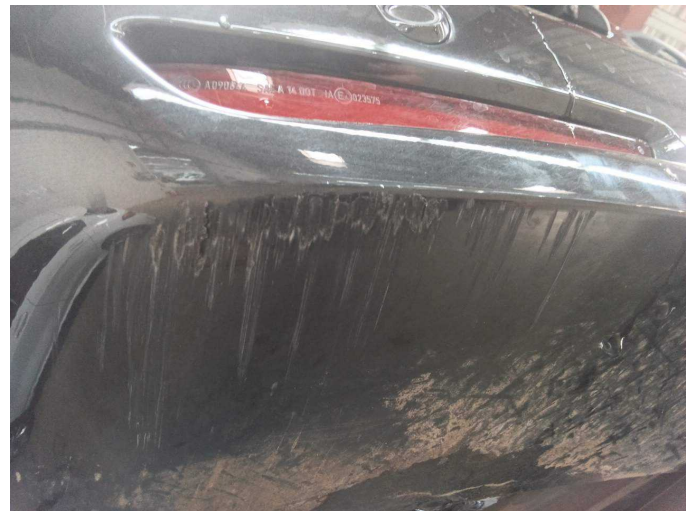
Damage 4: Rear bumper: Rear bumper - Scratch(es) - Paint

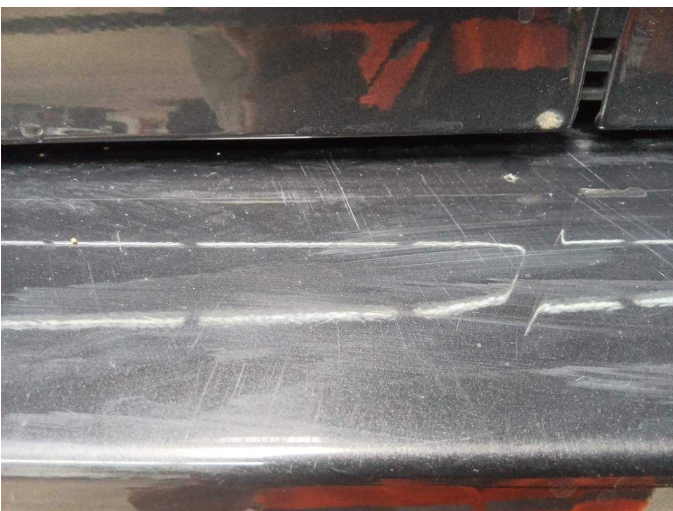
Damage 4: Rear bumper: Rear bumper - Scratch(es) - Paint

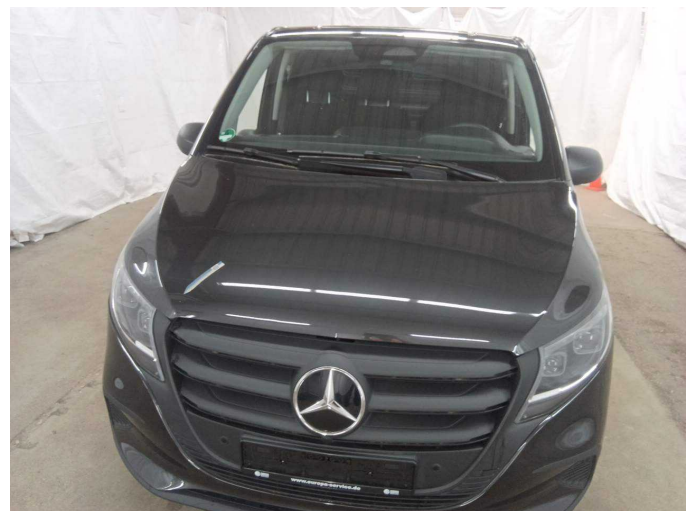
Damage 5: Bonnet: Bonnet - Dent / paintcoat damage - Repair and paint

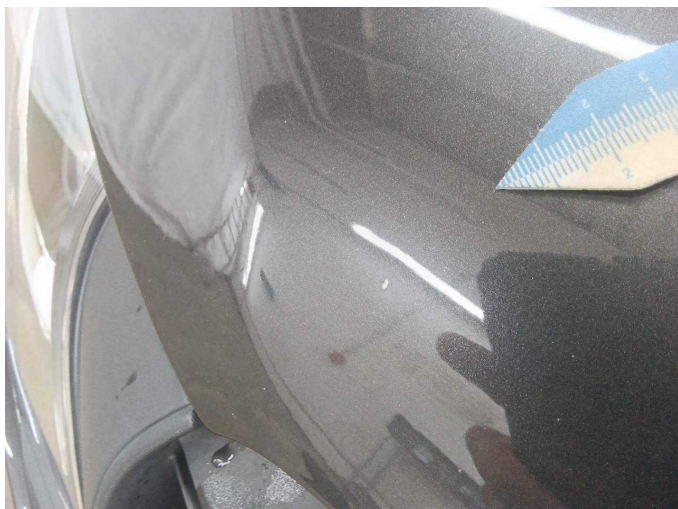
Damage 5: Bonnet: Bonnet - Dent / paintcoat damage - Repair and paint

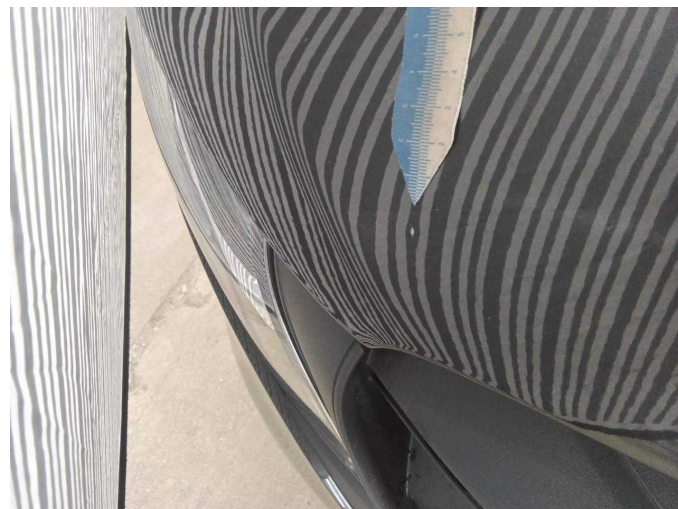
Damage 5: Bonnet: Bonnet - Dent / paintcoat damage - Repair and paint
