Expertise

Protocol number: 45819962  
Order No. / Reference: 26382533  
Inspection date: 8 Jun 2026

Manufacturer: Skoda  
VIN: TMBJJ7NX8NY023051

Model: Octavia Combi 2.0 TDI DSG Ambition

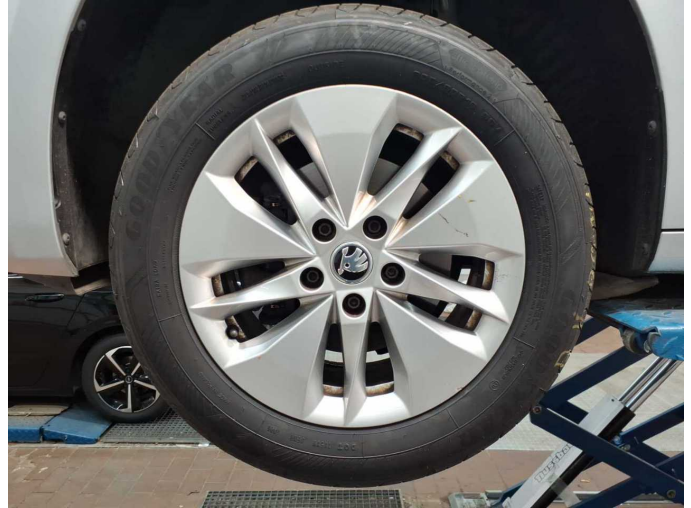
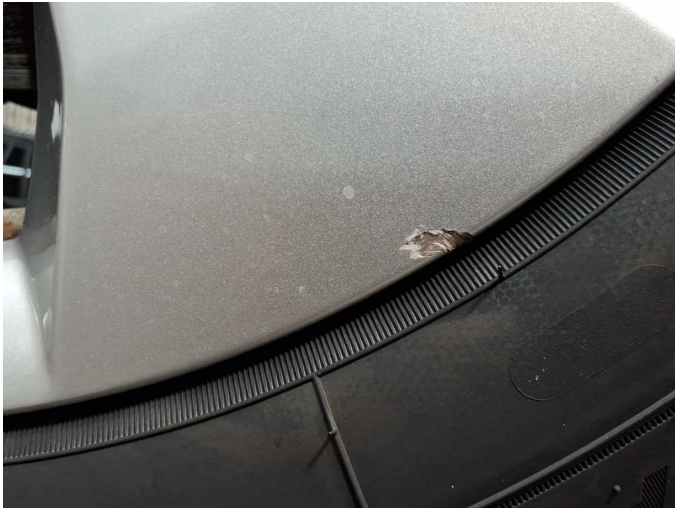
| No. | Component group | Description |
|---|---|---|
| 1 | Wheel / tyres | Alloy rim - front left side - Scratched - Loss in value |

**Damage 1:** Wheel / tyres: Alloy rim - front left side - Scratched - Loss in value

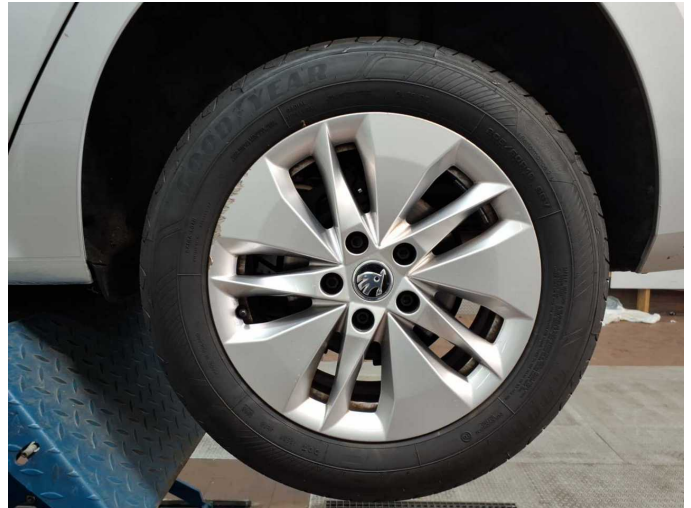
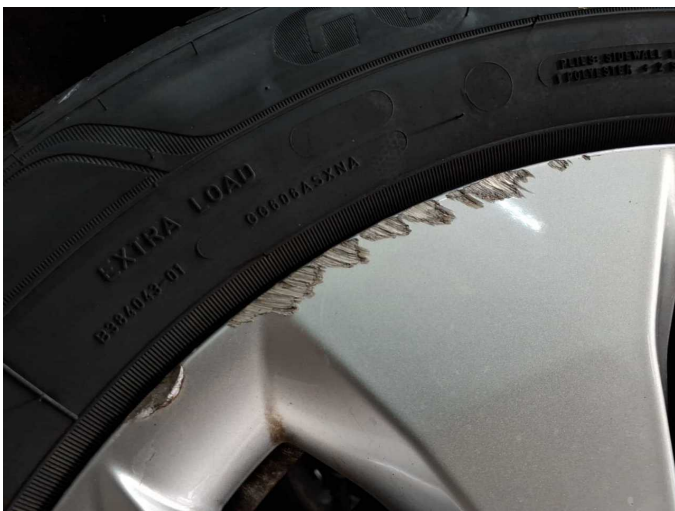
| No. | Component group | Description |
|---|---|---|
| 2 | Wheel / tyres | Alloy rim - rear left side - Scratched - Replace |

**Damage 2:** Wheel / tyres: Alloy rim - rear left side - Scratched - Replace

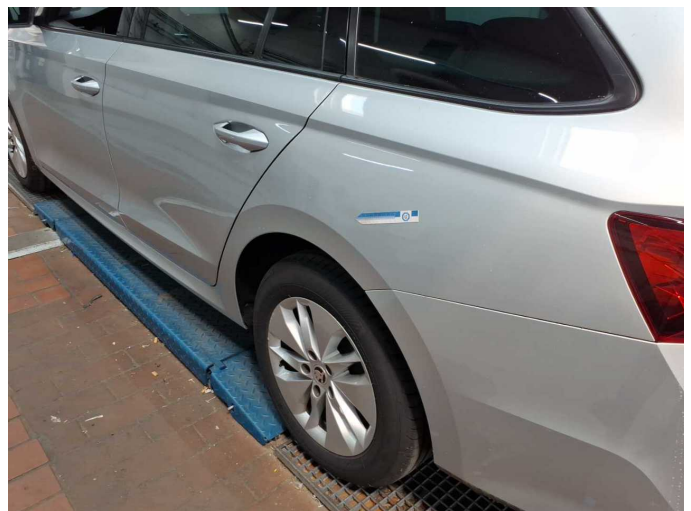
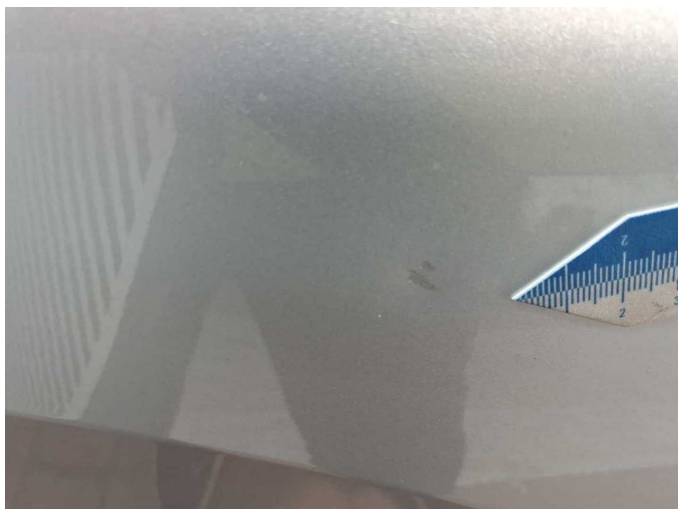
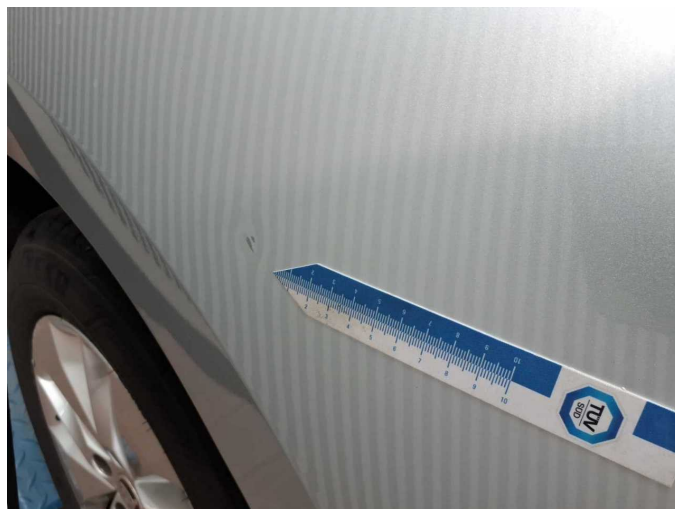
| No. | Component group | Description |
|---|---|---|
| 3 | Side panel - rear left side | Side panel - Dent / paintcoat damage - Paint |

**Damage 3:** Side panel - rear left side: Side panel - Dent / paintcoat damage - Paint

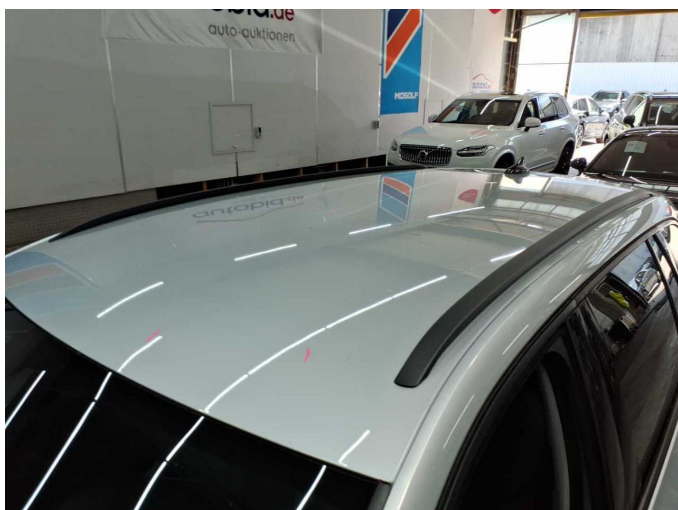
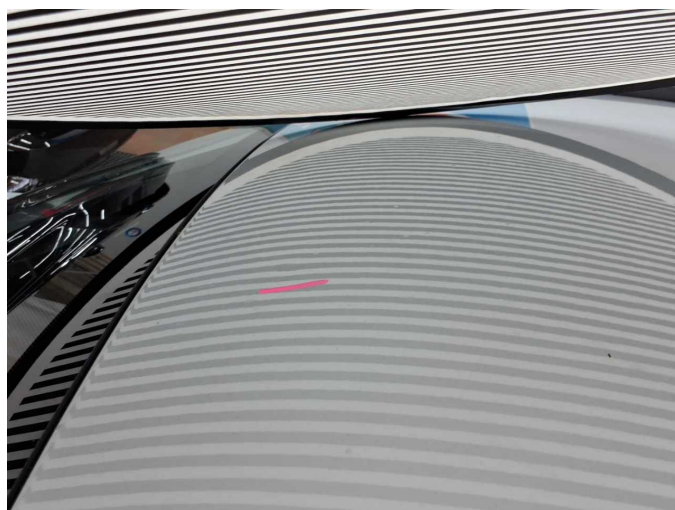
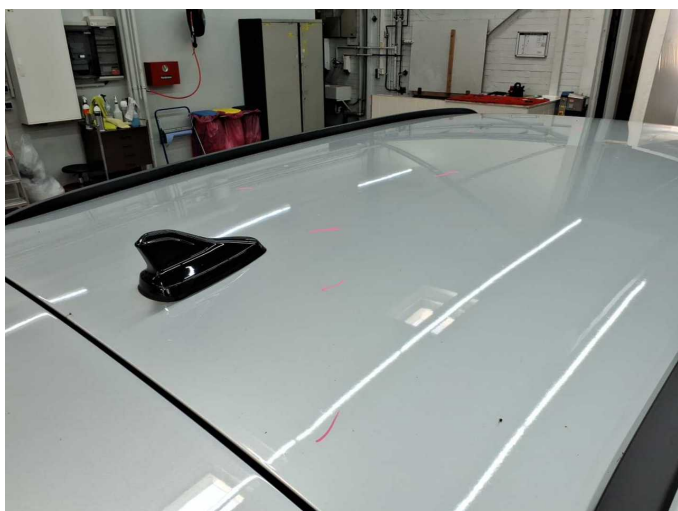
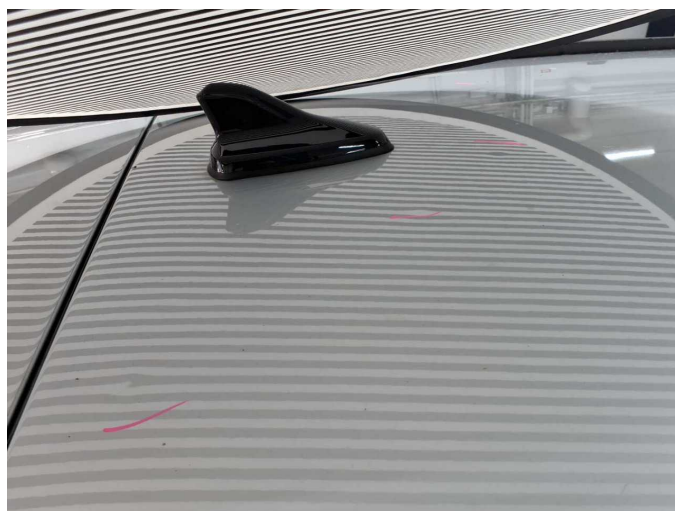
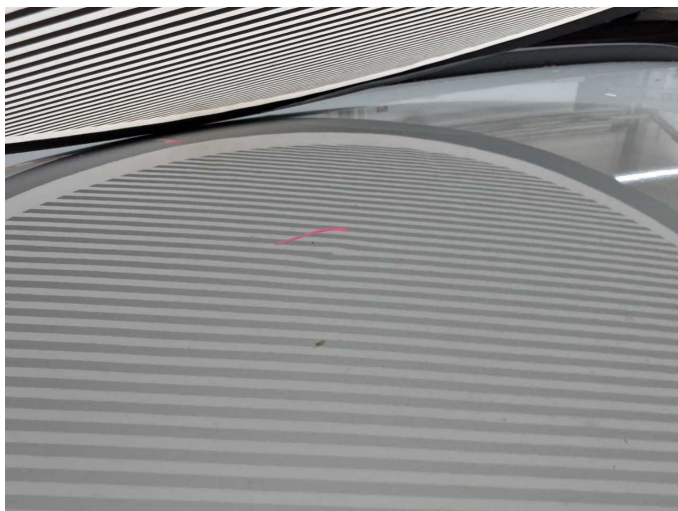
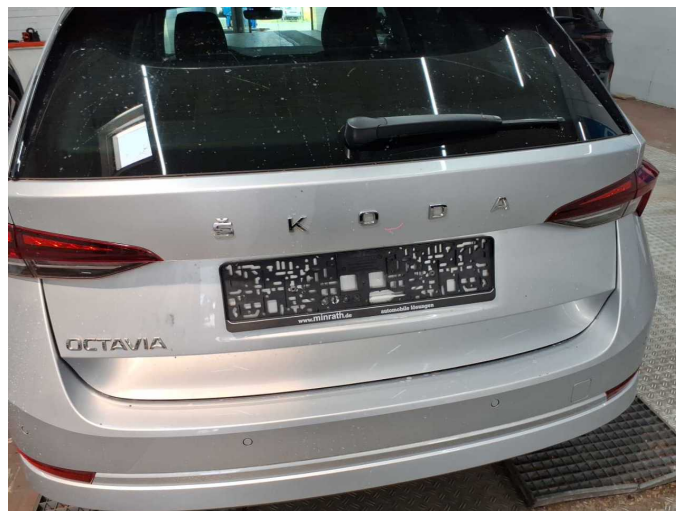
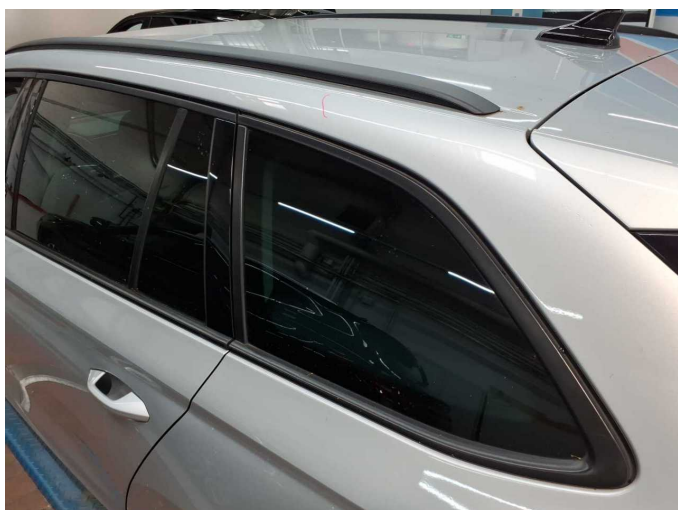
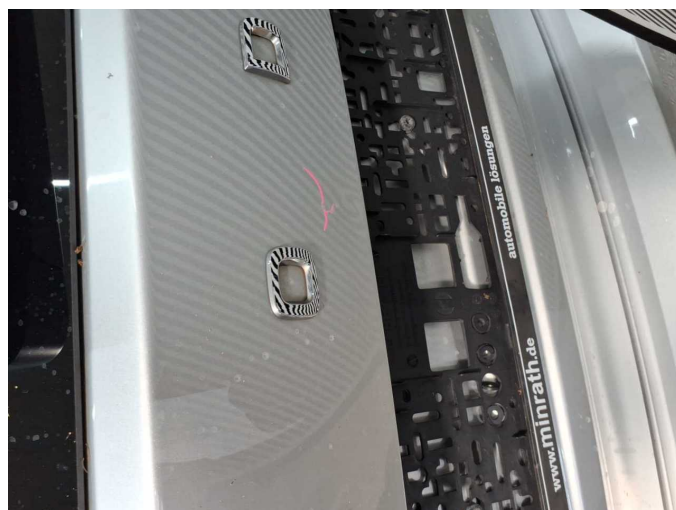
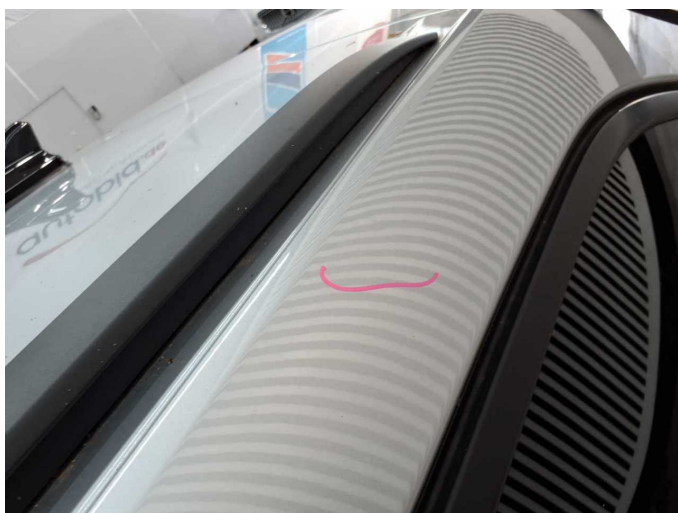
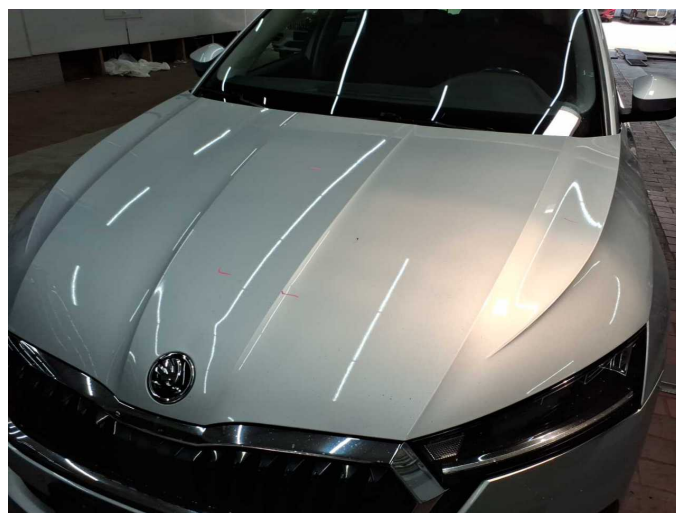
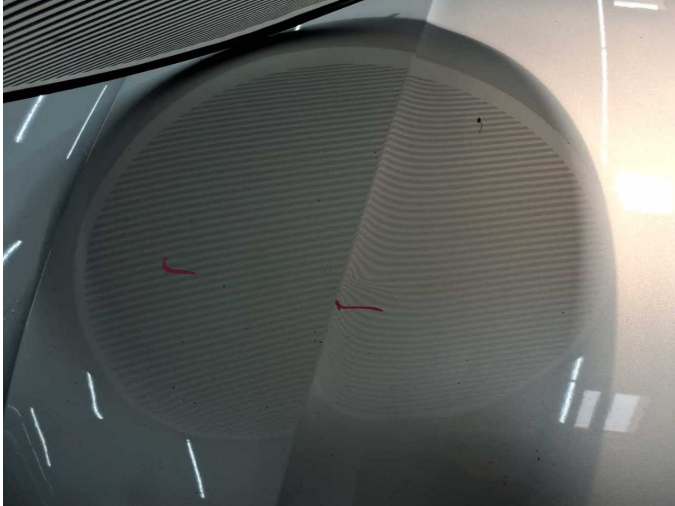
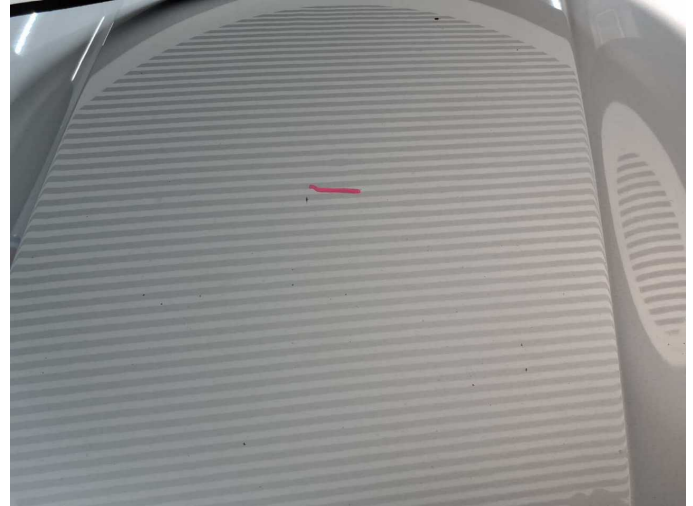
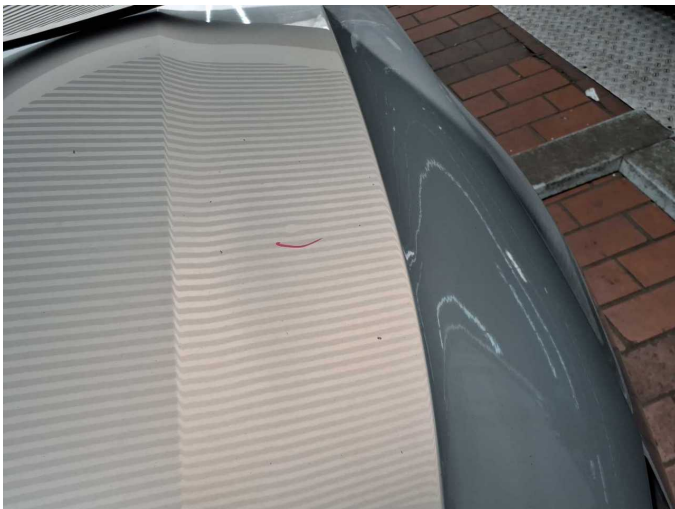
| No. | Component group | Description |
|---|---|---|
| 4 | Body | Body - Damage by hail - Smooth repair work |

**Damage 4:** Body: Body - Damage by hail - Smooth repair work

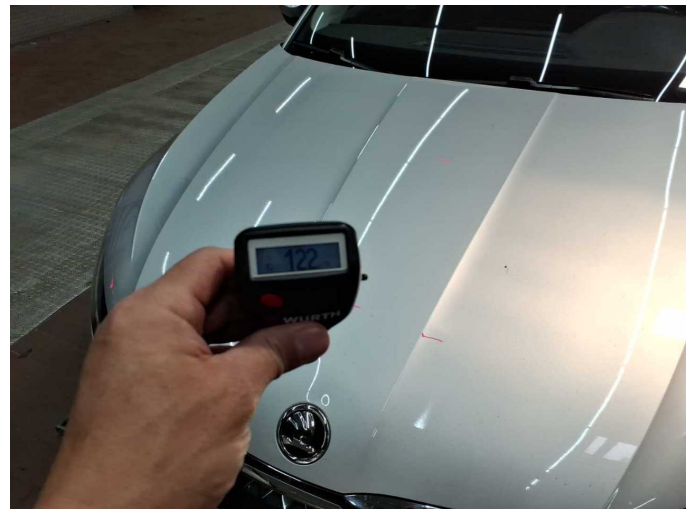
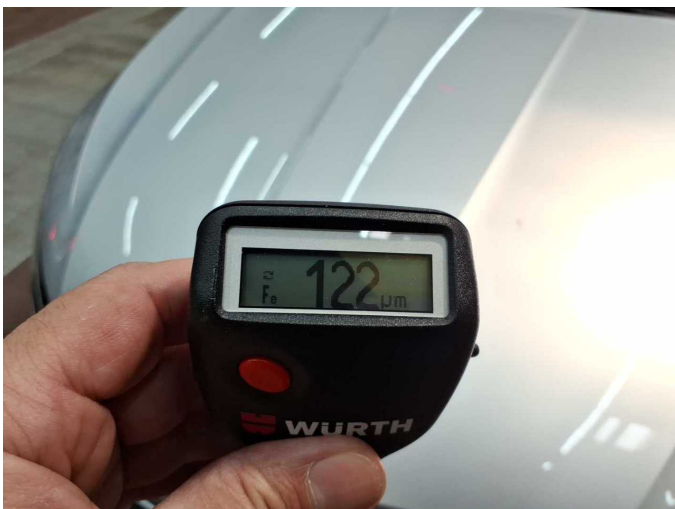
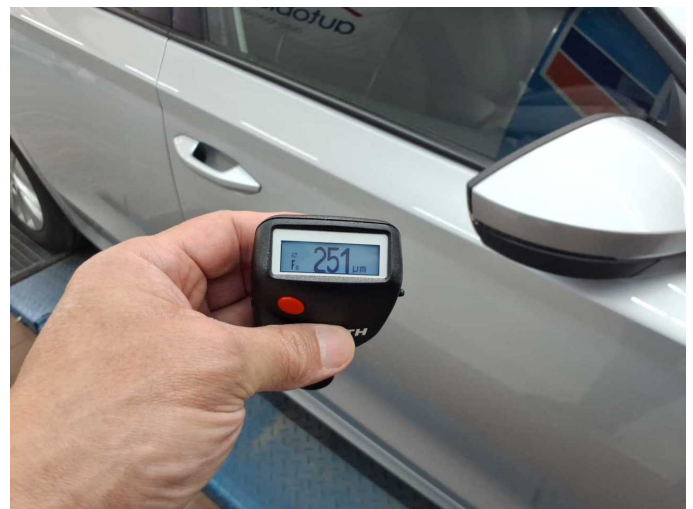
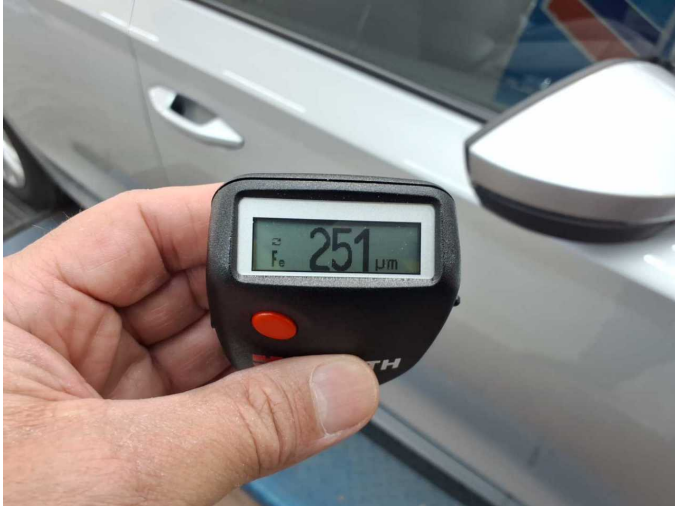
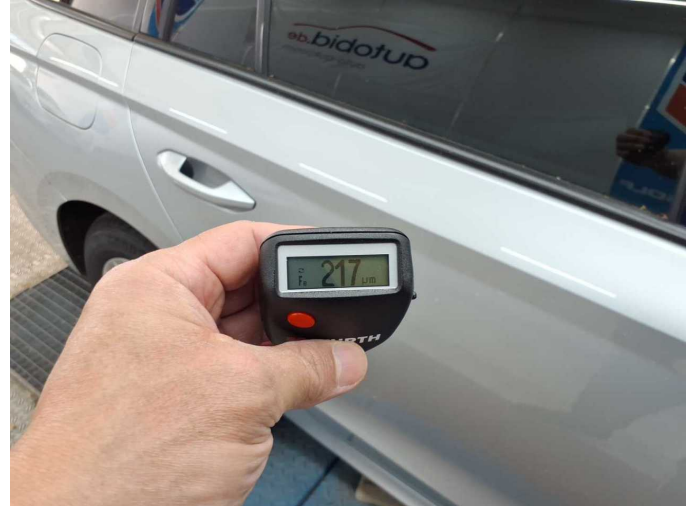
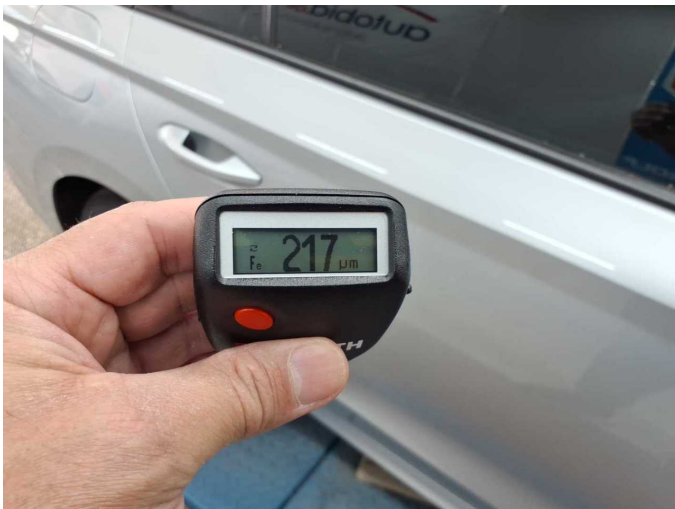
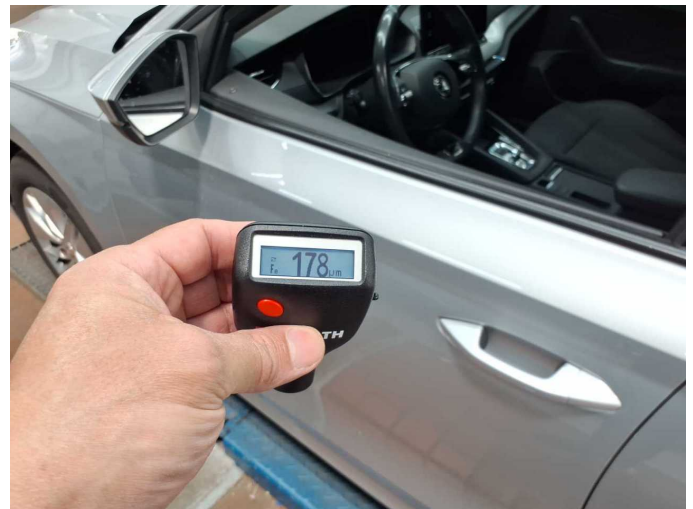
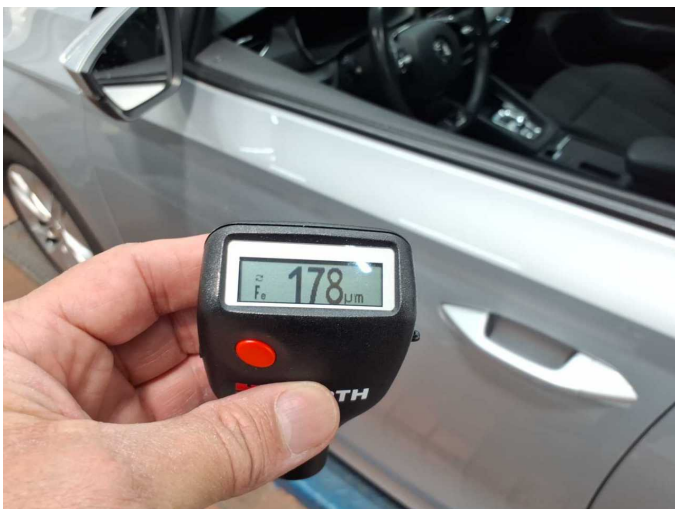
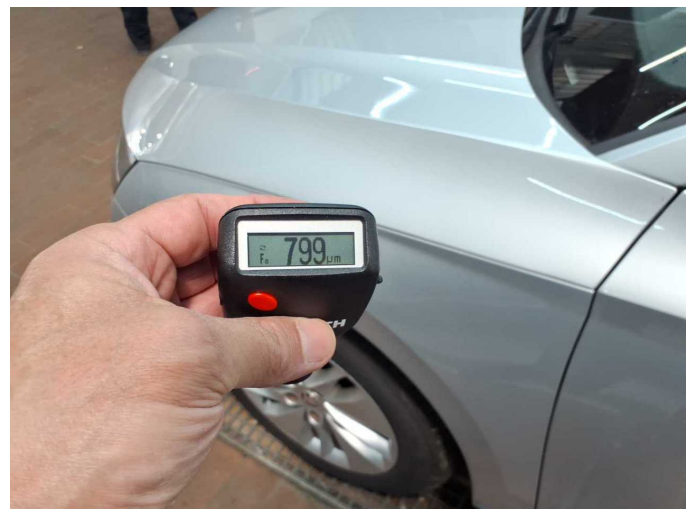
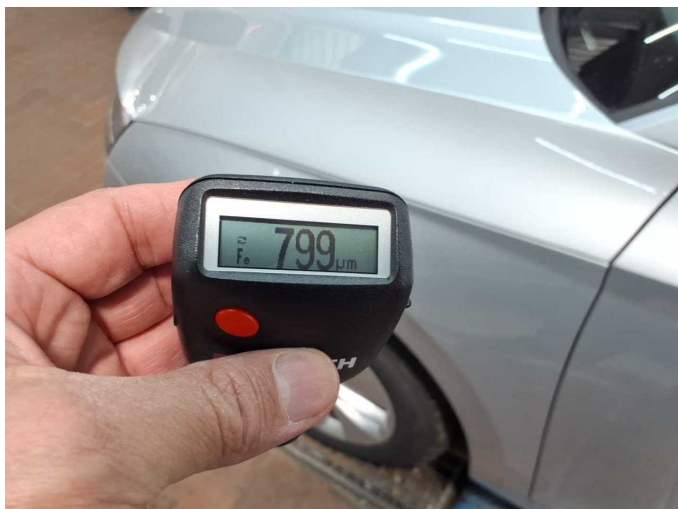
| No. | Repainting |
|---|---|
| 1 | Mudguard - left side, Bonnet, Door - rear right side, Door - front left side, Door - front right side, Professionally carried out |

| Mudguard - left side | 799 µm | Bonnet | 122 µm |
| Door - rear right side | 217 µm | Door - front left side | 178 µm |
| Door - front right side | 251 µm | | |

**Repainting 1:** Mudguard - left side, Bonnet, Door - rear right side, Door - front left side, Door - front right side
