Expertise

Protocol number: 45795870
Order No. / Reference: 26244060
Inspection date: 22 May 2026

Manufacturer: Volkswagen

Model: Golf Variant 2.0 TDI SCR Life

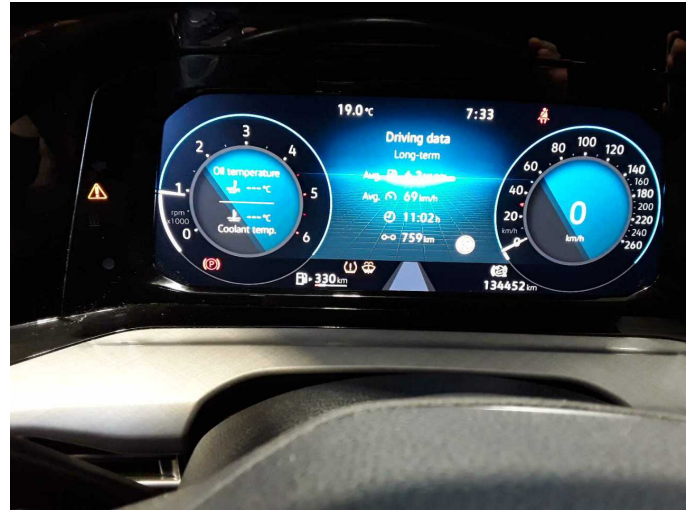
Damage 2: Instrument panel: Indicator light (Reifendruck) - on - Perform diagnosis

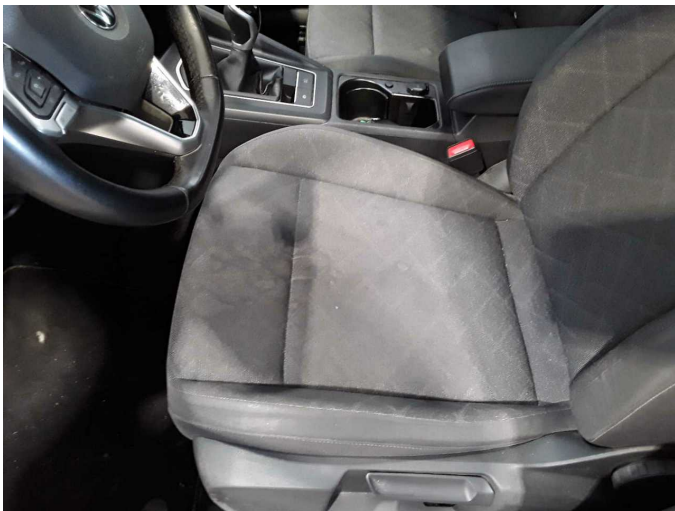
Damage 3: Seat - front: Seat cover - left side - Soiled - Clean

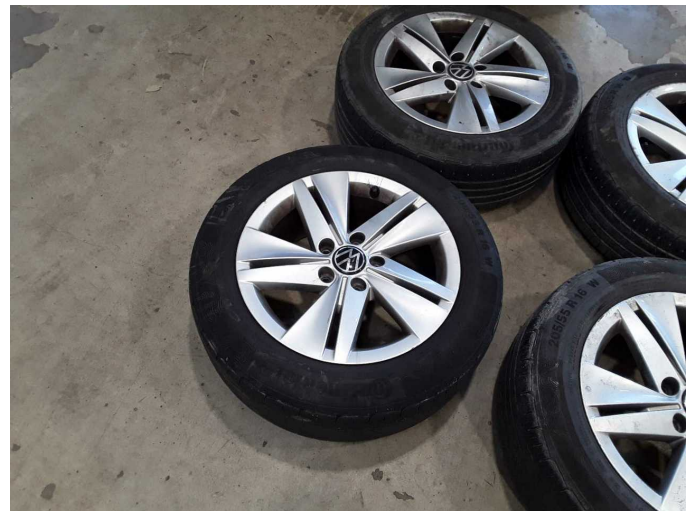
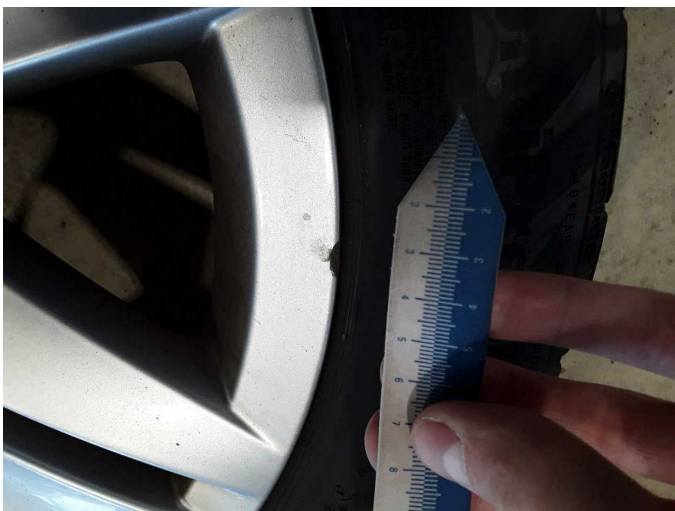
Damage 4: 2nd wheel set: 1 alloy rim - Scratch(es) - Loss in value

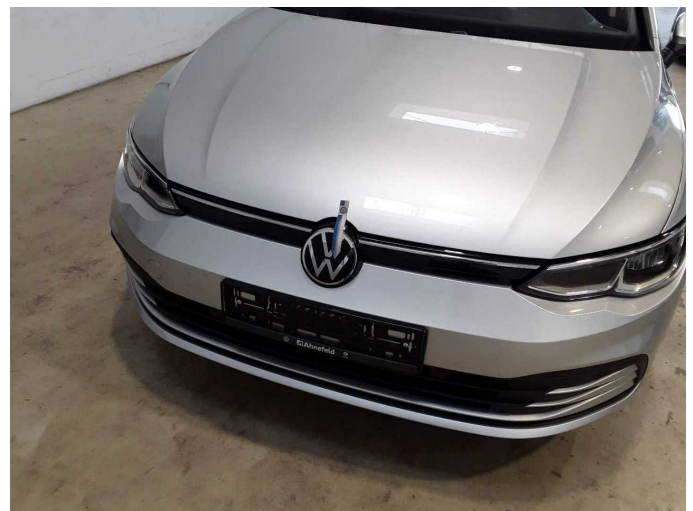
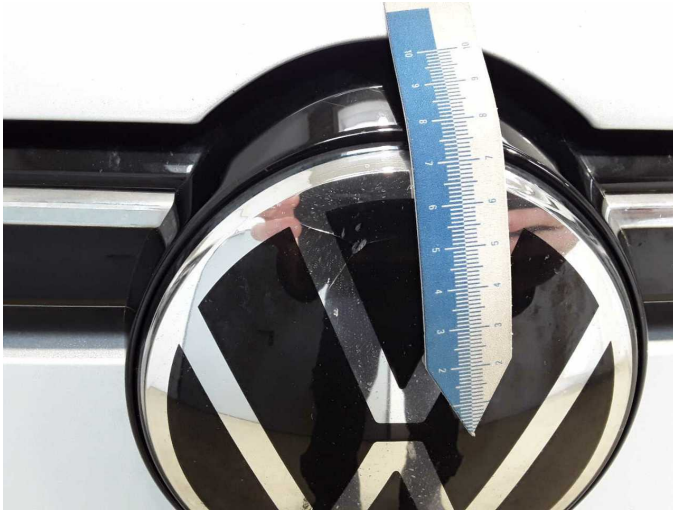
Damage 5: Front structure: Emblem - Broken / torn - Replace

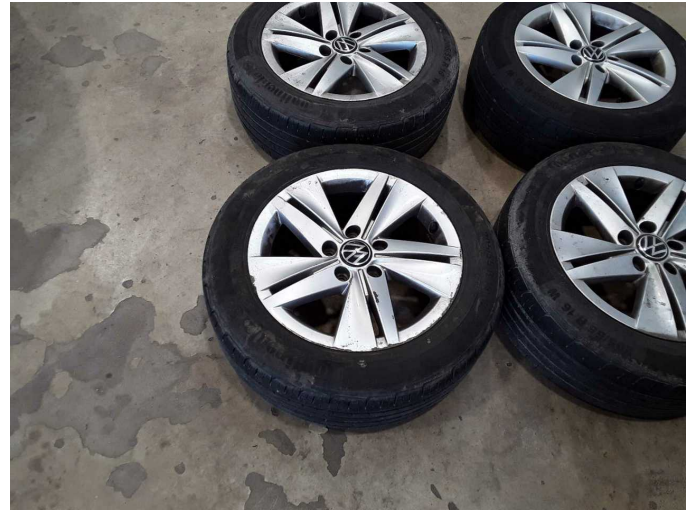
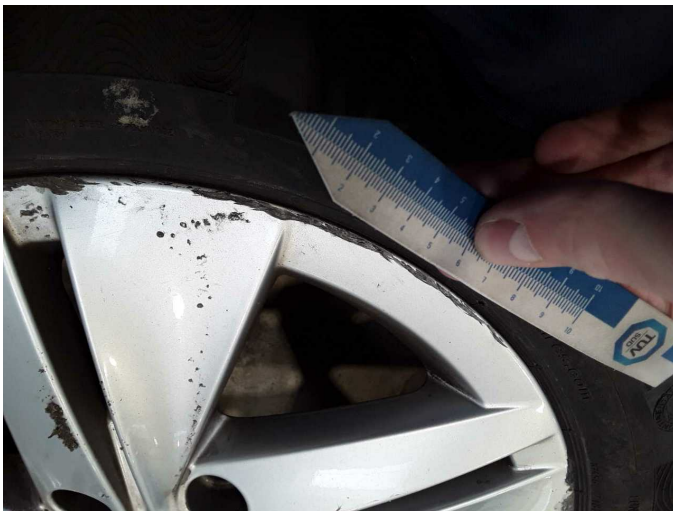
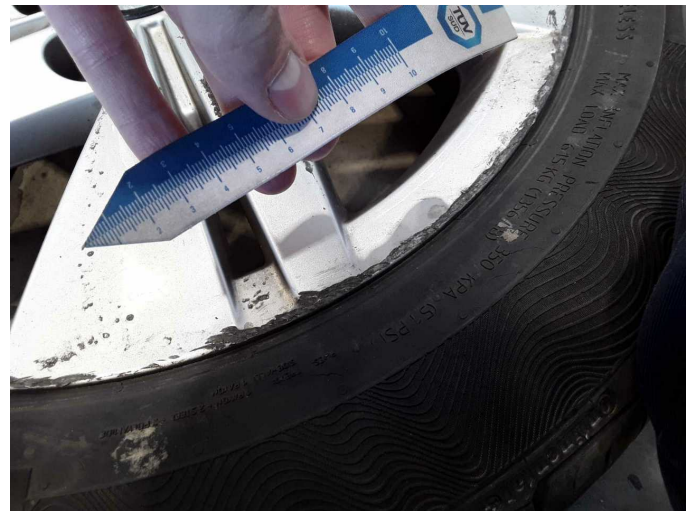
Damage 6: 2nd wheel set: 1 alloy rim - Scratch(es) - Replace

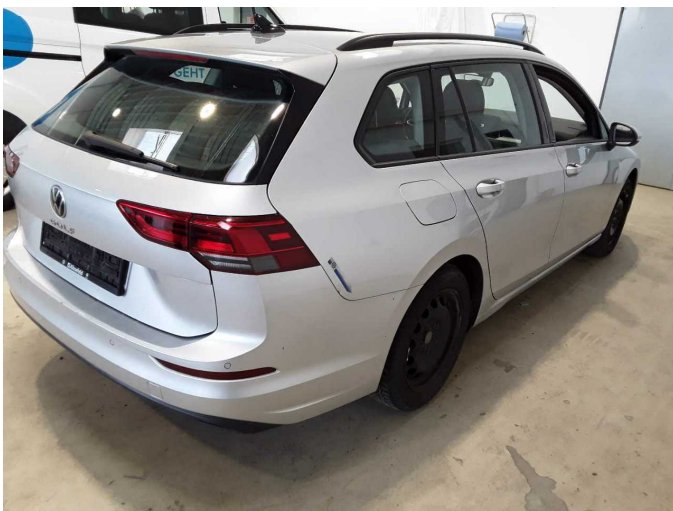
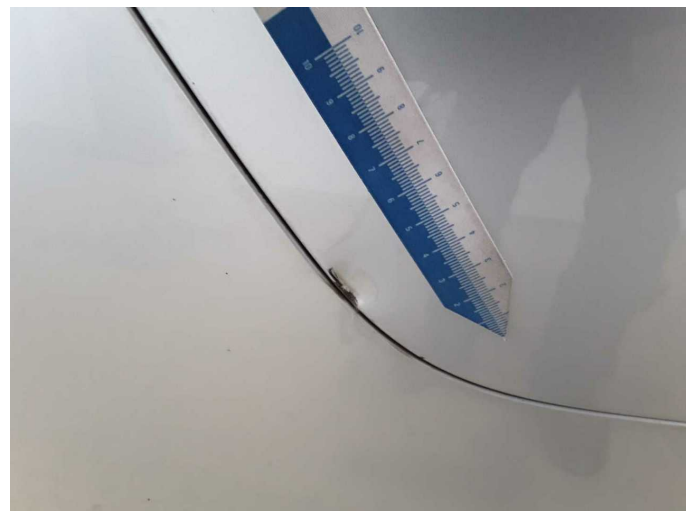
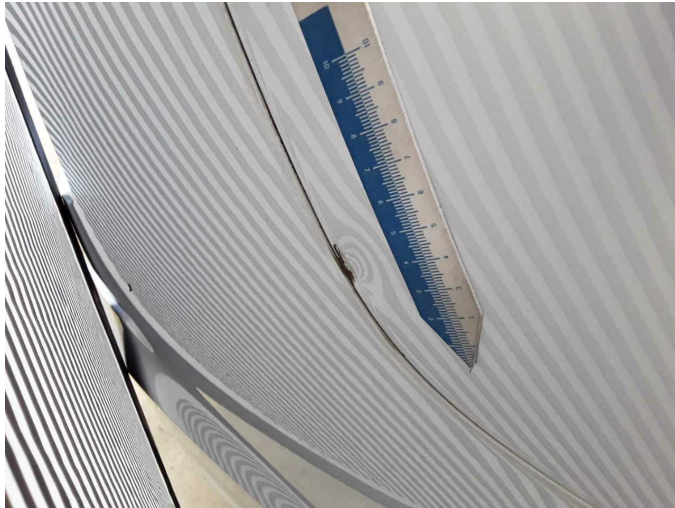
Damage 7: Side panel - rear right side: Side panel - Dent / paintcoat damage - Repair and paint

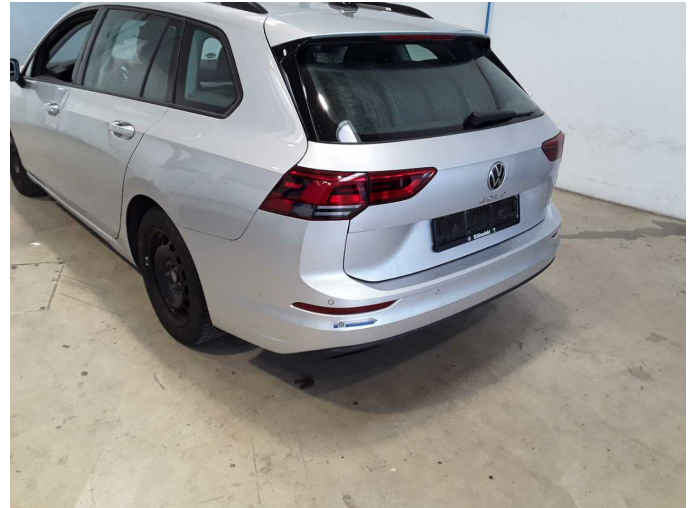
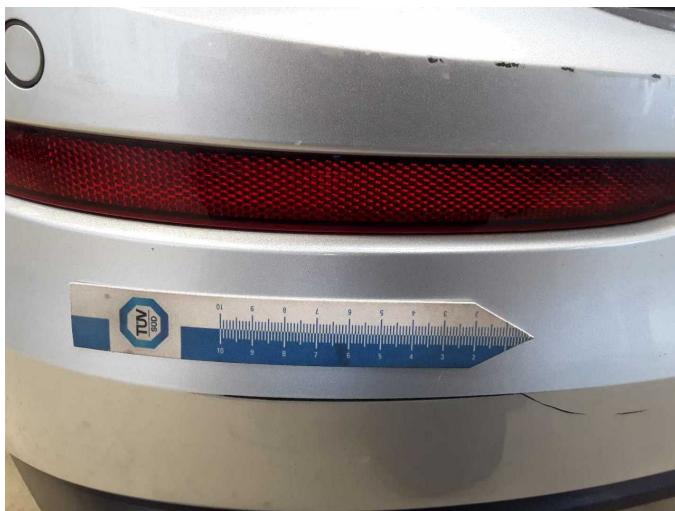
Damage 8: Rear bumper: Rear bumper - Scratch(es) - Paint

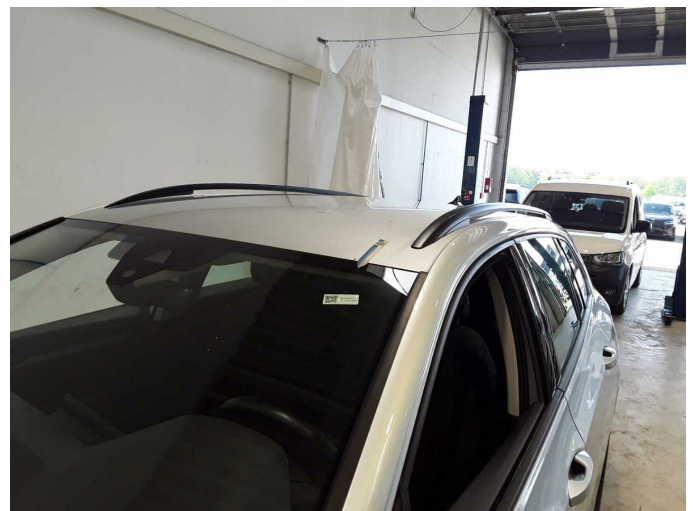
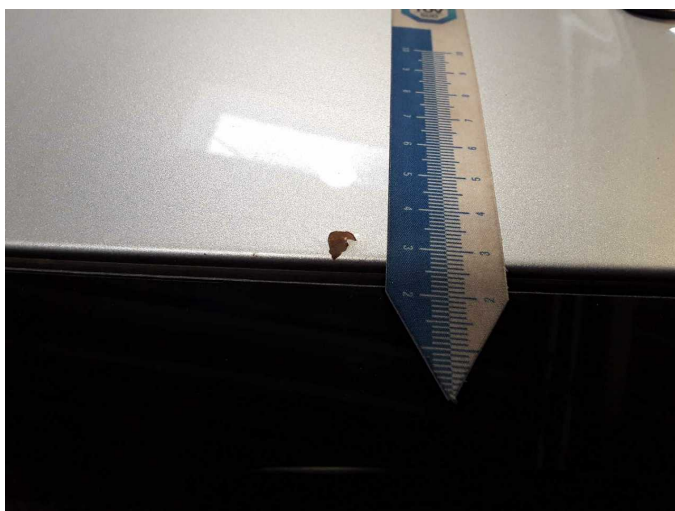
Damage 9: Roof: Roof - Corrosion - Repair and paint

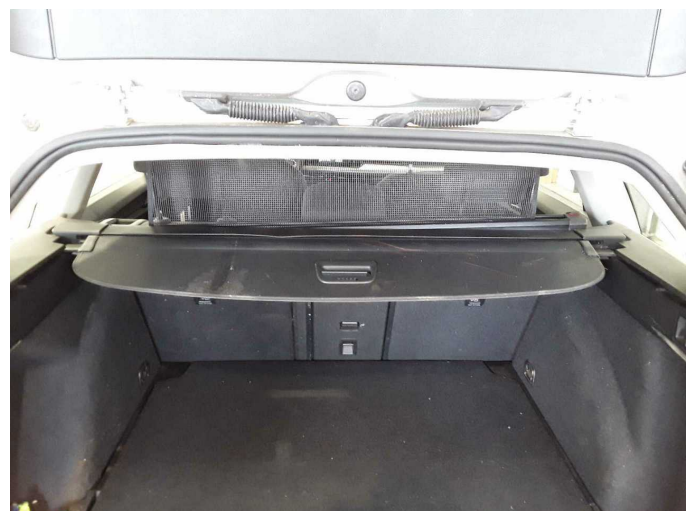
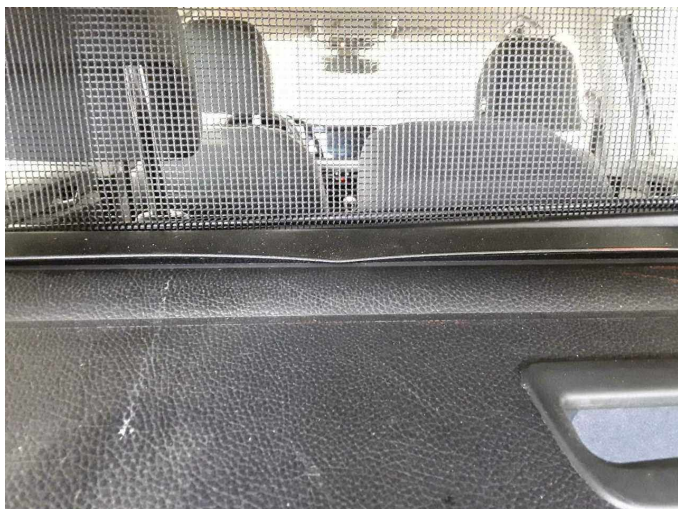
Wear and tear 1: Interior: Boot cover / roller cover - Deformed - No deduction
