Expertise

Protocol number: 46696969  
Order No. / Reference: 26687618  
Inspection date: 24 Jul 2026

| Manufacturer: Opel | Model: Astra 1.5 D Start/Stop Sports Tourer Automatik Edition |
| VIN: W0VBD8EV2N8043186 | |

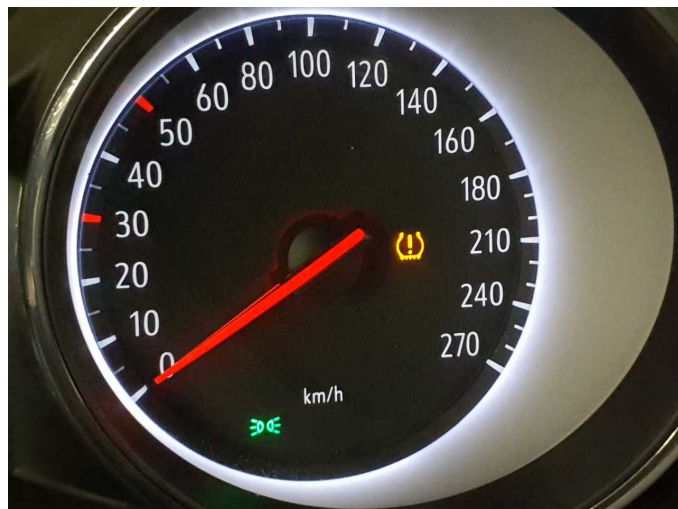
| No. | Component group | Description |
|---|---|---|
| 1 | Instrument panel | Indicator light (Reifendruckkontrolle) - on - Perform diagnosis |

**Damage 1:** Instrument panel: Indicator light (Reifendruckkontrolle) - on - Perform diagnosis

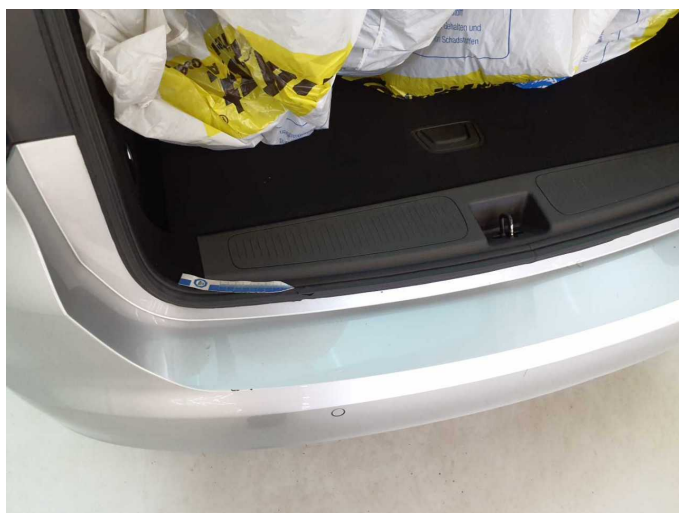
| No. | Component group | Description |
|---|---|---|
| 2 | Boot lid / rear door | Seal - Broken / torn - Replace |

**Damage 2:** Boot lid / rear door: Seal - Broken / torn - Replace

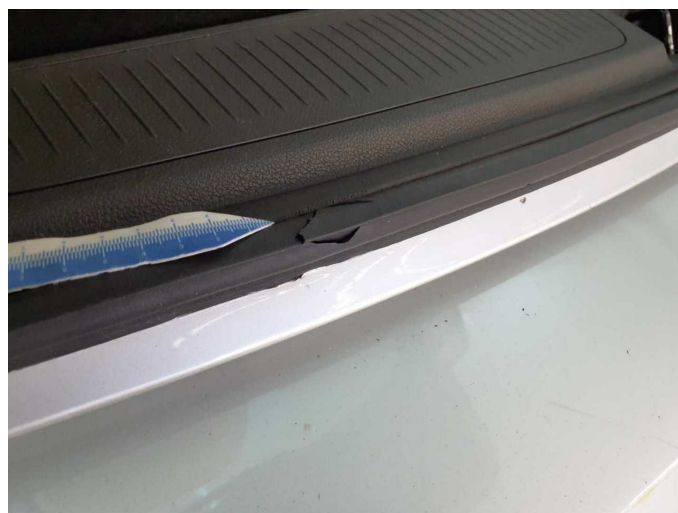
**Damage 2:** Boot lid / rear door: Seal - Broken / torn - Replace

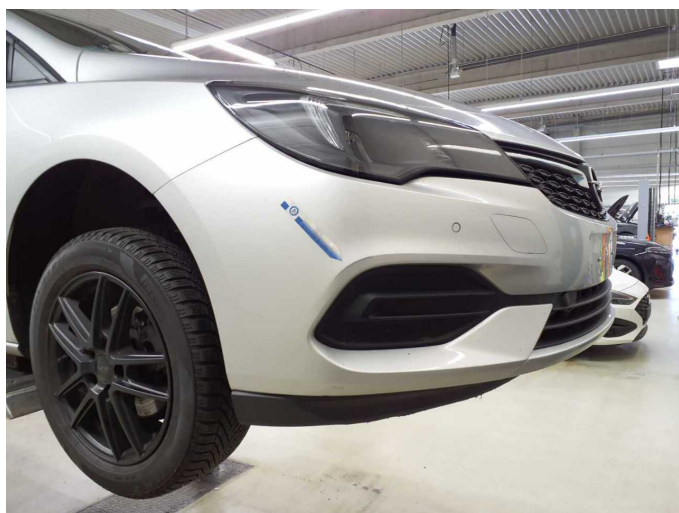
| No. | Component group | Description |
|---|---|---|
| 3 | Front bumper | Bumper with Parktronic - Scratched - Smart repair |

**Damage 3:** Front bumper: Bumper with Parktronic - Scratched - Smart repair

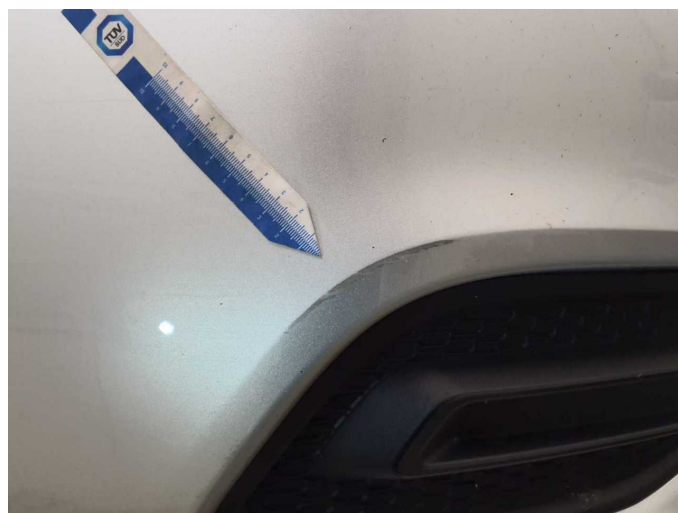
**Damage 3:** Front bumper: Bumper with Parktronic - Scratched - Smart repair

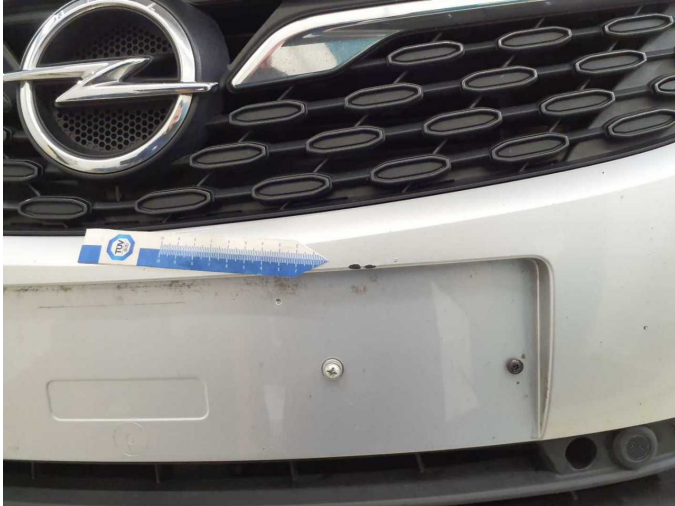
**Damage 3:** Front bumper: Bumper with Parktronic - Scratched - Smart repair

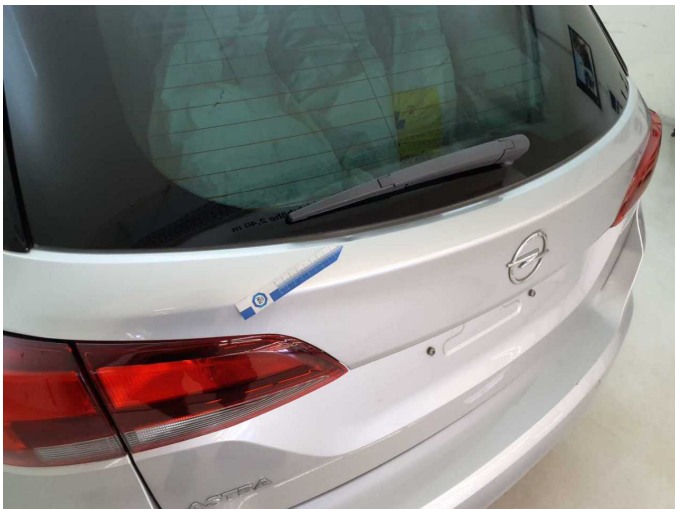
| No. | Component group | Description |
|---|---|---|
| 4 | Boot lid / rear door | Boot lid - dent(s) - Smart repair |

**Damage 4:** Boot lid / rear door: Boot lid - dent(s) - Smart repair

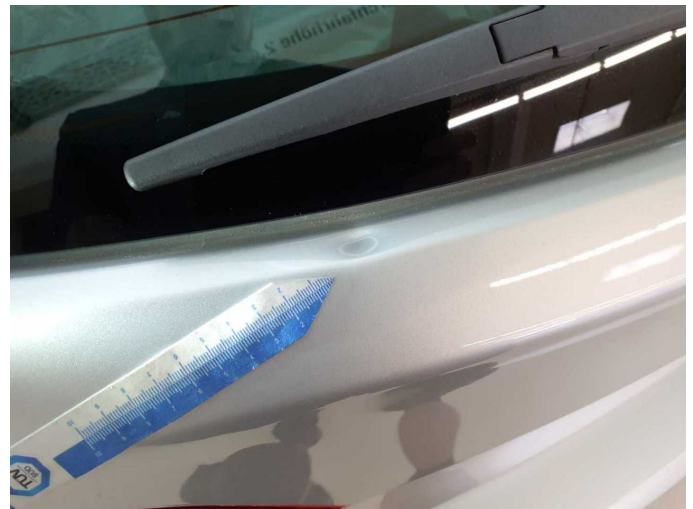
**Damage 4:** Boot lid / rear door: Boot lid - dent(s) - Smart repair

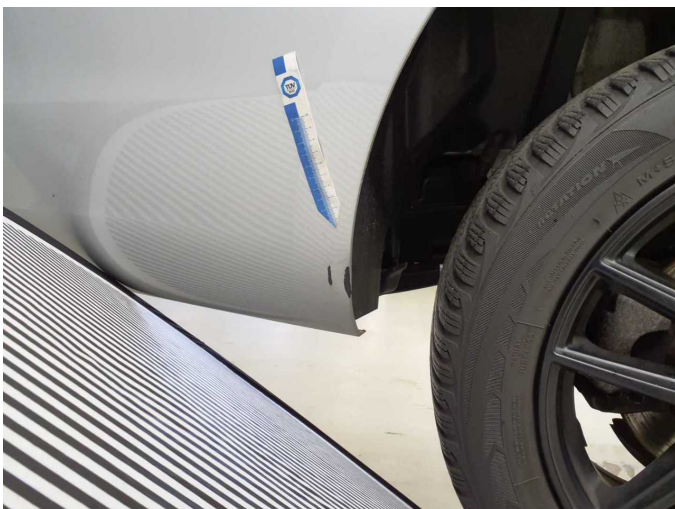
| No. | Component group | Description |
|---|---|---|
| 5 | Rear bumper | Bumper with Parktronic - Deformed - Repair and paint |

**Damage 5:** Rear bumper: Bumper with Parktronic - Deformed - Repair and paint

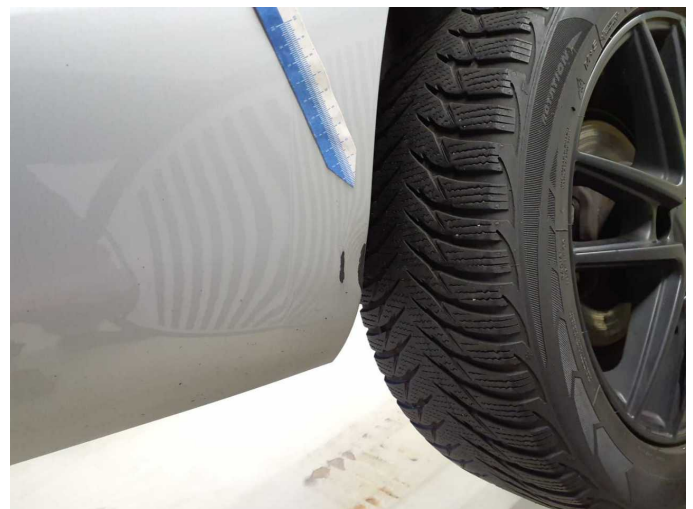
**Damage 5:** Rear bumper: Bumper with Parktronic - Deformed - Repair and paint

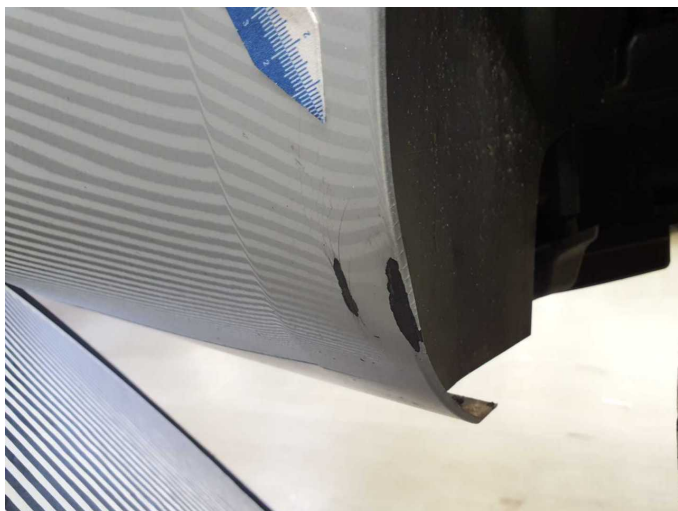
**Damage 5:** Rear bumper: Bumper with Parktronic - Deformed - Repair and paint

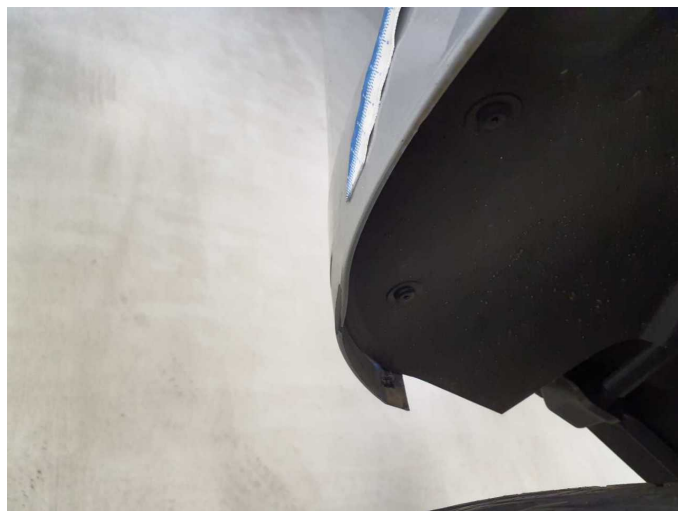
**Damage 5:** Rear bumper: Bumper with Parktronic - Deformed - Repair and paint
