Peugeot 308 SW '21

Vehicle information

Make:	Peugeot	License:	
Gearbox:	Automatic	Body color:	
Model:	308 SW '21	VIN:	VR3F4DGXTNY630695
Fuel type:	Petrol leaded	Power:	133 kW
Version:	308 SW PHEV 180 All.P.Bus.Aut	First registration	29/11/2022
Mileage:	120692 km	N° of doors:

Damage summary

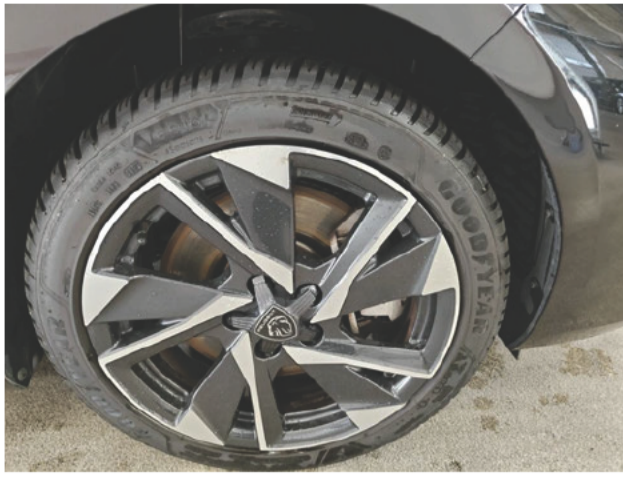
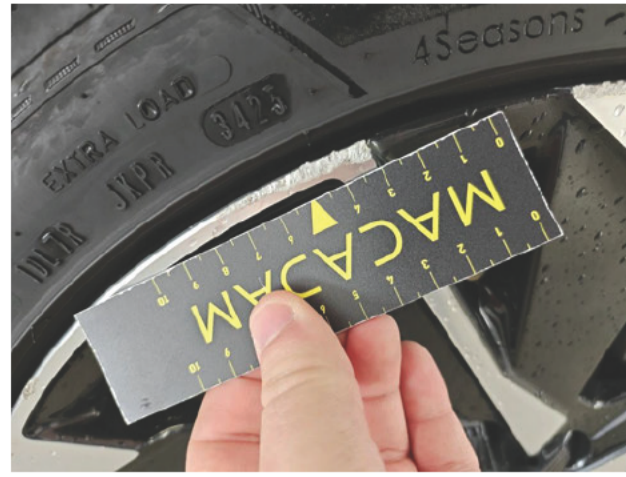
Alloy rim FR

Scratch(es)
Repair and paint (complete)
Right

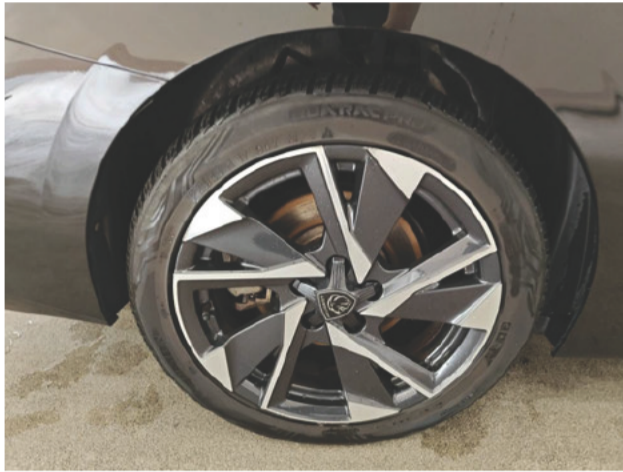
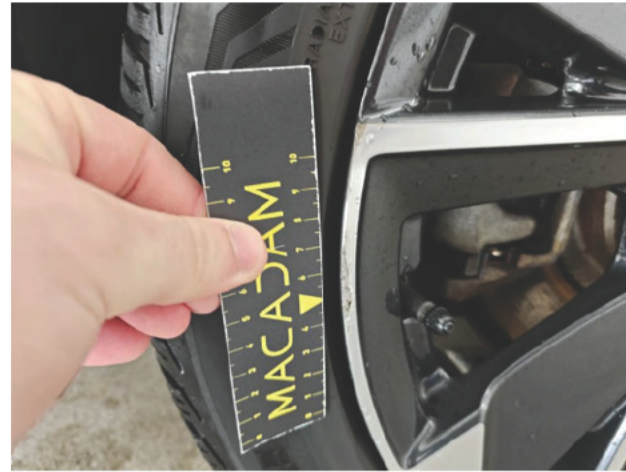
Alloy rim RR

Scratch(es)
Repair and paint (complete)
Right

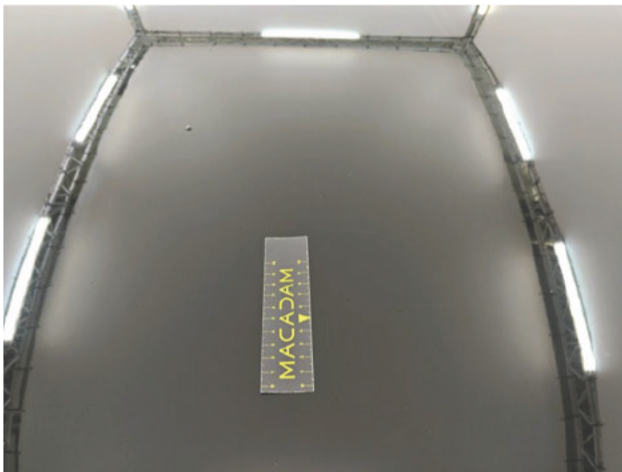
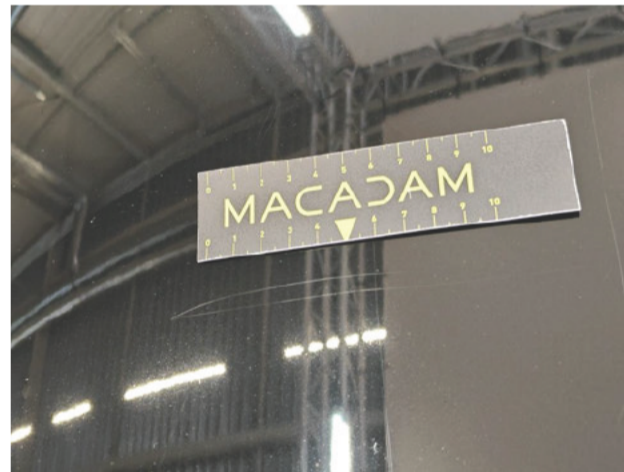
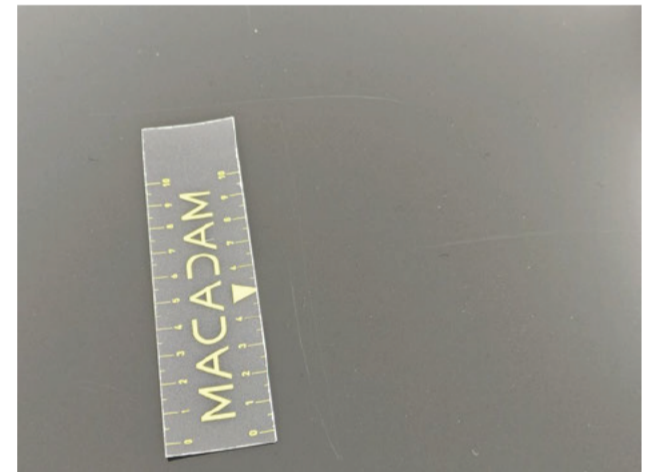
Bonnet

Scratch(es)
Repair and paint (complete)
Front

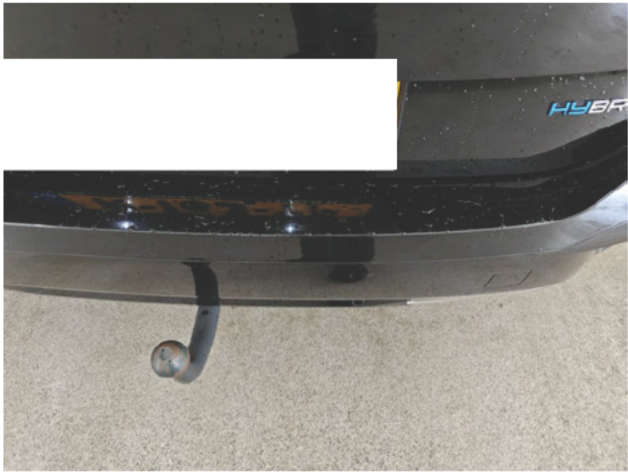
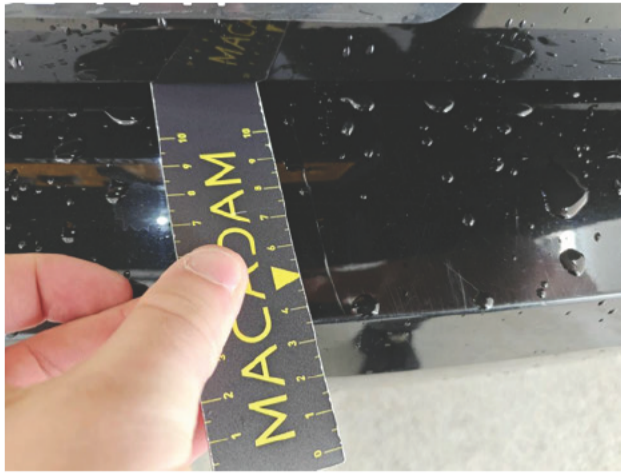
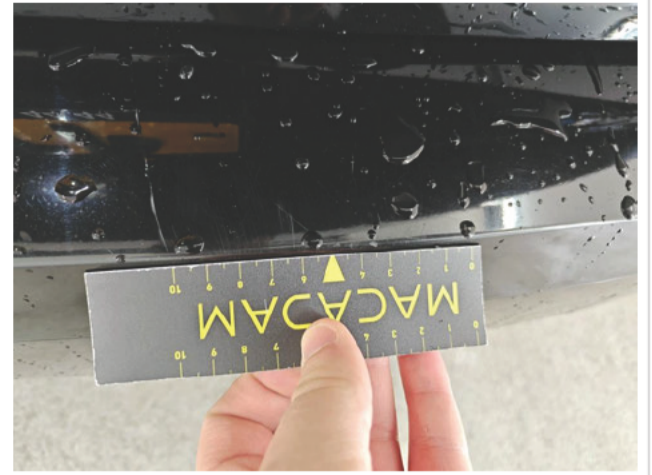
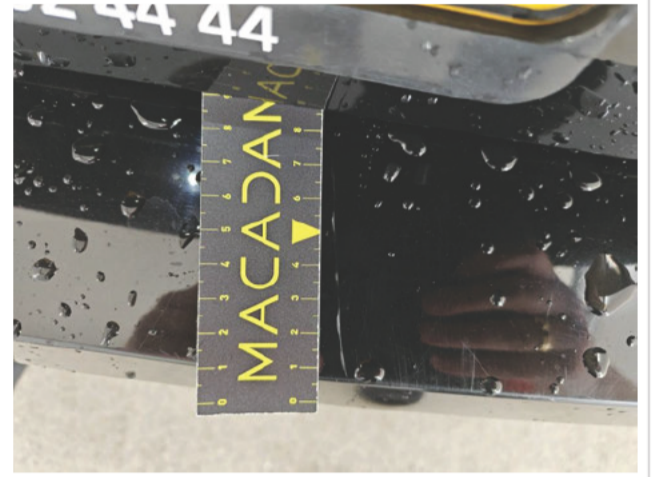
Bumper R

Scratch(es)

Repair and paint (complete)

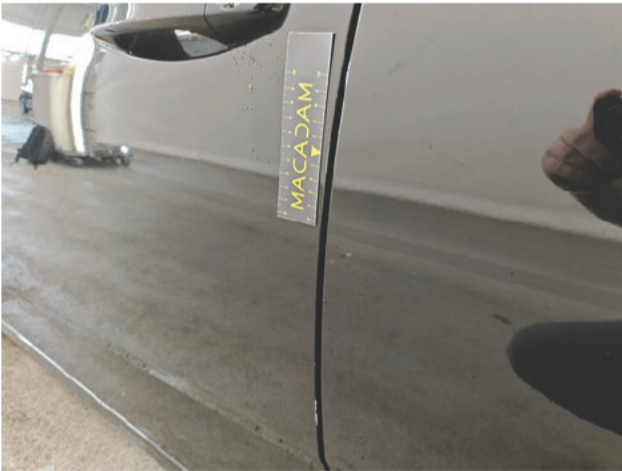
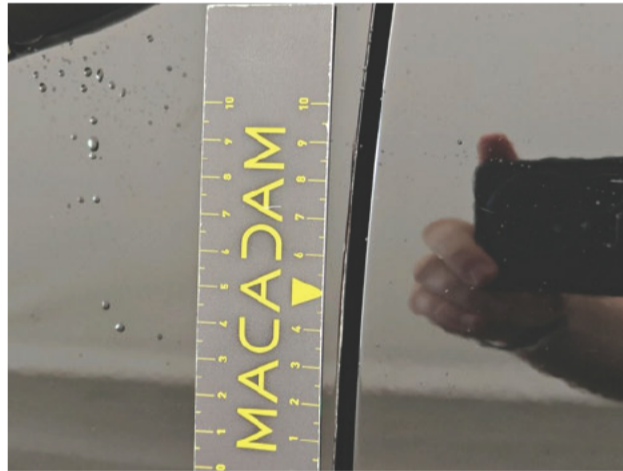
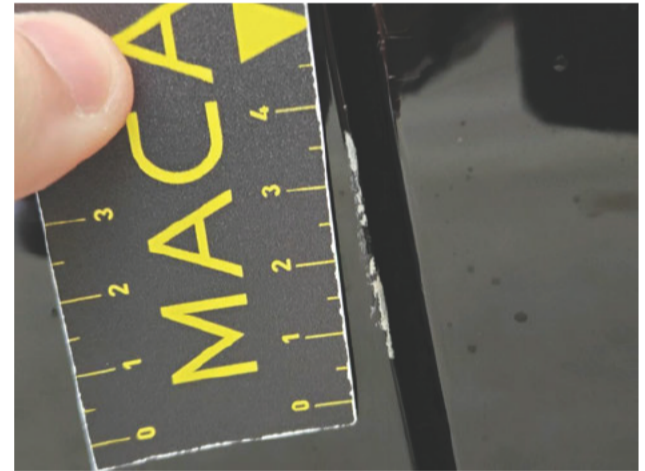
Door FL

Scratch(es)

Repair and paint (complete)

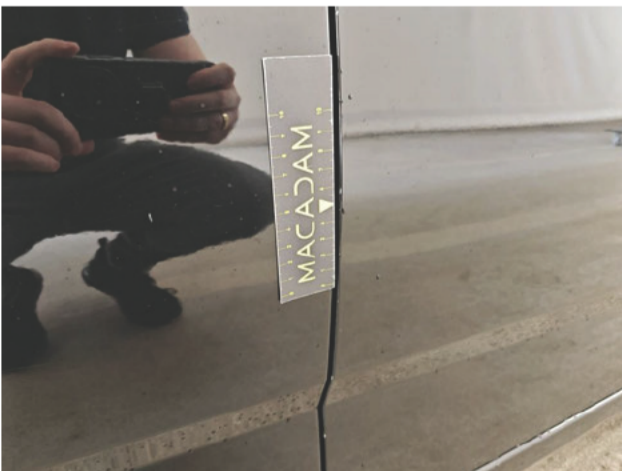
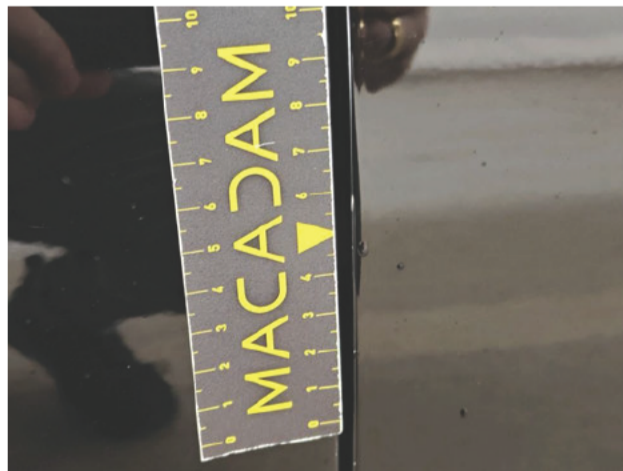
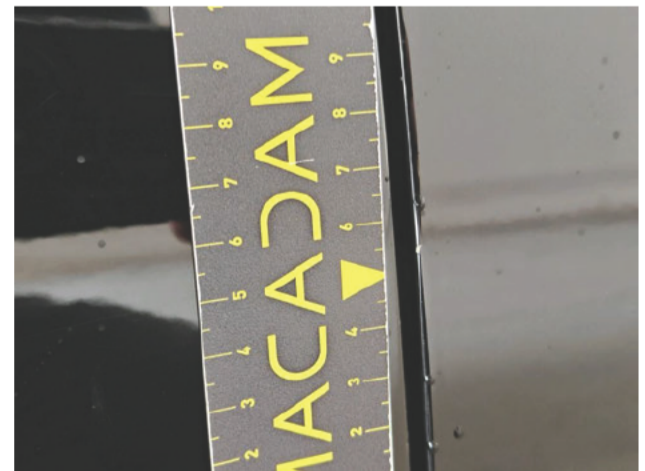
Door FR

Scratch(es)

Repair and paint (complete)

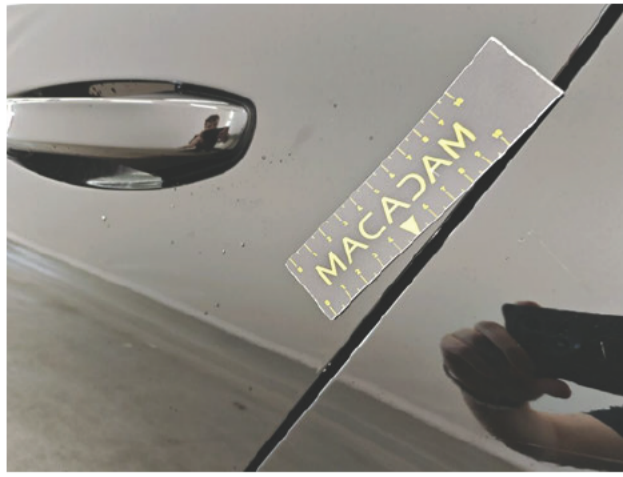
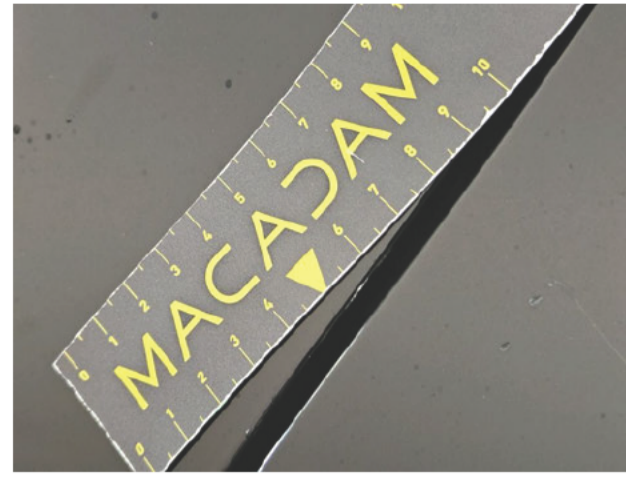
Door RL

Scratch(es)
Repair and paint (complete)
Left

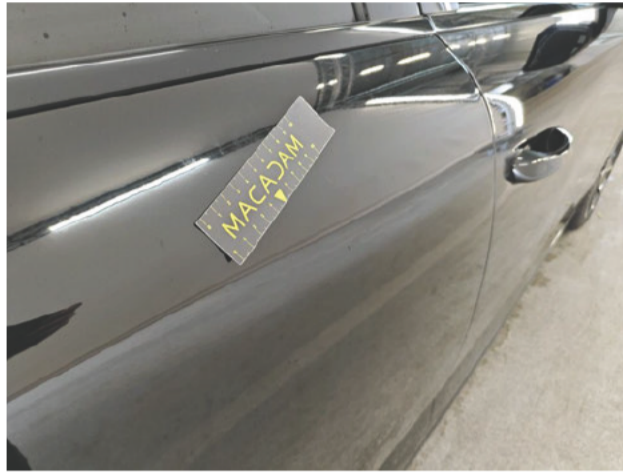
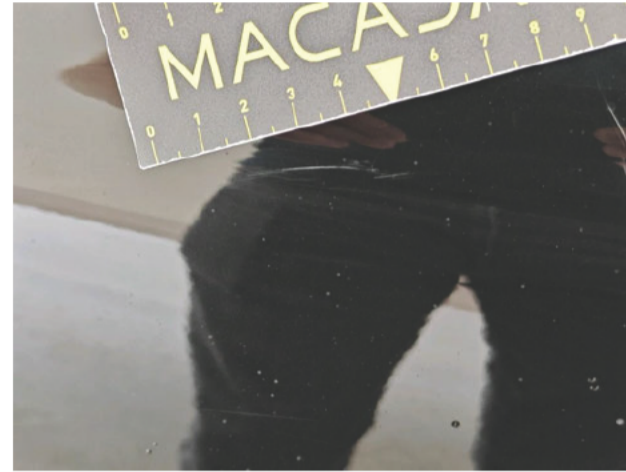
Door RR

Scratch(es)
Repair and paint (complete)
Right

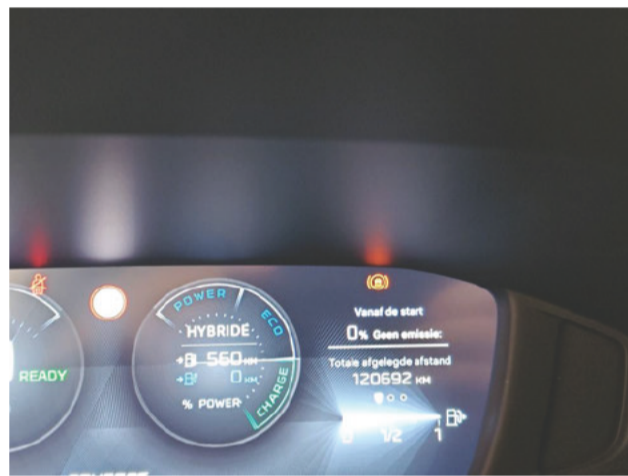
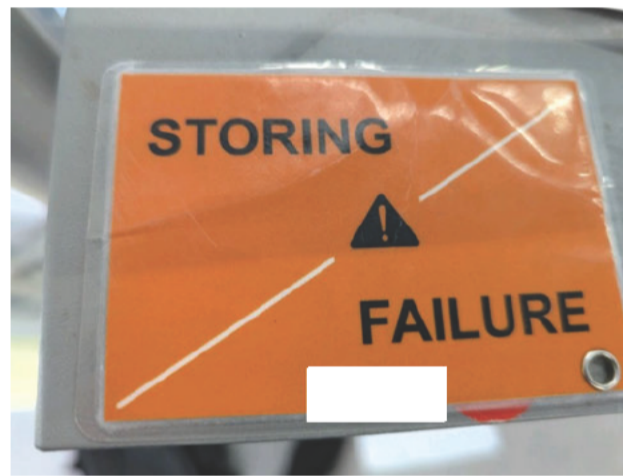
Malfunction

Not functioning (well)
Diagnosis
Interior

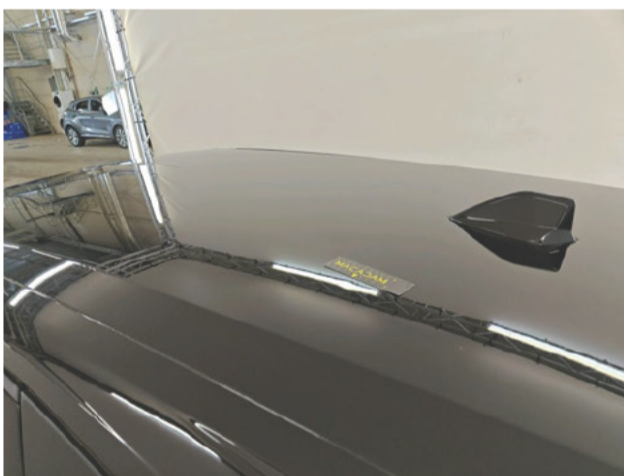
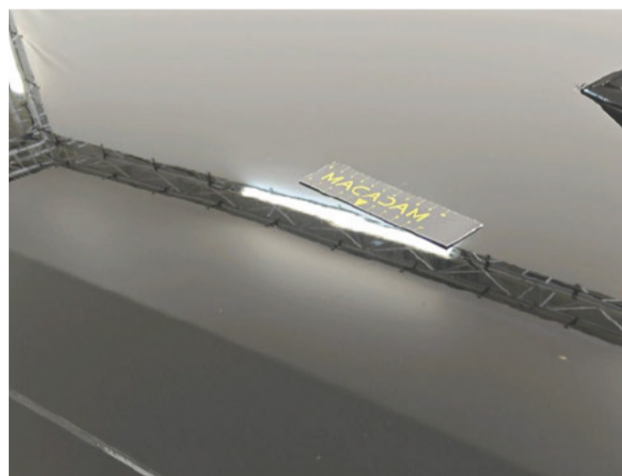
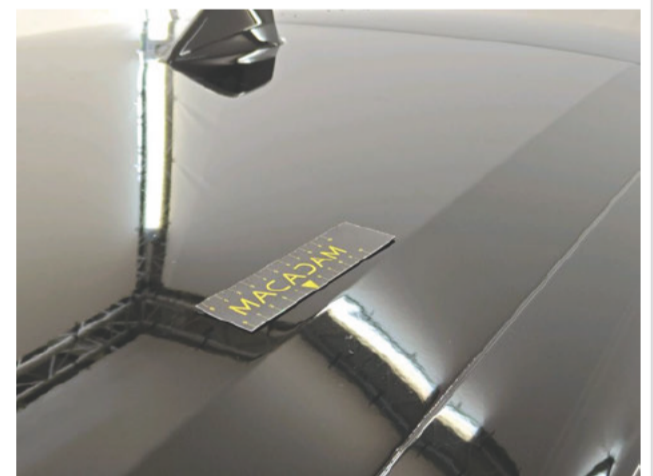
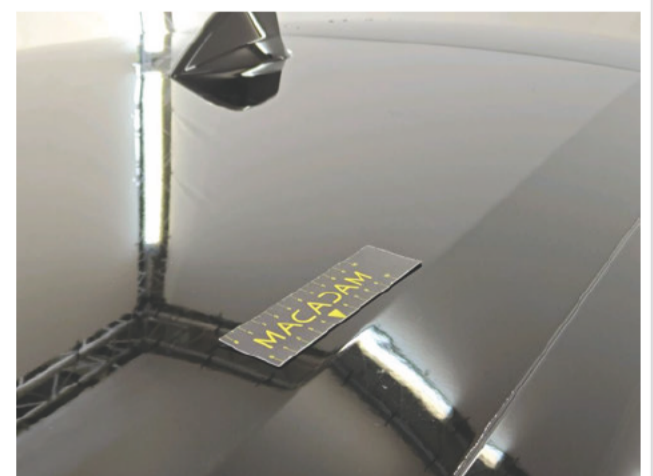
Dent(s)
Repair and paint (complete)
Roof & others

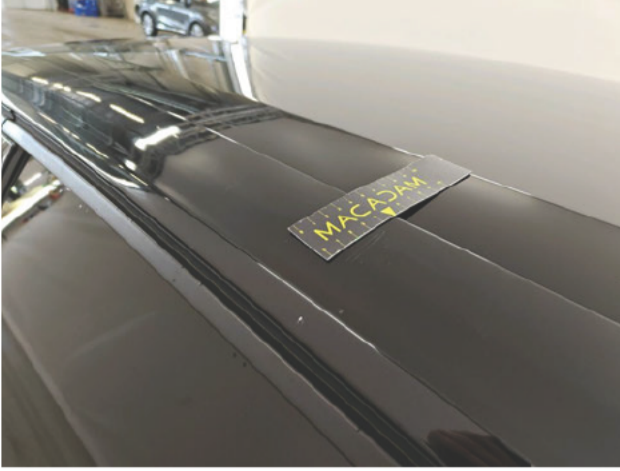
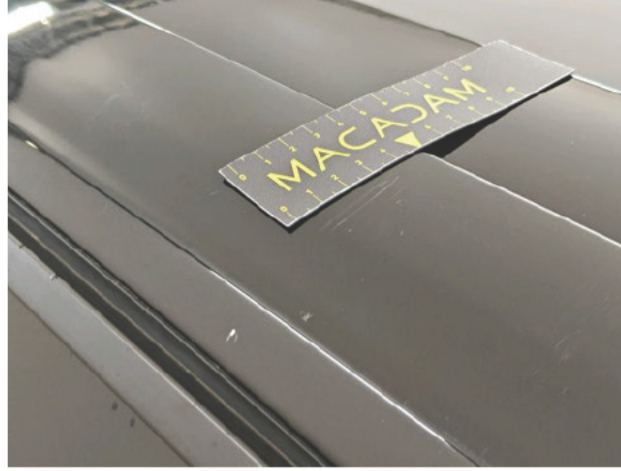
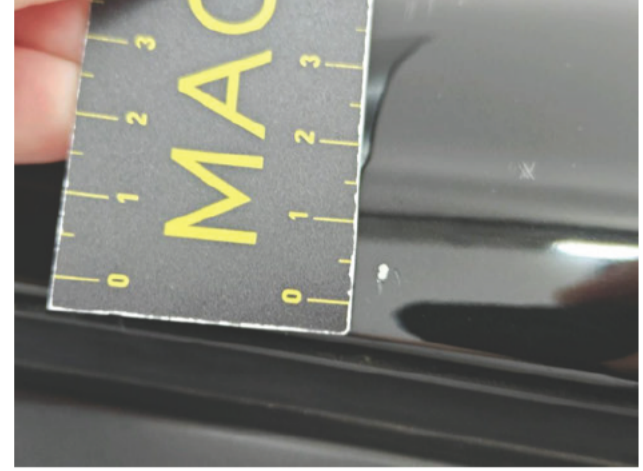
Roof pillar L

Scratch(es)

Repair and paint (complete)

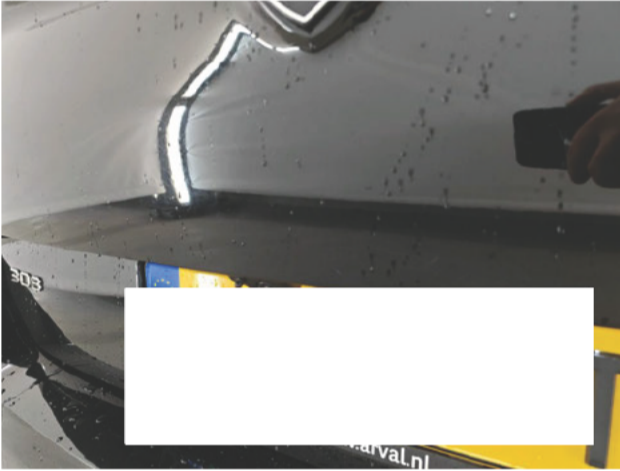
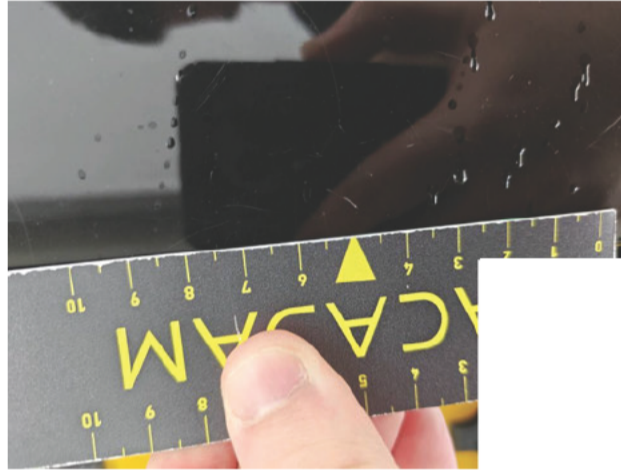
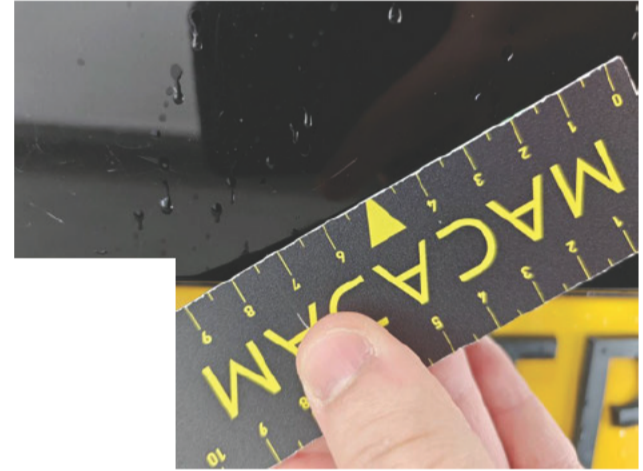
Tailgate / Boot

Scratch(es)

Repair and paint (complete)

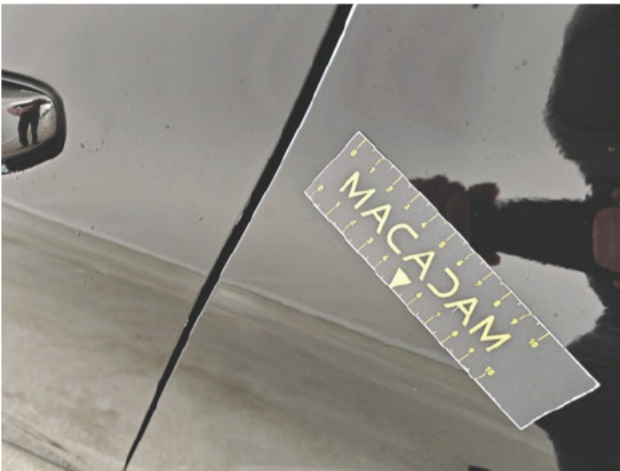
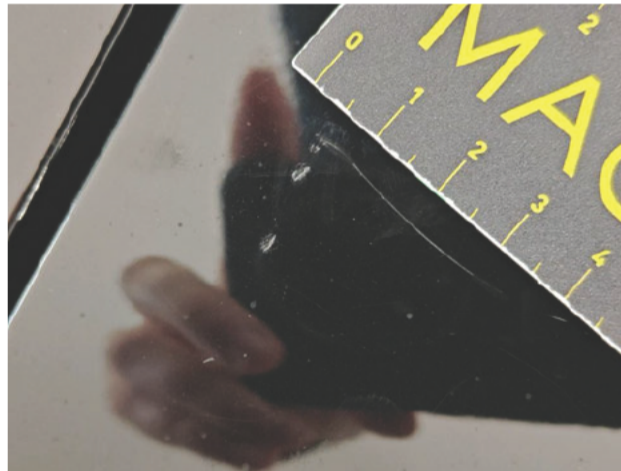
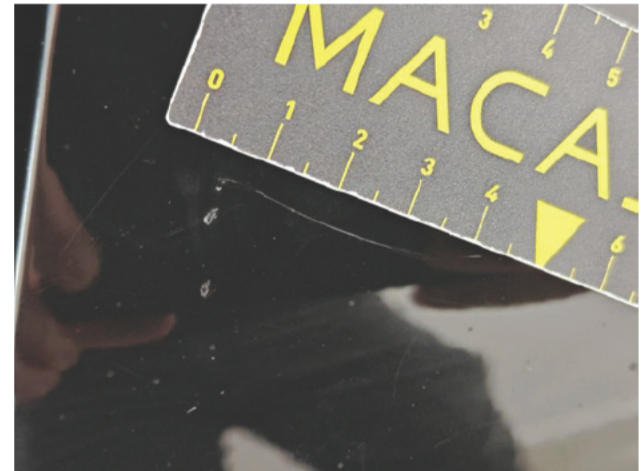
Wing RL

Bad repair

Repair and paint (complete)

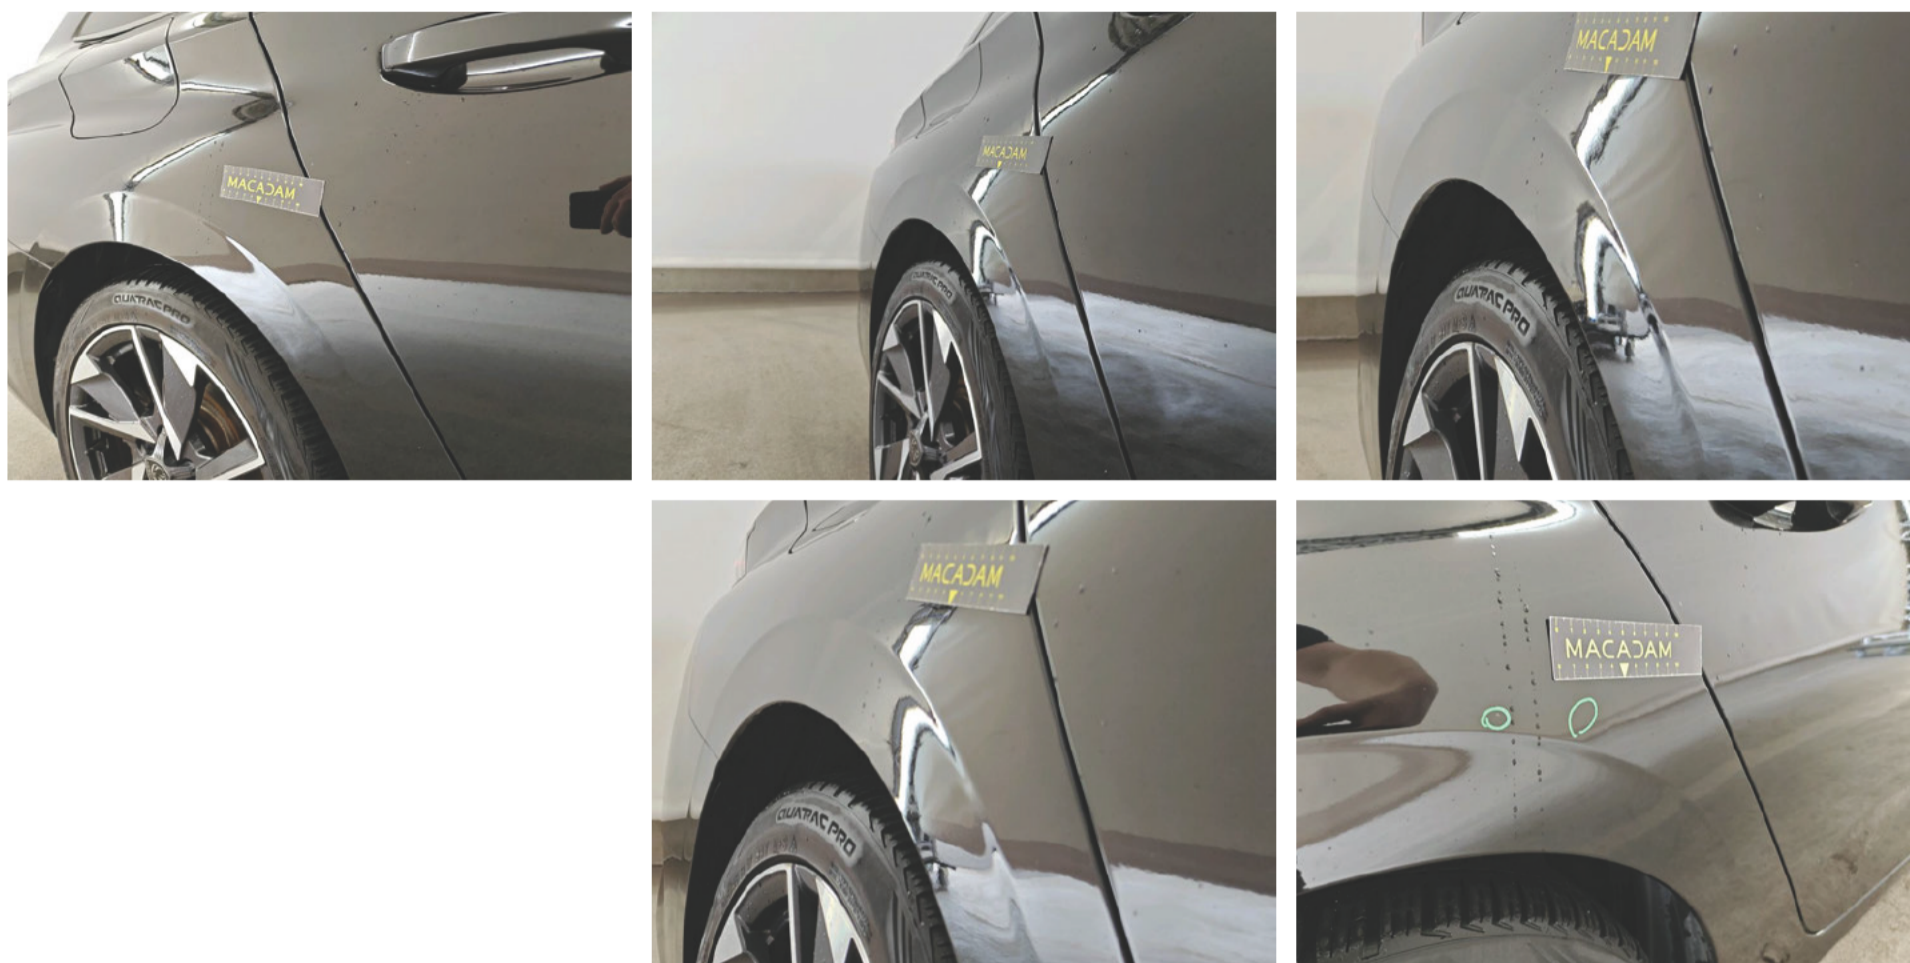
Wing RR

Dent(s)

Paintless dent repair
