## Expertise

Protocol number: 46128030  
Order No. / Reference: 26470192  
Inspection date: 23 Jun 2026

Model: Astra 1.5 D Automatik Elegance

An order was placed to prepare a sales report for the described vehicle. This report includes the following:

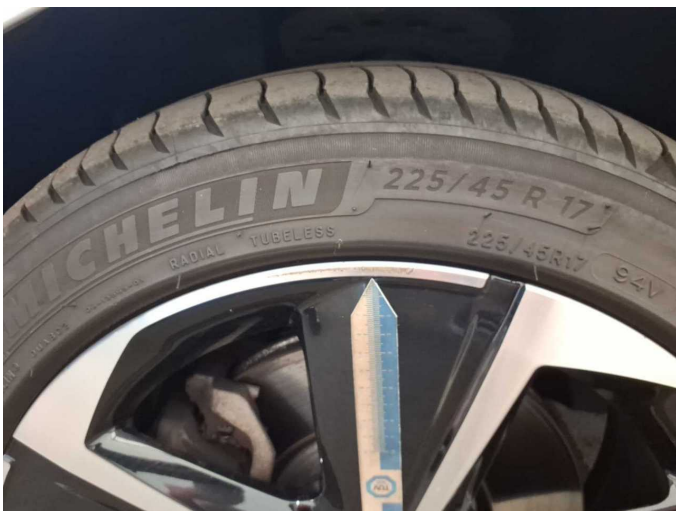
No.	Component group	Description
1	Wheel / tyres	Alloy rim - front left side - Scratch(es) - Loss in value
2	Wheel / tyres	Alloy rim - front right side - Scratch(es) - Loss in value

Damage 1: Wheel / tyres: Alloy rim - front left side - Scratch(es) - Loss in value

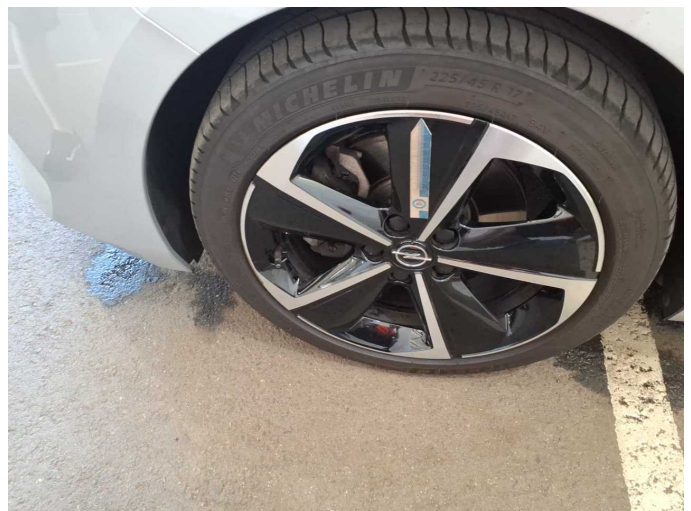
Damage 1: Wheel / tyres: Alloy rim - front left side - Scratch(es) - Loss in value

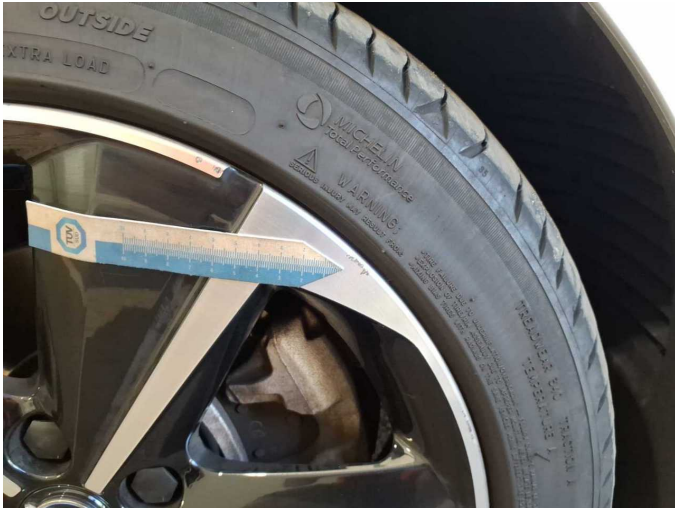
**Damage 2:** Wheel / tyres: Alloy rim - front right side - Scratch(es) - Loss in value

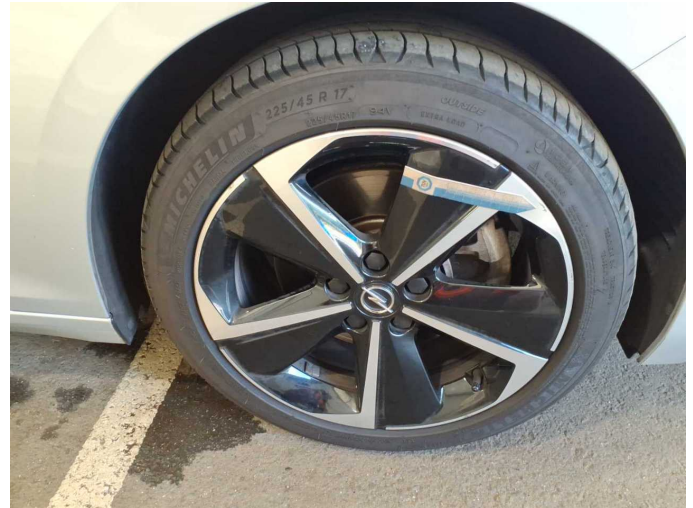
**Damage 2:** Wheel / tyres: Alloy rim - front right side - Scratch(es) - Loss in value

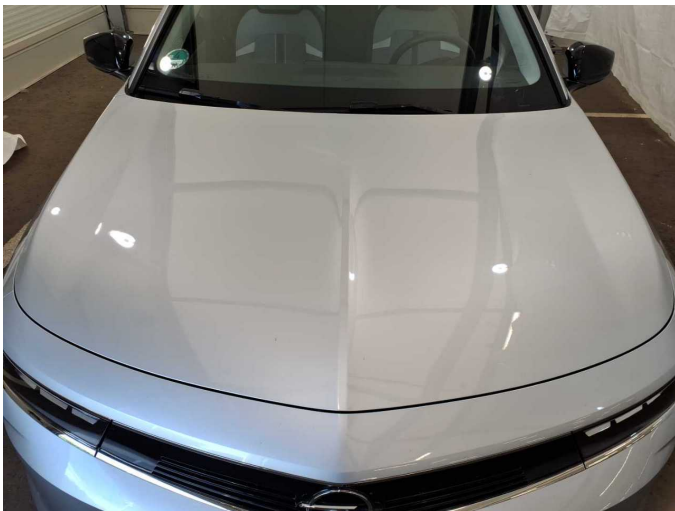
**Wear and tear 1:** Bonnet: Bonnet - Stone chips - No deduction

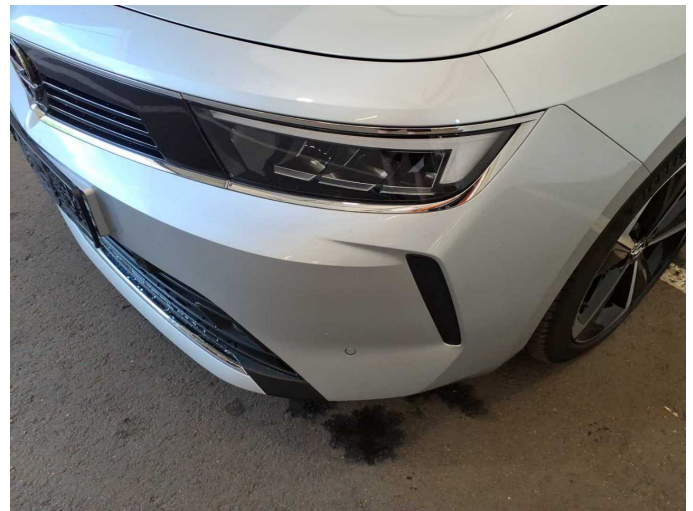
**Wear and tear 2:** Front bumper: Front bumper - Stone chips - No deduction

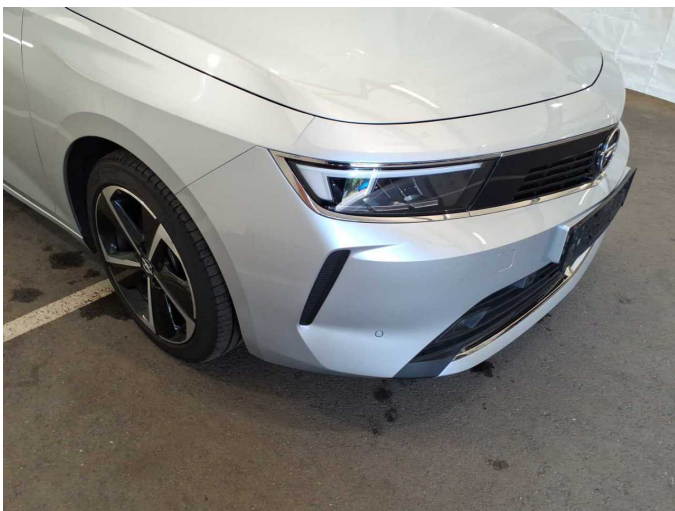
**Wear and tear 2:** Front bumper: Front bumper - Stone chips - No deduction

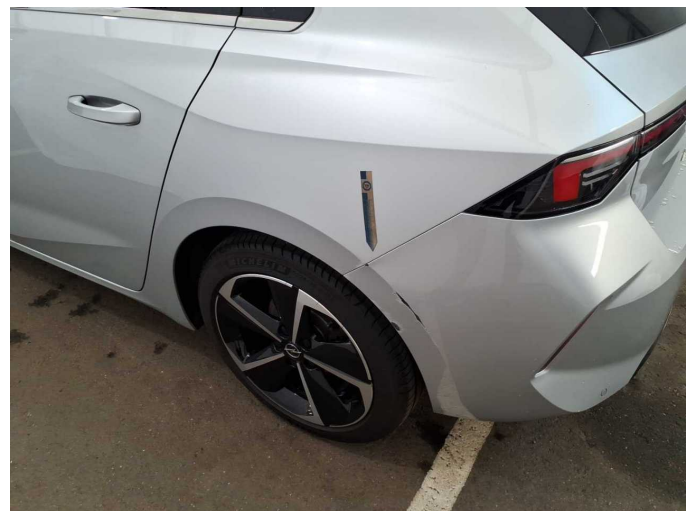
Non-repaired previous damages were found at the vehicle. The necessary repair costs are listed in the expert report or if necessary, are listed in detail in a separately enclosed repair cost calculation.

**Accident 1:** Rear, Side - left

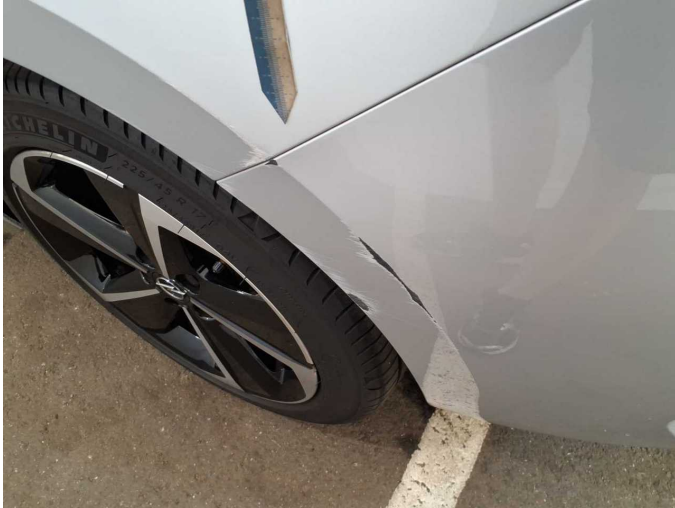
Accident 1: Rear, Side - left

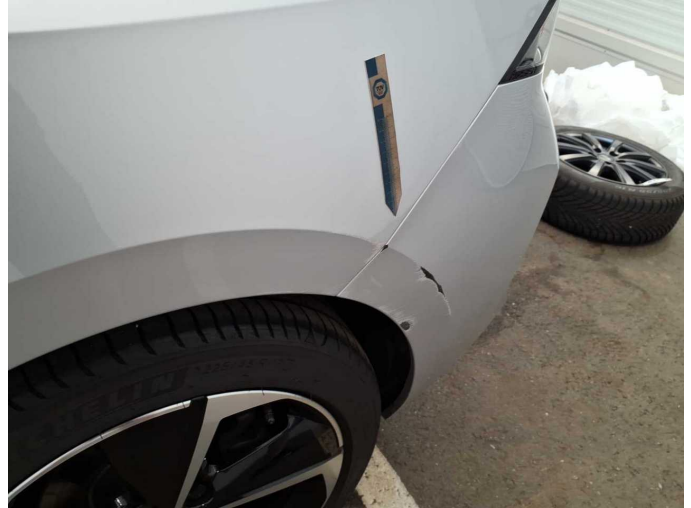
Accident 1: Rear, Side - left

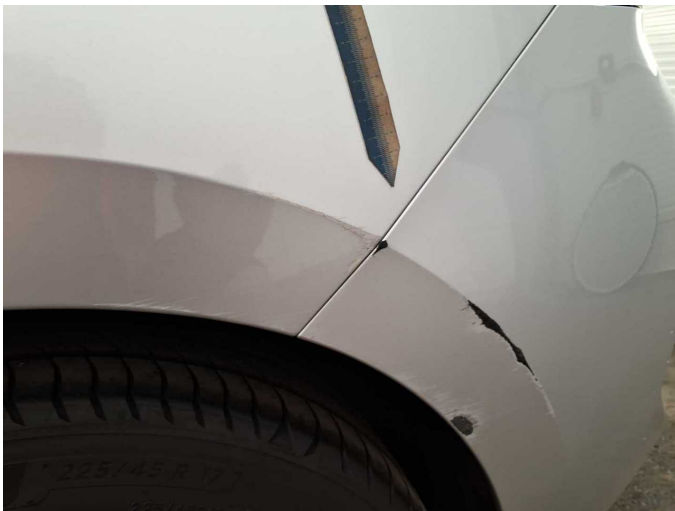
Accident 1: Rear, Side - left

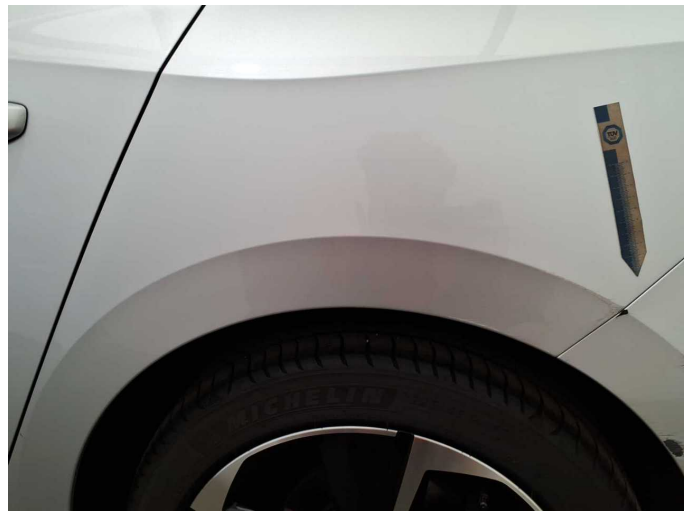
Accident 1: Rear, Side - left

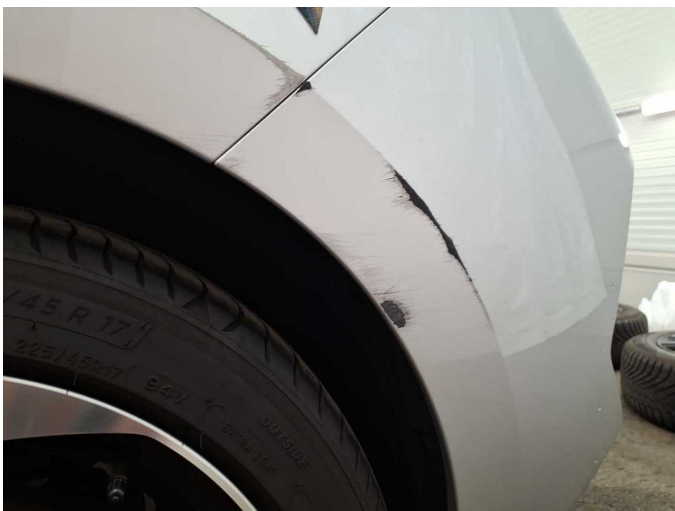
Accident 1: Rear, Side - left

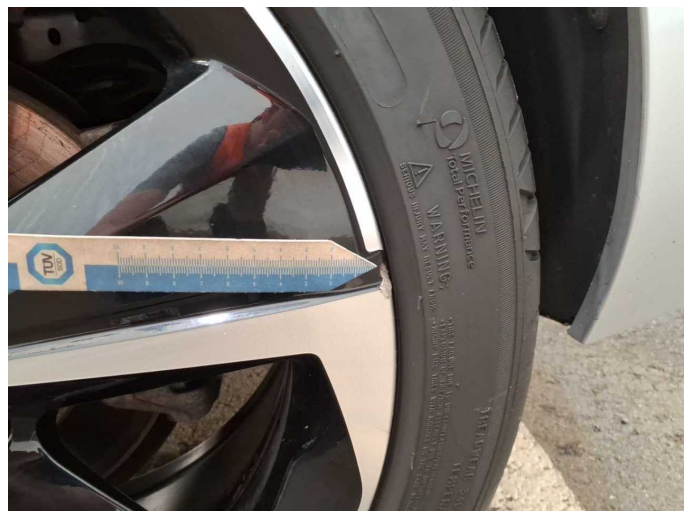
Accident 1: Rear, Side - left

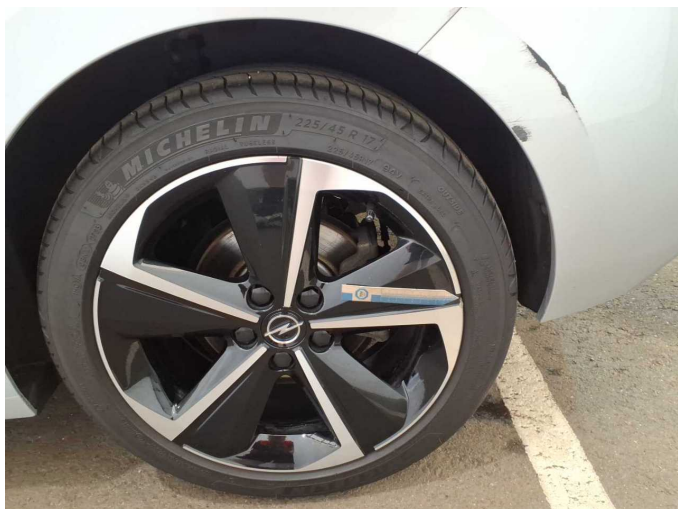
**Accident 1: Rear, Side - left**

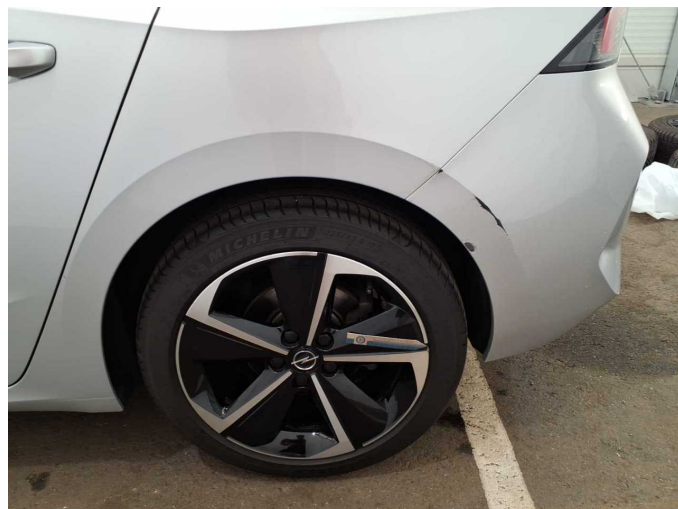
**Accident 1: Rear, Side - left**

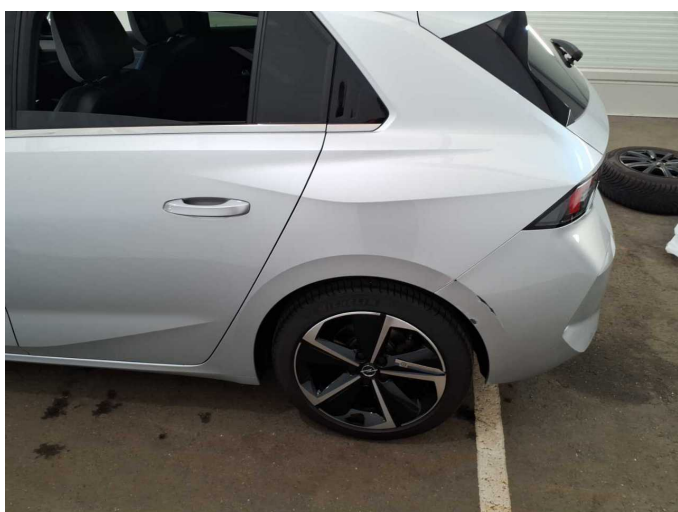
**Accident 1: Rear, Side - left**
