Expertise

Protocol number: 46028855  
Order No. / Reference: 26423211  
Inspection date: 17 Jun 2026

Manufacturer: Skoda  
VIN: TMBJR7NU3NC203145

Model: Karoq 1.5 TSI ACT Ambition

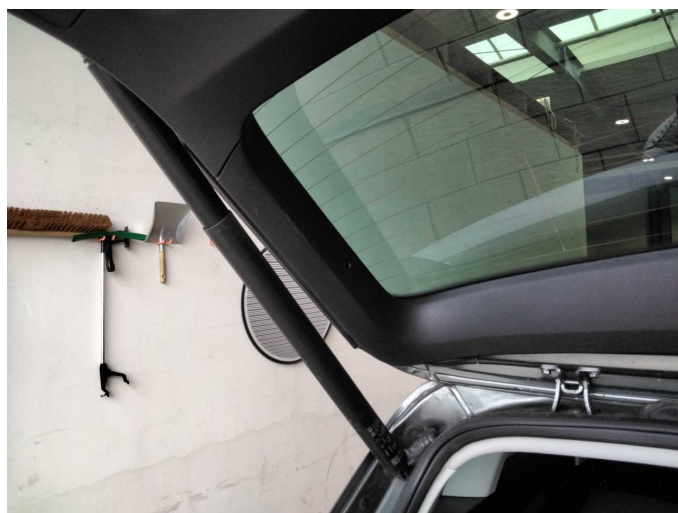
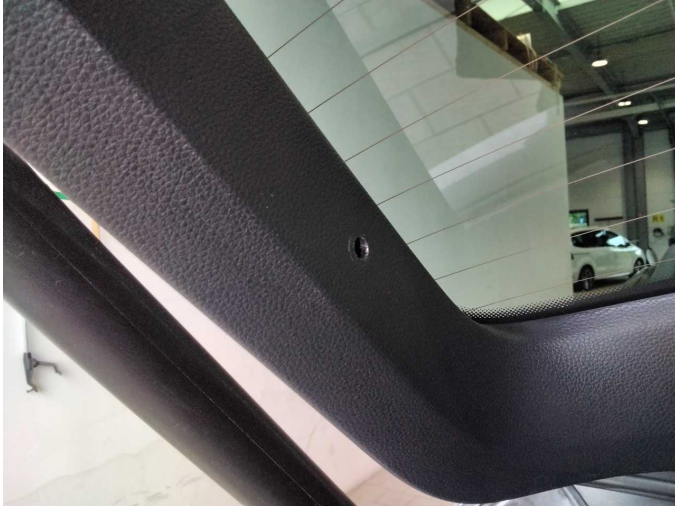
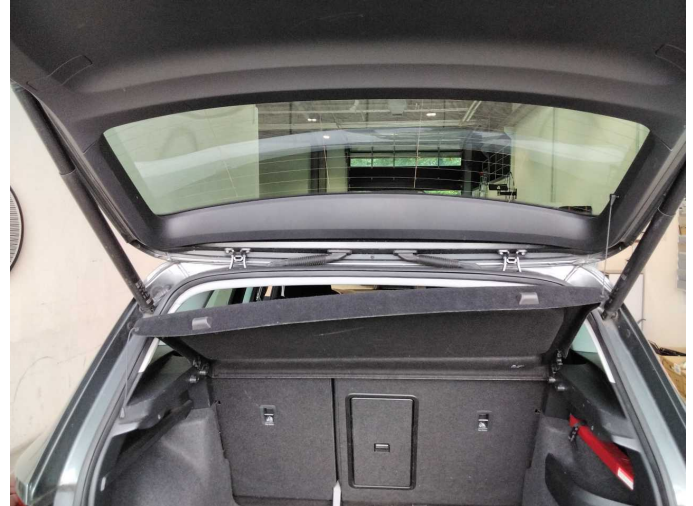
| No. | Component group | Description |
|---|---|---|
| 1 | Trim / covers | Boot lid - interior trim (Halterung) - Missing - Replace |

Damage 1: Trim / covers: Boot lid - interior trim (Halterung) - Missing - Replace

**Damage 1:** Trim / covers: Boot lid - interior trim (Halterung) - Missing - Replace

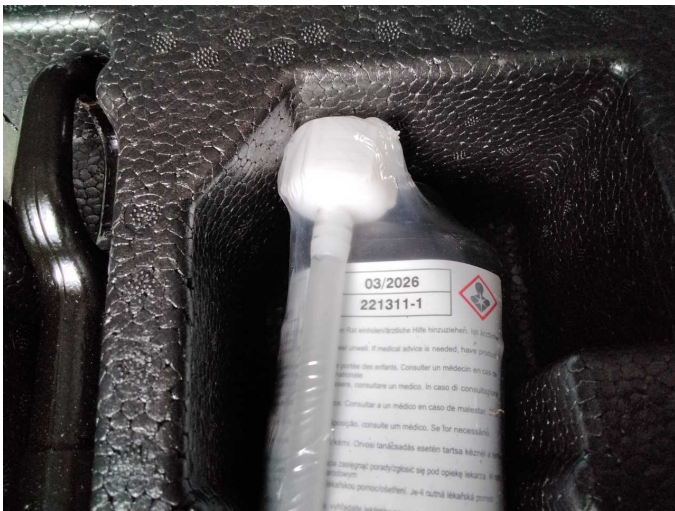
| No. | Component group | Description |
|---|---|---|
| 2 | Equipment | Tirefit filler - Expired - Replace |

**Damage 2:** Equipment: Tirefit filler - Expired - Replace

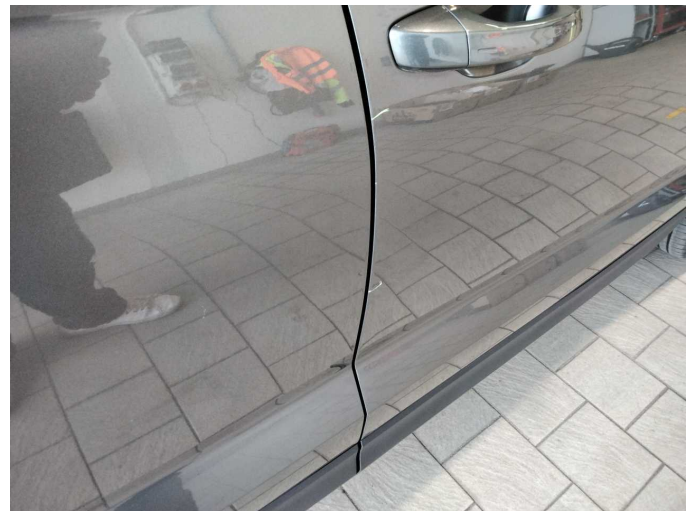
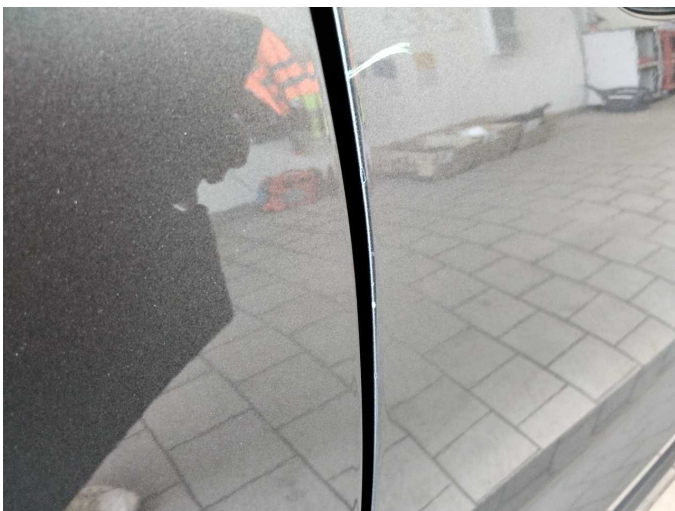
| No. | Component group | Description |
|---|---|---|
| 3 | Door - front right side | Door edge - Scratch(es) - Smart repair |

**Damage 3:** Door - front right side: Door edge - Scratch(es) - Smart repair

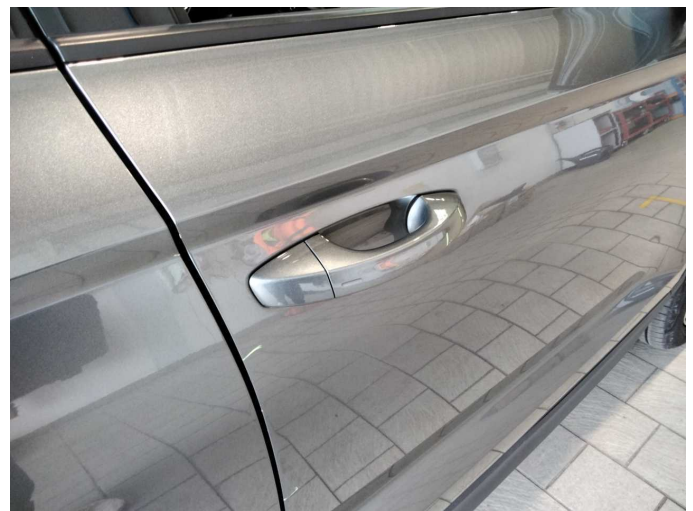
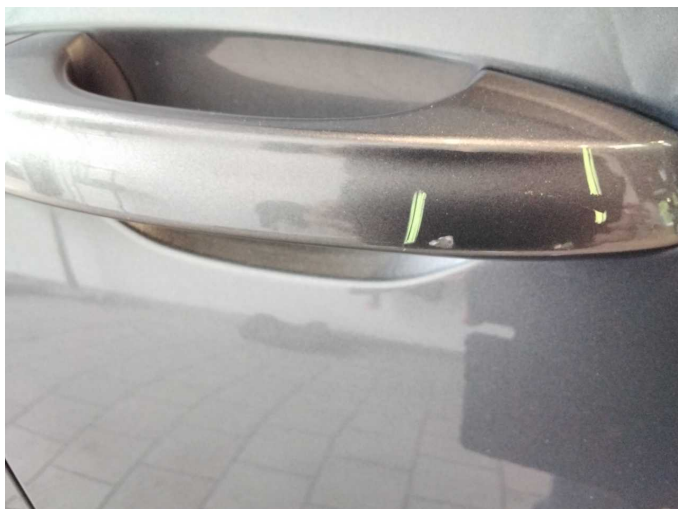
| No. | Component group | Description |
|---|---|---|
| 4 | Door - front right side | Door handle - outside - Scratch(es) - Smart repair |

**Damage 4:** Door - front right side: Door handle - outside - Scratch(es) - Smart repair

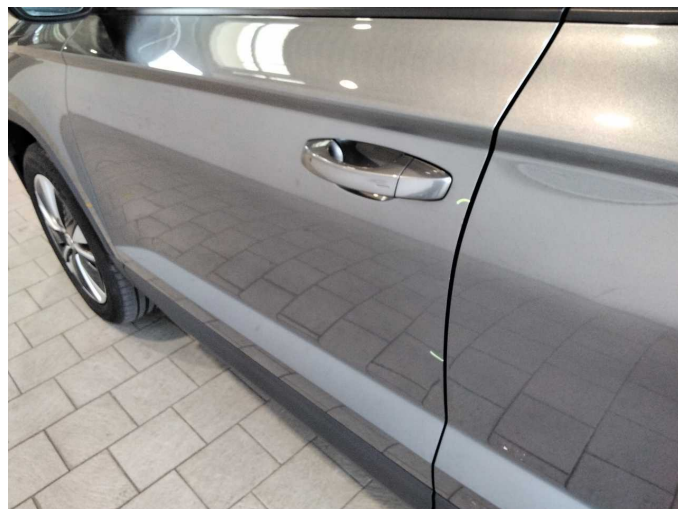
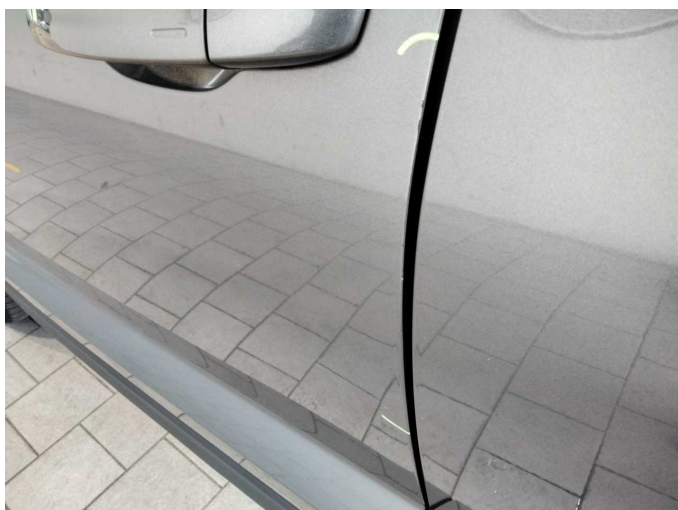
| No. | Component group | Description |
|---|---|---|
| 5 | Door - front left side | Door edge - Scratch(es) - Smart repair |

**Damage 5:** Door - front left side: Door edge - Scratch(es) - Smart repair

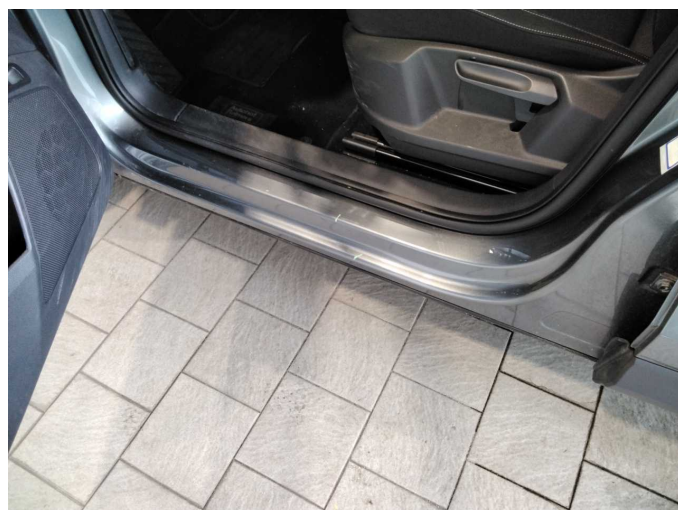
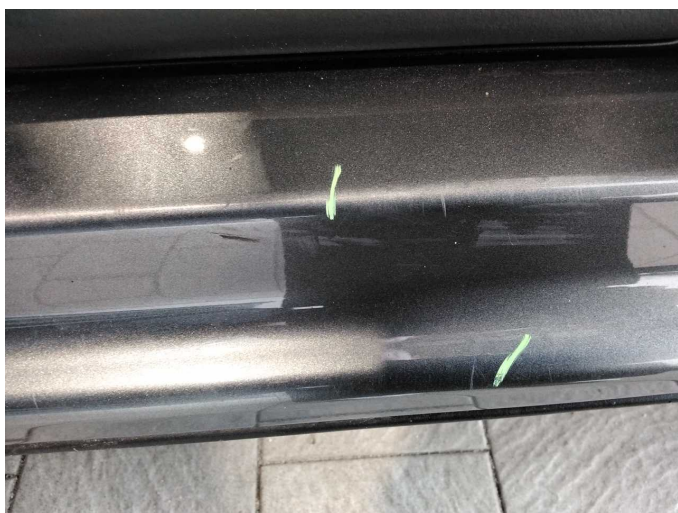
| No. | Component group | Description |
|---|---|---|
| 6 | Sill - left side | Sill - Scratch(es) - Smart repair |

**Damage 6:** Sill - left side: Sill - Scratch(es) - Smart repair

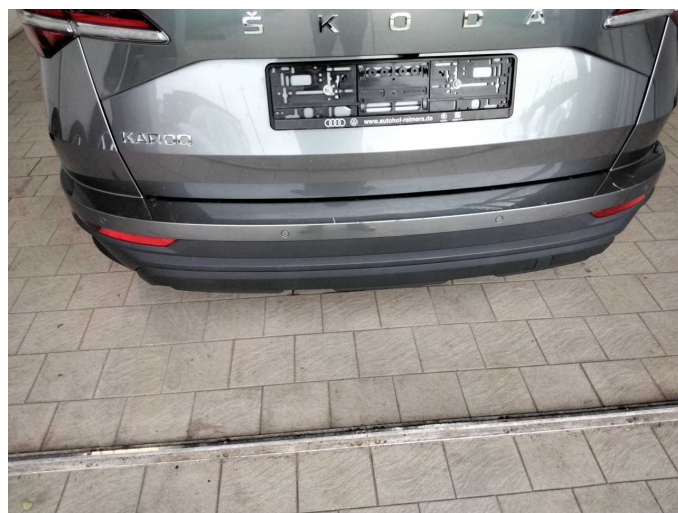
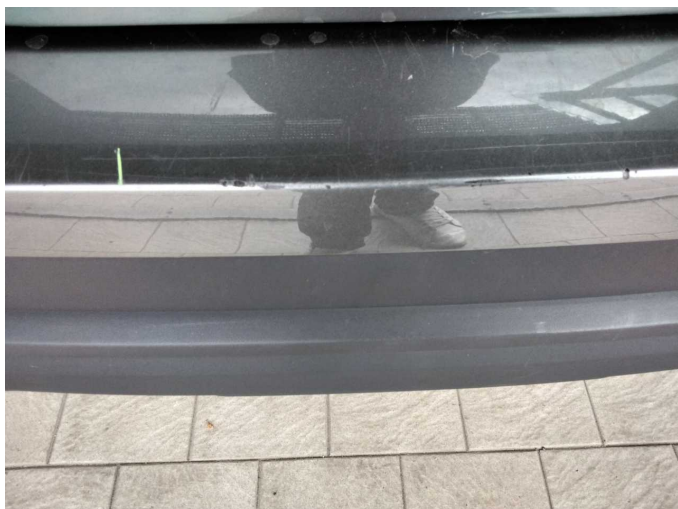
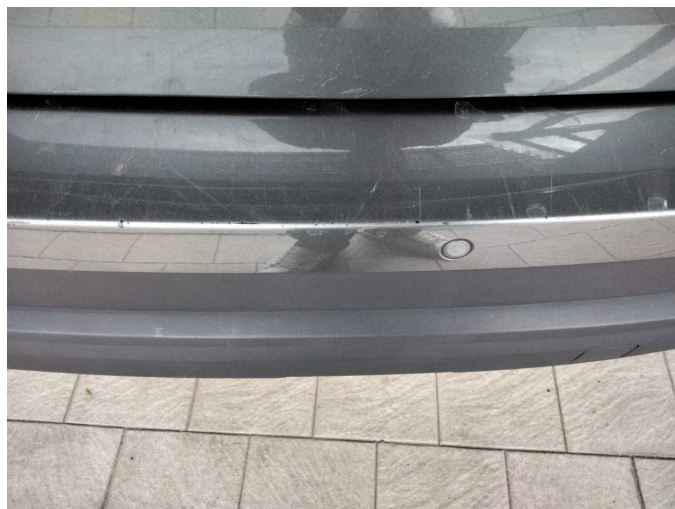
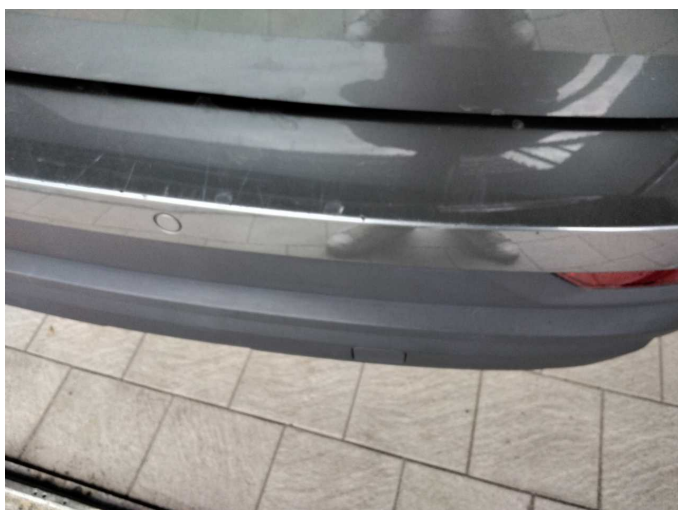
| No. | Component group | Description |
|---|---|---|
| 7 | Rear bumper | Rear bumper - Scratch(es) - Smart repair |

**Damage 7:** Rear bumper: Rear bumper - Scratch(es) - Smart repair

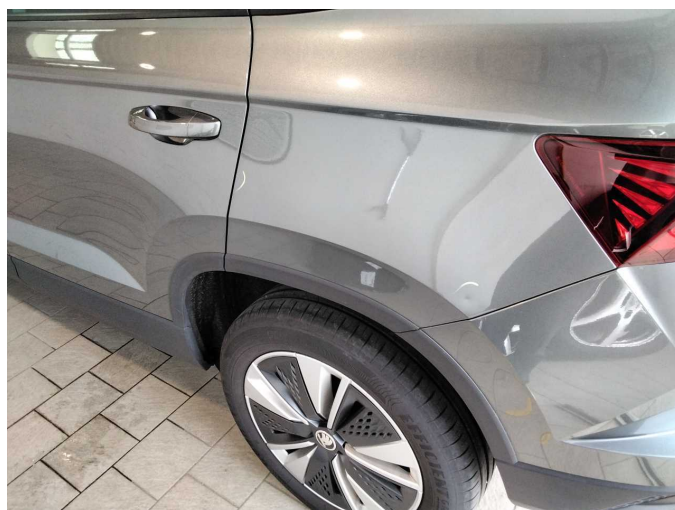
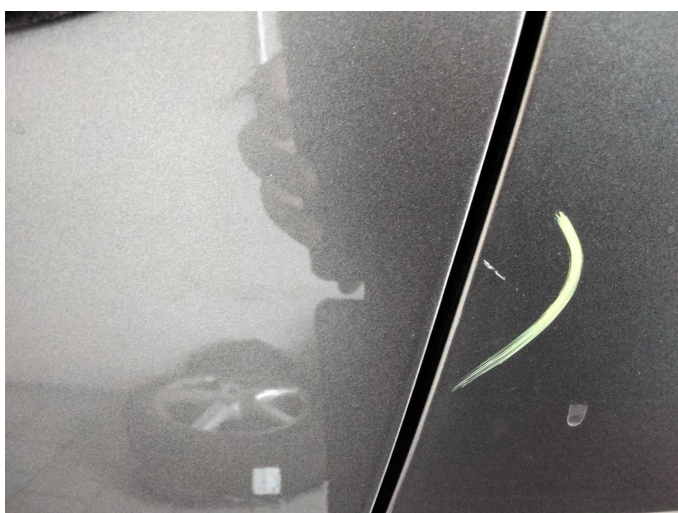
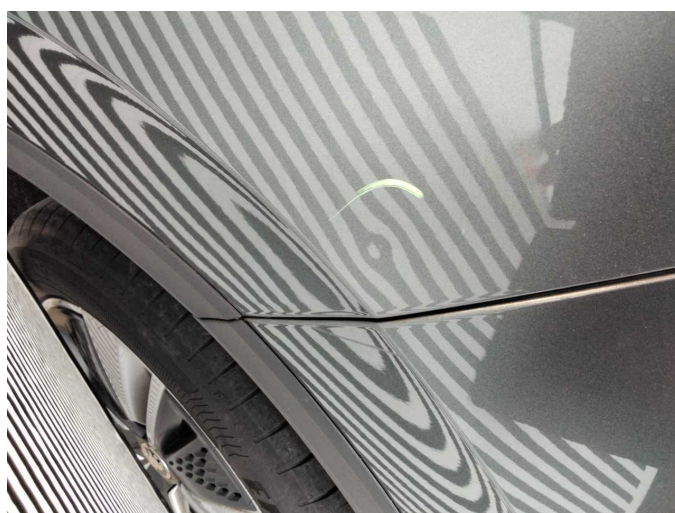
| No. | Component group | Description |
|---|---|---|
| 8 | Side panel - rear left side | Side panel (+ Kratzer Gebrauchsspur) - dent(s) - Smart repair |

**Damage 8:** Side panel - rear left side: Side panel (+ Kratzer Gebrauchsspur) - dent(s) - Smart repair

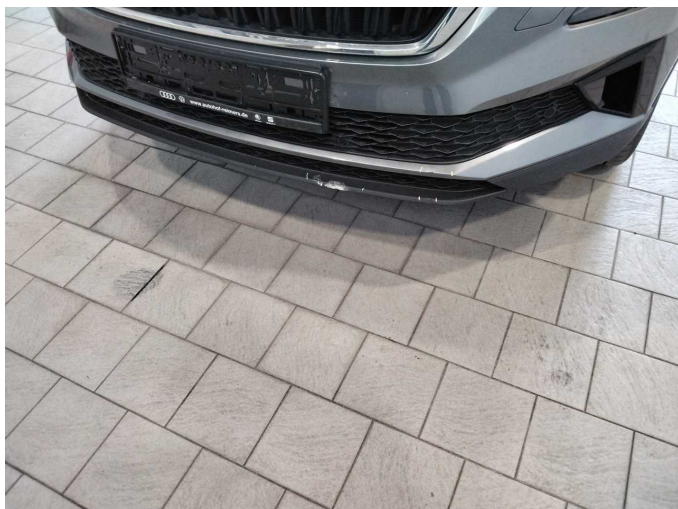
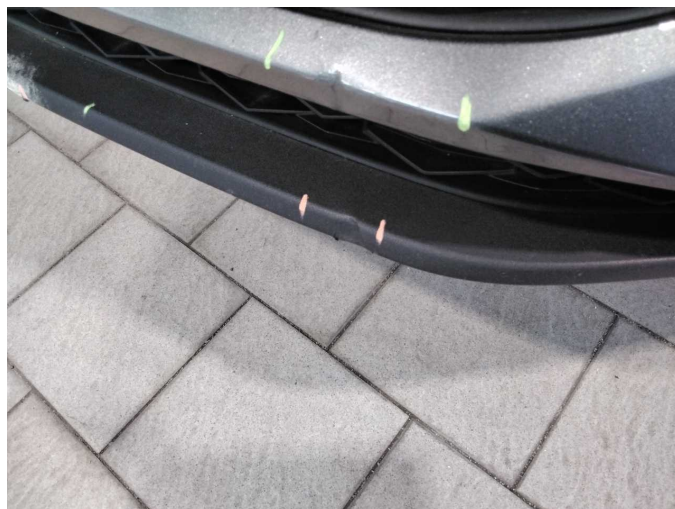
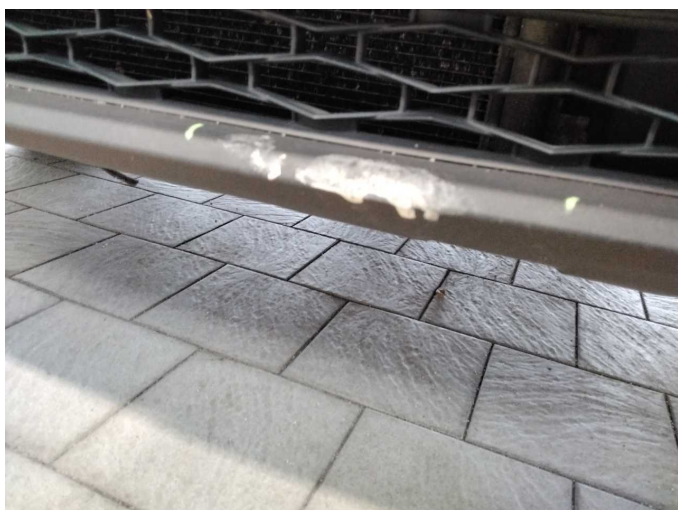
| No. | Component group | Description |
|---|---|---|
| 9 | Front bumper | Spoiler - Deformed - Replace |

**Damage 9:** Front bumper: Spoiler - Deformed - Replace

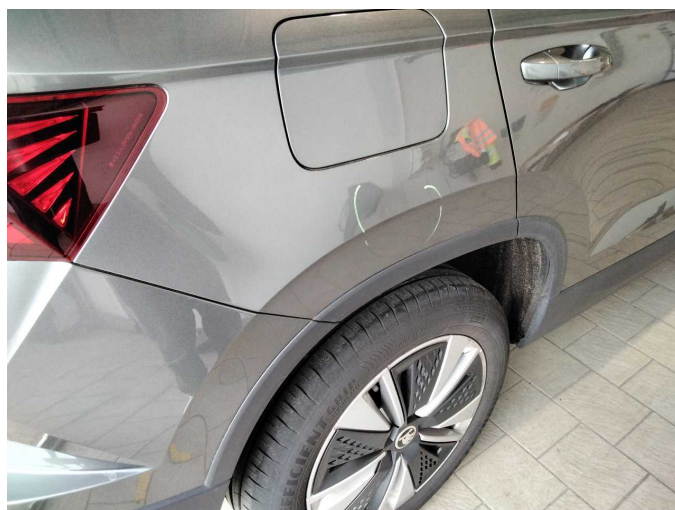
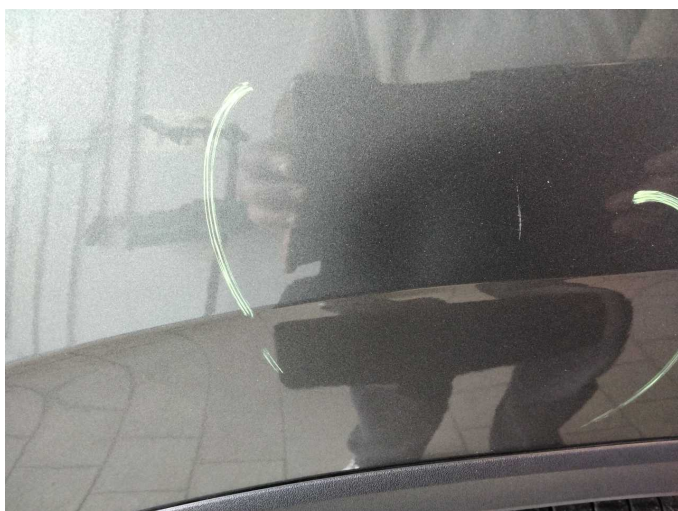
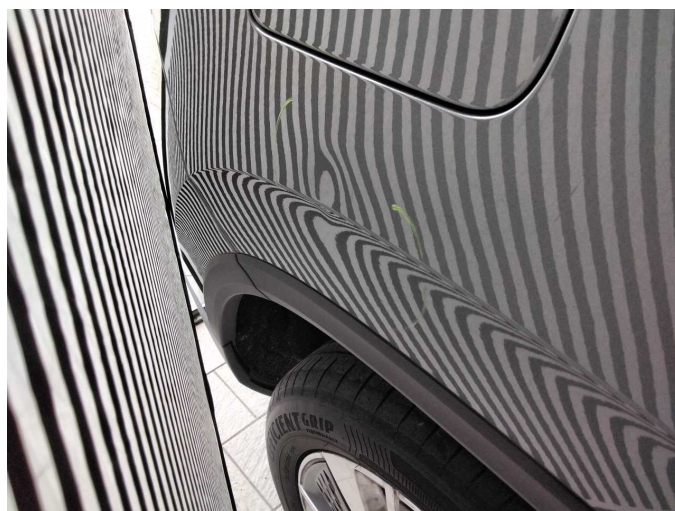
| No. | Component group | Description |
|---|---|---|
| 10 | Side panel - rear right side | Side panel - Dent / paintcoat damage - Repair and paint |

**Damage 10:** Side panel - rear right side: Side panel - Dent / paintcoat damage - Repair and paint

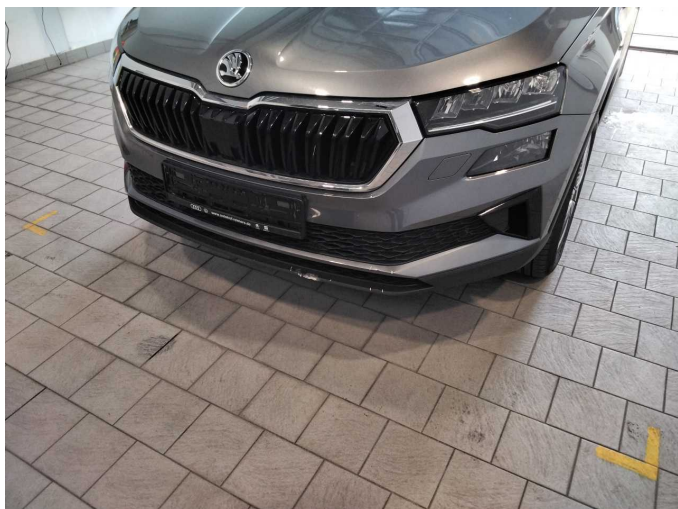
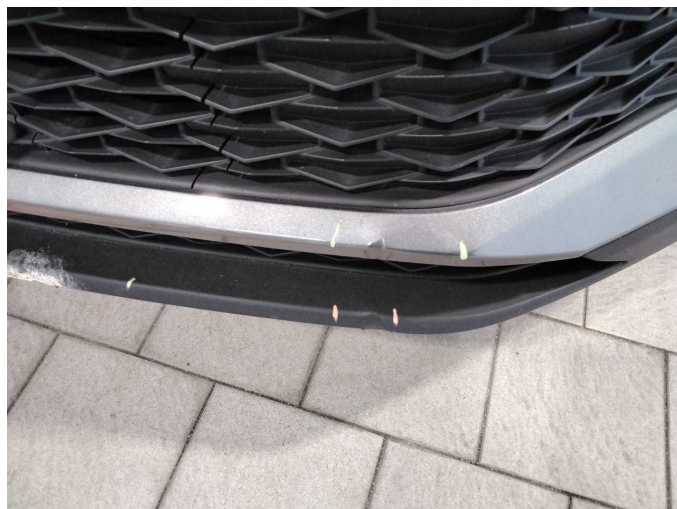
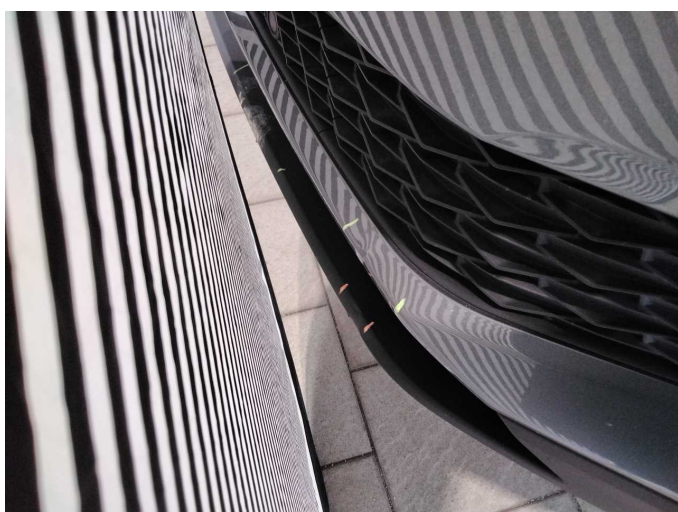
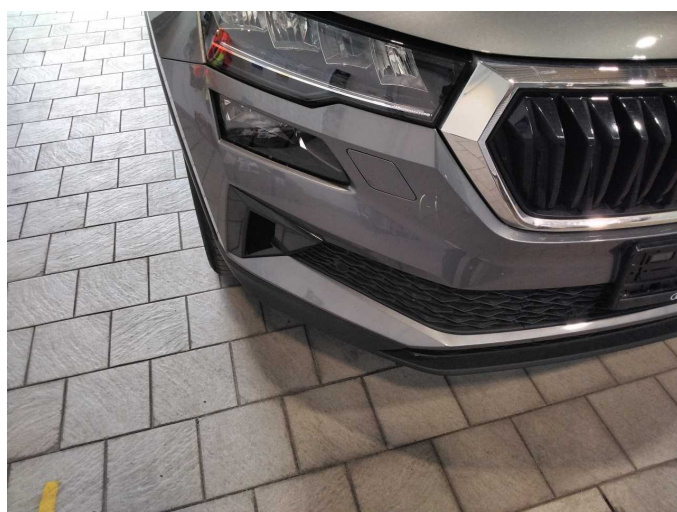
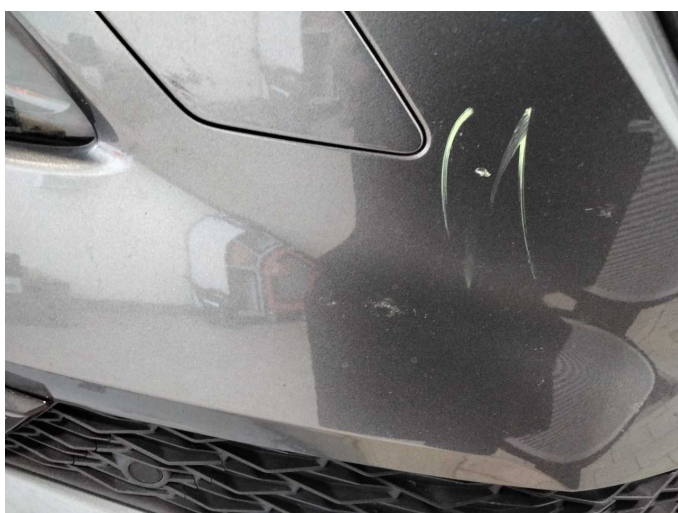
| No. | Component group | Description |
|---|---|---|
| 11 | Front bumper | Front bumper - Dent / paintcoat damage - Repair and paint |

**Damage 11:** Front bumper: Front bumper - Dent / paintcoat damage - Repair and paint

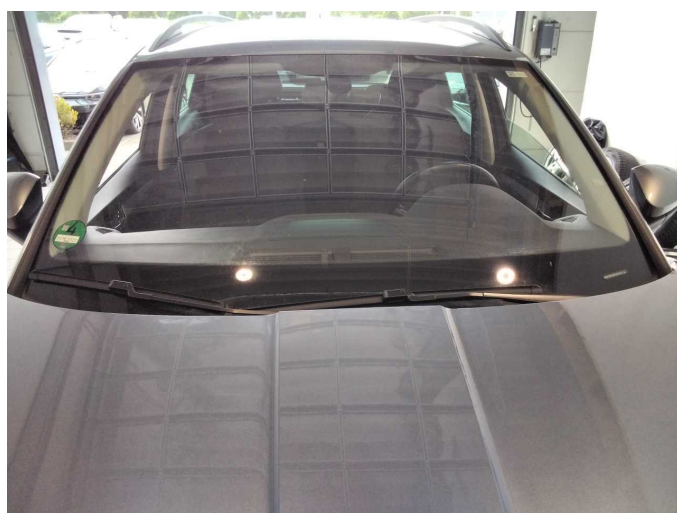
| No. | Component group | Description |
|---|---|---|
| 1 | Vehicle glazing | Windscreen - Stone chips - No deduction |

**Wear and tear 1:** Vehicle glazing: Windscreen - Stone chips - No deduction

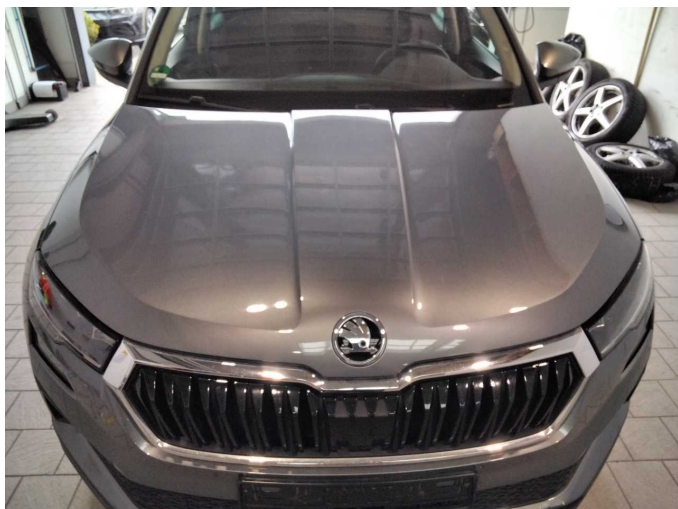
| No. | Component group | Description |
|---|---|---|
| 2 | Bonnet | Bonnet - Stone chips - No deduction |

**Wear and tear 2:** Bonnet: Bonnet - Stone chips - No deduction
