Expertise

Protocol number: 46403600  
Order No. / Reference: 26535201  
Inspection date: 7 Jul 2026

Manufacturer: Skoda  
VIN: TMBJW7NP6N7032645

Model: Superb Combi 1.4 TSI iV DSG Ambition

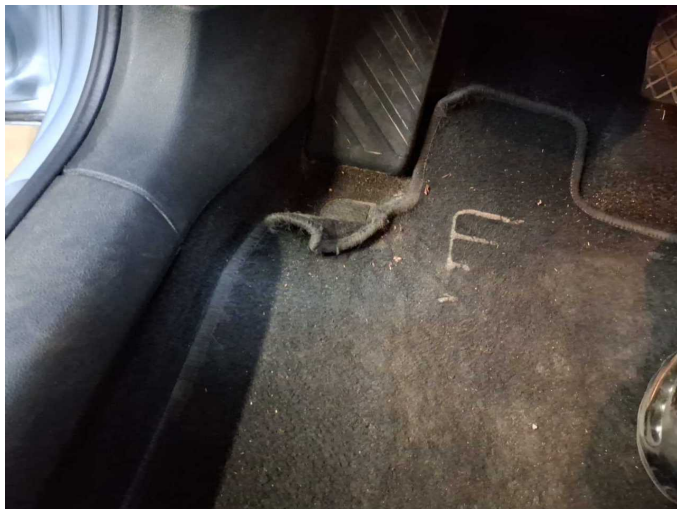
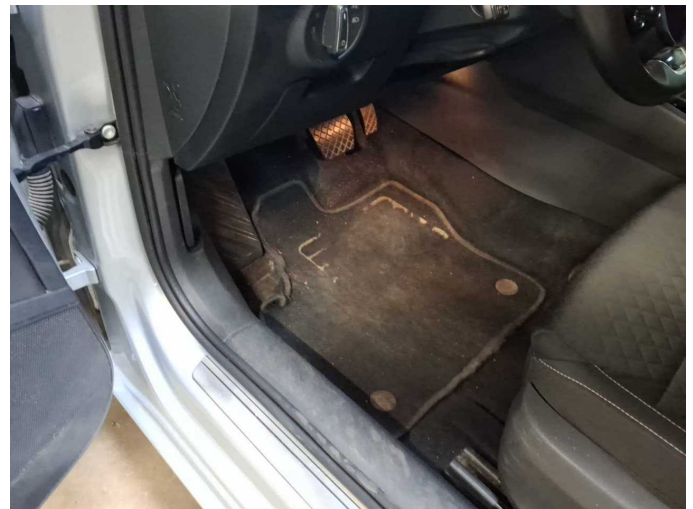
| No. | Component group | Description |
|---|---|---|
| 1 | Trim / covers | Floor mats - Deformed - Replace |

**Damage 1:** Trim / covers: Floor mats - Deformed - Replace

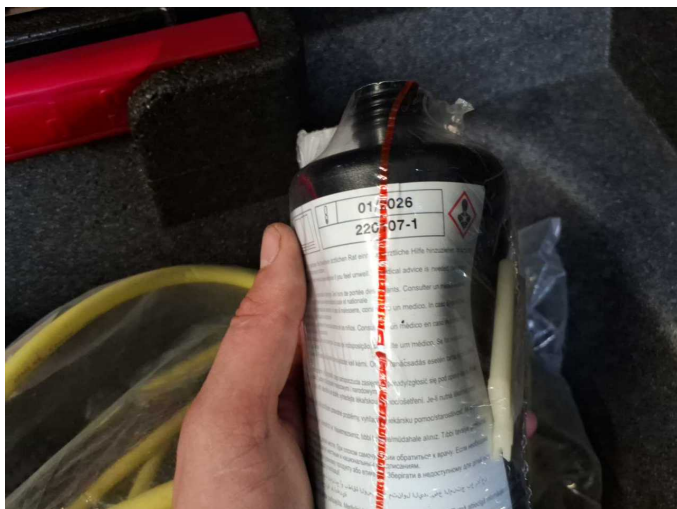
| Typ | Tyre size | Type of tyre | Manufacturer | Tread depth |
|---|---|---|---|---|
| | Tirefit | Expiration date 01/2026 | | |

| No. | Component group | Description |
|---|---|---|
| 2 | Equipment | Tirefit filler - Expired - Replace |

**Damage 2:** Equipment: Tirefit filler - Expired - Replace

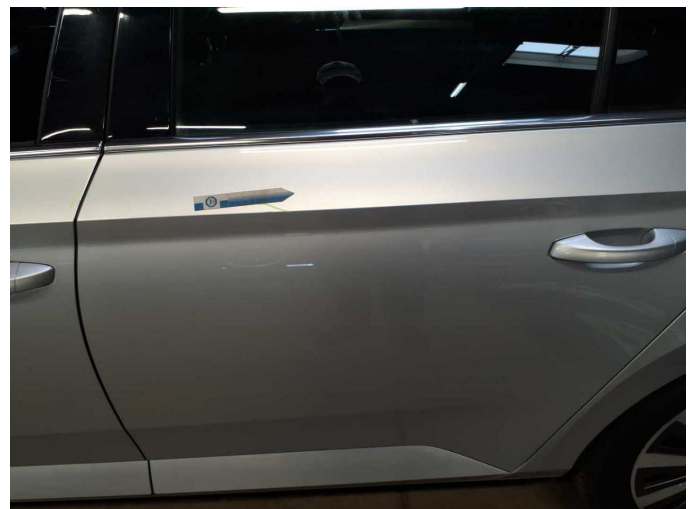
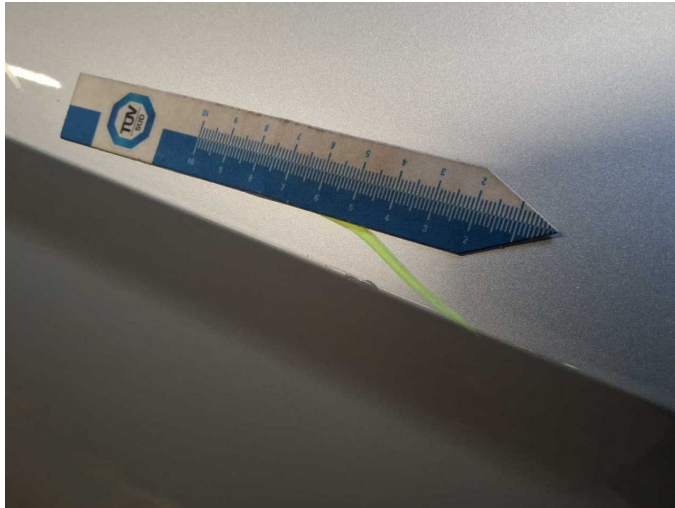
| No. | Component group | Description |
|---|---|---|
| 3 | Door - rear left side | Door - Scratch(es) - Smart repair |

**Damage 3:** Door - rear left side: Door - Scratch(es) - Smart repair

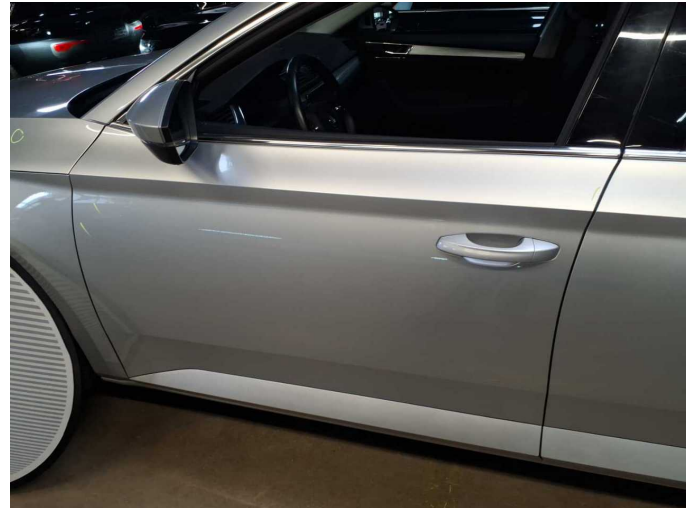
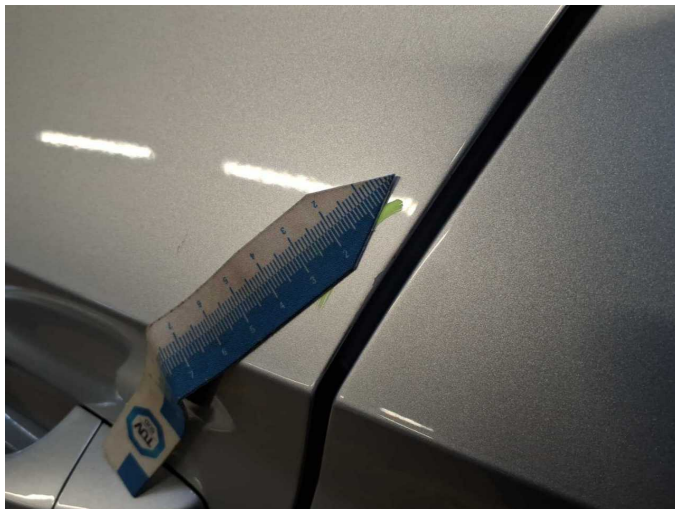
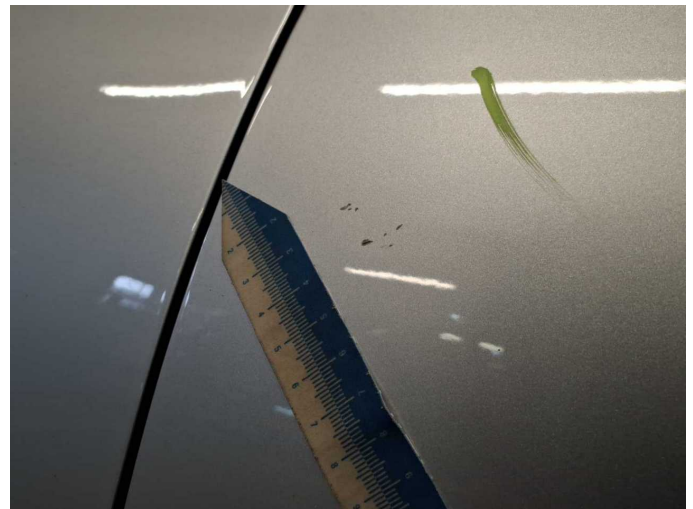
| No. | Component group | Description |
|---|---|---|
| 4 | Door - front left side | Door - Scratch(es) - Paint |

**Damage 4:** Door - front left side: Door - Scratch(es) - Paint

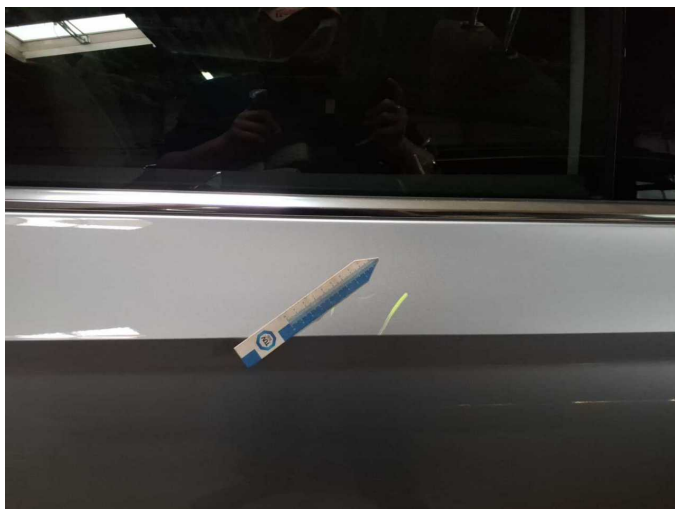
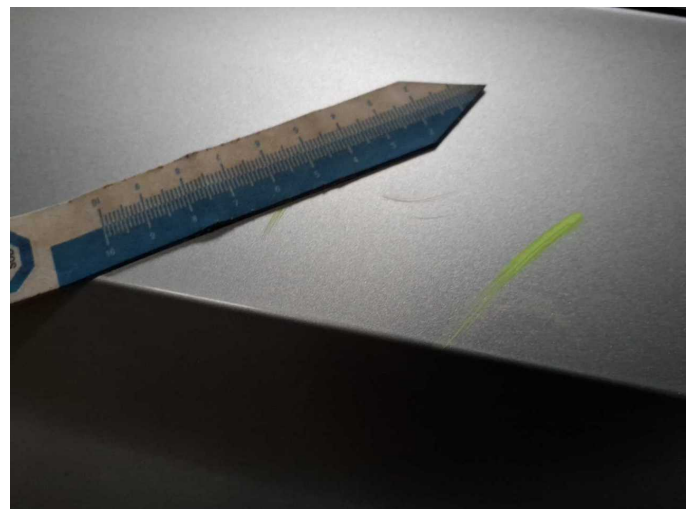
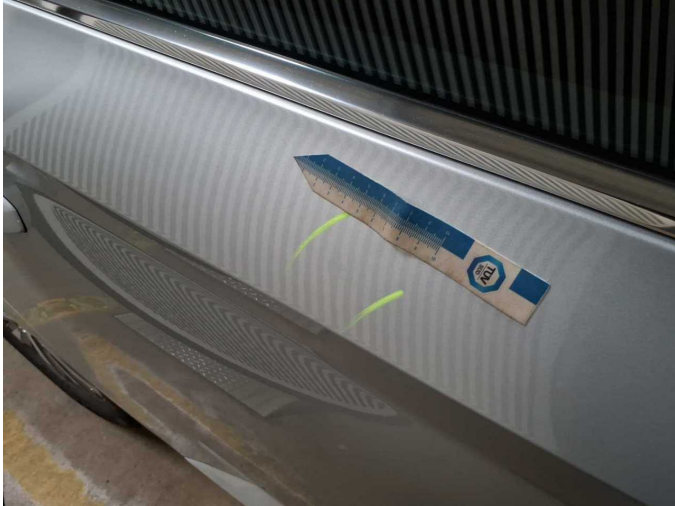
| No. | Component group | Description |
|---|---|---|
| 5 | Door - rear right side | Door - Dent / paintcoat damage - Repair and paint |

**Damage 5:** Door - rear right side: Door - Dent / paintcoat damage - Repair and paint

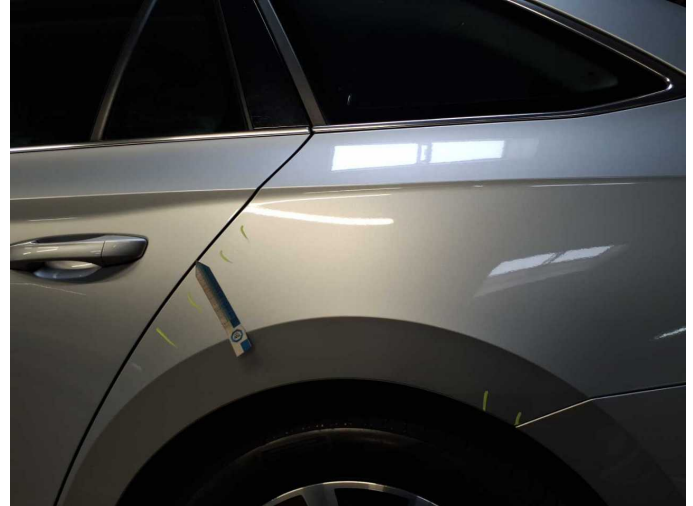
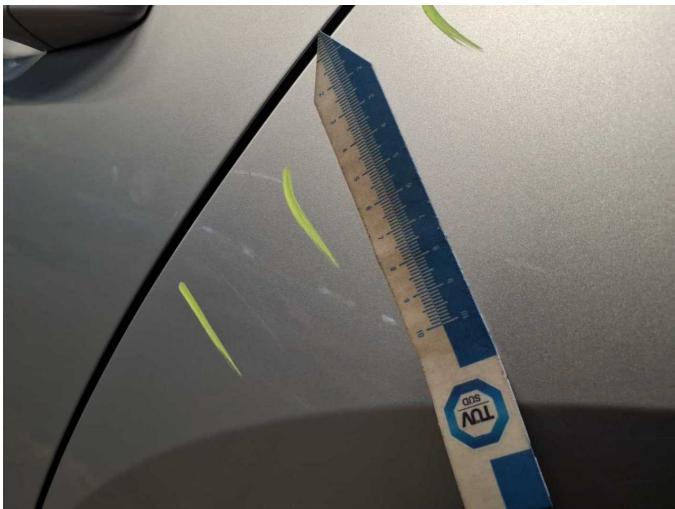
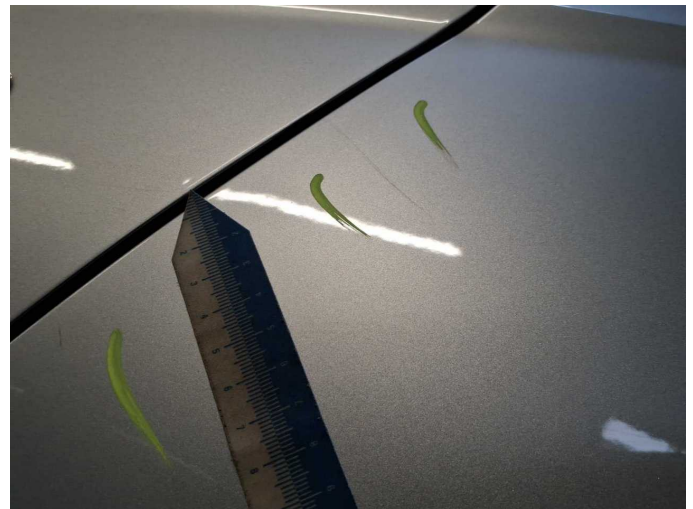
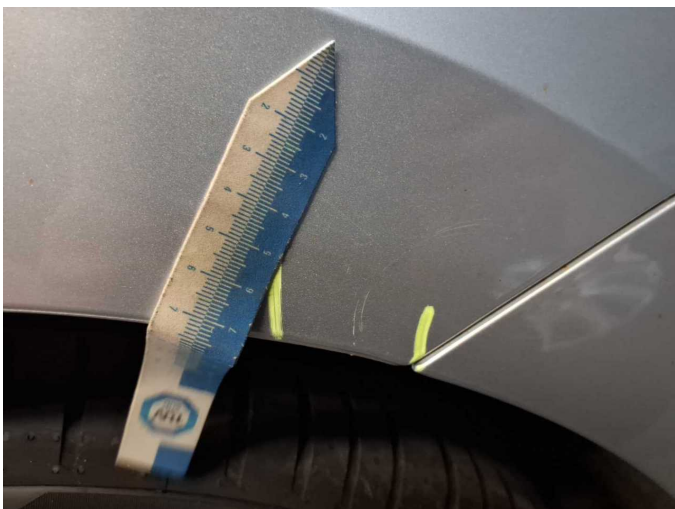
| No. | Component group | Description |
|---|---|---|
| 6 | Side panel - rear left side | Side panel - Scratch(es) - Paint |

**Damage 6:** Side panel - rear left side: Side panel - Scratch(es) - Paint

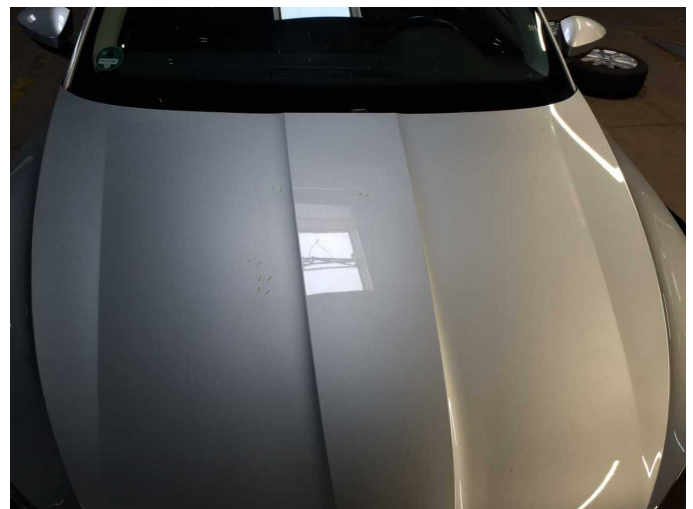
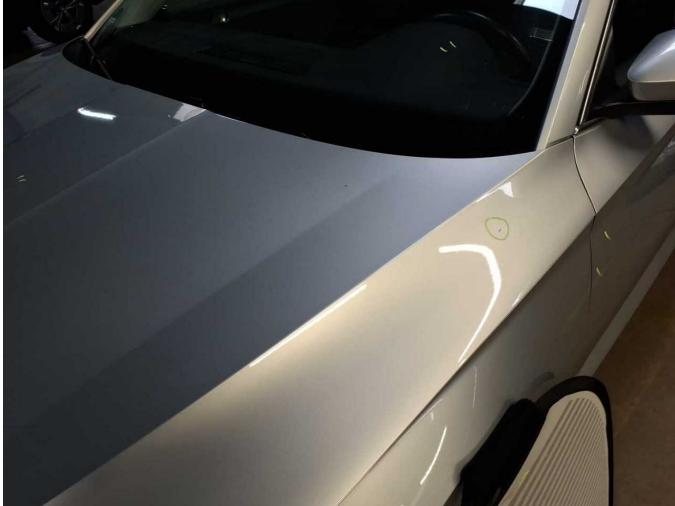
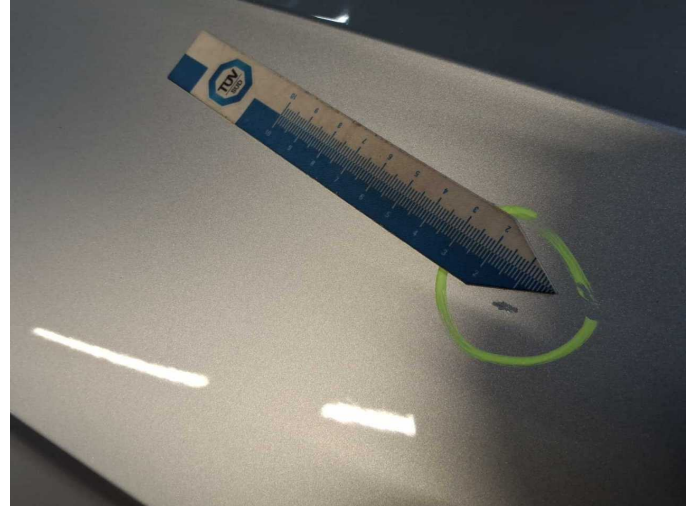
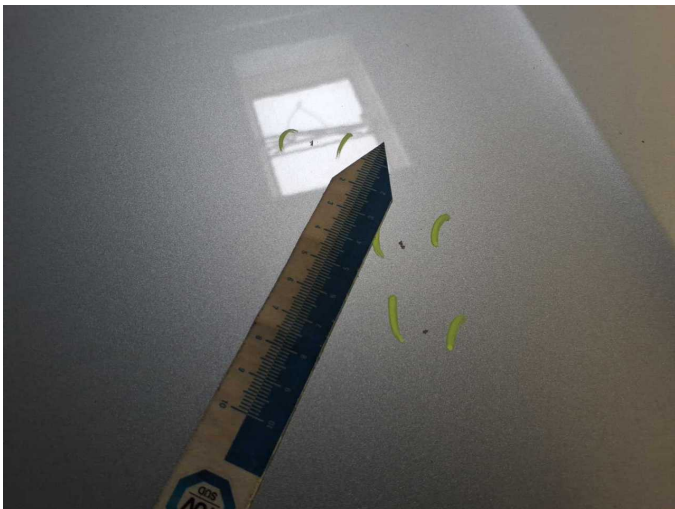
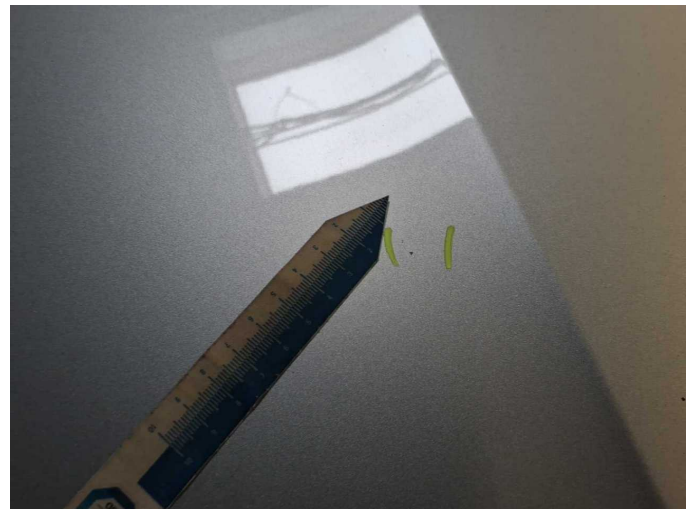
| No. | Component group | Description |
|---|---|---|
| 7 | Bonnet | Bonnet - Stone chips - Paint |

**Damage 7:** Bonnet: Bonnet - Stone chips - Paint

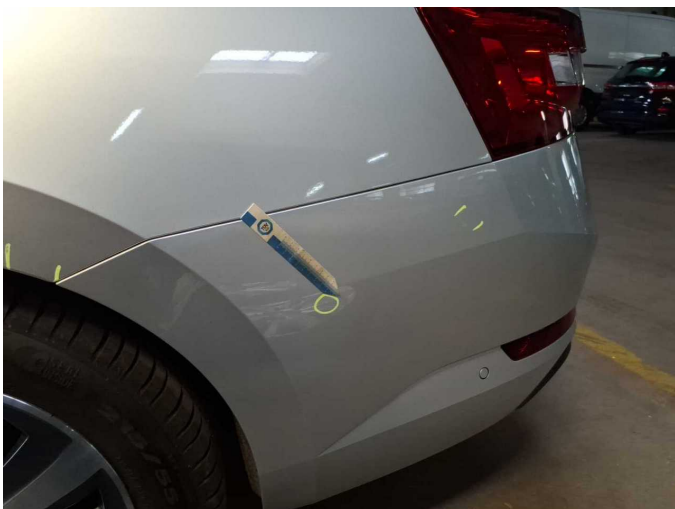
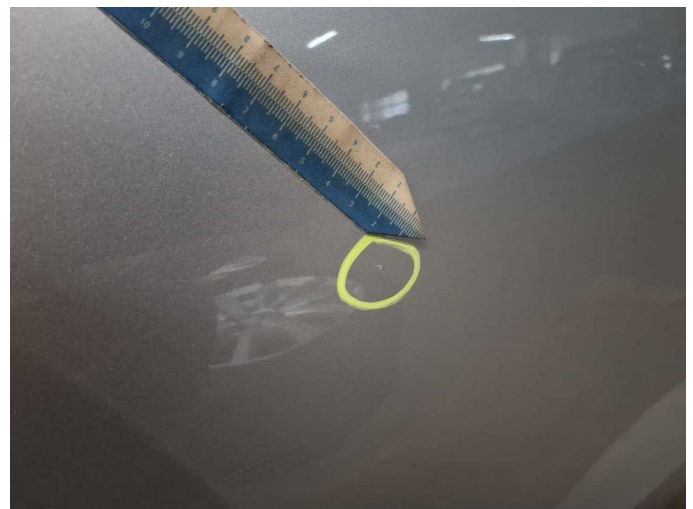
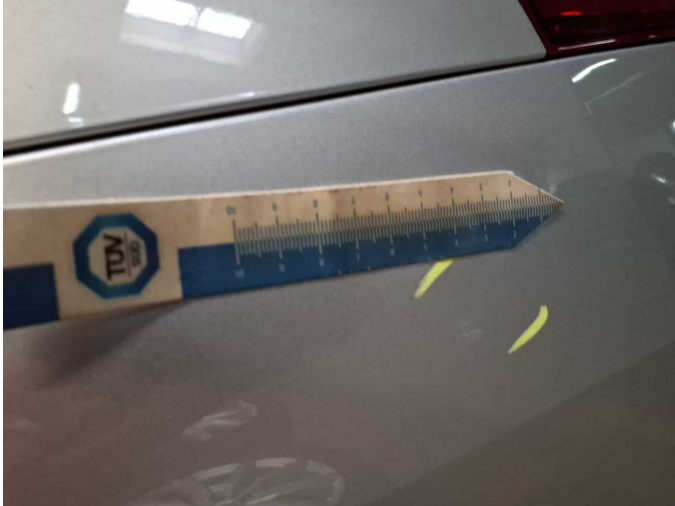
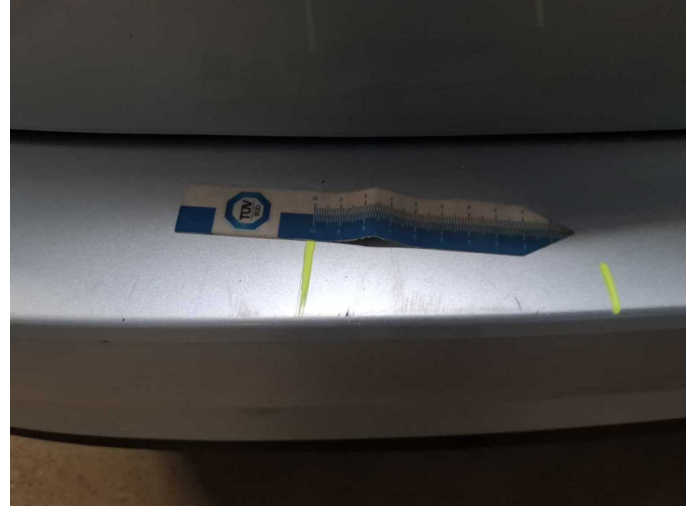
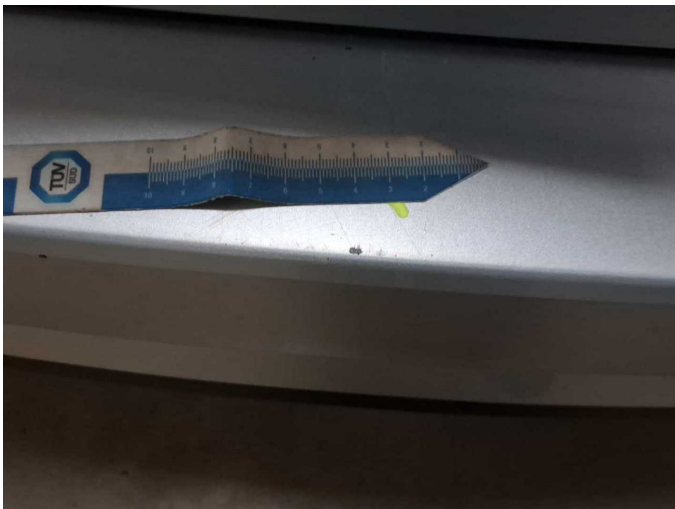
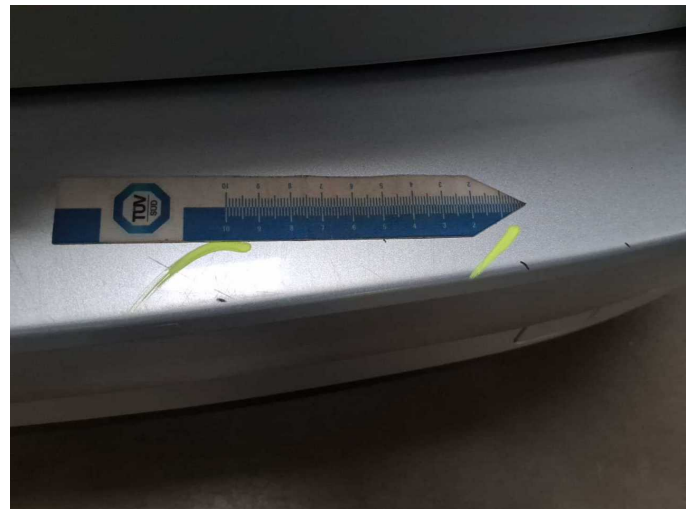
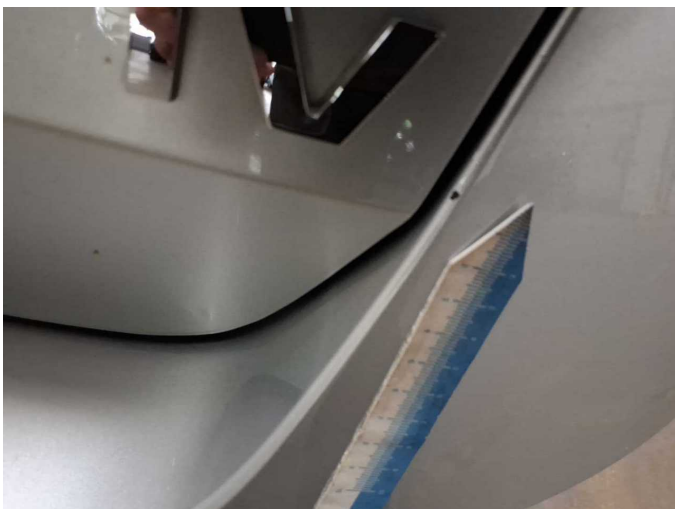
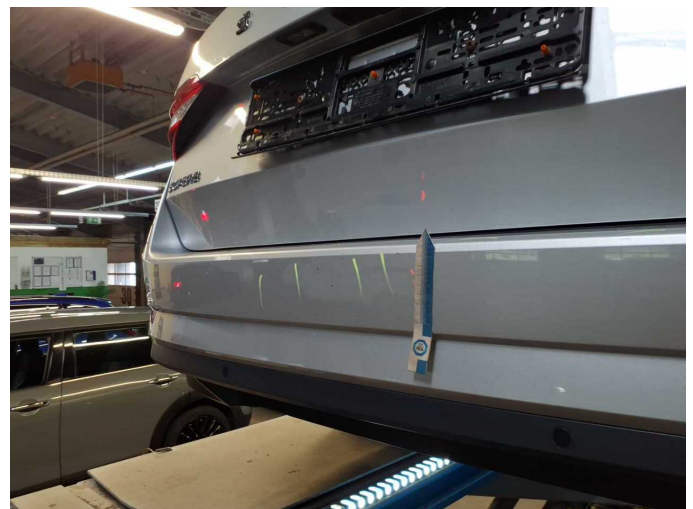
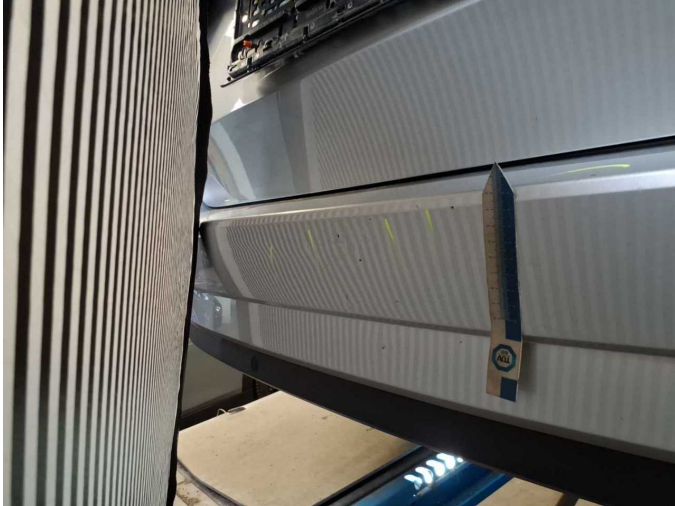
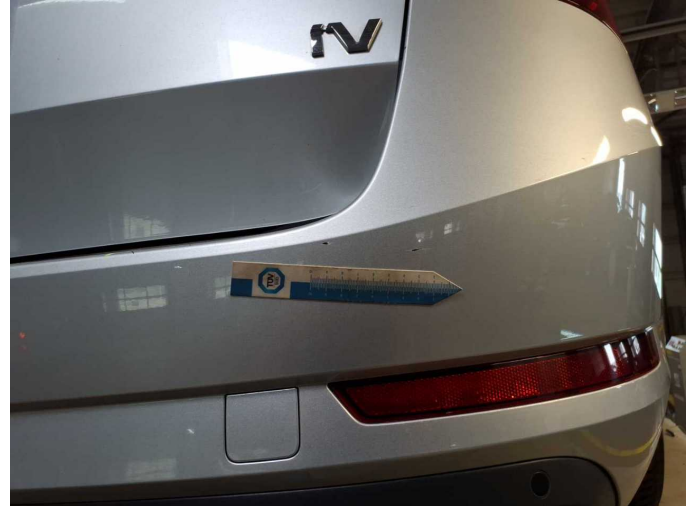
| No. | Component group | Description |
|---|---|---|
| 8 | Rear bumper | Rear bumper - Dent / paintcoat damage - Repair and paint |

**Damage 8:** Rear bumper: Rear bumper - Dent / paintcoat damage - Repair and paint

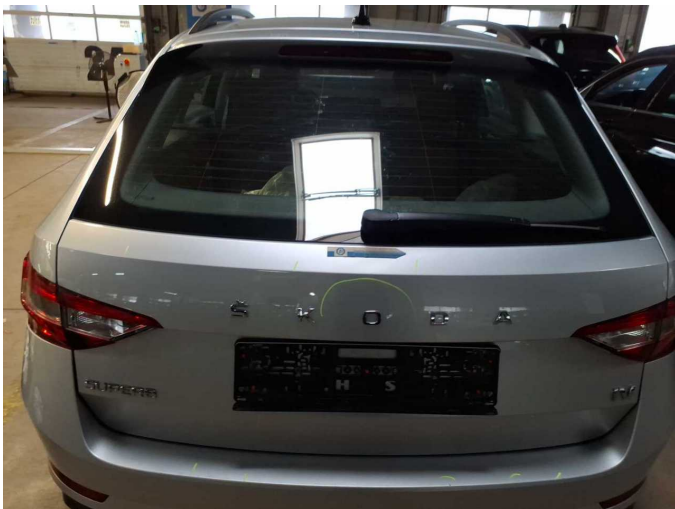
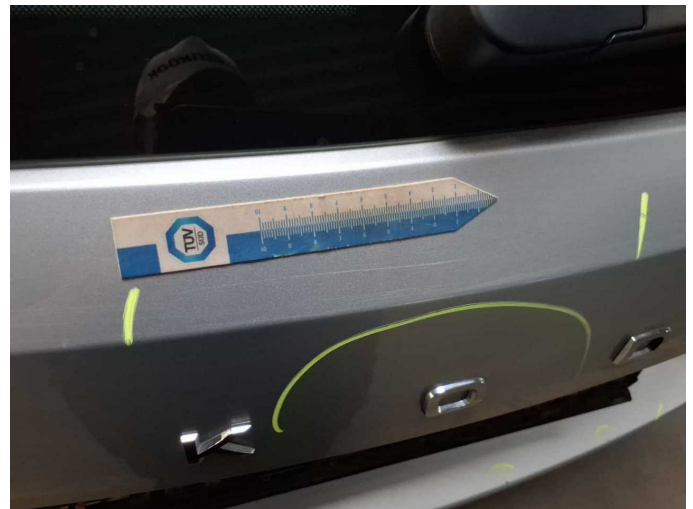
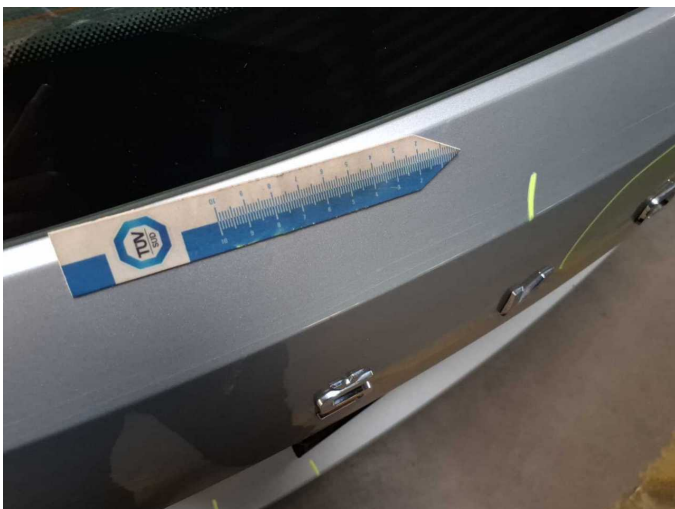
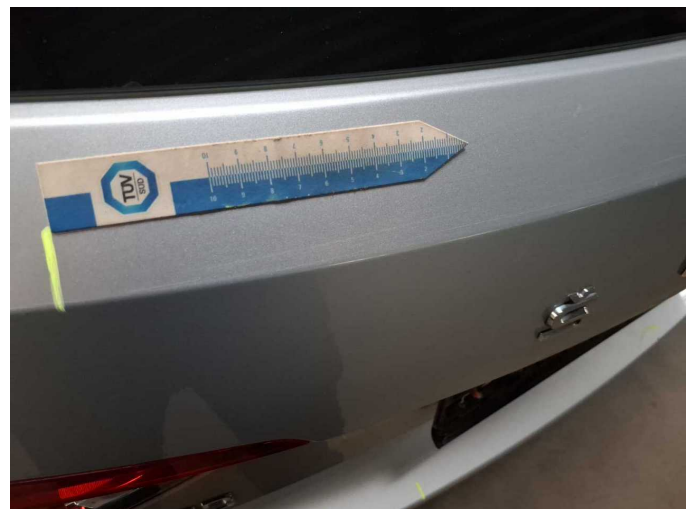
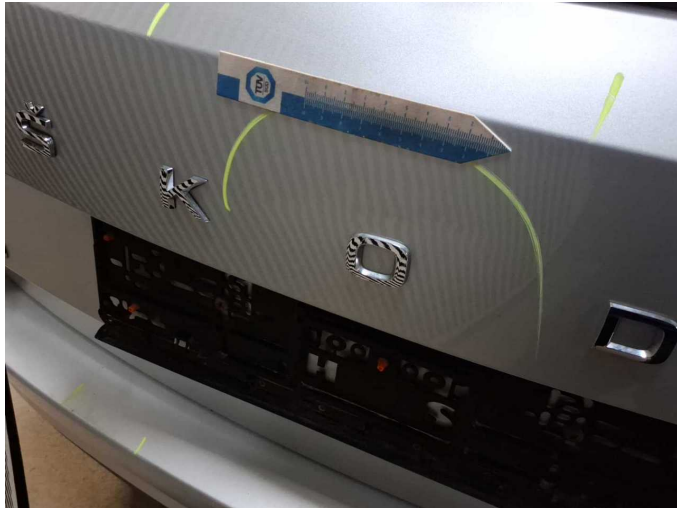
| No. | Component group | Description |
|---|---|---|
| 9 | Boot lid / rear door | Boot lid - Dent / paintcoat damage - Repair and paint |

**Damage 9:** Boot lid / rear door: Boot lid - Dent / paintcoat damage - Repair and paint

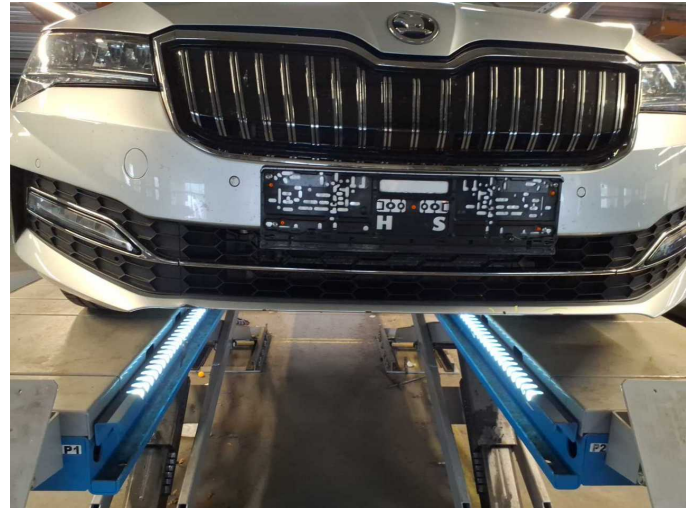
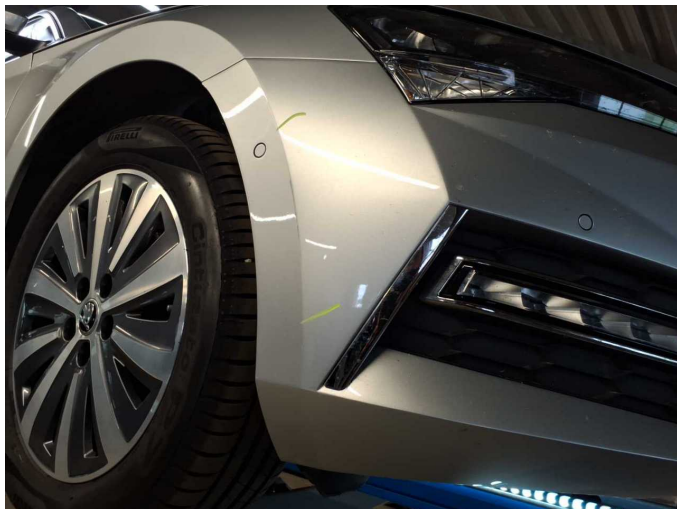
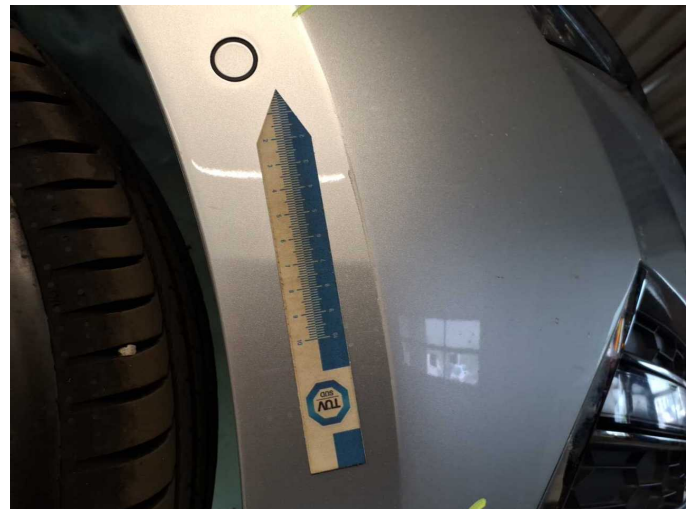
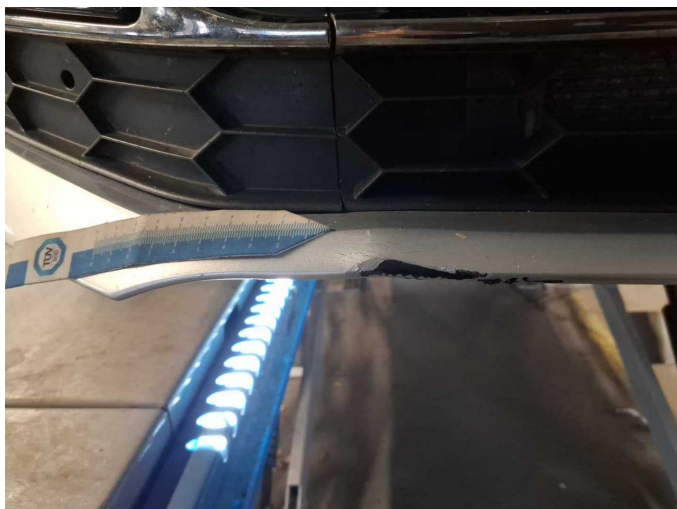
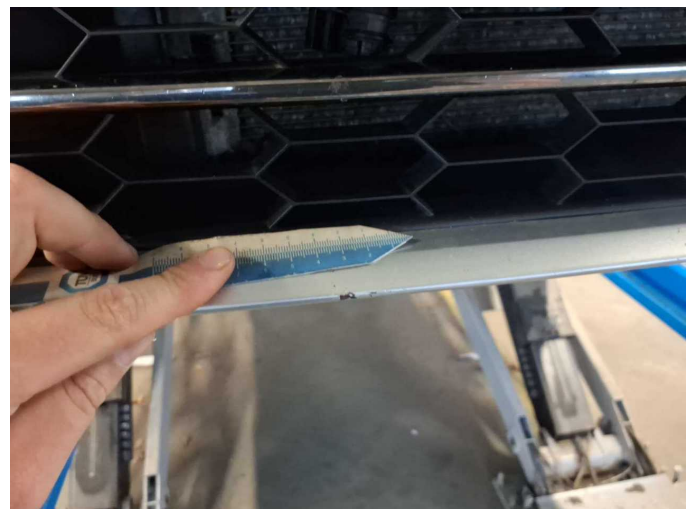
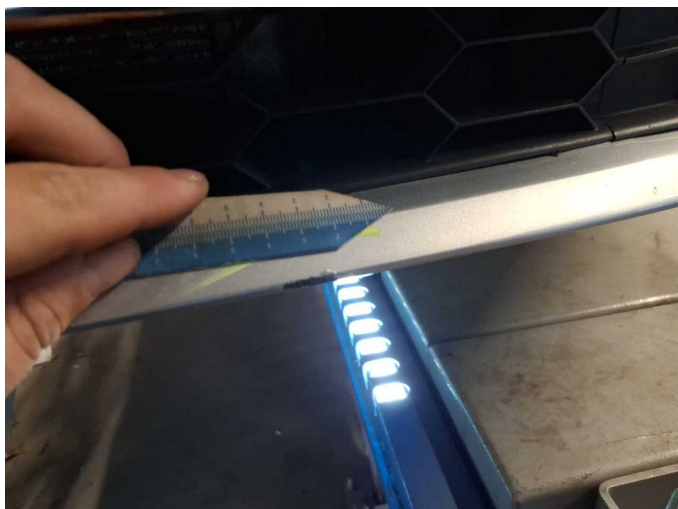
| No. | Component group | Description |
|---|---|---|
| 10 | Front bumper | Front bumper - Dent / paintcoat damage - Replace |

**Damage 10:** Front bumper: Front bumper - Dent / paintcoat damage - Replace

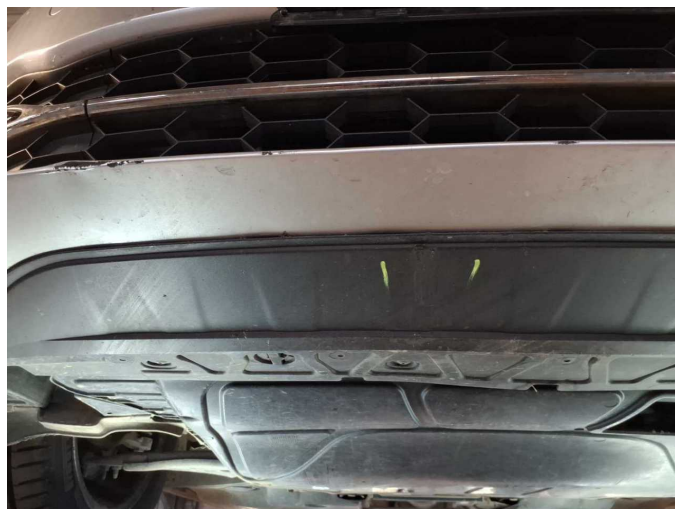
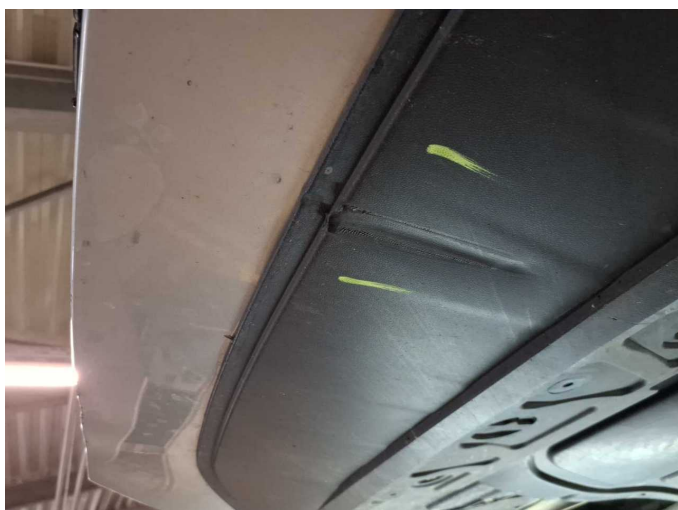
| No. | Component group | Description |
|---|---|---|
| 2 | Body | Underbody panelling - Scratch(es) - No deduction |

**Wear and tear 2:** Body: Underbody panelling - Scratch(es) - No deduction
