Expertise

Protocol number: 46841956  
Order No. / Reference: 26606591  
Inspection date: 3 Aug 2026

Manufacturer: Ford

Model: S-Max 2.5 Duratec FHEV TITANIUM

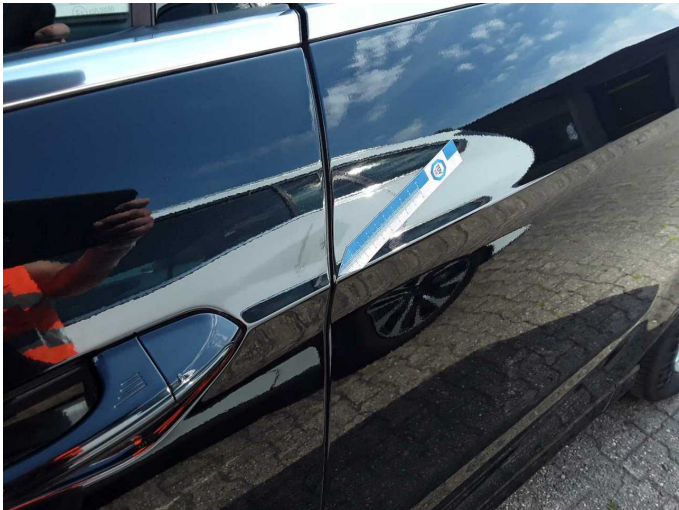
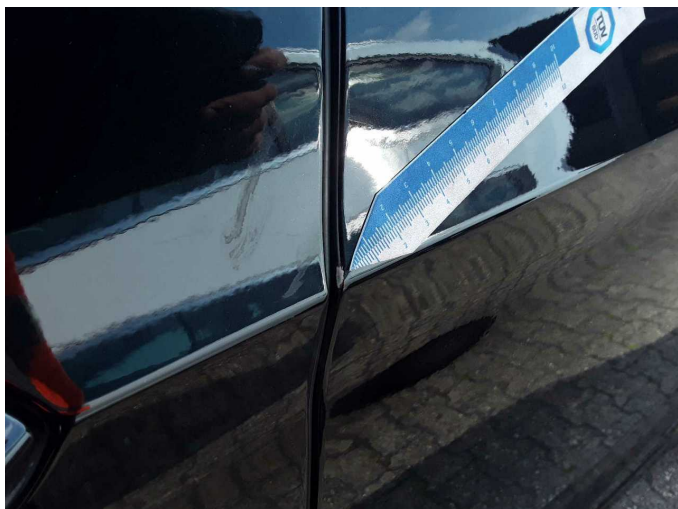
| No. | Component group | Description |
|---|---|---|
| 1 | Door - rear left side | Door - Dent / paintcoat damage - Smart repair |

Damage 1: Door - rear left side: Door - Dent / paintcoat damage - Smart repair

**Damage 1:** Door - rear left side: Door - Dent / paintcoat damage - Smart repair

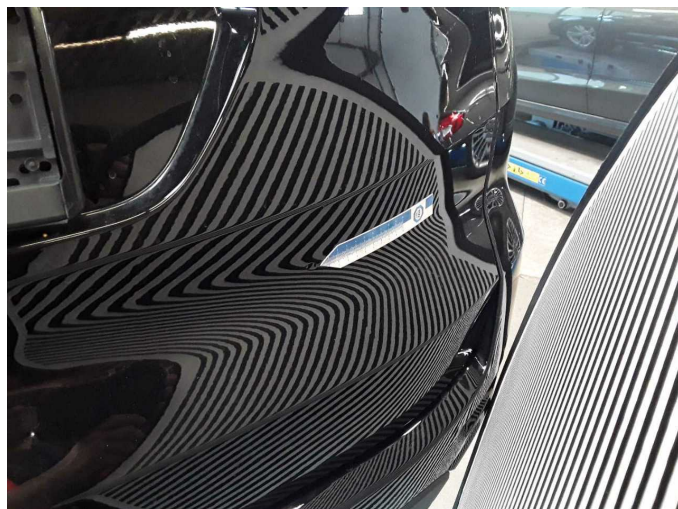
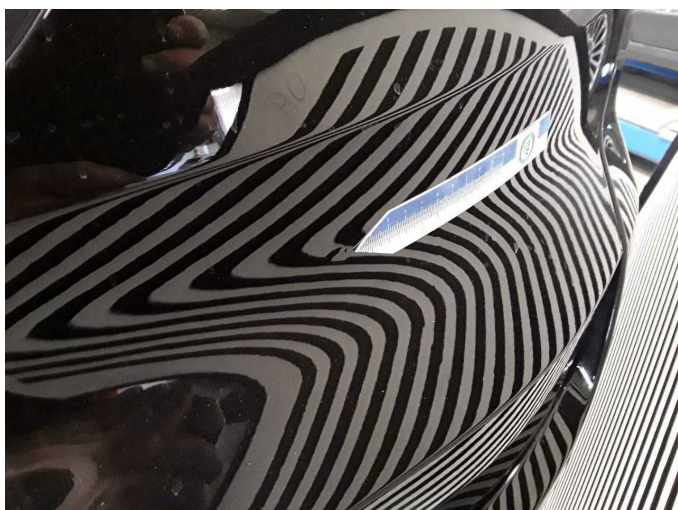
| No. | Component group | Description |
|---|---|---|
| 2 | Boot lid / rear door | Boot lid - Dent / paintcoat damage - Smart repair |

**Damage 2:** Boot lid / rear door: Boot lid - Dent / paintcoat damage - Smart repair

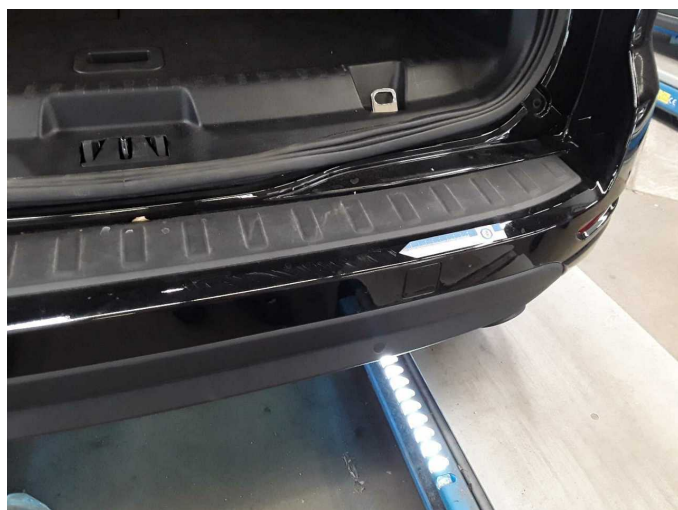
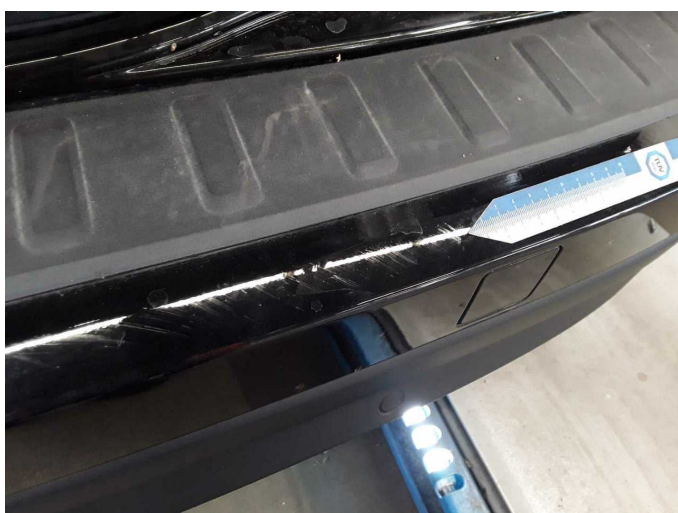
| No. | Component group | Description |
|---|---|---|
| 3 | Rear bumper | Rear bumper - Scratched - Paint |

**Damage 3:** Rear bumper: Rear bumper - Scratched - Paint

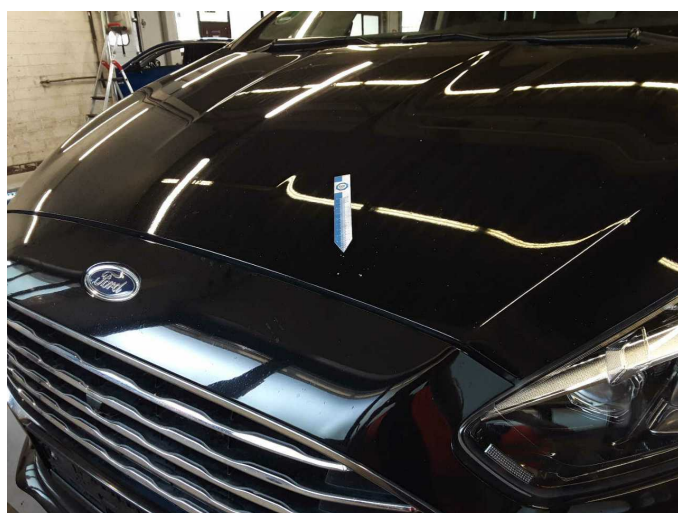
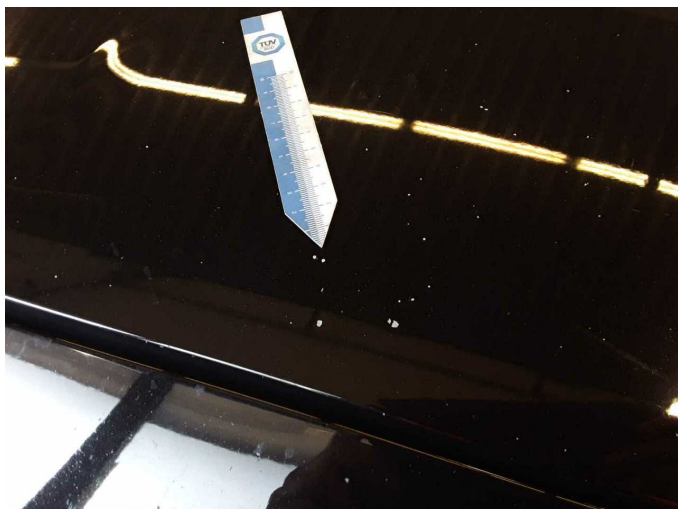
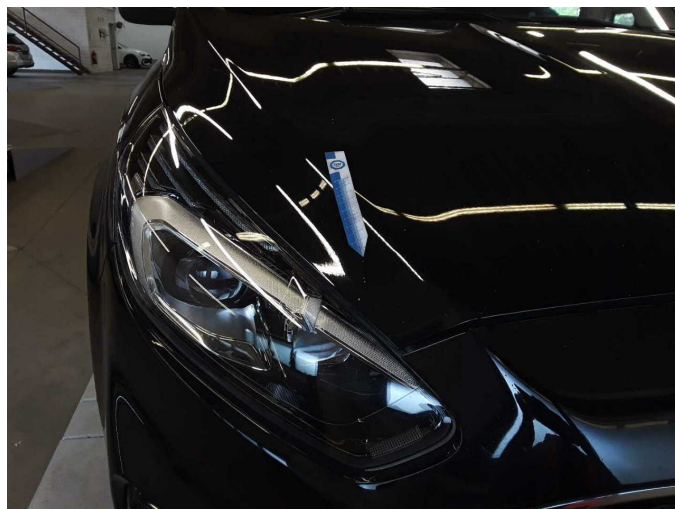
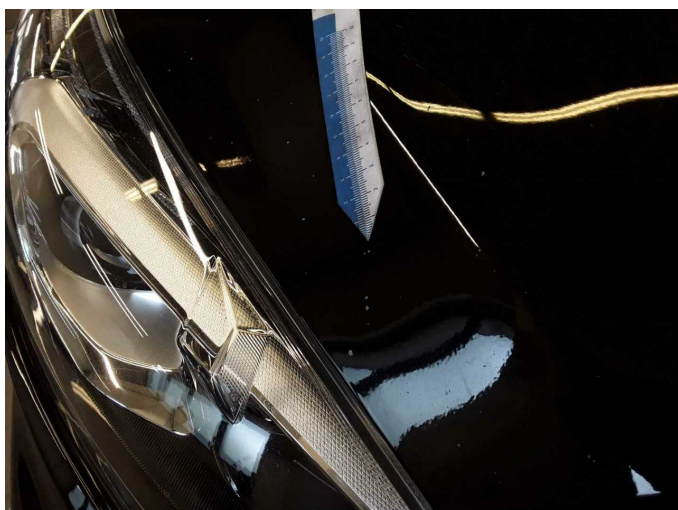
| No. | Component group | Description |
|---|---|---|
| 1 | Bonnet | Bonnet - Stone chips - No deduction |

**Wear and tear 1:** Bonnet: Bonnet - Stone chips - No deduction

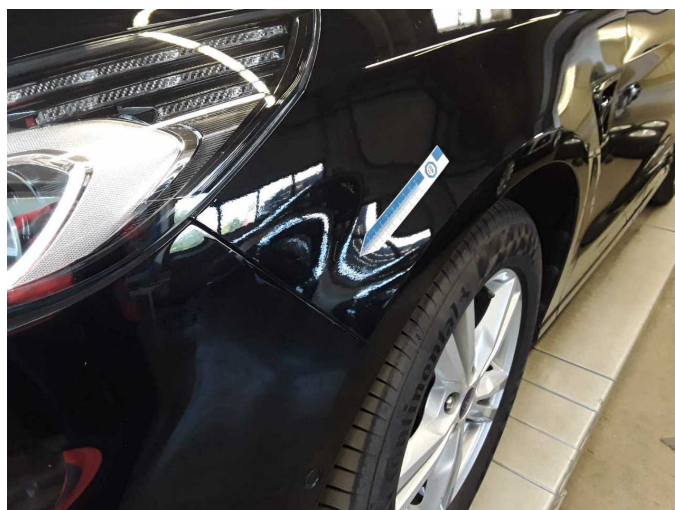
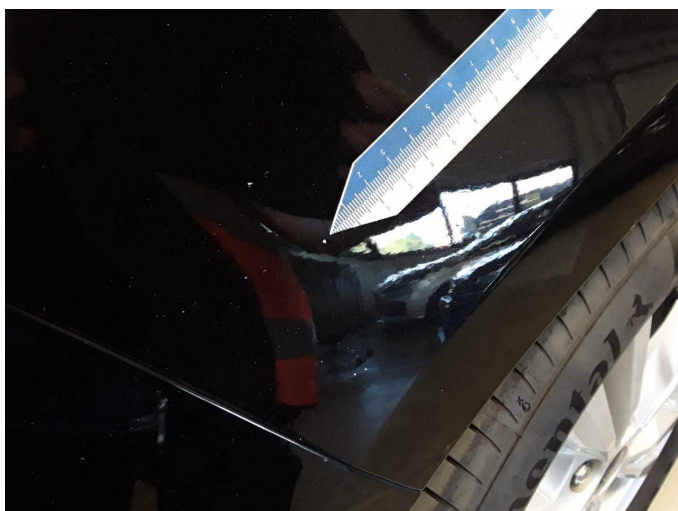
| No. | Component group | Description |
|---|---|---|
| 2 | Mudguard - left side | Mudguard - left side - Stone chips - No deduction |

**Wear and tear 2:** Mudguard - left side: Mudguard - left side - Stone chips - No deduction

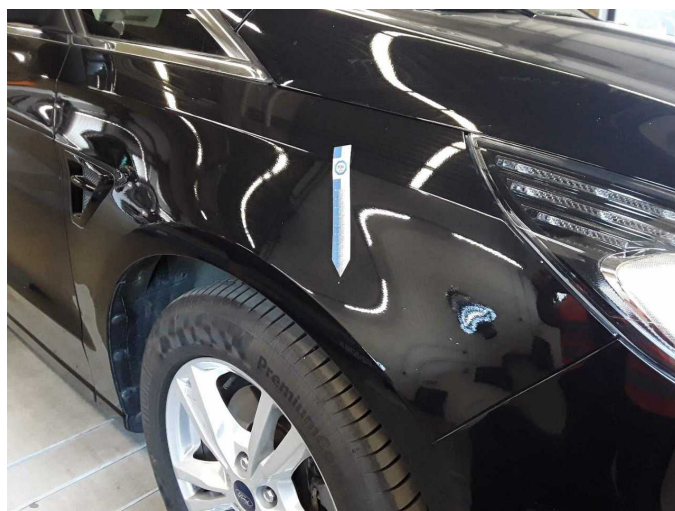
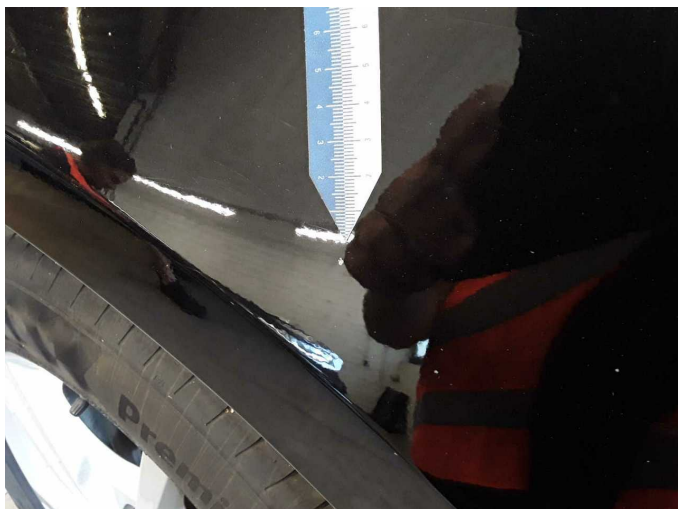
| No. | Component group | Description |
|---|---|---|
| 3 | Mudguard - right side | Mudguard - right side - Stone chips - No deduction |

**Wear and tear 3:** Mudguard - right side: Mudguard - right side - Stone chips - No deduction

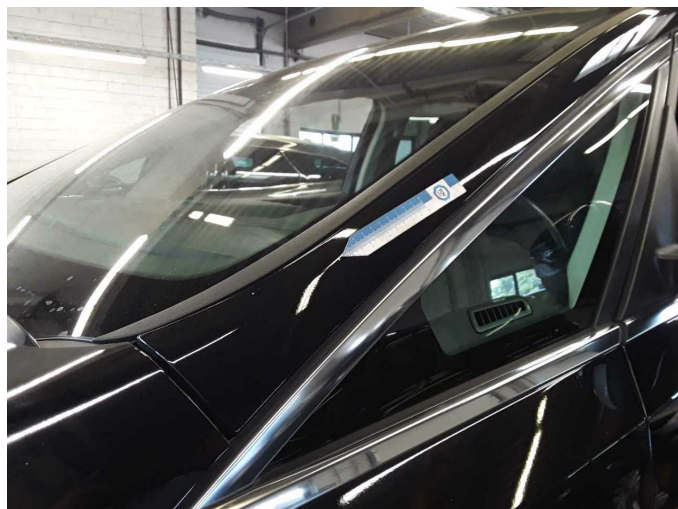
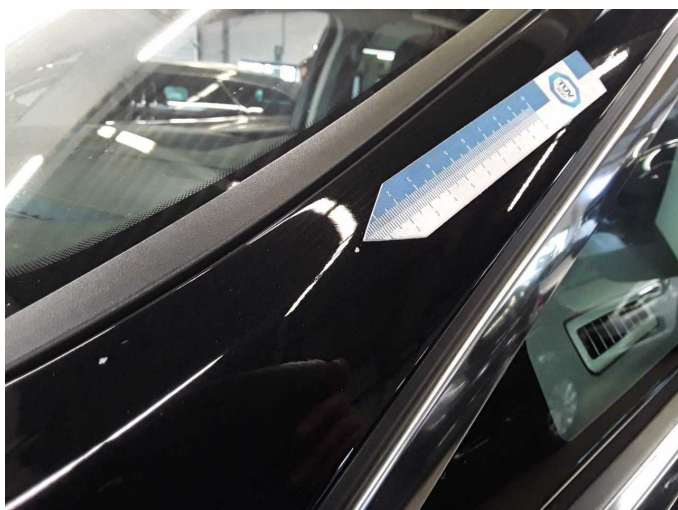
| No. | Component group | Description |
|---|---|---|
| 4 | Roof | Roof rail - left side - Stone chips - No deduction |

**Wear and tear 4:** Roof: Roof rail - left side - Stone chips - No deduction

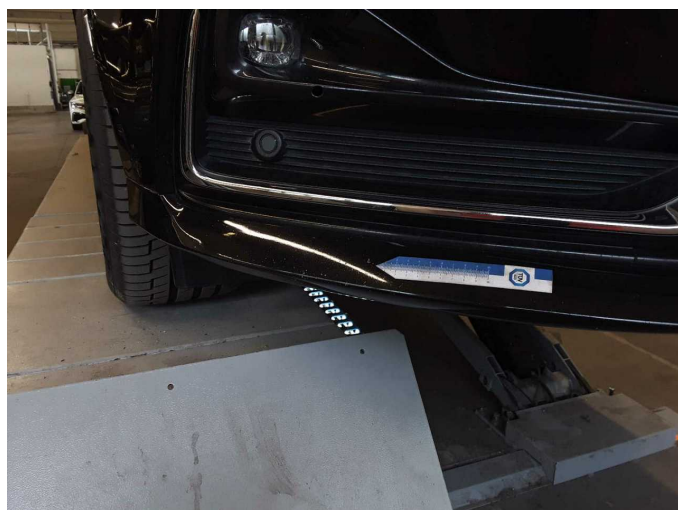
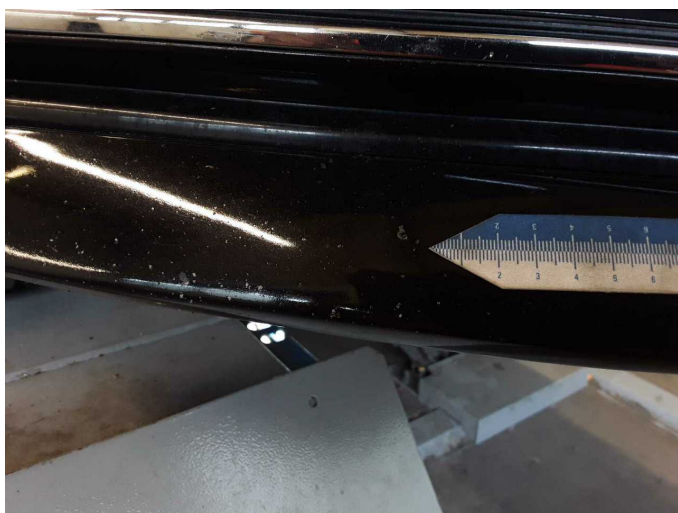
| No. | Component group | Description |
|---|---|---|
| 5 | Front bumper | Front bumper - Stone chips - No deduction |

**Wear and tear 5:** Front bumper: Front bumper - Stone chips - No deduction

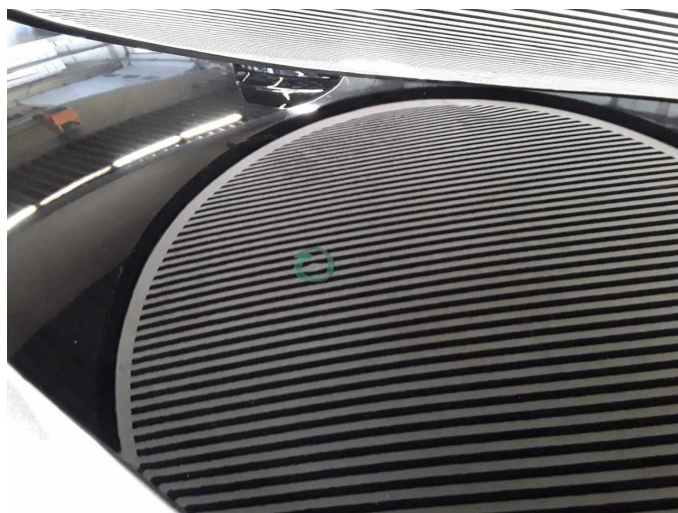
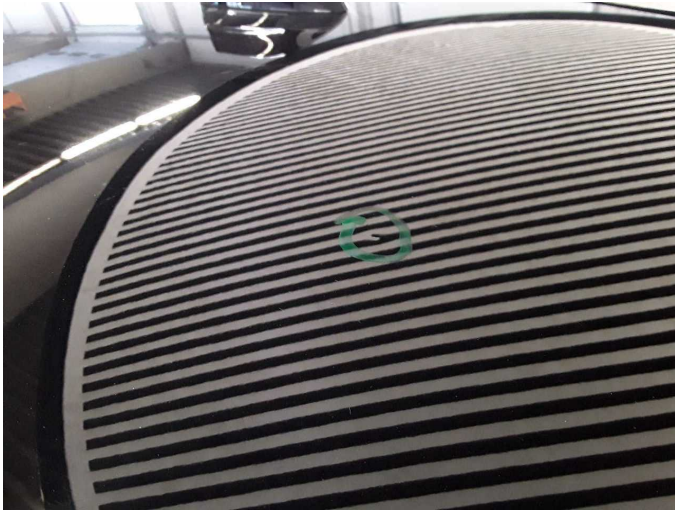
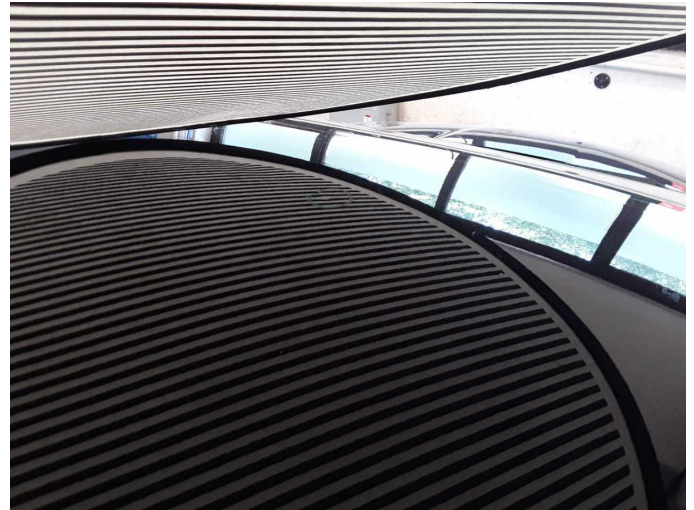
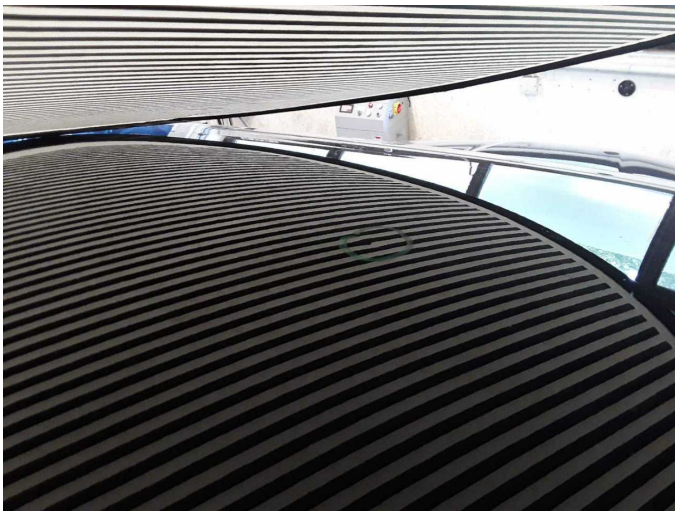
| No. | Component group | Description |
|---|---|---|
| 6 | Roof | Roof - dent(s) - Smooth repair work |

**Wear and tear 6:** Roof: Roof - dent(s) - Smooth repair work
