Expertise

Protocol number: 46311703
Order No. / Reference: 26412168
Inspection date: 1 Jul 2026

Model: Focus Turnier 1.0 EcoBoost Start-Stopp-System TITANIUM

VIN: WF0PXXGCHPNG35445

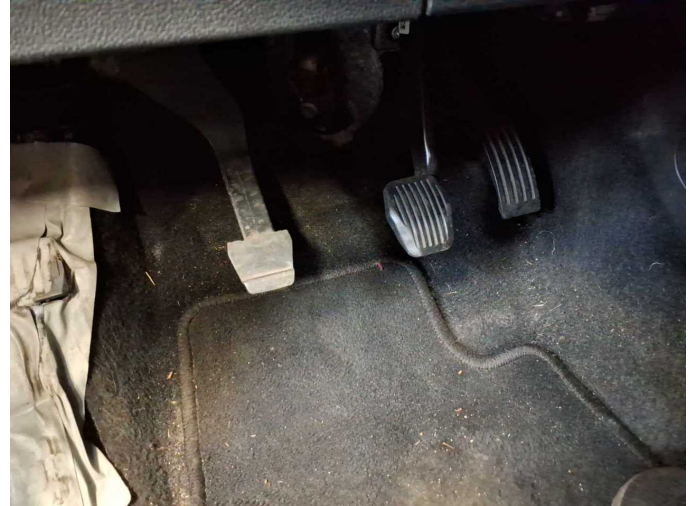
Damage 1: Pedal system: Clutch pedal cover / rubber - Missing - Replace

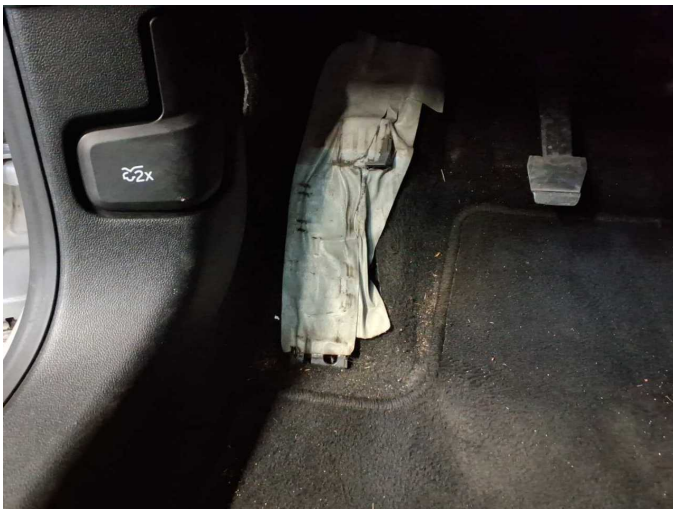
Damage 2: Misc.: Misc. (Fußablage) - Missing - Replace

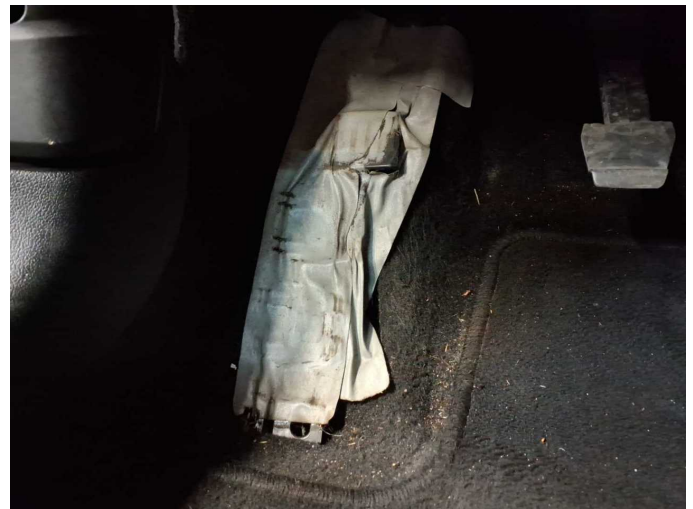
Damage 2: Misc.: Misc. (Fußablage) - Missing - Replace

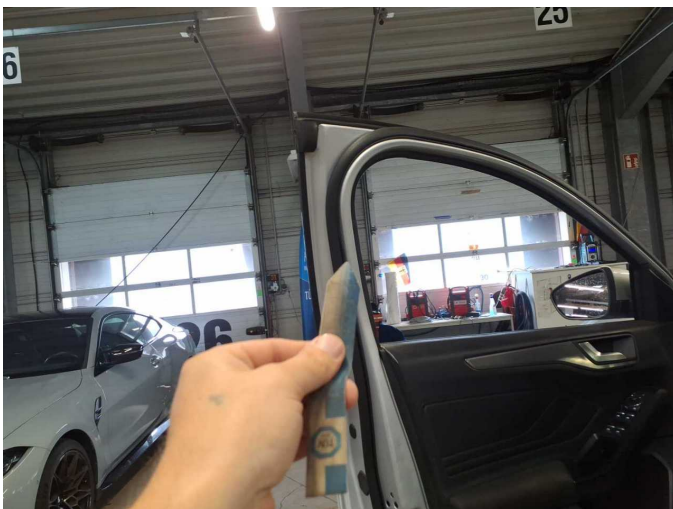
Damage 3: Door - front left side: Door seal - Loose - Repair

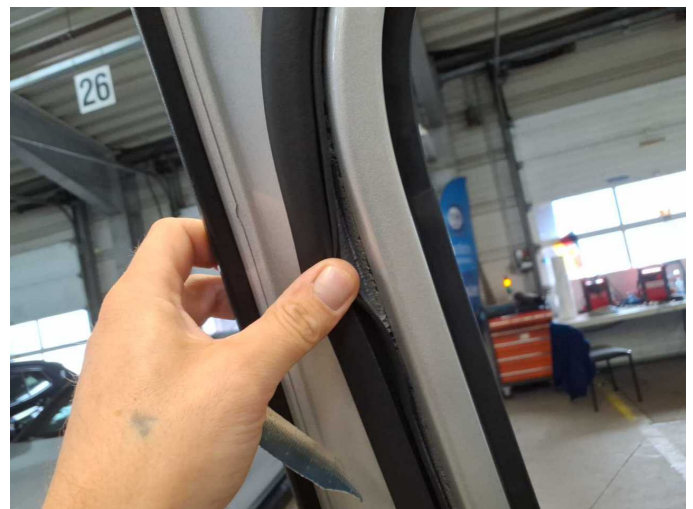
Damage 3: Door - front left side: Door seal - Loose - Repair

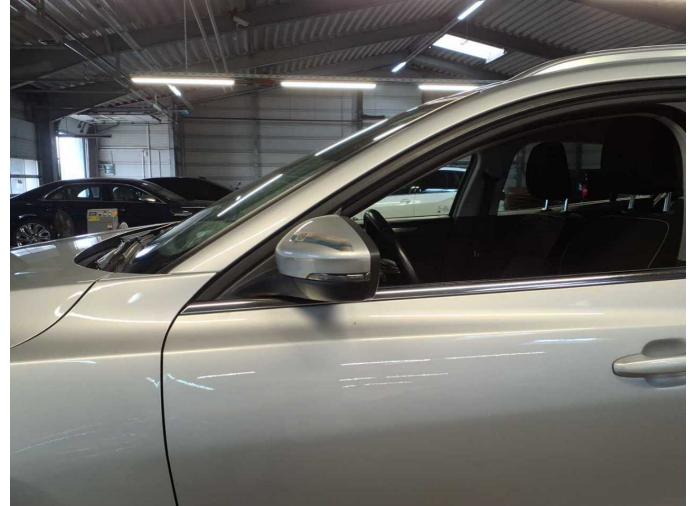
Damage 4: Wing mirror - left side: Cap - Scratch(es) - Smart repair

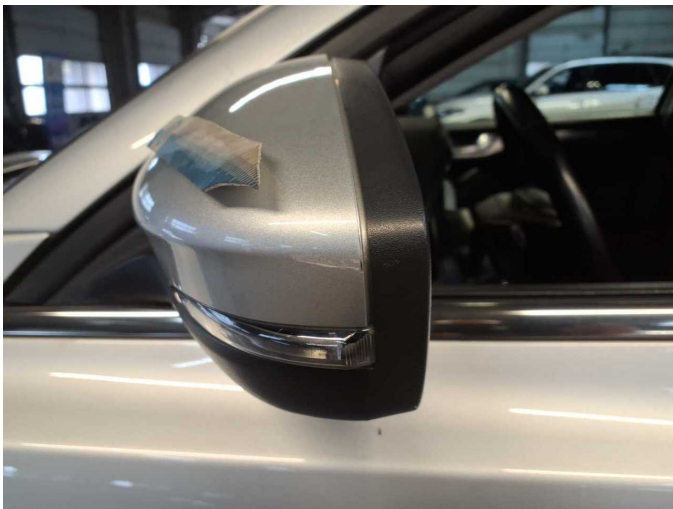
Damage 4: Wing mirror - left side: Cap - Scratch(es) - Smart repair

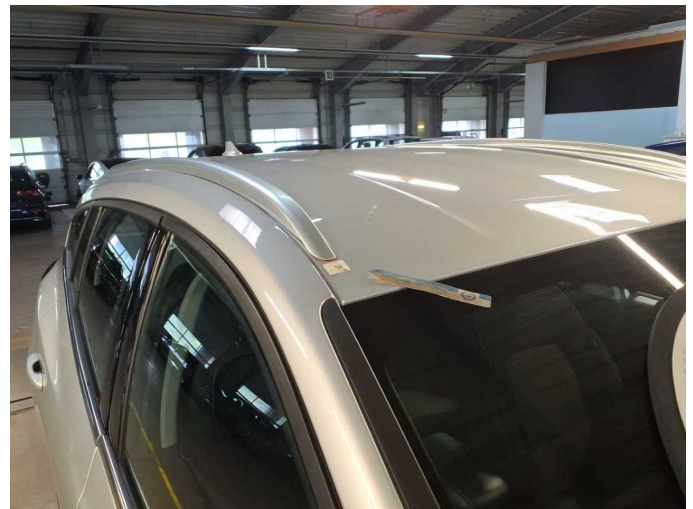
Damage 5: Roof: Roof - Glued / labelled - De-glu / neutralise

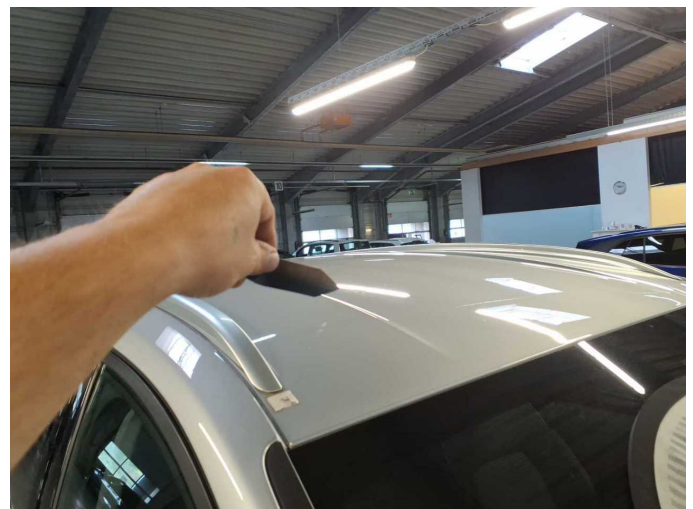
Damage 5: Roof: Roof - Glued / labelled - De-glu / neutralise

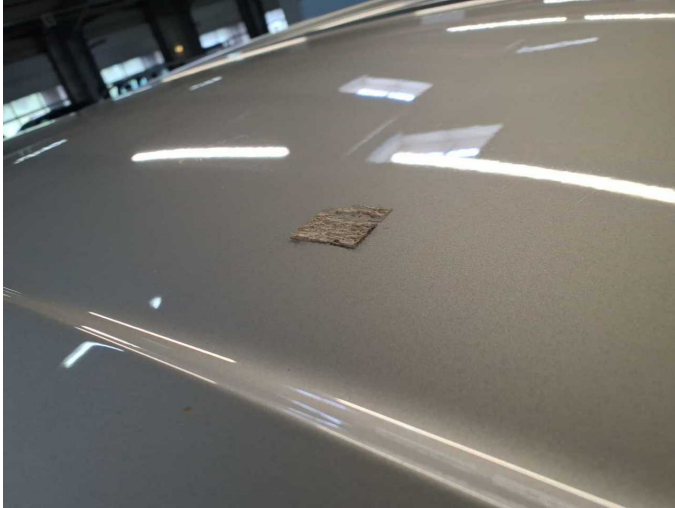
Damage 5: Roof: Roof - Glued / labelled - De-glue / neutralise

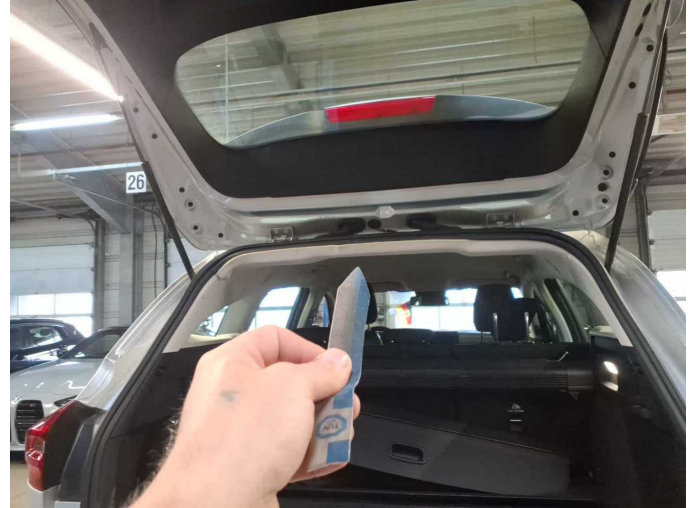
Damage 6: Trim / covers: Roof lining - Loose - Un- / install

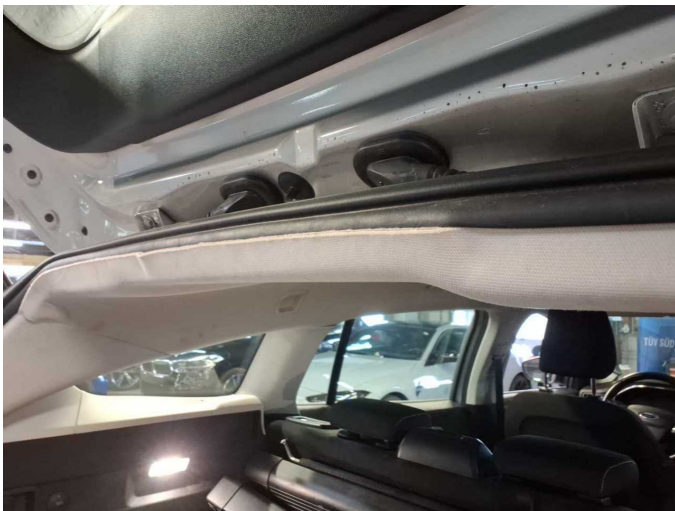
Damage 6: Trim / covers: Roof lining - Loose - Un- / install

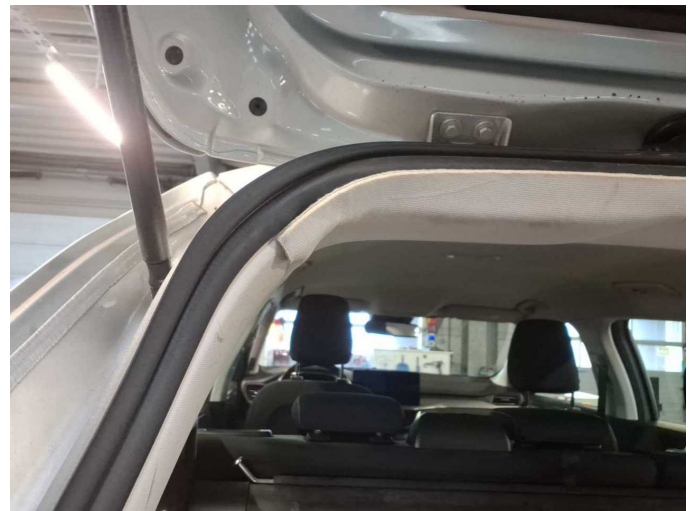
Damage 6: Trim / covers: Roof lining - Loose - Un- / install

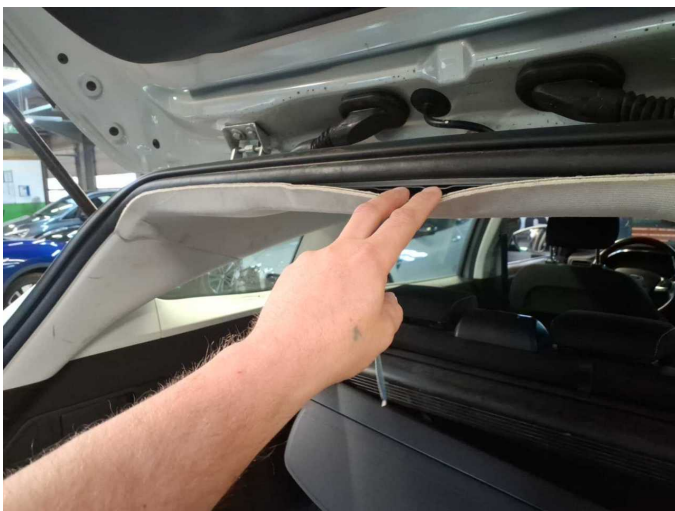
Damage 6: Trim / covers: Roof lining - Loose - Un- / install

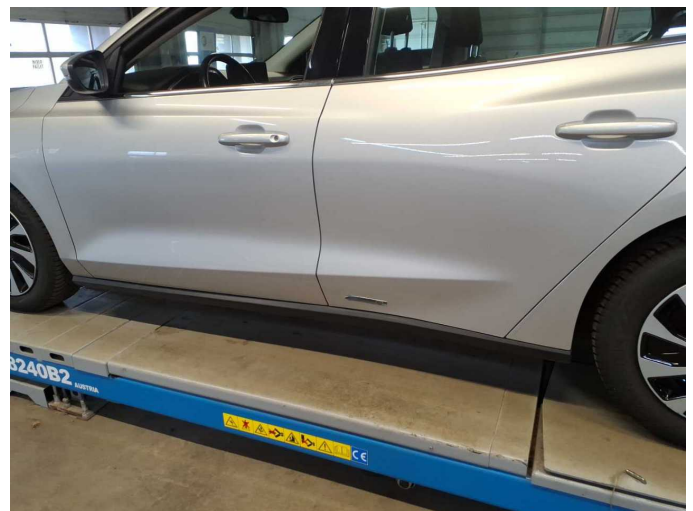
Damage 7: Door - rear left side: Door - dent(s) - Smooth repair work

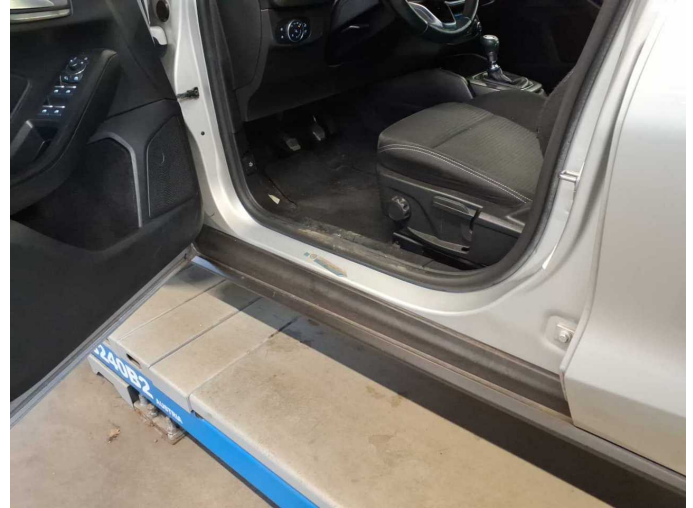
Damage 8: Sill - left side: Sill - dent(s) - Smooth repair work

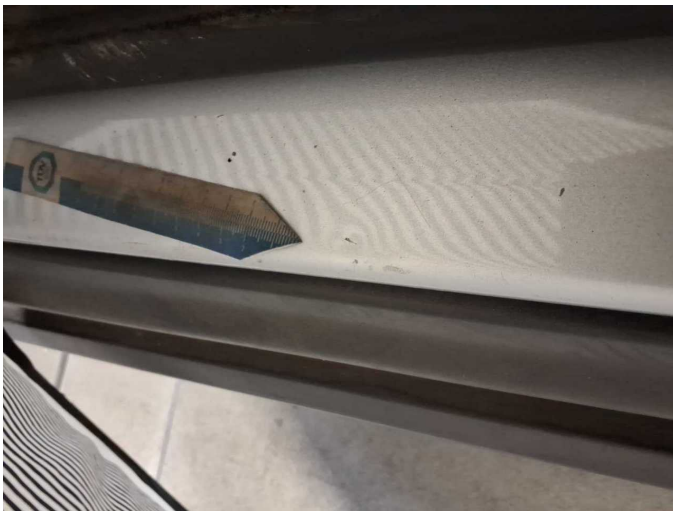
Damage 8: Sill - left side: Sill - dent(s) - Smooth repair work

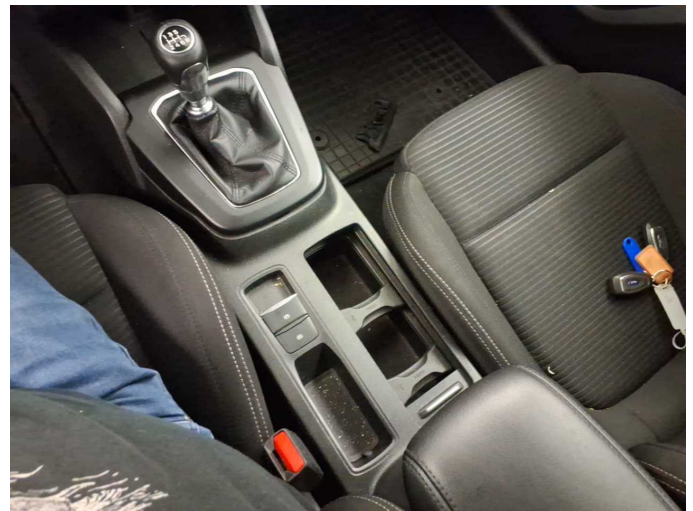
Damage 9: Instrument panel: Centre console - front (Evtl. Mehrkosten) - Loose - Un- / install

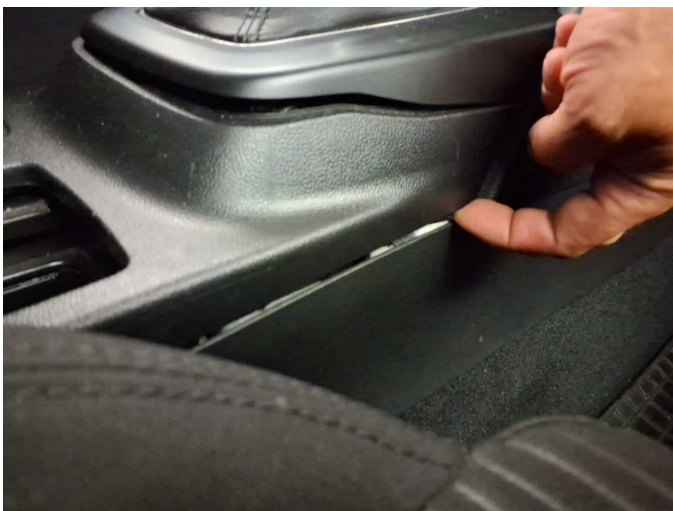
Damage 9: Instrument panel: Centre console - front (Evtl. Mehrkosten) - Loose - Un- / install

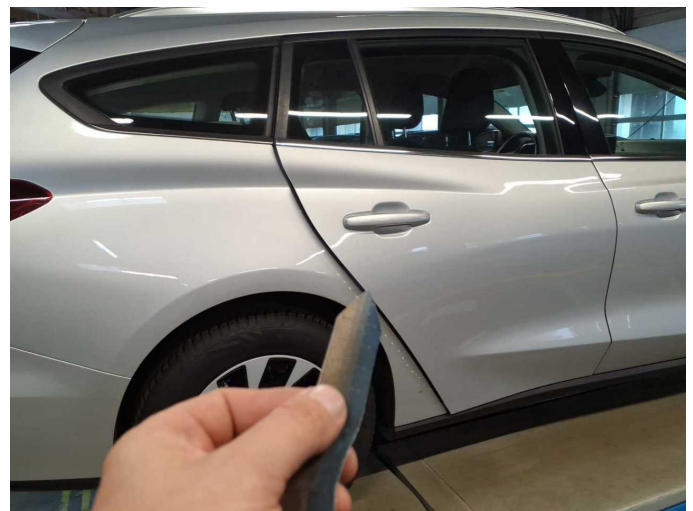
Damage 10: Door - rear right side: Door (Hängt durch, liegt nicht richtig an) - Malposition - Set / adjust

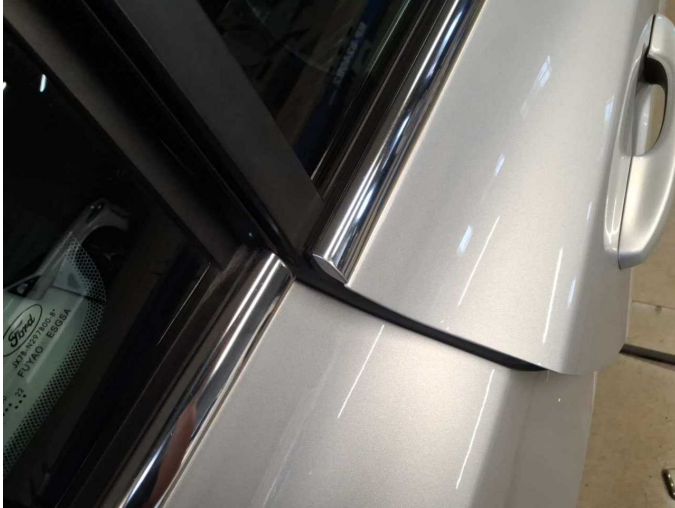
Damage 10: Door - rear right side: Door (Hängt durch, liegt nicht richtig an) - Malposition - Set / adjust

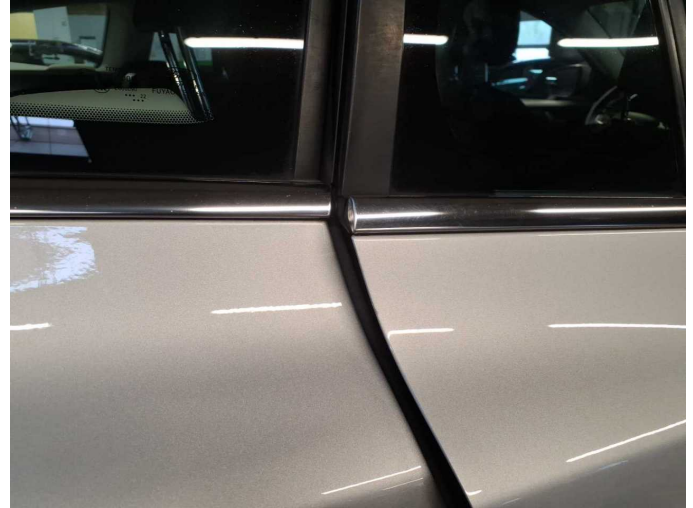
Damage 10: Door - rear right side: Door (Hängt durch, liegt nicht richtig an) - Malposition - Set / adjust

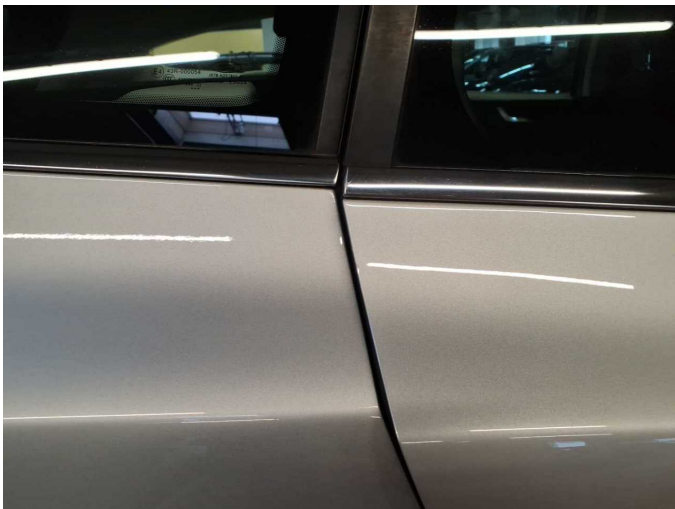
Damage 10: Door - rear right side: Door (Hängt durch, liegt nicht richtig an) - Malposition - Set / adjust

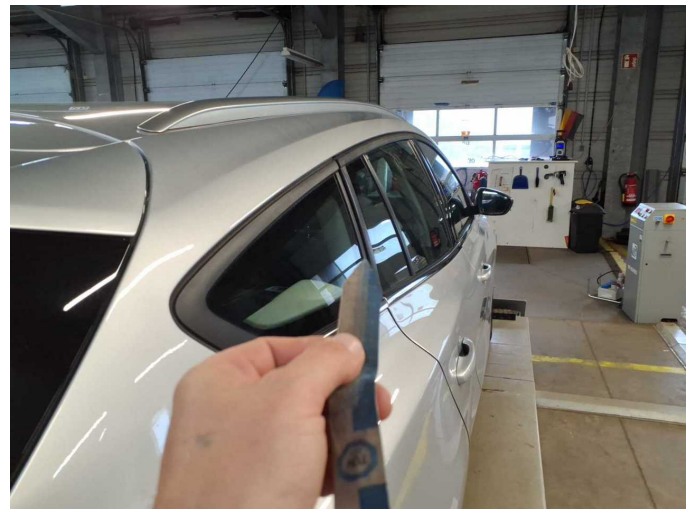
Damage 10: Door - rear right side: Door (Hängt durch, liegt nicht richtig an) - Malposition - Set / adjust

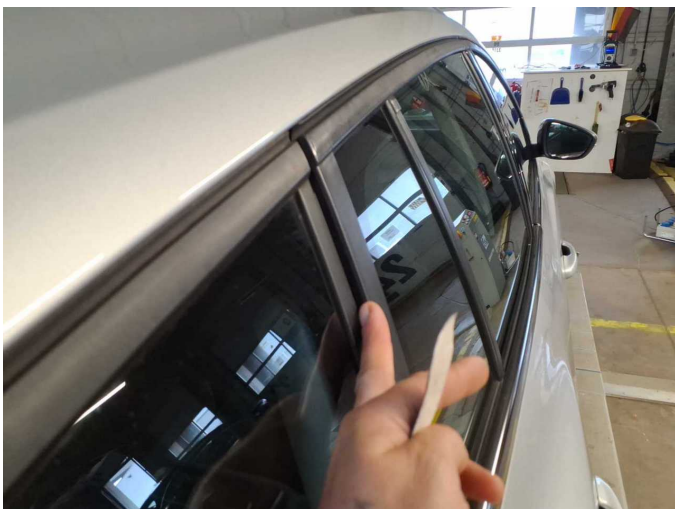
Damage 10: Door - rear right side: Door (Hängt durch, liegt nicht richtig an) - Malposition - Set / adjust

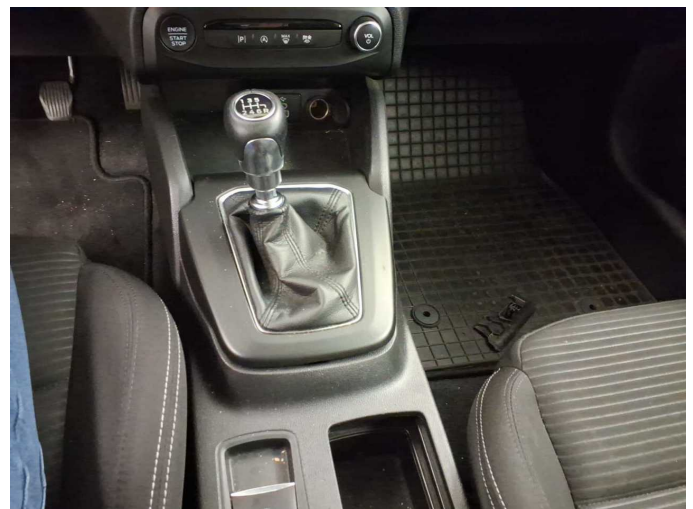
Damage 11: Misc.: Misc. (Abdeckung Schaltung, geklebt) - Broken / torn - Replace

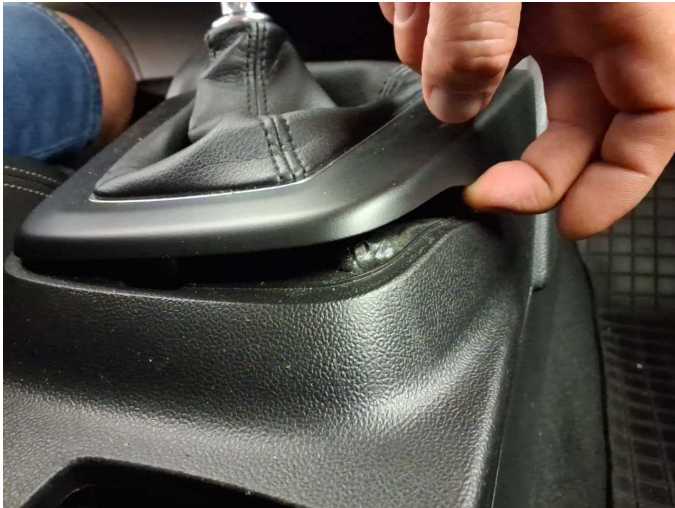
Damage 11: Misc.: Misc. (Abdeckung Schaltung, geklebt) - Broken / torn - Replace

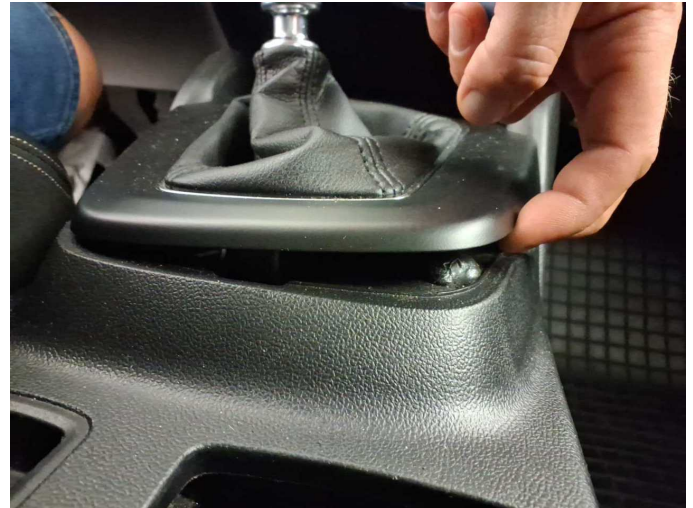
Damage 11: Misc.: Misc. (Abdeckung Schaltung, geklebt) - Broken / torn - Replace

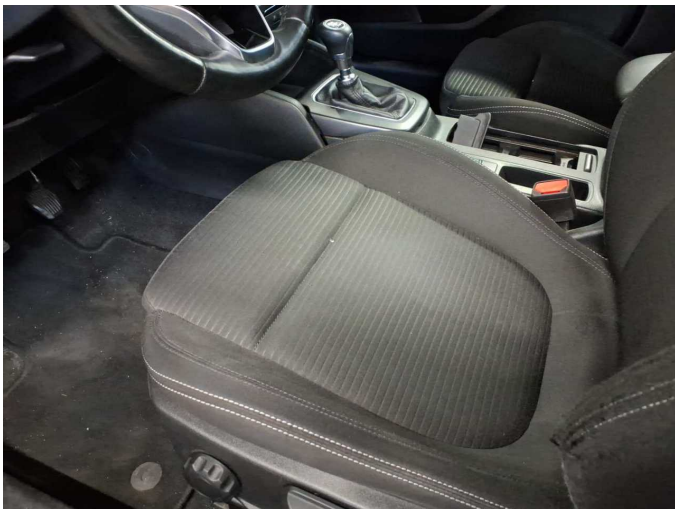
Damage 12: Seat - front: Seat cover - left side - Burn hole (cigarettes) - Smart repair

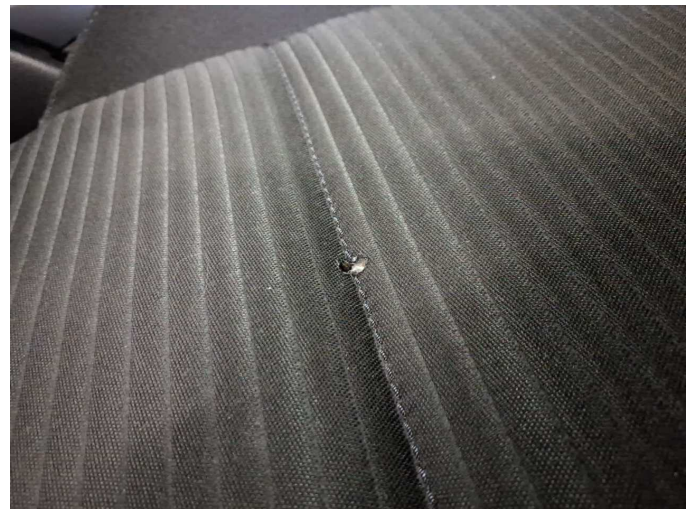
Damage 12: Seat - front: Seat cover - left side - Burn hole (cigarettes) - Smart repair

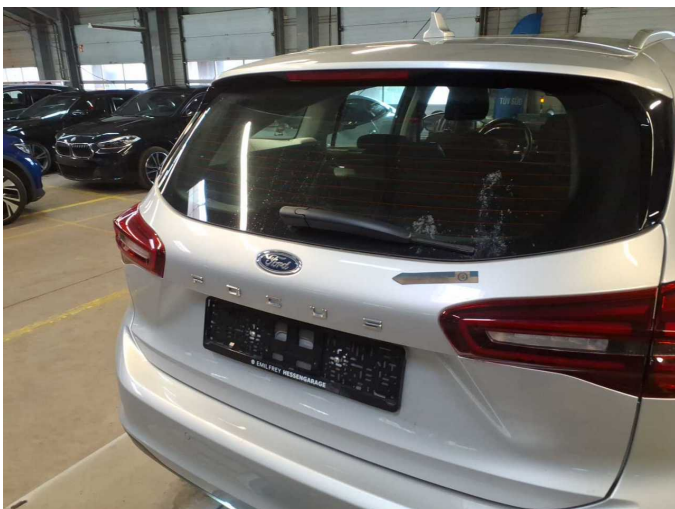
Damage 13: Boot lid / rear door: Boot lid - dent(s) - Smooth repair work

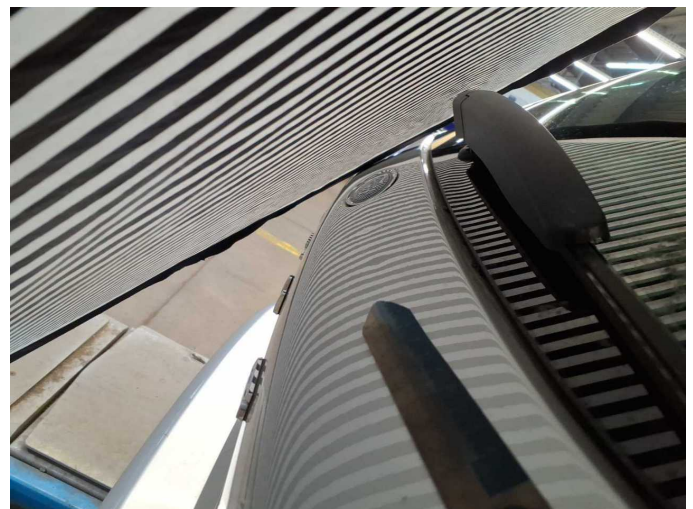
Damage 13: Boot lid / rear door: Boot lid - dent(s) - Smooth repair work

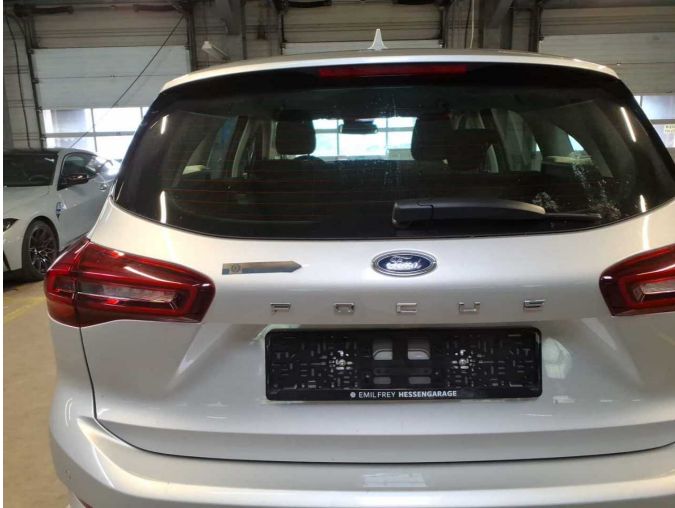
Damage 13: Boot lid / rear door: Boot lid - dent(s) - Smooth repair work

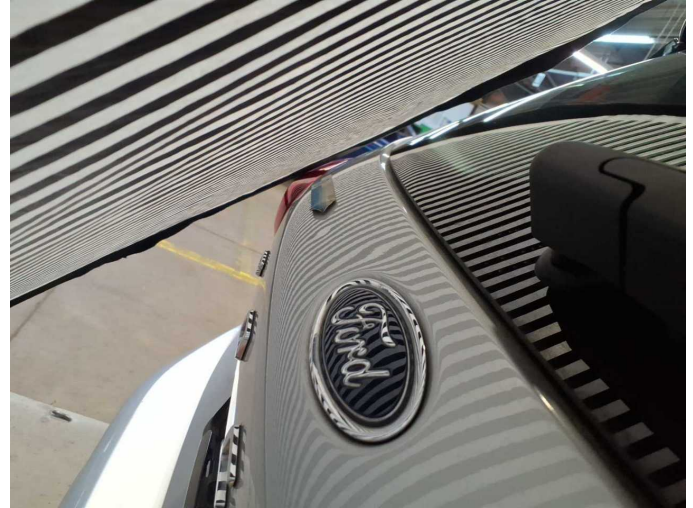
Damage 13: Boot lid / rear door: Boot lid - dent(s) - Smooth repair work

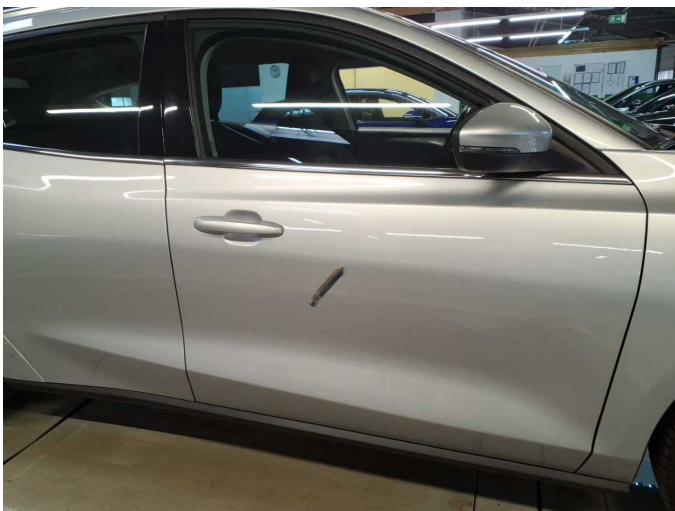
Damage 14: Door - front right side: Door - Dent / paintcoat damage - Smart repair

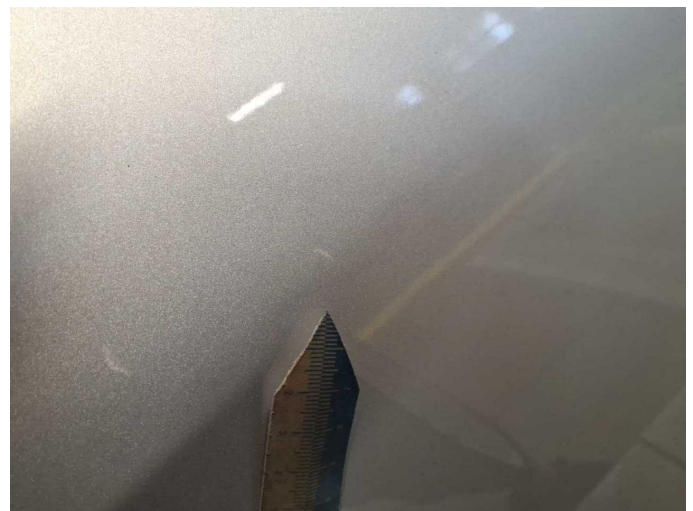
Damage 14: Door - front right side: Door - Dent / paintcoat damage - Smart repair

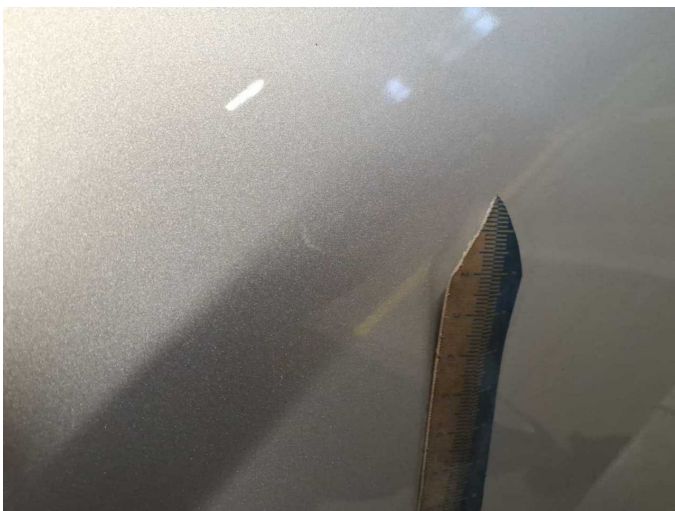
Damage 14: Door - front right side: Door - Dent / paintcoat damage - Smart repair

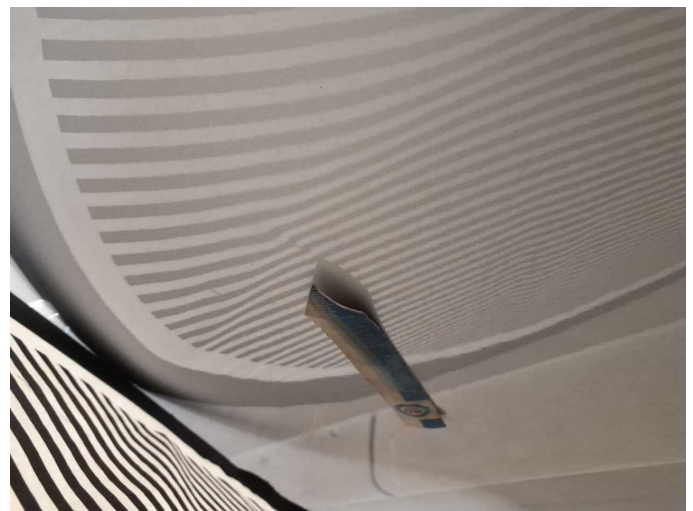
Damage 14: Door - front right side: Door - Dent / paintcoat damage - Smart repair

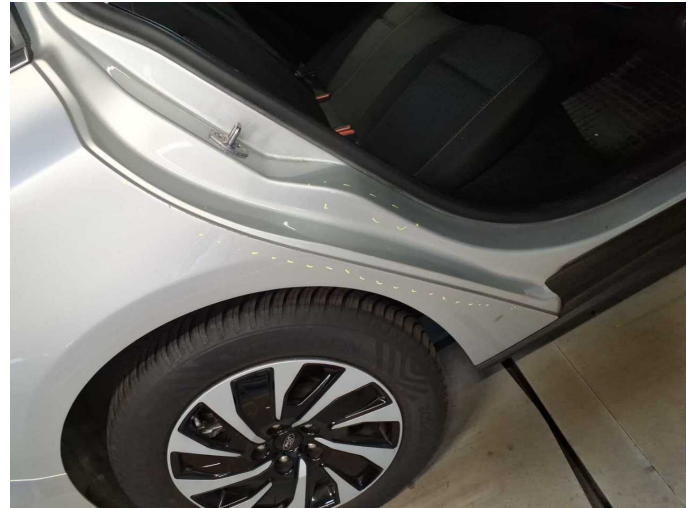
Damage 15: Side panel - rear right side: Side panel (+ Einstieg) - Scratch(es) - Smart repair

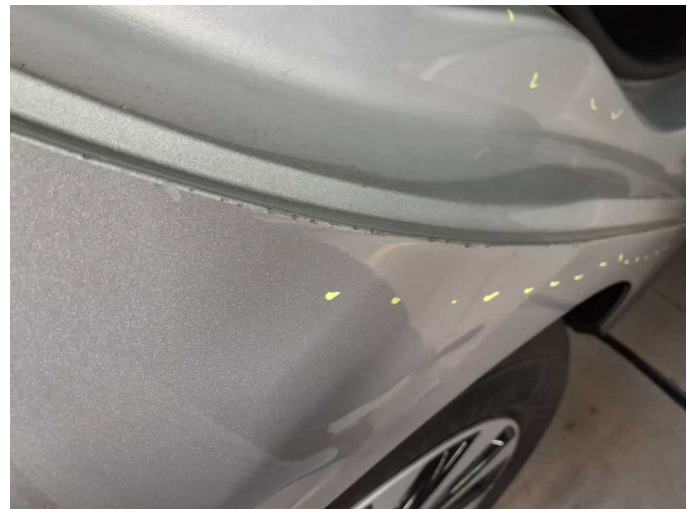
Damage 15: Side panel - rear right side: Side panel (+ Einstieg) - Scratch(es) - Smart repair

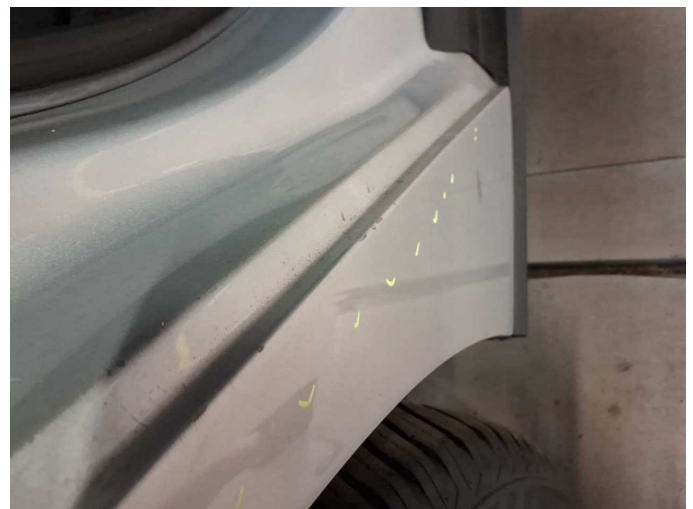
Damage 15: Side panel - rear right side: Side panel (+ Einstieg) - Scratch(es) - Smart repair

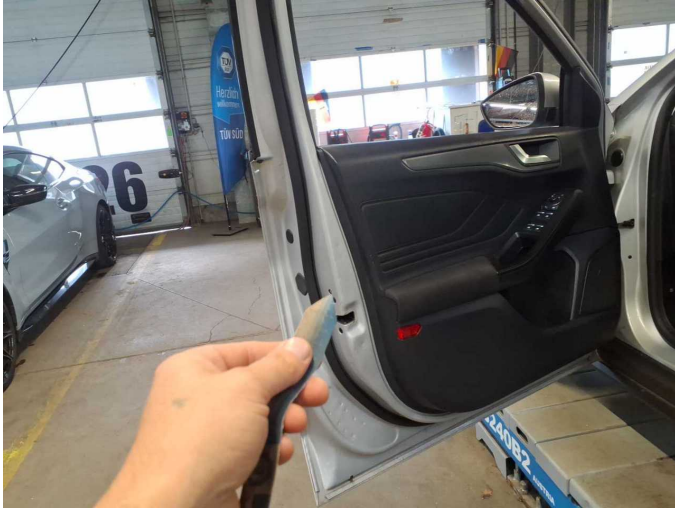
Damage 16: Door - front left side: Door (Innen) - dent(s) - Loss in value

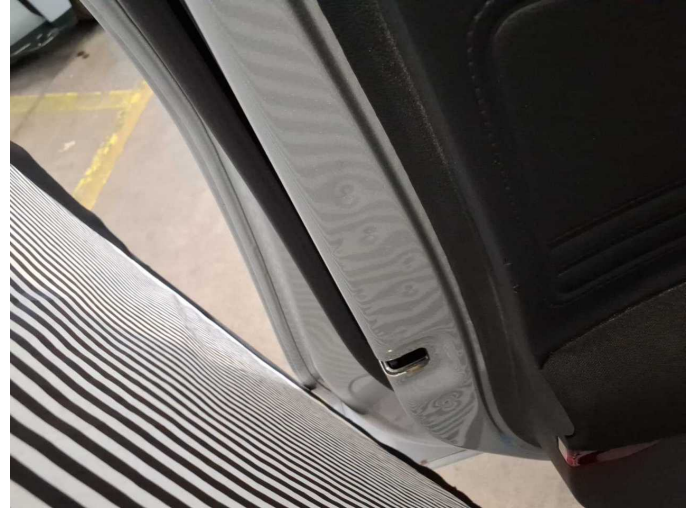
Damage 16: Door - front left side: Door (Innen) - dent(s) - Loss in value

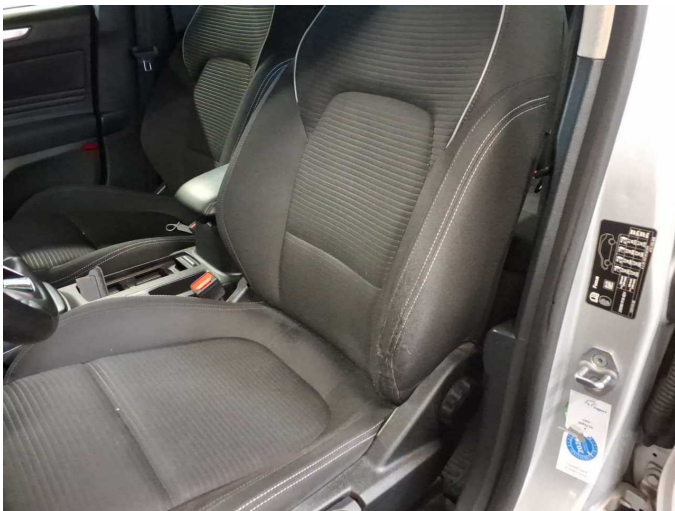
Damage 17: Seat - front: Seat cover - left side (Wange) - Broken / torn - Replace

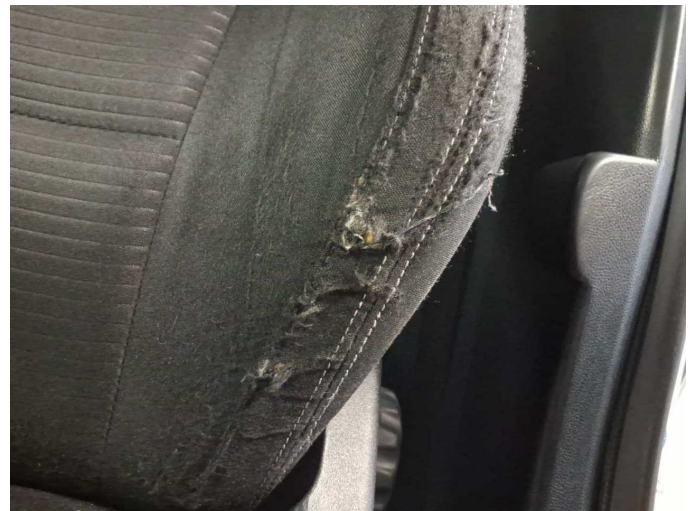
Damage 17: Seat - front: Seat cover - left side (Wange) - Broken / torn - Replace

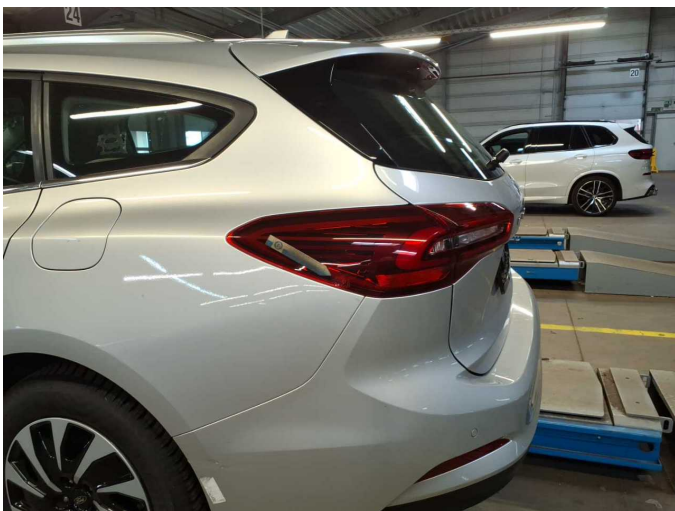
Damage 18: Tail light: Tail lamp - left side - Broken / torn - Replace

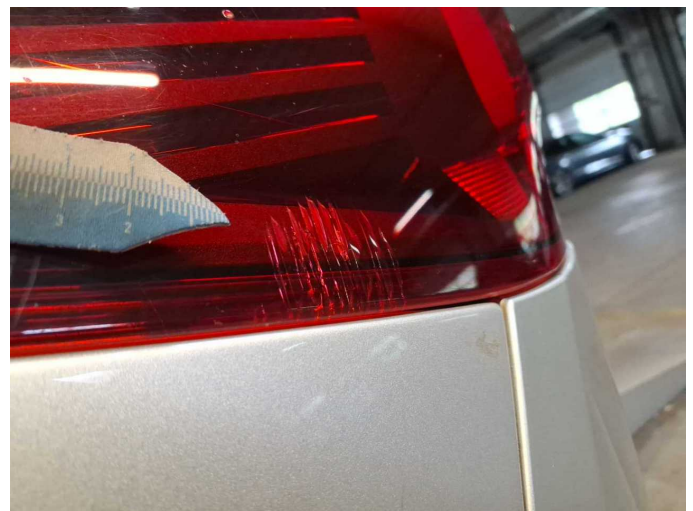
Damage 18: Tail light: Tail lamp - left side - Broken / torn - Replace

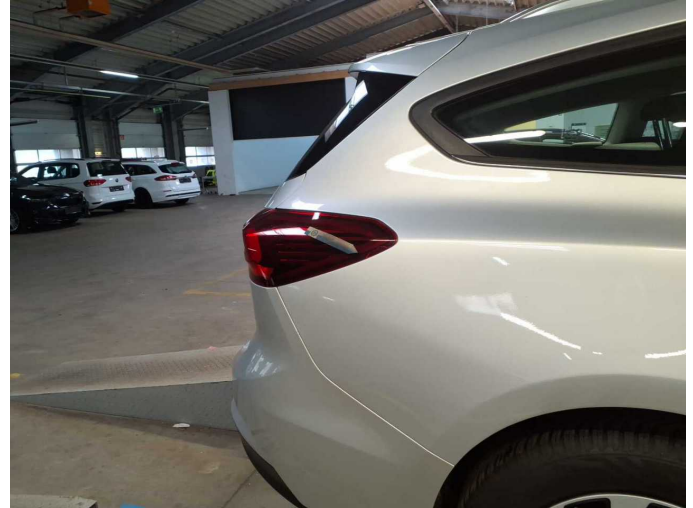
Damage 19: Tail light: Tail lamp - right side - Broken / torn - Replace

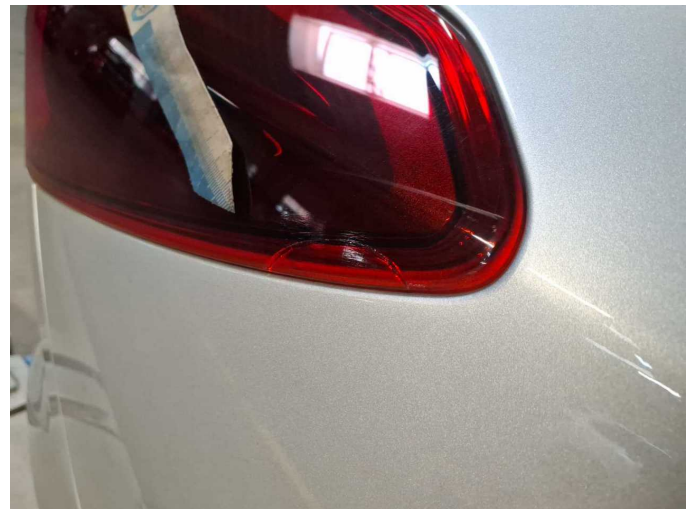
Damage 19: Tail light: Tail lamp - right side - Broken / torn - Replace

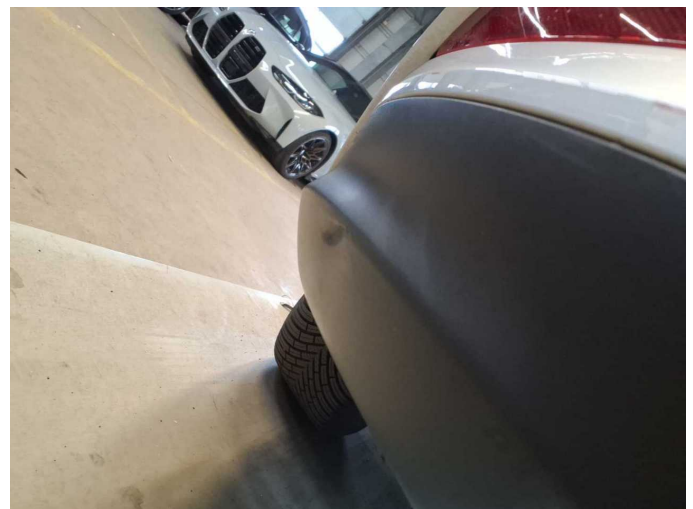
Damage 20: Rear bumper: Spoiler - Deformed - Replace

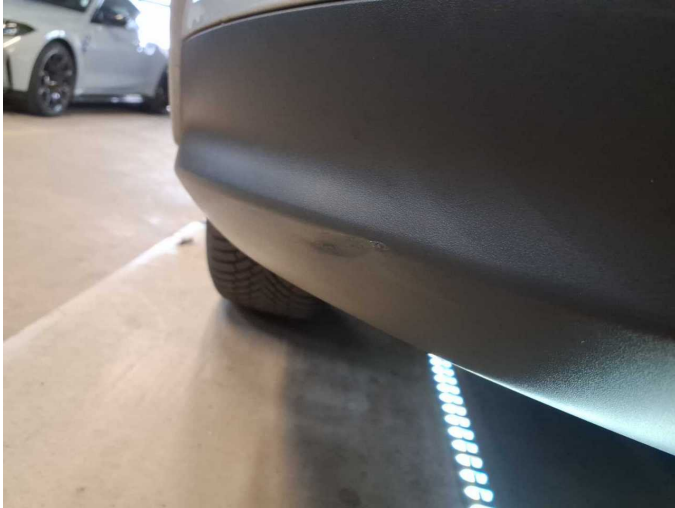
Damage 20: Rear bumper: Spoiler - Deformed - Replace

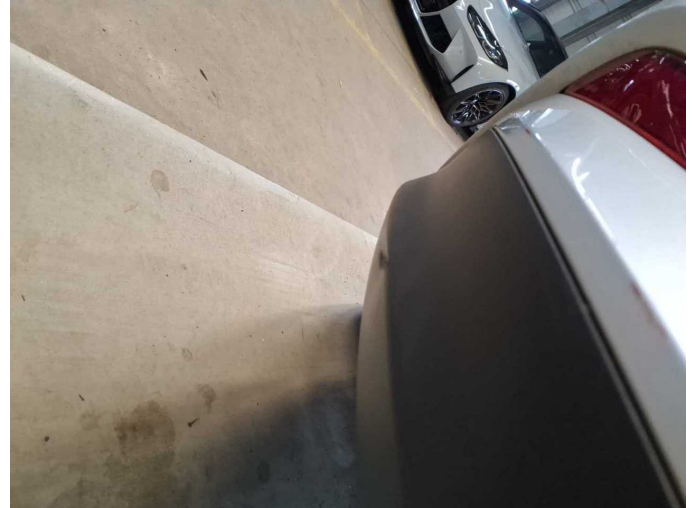
Damage 20: Rear bumper: Spoiler - Deformed - Replace

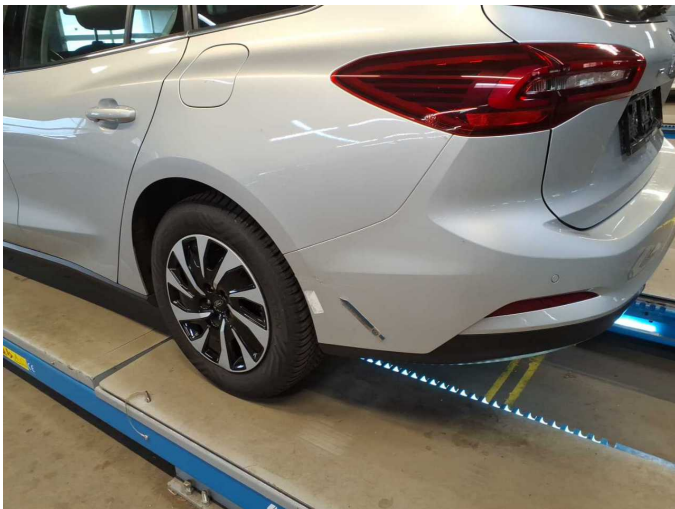
Damage 21: Rear bumper: Rear bumper - Scratched - Repair and paint

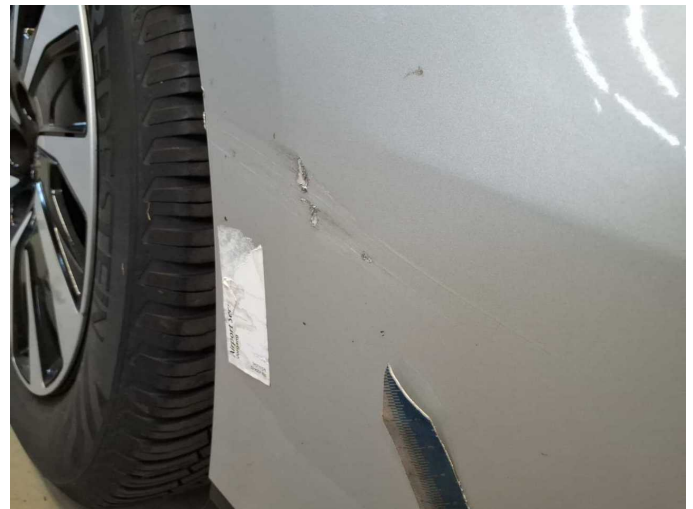
Damage 21: Rear bumper: Rear bumper - Scratched - Repair and paint

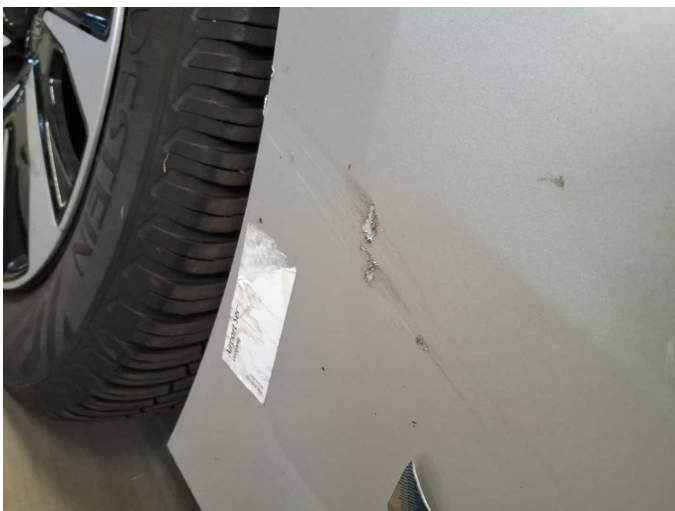
Damage 21: Rear bumper: Rear bumper - Scratched - Repair and paint

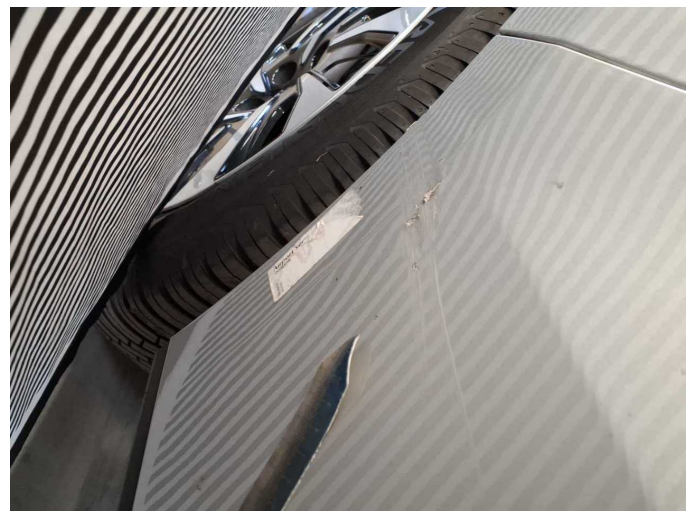
Damage 21: Rear bumper: Rear bumper - Scratched - Repair and paint

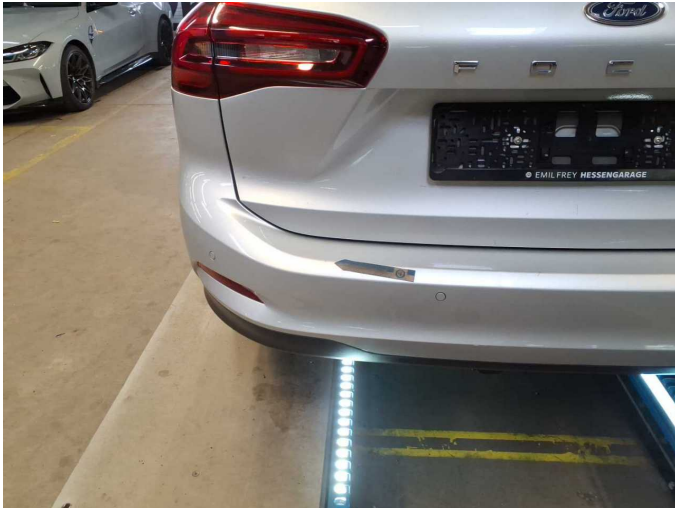
Damage 21: Rear bumper: Rear bumper - Scratched - Repair and paint

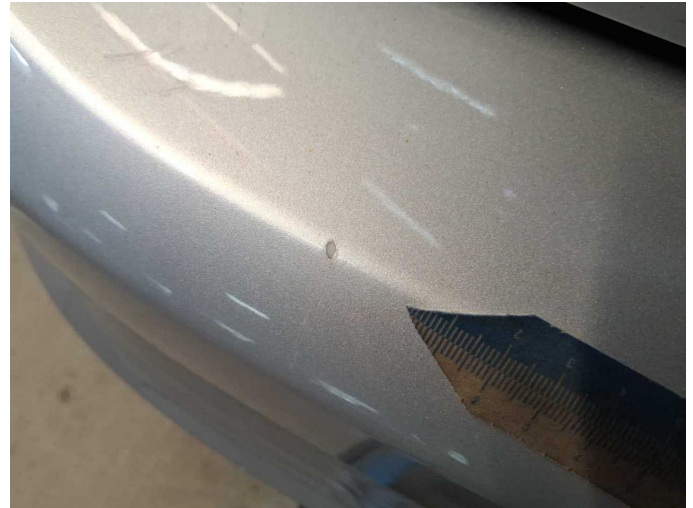
Damage 21: Rear bumper: Rear bumper - Scratched - Repair and paint

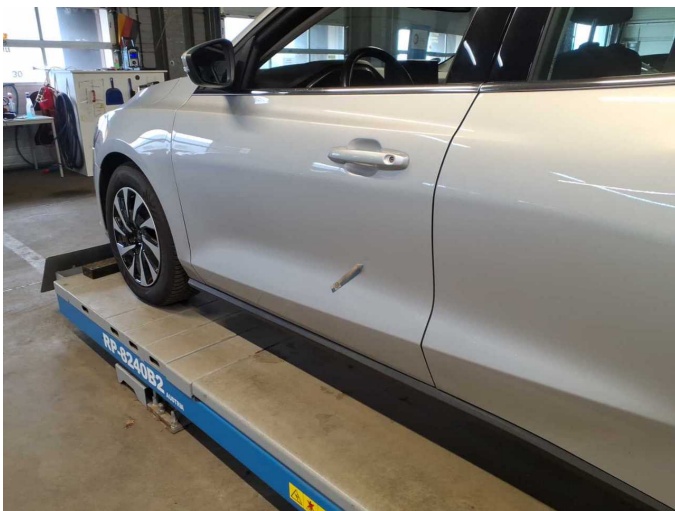
Damage 22: Door - front left side: Door - Dent / paintcoat damage - Repair and paint

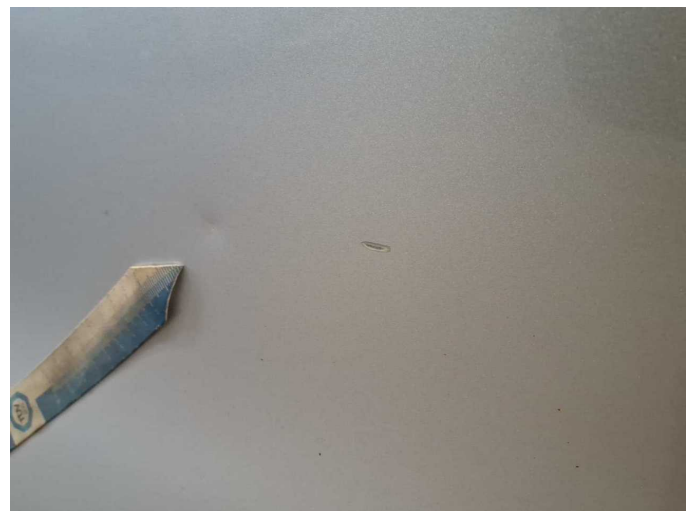
Damage 22: Door - front left side: Door - Dent / paintcoat damage - Repair and paint

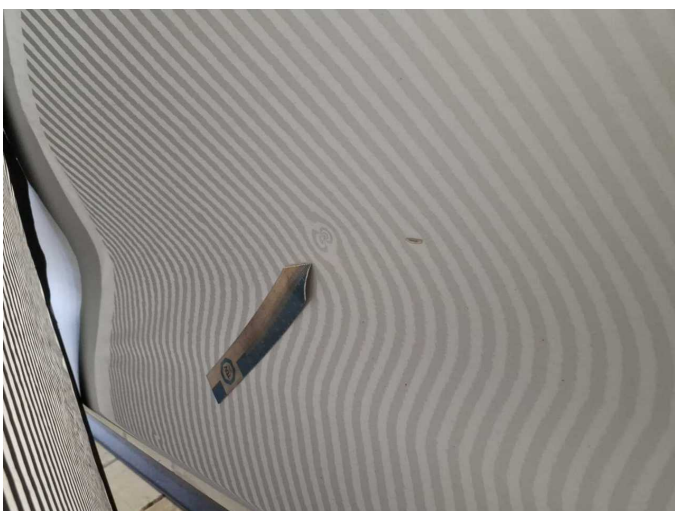
Damage 22: Door - front left side: Door - Dent / paintcoat damage - Repair and paint

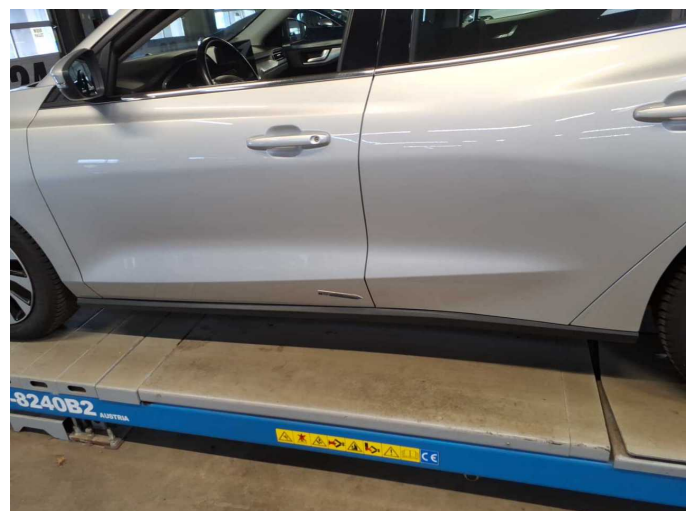
Damage 22: Door - front left side: Door - Dent / paintcoat damage - Repair and paint
