Expertise

Protocol number: 46311703
Order No. / Reference: 26412168
Inspection date: 1 Jul 2026

Model: Focus Turnier 1.0 EcoBoost Start-Stopp-System TITANIUM

VIN: WF0PXXGCHPNG35445

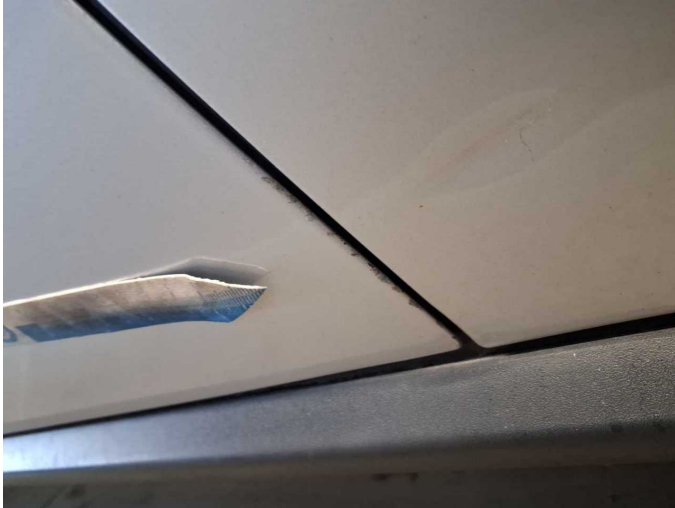
Damage 22: Door - front left side: Door - Dent / paintcoat damage - Repair and paint

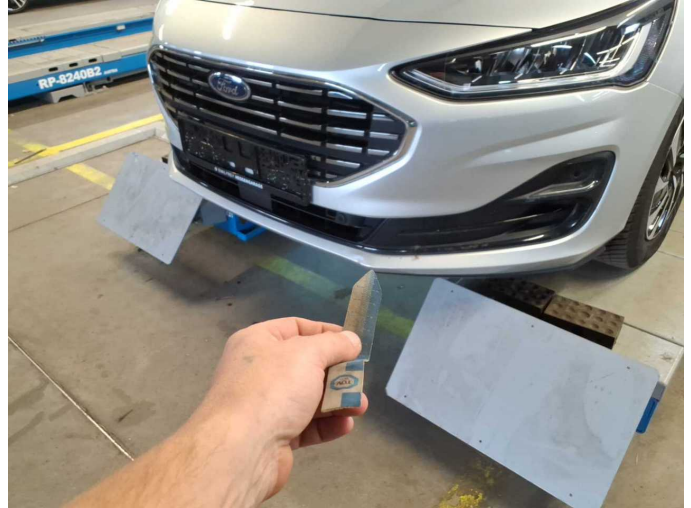
Damage 23: Front bumper: Front bumper - Deformed - Repair and paint

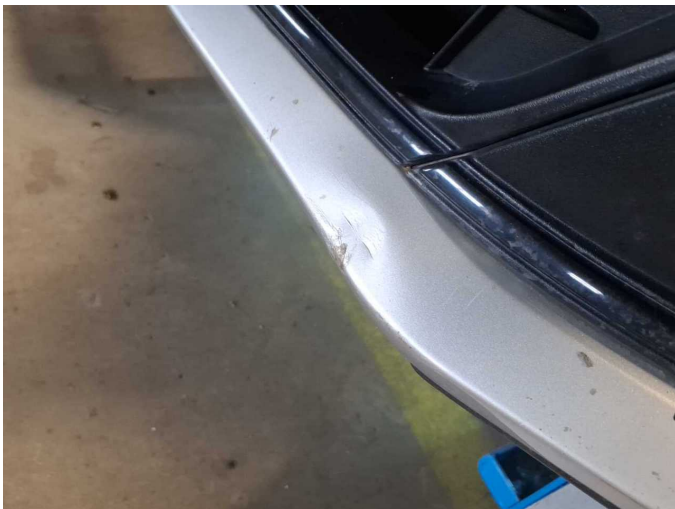
Damage 23: Front bumper: Front bumper - Deformed - Repair and paint

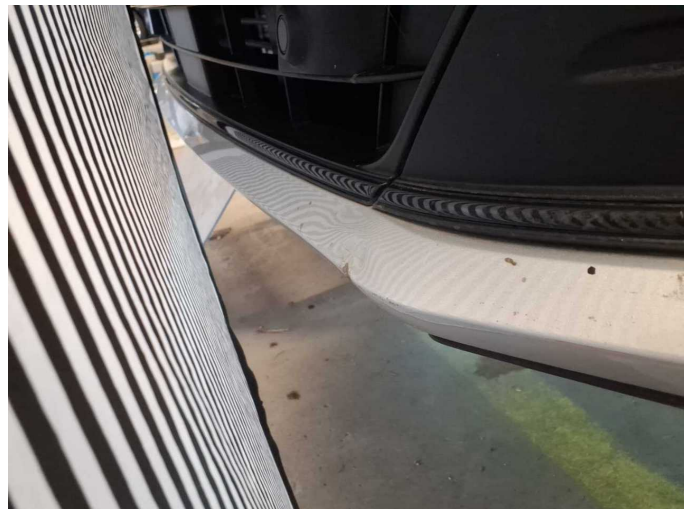
Damage 23: Front bumper: Front bumper - Deformed - Repair and paint

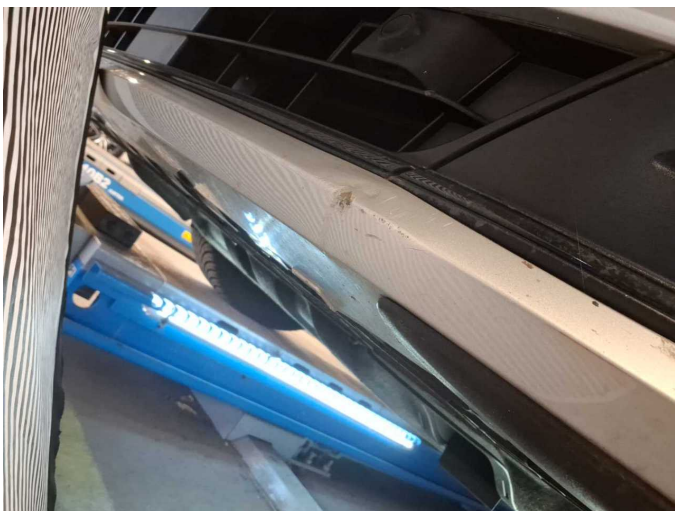
Damage 23: Front bumper: Front bumper - Deformed - Repair and paint

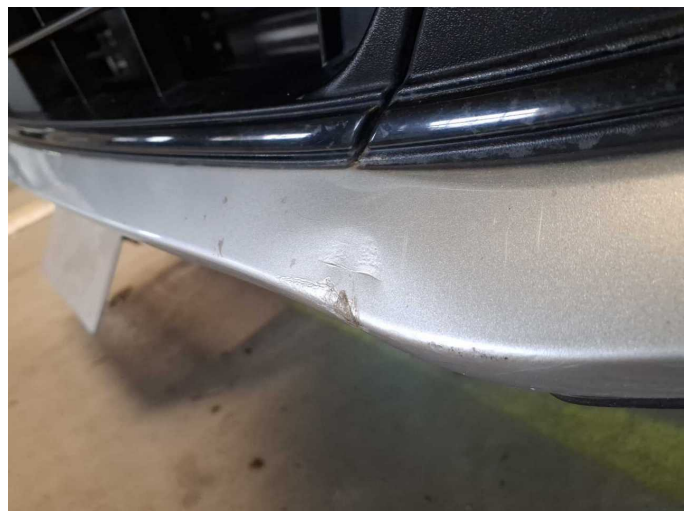
Damage 23: Front bumper: Front bumper - Deformed - Repair and paint

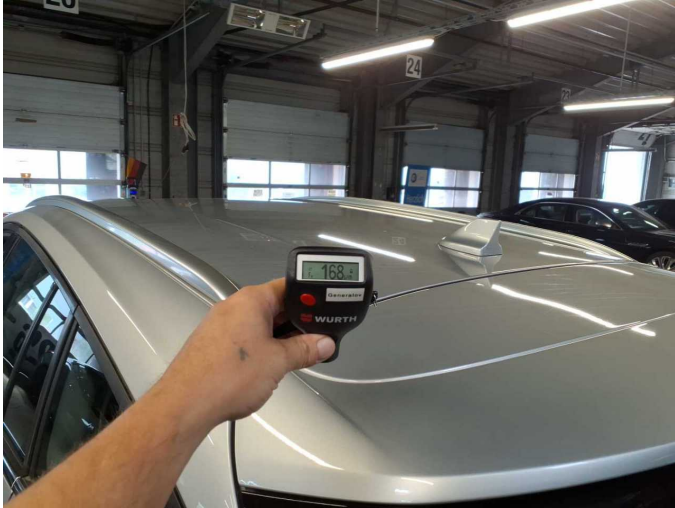
Repainting 1: Roof

No.	Repainting
1	Roof, Professionally carried out, Invoice of repair done Non-existent
2	Mudguard - left side, Professionally carried out, Invoice of repair done Non-existent
3	Side panel - rear right side, Professionally carried out, Invoice of repair done Non-existent
4	Door - front right side, Professionally carried out, Invoice of repair done Non-existent

Roof	168 µm	Mudguard - left side	169 µm
Side panel - rear right side	220 µm	Door - front right side	202 µm
