Expertise

Protocol number: 46791884  
Order No. / Reference: 26639576  
Inspection date: 29 Jul 2026

Manufacturer: Opel

Model: Insignia Sports Tourer 2.0 Diesel Business

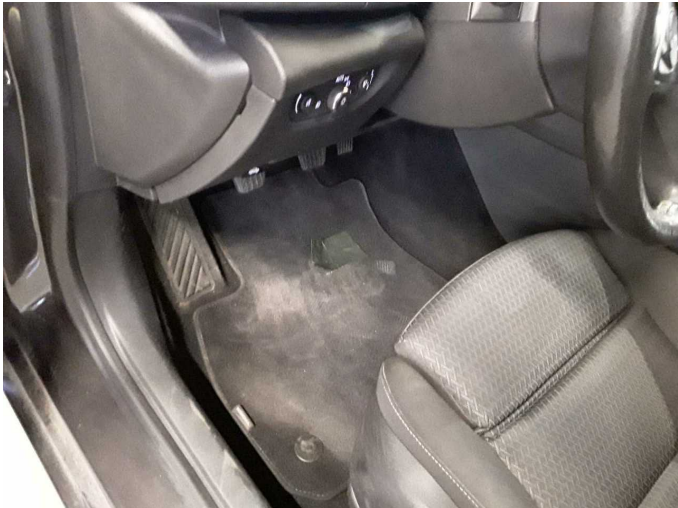
| No. | Component group | Description |
|---|---|---|
| 3 | Trim / covers | Floor mats - Damaged - Replace |

Damage 3: Trim / covers: Floor mats - Damaged - Replace

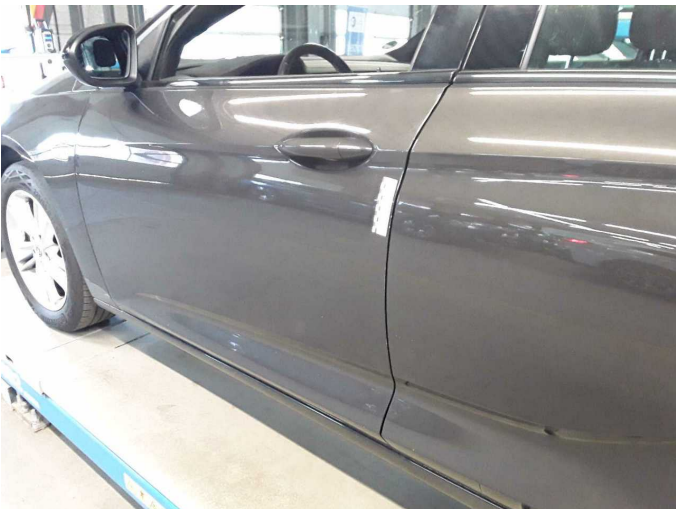
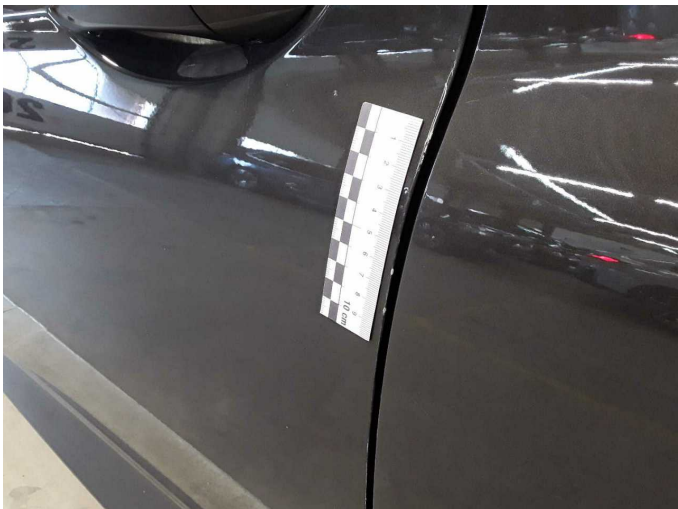
| No. | Component group | Description |
|---|---|---|
| 4 | Door - front left side | Door edge - Scratch(es) - Smart repair |

Damage 4: Door - front left side: Door edge - Scratch(es) - Smart repair

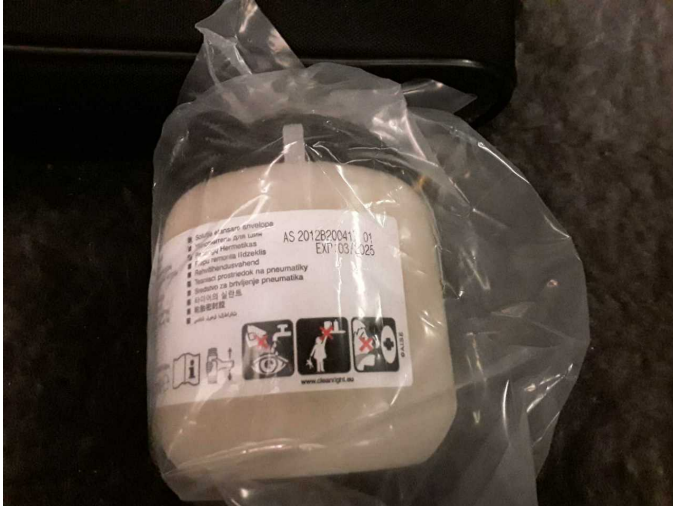
| No. | Component group | Description |
|---|---|---|
| 5 | Equipment | Tirefit filler - Expired - Replace |

**Damage 5:** Equipment: Tirefit filler - Expired - Replace

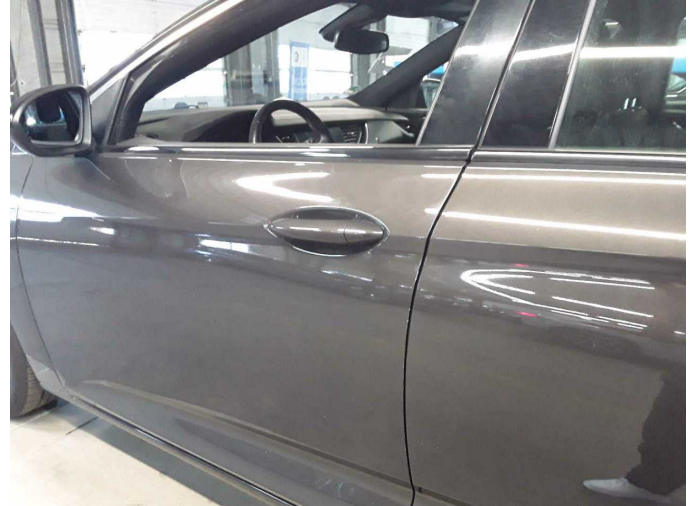
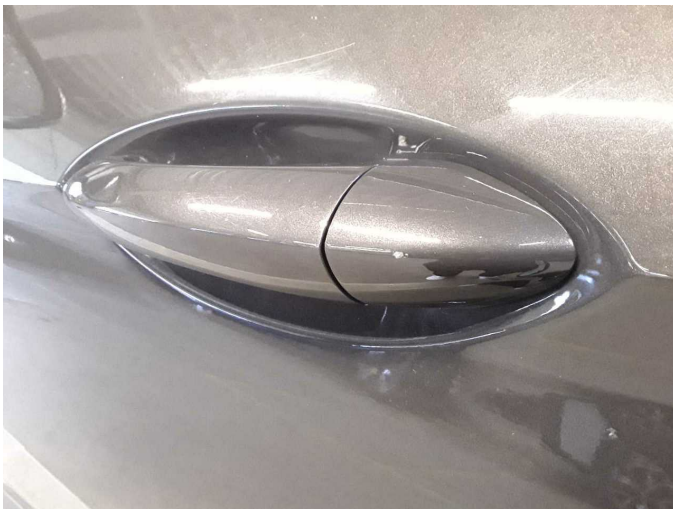
| No. | Component group | Description |
|---|---|---|
| 6 | Door - front left side | Door handle - outside - Scratch(es) - Smart repair |

**Damage 6:** Door - front left side: Door handle - outside - Scratch(es) - Smart repair

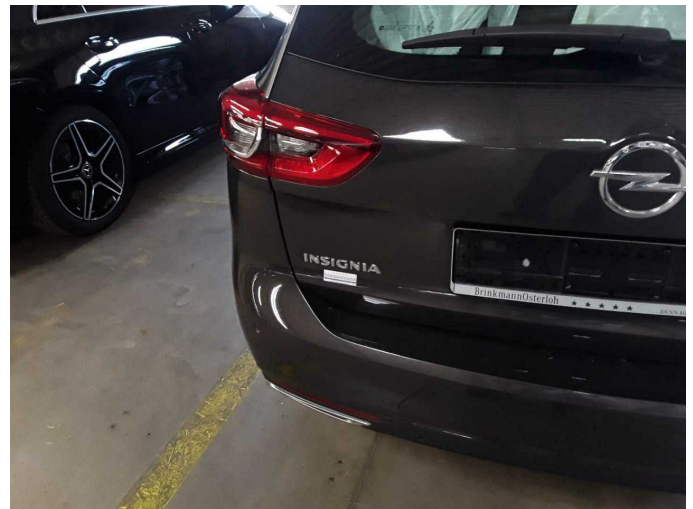
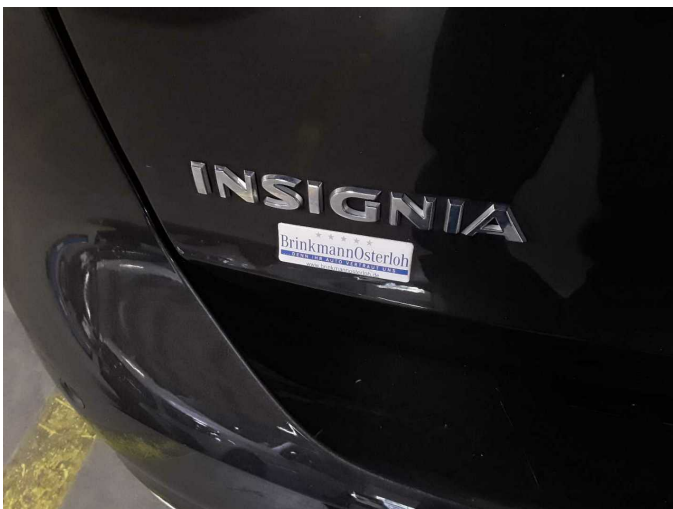
| No. | Component group | Description |
|---|---|---|
| 7 | Boot lid / rear door | Boot lid - Glued / labelled - De-glue / neutralise |

**Damage 7:** Boot lid / rear door: Boot lid - Glued / labelled - De-glue / neutralise

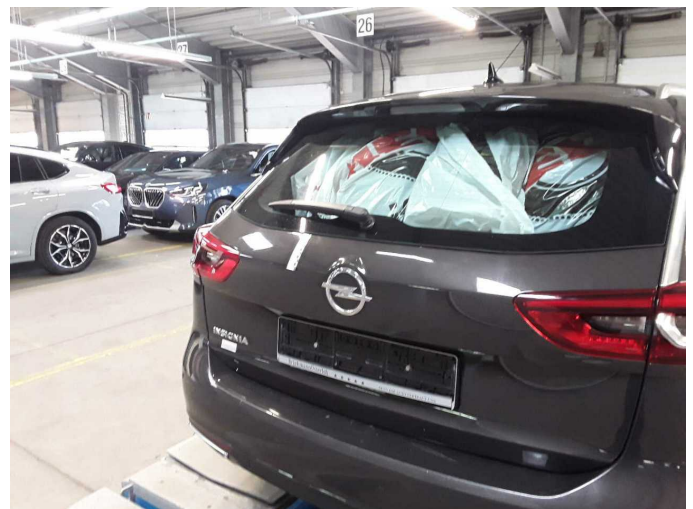
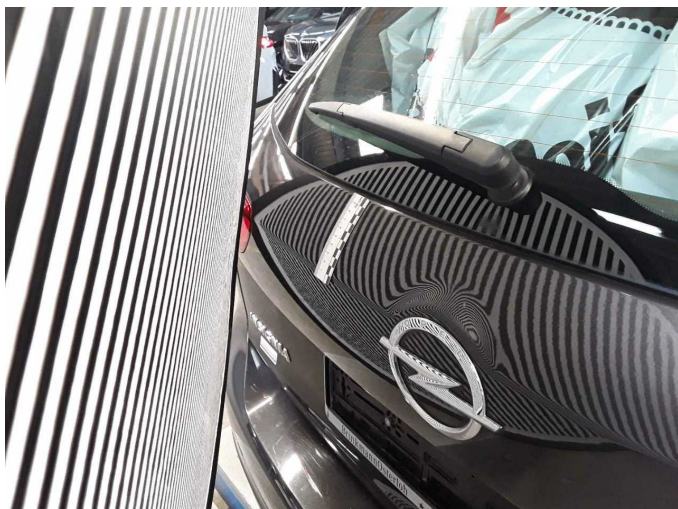
| No. | Component group | Description |
|---|---|---|
| 8 | Boot lid / rear door | Boot lid - dent(s) - Smooth repair work |

**Damage 8:** Boot lid / rear door: Boot lid - dent(s) - Smooth repair work

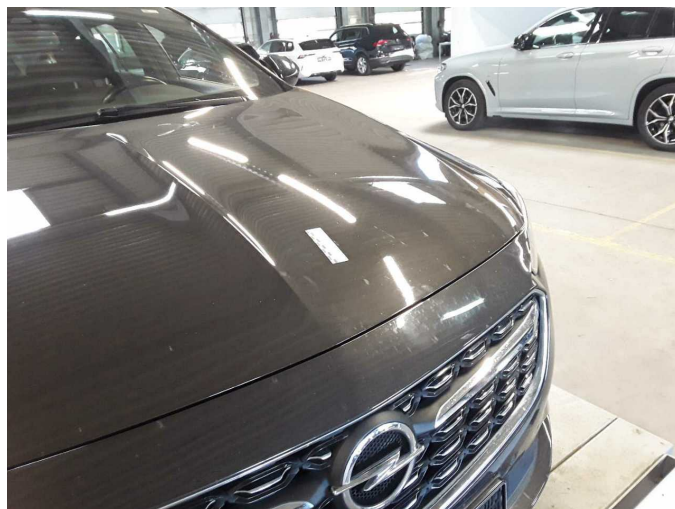
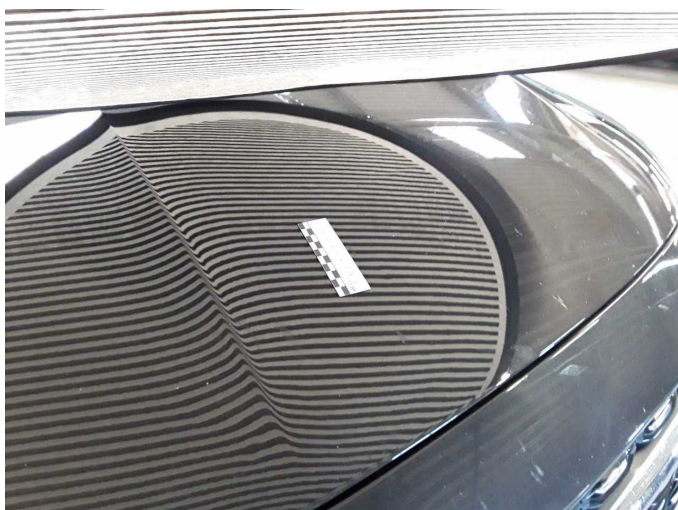
| No. | Component group | Description |
|---|---|---|
| 9 | Bonnet | Bonnet - dent(s) - Smooth repair work |

**Damage 9:** Bonnet: Bonnet - dent(s) - Smooth repair work

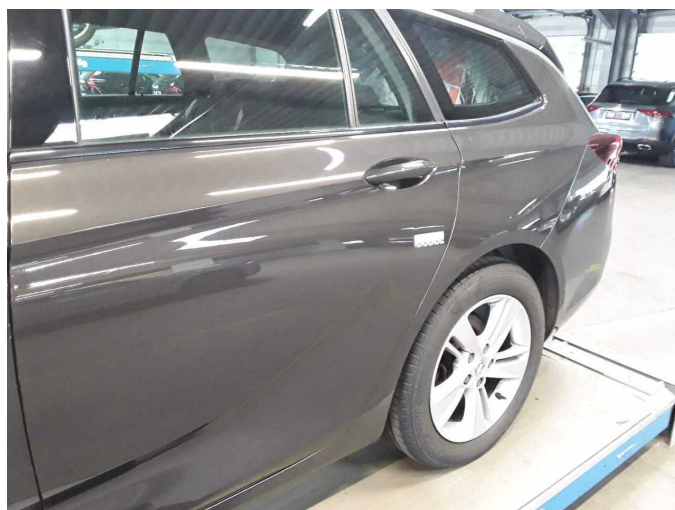
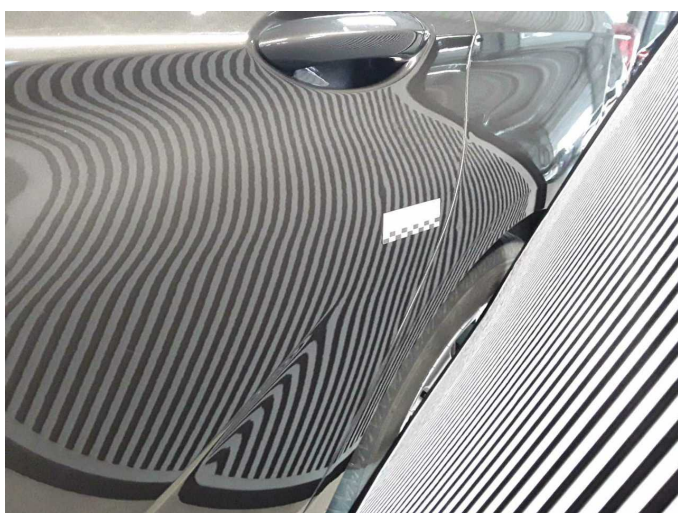
| No. | Component group | Description |
|---|---|---|
| 10 | Door - rear left side | Door - dent(s) - Smooth repair work |

**Damage 10:** Door - rear left side: Door - dent(s) - Smooth repair work

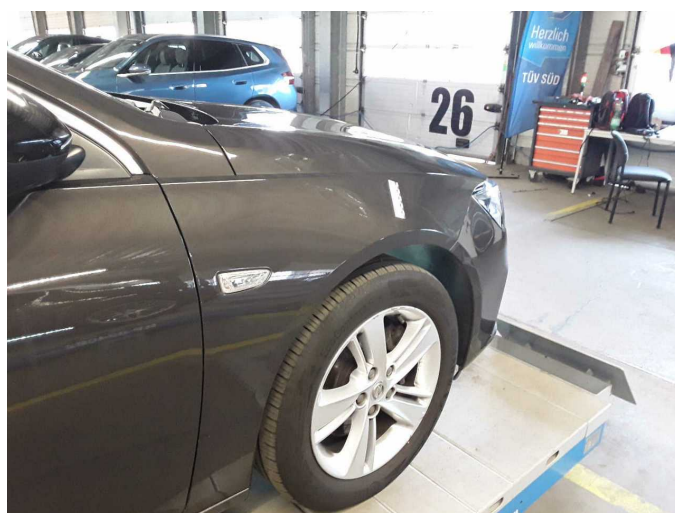
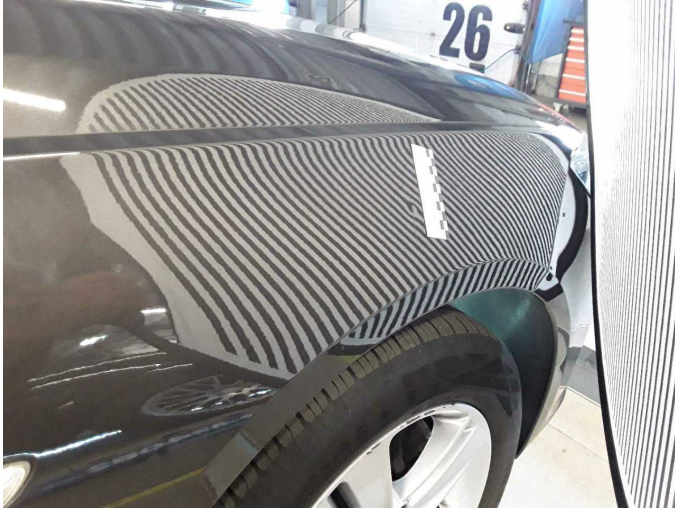
| No. | Component group | Description |
|---|---|---|
| 11 | Mudguard - right side | Mudguard - right side - dent(s) - Smooth repair work |

**Damage 11:** Mudguard - right side: Mudguard - right side - dent(s) - Smooth repair work

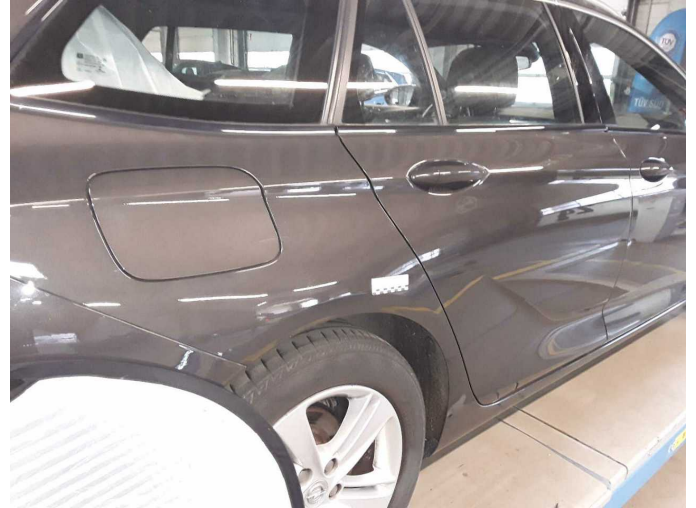
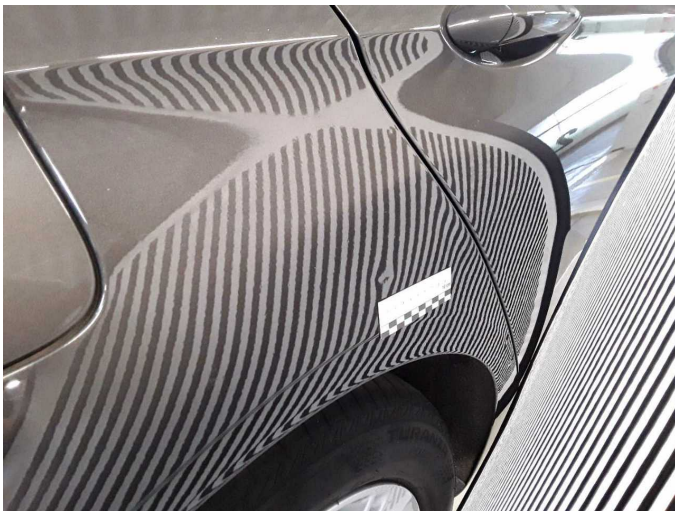
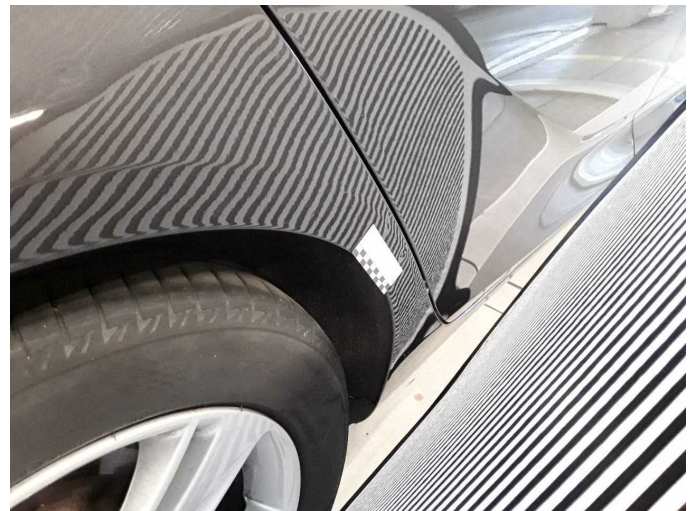
| No. | Component group | Description |
|---|---|---|
| 12 | Side panel - rear right side | Side panel - dent(s) - Smooth repair work |

**Damage 12:** Side panel - rear right side: Side panel - dent(s) - Smooth repair work

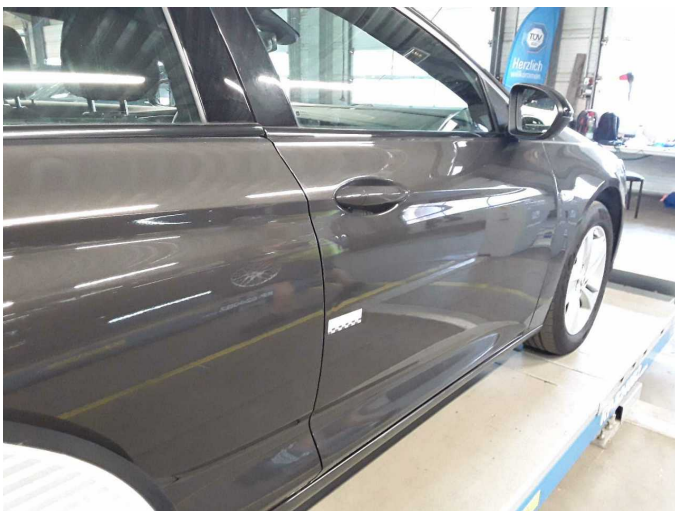
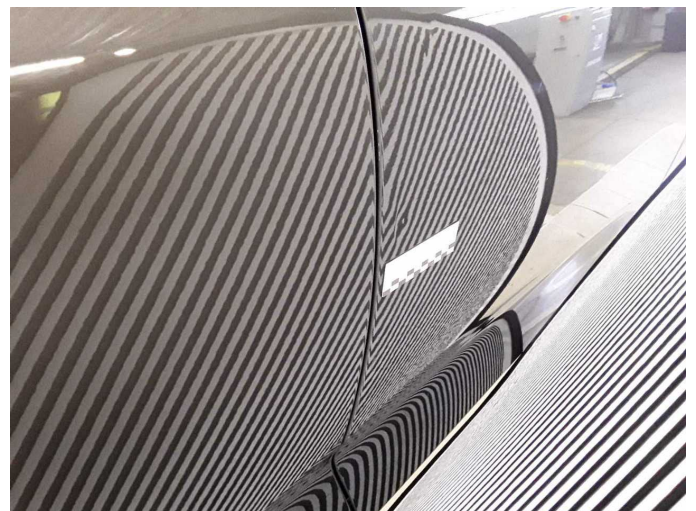
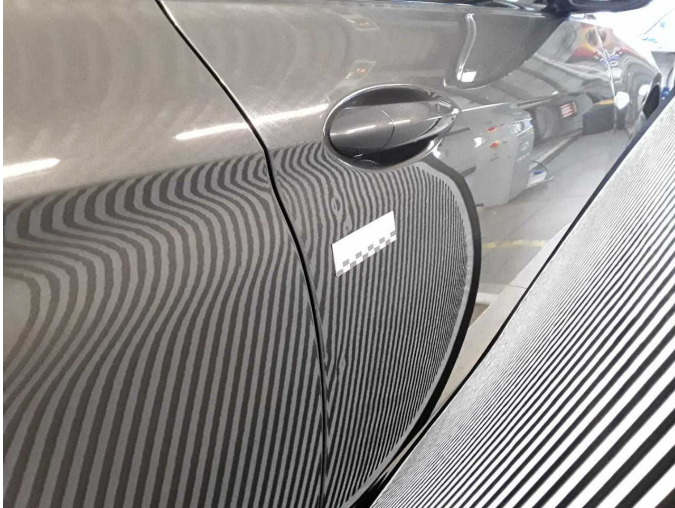
| No. | Component group | Description |
|---|---|---|
| 13 | Door - front right side | Door - dent(s) - Smooth repair work |

**Damage 13:** Door - front right side: Door - dent(s) - Smooth repair work

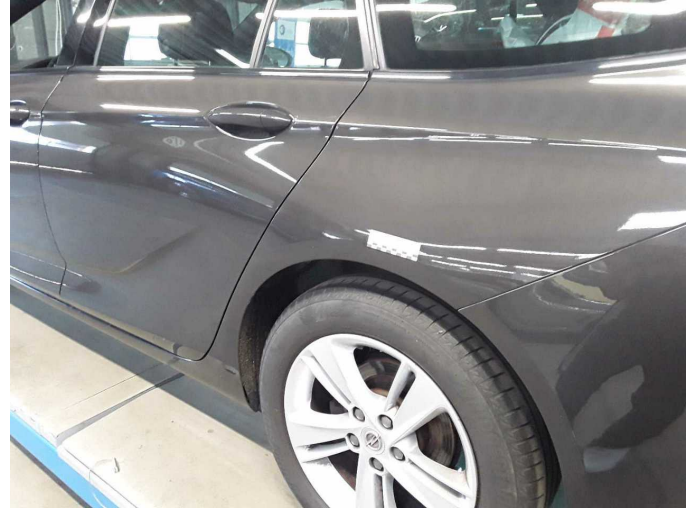
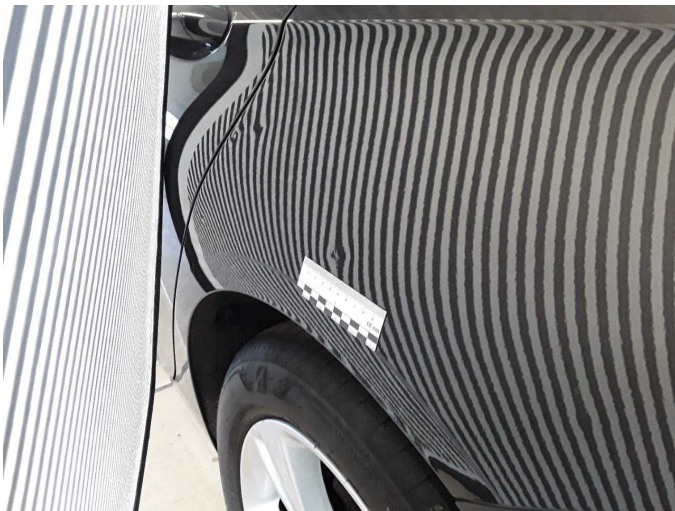
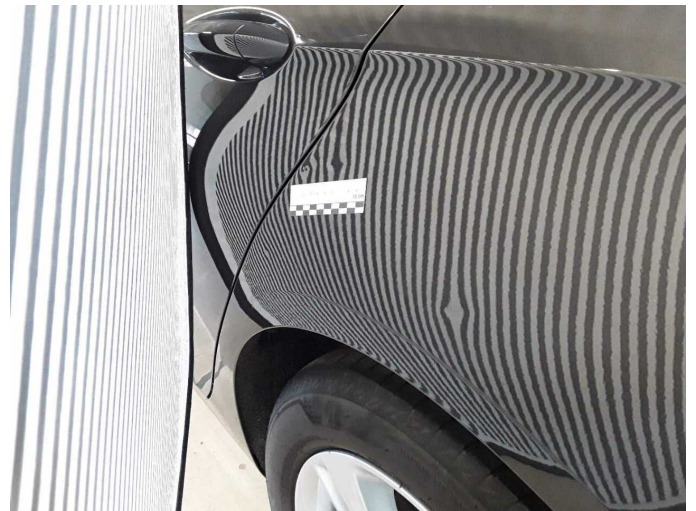
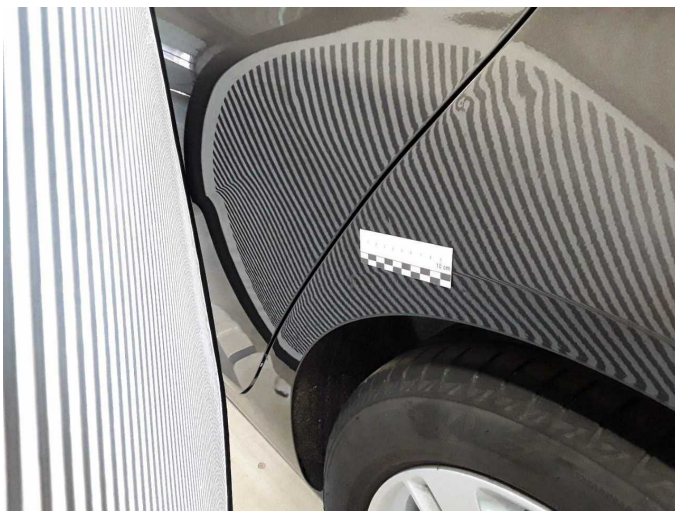
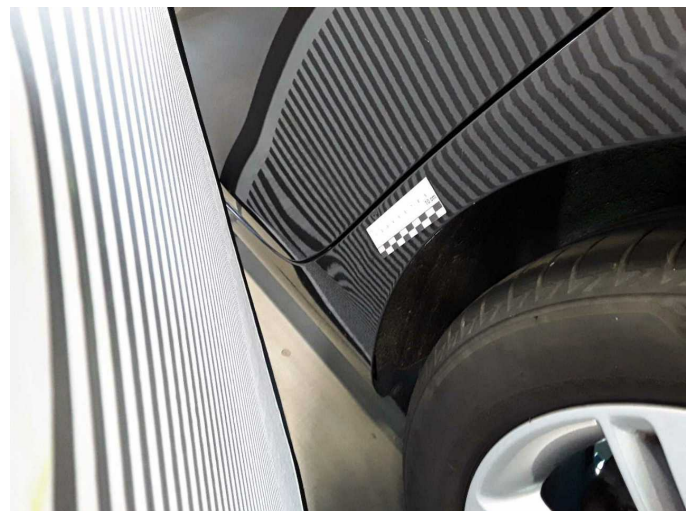
| No. | Component group | Description |
|---|---|---|
| 14 | Side panel - rear left side | Side panel - dent(s) - Smooth repair work |

**Damage 14:** Side panel - rear left side: Side panel - dent(s) - Smooth repair work

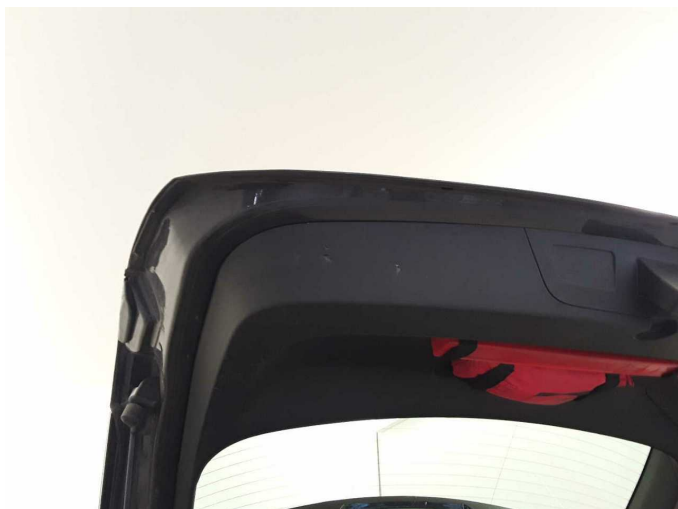
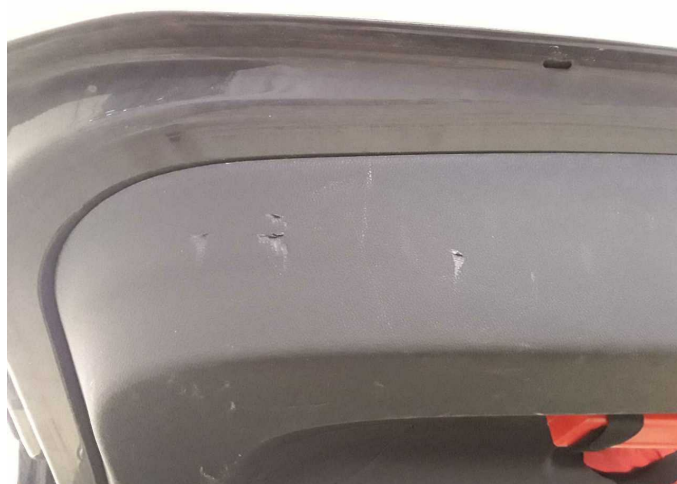
| No. | Component group | Description |
|---|---|---|
| 15 | Boot lid / rear door | Trim - standard - lower - Scratched - Loss in value |

**Damage 15:** Boot lid / rear door: Trim - standard - lower - Scratched - Loss in value

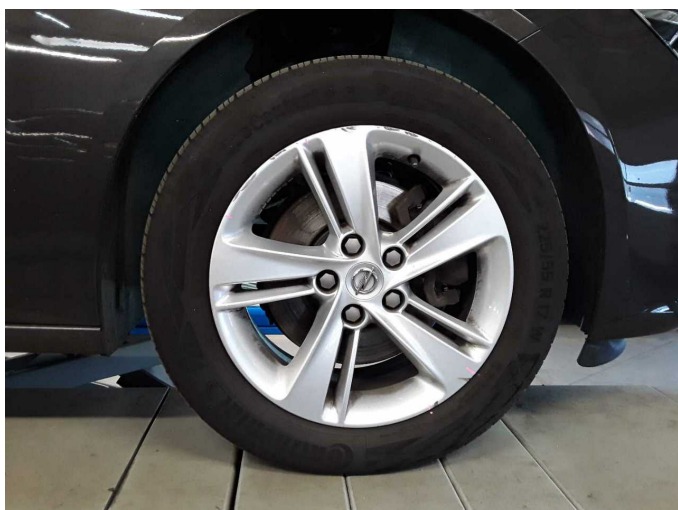
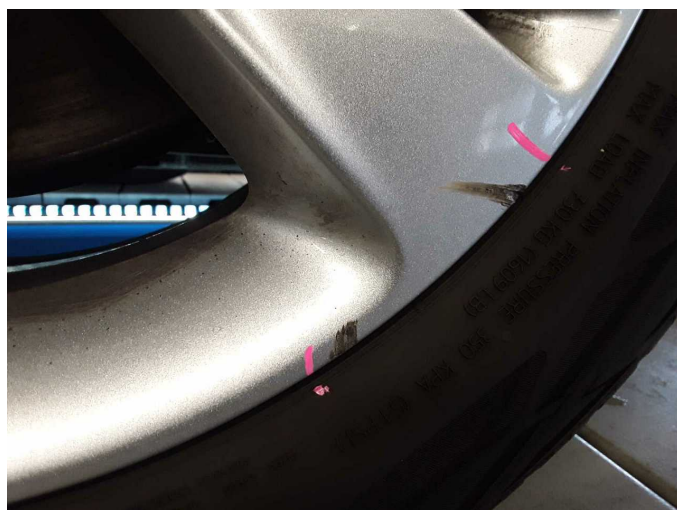
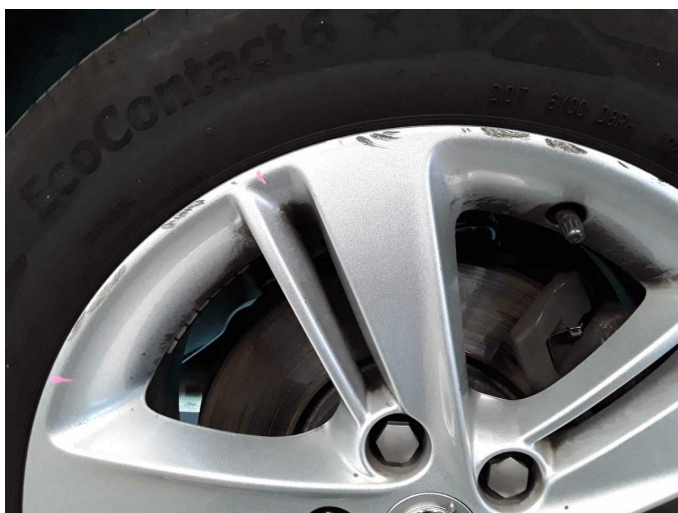
| No. | Component group | Description |
|---|---|---|
| 16 | Wheel / tyres | Alloy rim - front right side (Materialabtrag) - Scratch(es) - Replace |

**Damage 16:** Wheel / tyres: Alloy rim - front right side (Materialabtrag) - Scratch(es) - Replace

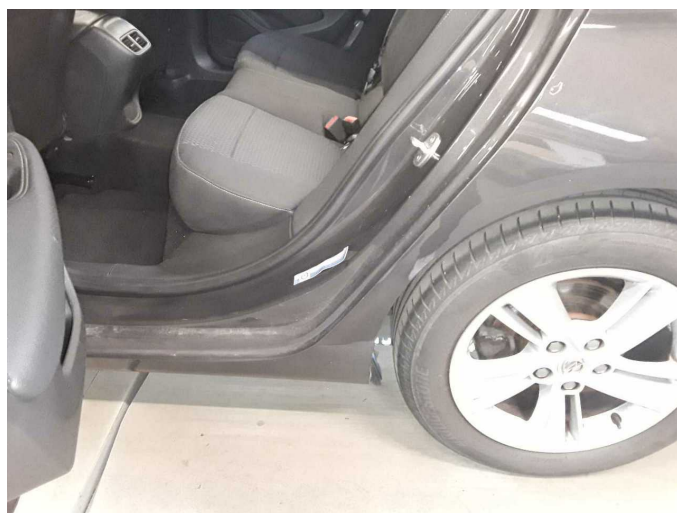
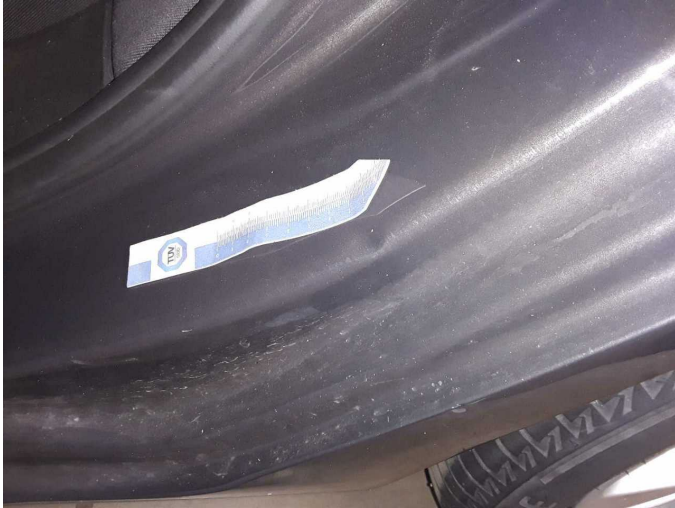
| No. | Component group | Description |
|---|---|---|
| 17 | Body | C-pillar - left side - Dent / paintcoat damage - Repair and paint |

**Damage 17:** Body: C-pillar - left side - Dent / paintcoat damage - Repair and paint

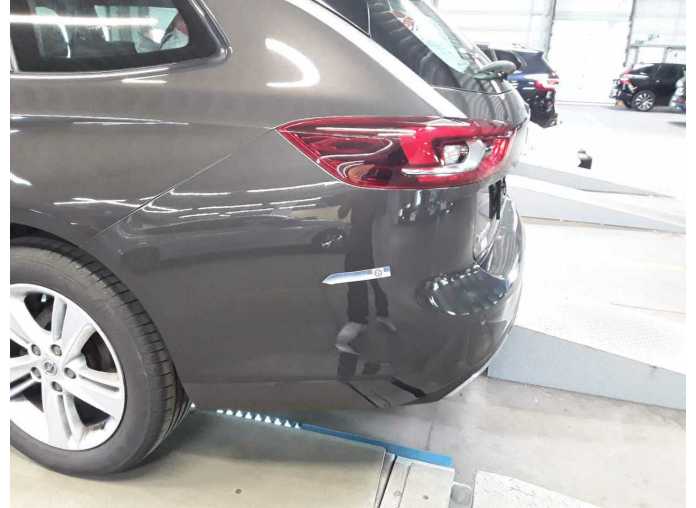
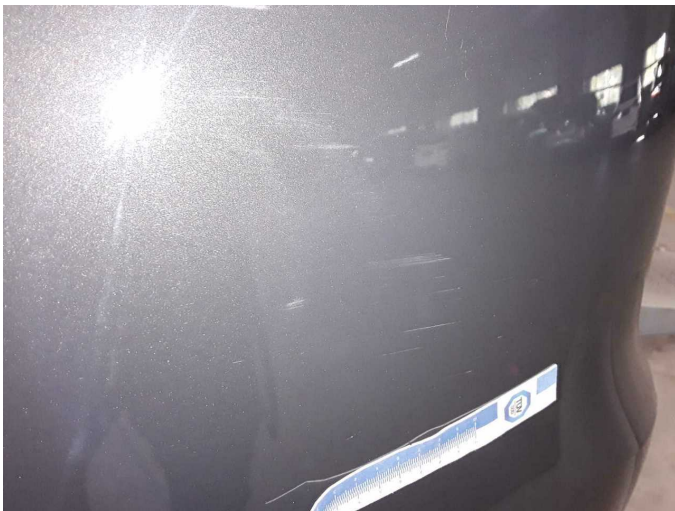
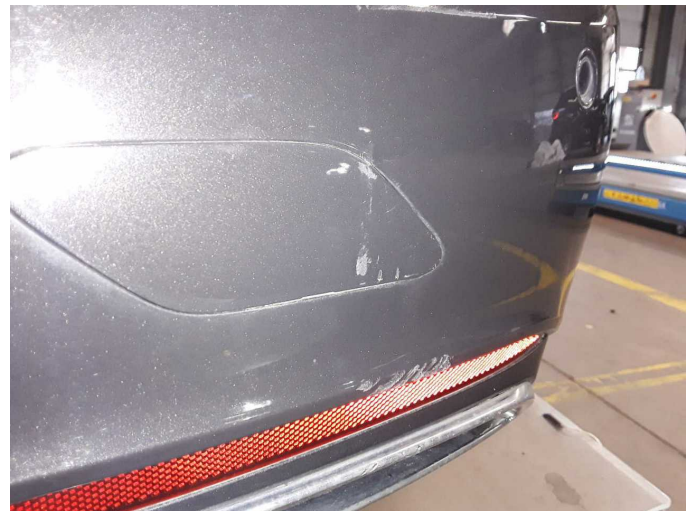
| No. | Component group | Description |
|---|---|---|
| 18 | Rear bumper | Rear bumper - Scratch(es) - Paint |

**Damage 18:** Rear bumper: Rear bumper - Scratch(es) - Paint
