Expertise

Protocol number: 46710467  
Order No. / Reference: 26759860  
Inspection date: 24 Jul 2026

| Manufacturer: Mercedes-Benz | Model: C 220 d T 9G-TRONIC AMG Line |
| VIN: W1KAH0EB7PF114324 | |

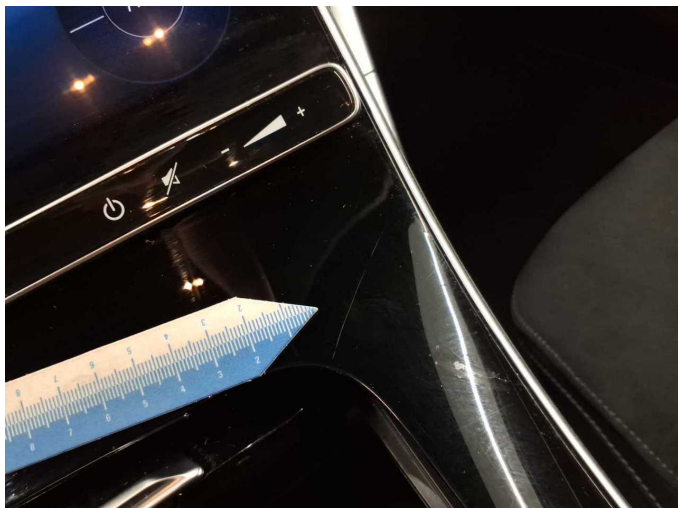
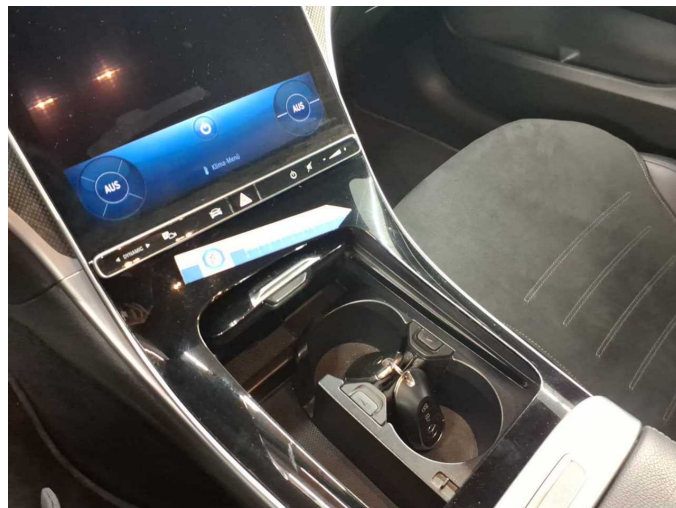
| No. | Component group | Description |
|---|---|---|
| 1 | Instrument panel | Centre console - front - Scratch(es) - Loss in value |

**Damage 1:** Instrument panel: Centre console - front - Scratch(es) - Loss in value

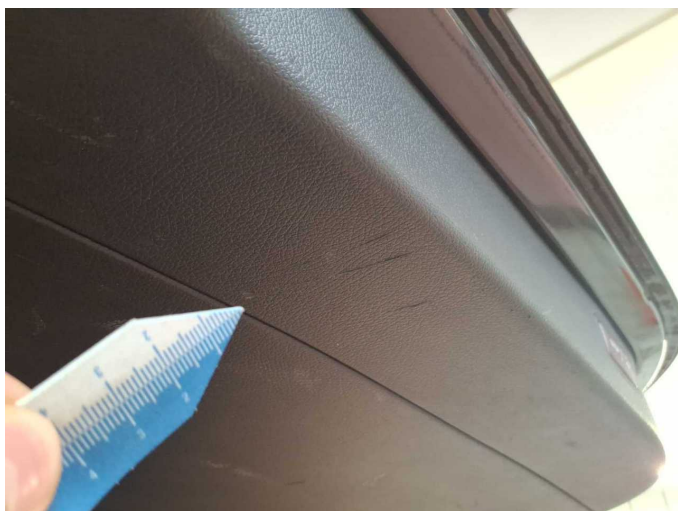
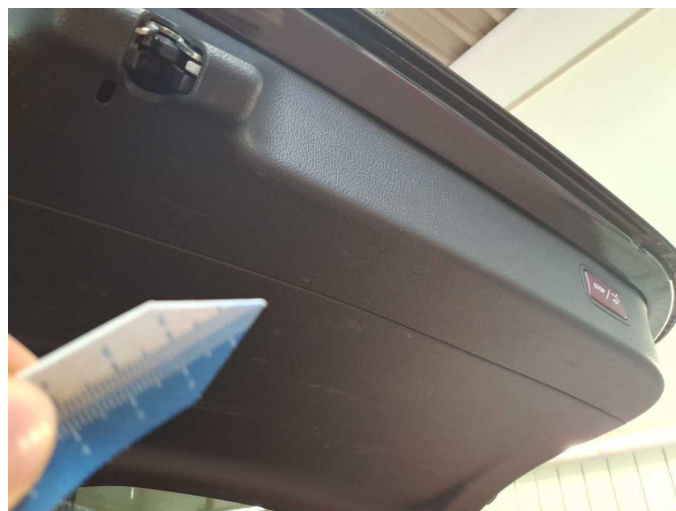
| No. | Component group | Description |
|---|---|---|
| 2 | Trim / covers | Boot lid - interior trim - Scratch(es) - Loss in value |

**Damage 2:** Trim / covers: Boot lid - interior trim - Scratch(es) - Loss in value

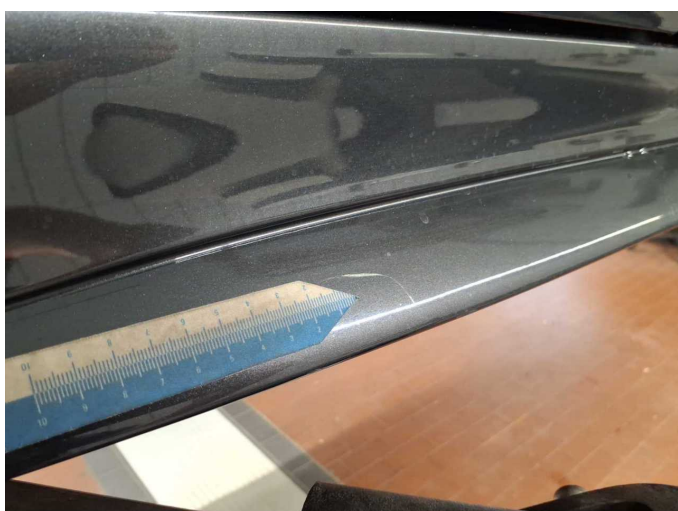
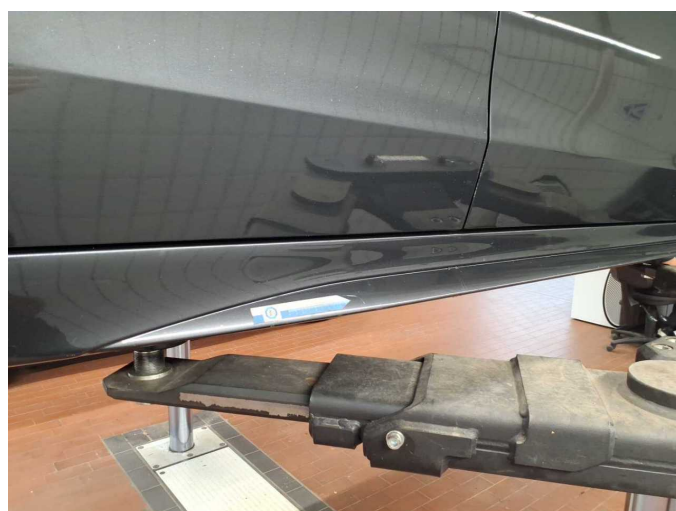
| No. | Component group | Description |
|---|---|---|
| 3 | Sill - right side | Trim - Scratch(es) - Smart repair |

**Damage 3:** Sill - right side: Trim - Scratch(es) - Smart repair

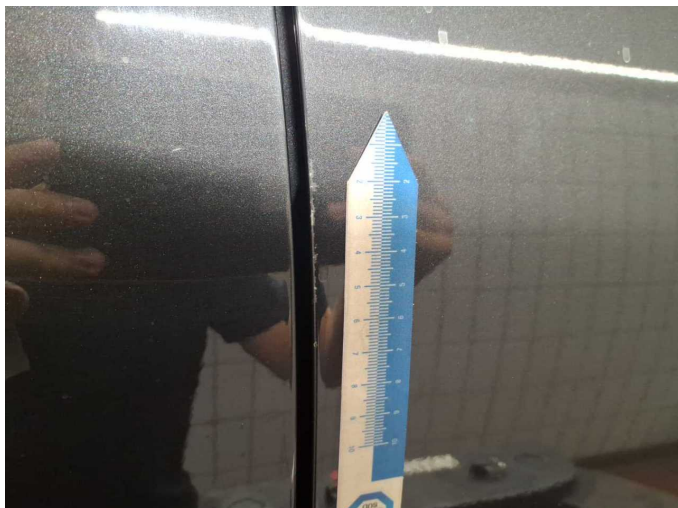
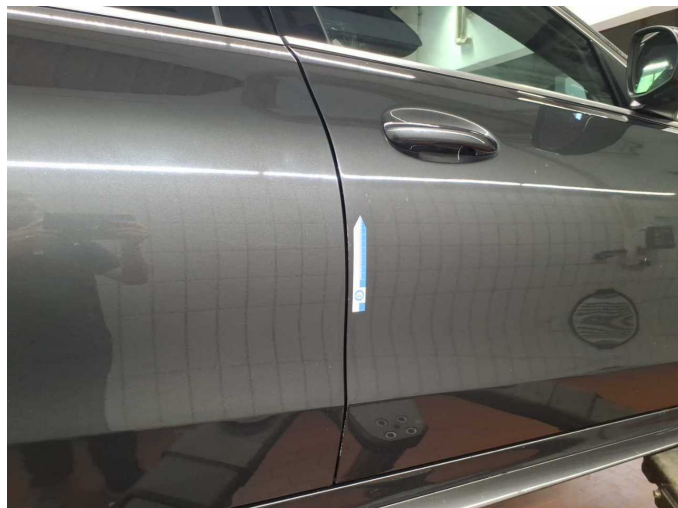
| No. | Component group | Description |
|---|---|---|
| 4 | Door - front right side | Door edge - Scratch(es) - Smart repair |

**Damage 4:** Door - front right side: Door edge - Scratch(es) - Smart repair

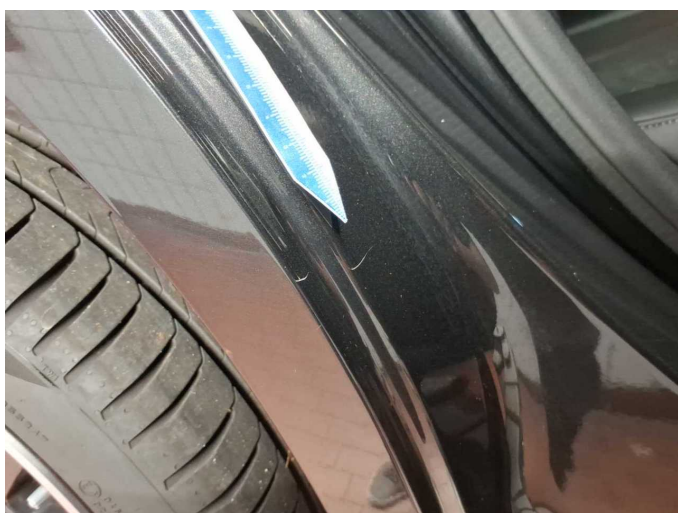
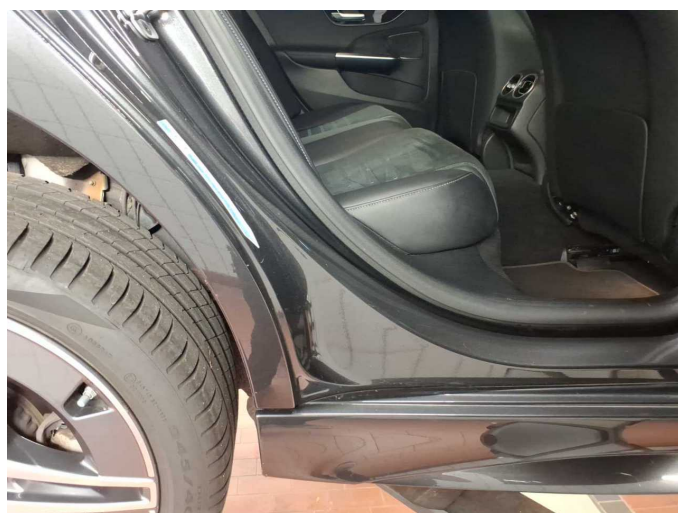
| No. | Component group | Description |
|---|---|---|
| 5 | Side panel - rear right side | Sill - Scratch(es) - Smart repair |

**Damage 5:** Side panel - rear right side: Sill - Scratch(es) - Smart repair

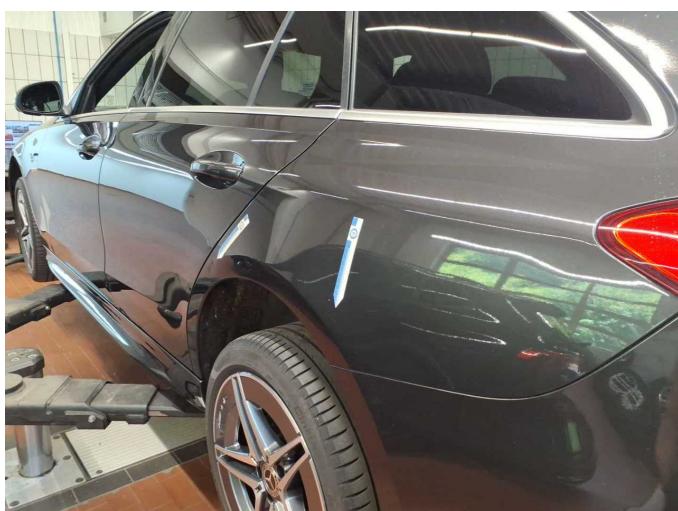
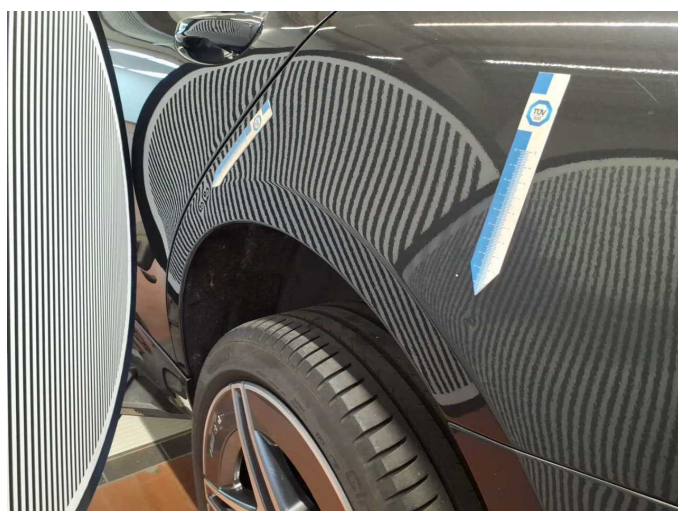
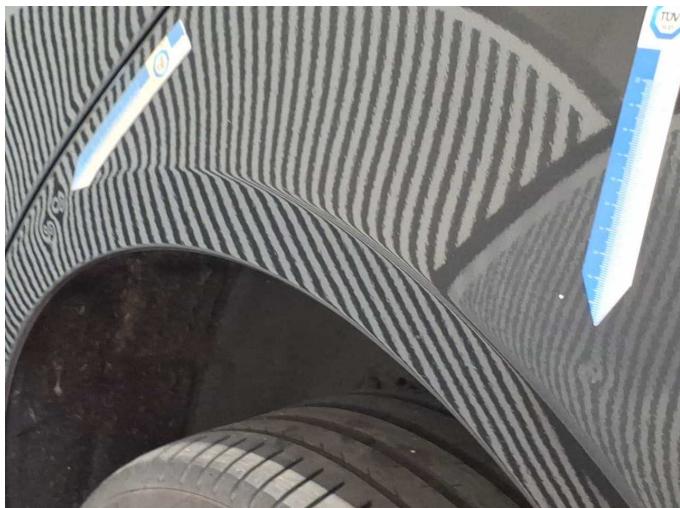
| No. | Component group | Description |
|---|---|---|
| 6 | Side panel - rear left side | Side panel - dent(s) - Smooth repair work |

**Damage 6:** Side panel - rear left side: Side panel - dent(s) - Smooth repair work

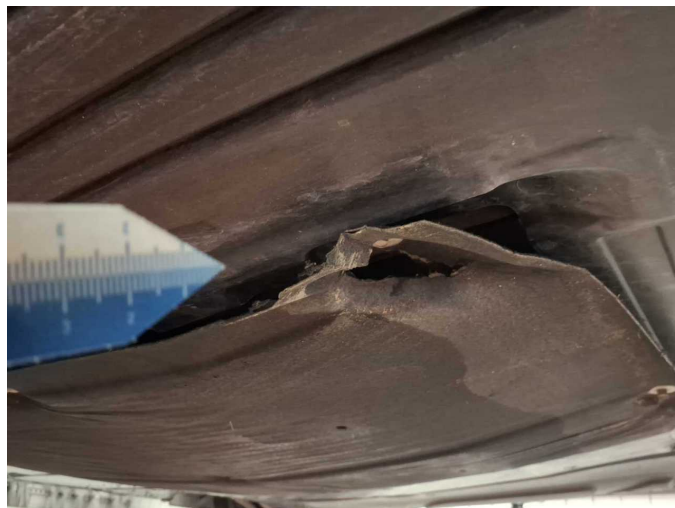
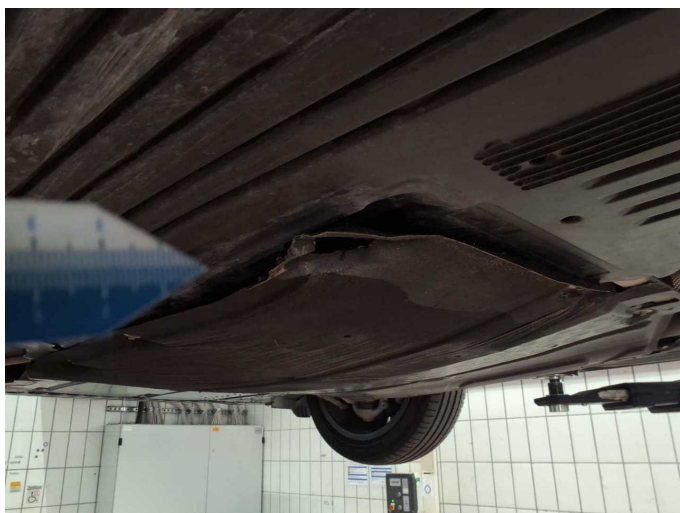
| No. | Component group | Description |
|---|---|---|
| 8 | Body | Underbody panelling - Broken / torn - Replace |

**Damage 8:** Body: Underbody panelling - Broken / torn - Replace

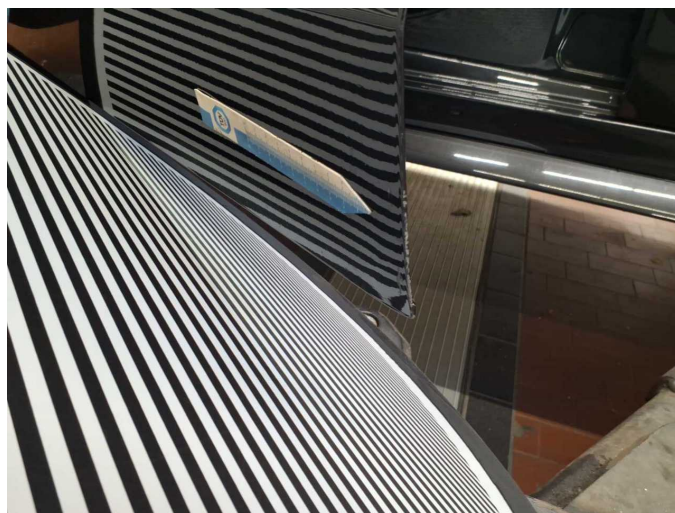
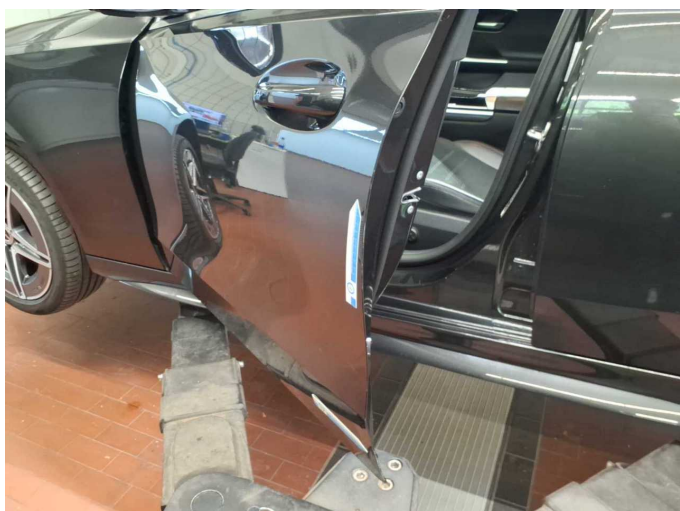
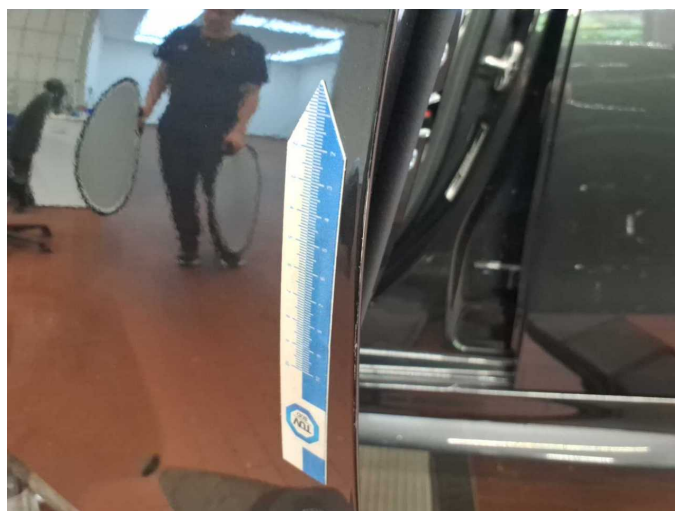
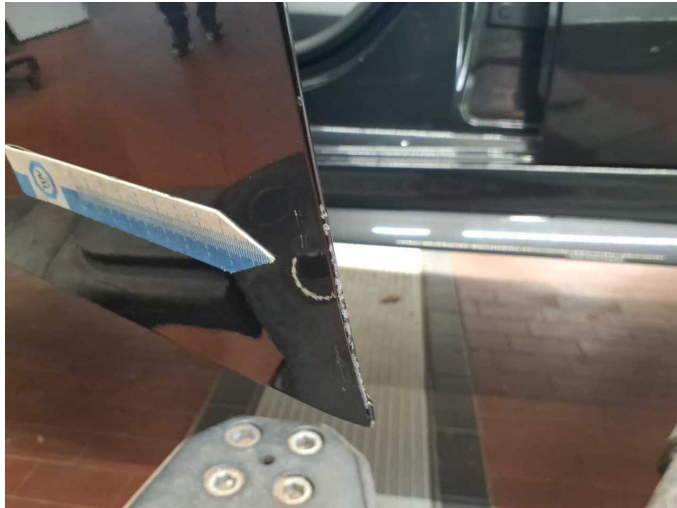
| No. | Component group | Description |
|---|---|---|
| 9 | Door - front left side | Door edge - Dent / paintcoat damage - Smart repair |

**Damage 9:** Door - front left side: Door edge - Dent / paintcoat damage - Smart repair

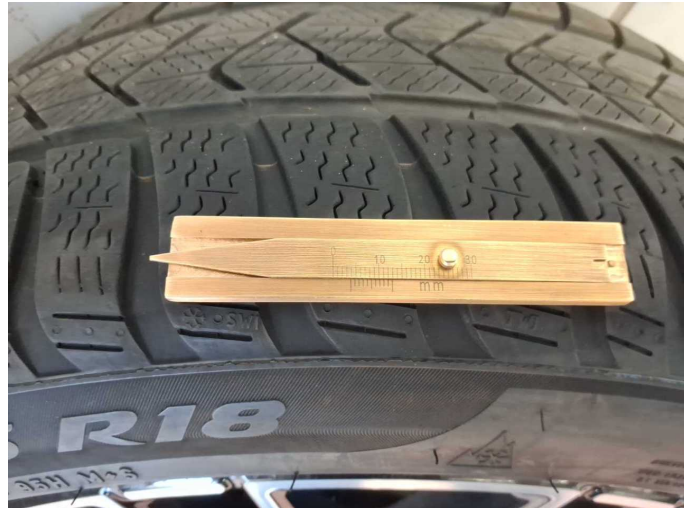
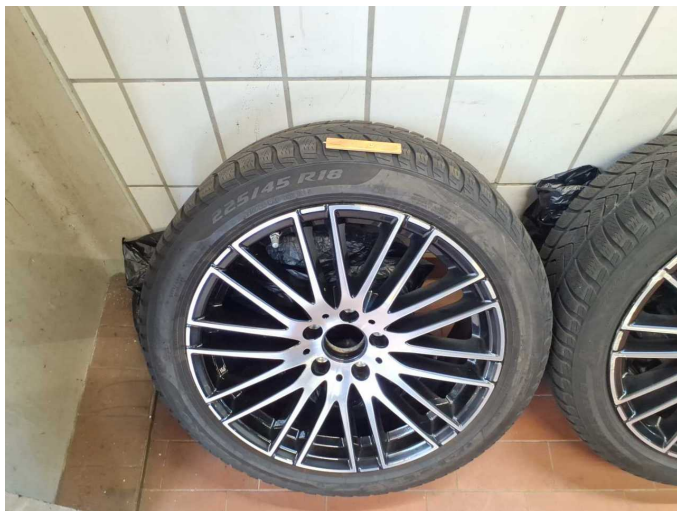
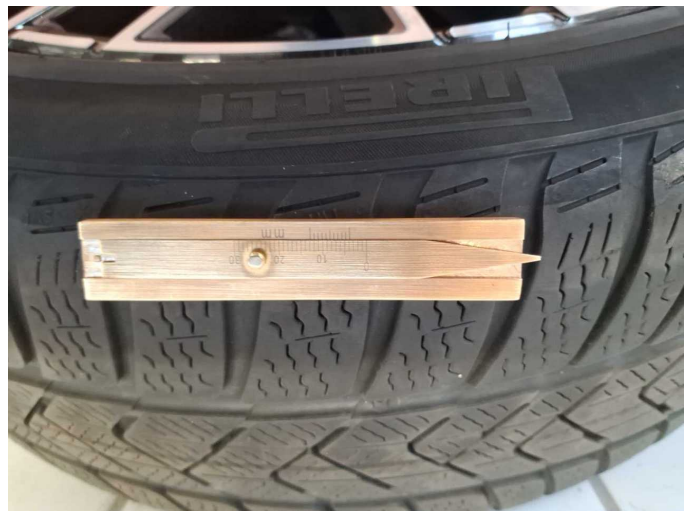
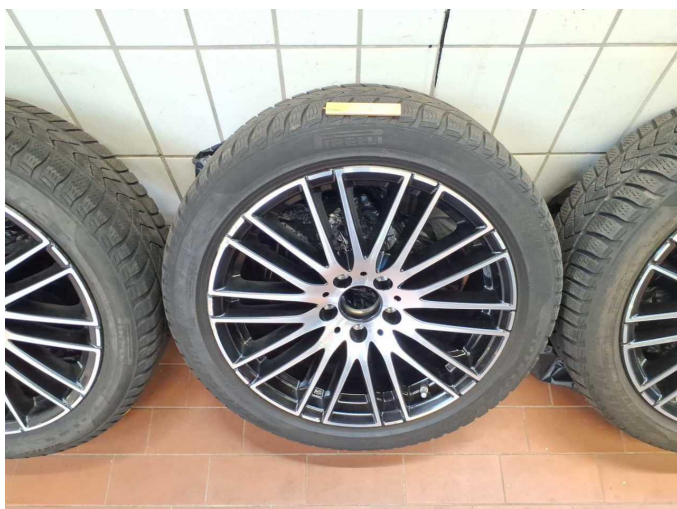
| No. | Component group | Description |
|---|---|---|
| 10 | 2nd wheel set | 2 tyres (4mm) - Does not meet the leasing specifications - Replace |

**Damage 10:** 2nd wheel set: 2 tyres (4mm) - Does not meet the leasing specifications - Replace

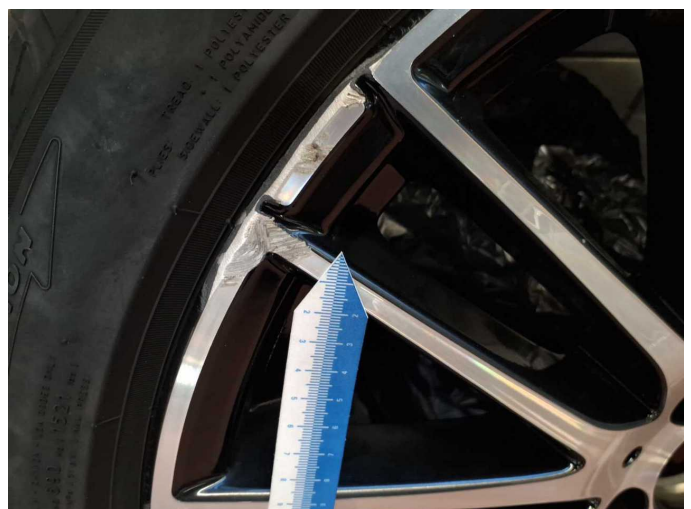
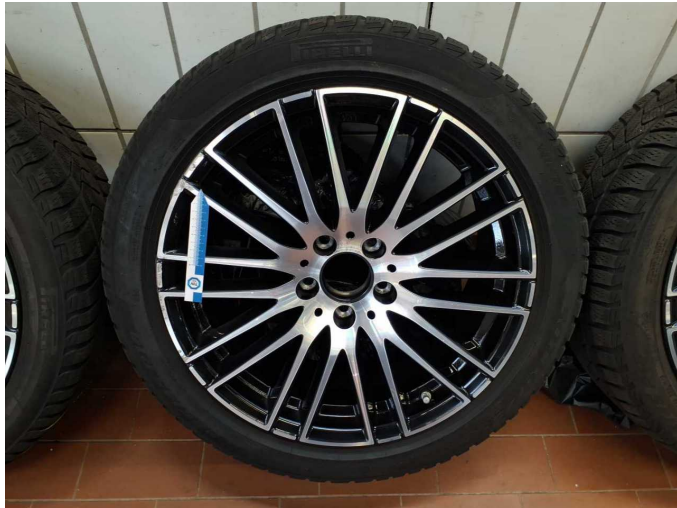
| No. | Component group | Description |
|---|---|---|
| 11 | 2nd wheel set | 1 alloy rim - Scratched - Loss in value |

**Damage 11:** 2nd wheel set: 1 alloy rim - Scratched - Loss in value

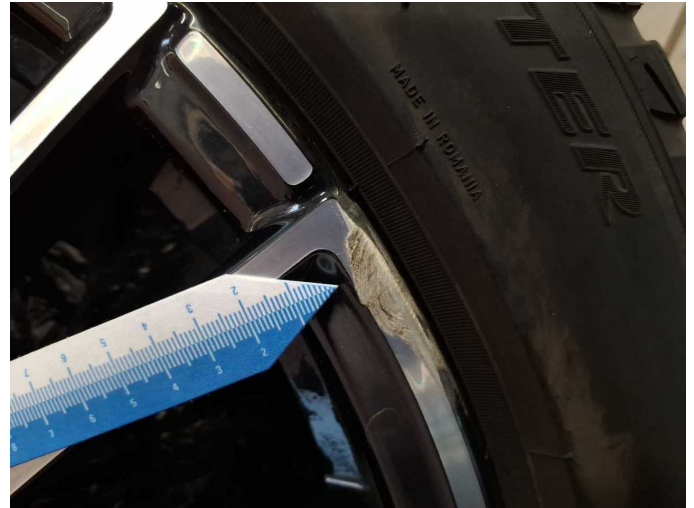
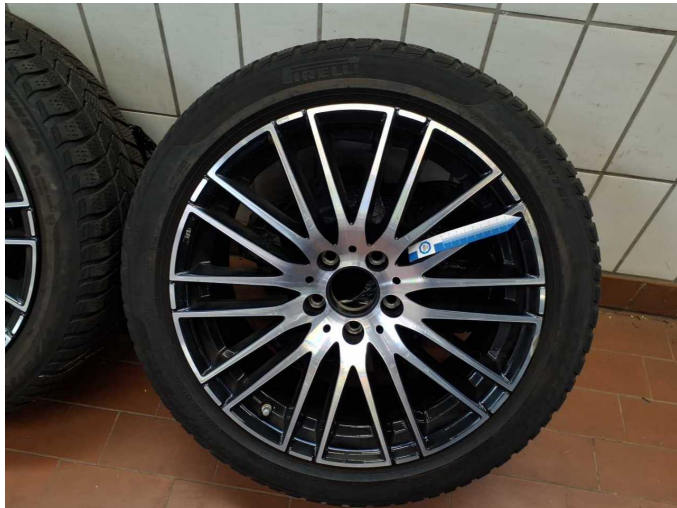
| No. | Component group | Description |
|---|---|---|
| 12 | 2nd wheel set | 1 alloy rim - Scratched - Loss in value |

**Damage 12:** 2nd wheel set: 1 alloy rim - Scratched - Loss in value

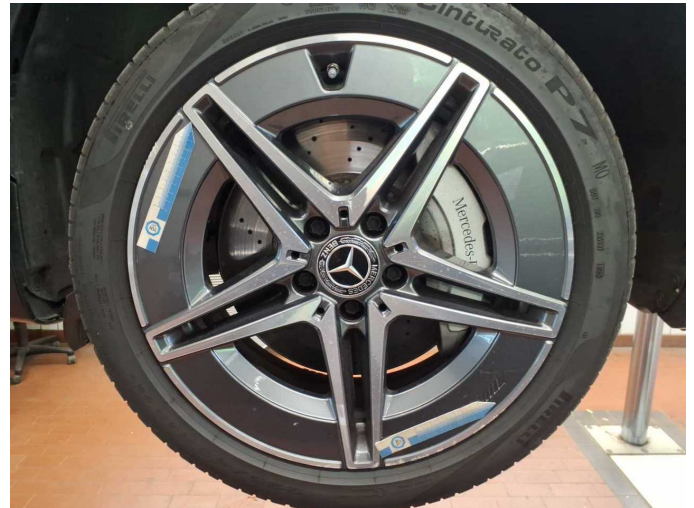
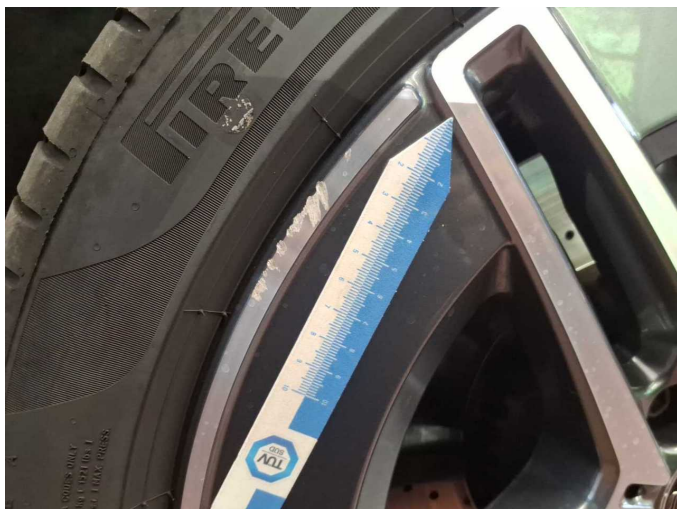
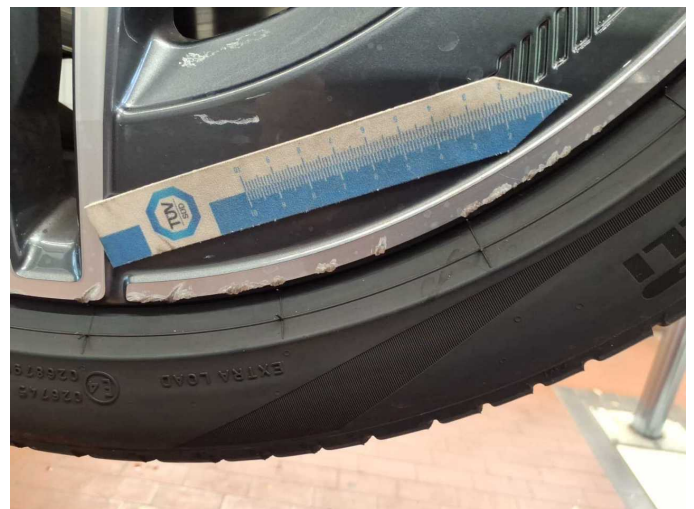
| No. | Component group | Description |
|---|---|---|
| 13 | Wheel / tyres | Alloy rim - front left side - Scratched - Loss in value |

**Damage 13:** Wheel / tyres: Alloy rim - front left side - Scratched - Loss in value

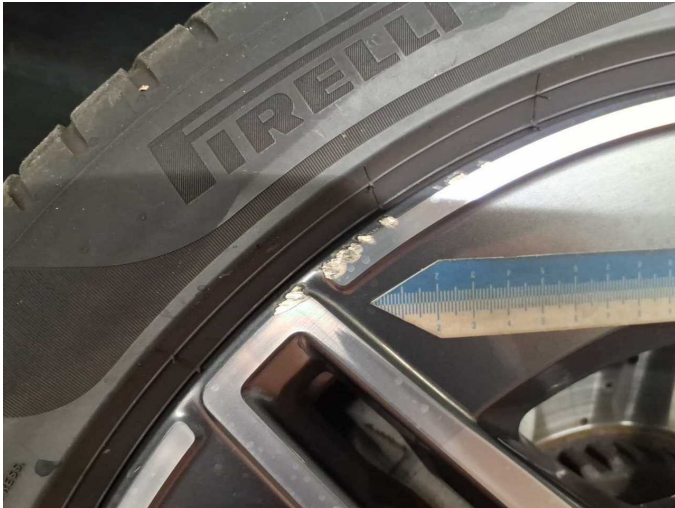
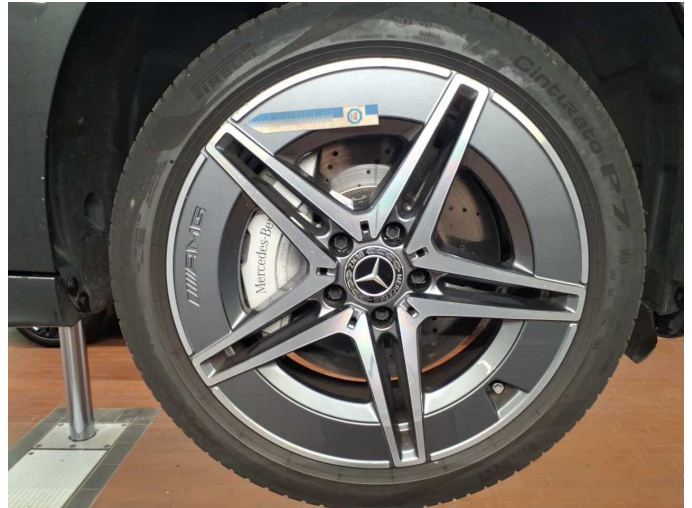
| No. | Component group | Description |
|---|---|---|
| 14 | Wheel / tyres | Alloy rim - front right side - Scratched - Loss in value |

**Damage 14:** Wheel / tyres: Alloy rim - front right side - Scratched - Loss in value

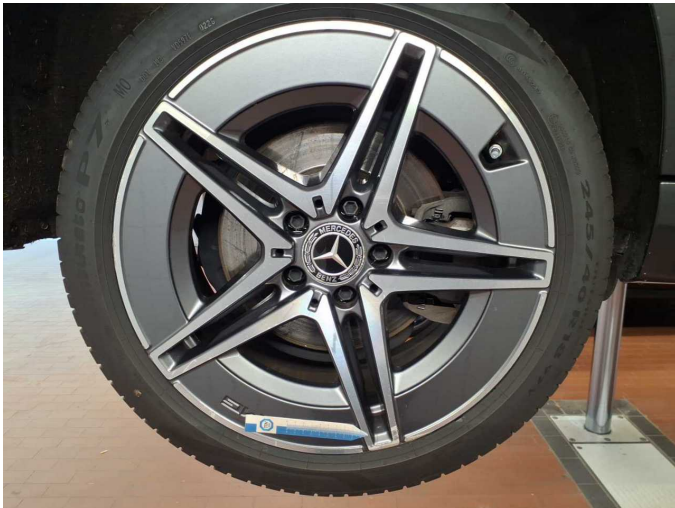
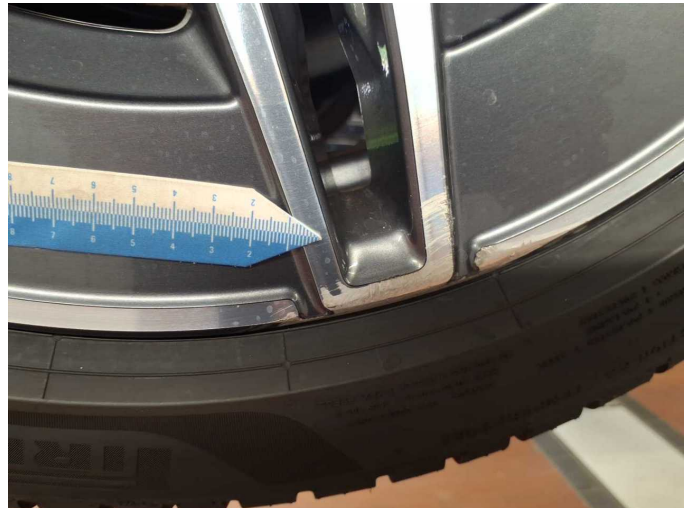
| No. | Component group | Description |
|---|---|---|
| 15 | Wheel / tyres | Alloy rim - rear right side - Scratched - Loss in value |

**Damage 15:** Wheel / tyres: Alloy rim - rear right side - Scratched - Loss in value

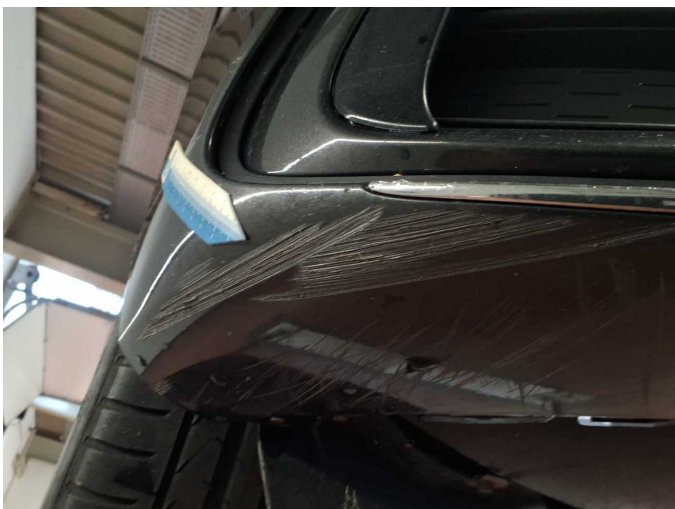
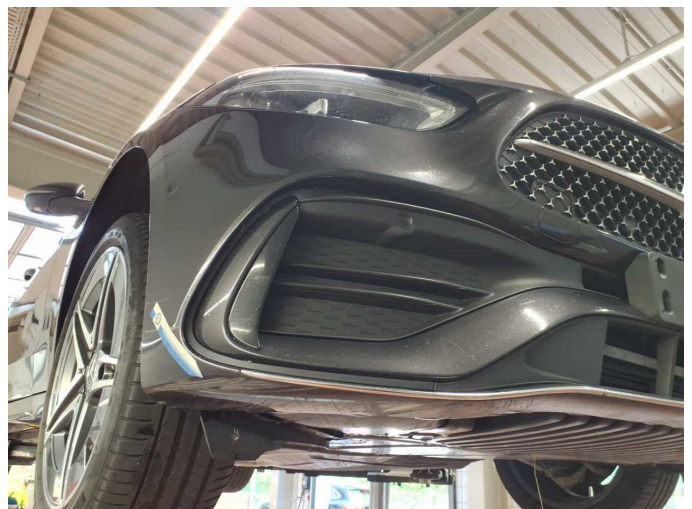
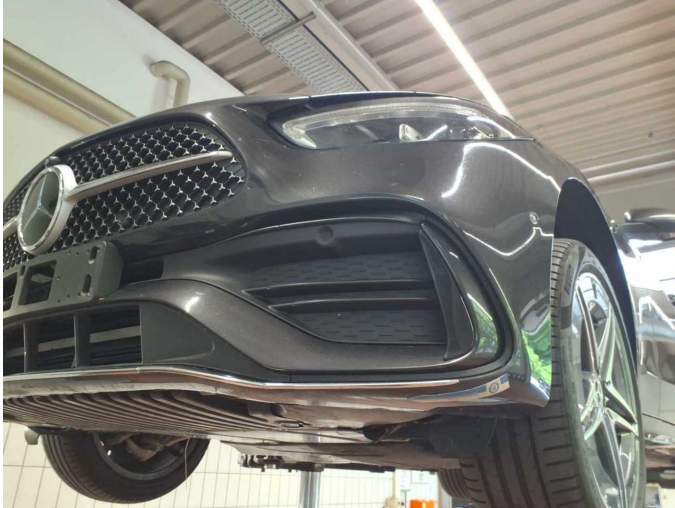
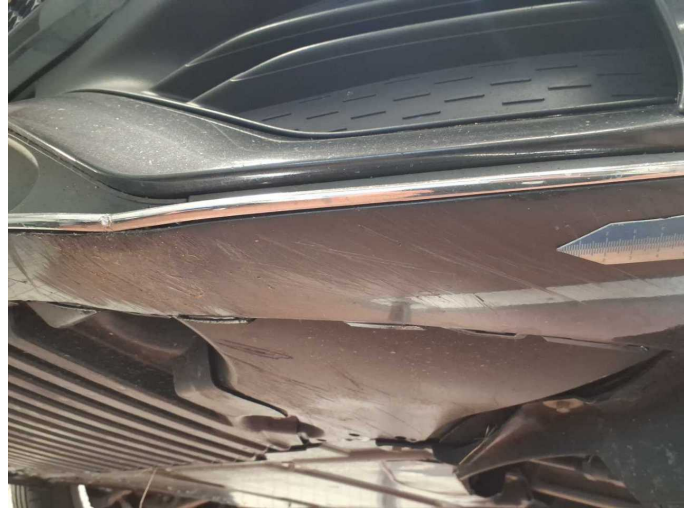
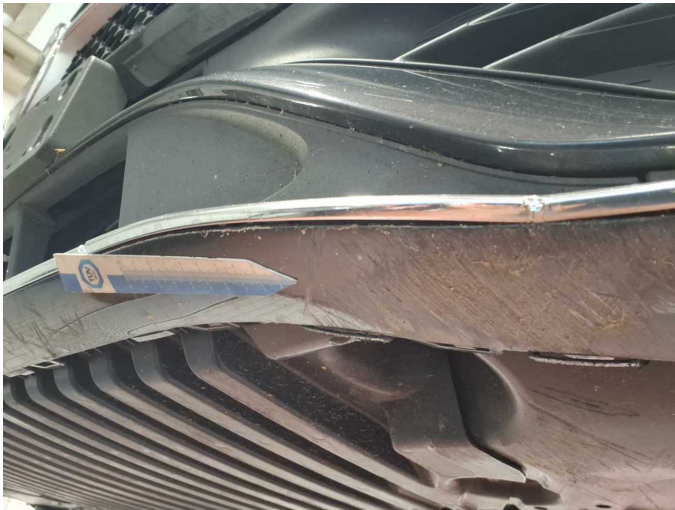
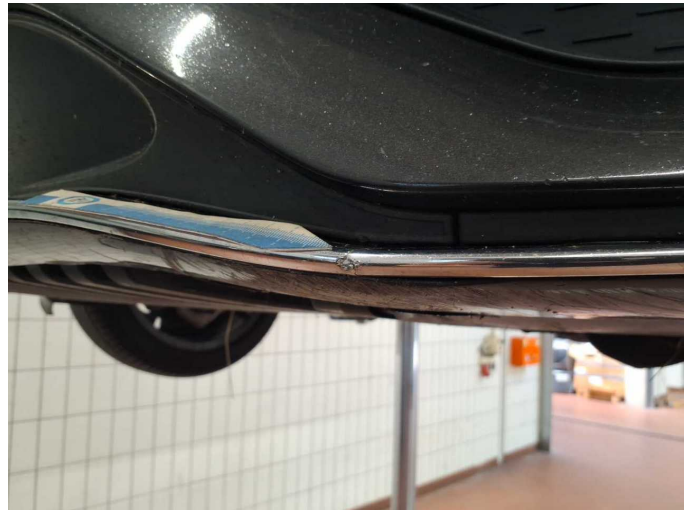
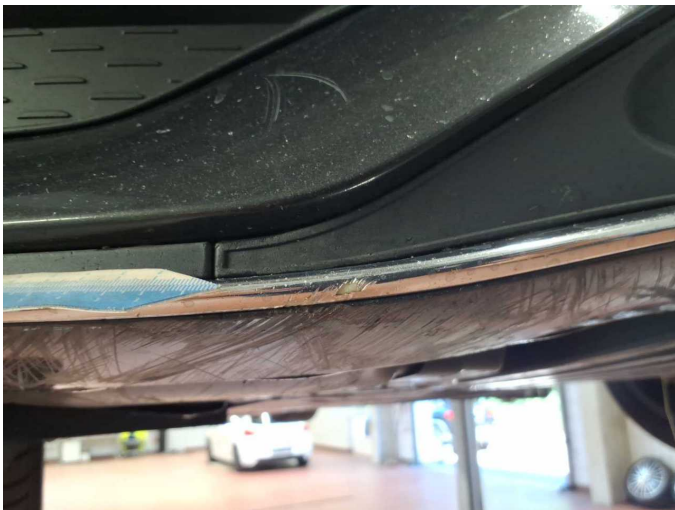
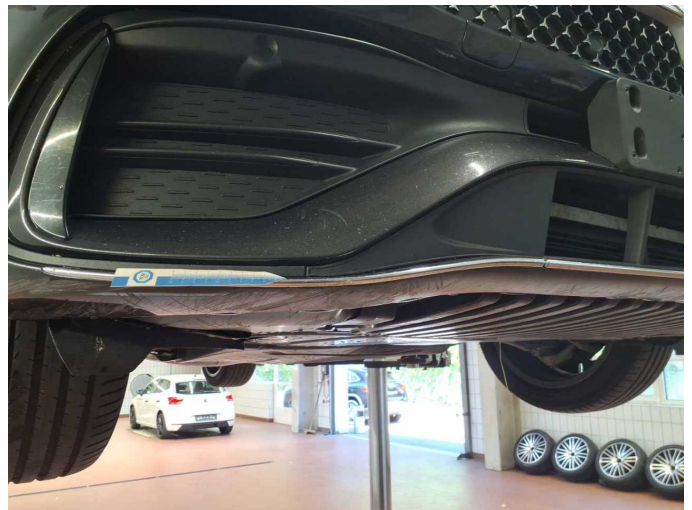
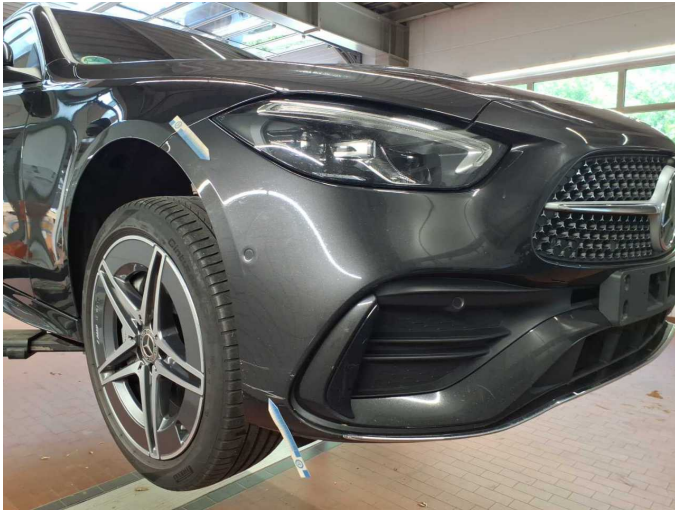
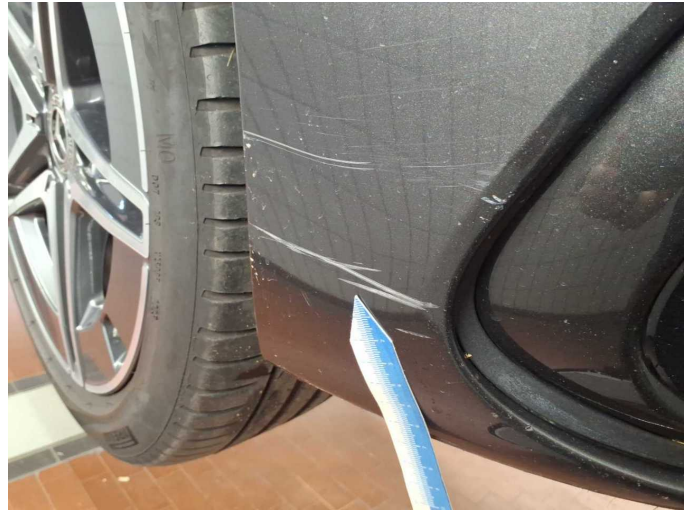
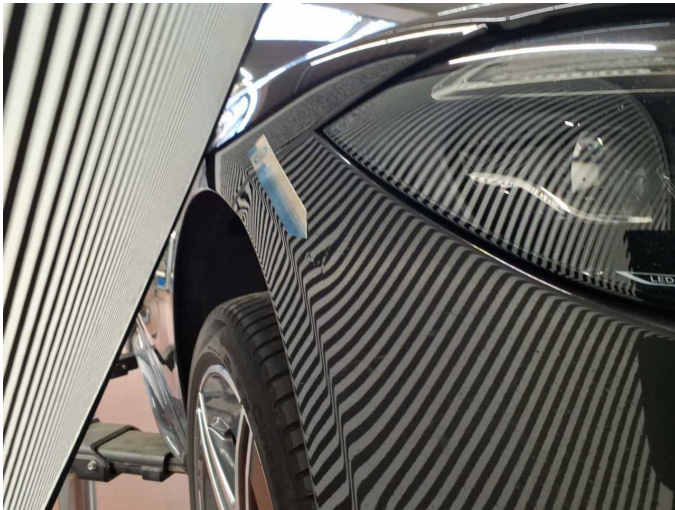
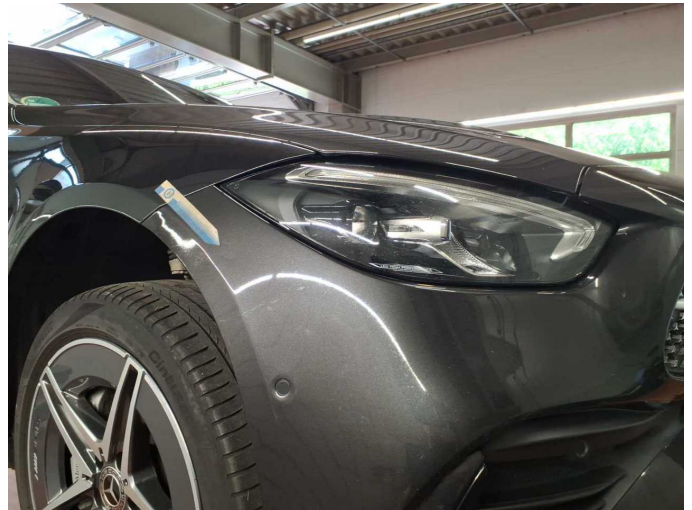
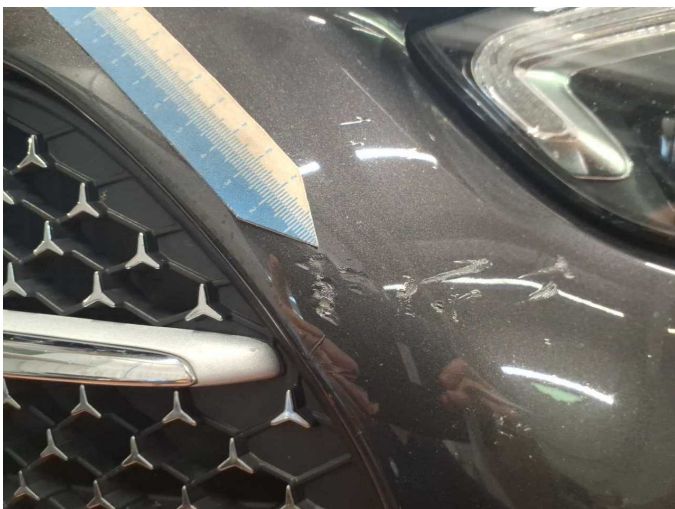
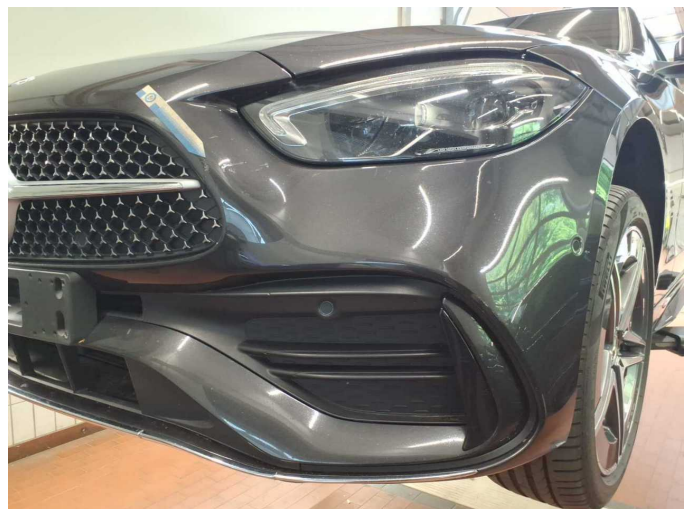
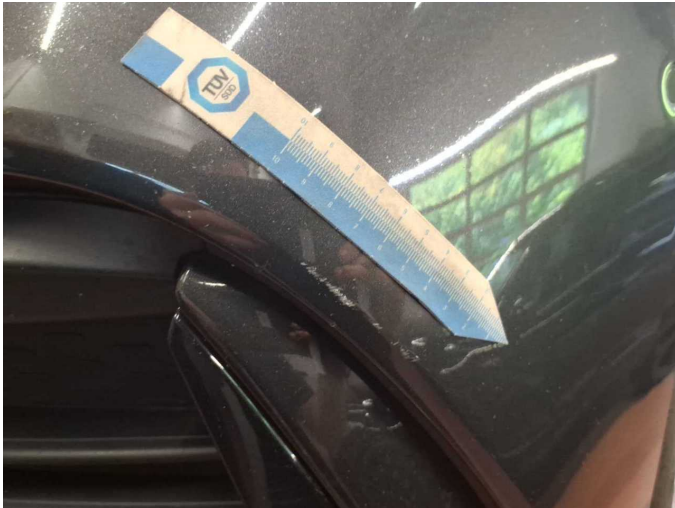
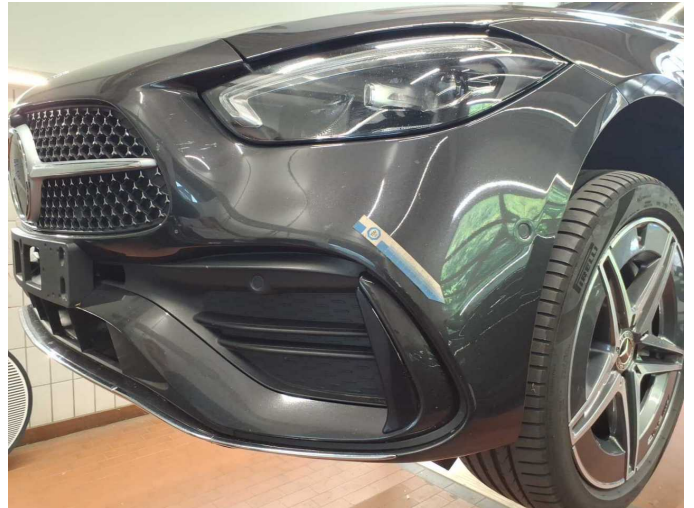
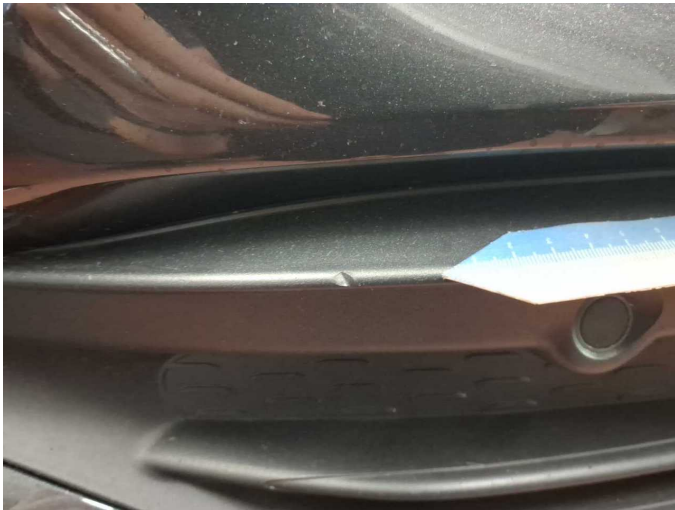
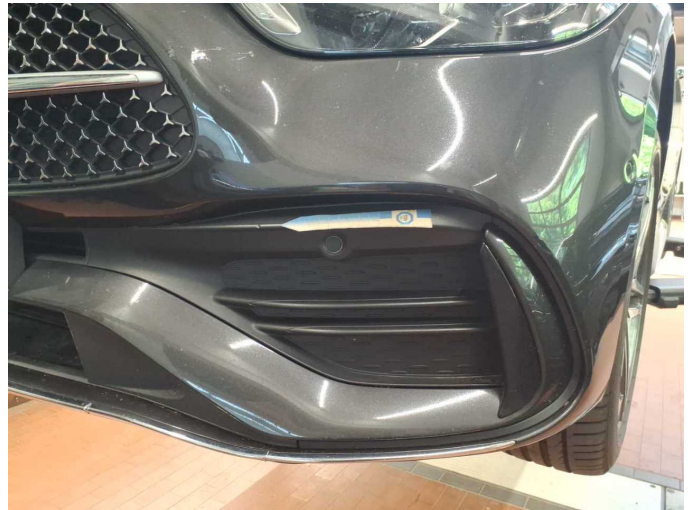
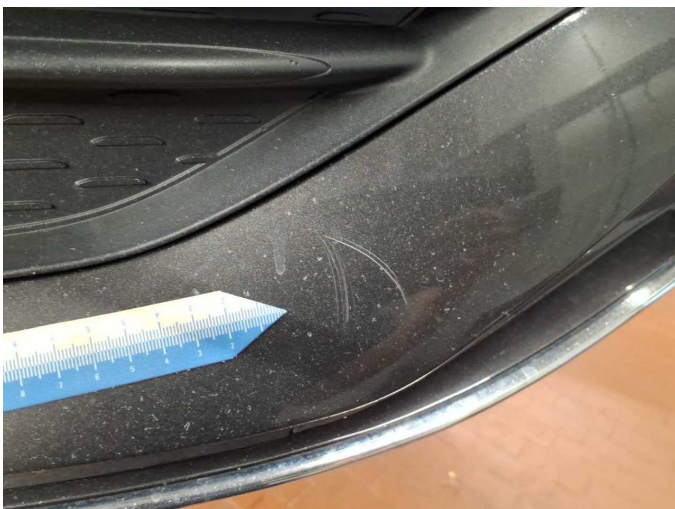
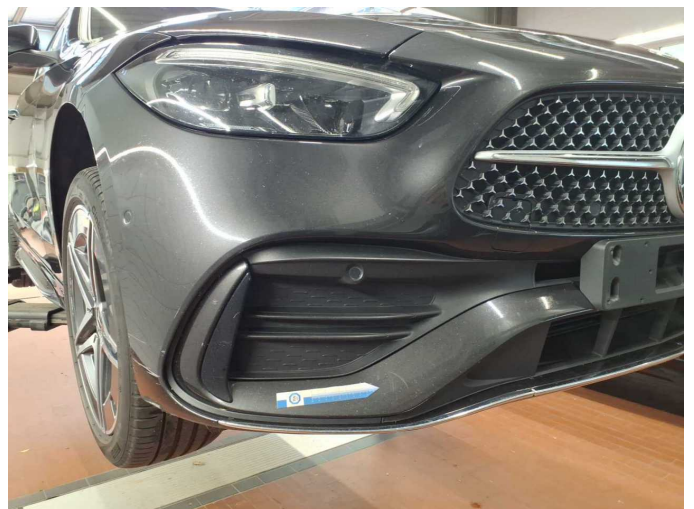
| No. | Component group | Description |
|---|---|---|
| 16 | Front bumper | Front bumper - Scratched - Repair and paint |

**Damage 16:** Front bumper: Front bumper - Scratched - Repair and paint

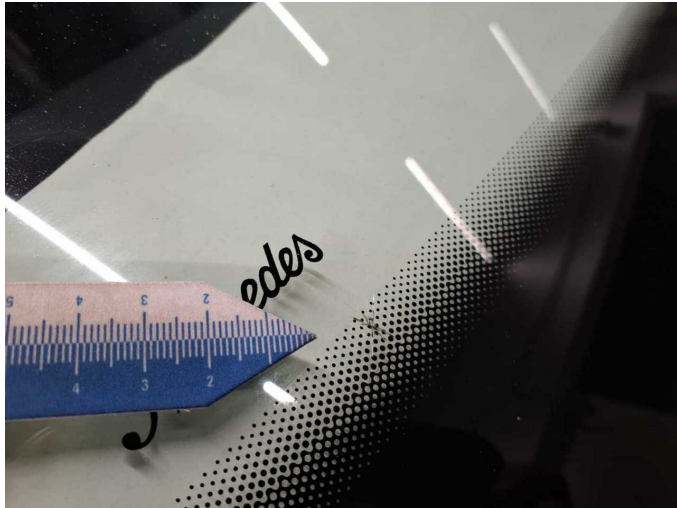
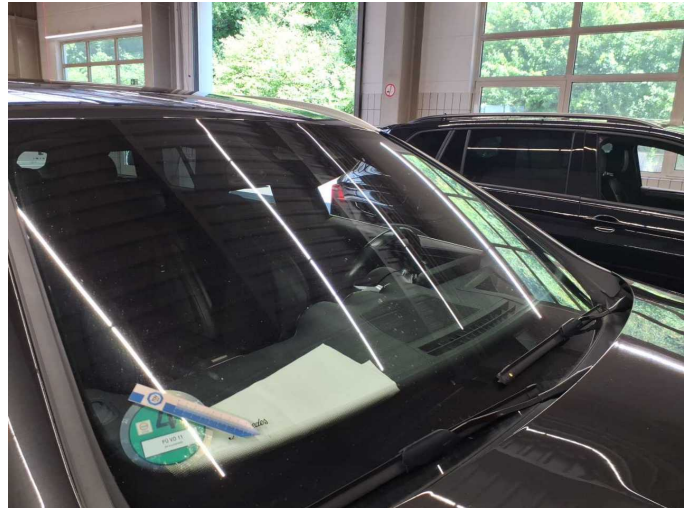
| No. | Component group | Description |
|---|---|---|
| 17 | Vehicle glazing | Windscreen - Stone chips - repair according to calculation |

**Damage 17:** Vehicle glazing: Windscreen - Stone chips - repair according to calculation

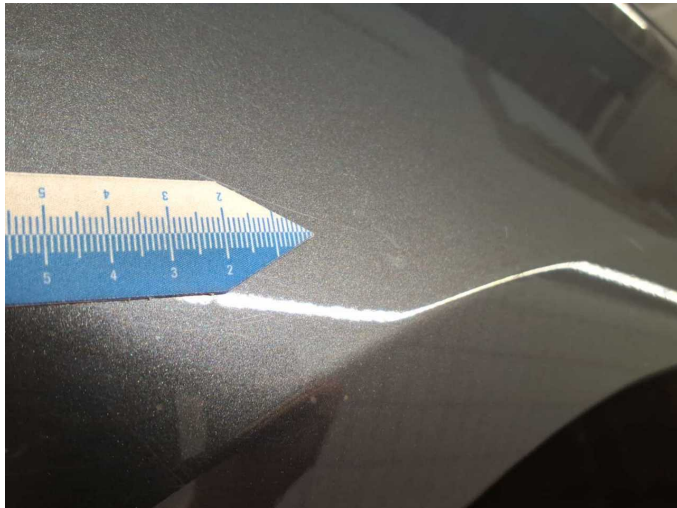
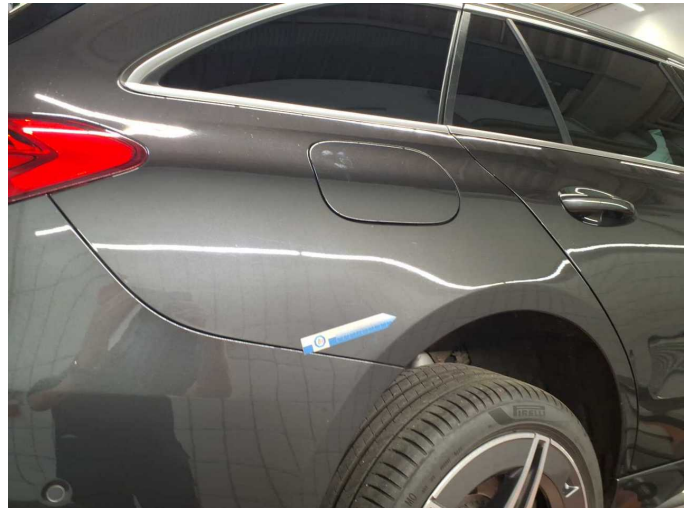
| No. | Component group | Description |
|---|---|---|
| 1 | Side panel - rear right side | Side panel - Scratch(es) - No deduction |

**Wear and tear 1:** Side panel - rear right side: Side panel - Scratch(es) - No deduction

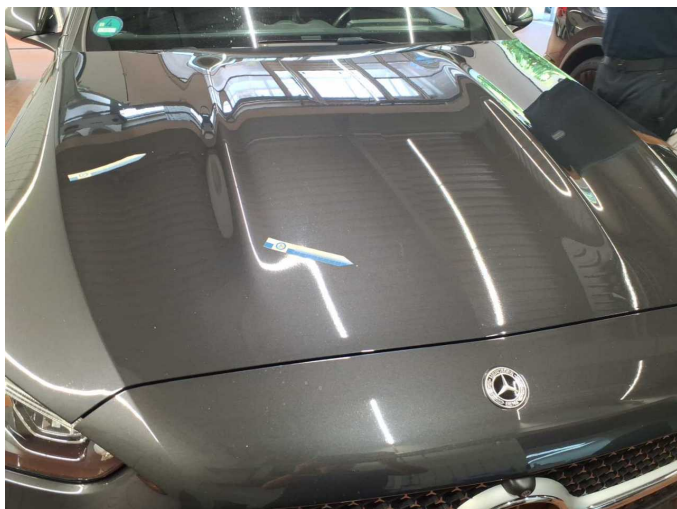
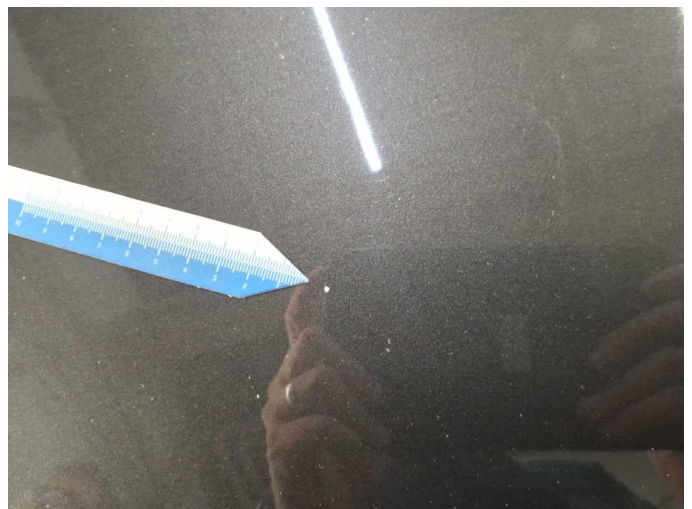
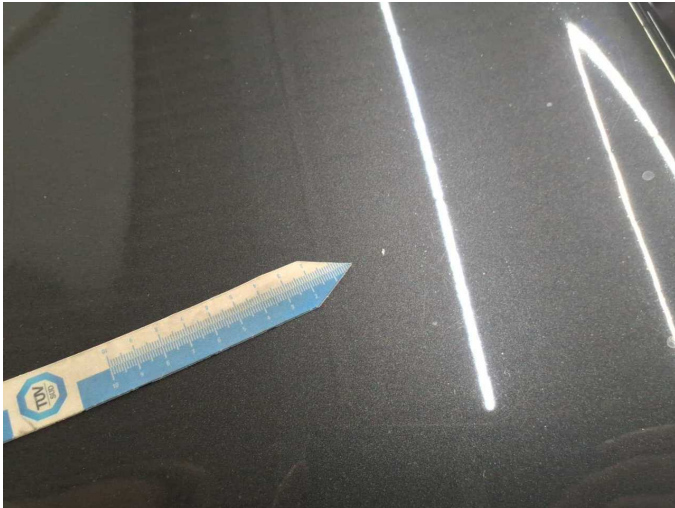
| No. | Component group | Description |
|---|---|---|
| 3 | Bonnet | Bonnet - Stone chips - No deduction |

**Wear and tear 3:** Bonnet: Bonnet - Stone chips - No deduction

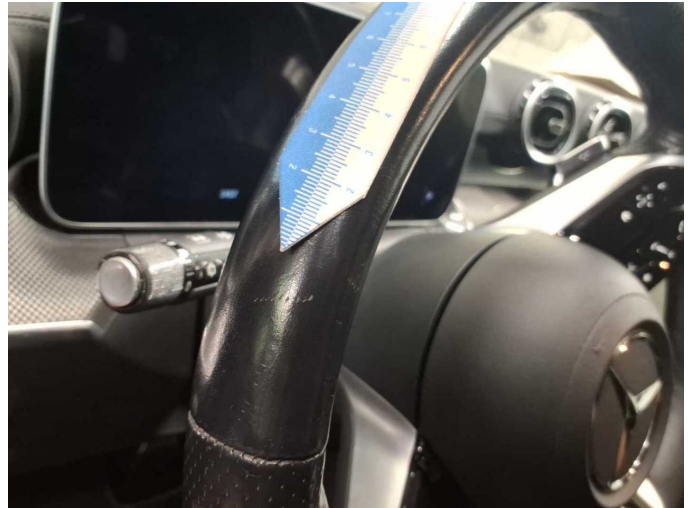
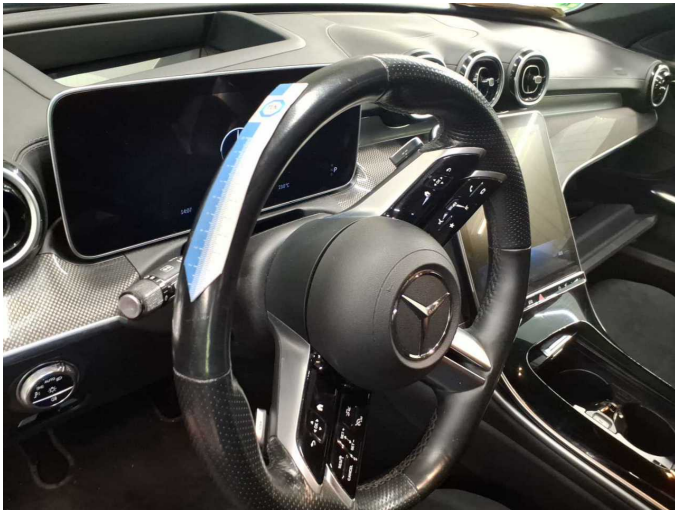
| No. | Component group | Description |
|---|---|---|
| 4 | Steering system | Steering wheel - Scratch(es) - No deduction |

**Wear and tear 4:** Steering system: Steering wheel - Scratch(es) - No deduction
