Expertise

Protocol number: 46710467  
Order No. / Reference: 26759860  
Inspection date: 24 Jul 2026

| Manufacturer: Mercedes-Benz | Model: C 220 d T 9G-TRONIC AMG Line |
| VIN: W1KAH0EB7PF114324 | |

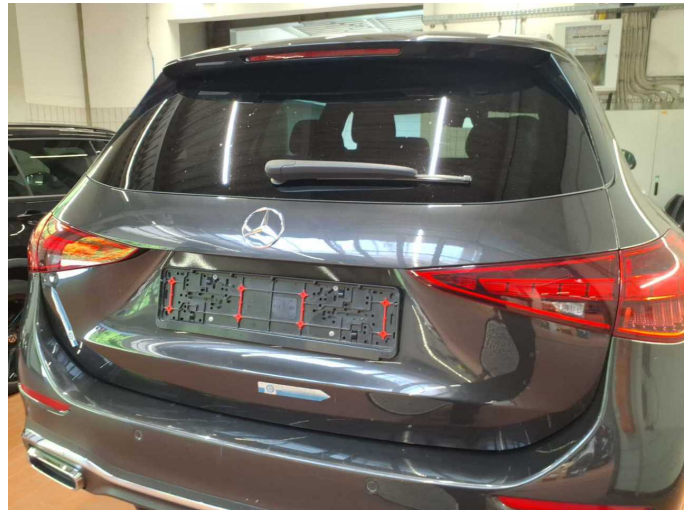
| No. | Accident |
|---|---|
| 1 | Rear |

**Accident 1:** Rear

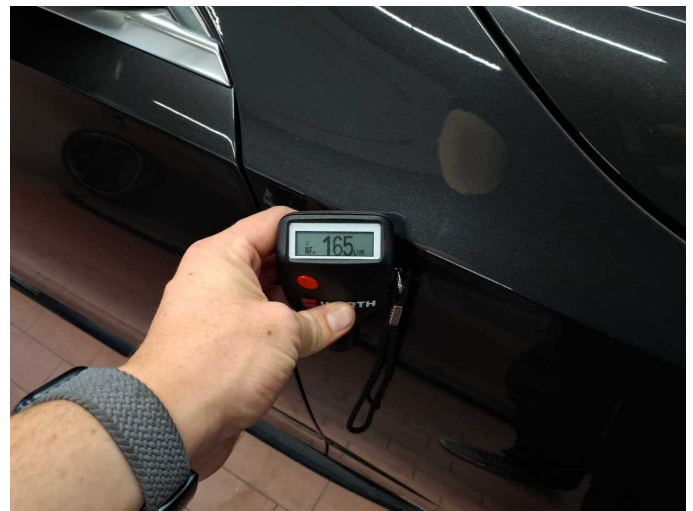
| No. | Repainting |
|---|---|
| 1 | Mudguard - right side, Professionally carried out, Invoice of repair done Non-existent |

| Mudguard - right side | 165 µm | Door - rear right side | 180 µm |

**Repainting 1: Mudguard - right side**
