Expertise

Protocol number: 46365776
Order No. / Reference: 25903019-1
Inspection date: 19 Mar 2026

Manufacturer: Opel

Model: Vivaro 2.0 D Cargo M Autm. Elegance

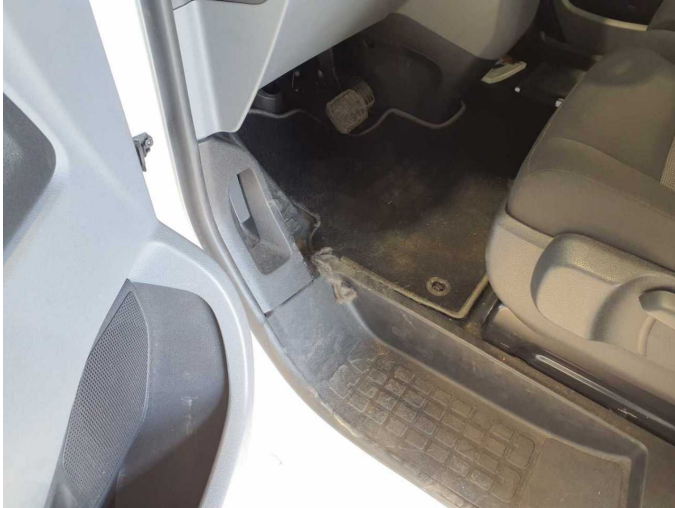
Damage 1: Trim / covers: Floor mats - Broken / torn - Replace

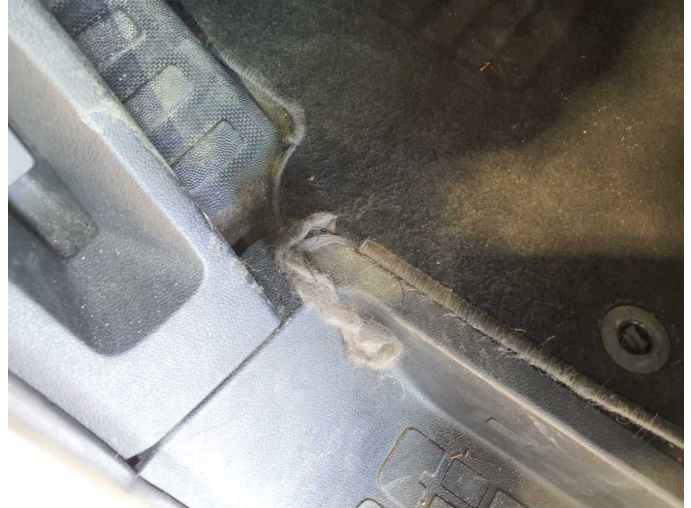
Damage 1: Trim / covers: Floor mats - Broken / torn - Replace

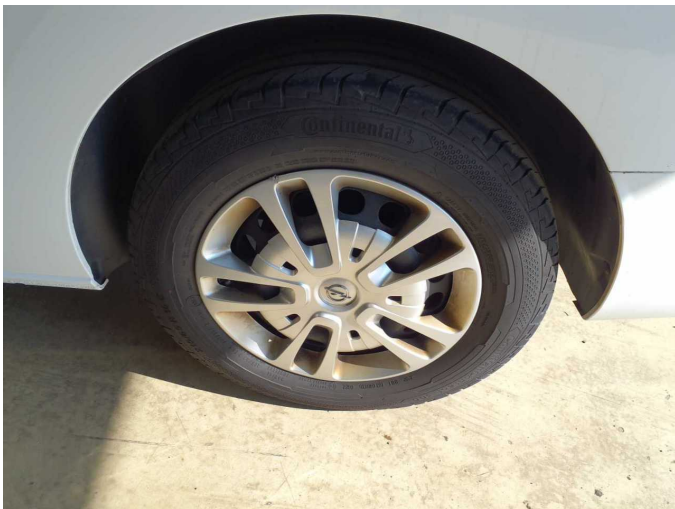
Damage 2: Wheel / tyres: Wheel cover - rear left side - Scratch(es) - Replace

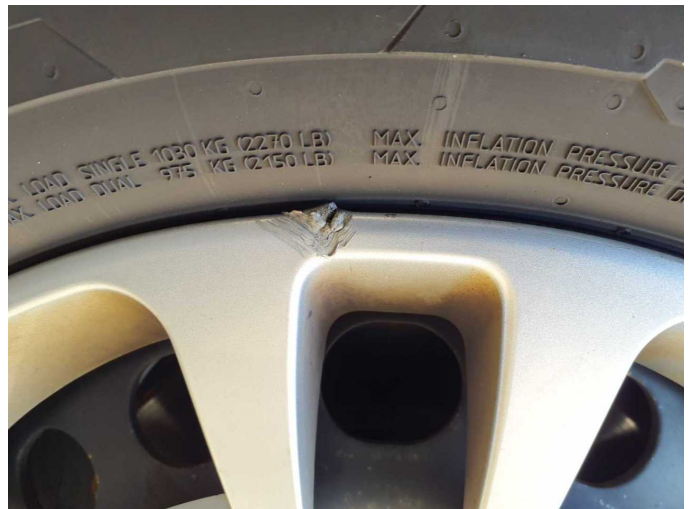
Damage 2: Wheel / tyres: Wheel cover - rear left side - Scratch(es) - Replace

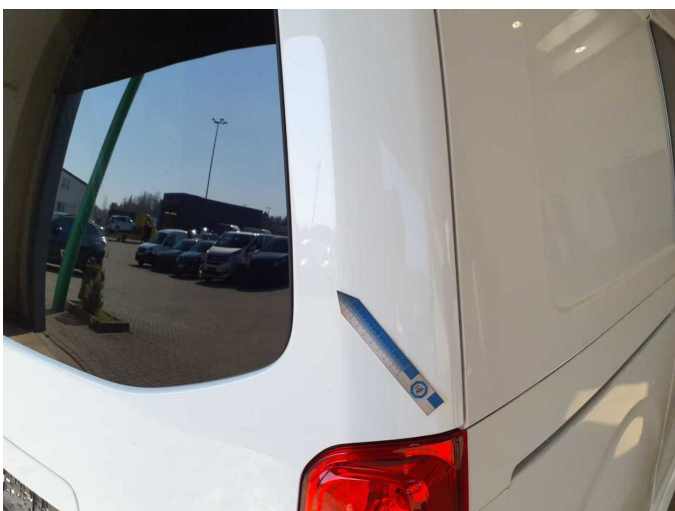
Damage 3: Boot lid / rear door: Boot lid - Scratch(es) - Smart repair

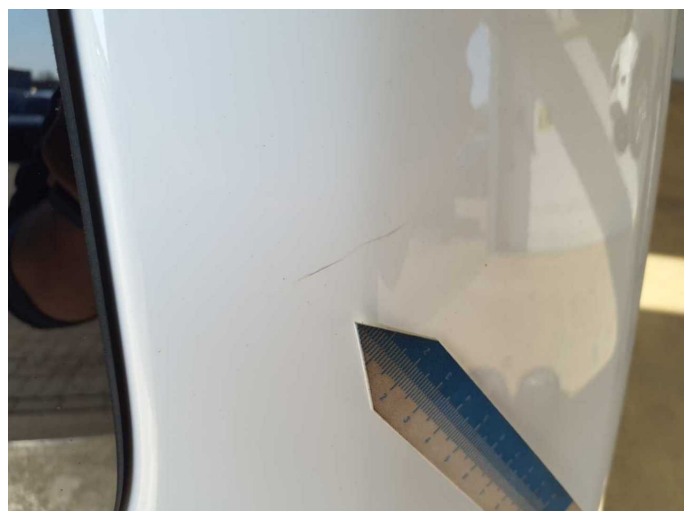
Damage 3: Boot lid / rear door: Boot lid - Scratch(es) - Smart repair

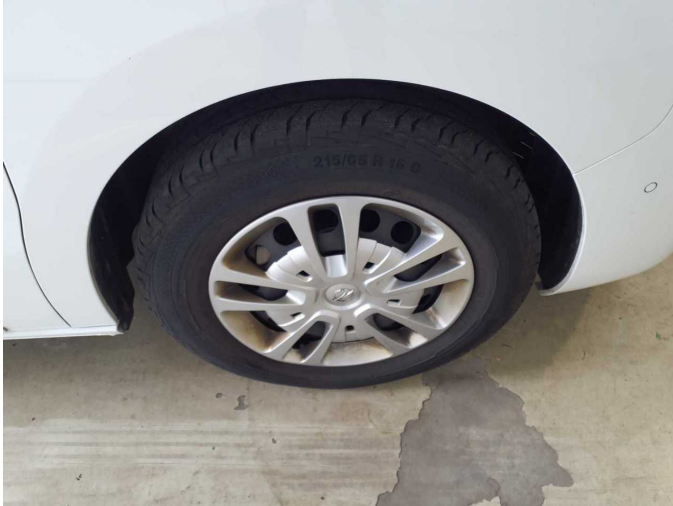
Damage 4: Wheel / tyres: Tyre - front right side - Damaged - Replace

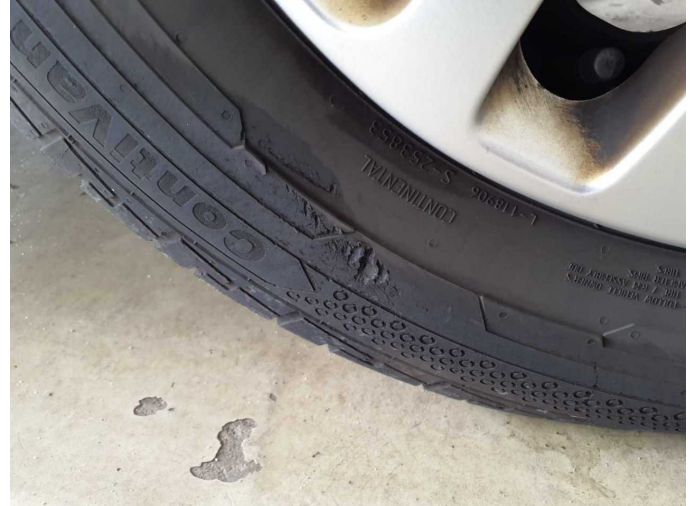
Damage 4: Wheel / tyres: Tyre - front right side - Damaged - Replace

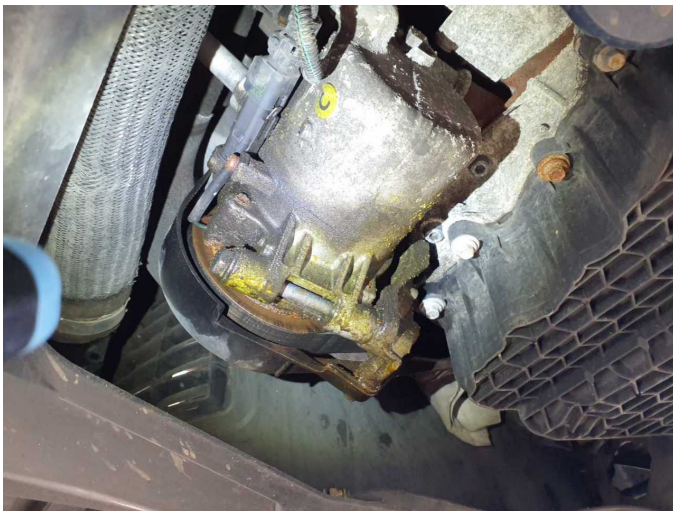
Damage 5: Engine: Engine - Leaking - Perform diagnosis

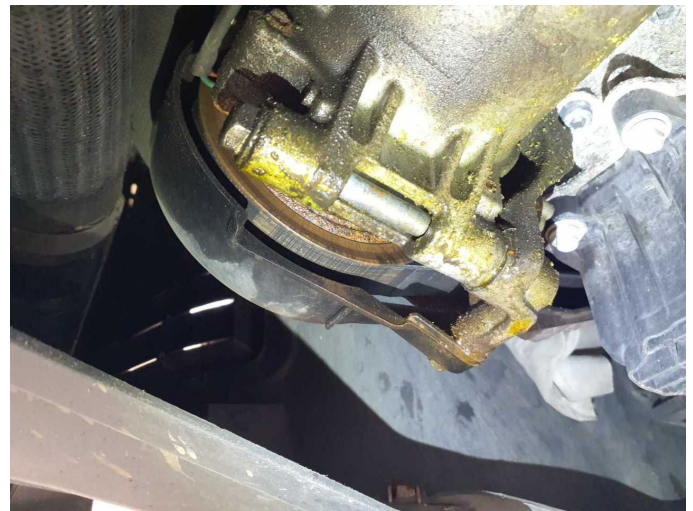
Damage 5: Engine: Engine - Leaking - Perform diagnosis

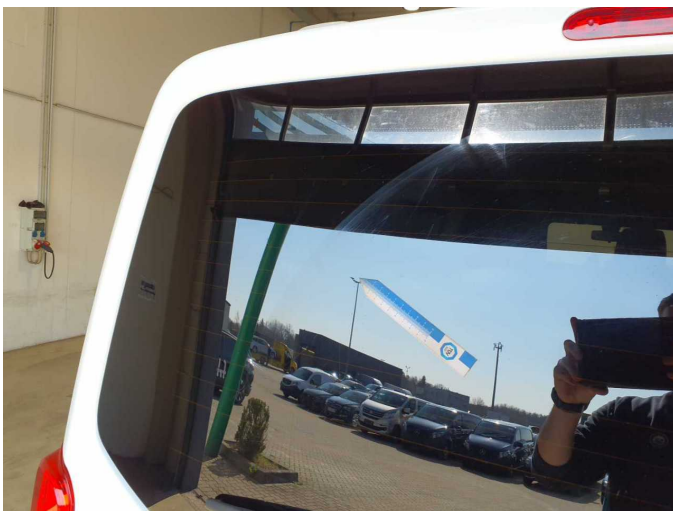
Damage 6: Vehicle glazing: Rear window - Scratch(es) - Loss in value

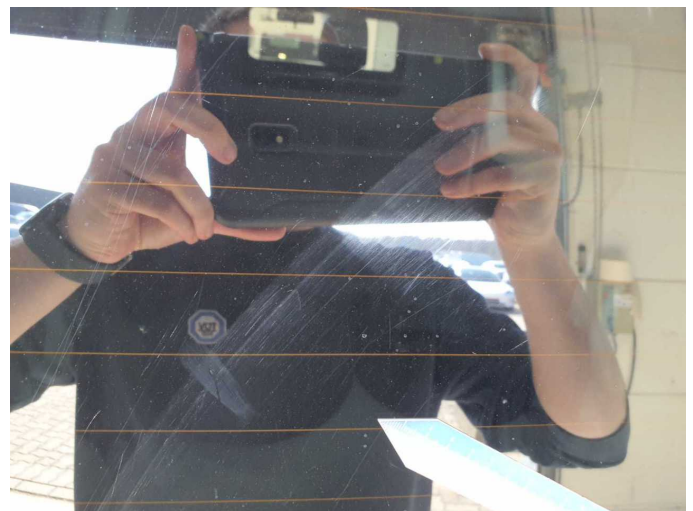
Damage 6: Vehicle glazing: Rear window - Scratch(es) - Loss in value

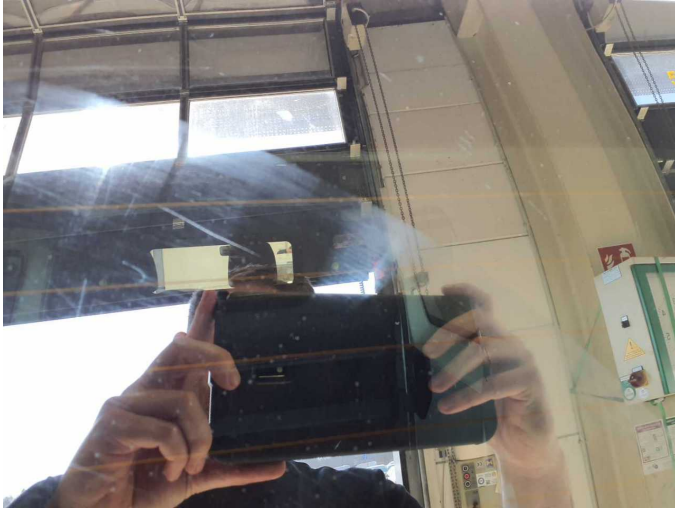
Damage 6: Vehicle glazing: Rear window - Scratch(es) - Loss in value

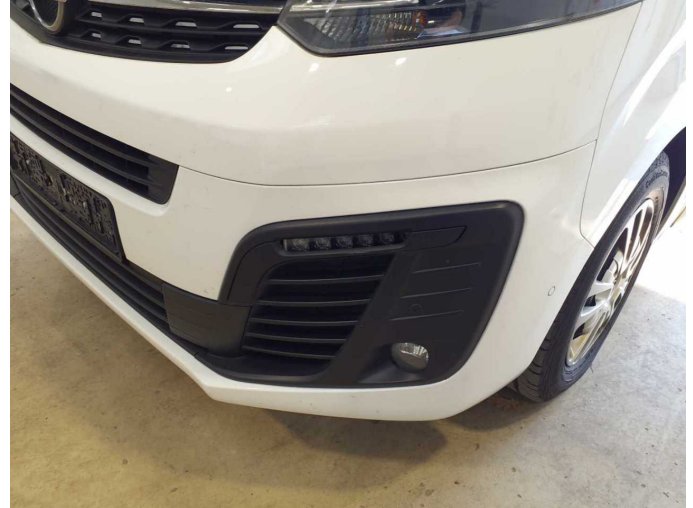
Damage 7: Additional lamp: Daytime running light - Broken / torn - Replace

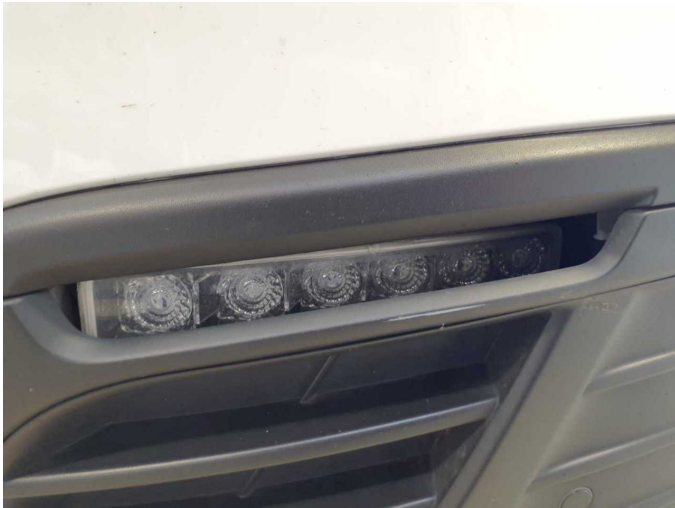
Damage 7: Additional lamp: Daytime running light - Broken / torn - Replace

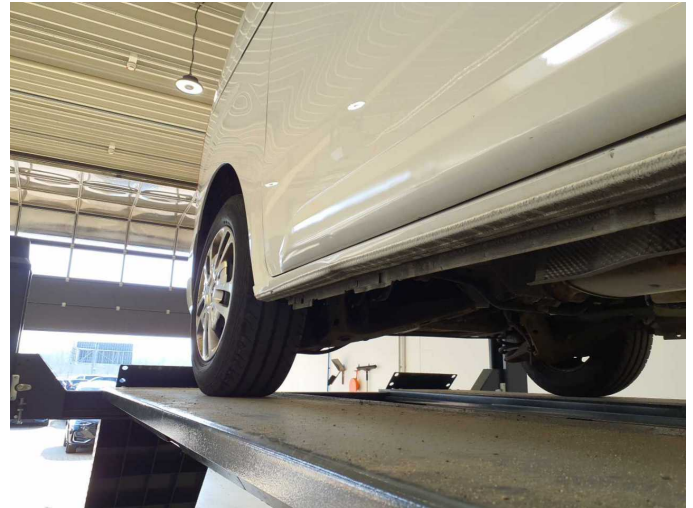
Damage 8: Sill - right side: Sill - dent(s) - Repair and paint

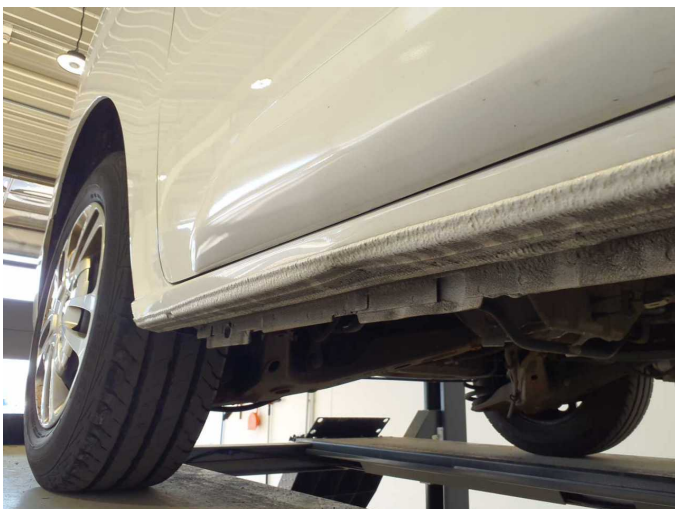
Damage 8: Sill - right side: Sill - dent(s) - Repair and paint

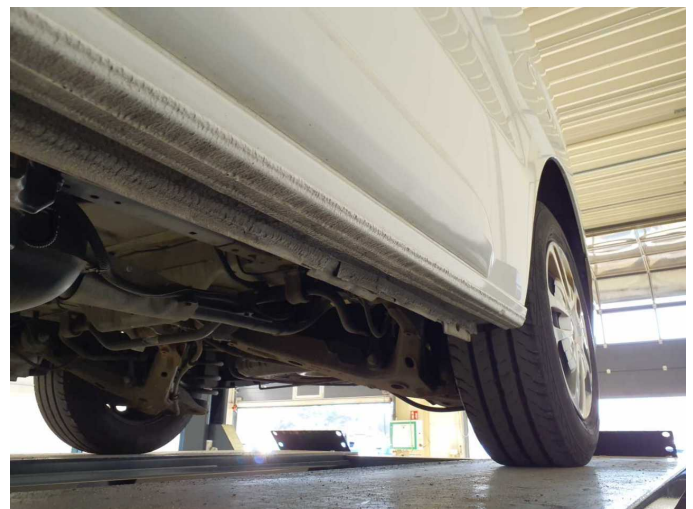
Damage 9: Sill - left side: Sill - dent(s) - Repair and paint

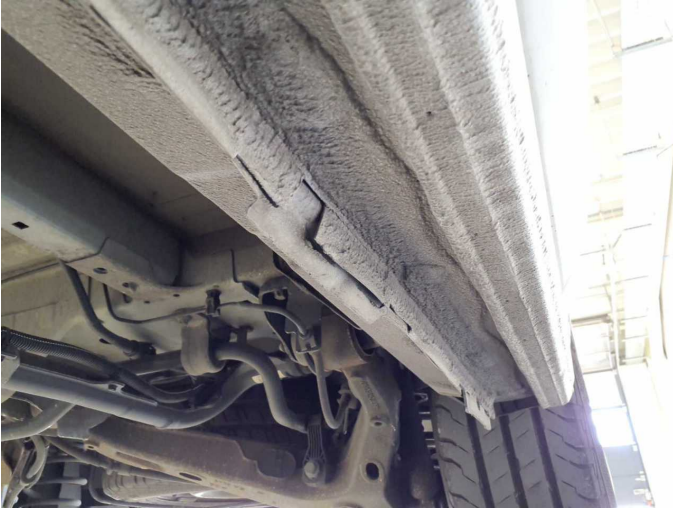
Damage 9: Sill - left side: Sill - dent(s) - Repair and paint

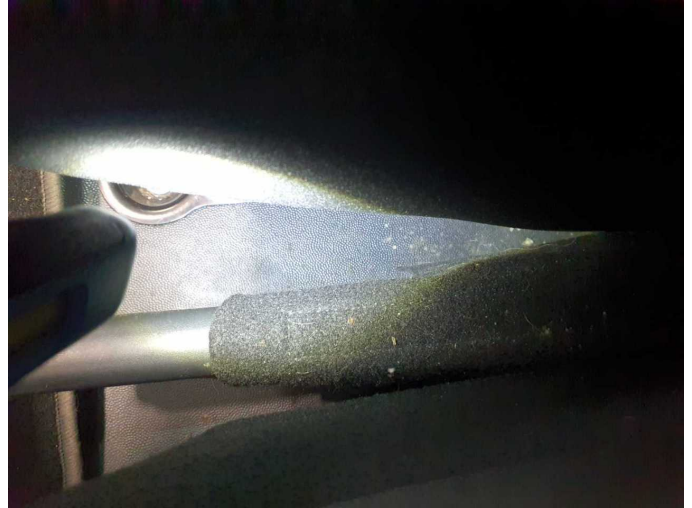
Damage 10: Interior: Interior - Soiled - Clean

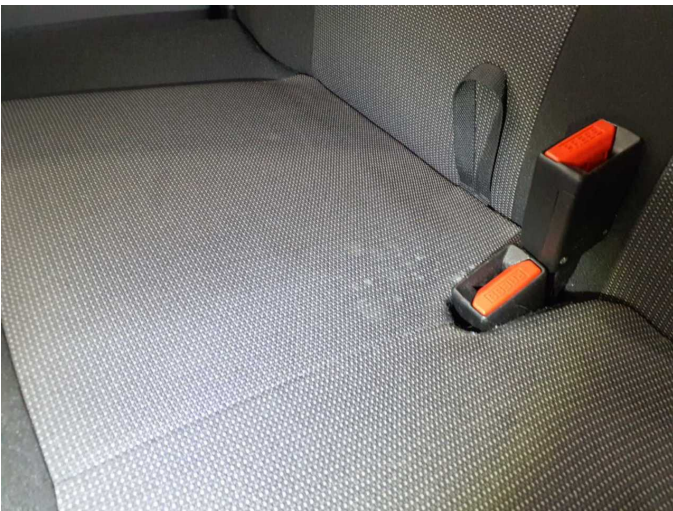
Damage 10: Interior: Interior - Soiled - Clean

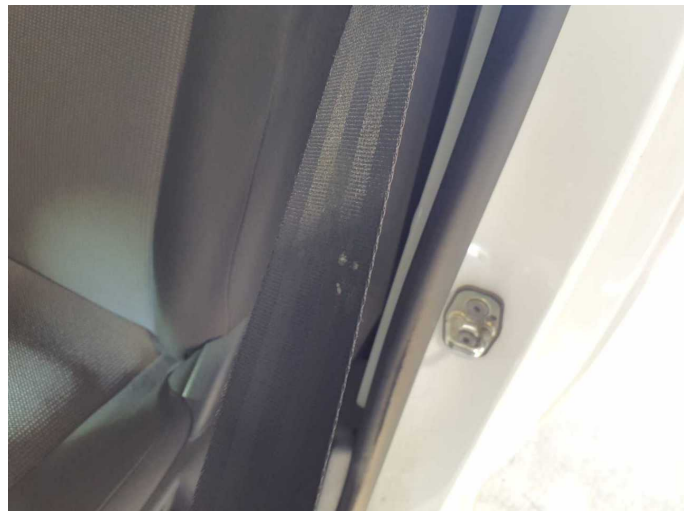
Damage 10: Interior: Interior - Soiled - Clean

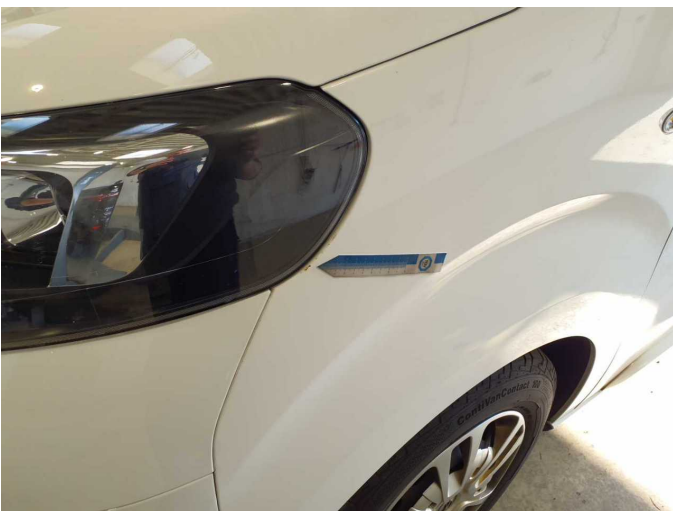
Damage 11: Mudguard - left side: Mudguard - left side - Corrosion - Repair and paint

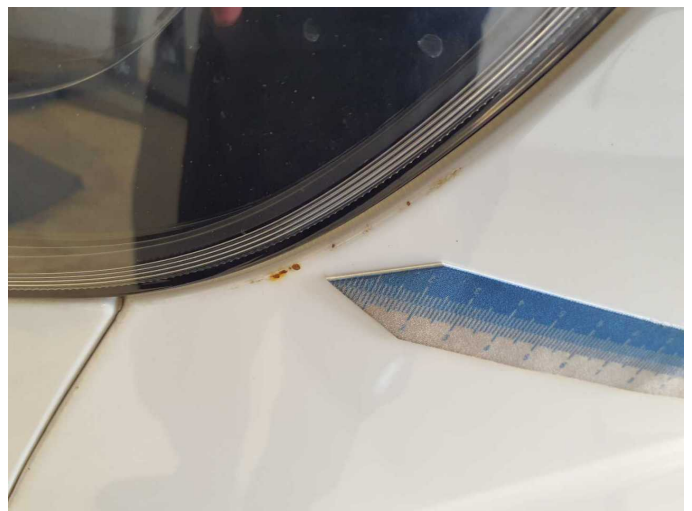
Damage 11: Mudguard - left side: Mudguard - left side - Corrosion - Repair and paint

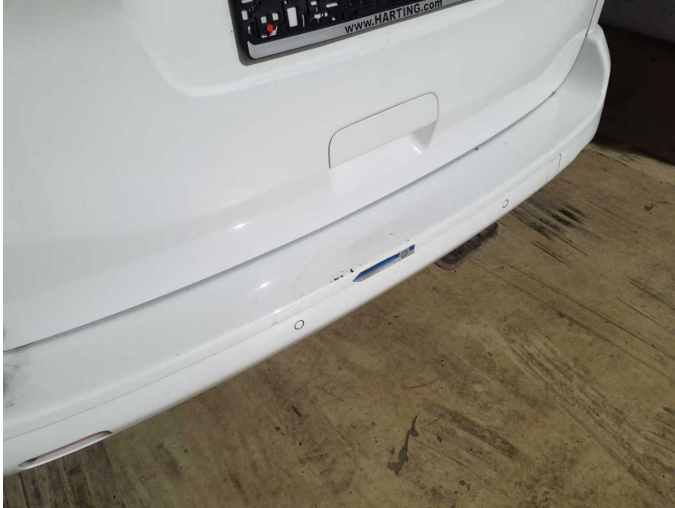
Damage 12: Rear bumper: Rear bumper - Scratched - Repair and paint

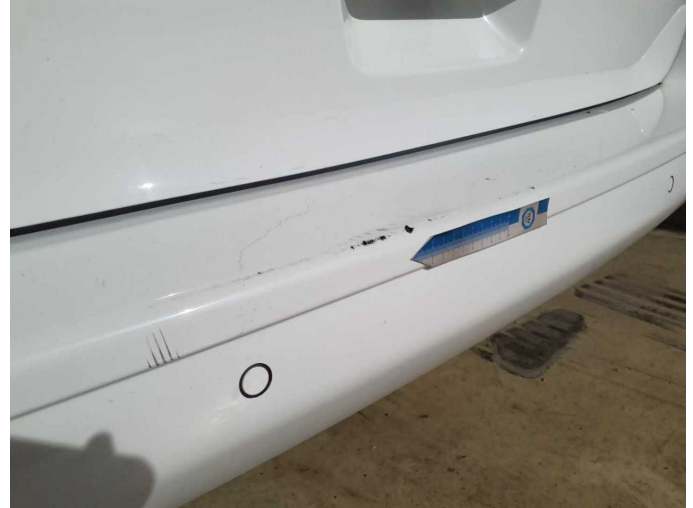
Damage 12: Rear bumper: Rear bumper - Scratched - Repair and paint

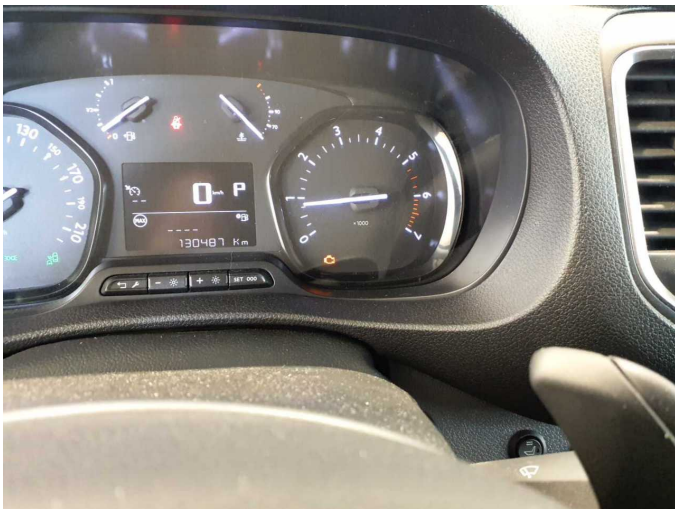
Damage 13: Engine: Engine (MKL an, AGR Ventil mit Abgaskühler muss ersetzt werden) - Sub-function - repair according to calculation

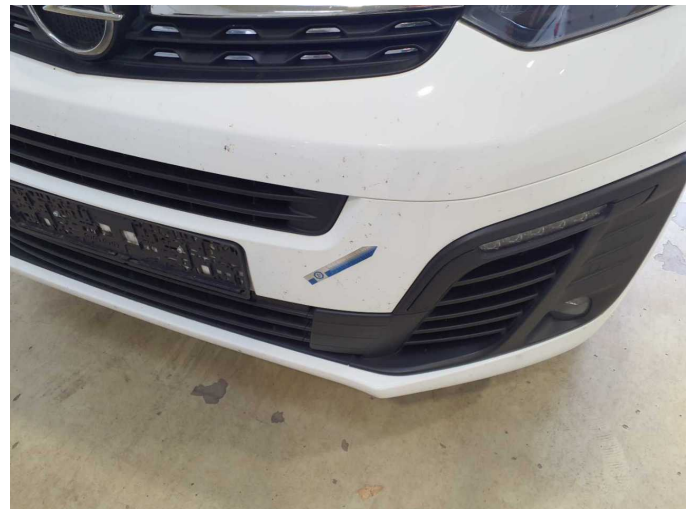
Damage 14: Front bumper: Front bumper - Scratch(es) - Paint

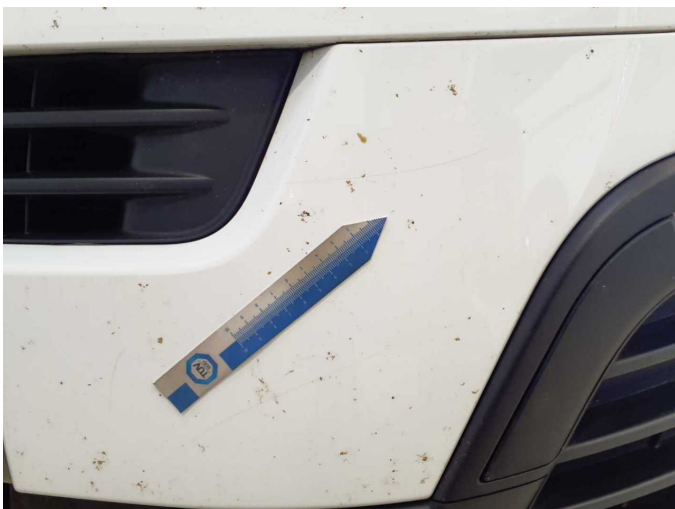
Damage 14: Front bumper: Front bumper - Scratch(es) - Paint

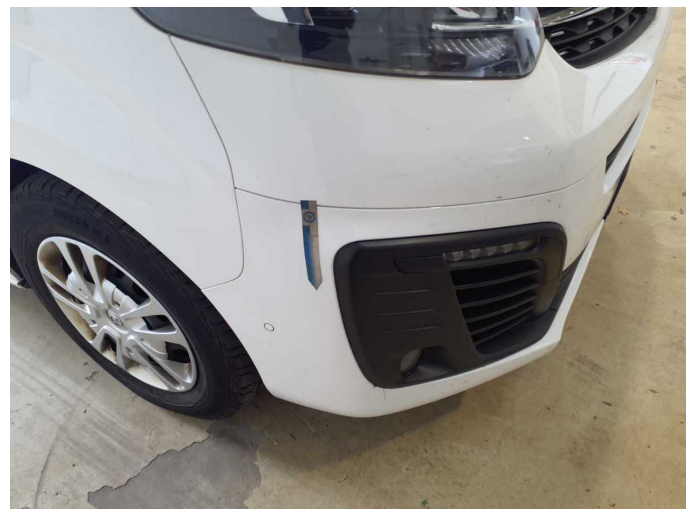
Damage 14: Front bumper: Front bumper - Scratch(es) - Paint

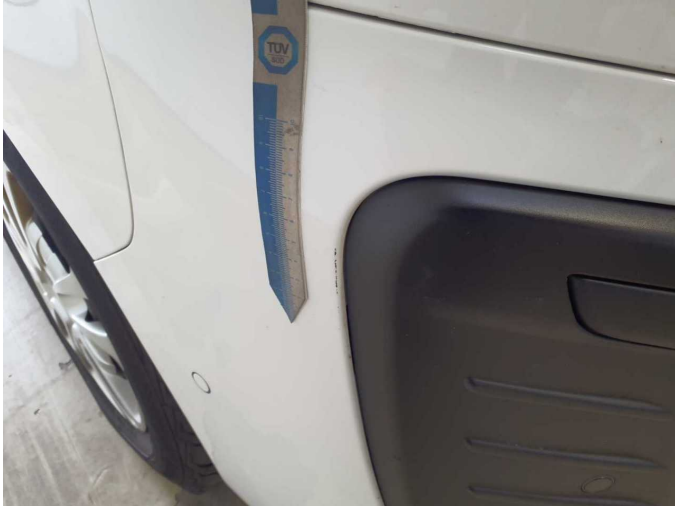
Damage 14: Front bumper: Front bumper - Scratch(es) - Paint

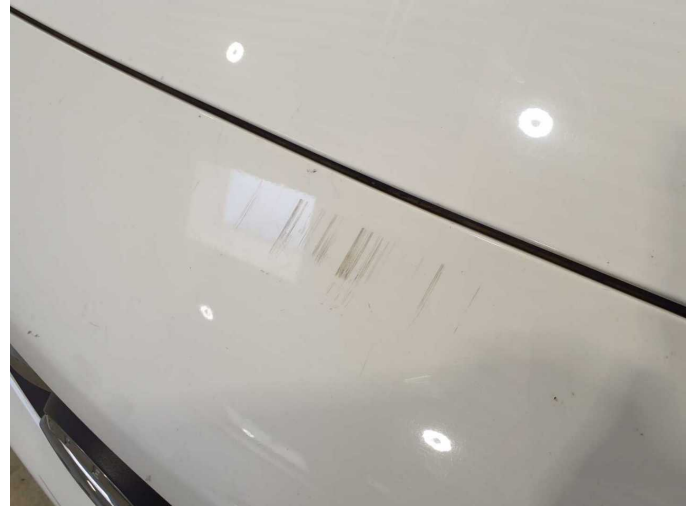
Damage 14: Front bumper: Front bumper - Scratch(es) - Paint

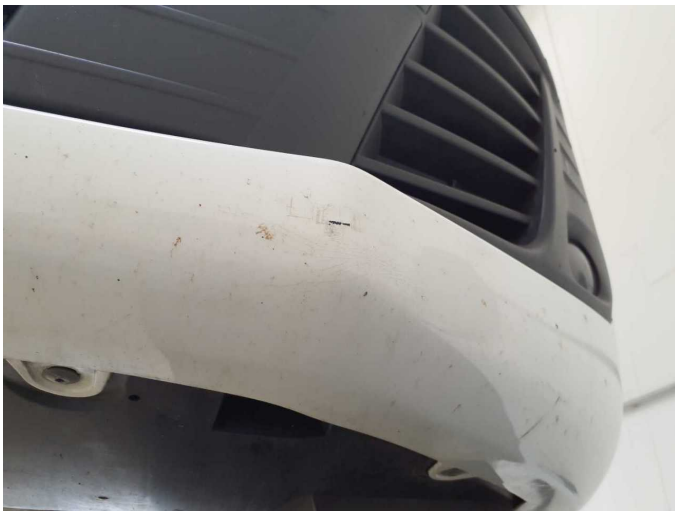
Damage 14: Front bumper: Front bumper - Scratch(es) - Paint

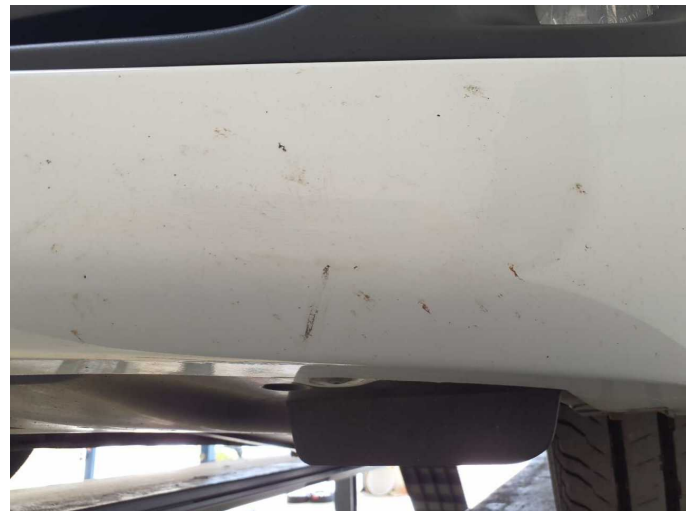
Damage 14: Front bumper: Front bumper - Scratch(es) - Paint

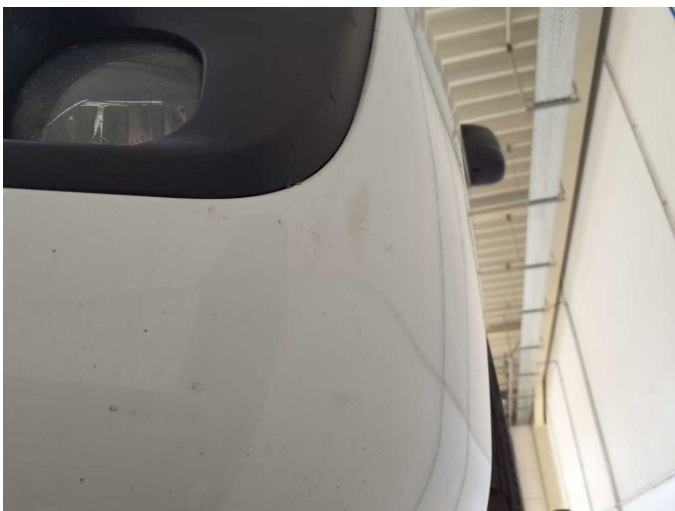
Damage 14: Front bumper: Front bumper - Scratch(es) - Paint

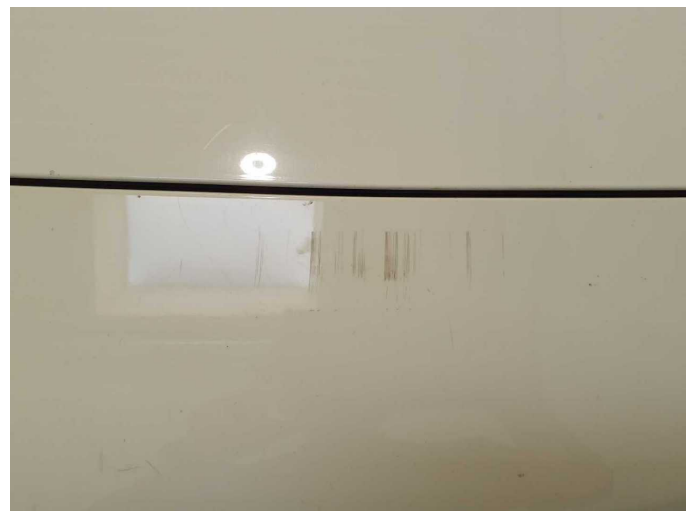
Damage 14: Front bumper: Front bumper - Scratch(es) - Paint

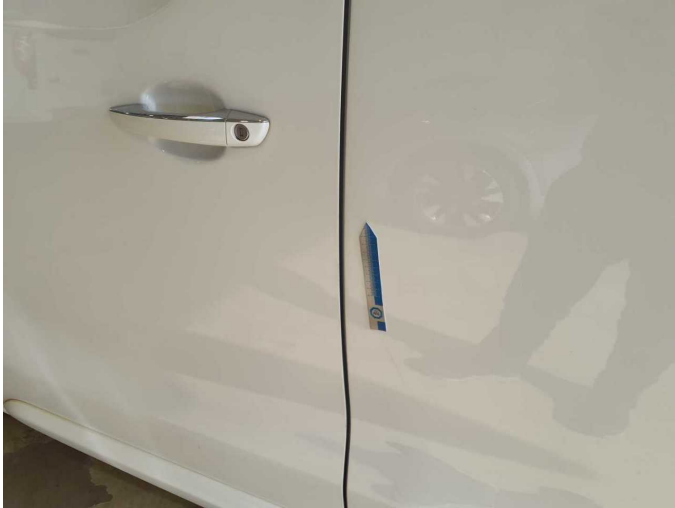
Wear and tear 2: Side panel - rear left side: Side panel - Scratch(es) - No deduction

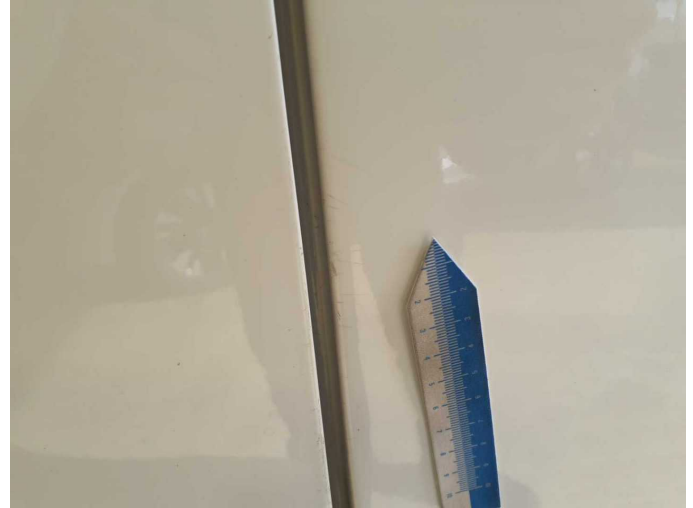
Wear and tear 2: Side panel - rear left side: Side panel - Scratch(es) - No deduction

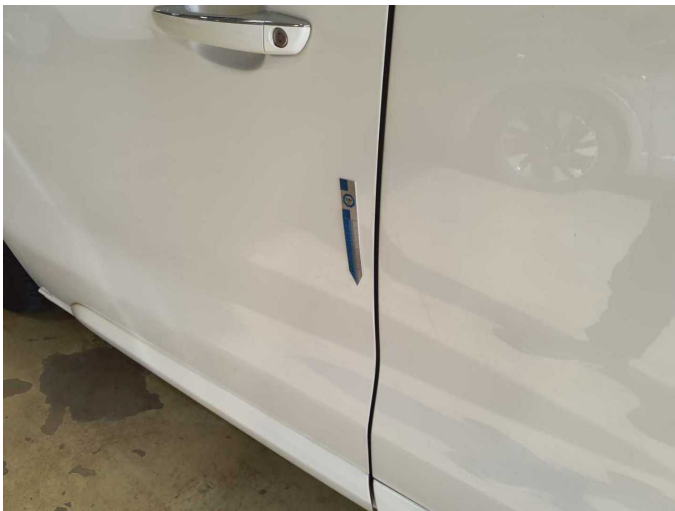
Wear and tear 3: Door - front left side: Door edge - Scratch(es) - No deduction

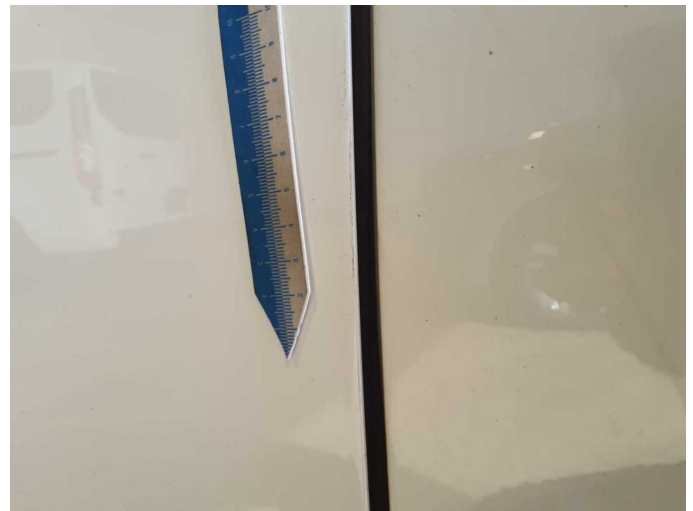
Wear and tear 3: Door - front left side: Door edge - Scratch(es) - No deduction

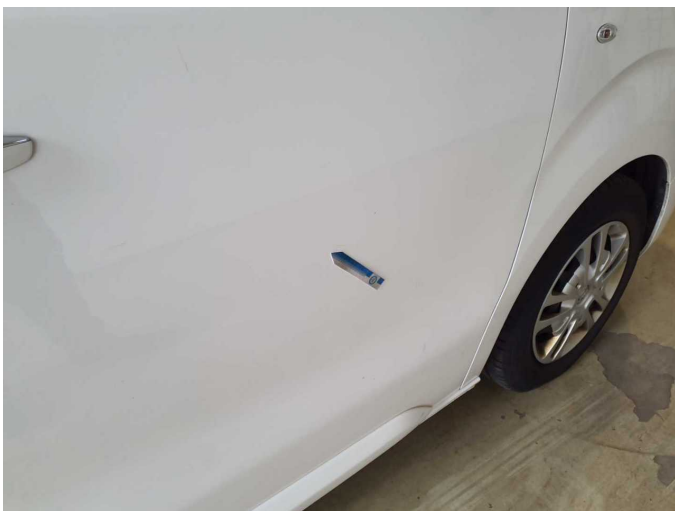
Wear and tear 4: Door - front right side: Door - Scratch(es) - No deduction

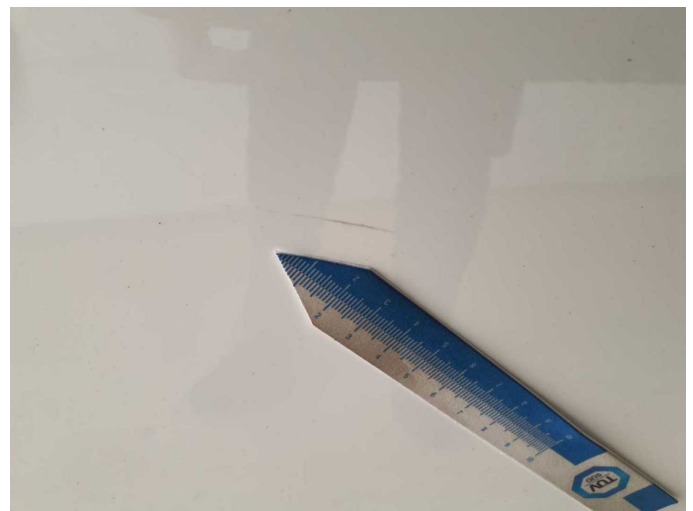
Wear and tear 4: Door - front right side: Door - Scratch(es) - No deduction
