Expertise

Protocol number: 46509526  
Order No. / Reference: 26164449  
Inspection date: 13 Jul 2026

Manufacturer: Mercedes-Benz  
VIN: W1VVLBEZXT4564065

Model: Vito 116 CDI Lang HA PRO

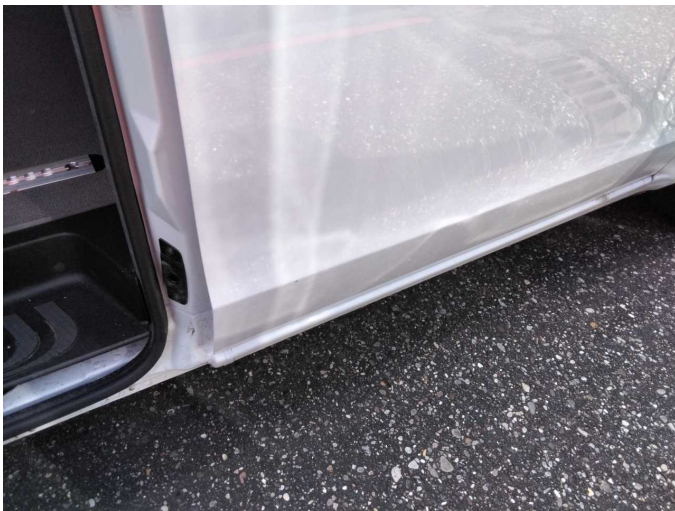
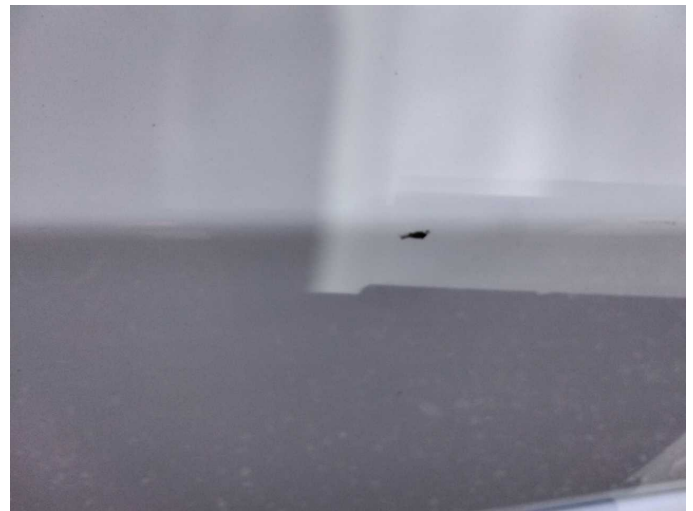
| No. | Component group | Description |
|---|---|---|
| 2 | Door - front right side | Door - Scratch(es) - Smart repair |

Damage 2: Door - front right side: Door - Scratch(es) - Smart repair

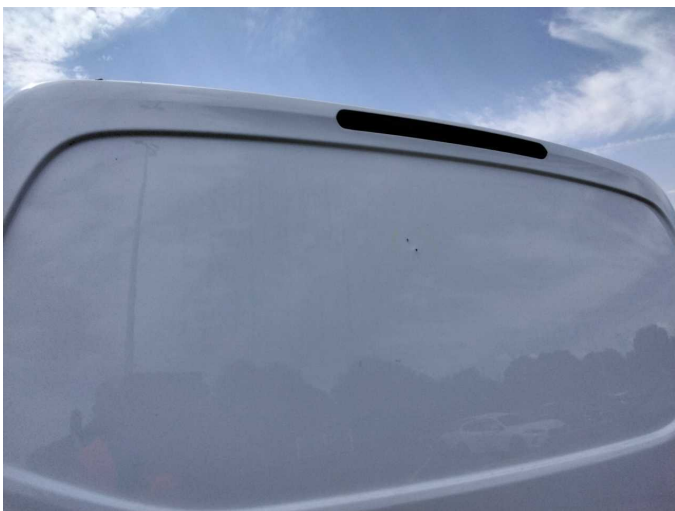
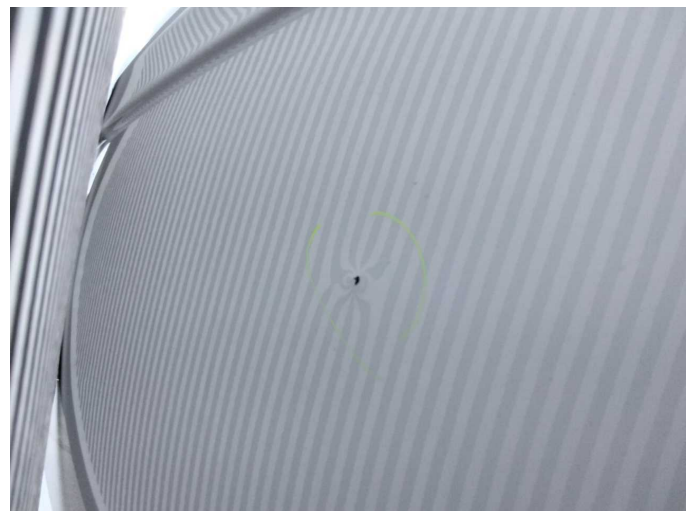
| No. | Component group | Description |
|---|---|---|
| 3 | Boot lid / rear door | Boot lid - Dent / paintcoat damage - Smart repair |

Damage 3: Boot lid / rear door: Boot lid - Dent / paintcoat damage - Smart repair
