## 2-FGR-234

2-FGR-234 · 50e M Sportpakket · 6 August 2026 · Zaventem (BE)

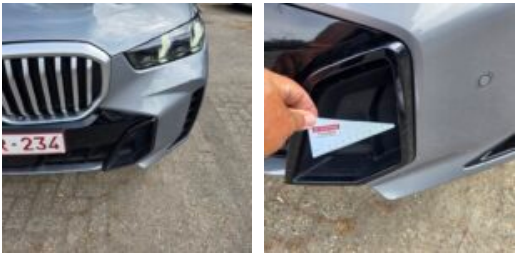
| Damage Part | Damage Type | Notes | Repair Type | Acceptable |
| Bumper – Front | Scratch(es) | Luchtinlaat | Spray | No |

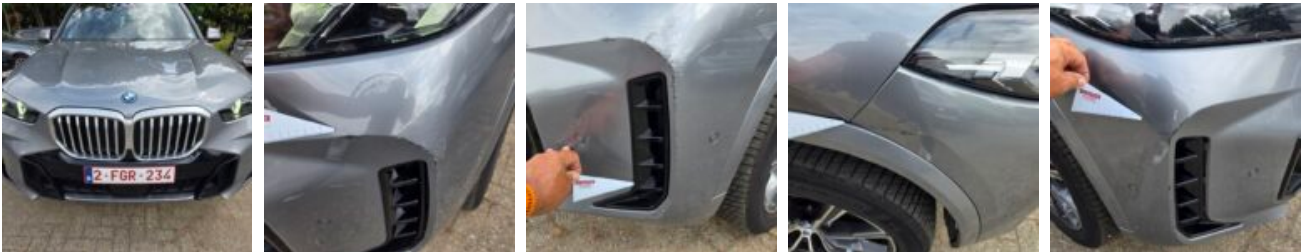
| Damage Part | Damage Type | Repair Type | Acceptable |
| Bumper – Front | Scratch(es) | Spray | No |

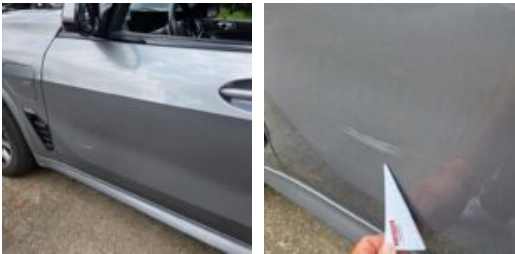
| Damage Part | Damage Type | Repair Type | Acceptable |
| Frontdoor – Left | Scratch(es) | Spray | No |

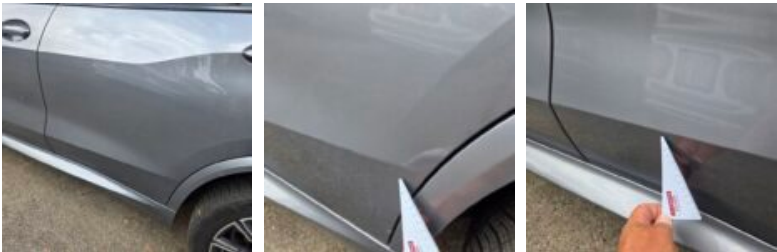
| Damage Part | Damage Type | Repair Type | Acceptable |
| Reardoor – Left | Small scratch(es) | Touch-up | No |
