Expertise

Protocol number: 46888351  
Order No. / Reference: 26783107  
Inspection date: 5 Aug 2026

Manufacturer: Opel

Model: Astra 1.5 D Start/Stop Sports Tourer Elegance

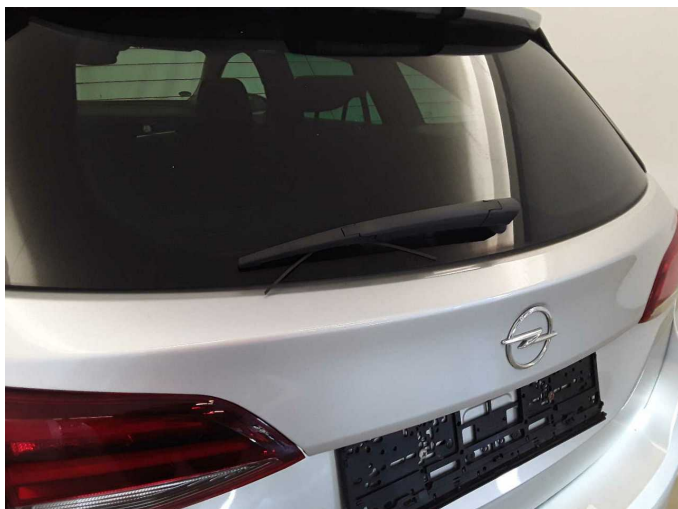
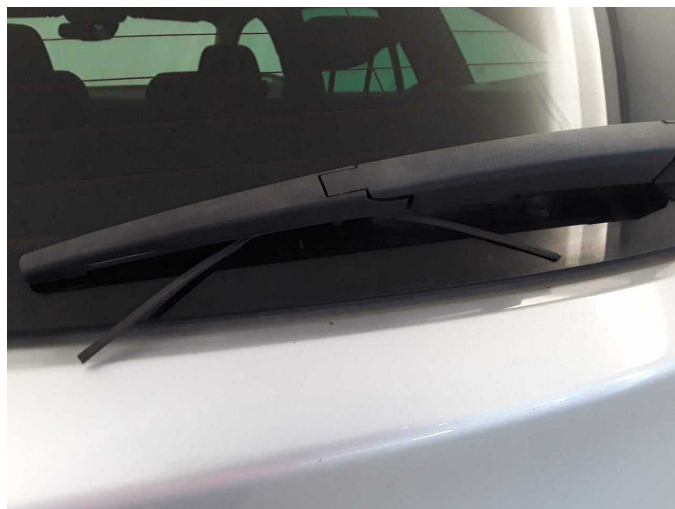
| No. | Component group | Description |
|---|---|---|
| 1 | Screen cleaning | Wiper arm - rear - Damaged - Replace |

**Damage 1:** Screen cleaning: Wiper arm - rear - Damaged - Replace

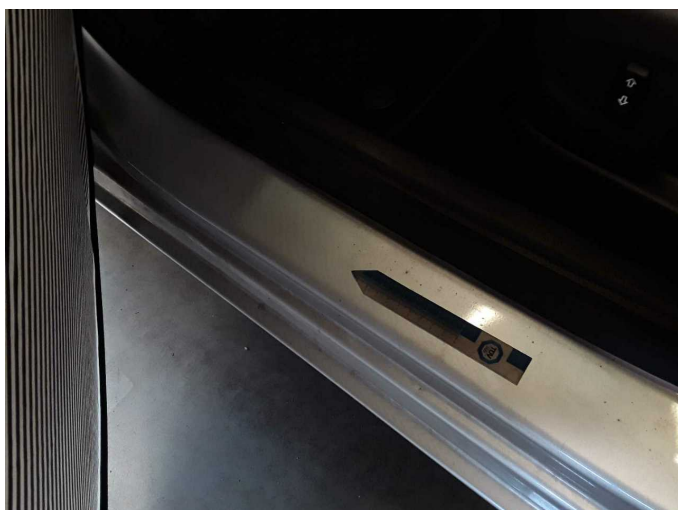
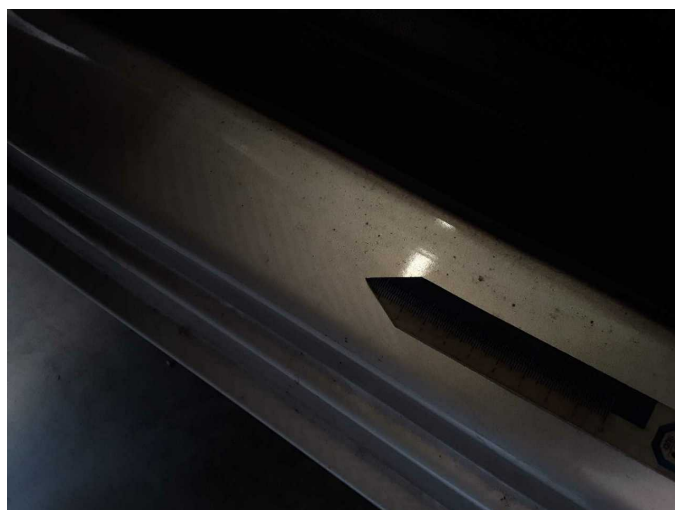
| No. | Component group | Description |
|---|---|---|
| 2 | Sill - left side | Sill - dent(s) - Smooth repair work |

**Damage 2:** Sill - left side: Sill - dent(s) - Smooth repair work

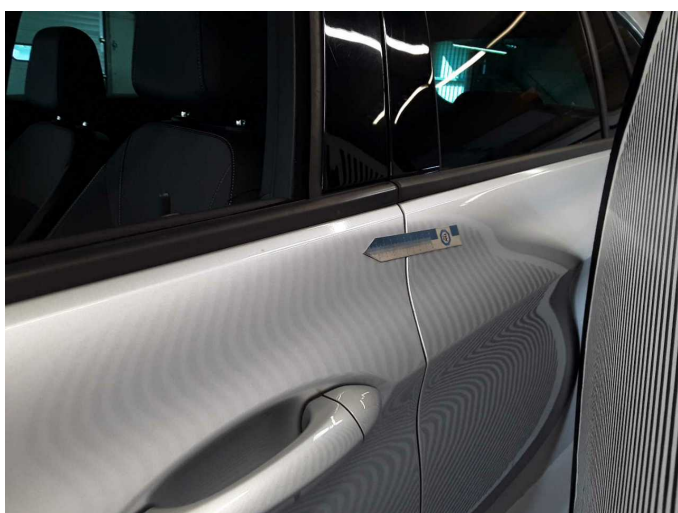
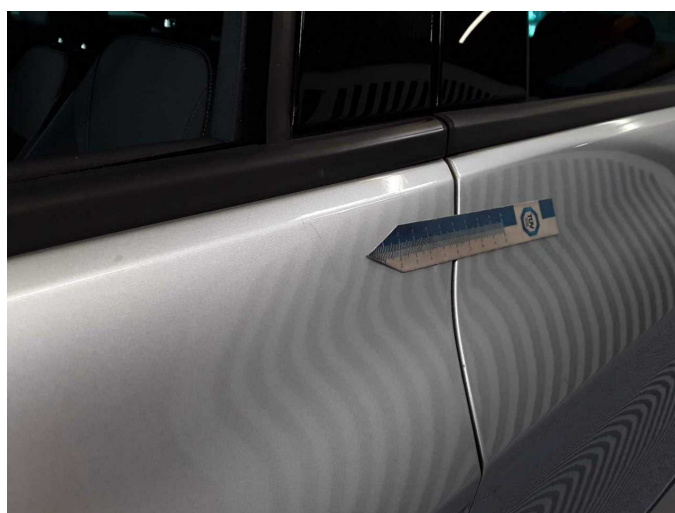
| No. | Component group | Description |
|---|---|---|
| 3 | Door - front left side | Door - dent(s) - Smooth repair work |

**Damage 3:** Door - front left side: Door - dent(s) - Smooth repair work

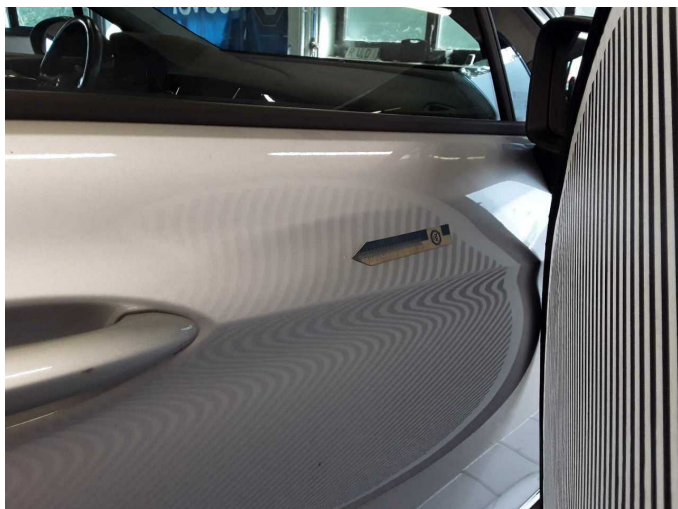
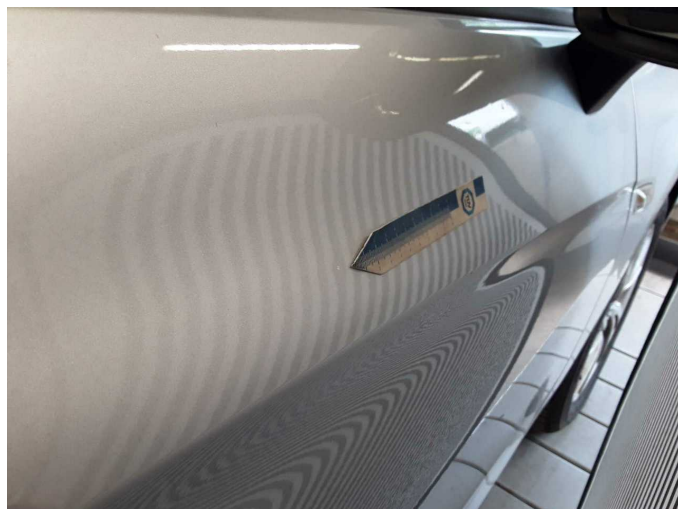
| No. | Component group | Description |
|---|---|---|
| 4 | Door - front right side | Door - dent(s) - Smooth repair work |

**Damage 4:** Door - front right side: Door - dent(s) - Smooth repair work

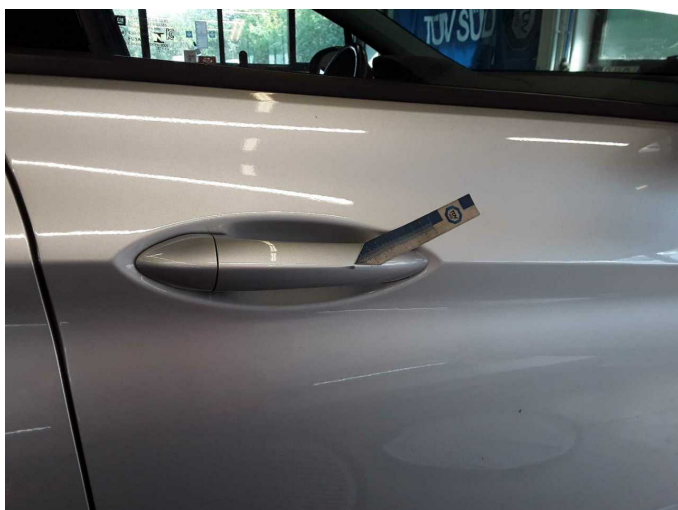
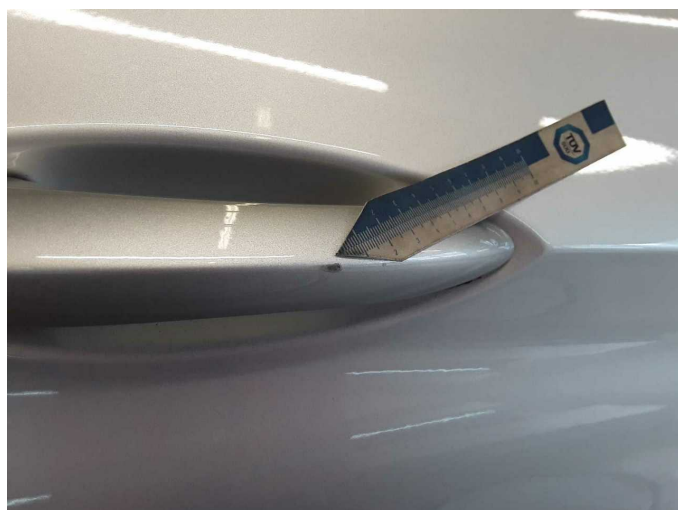
| No. | Component group | Description |
|---|---|---|
| 5 | Door - front right side | Door handle - outside - Scratch(es) - Paint |

**Damage 5:** Door - front right side: Door handle - outside - Scratch(es) - Paint

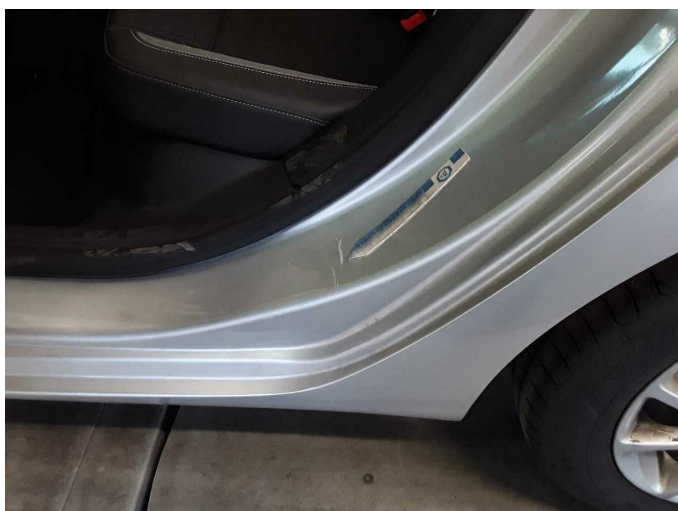
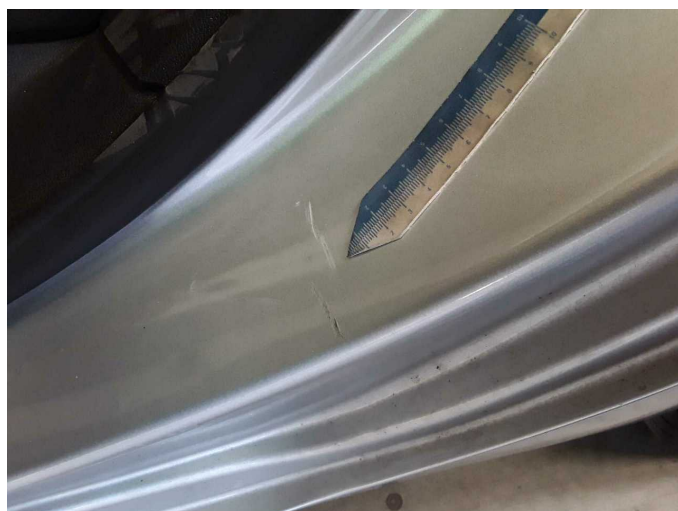
| No. | Component group | Description |
|---|---|---|
| 6 | Side panel - rear left side | Elbow - Scratched - Smart repair |

**Damage 6:** Side panel - rear left side: Elbow - Scratched - Smart repair

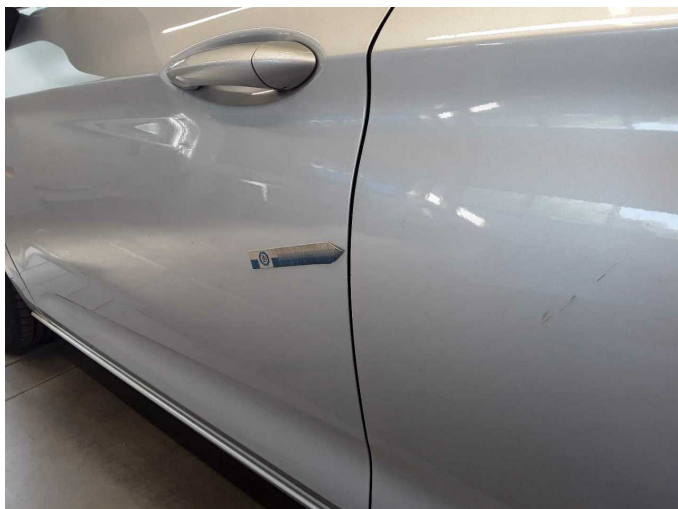
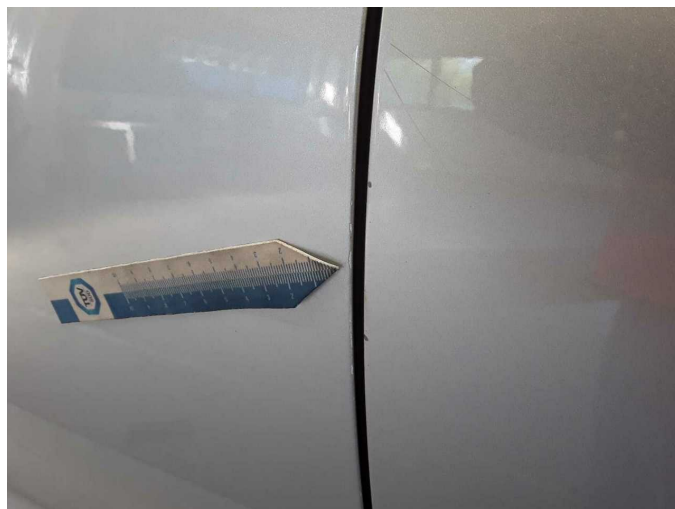
| No. | Component group | Description |
|---|---|---|
| 7 | Door - front left side | Door edge - Scratched - Smart repair |

**Damage 7:** Door - front left side: Door edge - Scratched - Smart repair

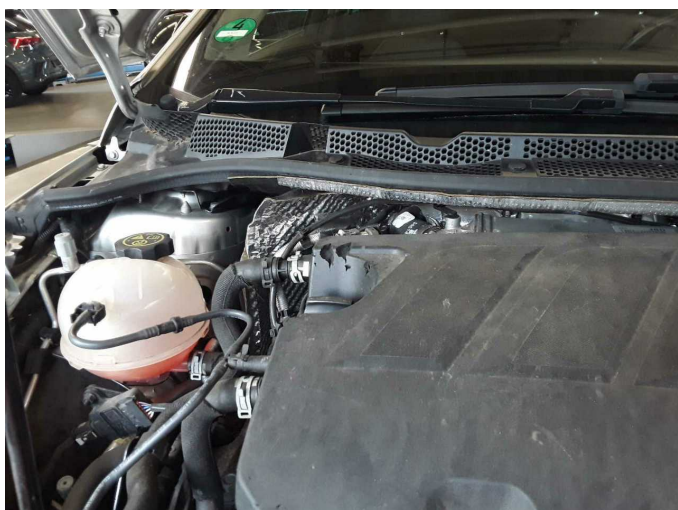
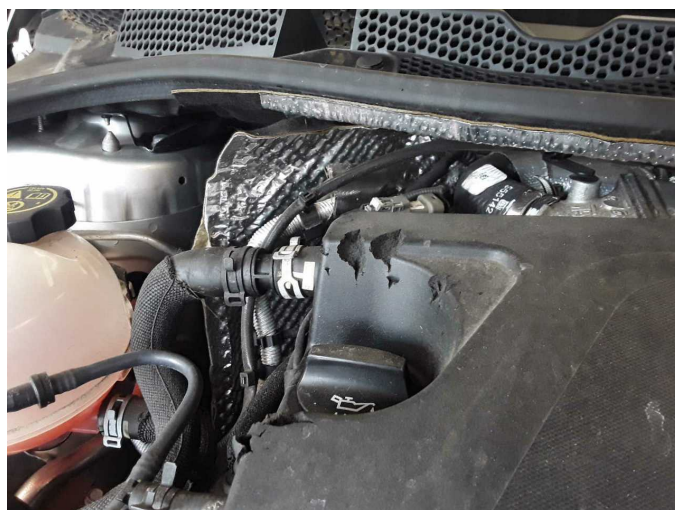
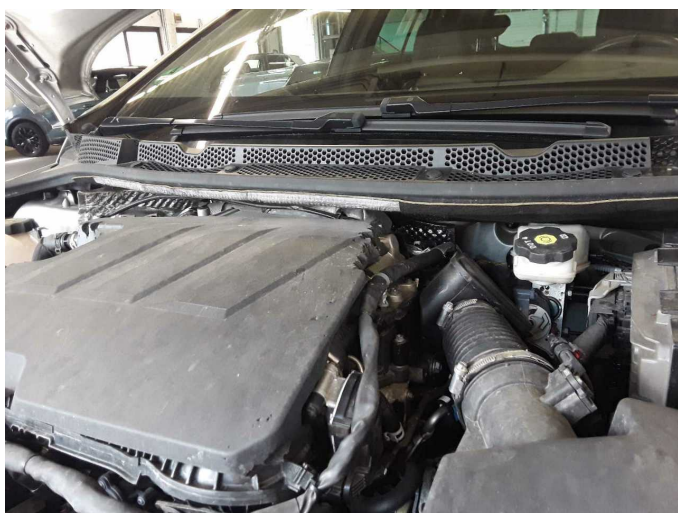
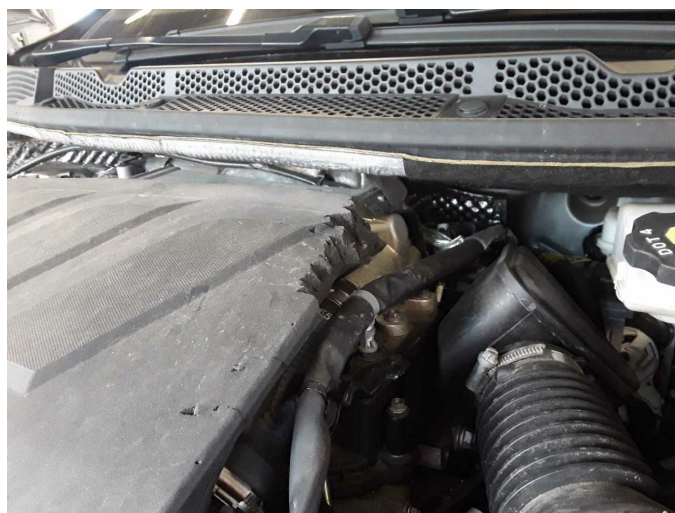
| No. | Component group | Description |
|---|---|---|
| 8 | Engine | Engine cover - Broken / torn - Replace |

**Damage 8:** Engine: Engine cover - Broken / torn - Replace

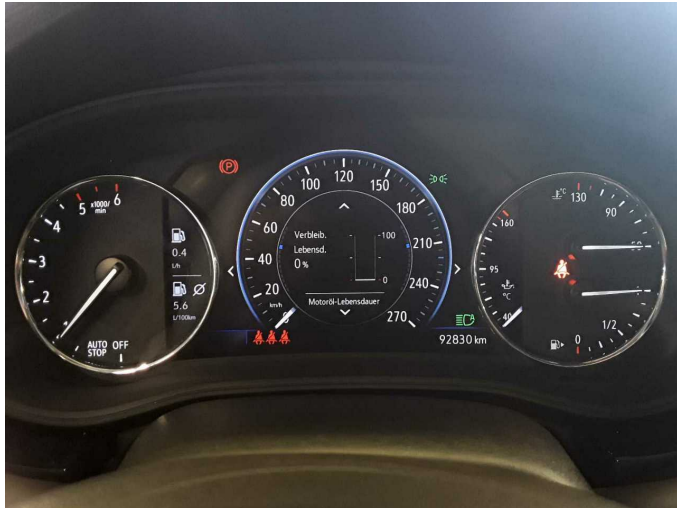
| No. | Component group | Description |
|---|---|---|
| 9 | Misc. | Inspection / maintenance - Due - Perform |

**Damage 9:** Misc.: Inspection / maintenance - Due - Perform

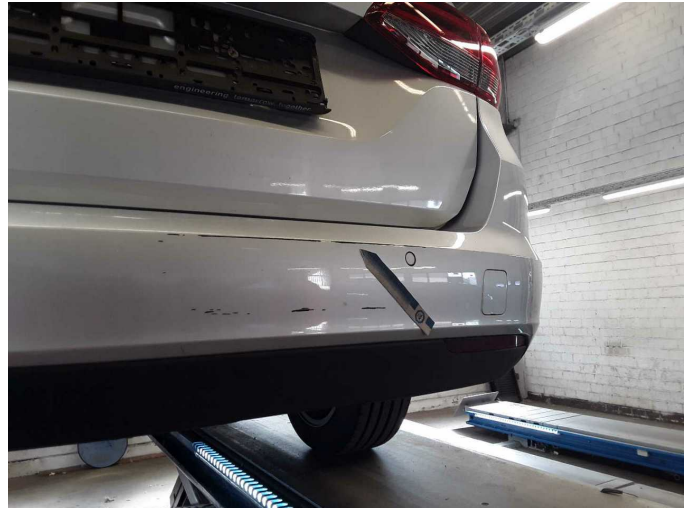
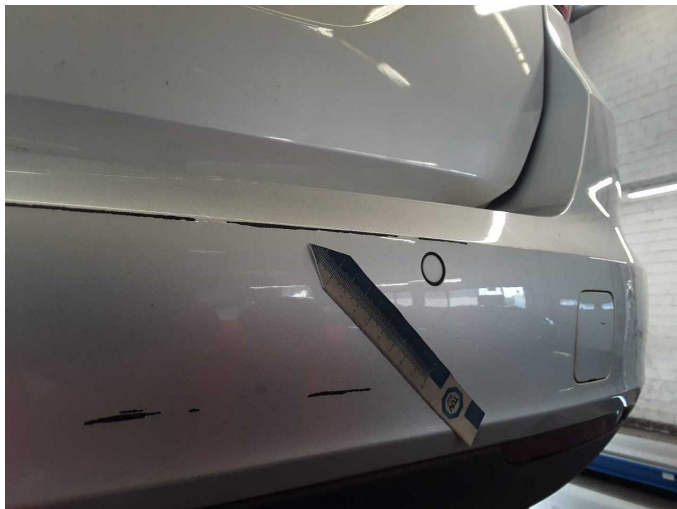
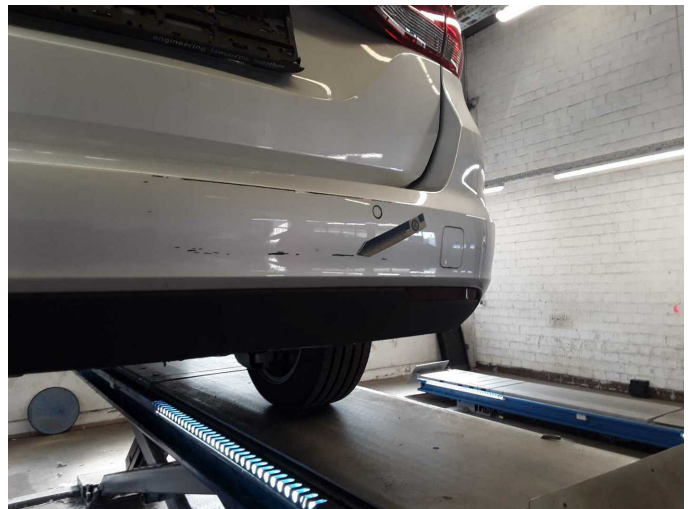
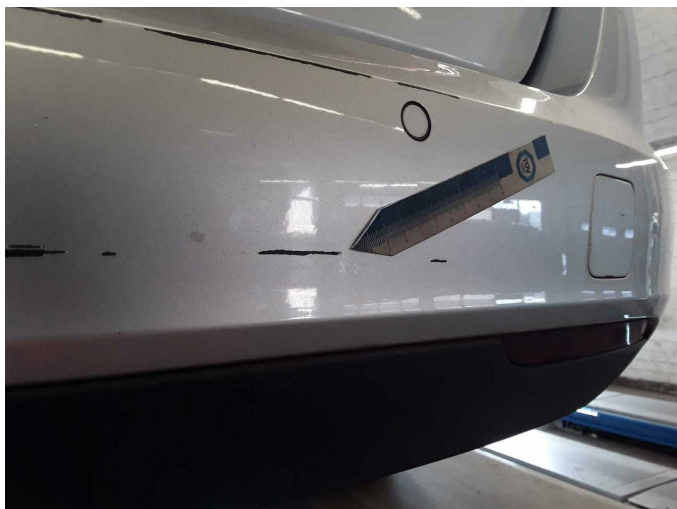
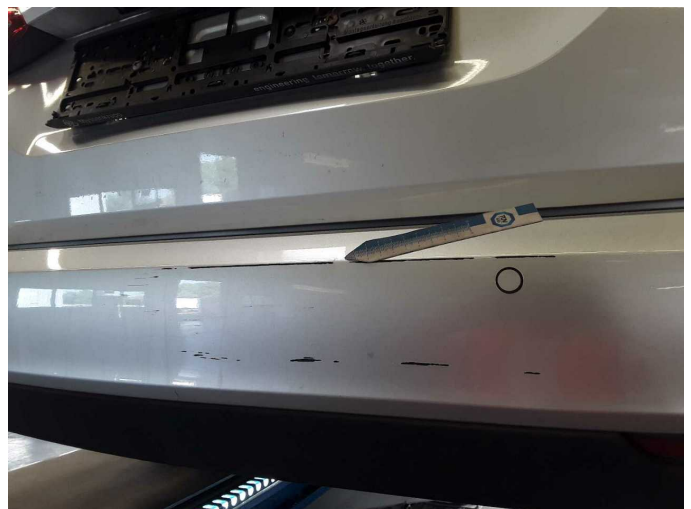
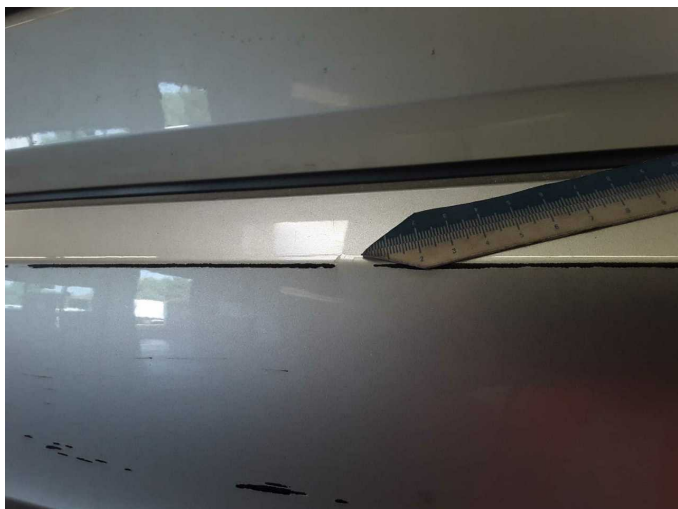
| No. | Component group | Description |
|---|---|---|
| 10 | Rear bumper | Rear bumper - Scratched - Repair and paint |

**Damage 10:** Rear bumper: Rear bumper - Scratched - Repair and paint

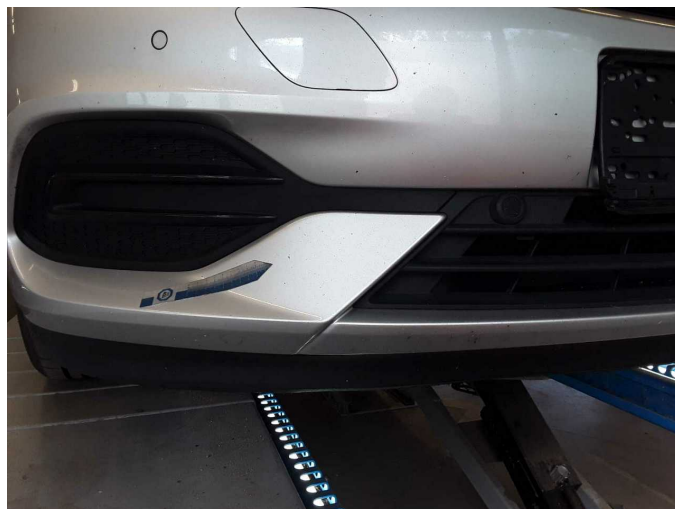
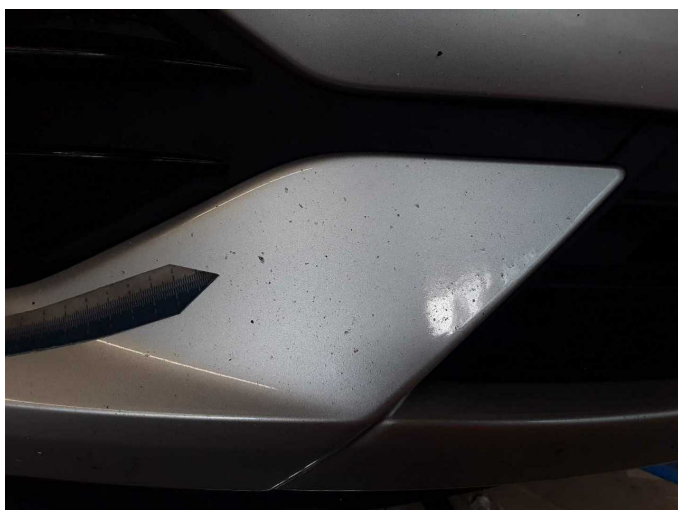
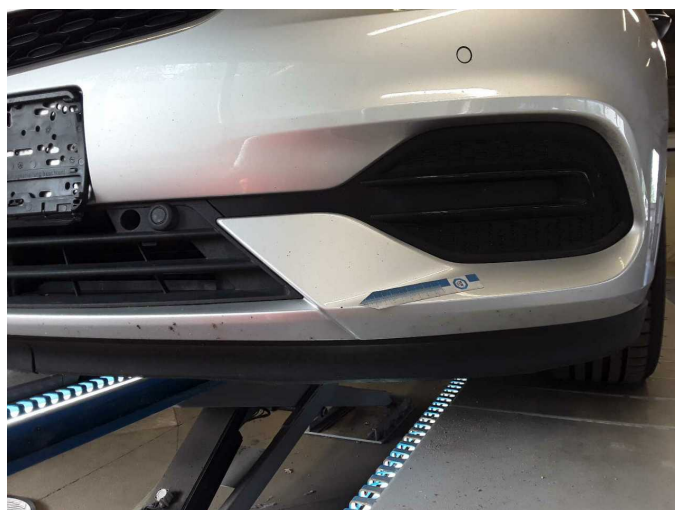
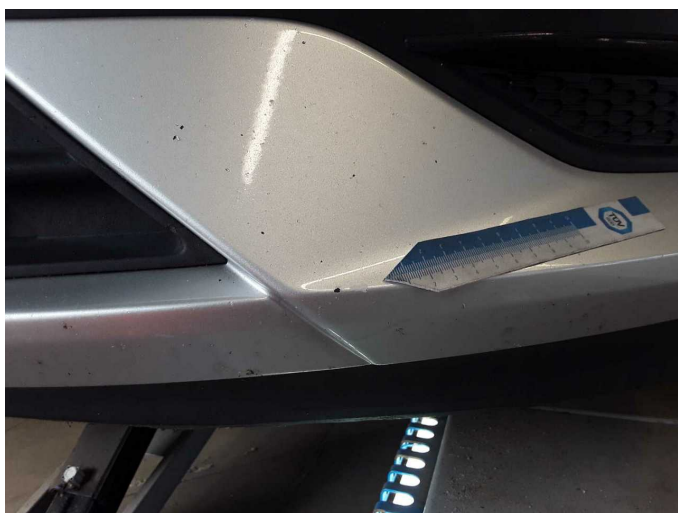
| No. | Component group | Description |
|---|---|---|
| 11 | Front bumper | Front bumper - Stone chips - Paint |

**Damage 11:** Front bumper: Front bumper - Stone chips - Paint

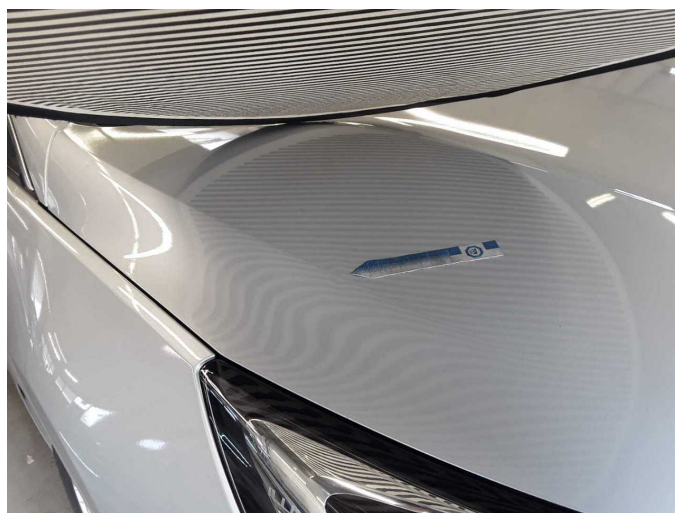
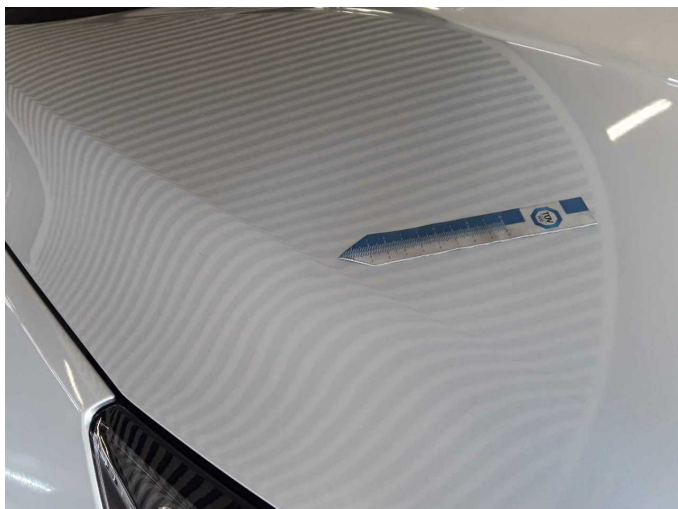
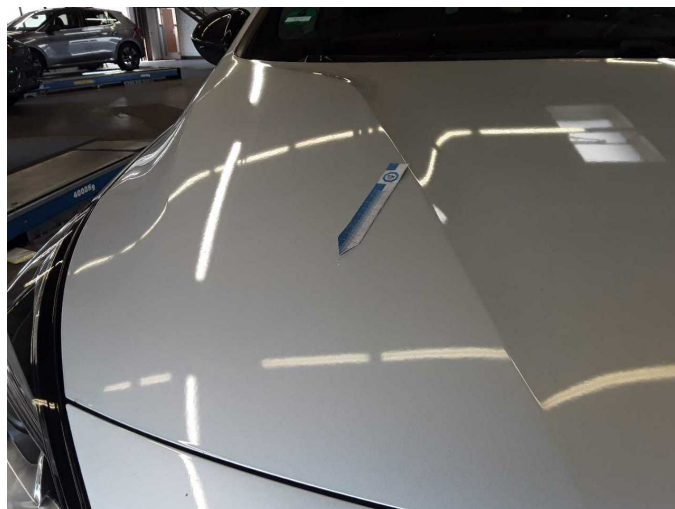
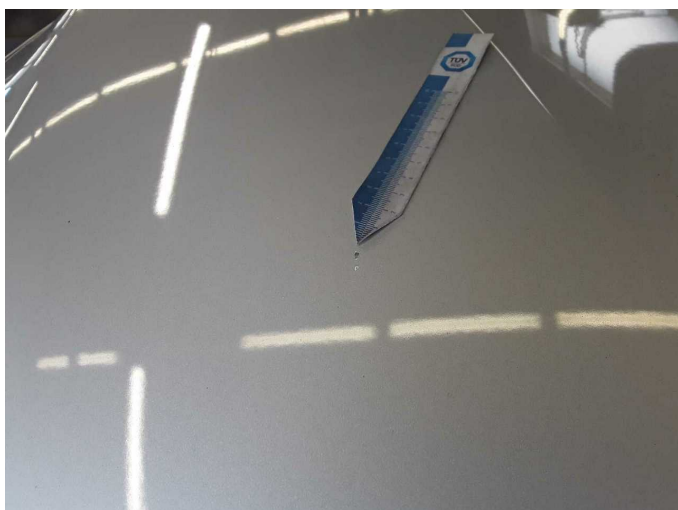
| No. | Component group | Description |
|---|---|---|
| 12 | Bonnet | Bonnet - Dent / paintcoat damage - Repair and paint |

**Damage 12:** Bonnet: Bonnet - Dent / paintcoat damage - Repair and paint

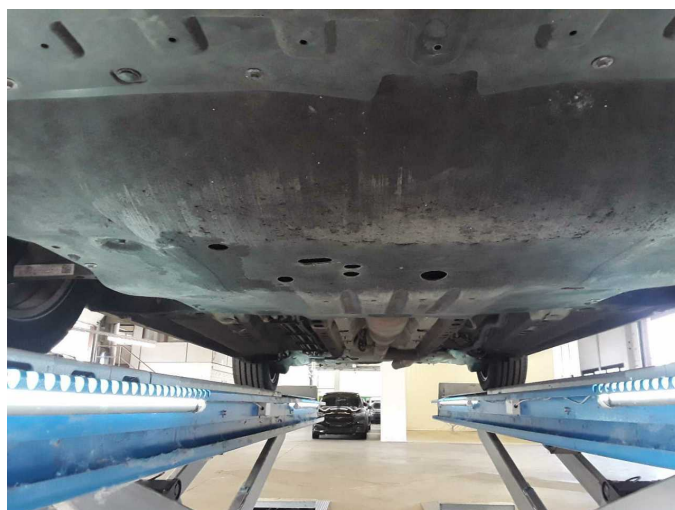
| No. | Component group | Description |
|---|---|---|
| 1 | Body | Underbody panelling - Scratched - No deduction |

**Wear and tear 1:** Body: Underbody panelling - Scratched - No deduction

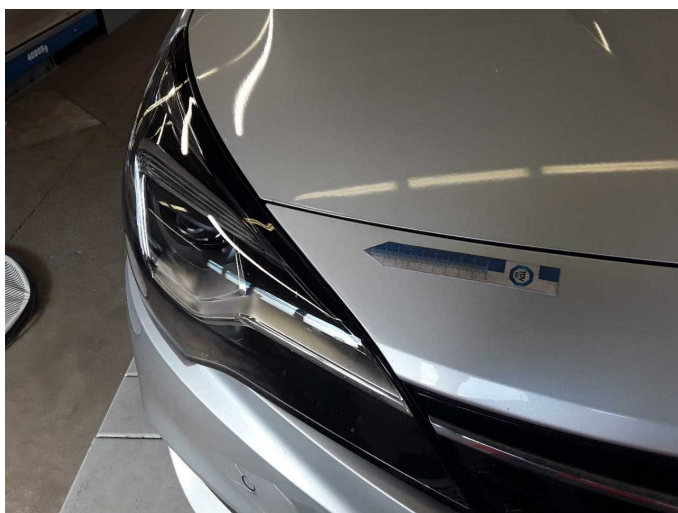
| No. | Component group | Description |
|---|---|---|
| 2 | Bonnet | Bonnet (Vorn) - Stone chips - No deduction |

**Wear and tear 2:** Bonnet: Bonnet (Vorn) - Stone chips - No deduction

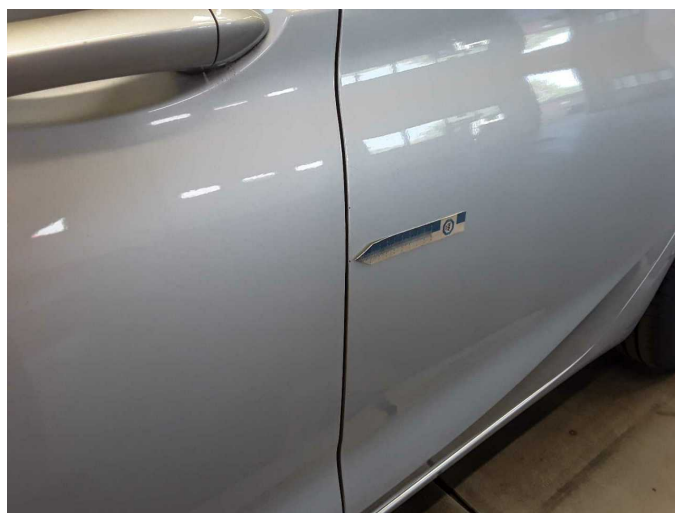
| No. | Component group | Description |
|---|---|---|
| 3 | Door - rear left side | Door - Stone chips - No deduction |

**Wear and tear 3:** Door - rear left side: Door - Stone chips - No deduction

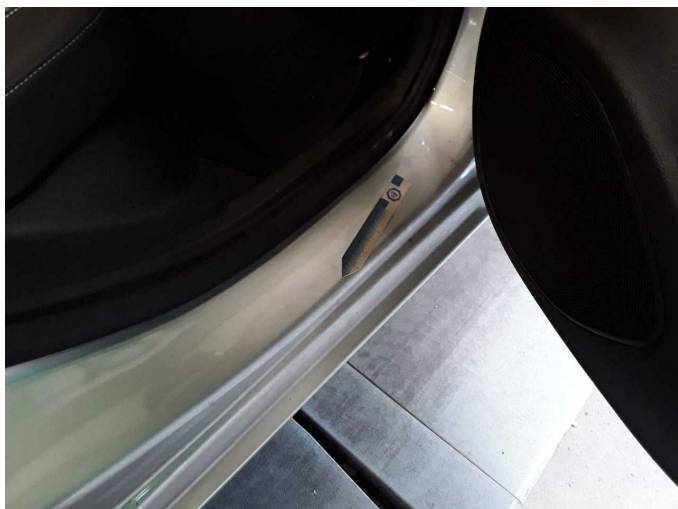
| No. | Component group | Description |
|---|---|---|
| 4 | Side panel - rear right side | Sill - Scratch(es) - No deduction |

**Wear and tear 4:** Side panel - rear right side: Sill - Scratch(es) - No deduction
