Expertise

Protocol number: 46225008
Order No. / Reference: 26566091
Inspection date: 29 Jun 2026

Manufacturer: Opel

Model: Combo Cargo 1.5 D EHZ Edition

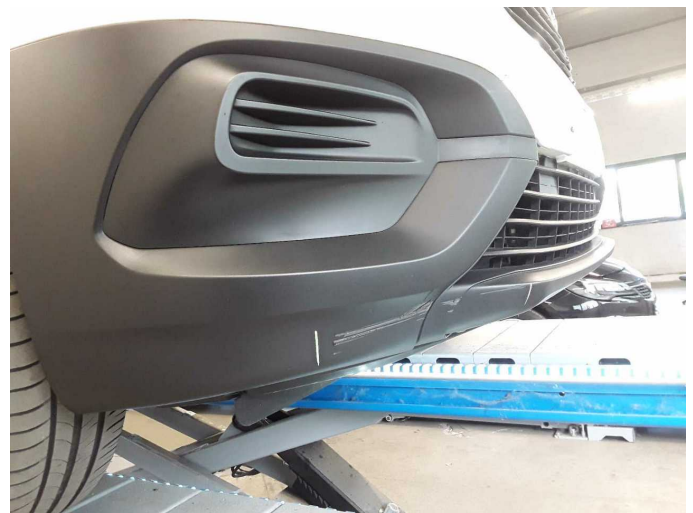
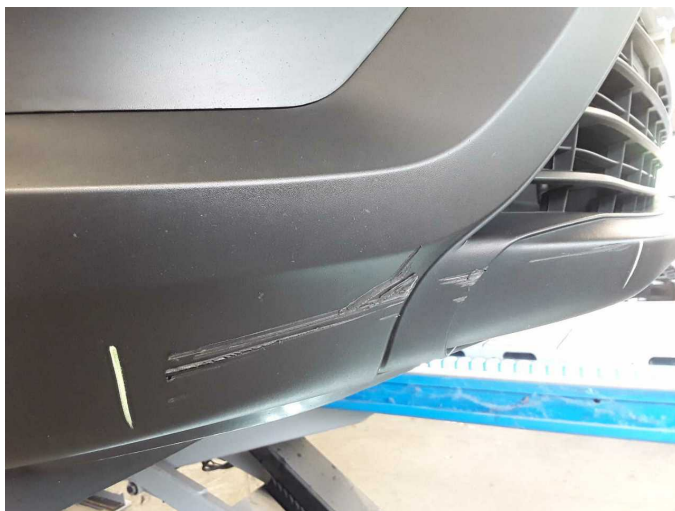
Damage 1: Front bumper: Front bumper (unpainted) - Scratched - Loss in value

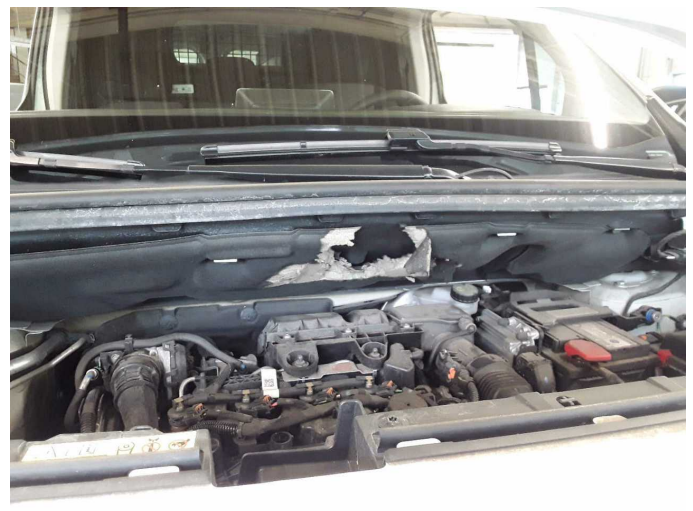
Damage 2: Cab: Insulation lining - Damaged - Replace

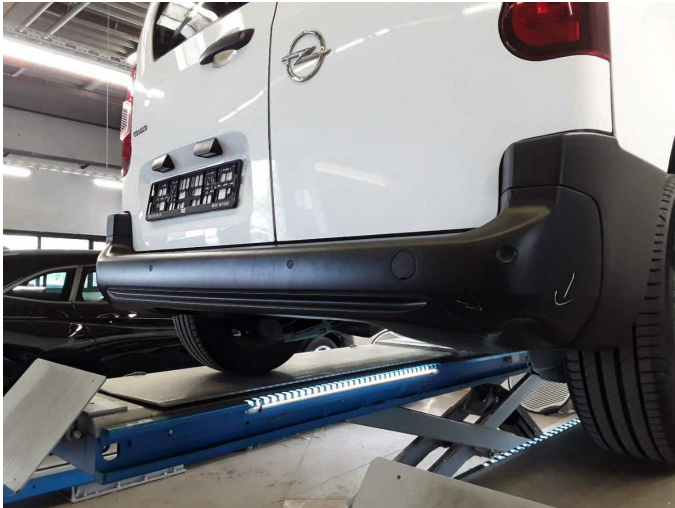
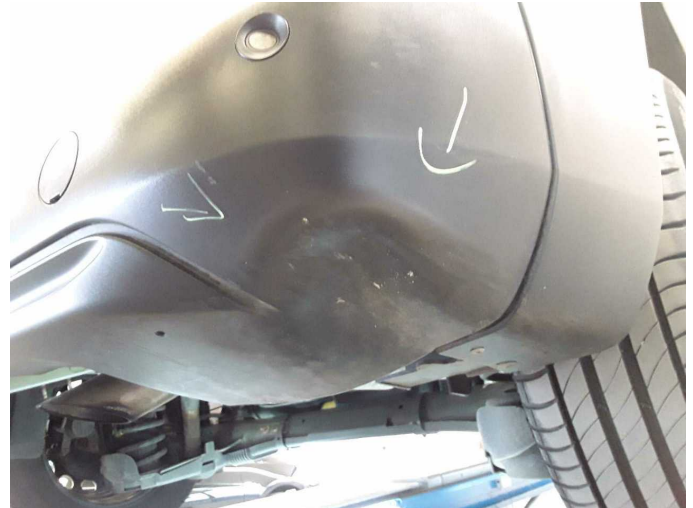
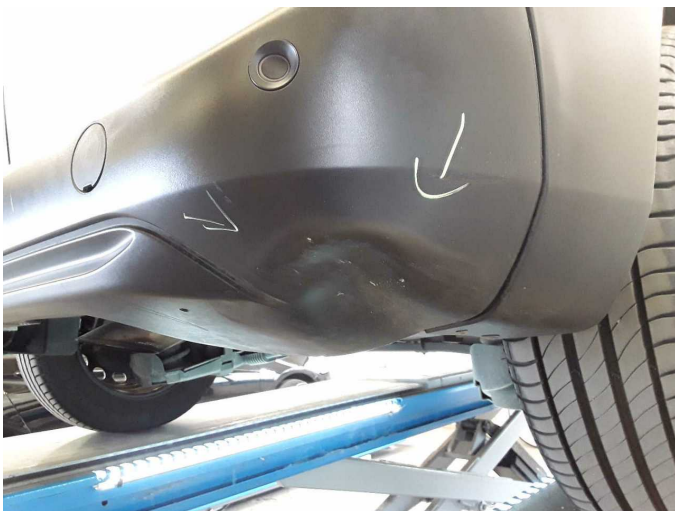
Damage 3: Rear bumper: Rear bumper (unpainted) - Deformed - Replace

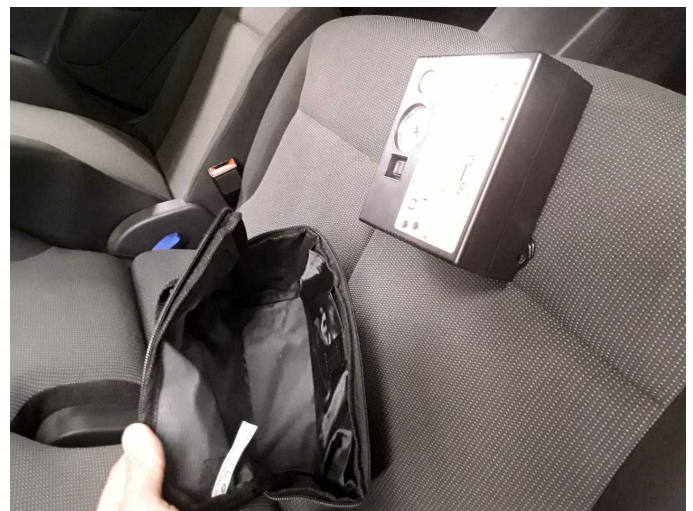
Missing part 1: Equipment: Tirefit filler - Missing - Replace

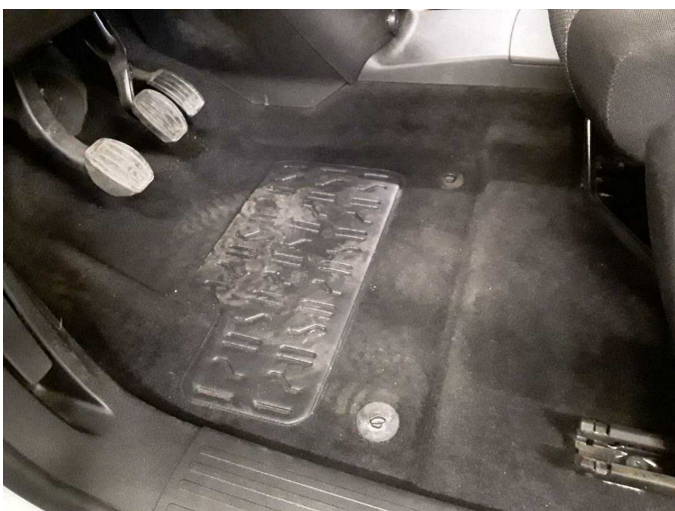
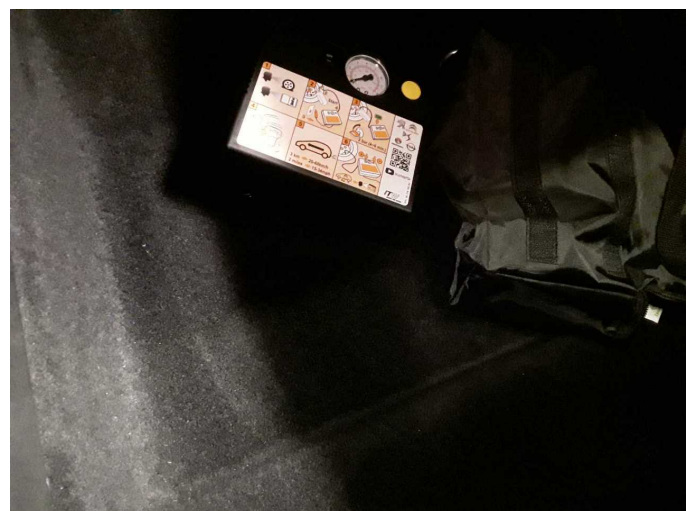
Missing part 2: Trim / covers: Floor mats - Missing - Replace
