Expertise

Protocol number: 46053681  
Order No. / Reference: 26453481  
Inspection date: 17 Jun 2026

Manufacturer: Mercedes-Benz  
VIN: W1N0J2DBXPG135582

Model: GLC-Coupe 400 d 4Matic 9G-TRONIC

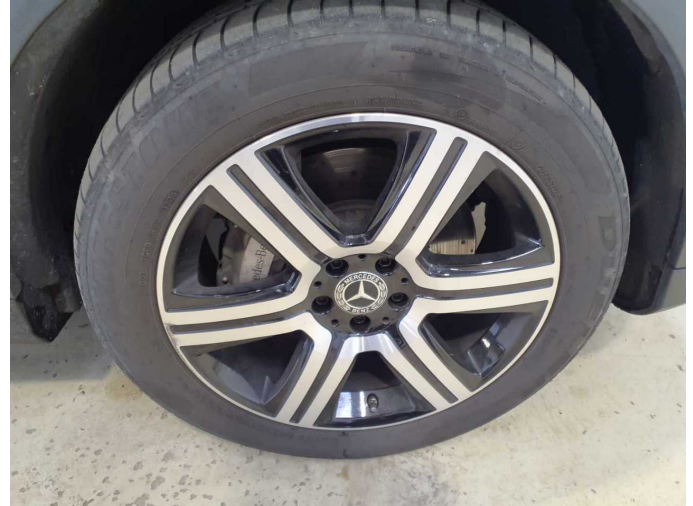
| No. | Component group | Description |
|---|---|---|
| 2 | Wheel / tyres | Alloy rim - front right side - Scratched - Loss in value |

**Damage 2:** Wheel / tyres: Alloy rim - front right side - Scratched - Loss in value

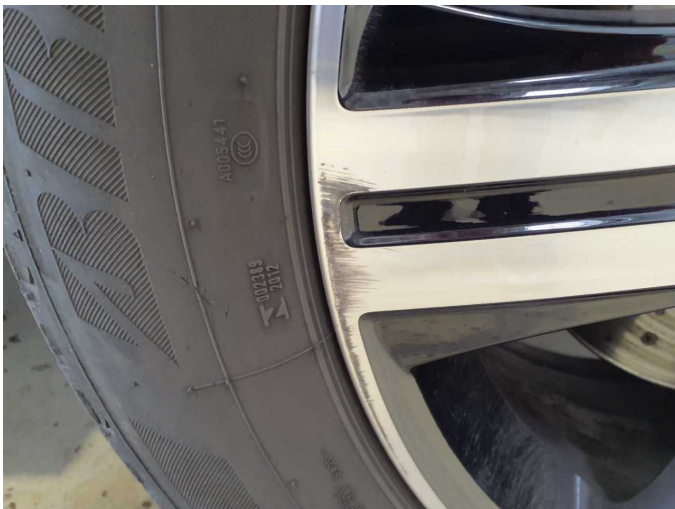
**Damage 2:** Wheel / tyres: Alloy rim - front right side - Scratched - Loss in value

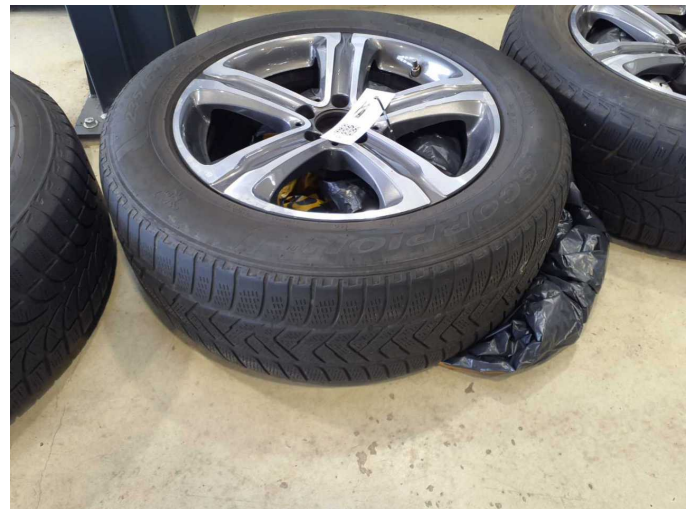
| No. | Component group | Description |
|---|---|---|
| 3 | 2nd wheel set | 2 tyres - Does not meet the leasing specifications - Replace |

**Damage 3:** 2nd wheel set: 2 tyres - Does not meet the leasing specifications - Replace

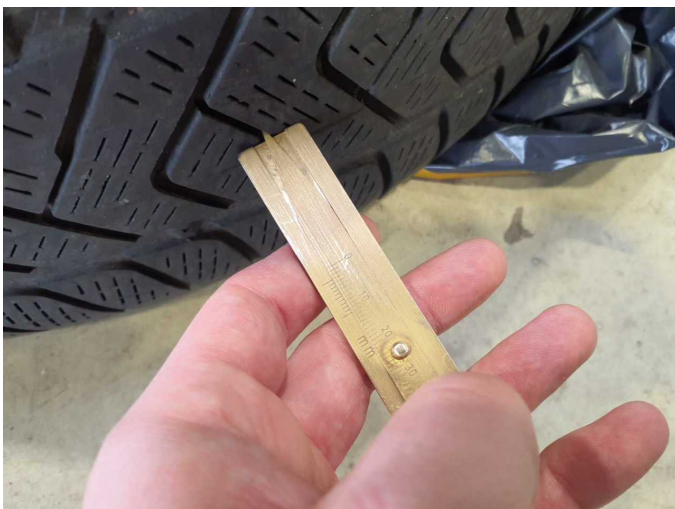
**Damage 3:** 2nd wheel set: 2 tyres - Does not meet the leasing specifications - Replace

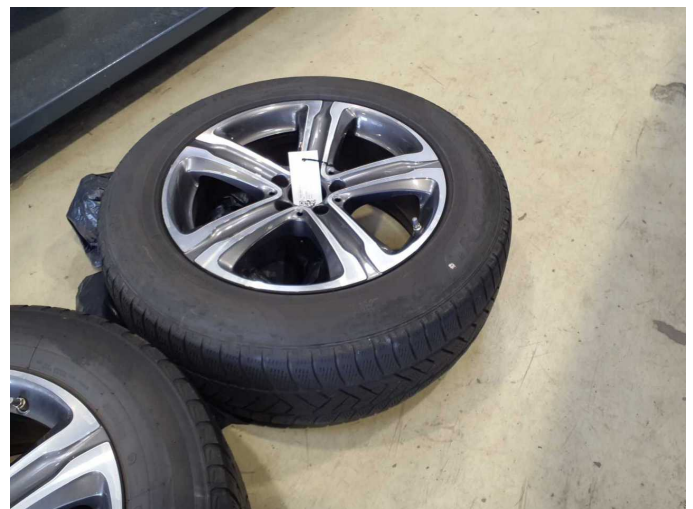
**Damage 3:** 2nd wheel set: 2 tyres - Does not meet the leasing specifications - Replace

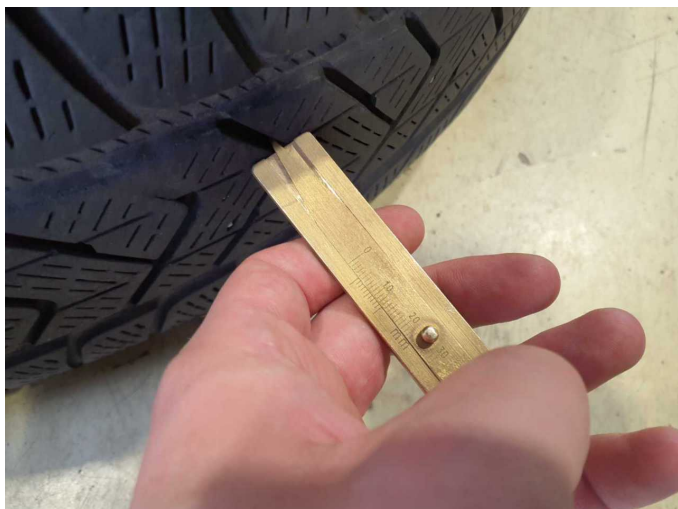
**Damage 3:** 2nd wheel set: 2 tyres - Does not meet the leasing specifications - Replace

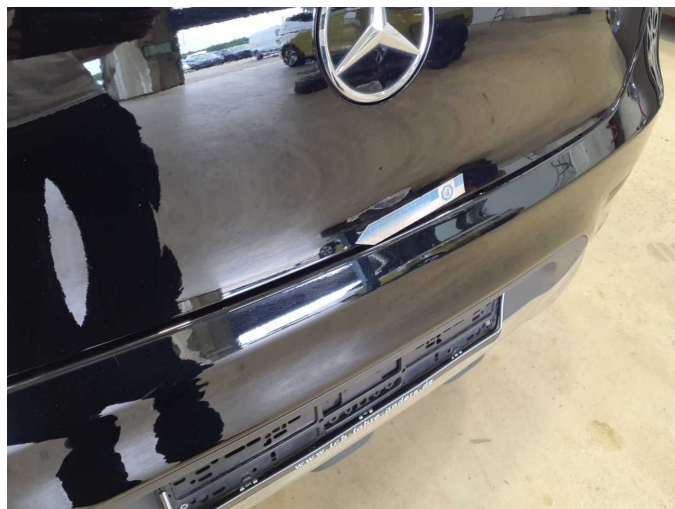
| No. | Component group | Description |
|---|---|---|
| 4 | Boot lid / rear door | Boot lid - Corrosion - Repair and paint |

**Damage 4:** Boot lid / rear door: Boot lid - Corrosion - Repair and paint

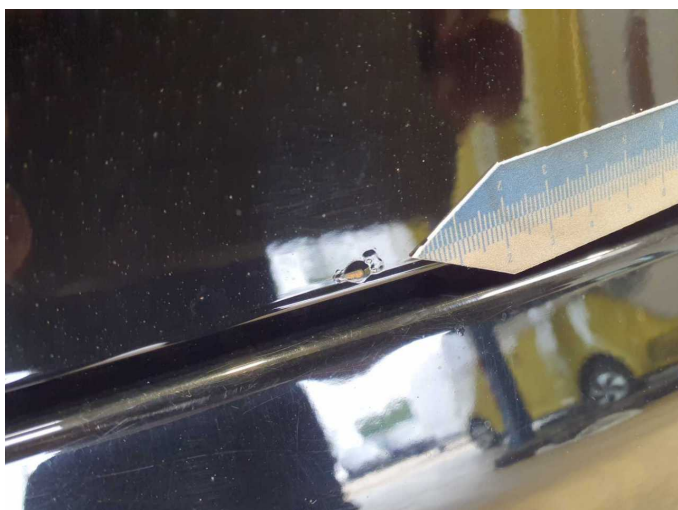
**Damage 4:** Boot lid / rear door: Boot lid - Corrosion - Repair and paint

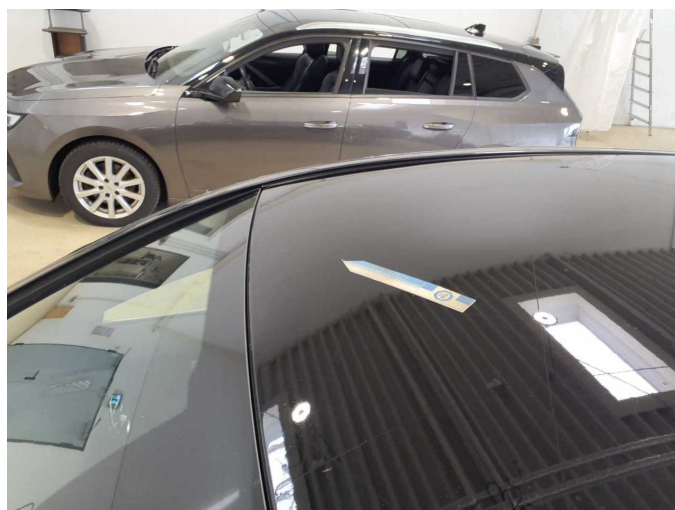
| No. | Component group | Description |
|---|---|---|
| 5 | Roof | Roof - Stone chips - Paint |

**Damage 5:** Roof: Roof - Stone chips - Paint

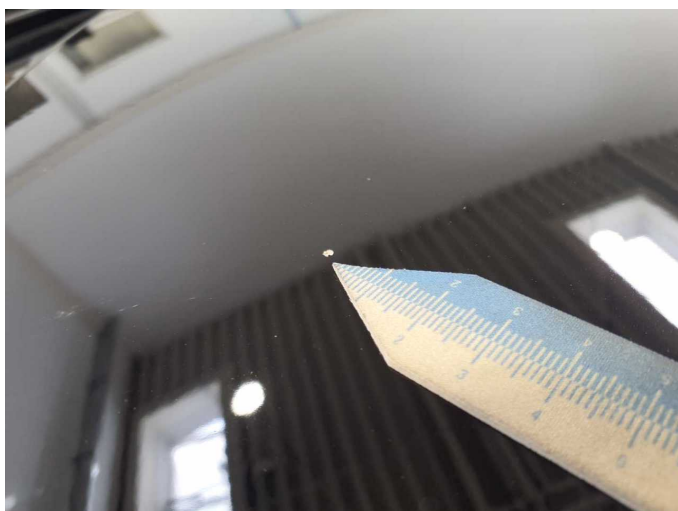
**Damage 5:** Roof: Roof - Stone chips - Paint

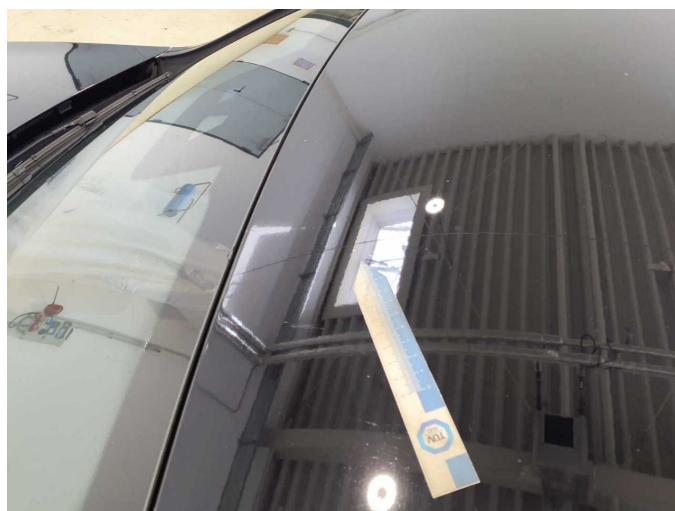
**Damage 5:** Roof: Roof - Stone chips - Paint

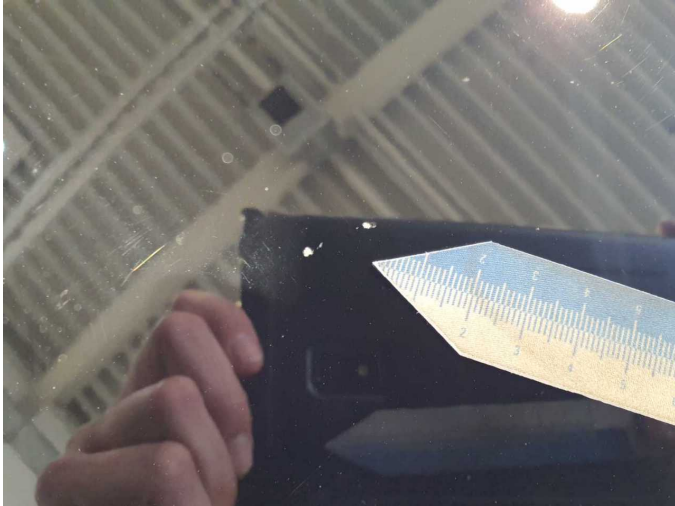
**Damage 5:** Roof: Roof - Stone chips - Paint

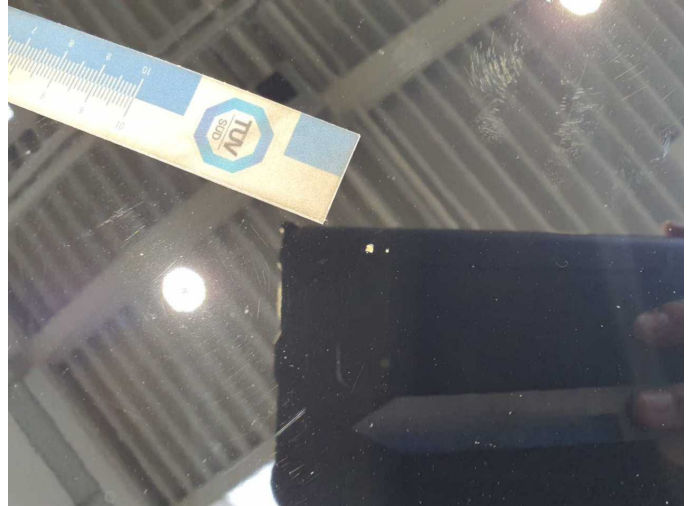
**Damage 5:** Roof: Roof - Stone chips - Paint

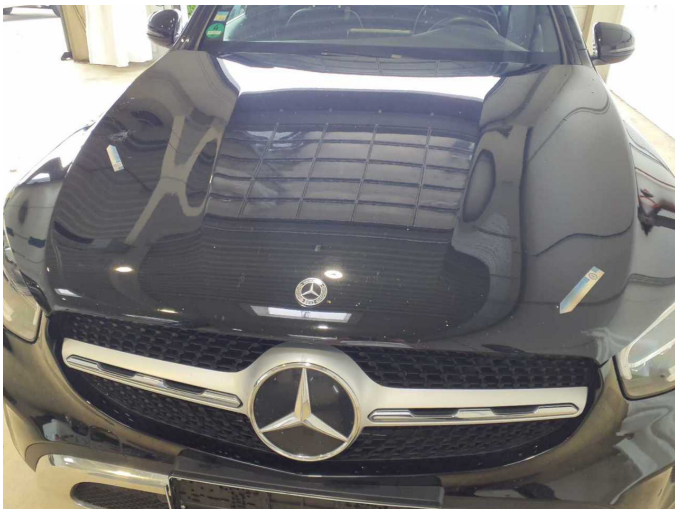
| No. | Component group | Description |
|---|---|---|
| 6 | Bonnet | Bonnet (Steinschläge und Anätzung) - Paint defect - Paint |

**Damage 6:** Bonnet: Bonnet (Steinschläge und Anätzung) - Paint defect - Paint

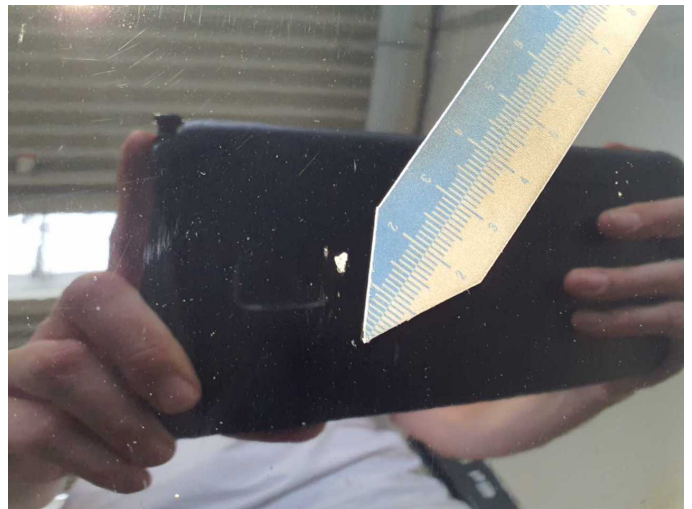
**Damage 6:** Bonnet: Bonnet (Steinschläge und Anätzung) - Paint defect - Paint

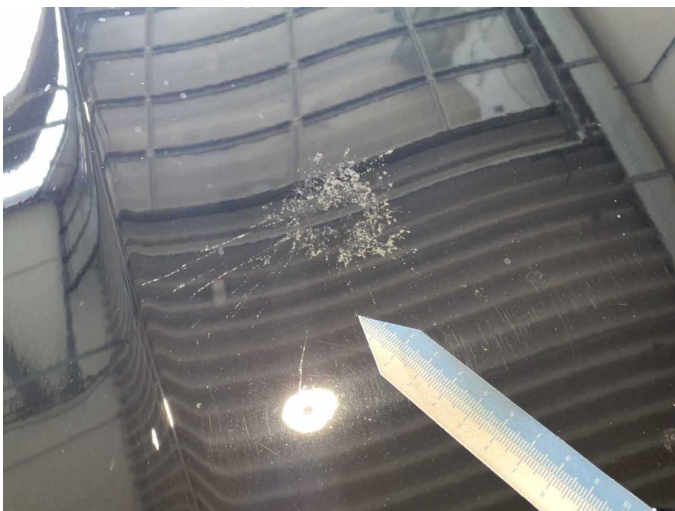
**Damage 6:** Bonnet: Bonnet (Steinschläge und Anätzung) - Paint defect - Paint

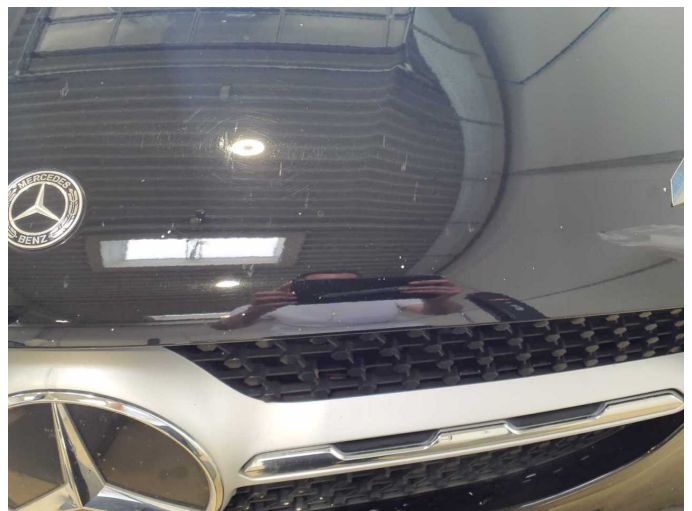
**Damage 6:** Bonnet: Bonnet (Steinschläge und Anätzung) - Paint defect - Paint

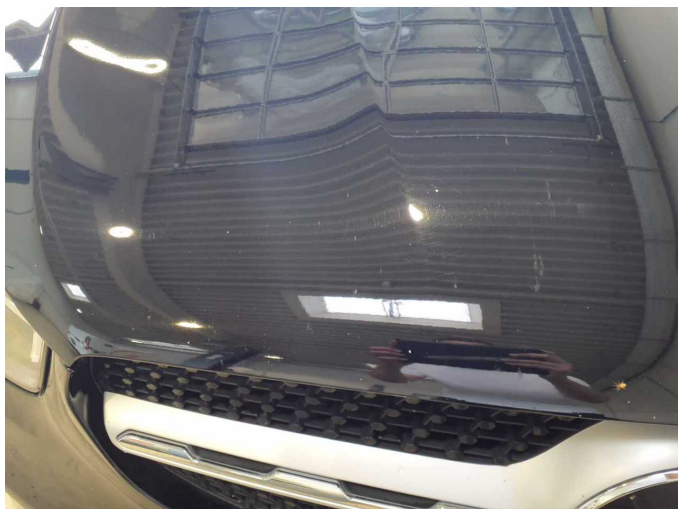
**Damage 6:** Bonnet: Bonnet (Steinschläge und Anätzung) - Paint defect - Paint

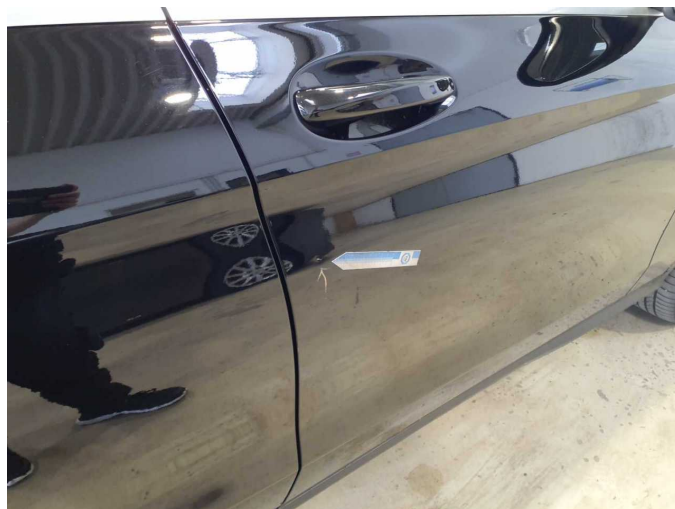
| No. | Component group | Description |
|---|---|---|
| 7 | Door - front right side | Door - Dent / paintcoat damage - Repair and paint |

**Damage 7:** Door - front right side: Door - Dent / paintcoat damage - Repair and paint

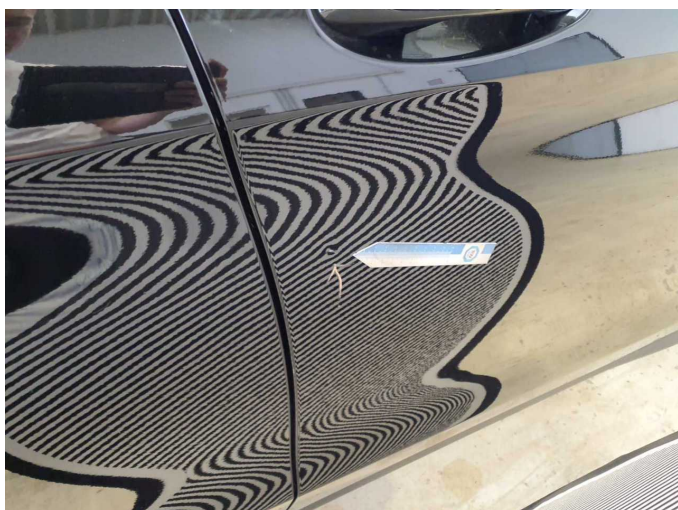
**Damage 7:** Door - front right side: Door - Dent / paintcoat damage - Repair and paint

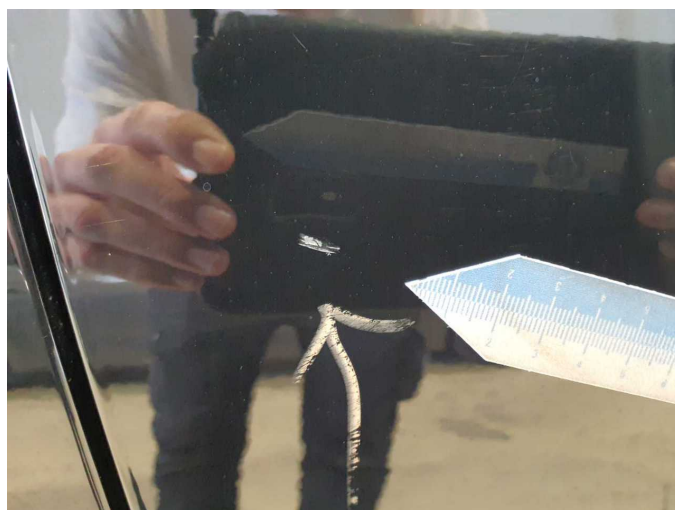
**Damage 7:** Door - front right side: Door - Dent / paintcoat damage - Repair and paint
