Expertise

Protocol number: 44071497
Order number / reference: 25858134
Inspection date: 16 Feb 2026

Model: 317 CDI Sprinter Standard HA 9G-TRONIC PRO

VIN: W1V3KBFZ7TP864105

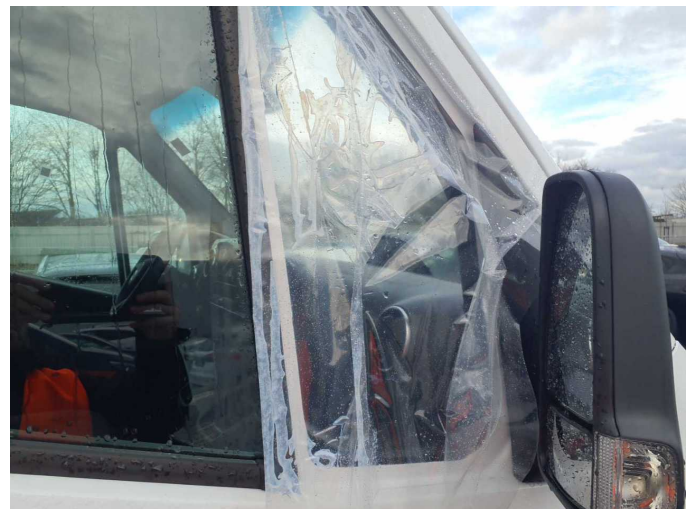
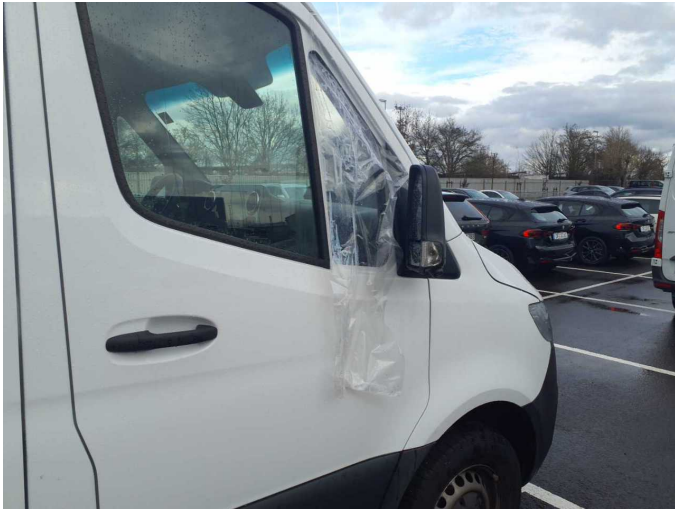
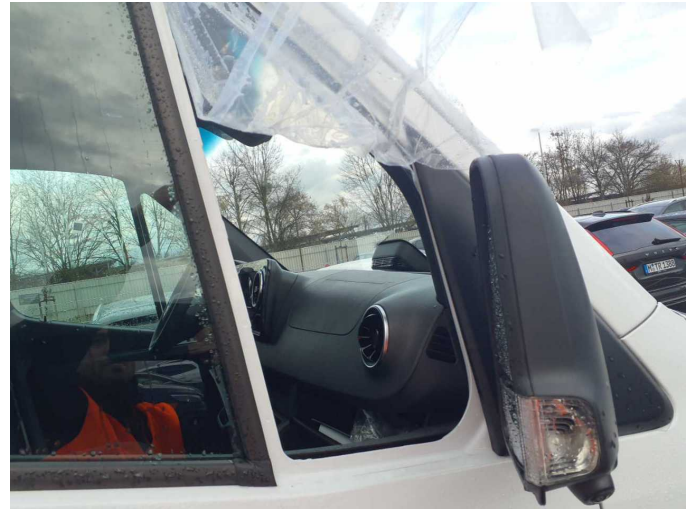
Damage 1: Vehicle glazing: Triangular window - right side - Damaged - Replace

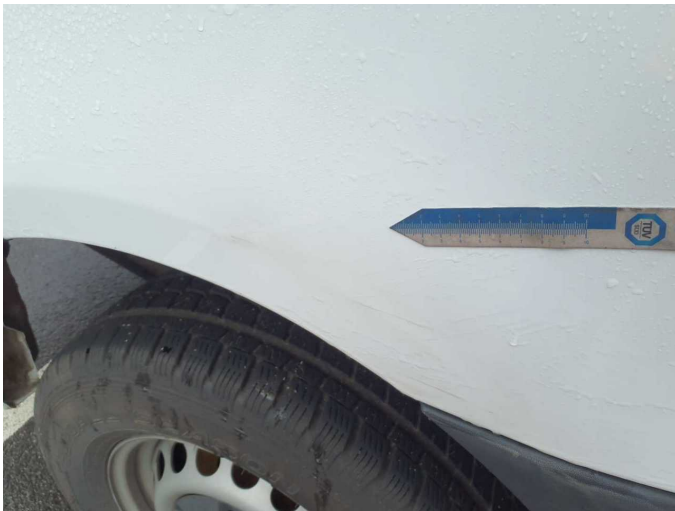
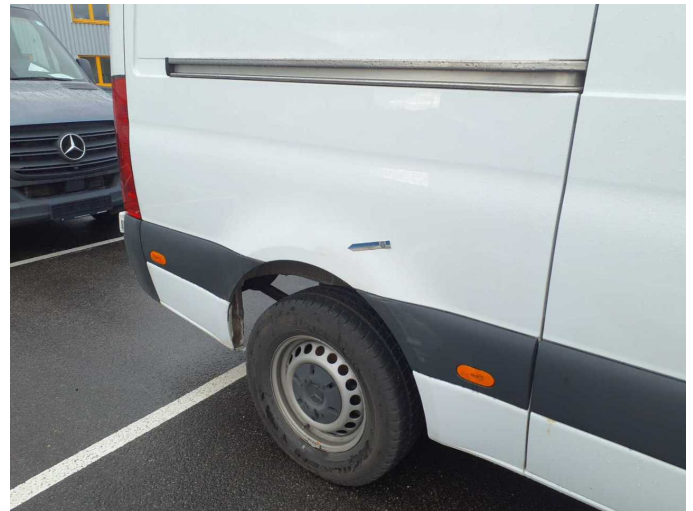
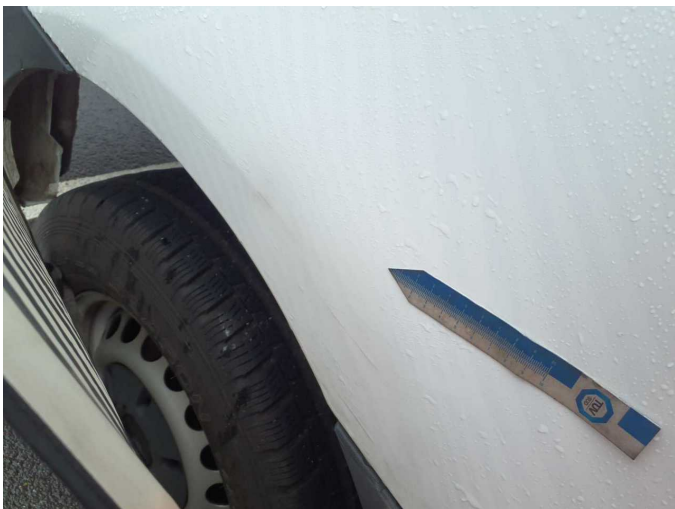
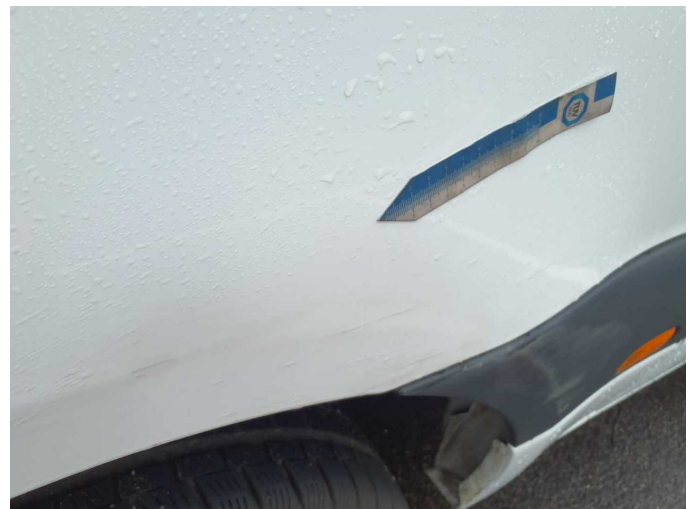
Damage 2: Side panel - rear right side: Side panel - Dent / paintcoat damage - Repair and paint

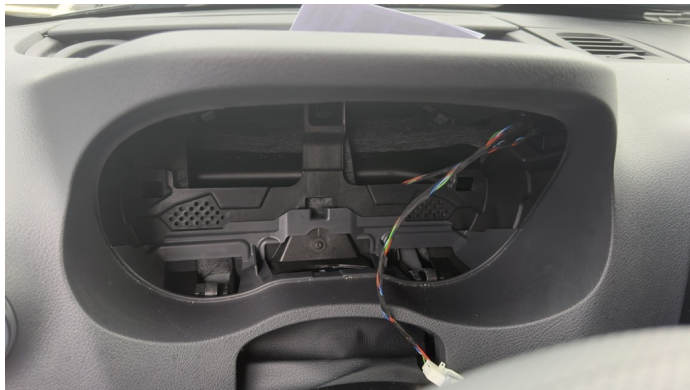
Damage 3: Instrument panel: Instrument cluster (Steckverbindung Kabelbaum intakt) - Missing - Replace

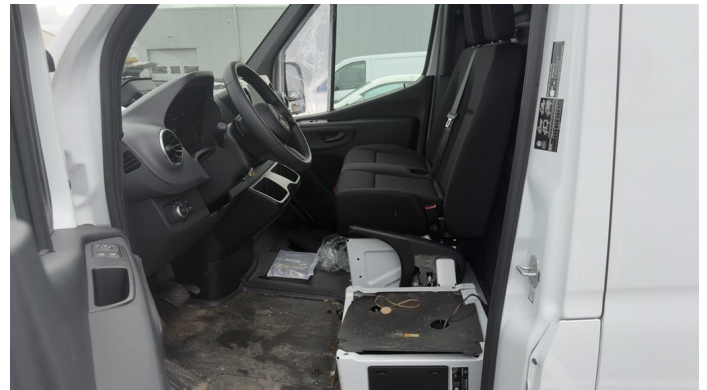
Damage 4: Seat - front: Seat - left side - Missing - Replace
