## Expertise

Protocol number: 46218536  
Order No. / Reference: 26530074  
Inspection date: 23 Jun 2026

Manufacturer: Opel

Model: Grandland X 1.5 D Start/Stop Automatik Elegance

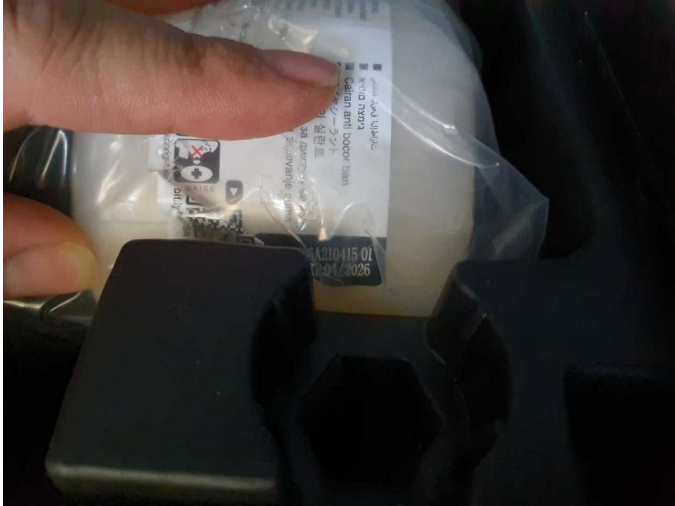
**Damage 1:** Equipment: Tirefit filler - Expired - Replace

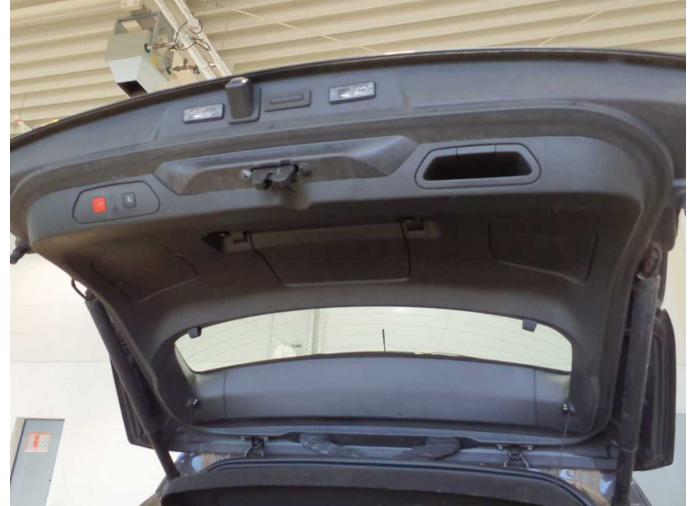
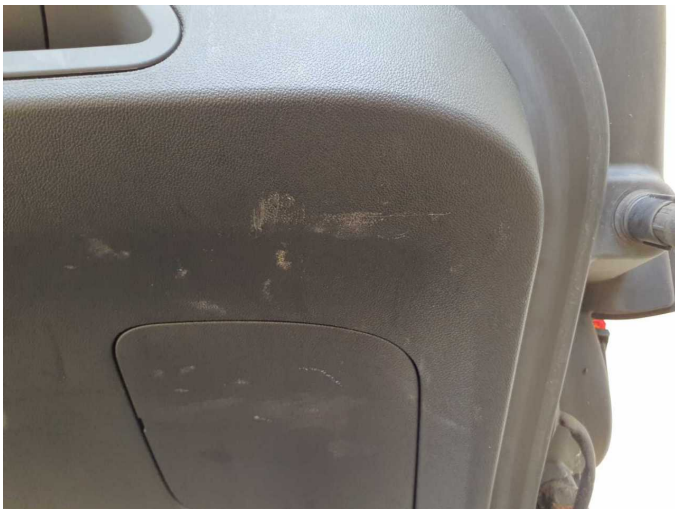
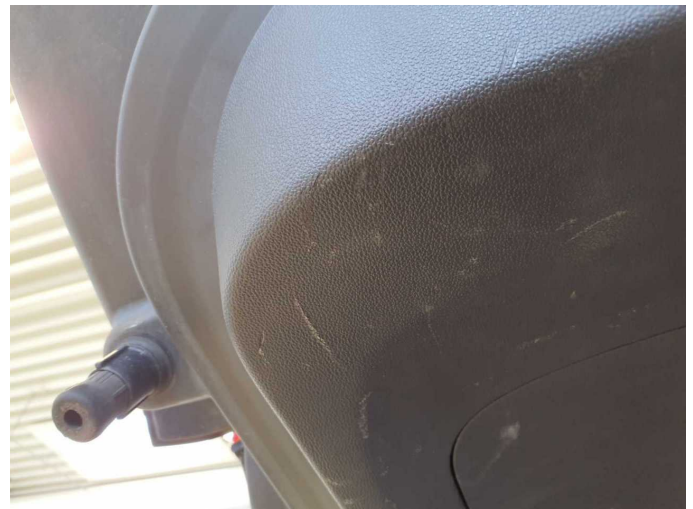
**Damage 2:** Trim / covers: Boot lid - interior trim - Scratch(es) - Loss in value

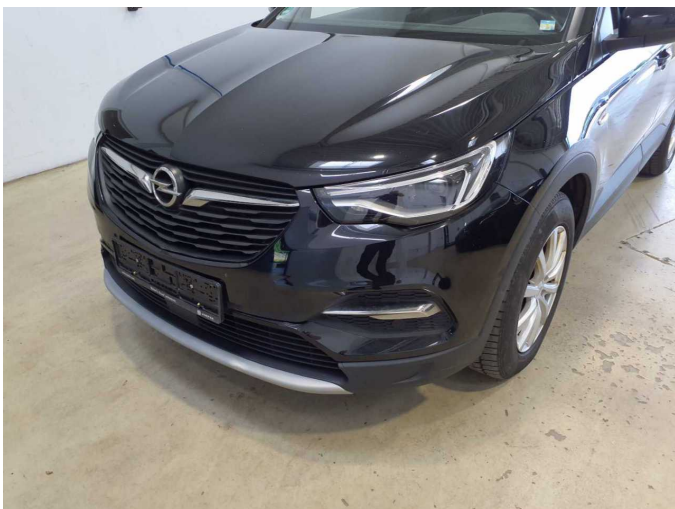
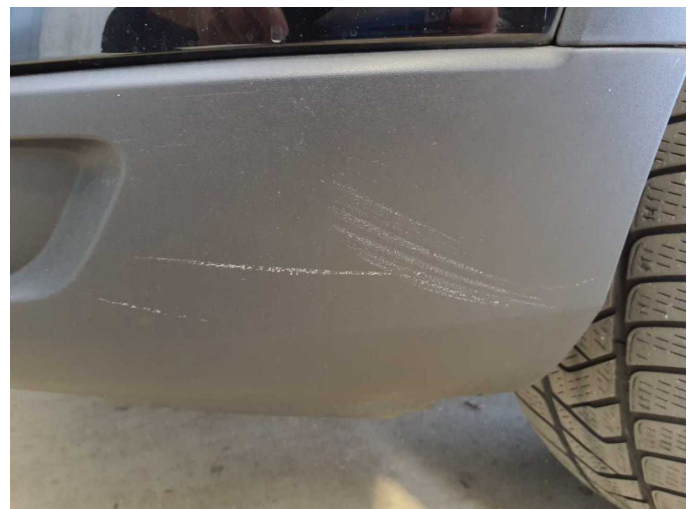
**Damage 3:** Front bumper: Spoiler - Scratch(es) - Loss in value

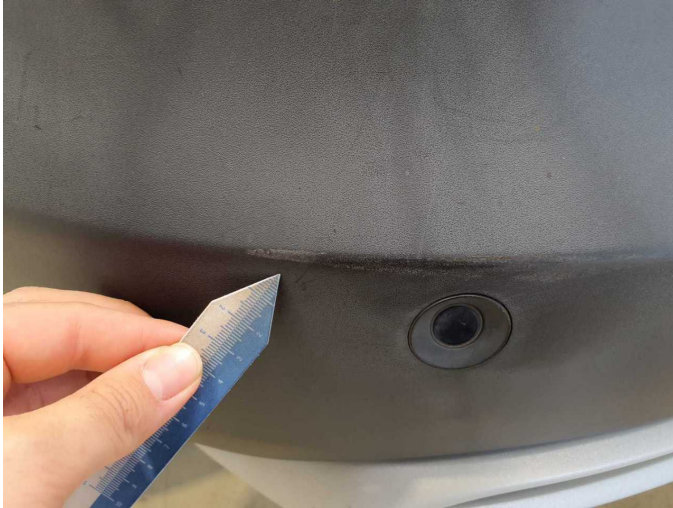
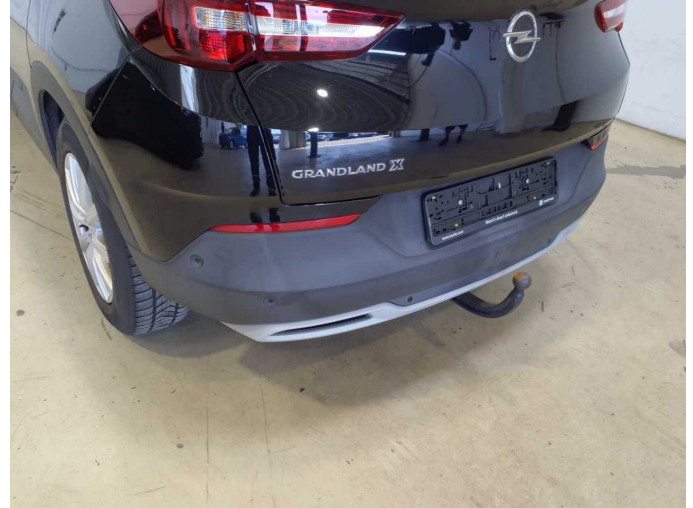
**Damage 4:** Rear bumper: Spoiler - Scratch(es) - Loss in value

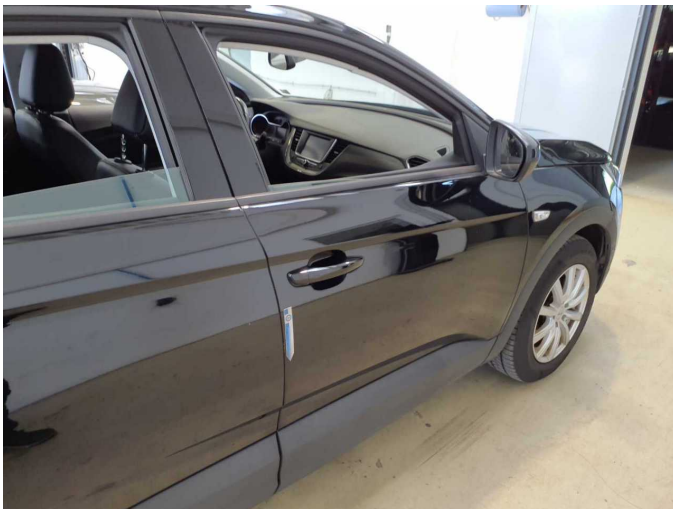
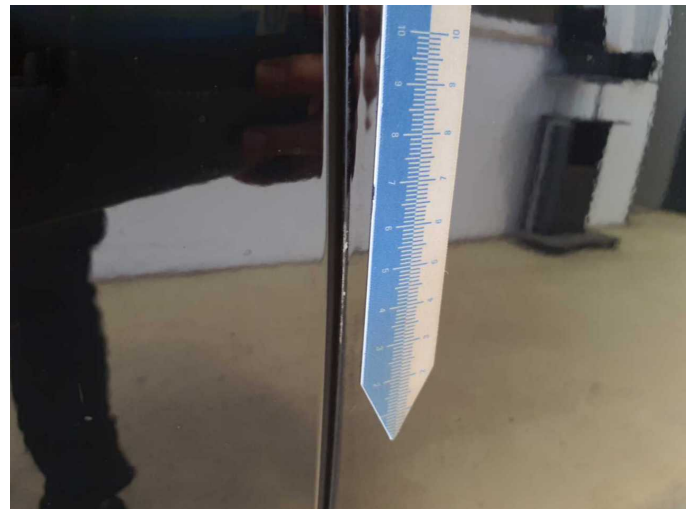
**Damage 5:** Door - front right side: Door edge - Scratch(es) - Smart repair

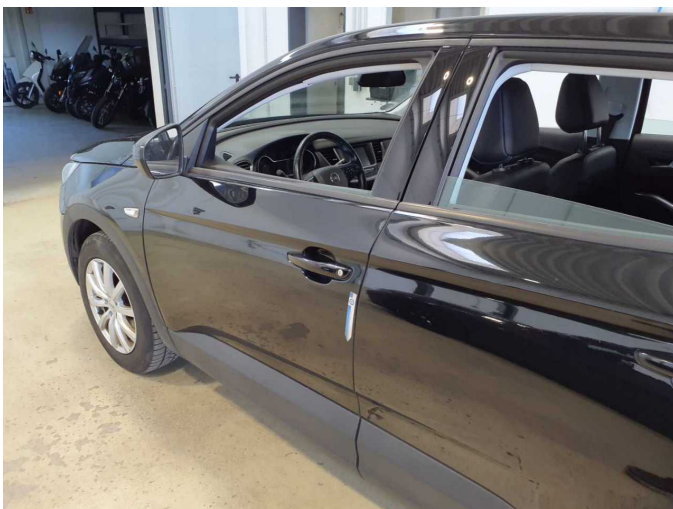
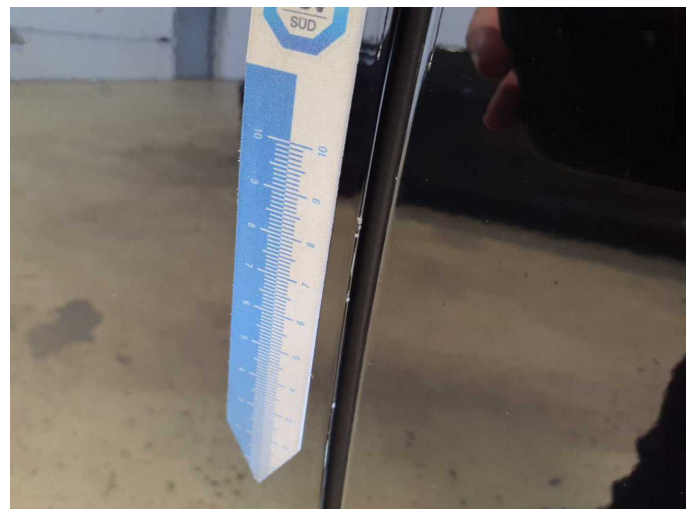
**Damage 6:** Door - front left side: Door edge - Scratch(es) - Smart repair

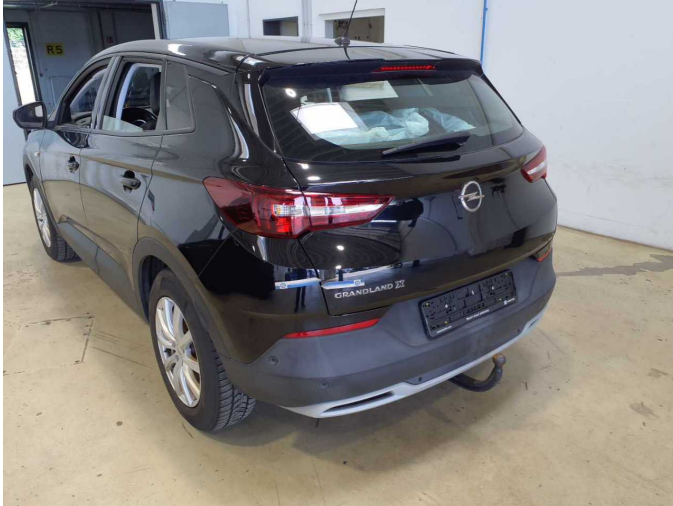
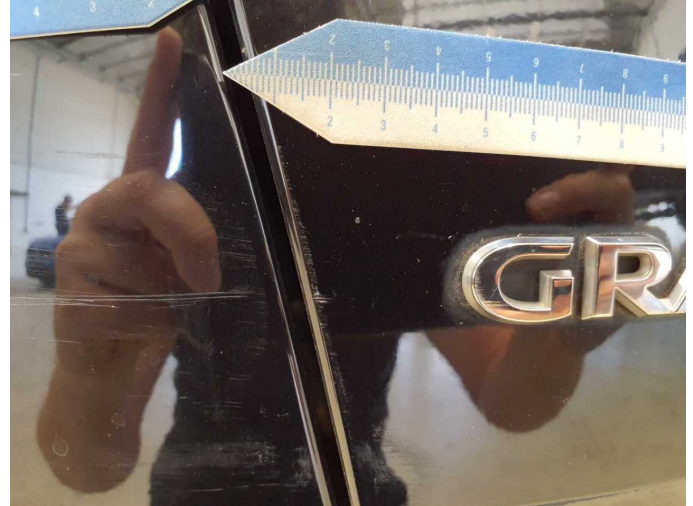
**Damage 7:** Boot lid / rear door: Boot lid - Scratch(es) - Smart repair

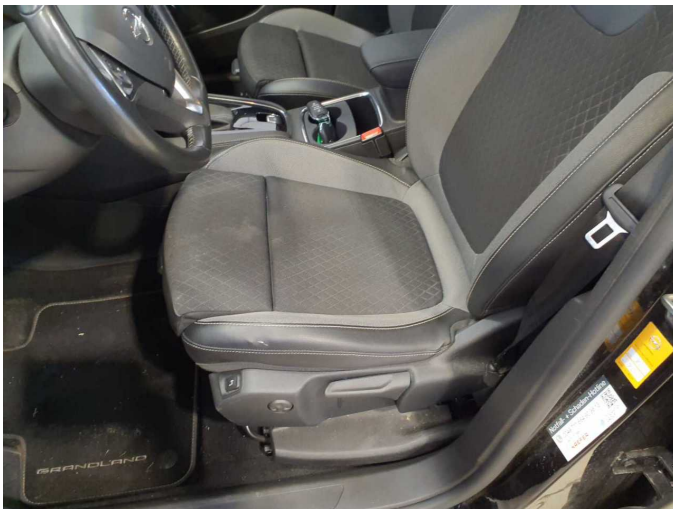
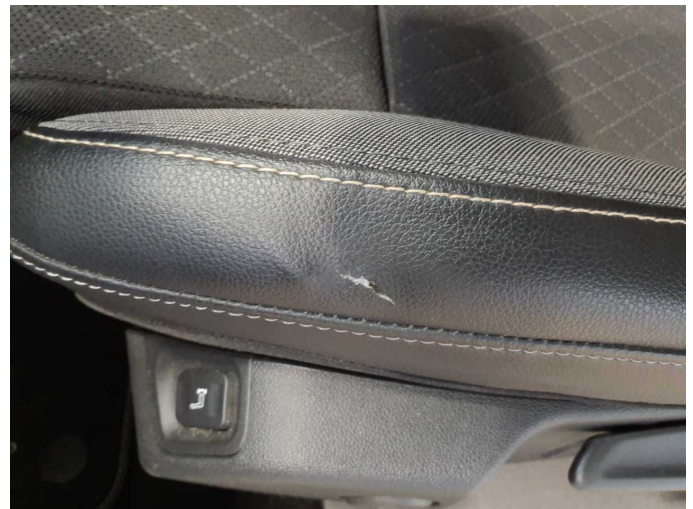
**Damage 8:** Seat - front: Seat cover - left side - Scratch(es) - Smart repair

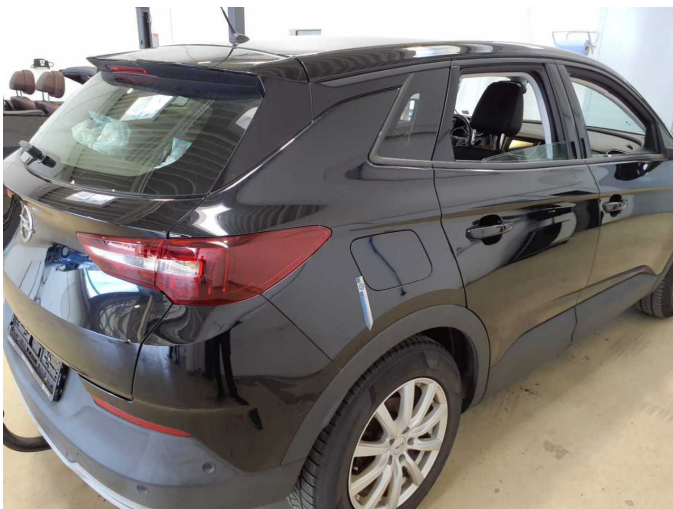
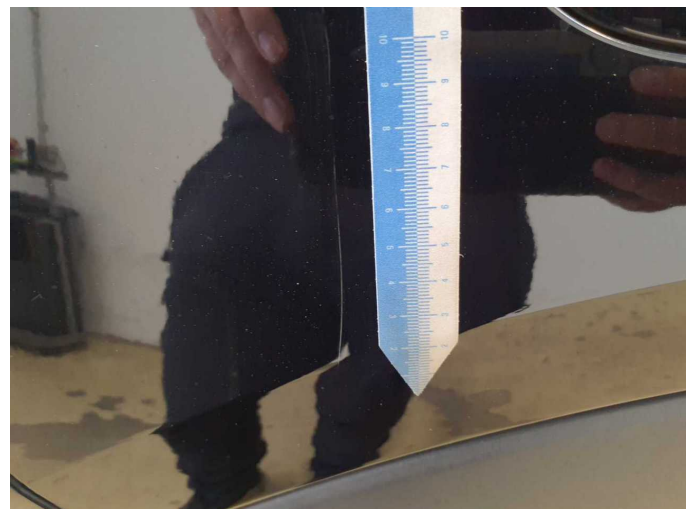
**Damage 9:** Side panel - rear right side: Side panel - Scratch(es) - Smart repair

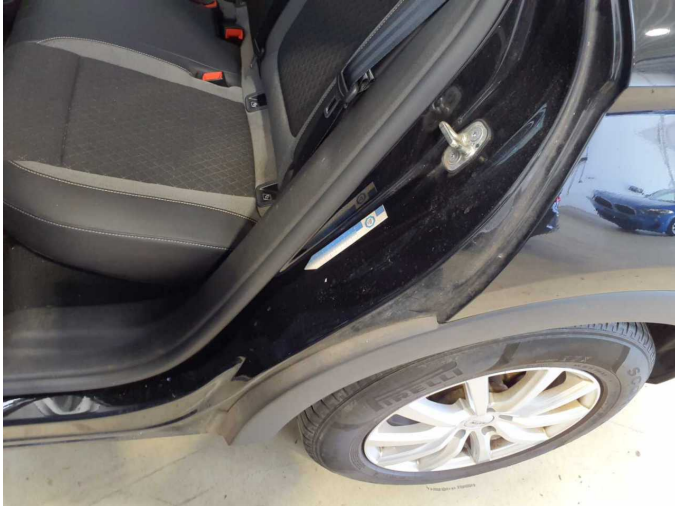
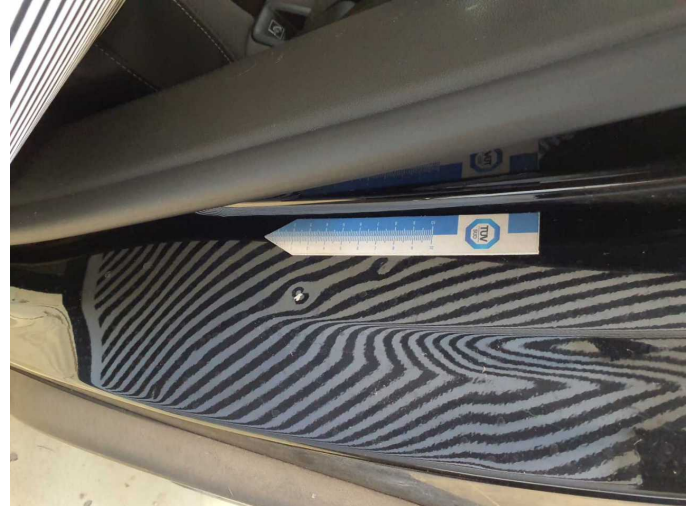
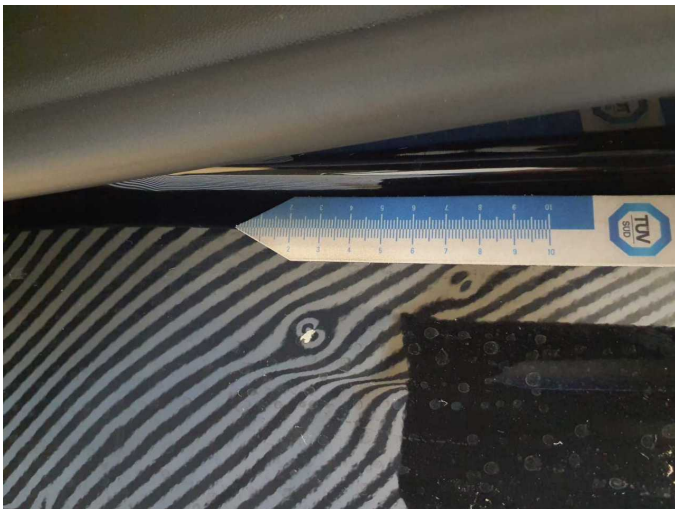
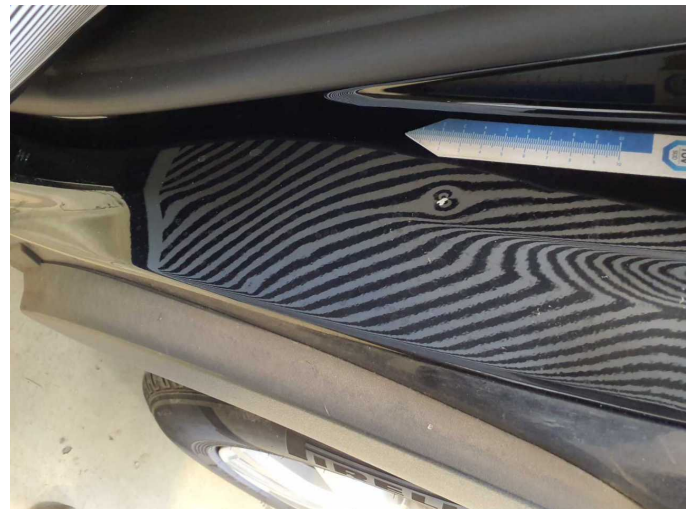
**Damage 10:** Side panel - rear left side: Sill - Dent / paintcoat damage - Smart repair

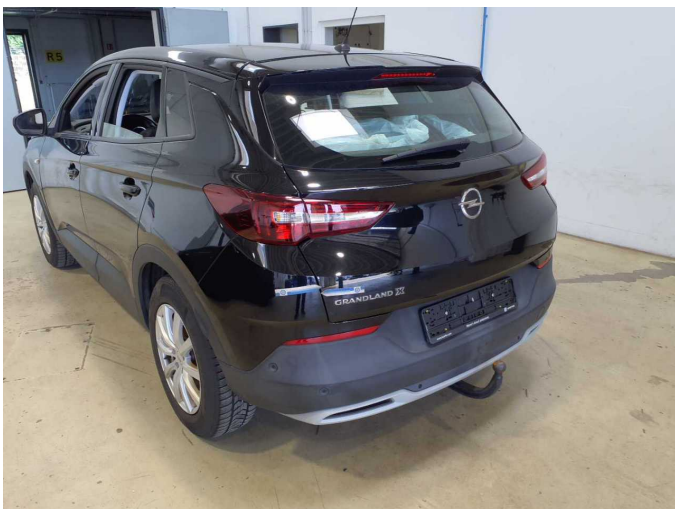
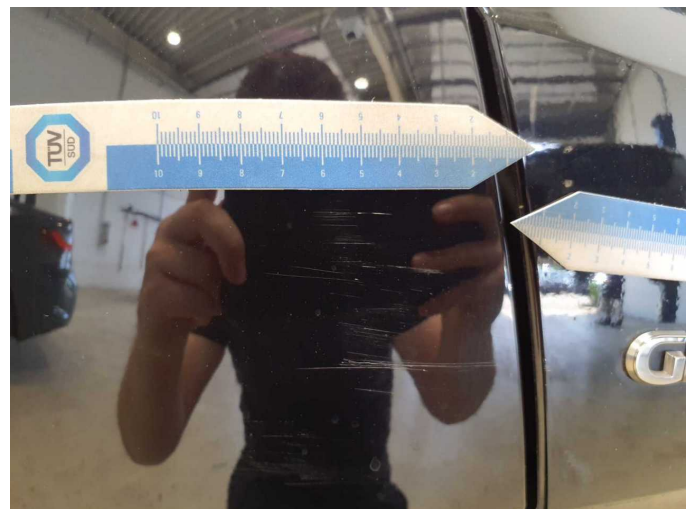
**Damage 11:** Rear bumper: Rear bumper - Scratch(es) - Smart repair

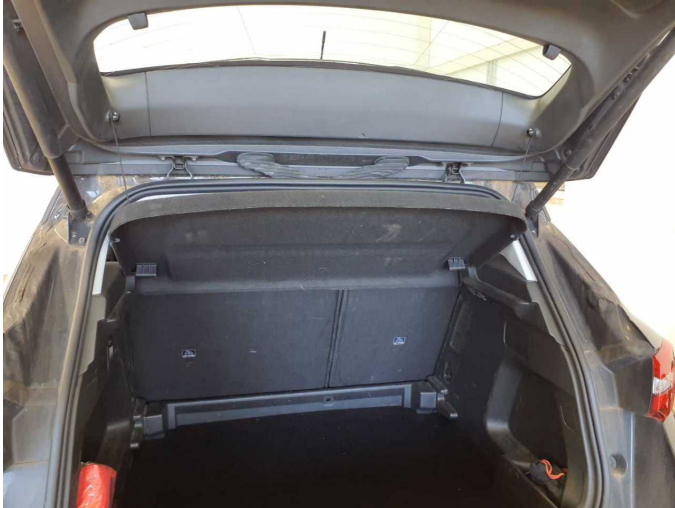
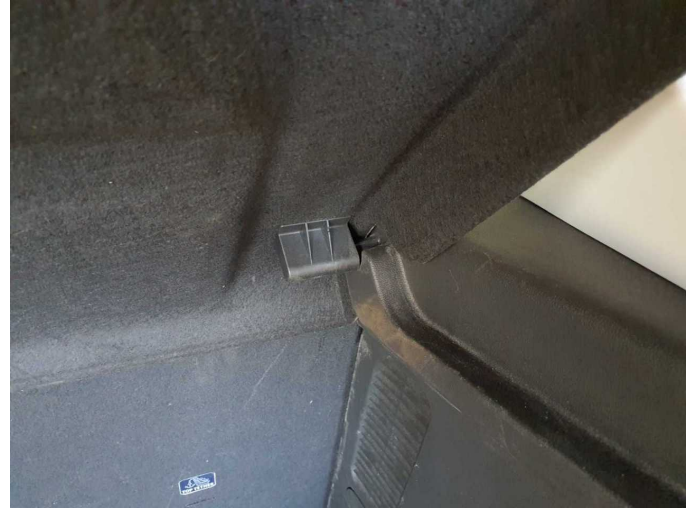
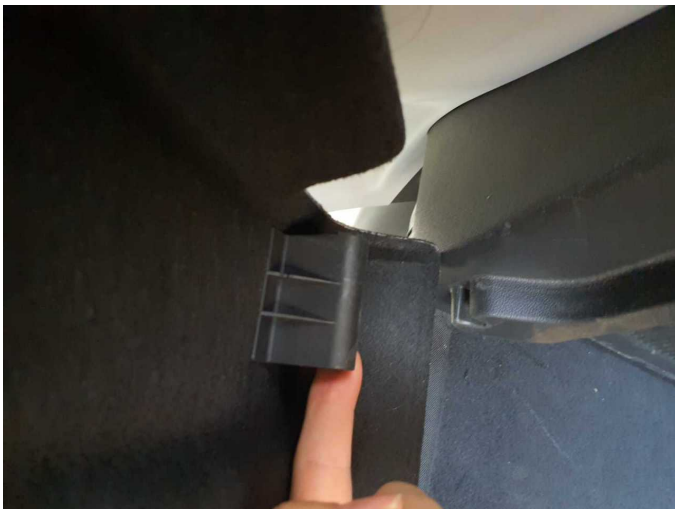
**Damage 12:** Interior: Boot cover / roller cover - Broken / torn - Replace

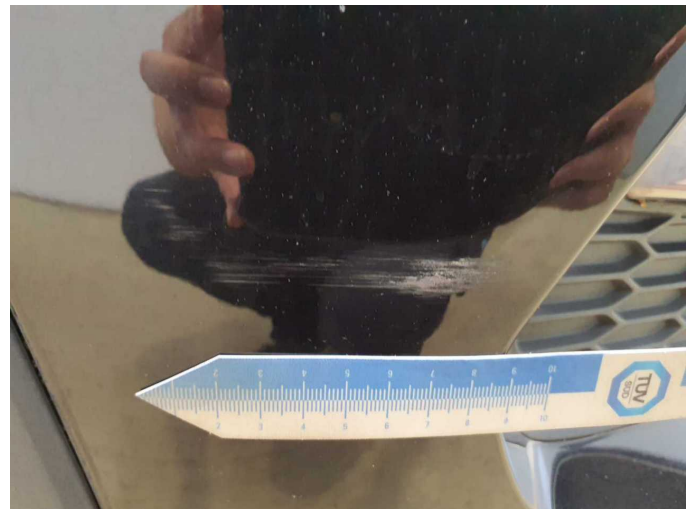
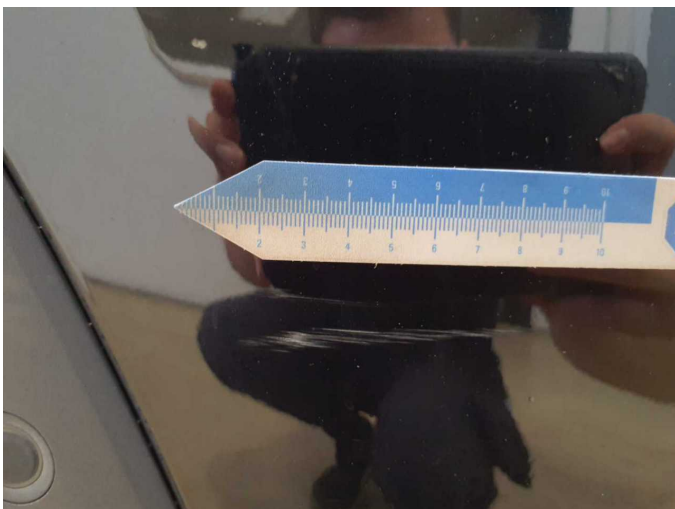
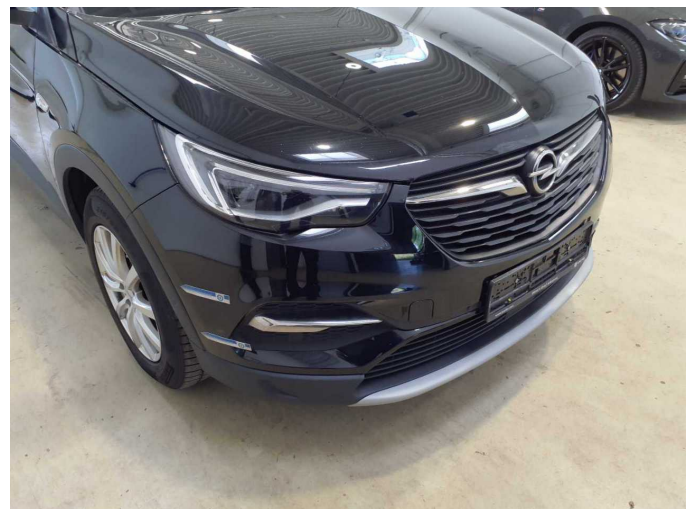
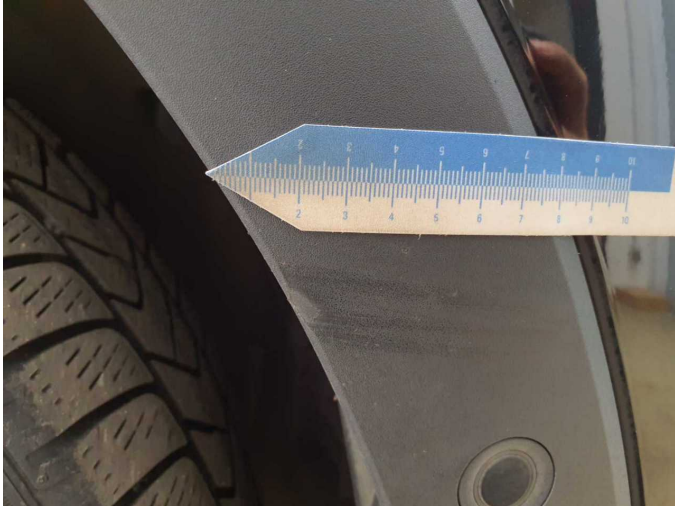
**Damage 13:** Front bumper: Front bumper (Zusätzlich Blende rechts Kratzer) - Scratch(es) - Paint

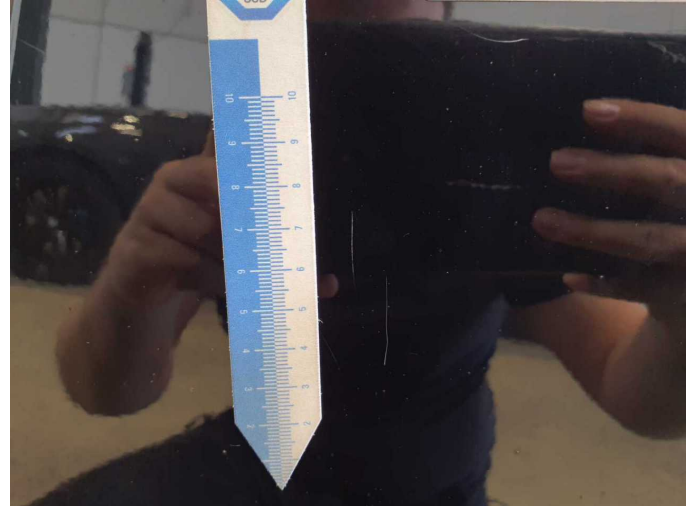
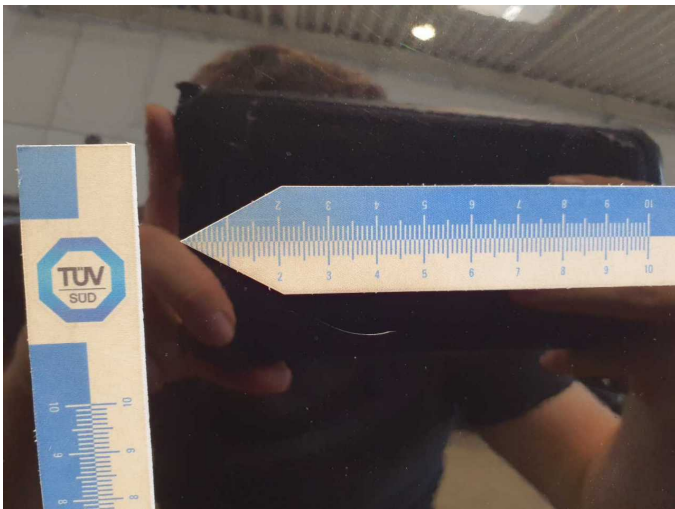
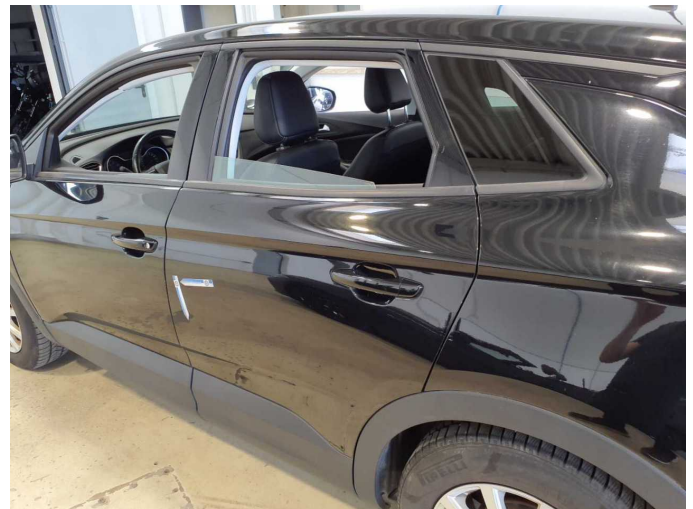
**Damage 14:** Door - rear left side: Door - Scratch(es) - Paint

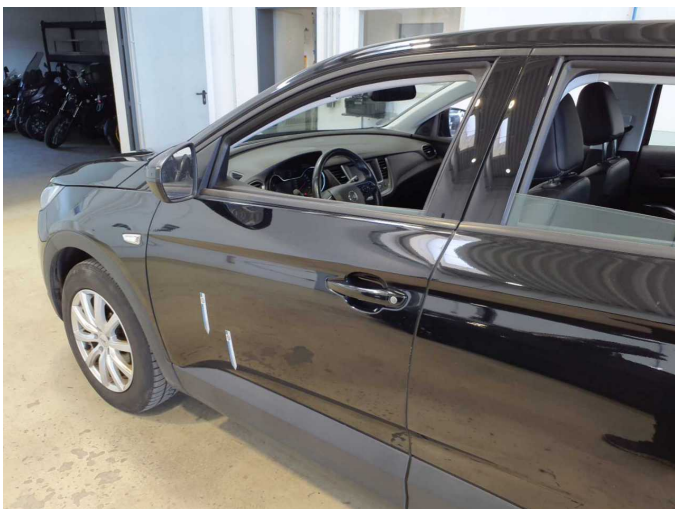
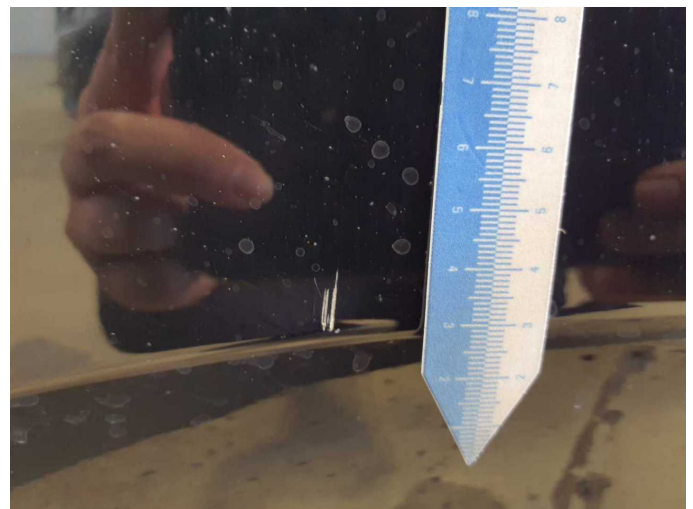
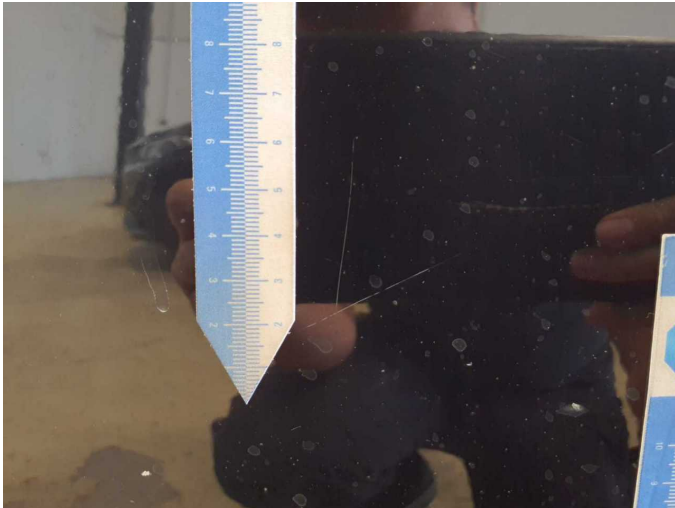
**Damage 15:** Door - front left side: Door - Scratch(es) - Paint

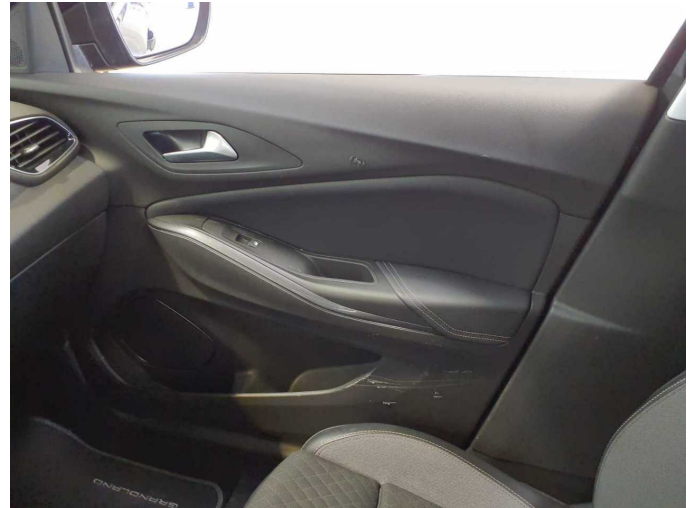
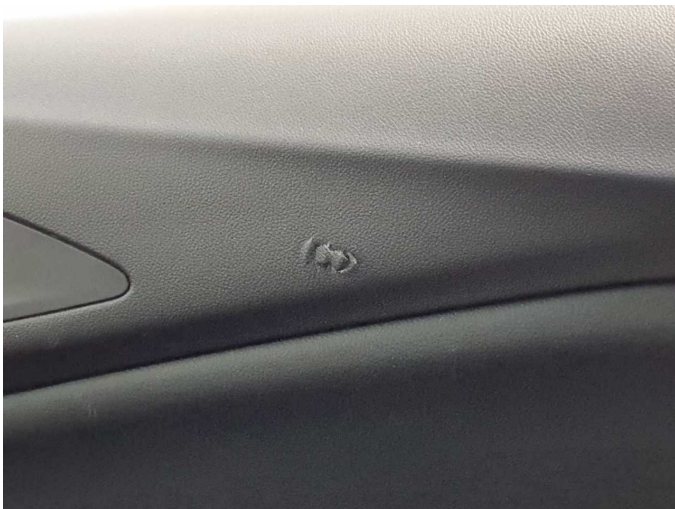
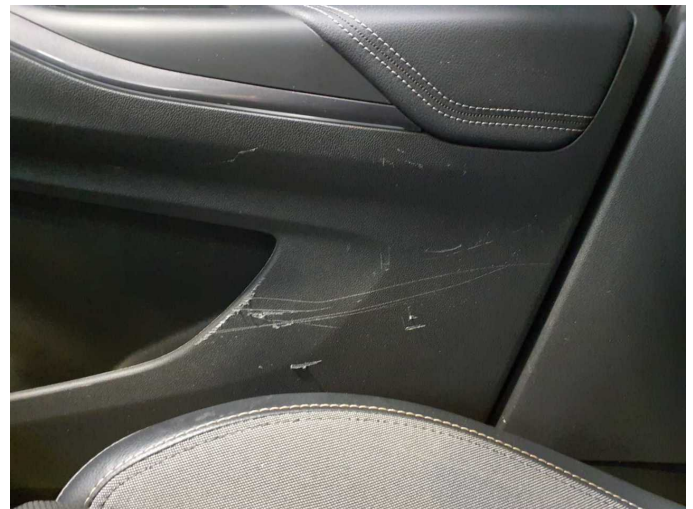
**Damage 16:** Trim / covers: Door trim - front right side - Scratched - Replace

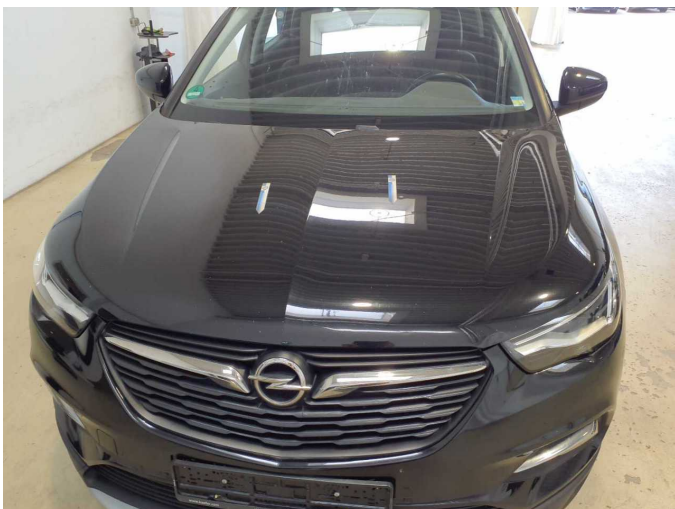
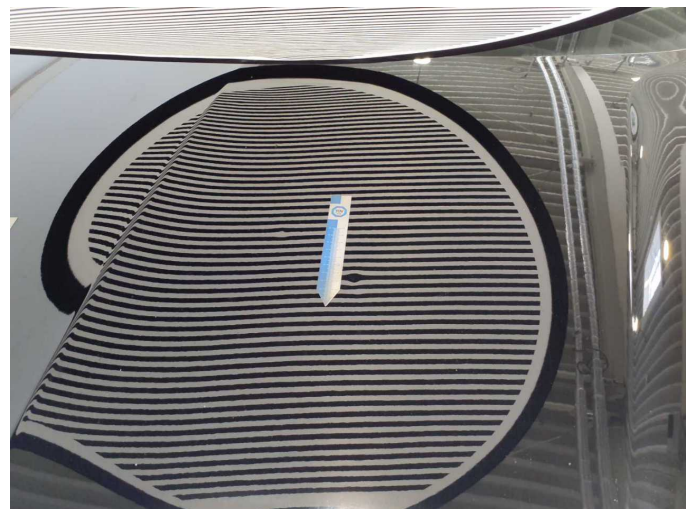
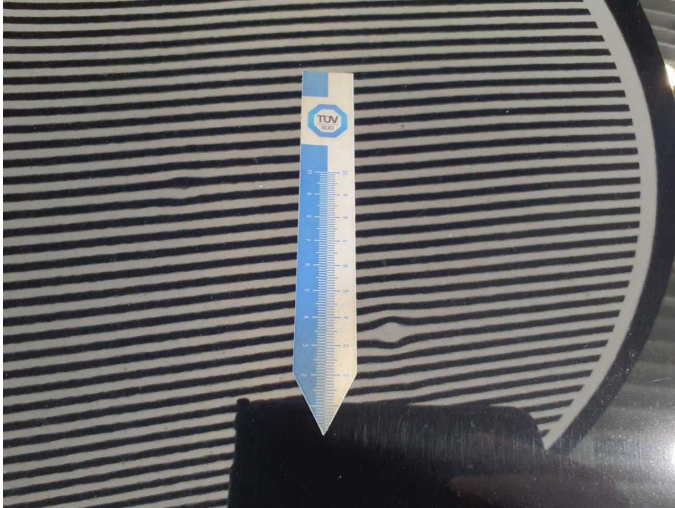
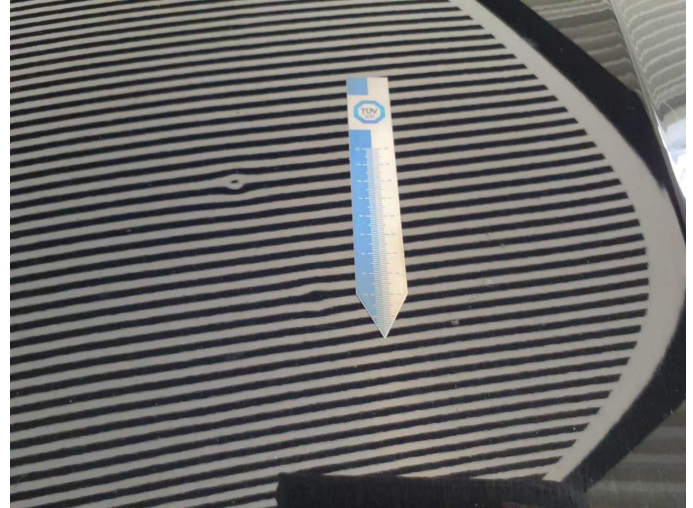
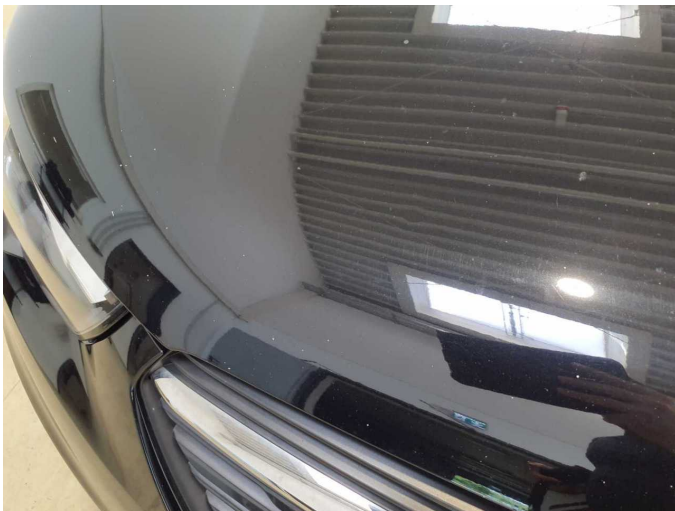
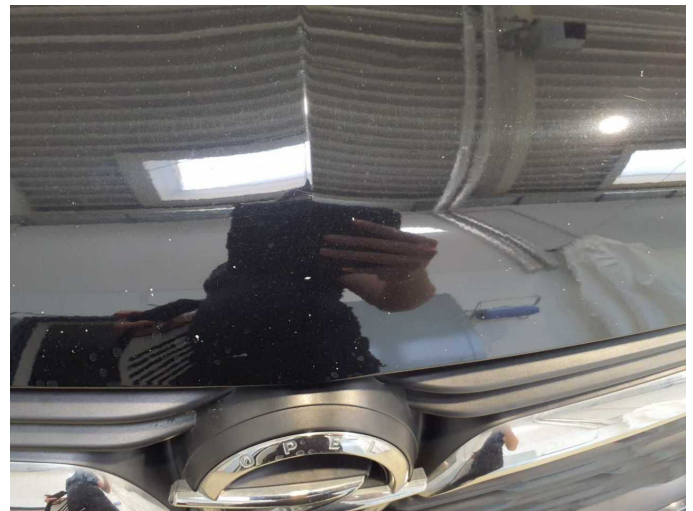
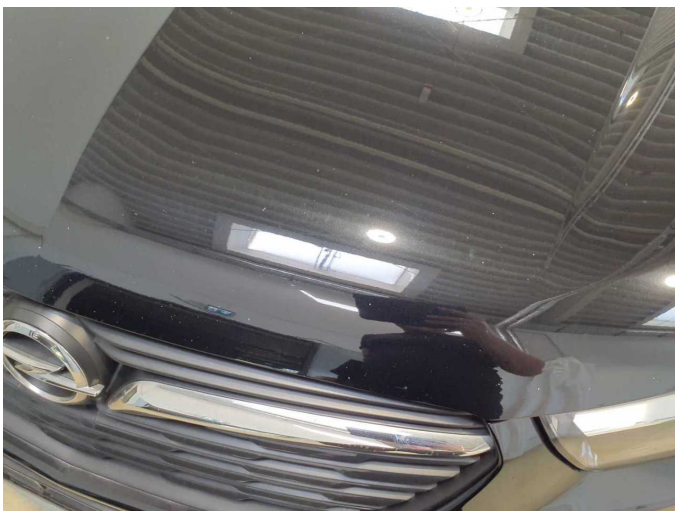
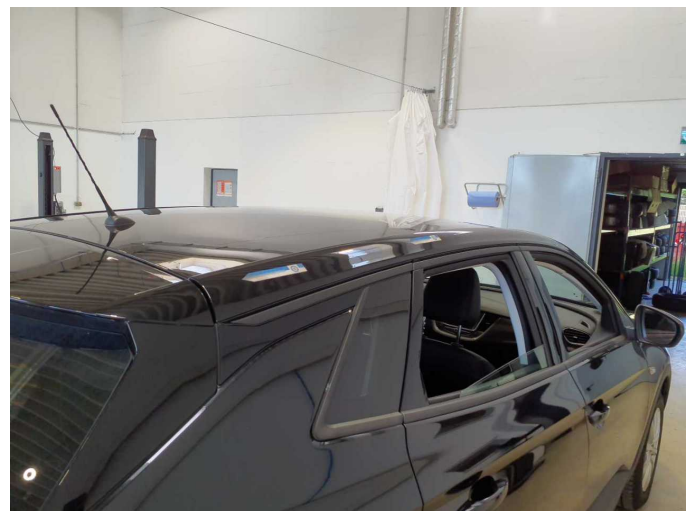
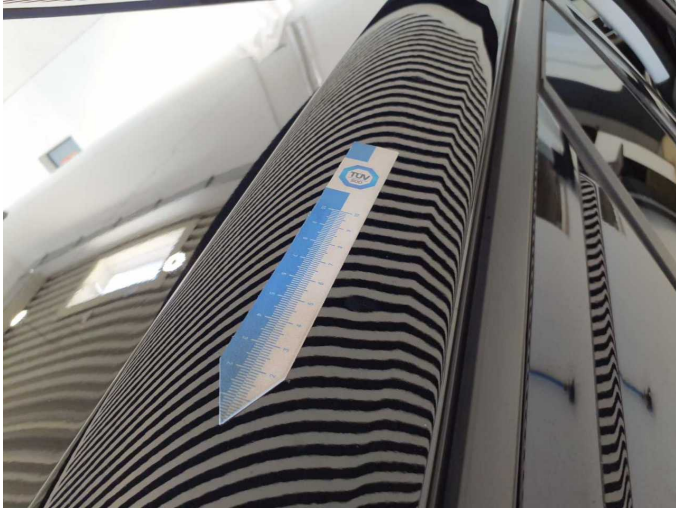
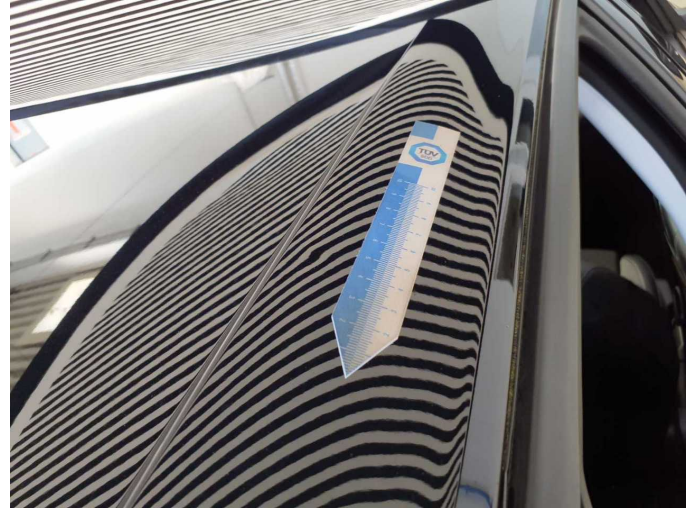
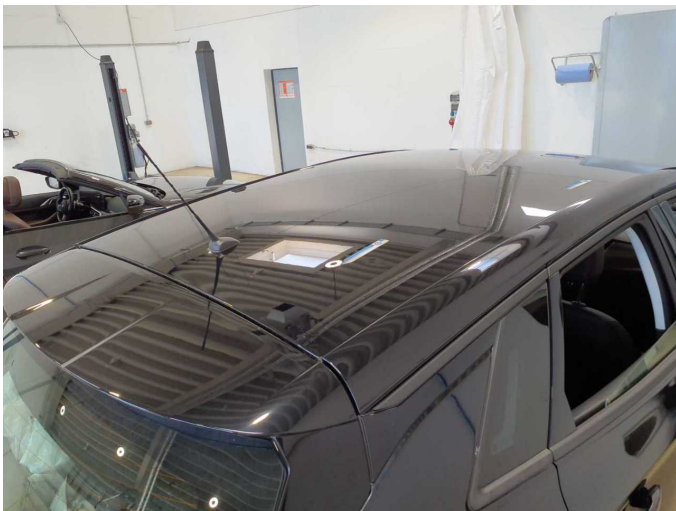
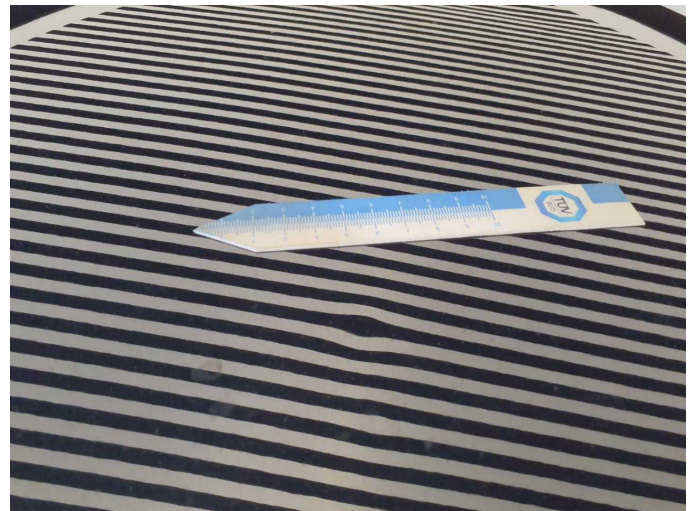
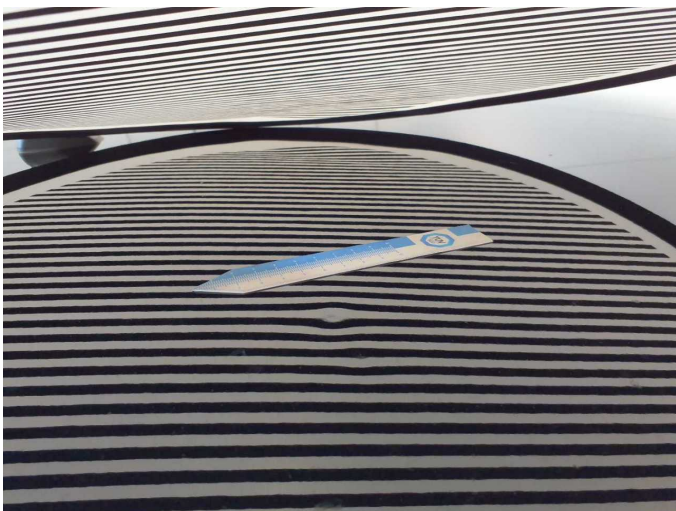
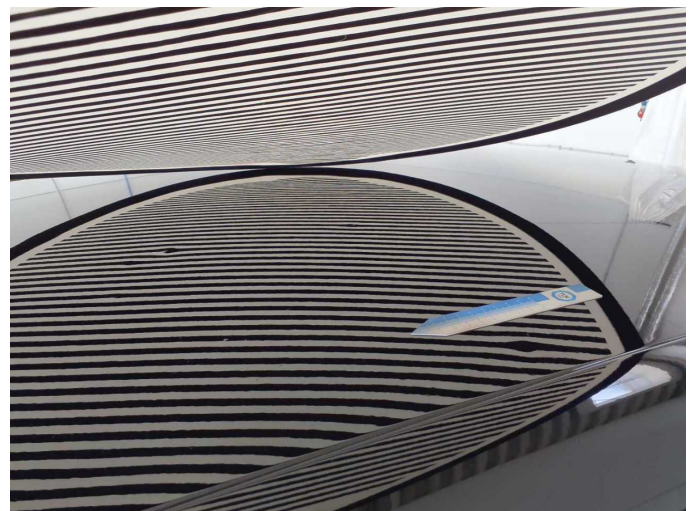
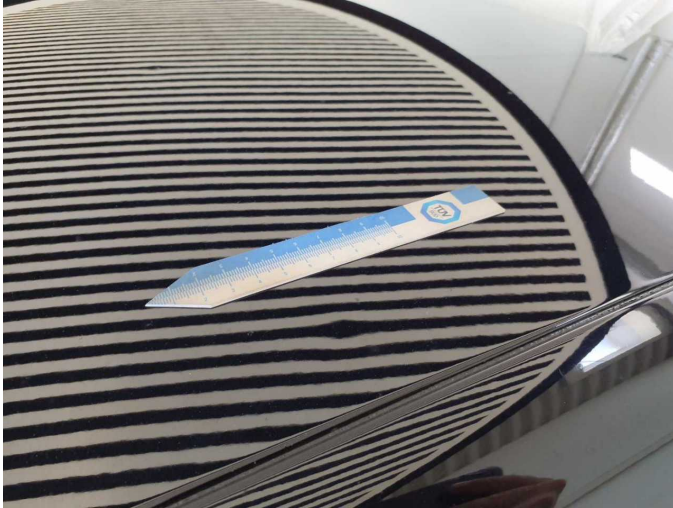
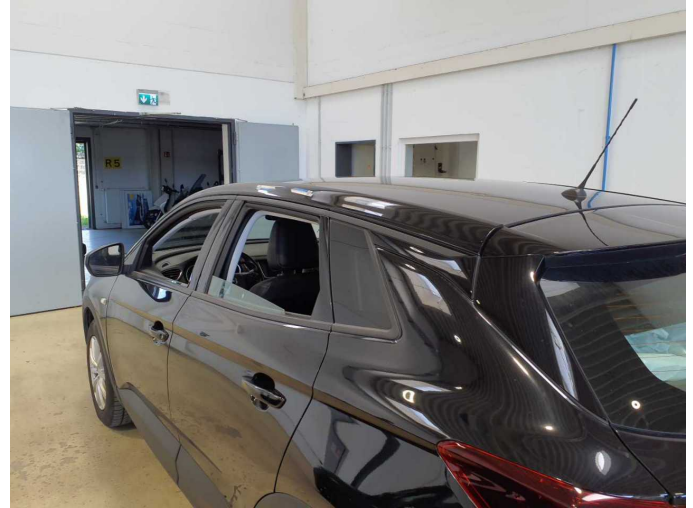
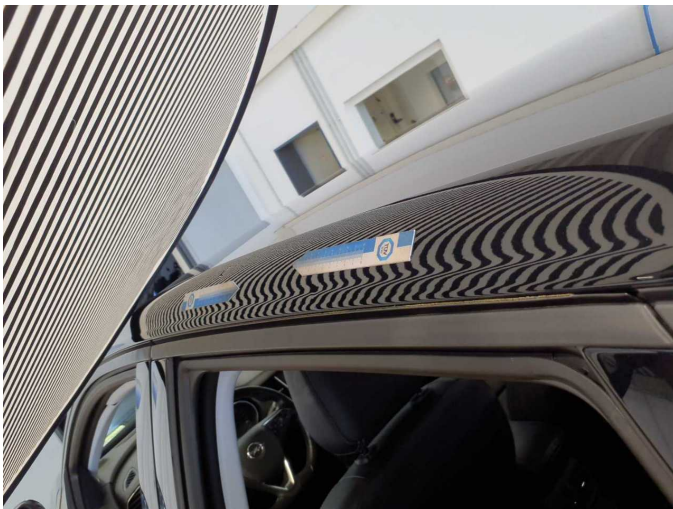
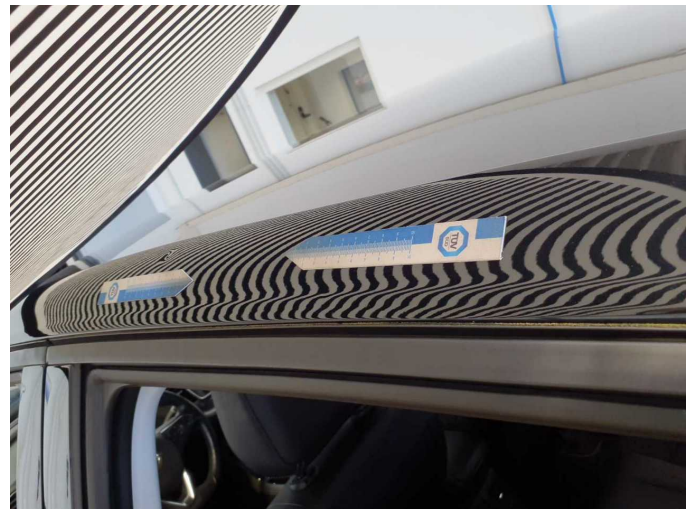
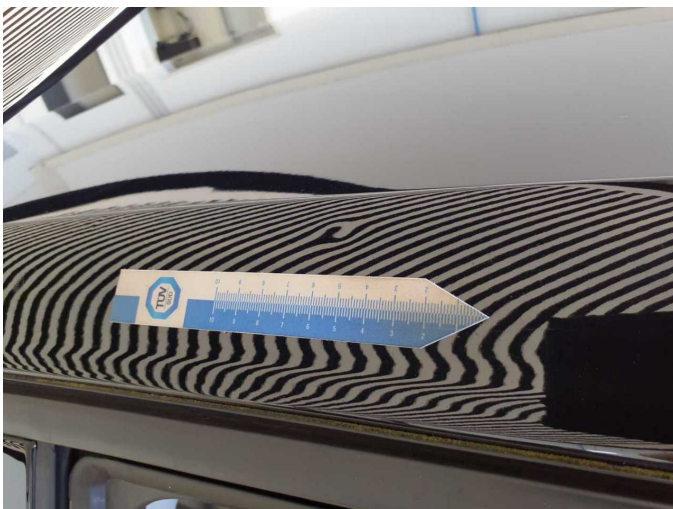
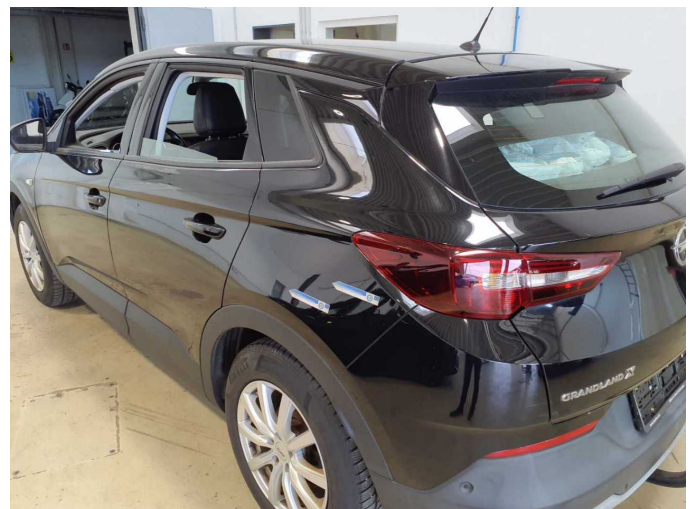
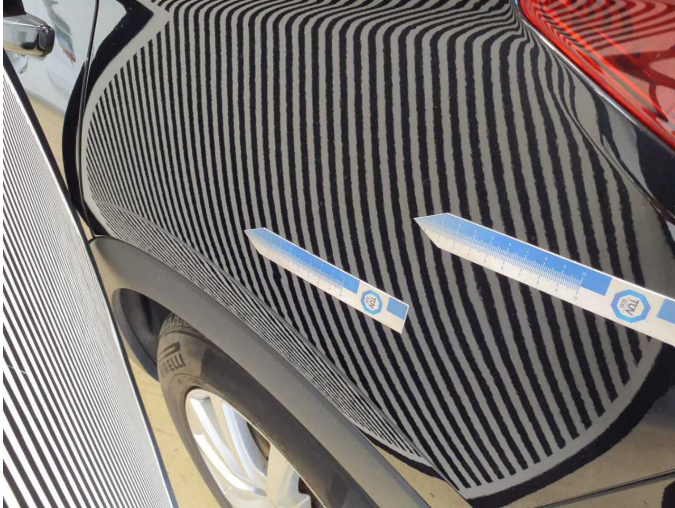
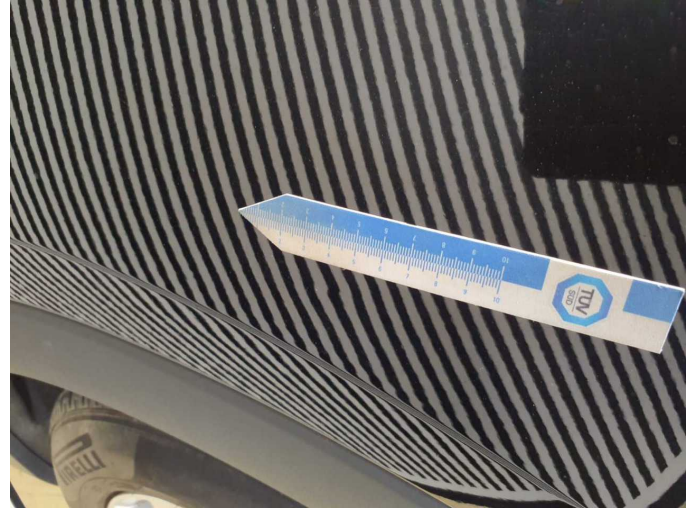
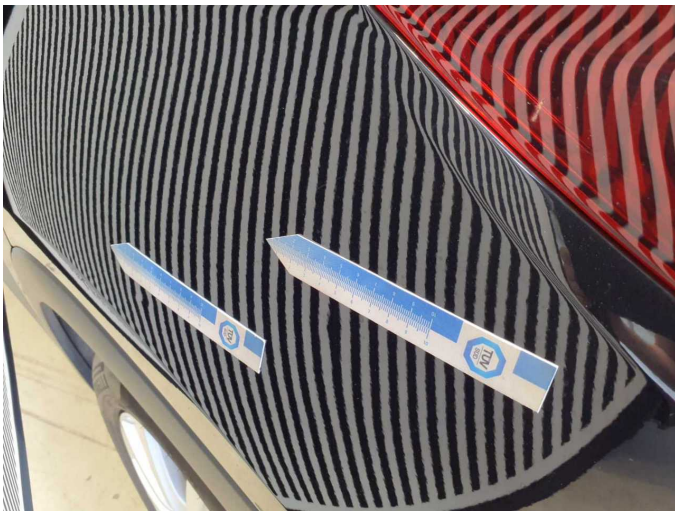
**Damage 17:** Body: Body - Damage by hail - Smooth repair work

Damage 17: Body: Body - Damage by hail - Smooth repair work
