Expertise

Protocol number: 46294595  
Order No. / Reference: 26614737  
Inspection date: 30 Jun 2026

Manufacturer: Ford

Model: Kuga 1.5 EcoBlue Aut. COOL&CONNECT

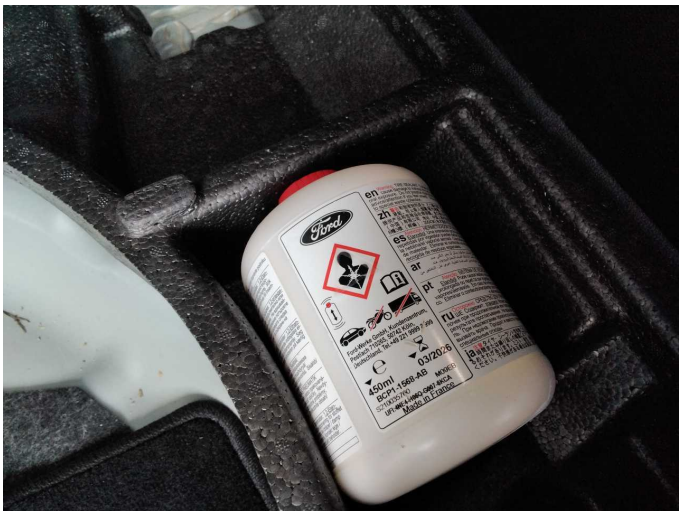
| No. | Component group | Description |
|---|---|---|
| 1 | Equipment | Tirefit filler - Expired - Replace |

Damage 1: Equipment: Tirefit filler - Expired - Replace

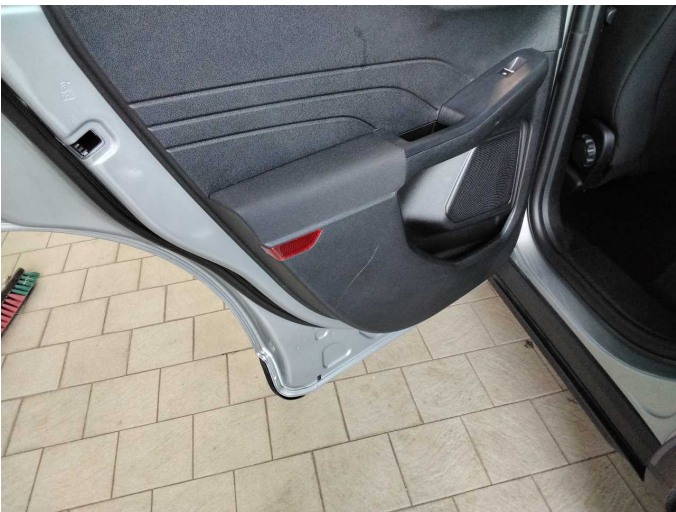
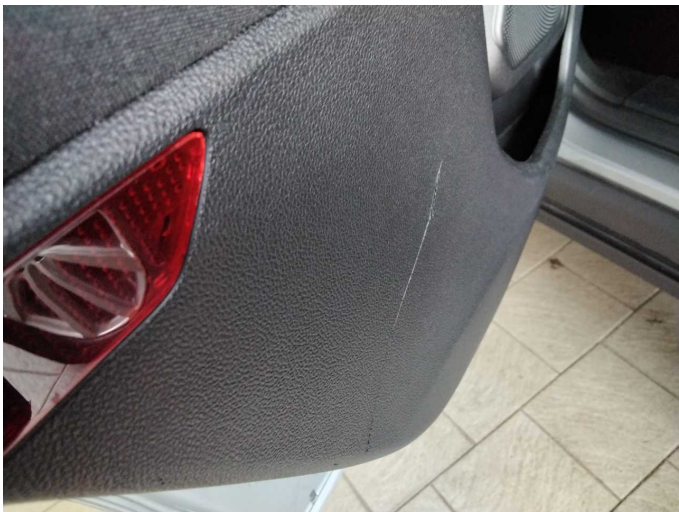
| No. | Component group | Description |
|---|---|---|
| 2 | Trim / covers | Door trim - rear left side - Scratch(es) - Loss in value |

Damage 2: Trim / covers: Door trim - rear left side - Scratch(es) - Loss in value

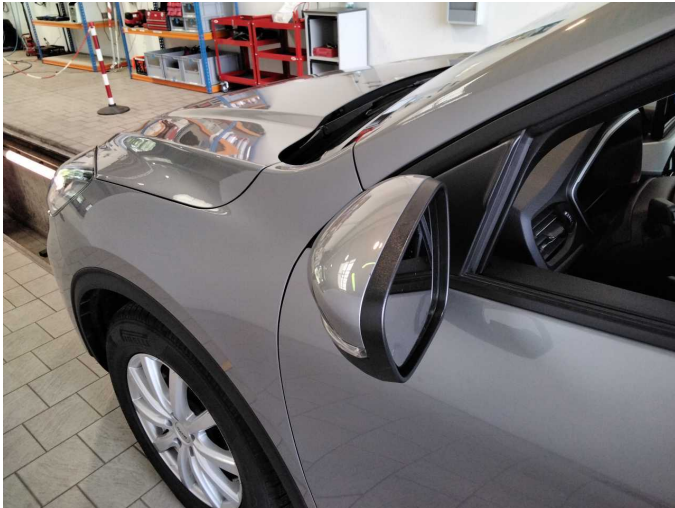
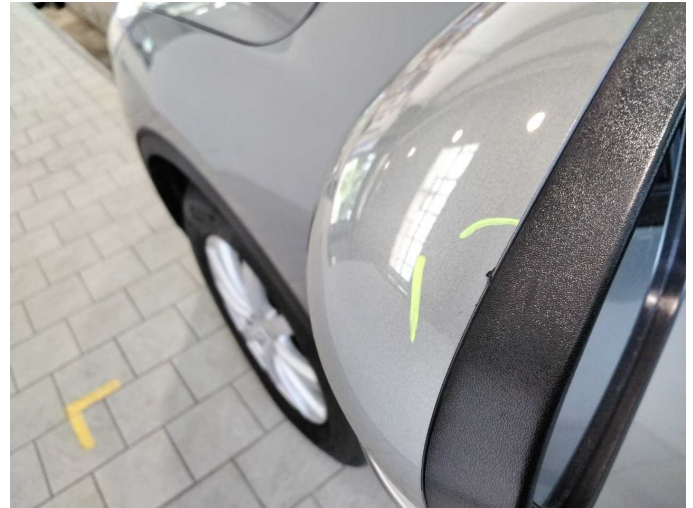
| No. | Component group | Description |
|---|---|---|
| 3 | Wing mirror - left side | Cap - Scratch(es) - Smart repair |

**Damage 3:** Wing mirror - left side: Cap - Scratch(es) - Smart repair

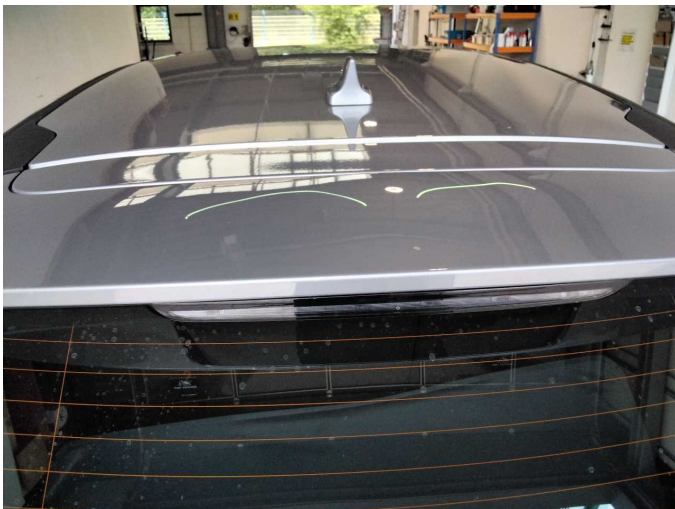
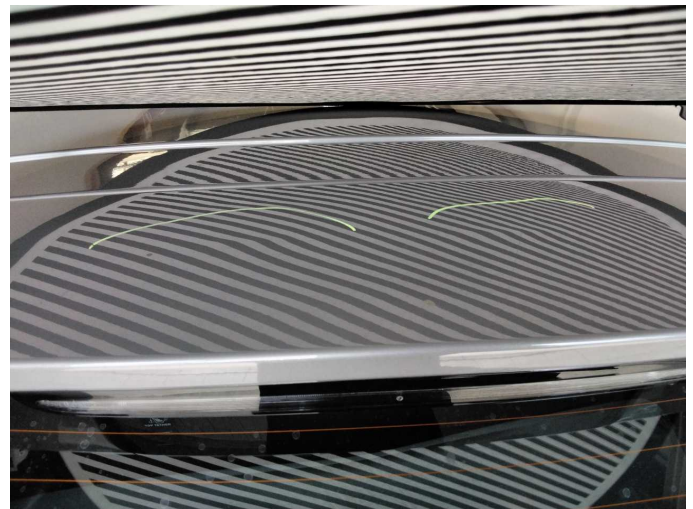
| No. | Component group | Description |
|---|---|---|
| 4 | Boot lid / rear door | Boot lid - dent(s) - Smooth repair work |

**Damage 4:** Boot lid / rear door: Boot lid - dent(s) - Smooth repair work

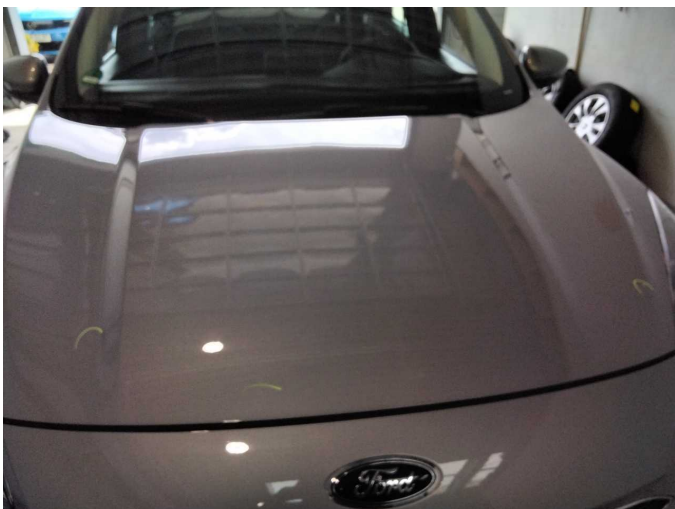
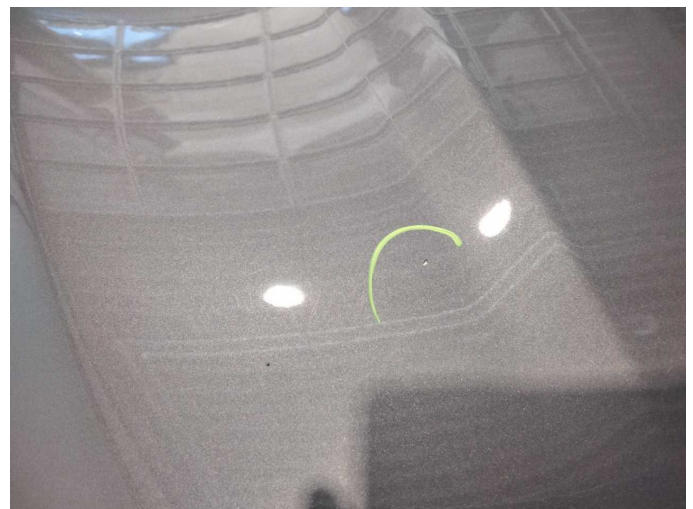
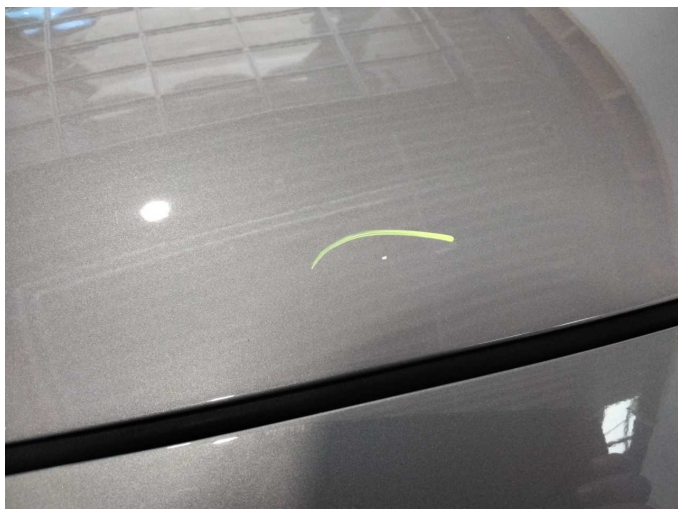
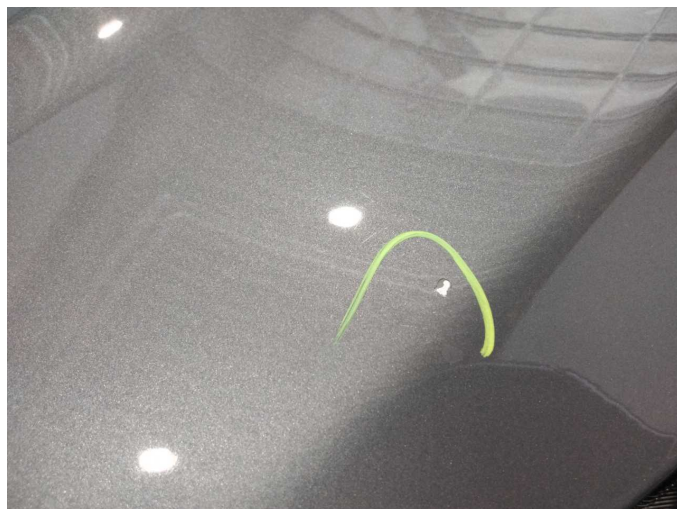
| No. | Component group | Description |
|---|---|---|
| 5 | Bonnet | Bonnet - Scratch(es) - Paint |

**Damage 5:** Bonnet: Bonnet - Scratch(es) - Paint

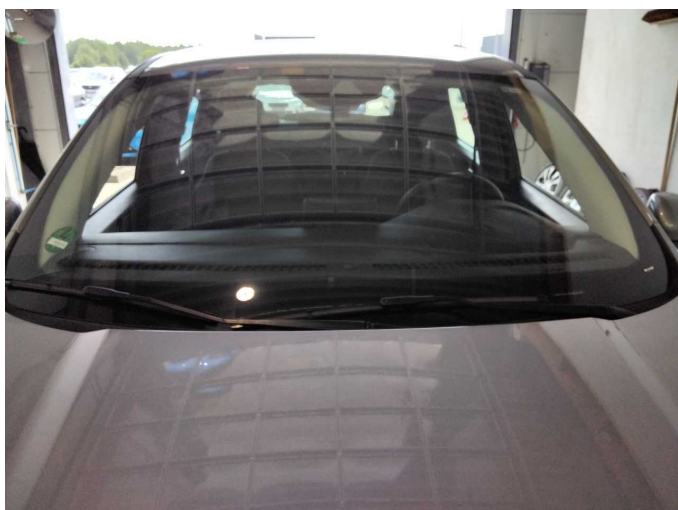
| No. | Component group | Description |
|---|---|---|
| 1 | Vehicle glazing | Windscreen - Stone chips - No deduction |

**Wear and tear 1:** Vehicle glazing: Windscreen - Stone chips - No deduction

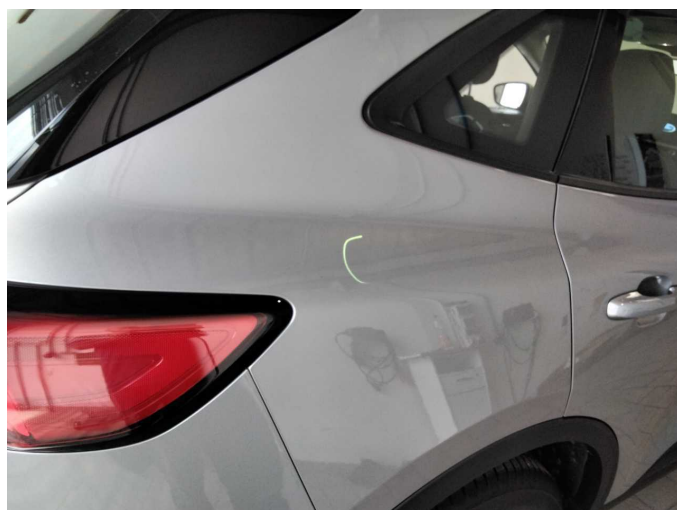
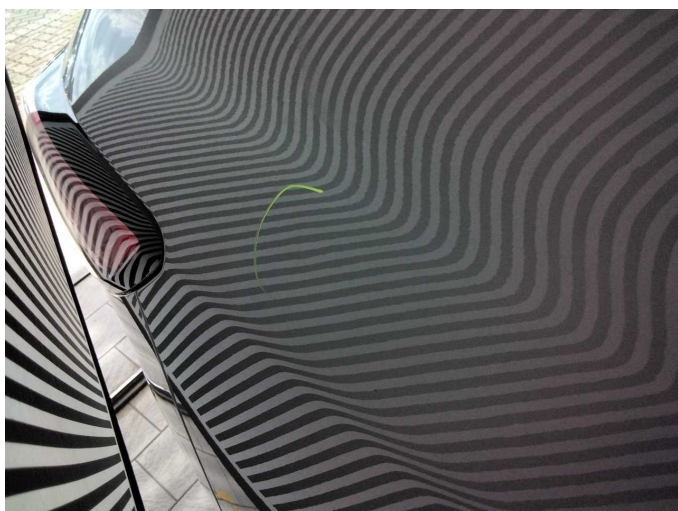
| No. | Component group | Description |
|---|---|---|
| 3 | Side panel - rear right side | Side panel - dent(s) - No deduction |

**Wear and tear 3:** Side panel - rear right side: Side panel - dent(s) - No deduction

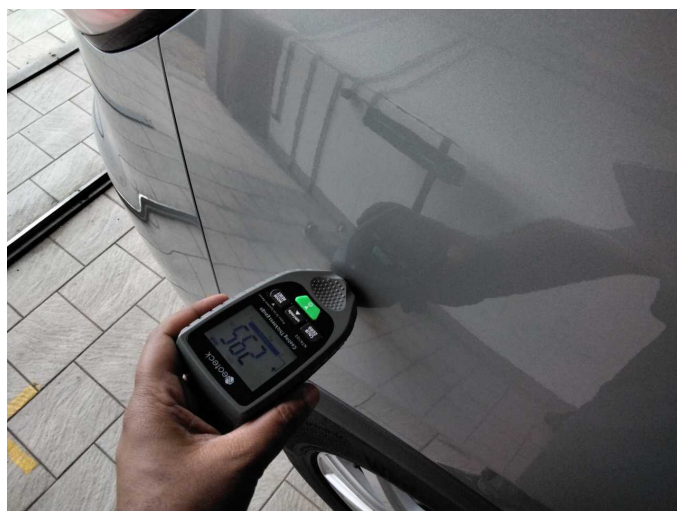
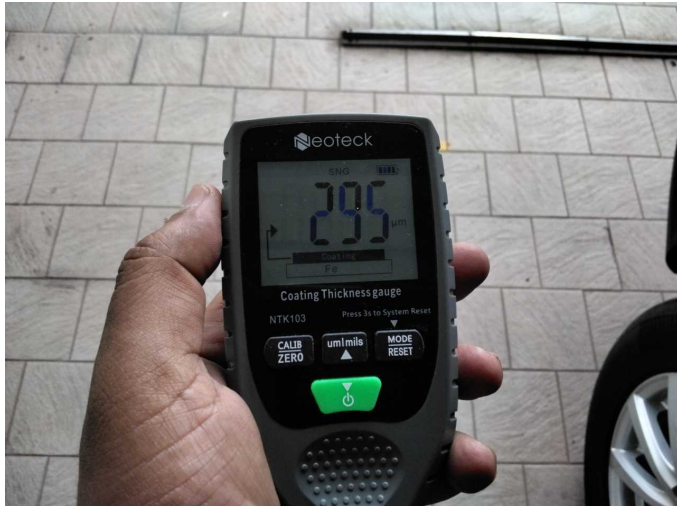
| 1 | Side panel - rear right side, Door - front left side |

| Side panel - rear right side | 295 µm | Door - front left side | 275 µm |

**Side panel - rear right side:** 295 µm

Side panel - rear right side: 295 µm

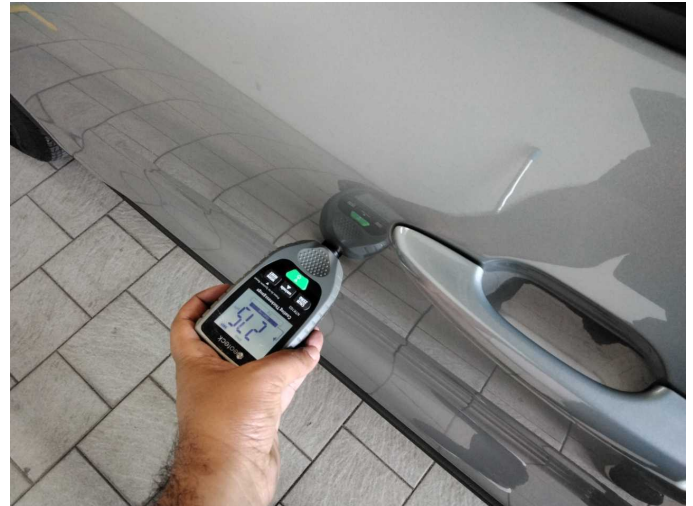
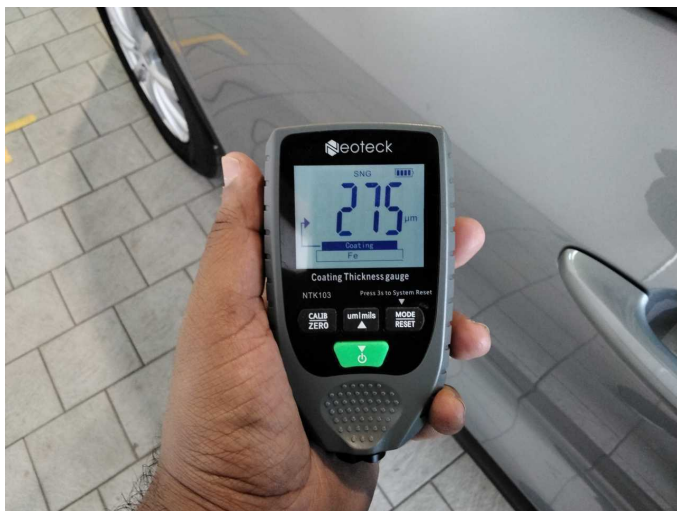
Door - front left side: 275 µm
