Expertise

Protocol number: 46055543  
Order No. / Reference: 26438889  
Inspection date: 19 Jun 2026

Manufacturer: Ford

Model: Kuga 2.5 Duratec FHEV TITANIUM

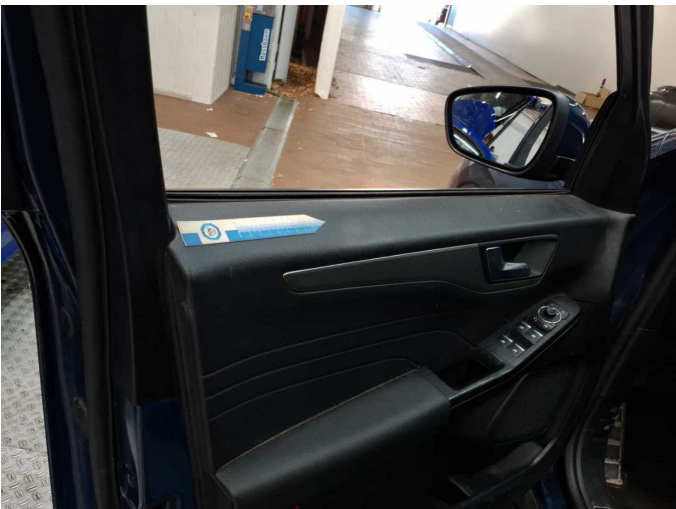
| No. | Component group | Description |
|---|---|---|
| 3 | Trim / covers | Door trim - front left side - dent(s) - Loss in value |

Damage 3: Trim / covers: Door trim - front left side - dent(s) - Loss in value

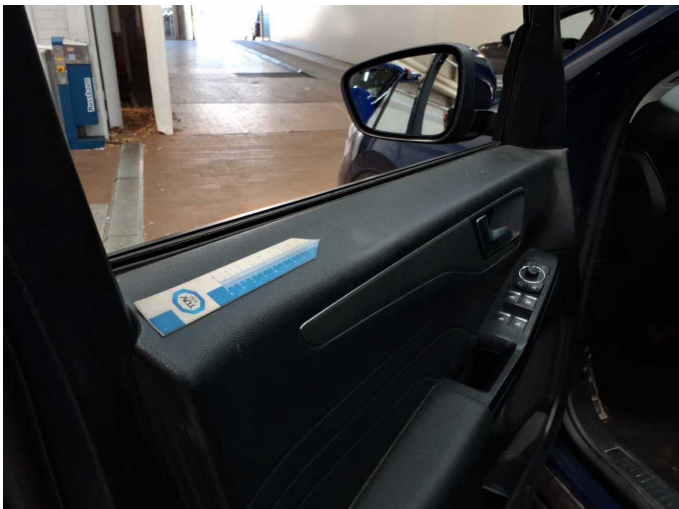
Damage 3: Trim / covers: Door trim - front left side - dent(s) - Loss in value

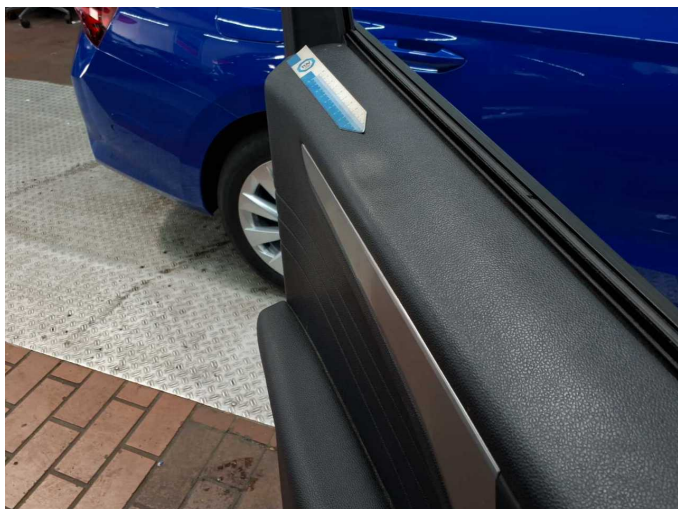
**Damage 3:** Trim / covers: Door trim - front left side - dent(s) - Loss in value

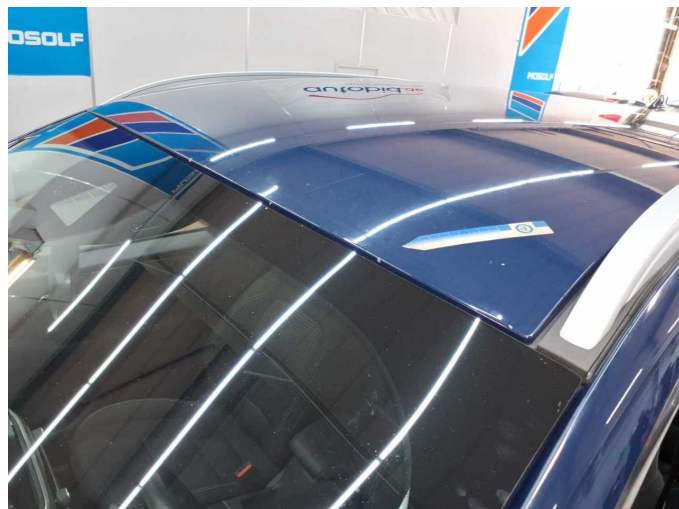
| No. | Component group | Description |
|---|---|---|
| 4 | Roof | Roof - Stone chips - Smart repair |

**Damage 4:** Roof: Roof - Stone chips - Smart repair

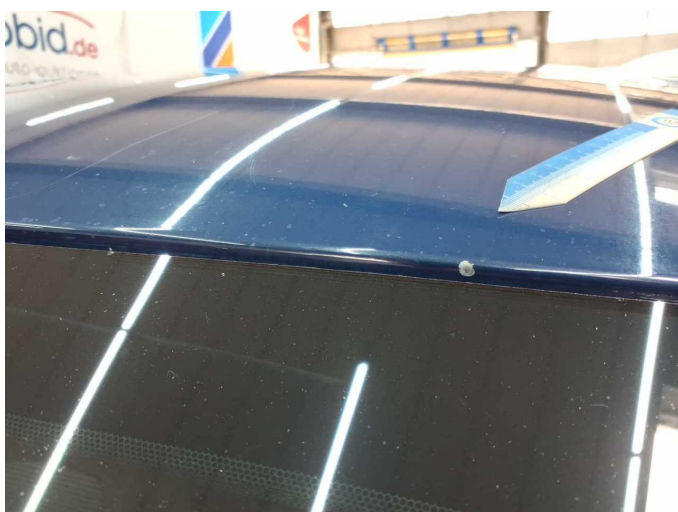
**Damage 4:** Roof: Roof - Stone chips - Smart repair

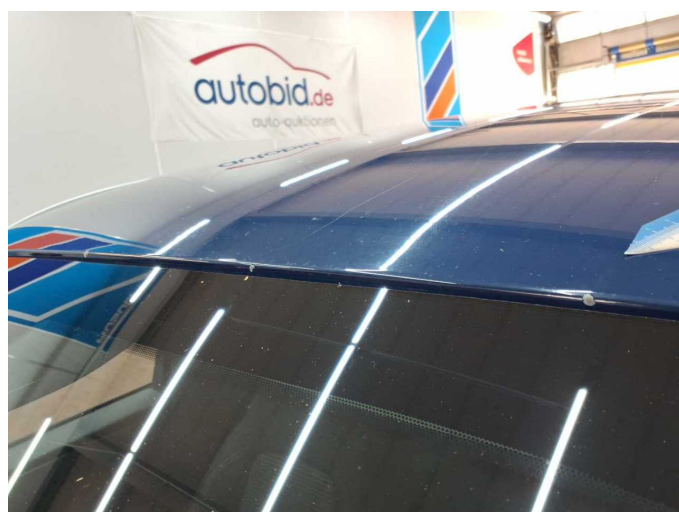
**Damage 4:** Roof: Roof - Stone chips - Smart repair

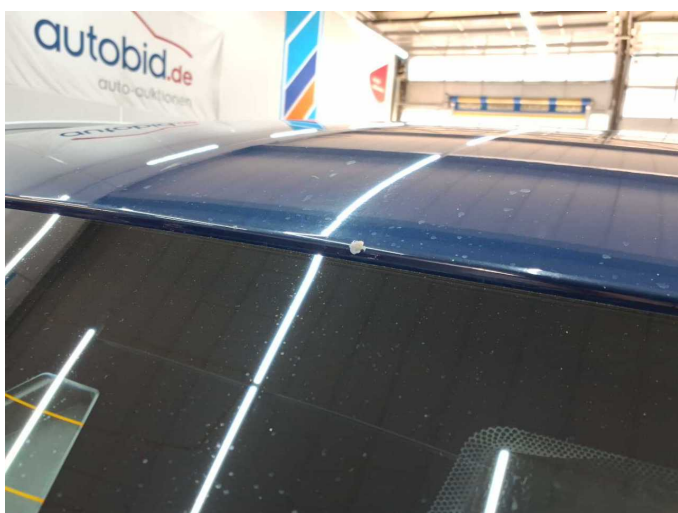
**Damage 4:** Roof: Roof - Stone chips - Smart repair

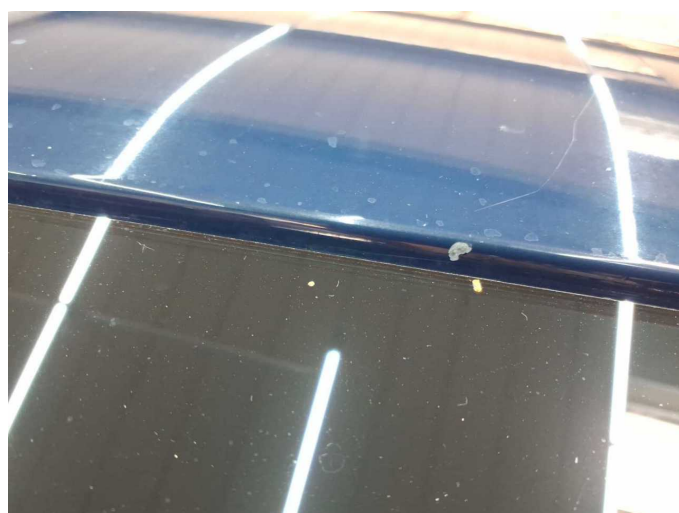
**Damage 4:** Roof: Roof - Stone chips - Smart repair

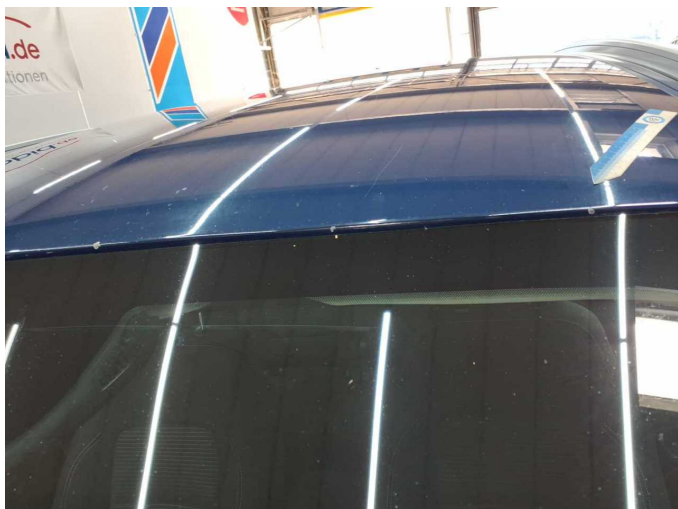
**Damage 4:** Roof: Roof - Stone chips - Smart repair

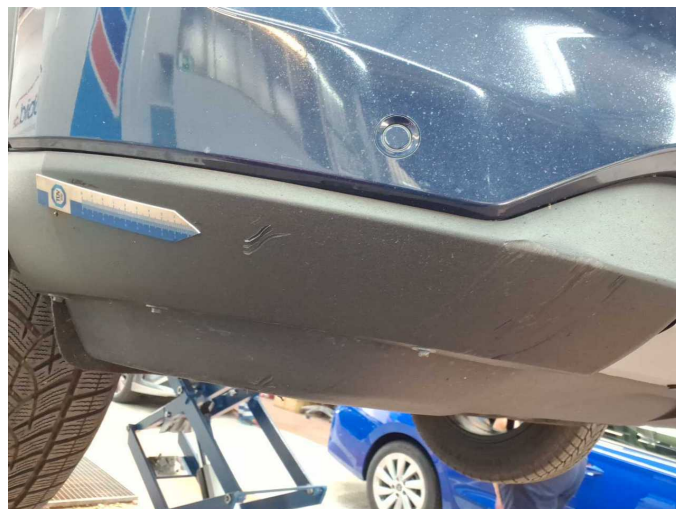
| No. | Component group | Description |
|---|---|---|
| 5 | Front bumper | Spoiler - Scratch(es) - Replace |

**Damage 5:** Front bumper: Spoiler - Scratch(es) - Replace

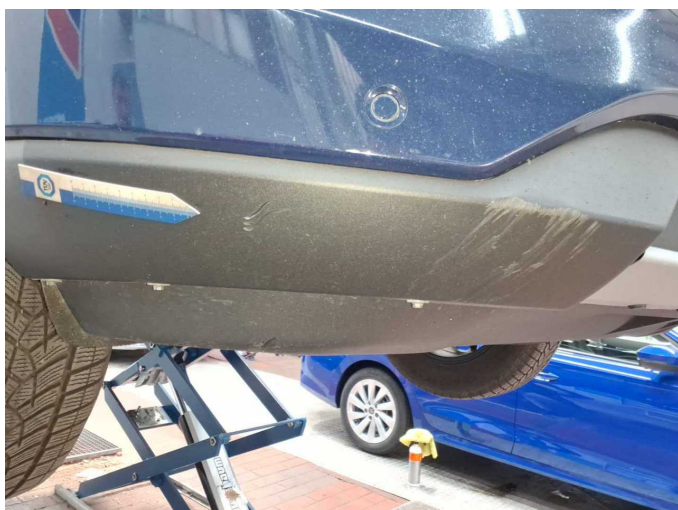
**Damage 5:** Front bumper: Spoiler - Scratch(es) - Replace

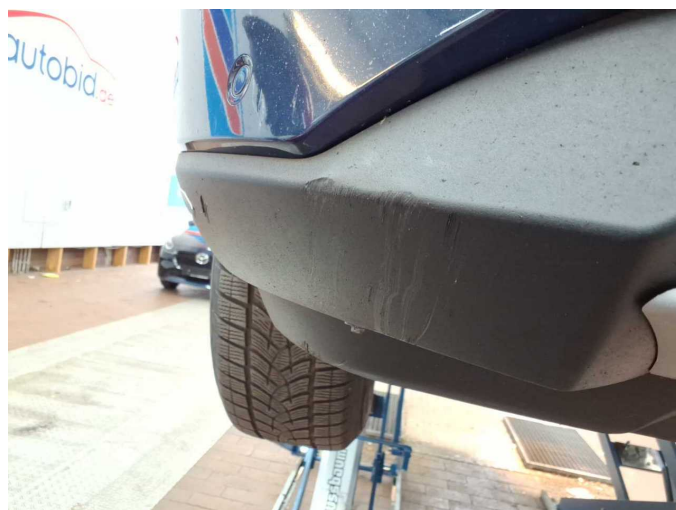
**Damage 5:** Front bumper: Spoiler - Scratch(es) - Replace

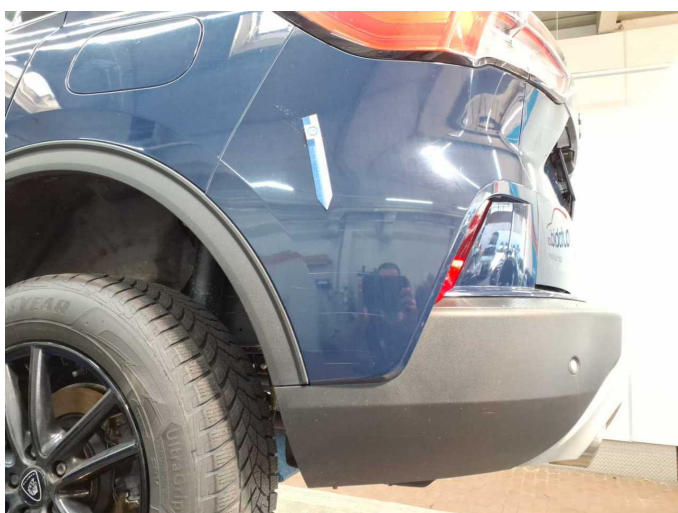
| No. | Component group | Description |
|---|---|---|
| 6 | Rear bumper | Rear bumper - Scratch(es) - Paint |

**Damage 6:** Rear bumper: Rear bumper - Scratch(es) - Paint

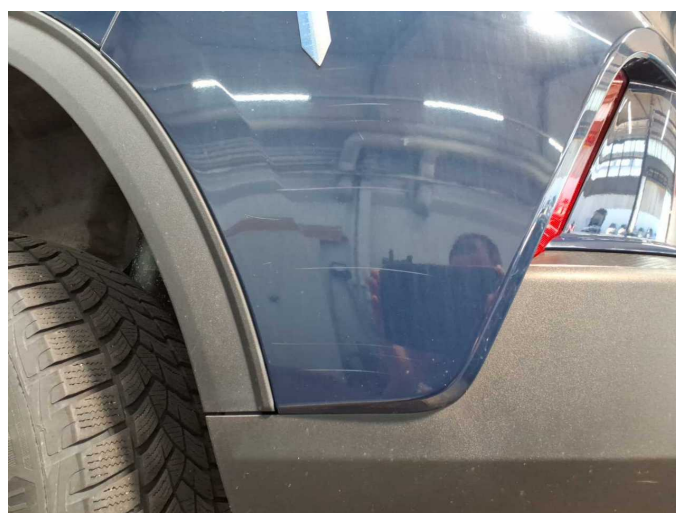
**Damage 6:** Rear bumper: Rear bumper - Scratch(es) - Paint

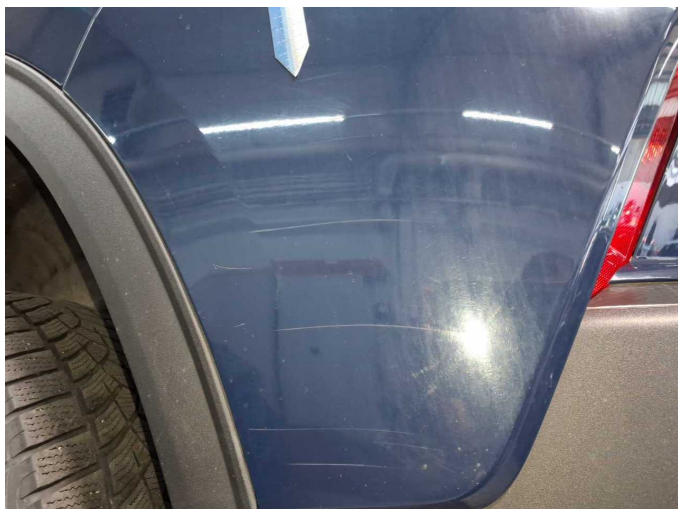
**Damage 6:** Rear bumper: Rear bumper - Scratch(es) - Paint

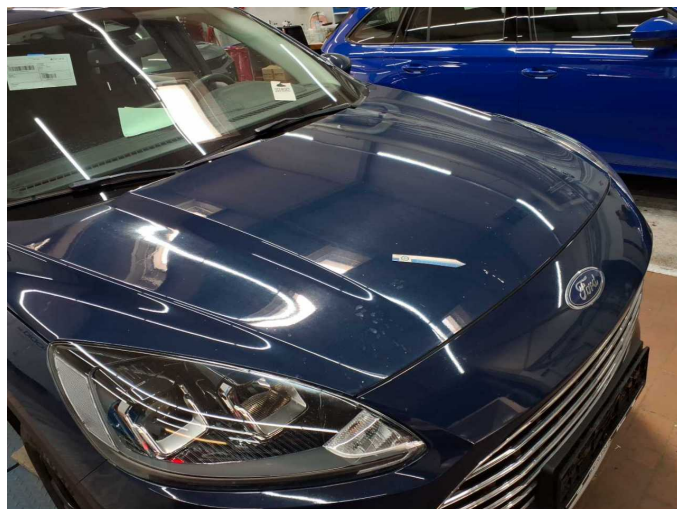
| No. | Component group | Description |
|---|---|---|
| 7 | Bonnet | Bonnet (+Steinschläge) - Dent / paintcoat damage - Repair and paint |

**Damage 7:** Bonnet: Bonnet (+Steinschläge) - Dent / paintcoat damage - Repair and paint

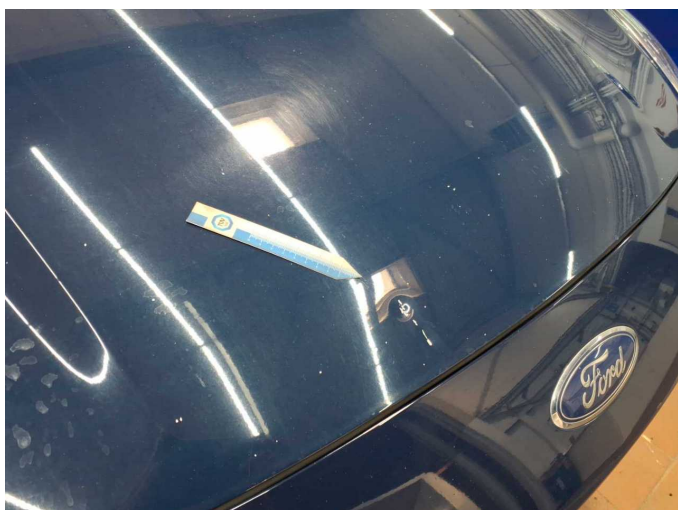
**Damage 7:** Bonnet: Bonnet (+Steinschläge) - Dent / paintcoat damage - Repair and paint

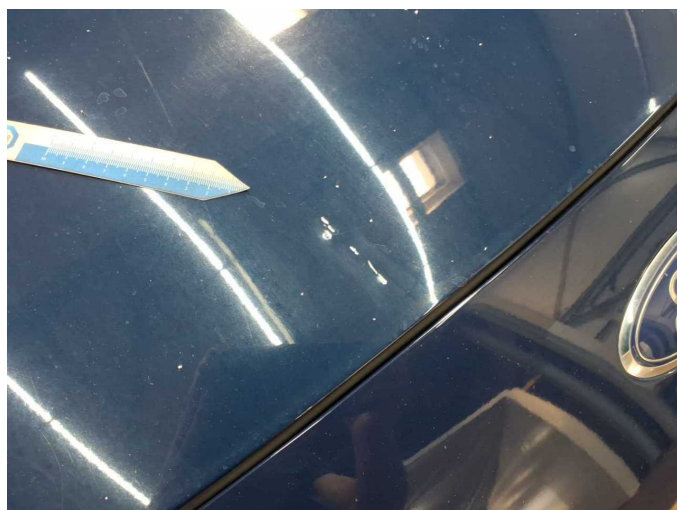
**Damage 7:** Bonnet: Bonnet (+Steinschläge) - Dent / paintcoat damage - Repair and paint

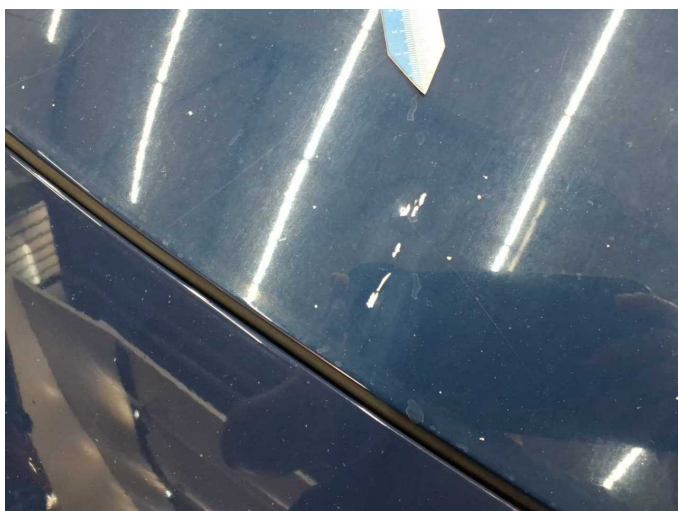
**Damage 7:** Bonnet: Bonnet (+Steinschläge) - Dent / paintcoat damage - Repair and paint

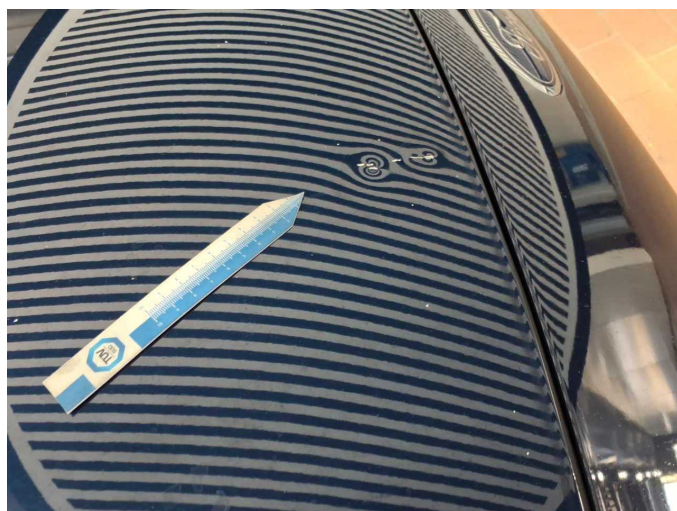
**Damage 7:** Bonnet: Bonnet (+Steinschläge) - Dent / paintcoat damage - Repair and paint
