Expertise

Protocol number: 46348088
Order No. / Reference: 26593956
Inspection date: 2 Jul 2026

Model: Transit Custom 300 L1H1 LKW VA Trend

VIN: WF0YXXTTGYNA84211

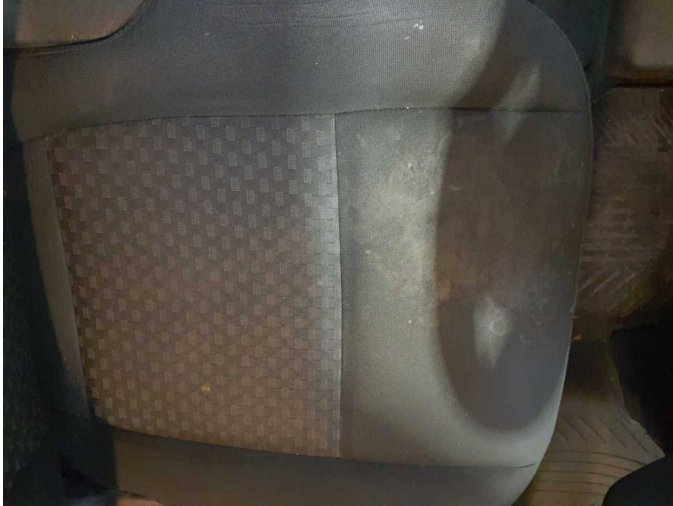
Damage 1: Seat - front: Seat upholstery - left side - Soiled - Clean

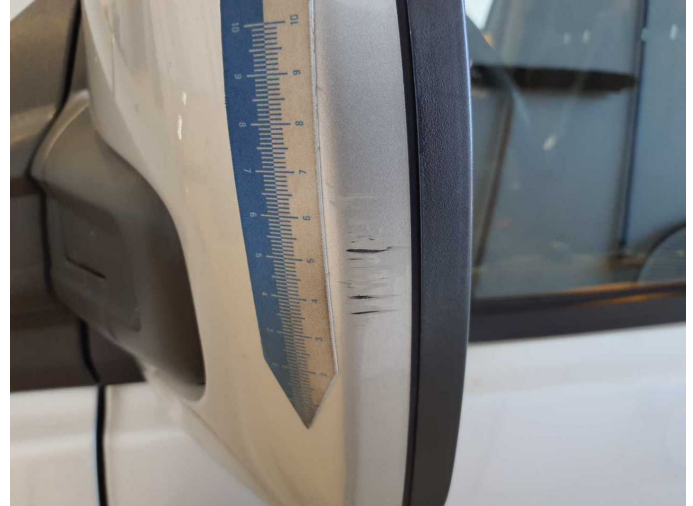
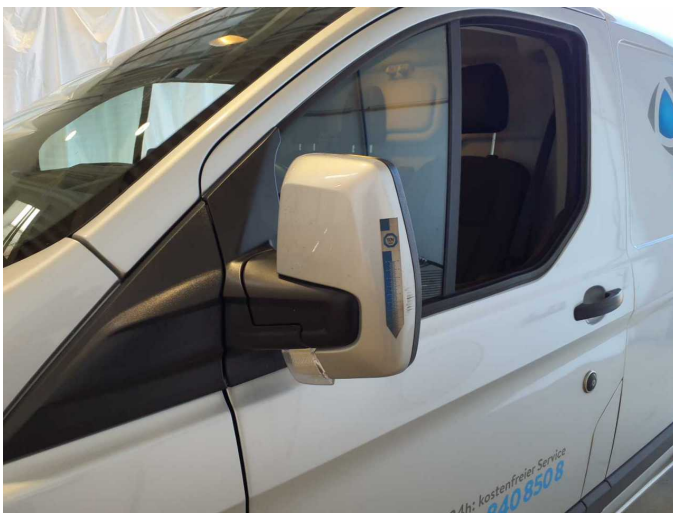
Damage 2: Wing mirror - left side: Cap - Scratch(es) - Paint

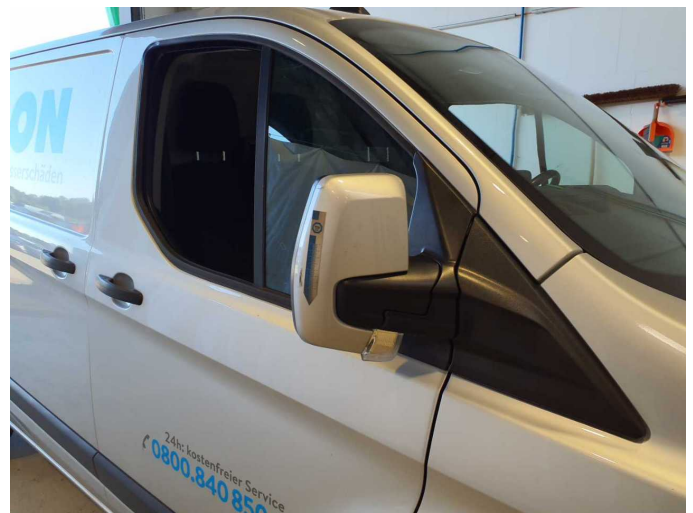
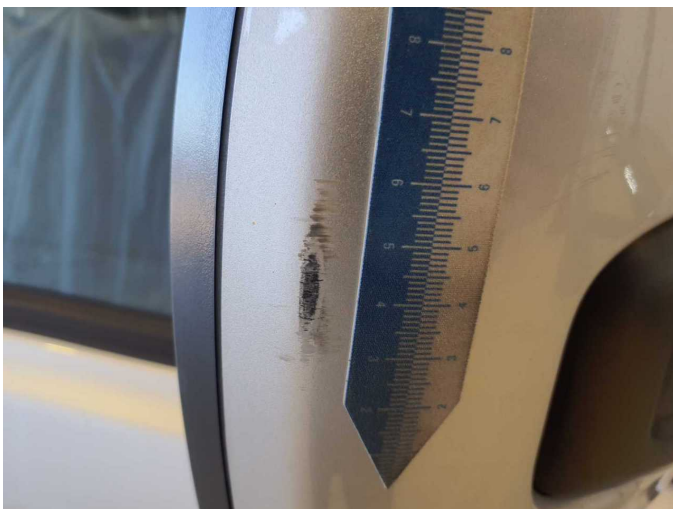
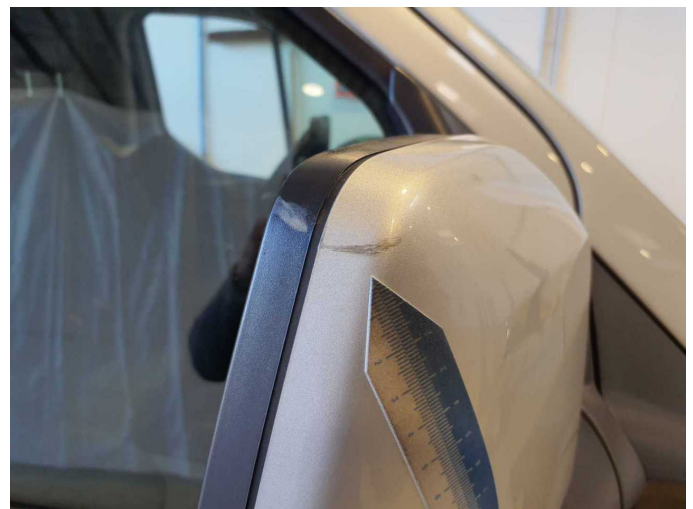
Damage 3: Wing mirror - right side: Cap (Zusätzlich Gehäuse Kratzer) - Scratch(es) - Paint

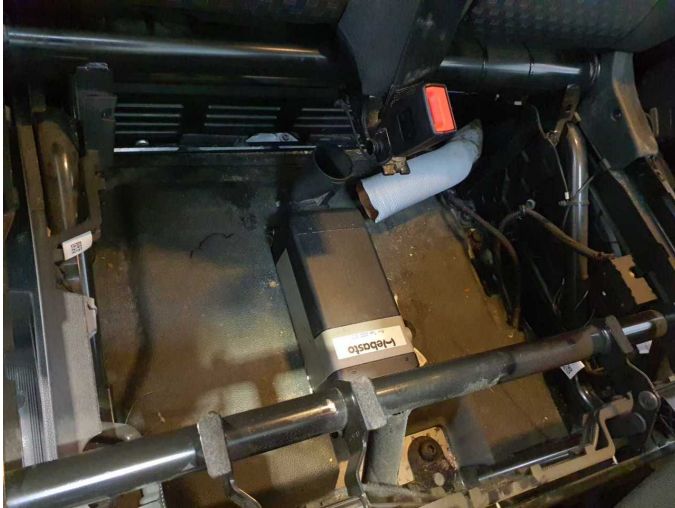
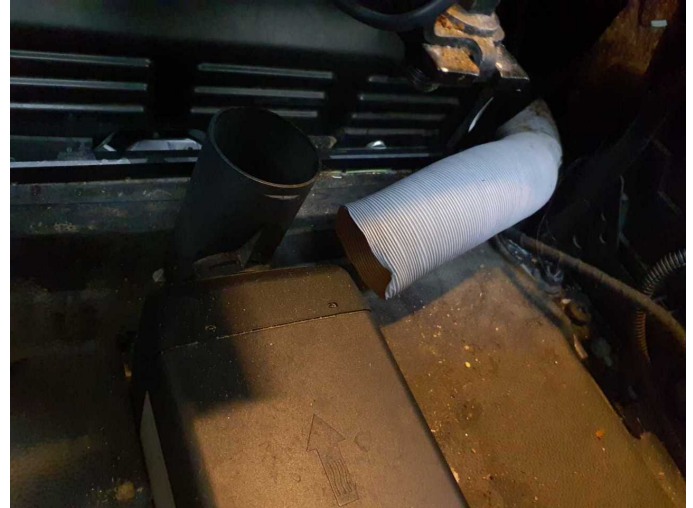
Damage 4: Heating system: Auxiliary heating (Schlauch abgezogen) - Functional / admissibility - Perform diagnosis

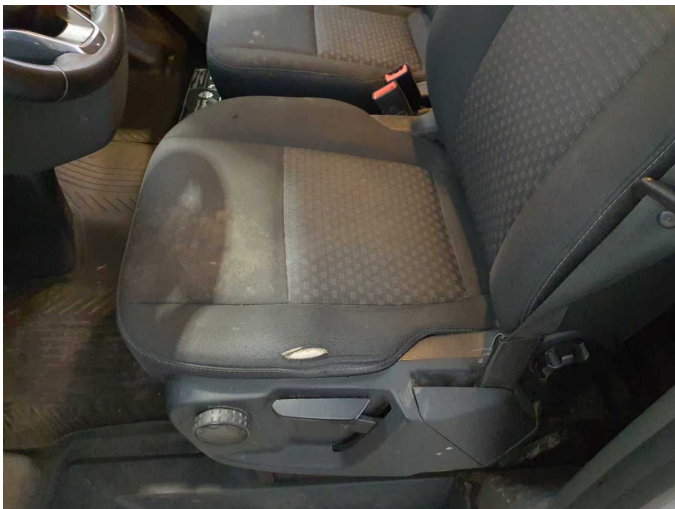
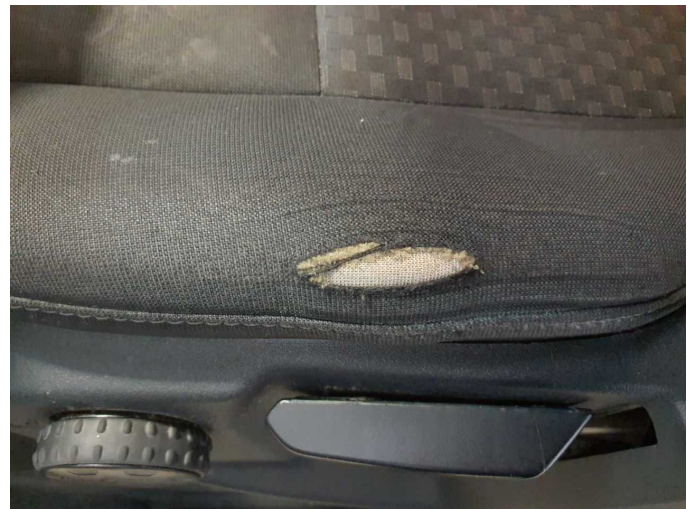
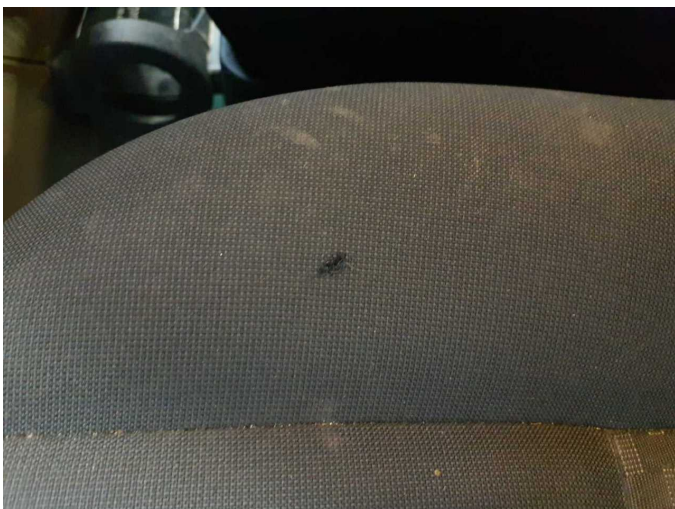
Damage 5: Seat - front: Seat upholstery - left side - Broken / torn - Smart repair

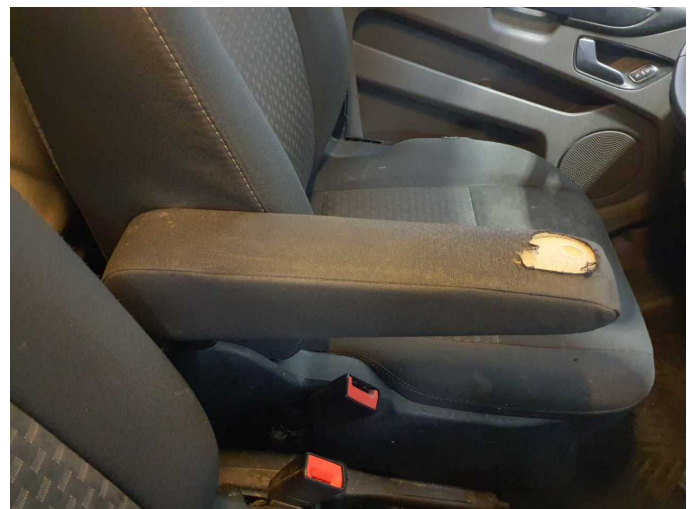
Damage 7: Seat - front: armrests - Worn - Replace

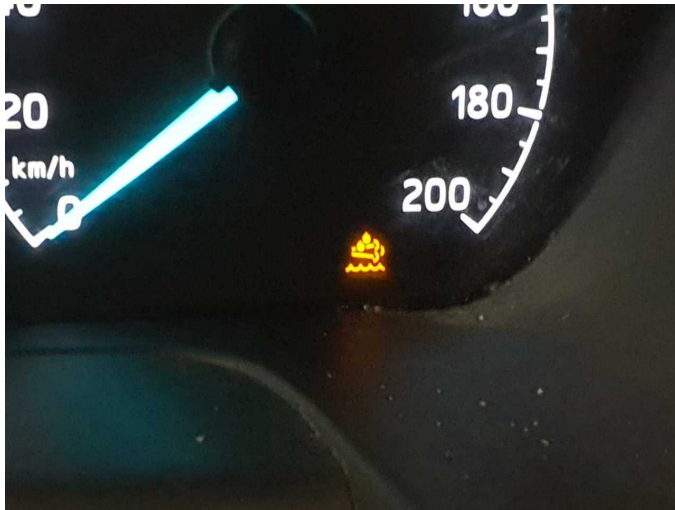
Damage 8: Instrument panel: Indicator light (Abgassystem) - on - Perform diagnosis

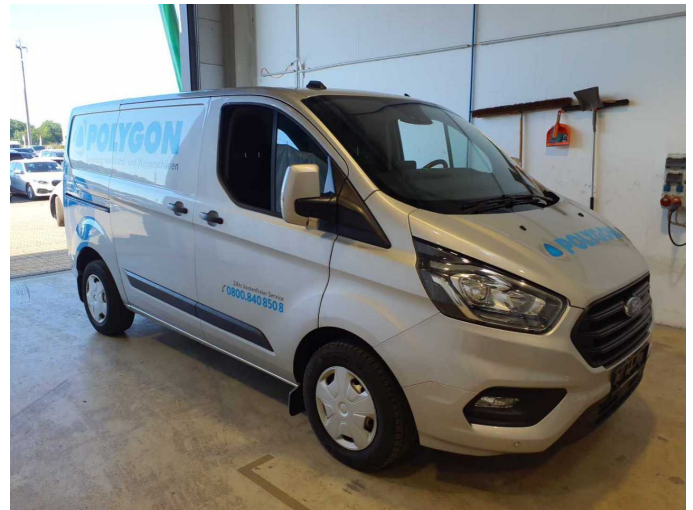
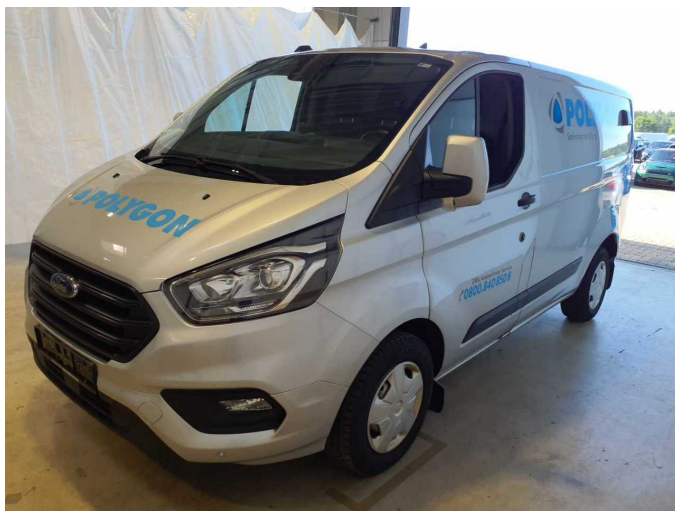
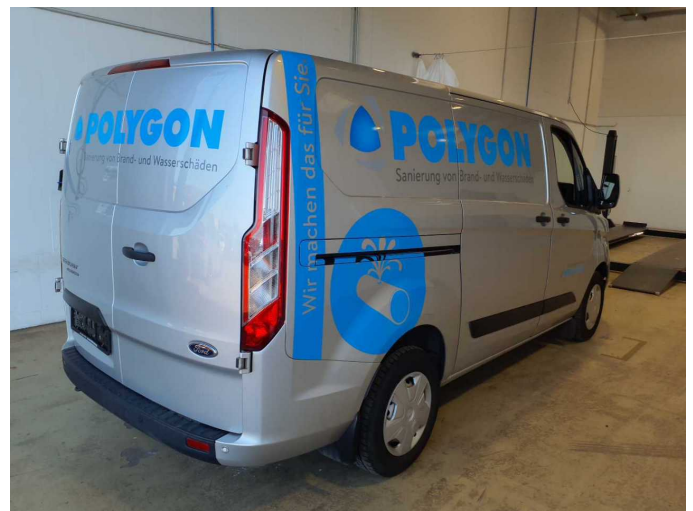
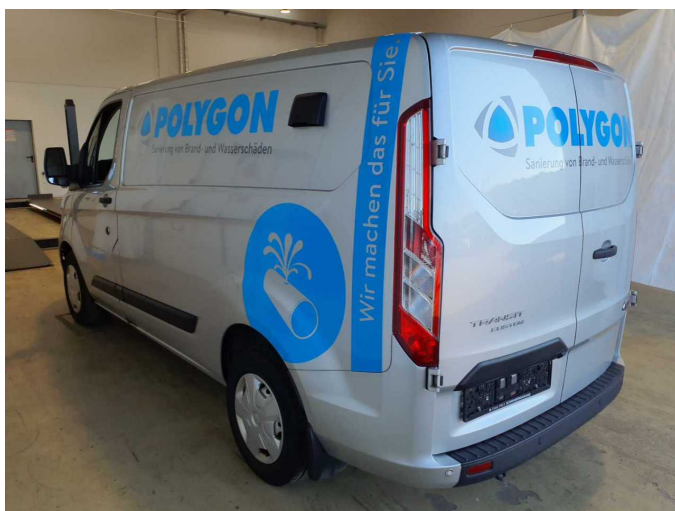
Damage 9: Misc.: Vehicle (schadenausweitung möglich 8 Bauteile) - Glued / labelled - De-glue / neutralise

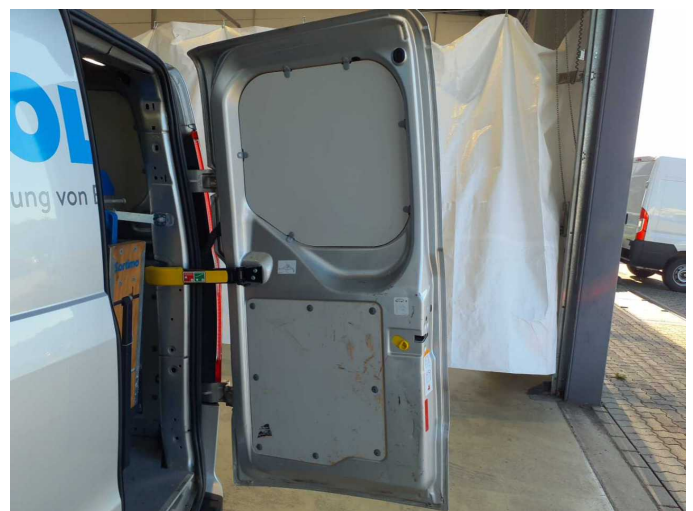
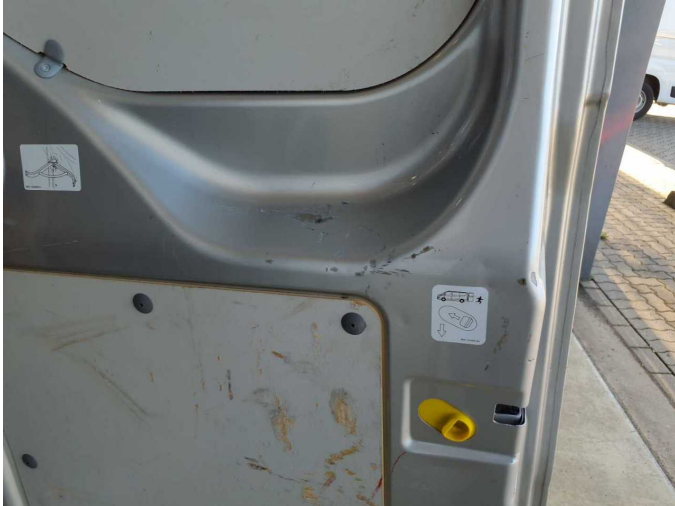
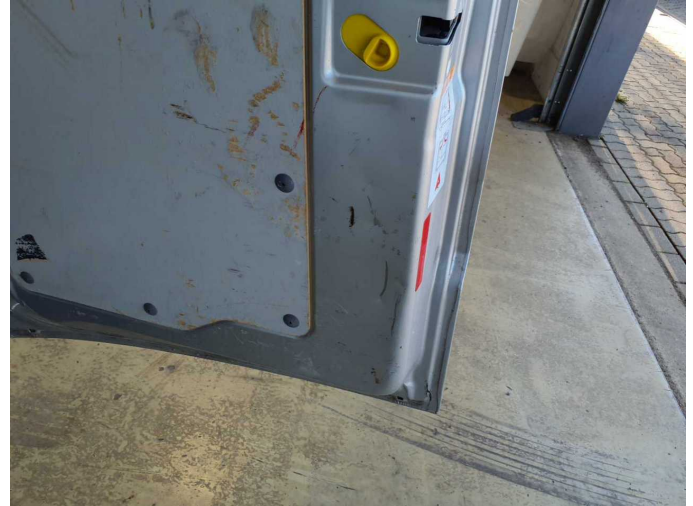
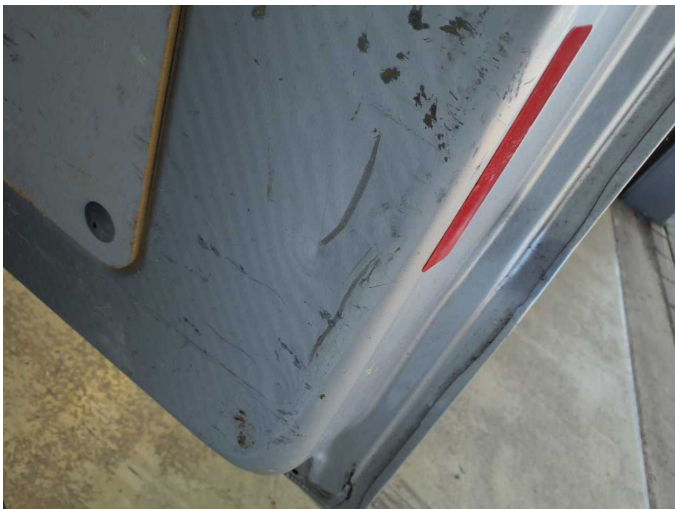
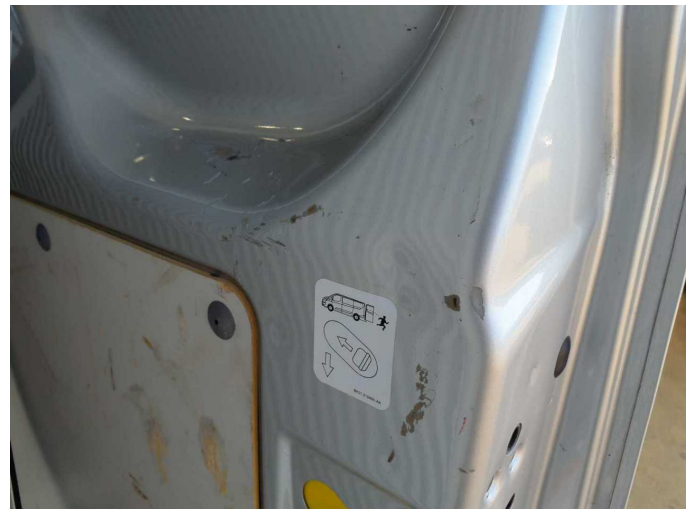
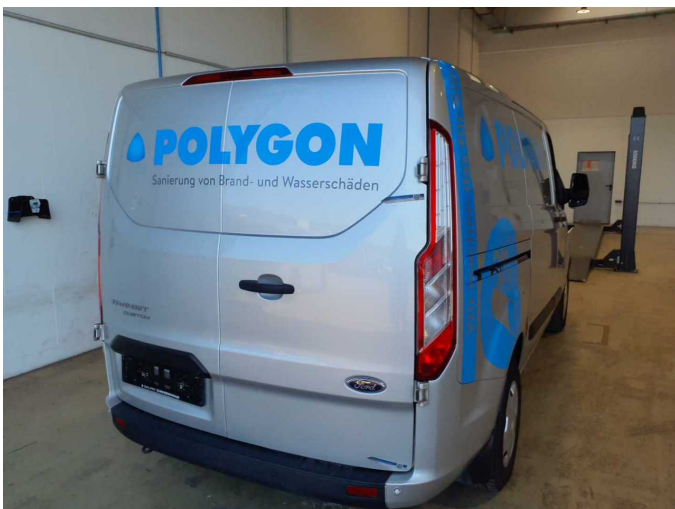
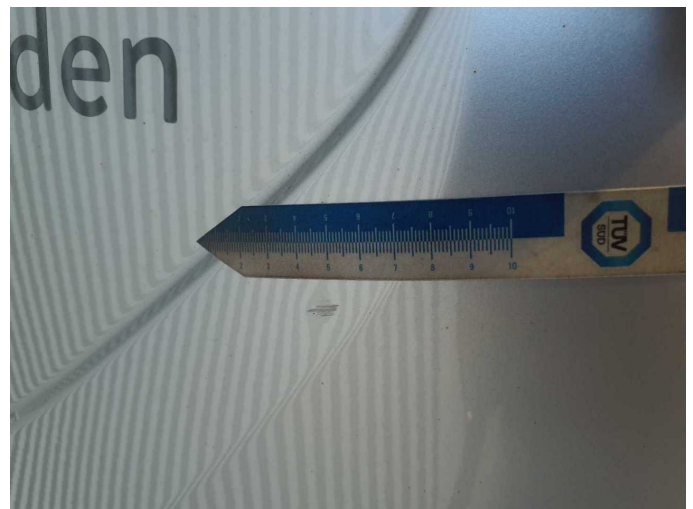
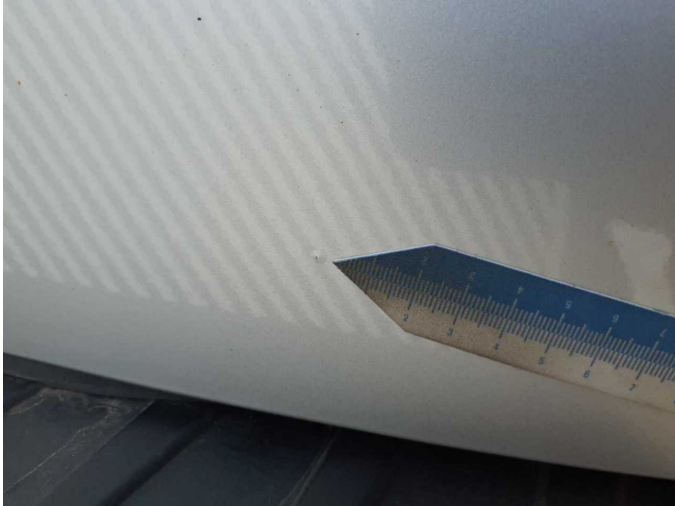
Damage 10: Boot lid / rear door: Rear door - right side (Schwergängig, zusätzlich Korrosion) - Dent / paintcoat damage - Repair and paint

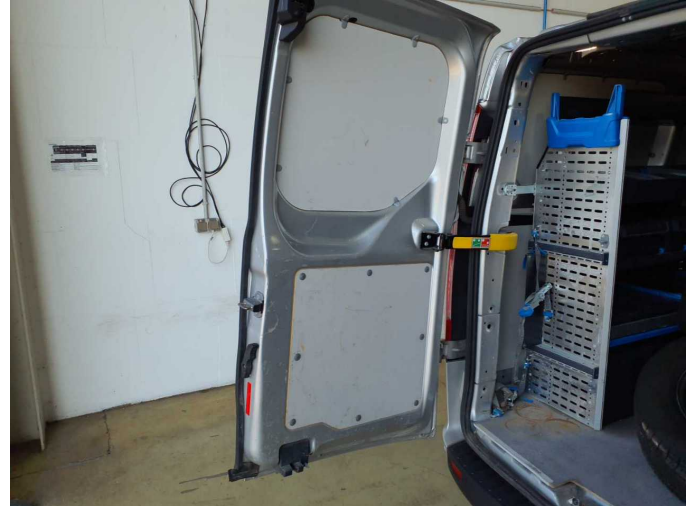
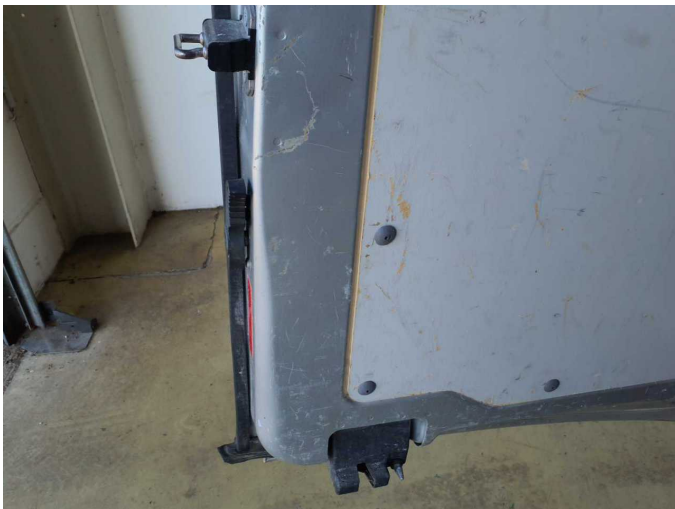
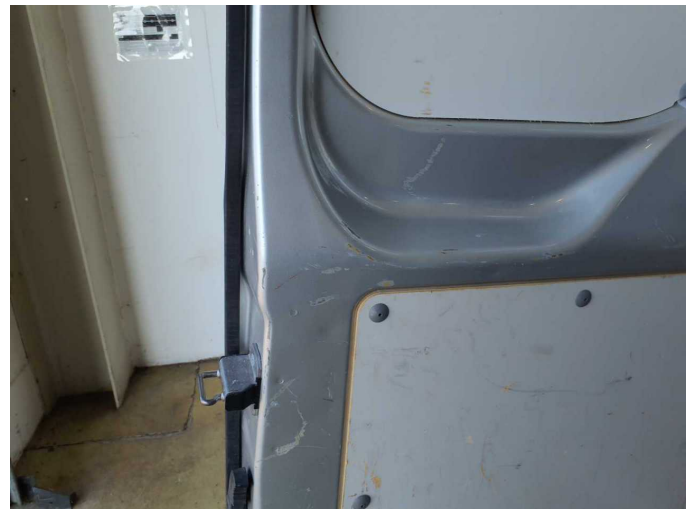
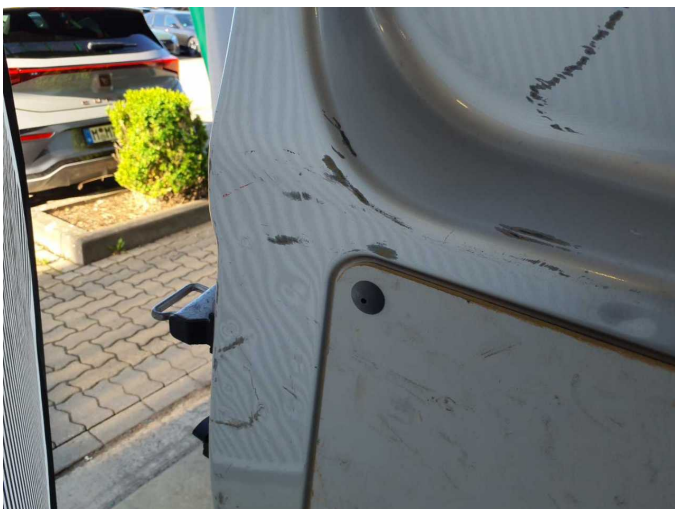
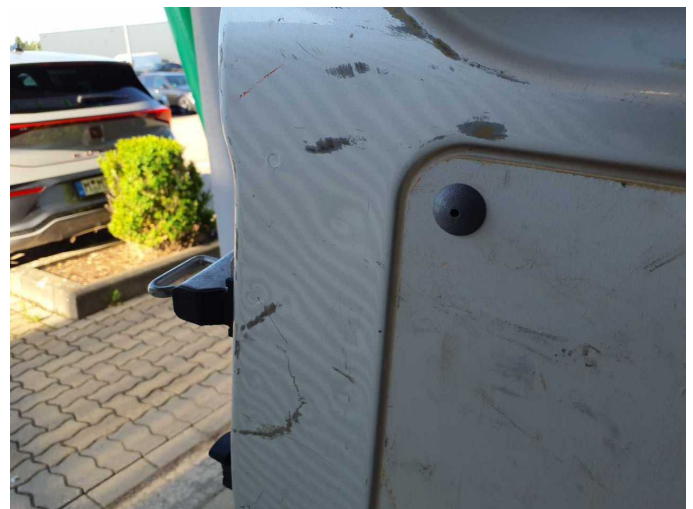
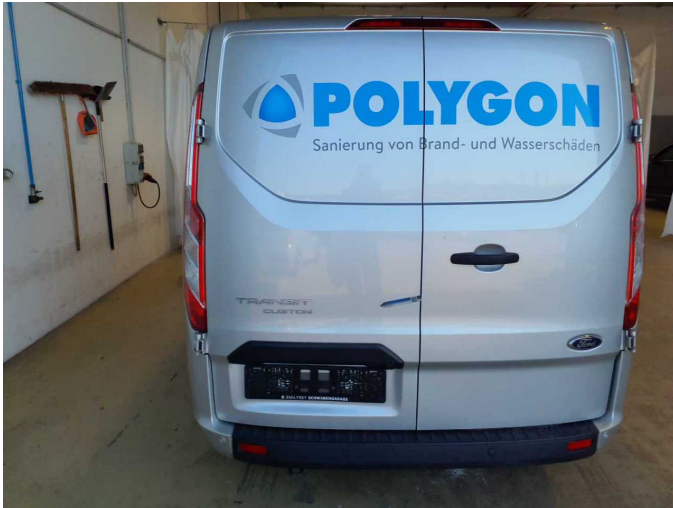
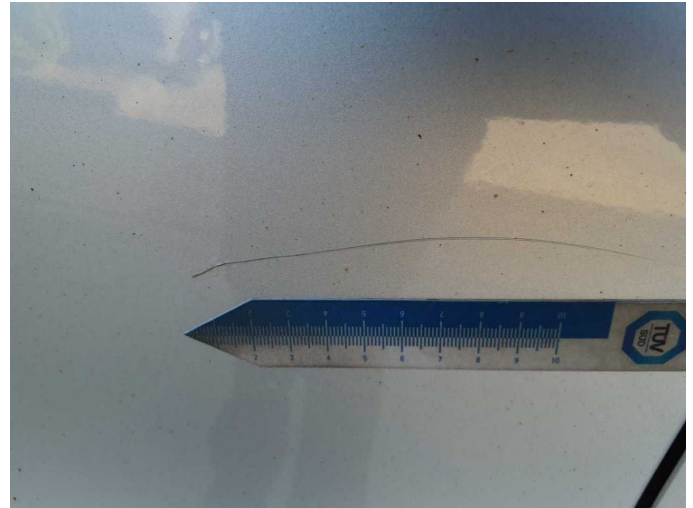
Damage 11: Boot lid / rear door: Rear door - left side - Dent / paintcoat damage - Repair and paint

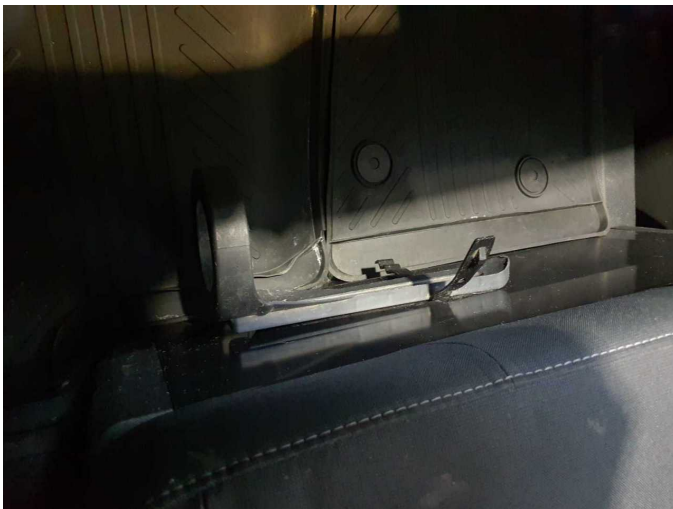
Missing part 1: Equipment: Fire extinguisher - Missing - Replace
