Expertise

Protocol number: 46324613  
Order No. / Reference: 26652653  
Inspection date: 2 Jul 2026

Manufacturer: Skoda  
VIN: TMBJJ7NX3NY065448

Model: Octavia Combi 2.0 TDI DSG Ambition

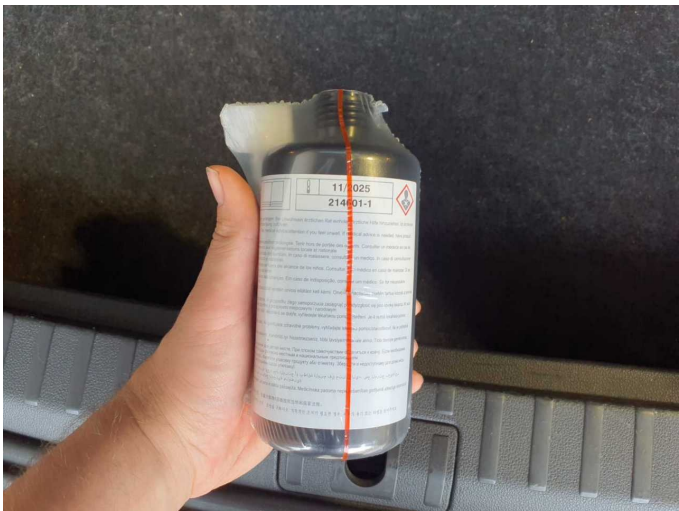
| No. | Component group | Description |
|---|---|---|
| 3 | Equipment | Tirefit filler - Expired - Replace |

Damage 3: Equipment: Tirefit filler - Expired - Replace

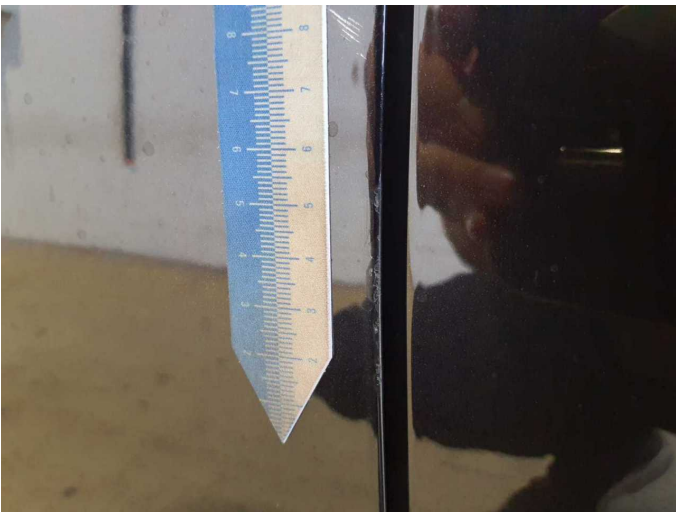
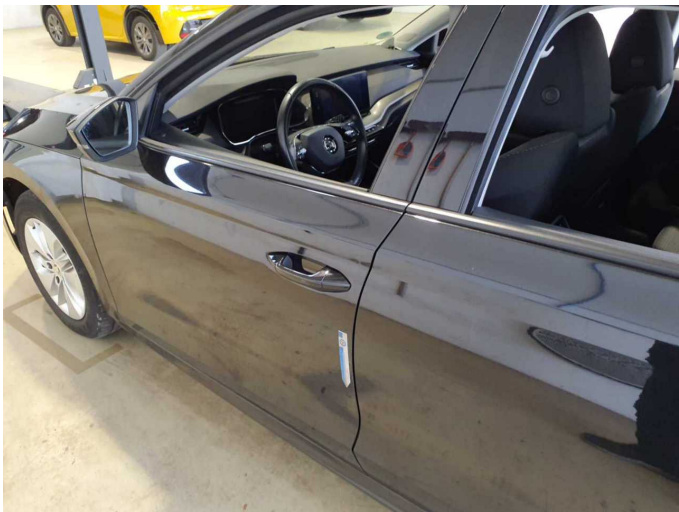
| No. | Component group | Description |
|---|---|---|
| 4 | Door - front left side | Door edge - Scratch(es) - Smart repair |

Damage 4: Door - front left side: Door edge - Scratch(es) - Smart repair

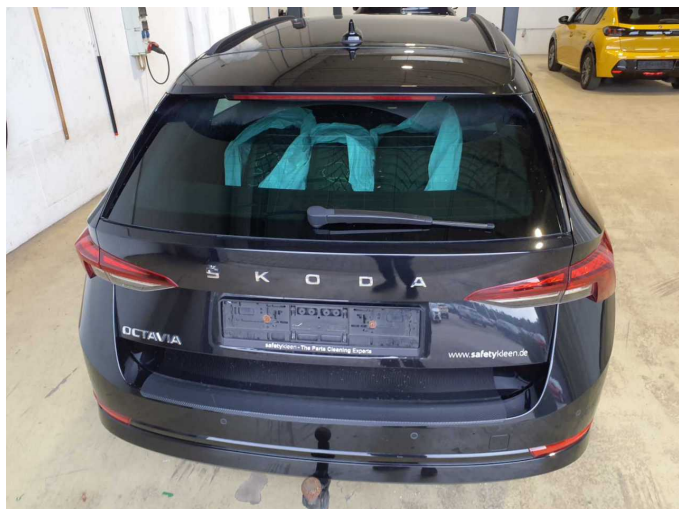
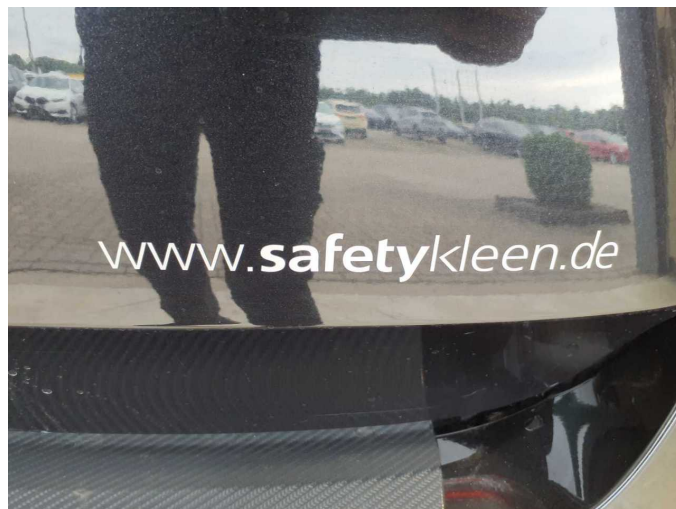
| No. | Component group | Description |
|---|---|---|
| 5 | Boot lid / rear door | Boot lid - Glued / labelled - De-glue / neutralise |

**Damage 5:** Boot lid / rear door: Boot lid - Glued / labelled - De-glue / neutralise

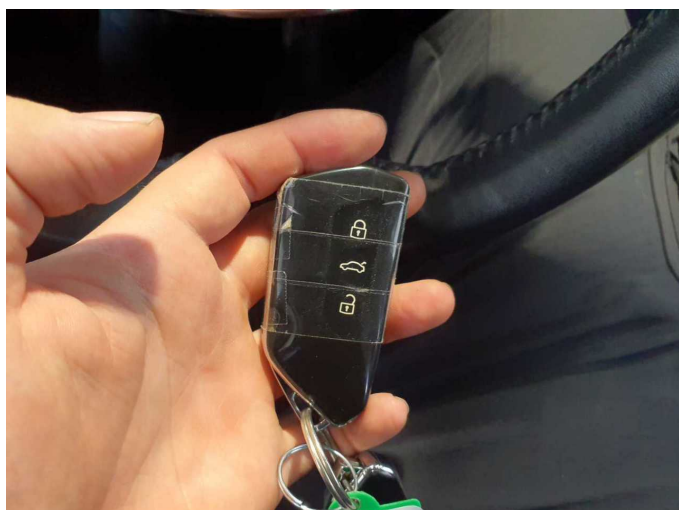
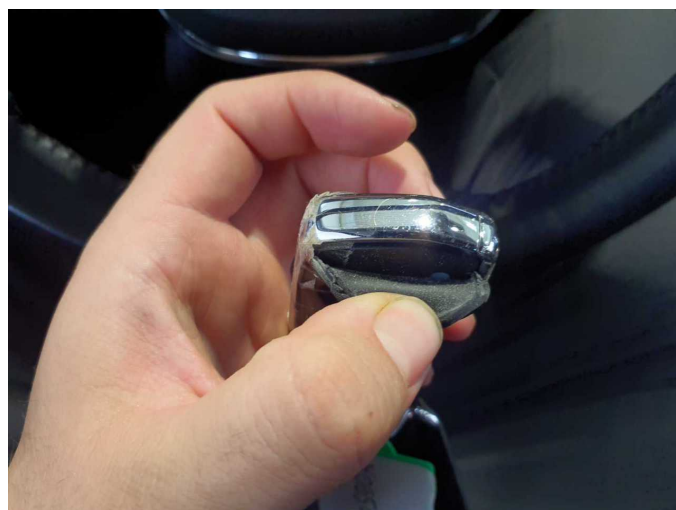
| No. | Component group | Description |
|---|---|---|
| 6 | Equipment | Vehicle key - Loose - Loss in value |

**Damage 6:** Equipment: Vehicle key - Loose - Loss in value

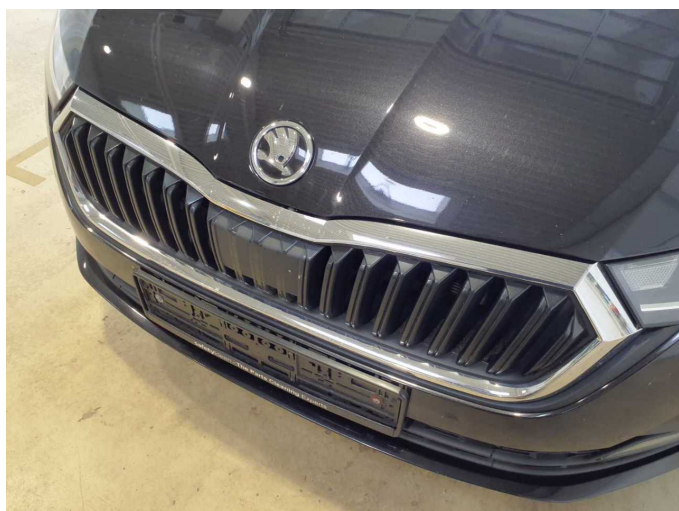
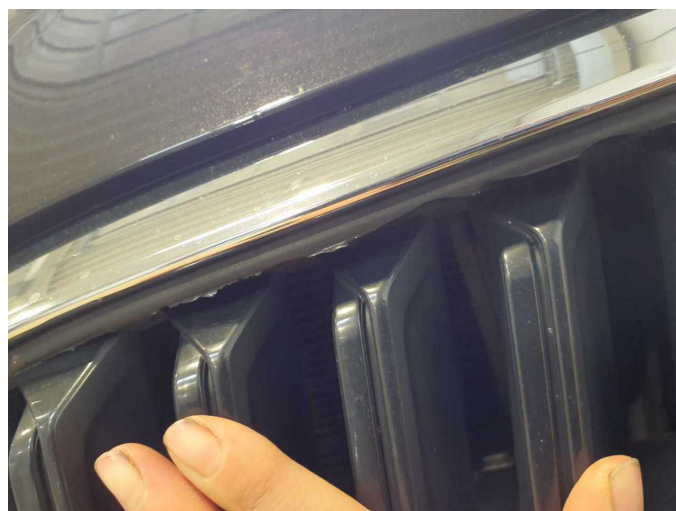
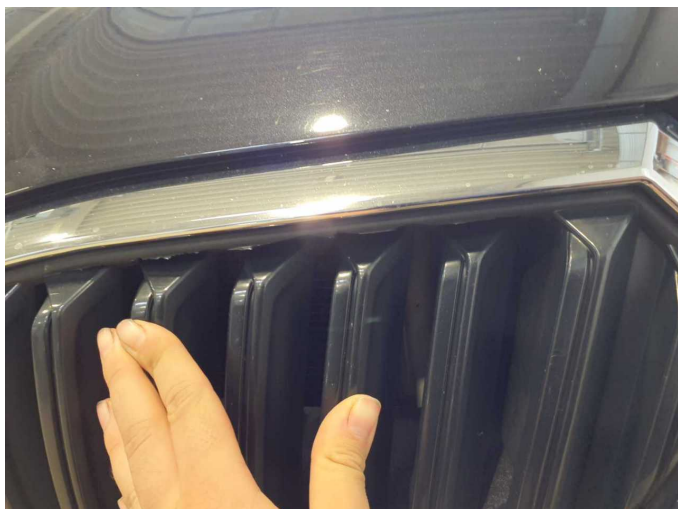
| No. | Component group | Description |
|---|---|---|
| 7 | Bonnet | Radiator grille - Broken / torn - Replace |

**Damage 7:** Bonnet: Radiator grille - Broken / torn - Replace

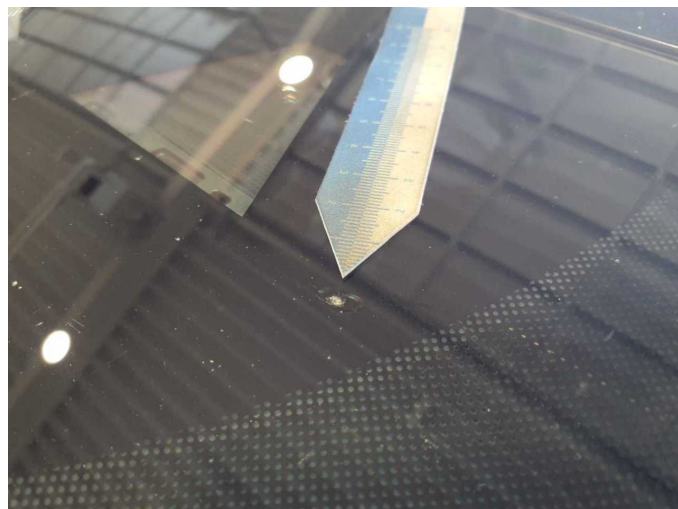
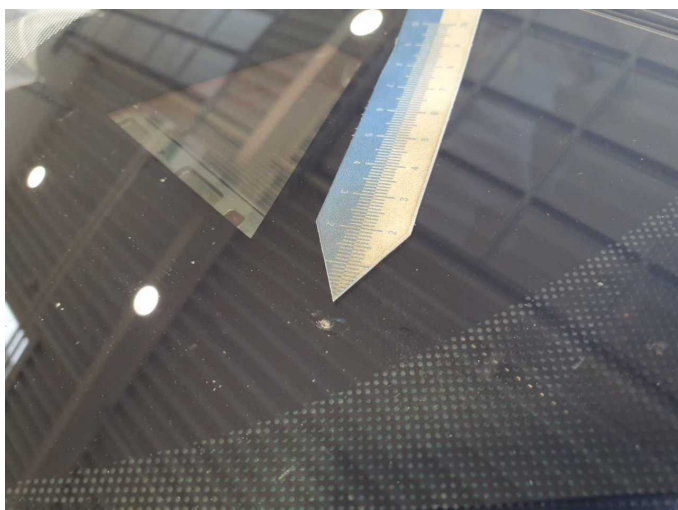
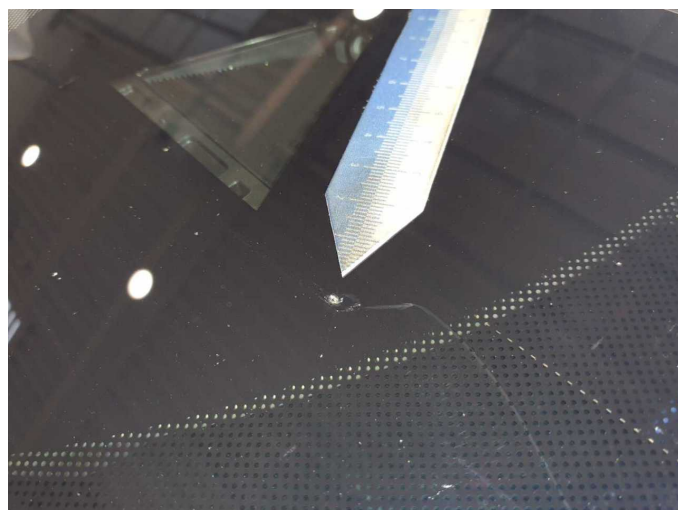
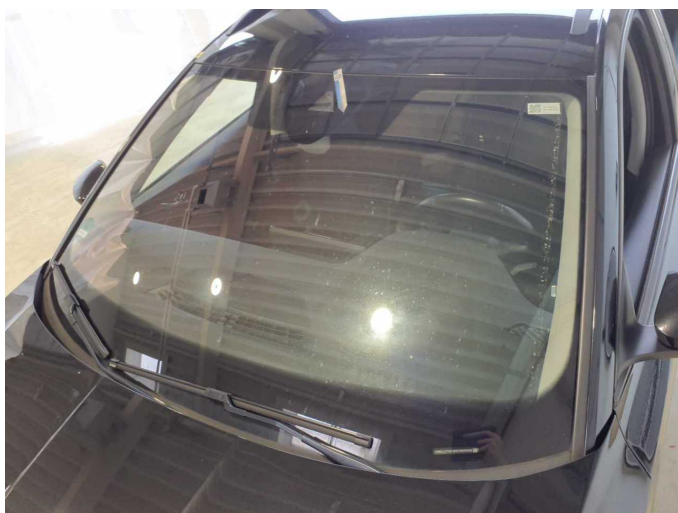
| No. | Component group | Description |
|---|---|---|
| 8 | Vehicle glazing | Windscreen - Stone chips - Replace |

**Damage 8:** Vehicle glazing: Windscreen - Stone chips - Replace

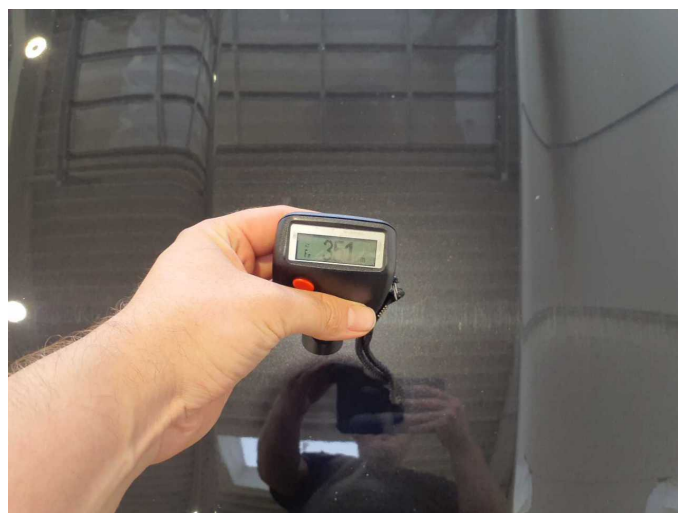
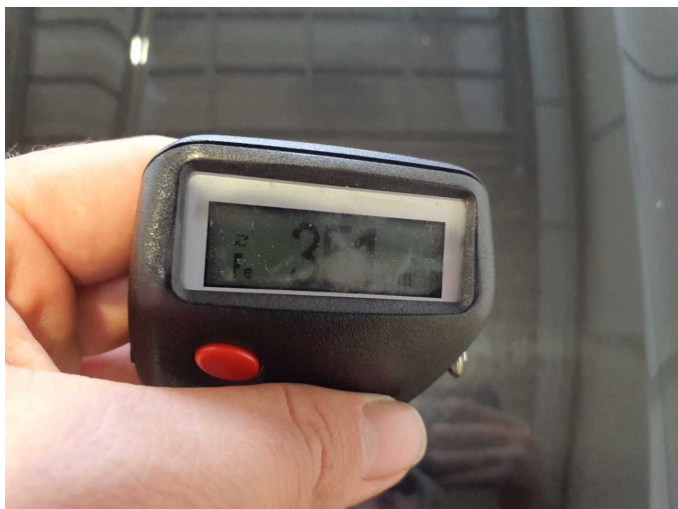
**Repainting 1:** Bonnet

1 Bonnet, Professionally carried out, Invoice of repair done Non-existent

Bonnet 351 µm |
