Expertise

Protocol number: 46368189
Order No. / Reference: 26185489
Inspection date: 2 Jul 2026

Model: Vito 116 CDI Extralang HA Aut. PRO

VIN: W1VVLCEZ1T4566289

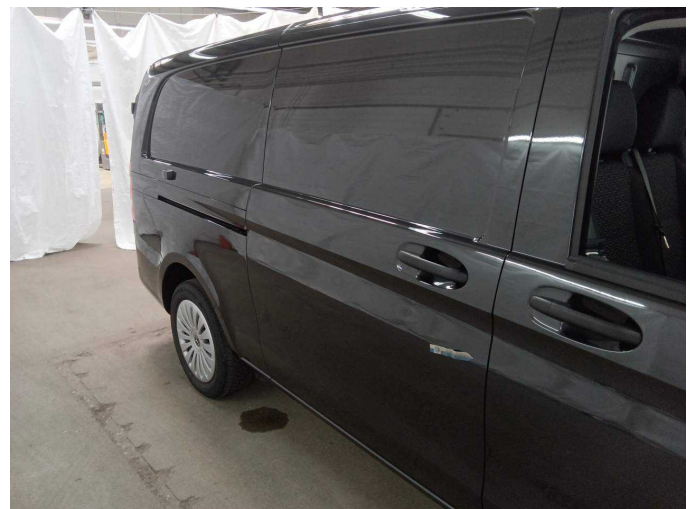
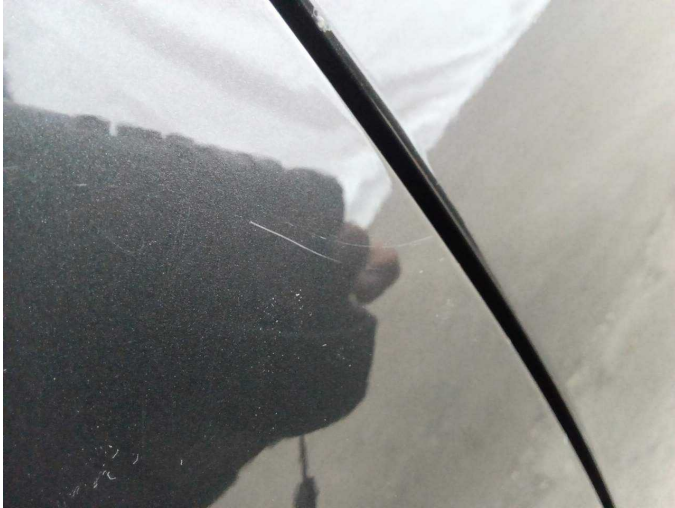
Damage 1: Sliding door, right: Sliding door - Scratch(es) - Smart repair

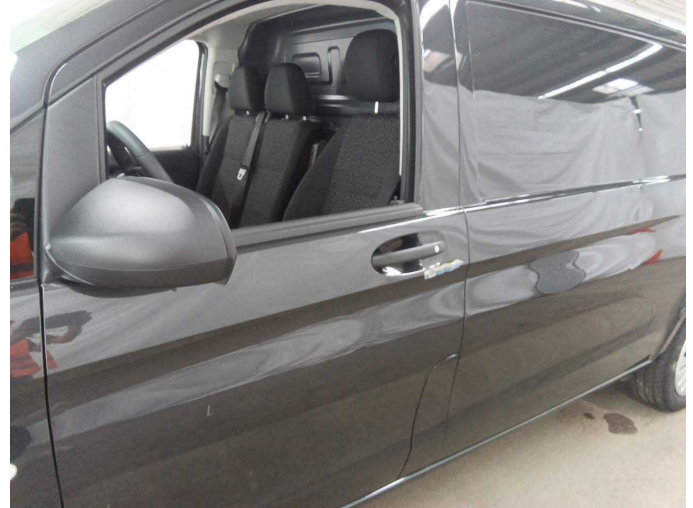
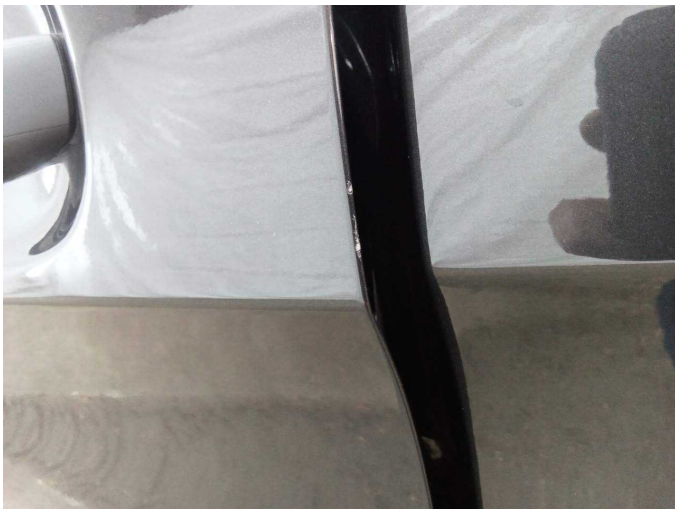
Damage 2: Door - front left side: Door edge - Scratch(es) - Smart repair

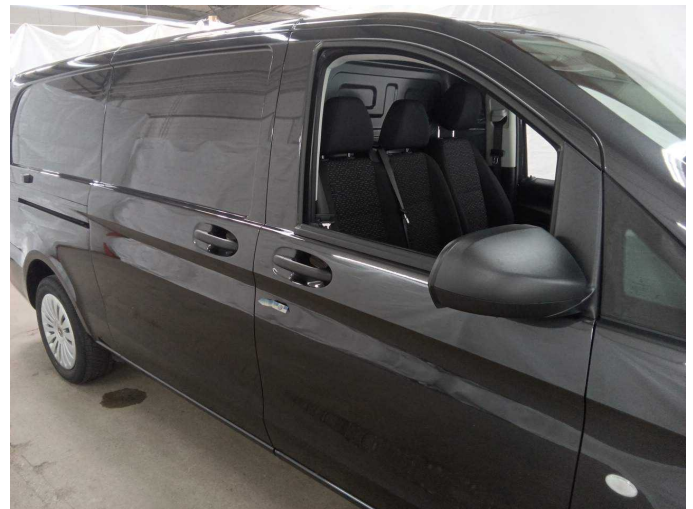
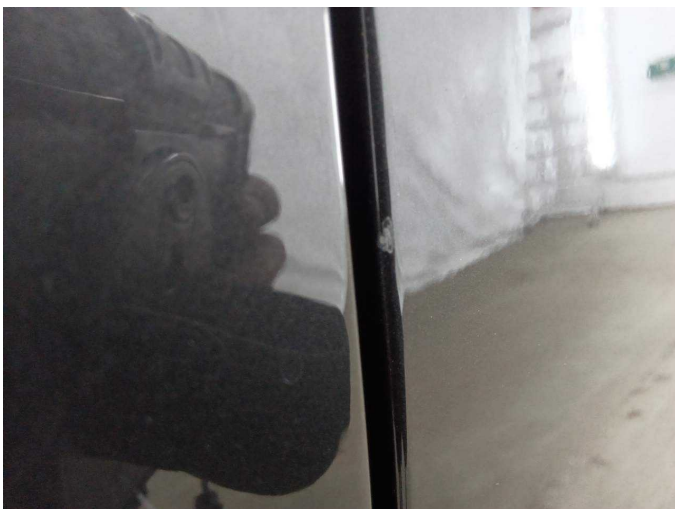
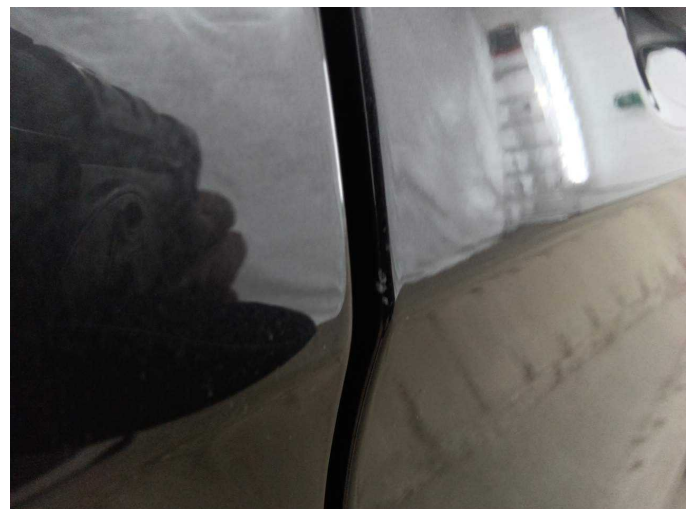
Damage 3: Door - front right side: Door edge - Scratch(es) - Smart repair

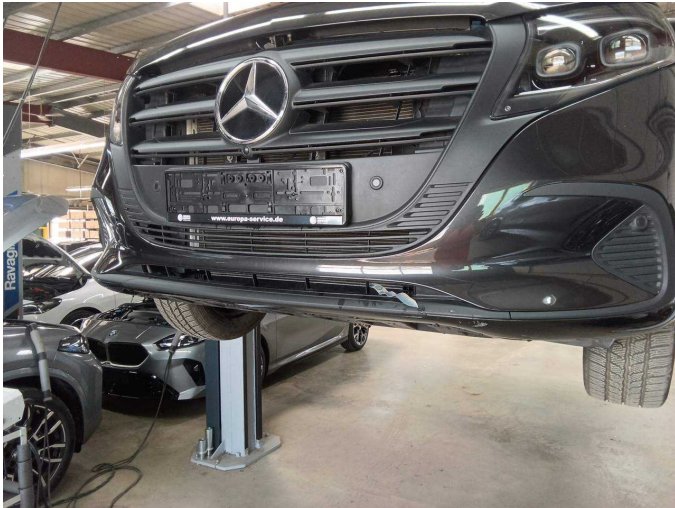
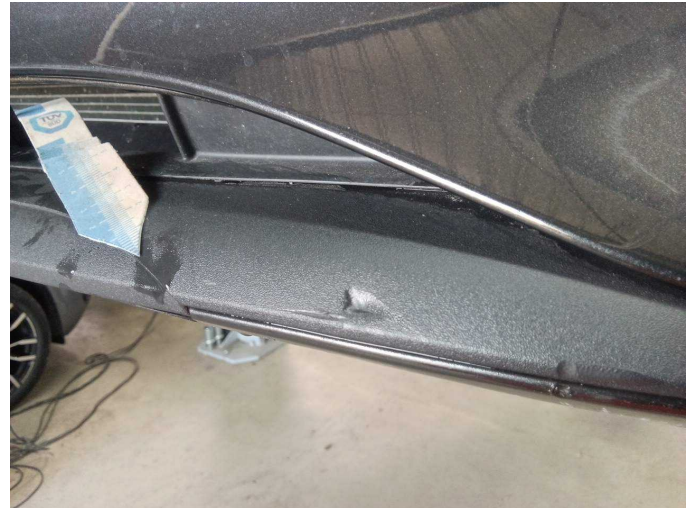
Damage 4: Front bumper: Protection strip - centre - Damaged - Replace

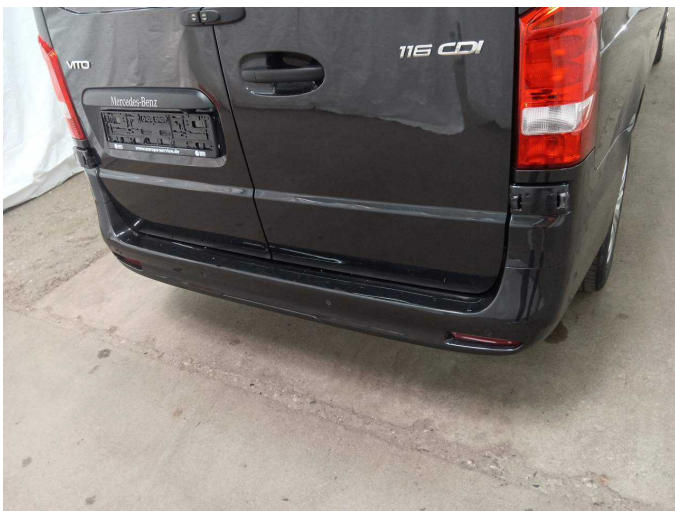
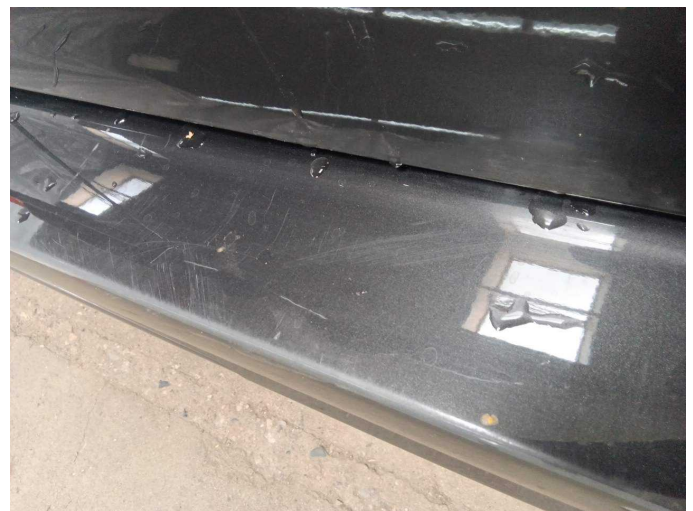
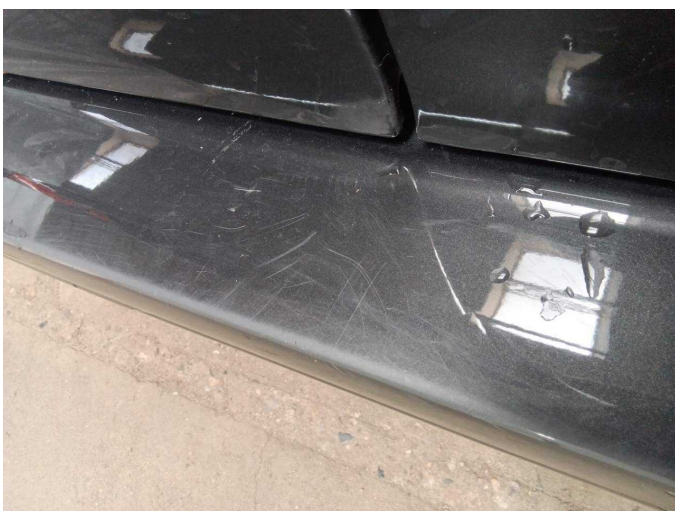
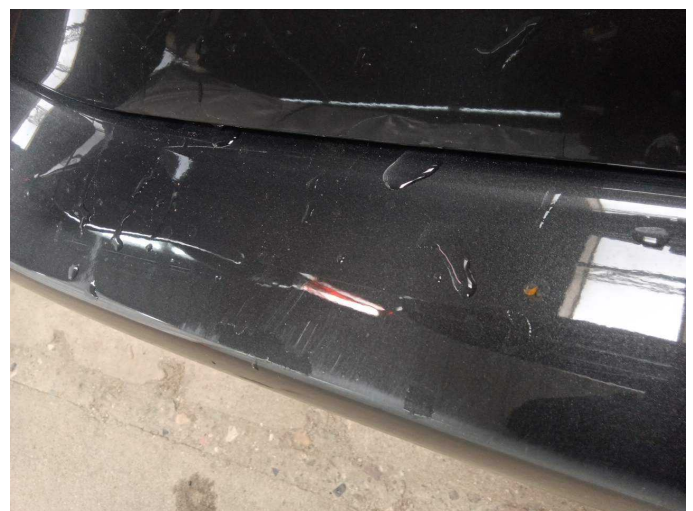
Damage 5: Rear bumper: Rear bumper - Scratch(es) - Paint

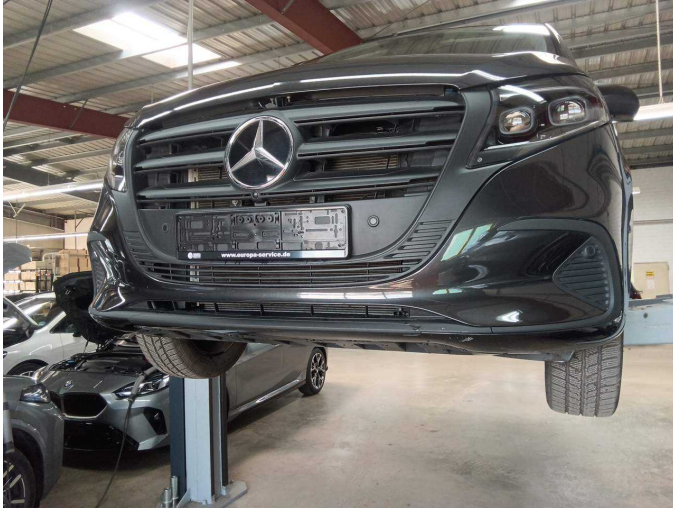
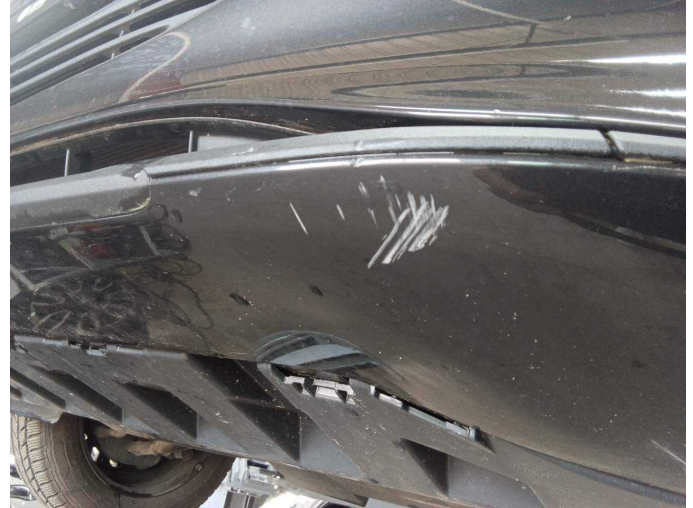
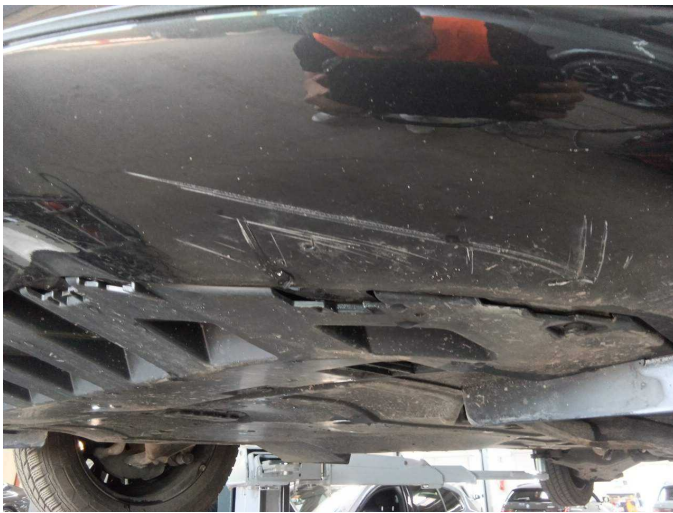
Damage 6: Front bumper: Front bumper - Scratch(es) - Paint

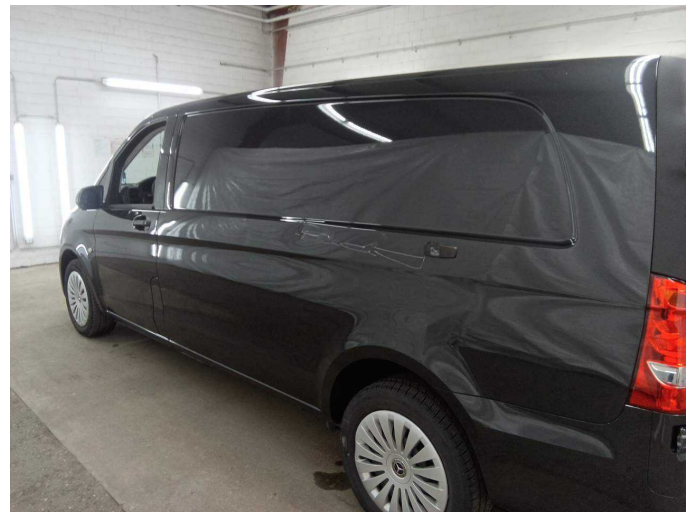
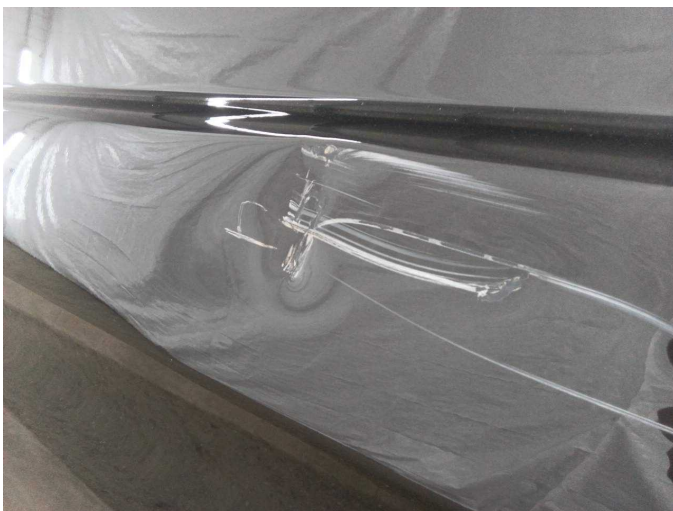
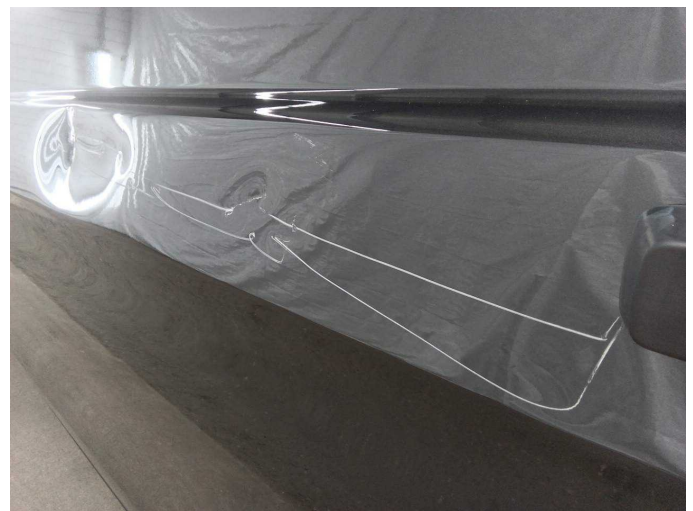
Damage 7: Side panel - rear left side: Side panel - Dent / paintcoat damage - Repair and paint

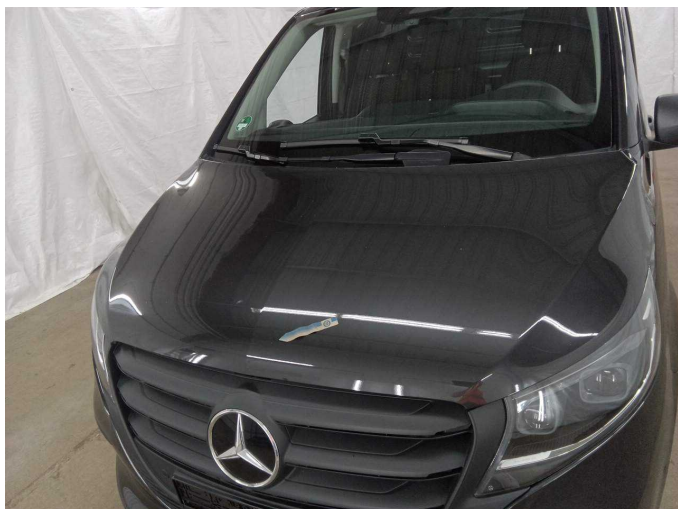
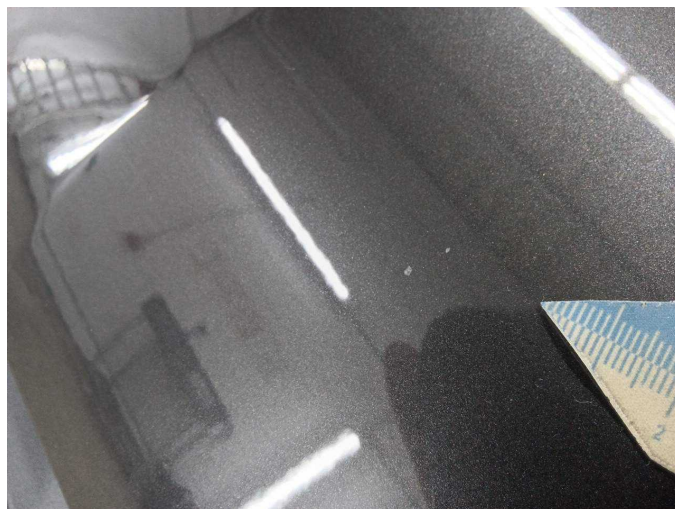
Wear and tear 1: Bonnet: Bonnet - Stone chips - No deduction
