Expertise

Protocol number: 46428400  
Order No. / Reference: 26655853  
Inspection date: 2 Jul 2026

Model: Astra 1.2 Turbo Hybrid 48 V GS

VIN: VXKFHPYXS1020234

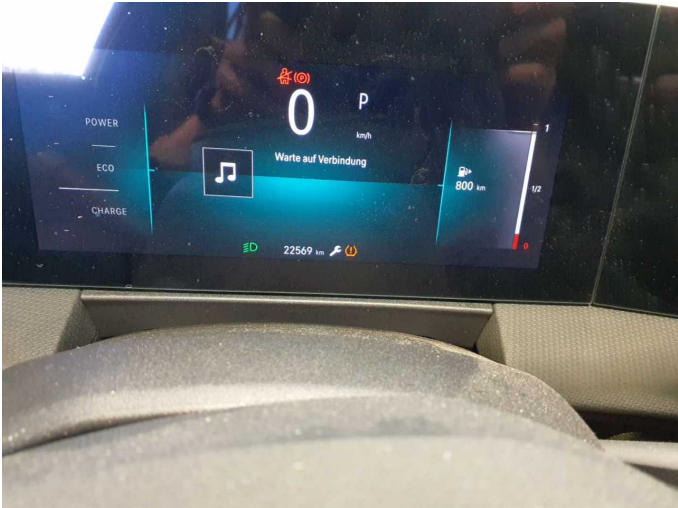
| No. | Component group | Description |
|---|---|---|
| 1 | Wheel / tyres | Pressure sensor (Reifen druck) - on - Diagnosed and repair if necessary |

Damage 1: Wheel / tyres: Pressure sensor (Reifen druck) - on - Diagnosed and repair if necessary

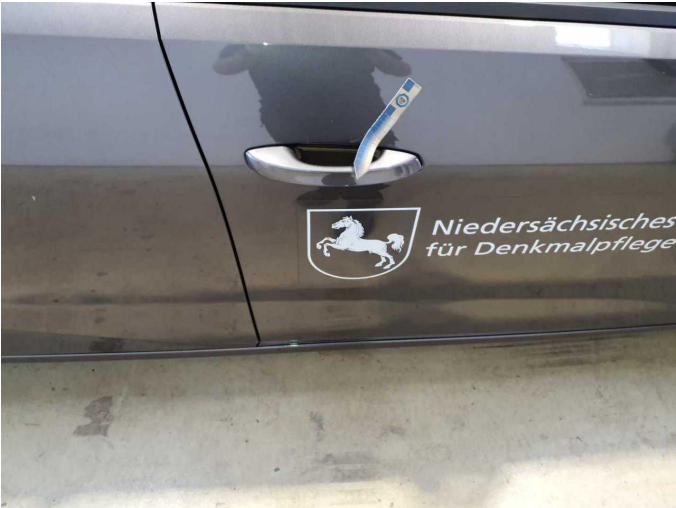
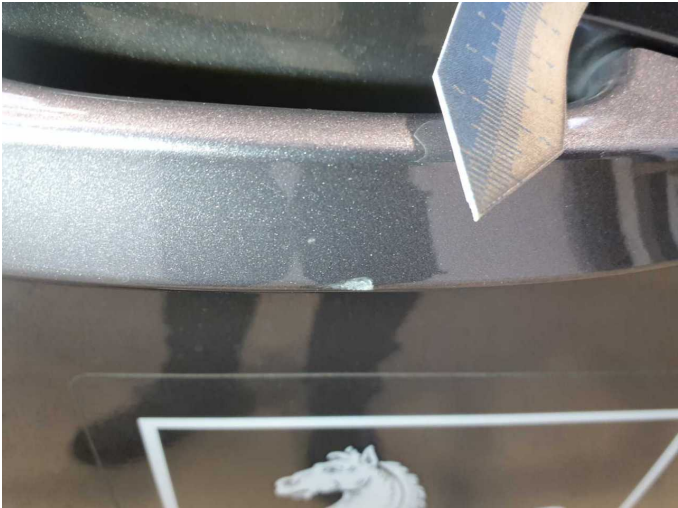
| No. | Component group | Description |
|---|---|---|
| 2 | Door - front right side | Door handle - outside - Scratch(es) - Smart repair |

Damage 2: Door - front right side: Door handle - outside - Scratch(es) - Smart repair

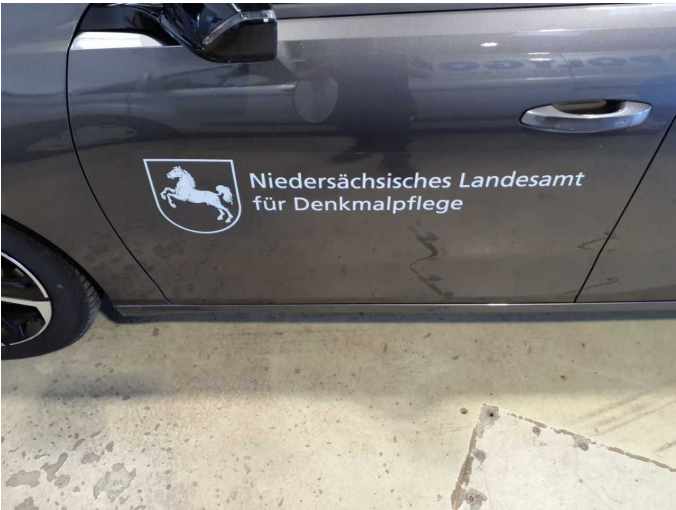
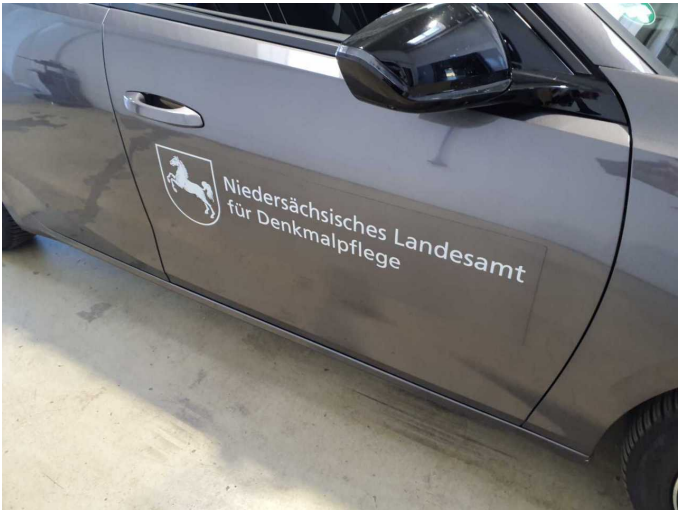
| No. | Component group | Description |
|---|---|---|
| 3 | Body | Body - Glued / labelled - De-glue / neutralise |

Damage 3: Body: Body - Glued / labelled - De-glue / neutralise

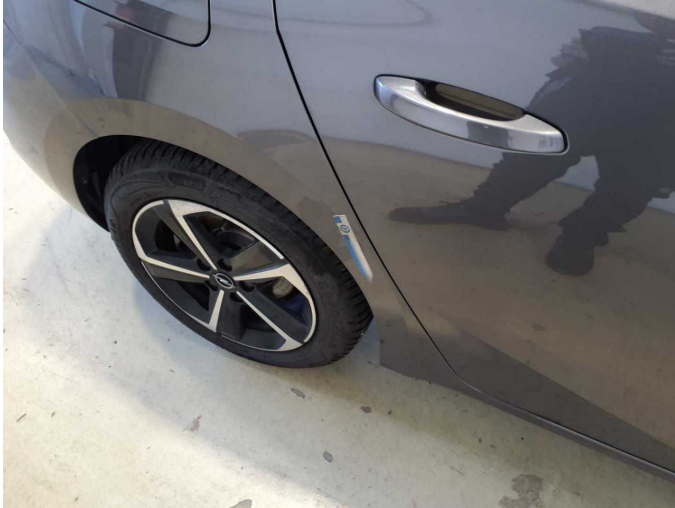
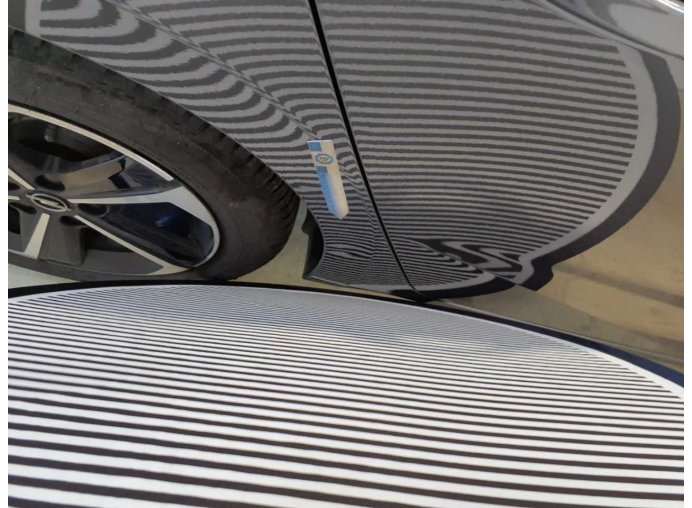
| No. | Component group | Description |
|---|---|---|
| 4 | Side panel - rear right side | Side panel - dent(s) - Smooth repair work |

**Damage 4:** Side panel - rear right side: Side panel - dent(s) - Smooth repair work

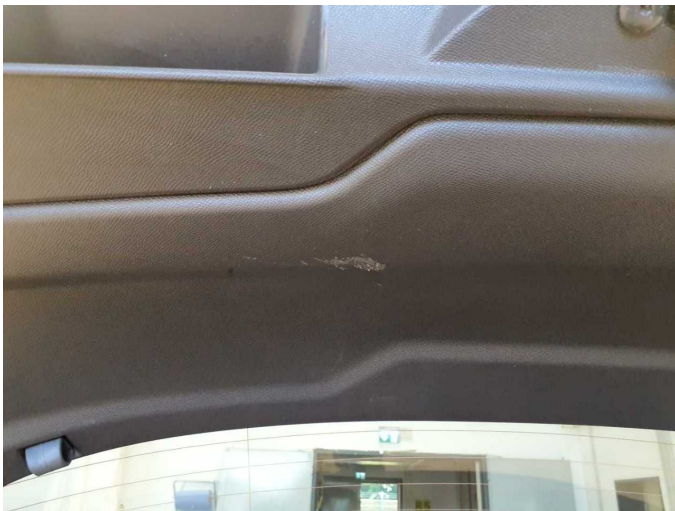
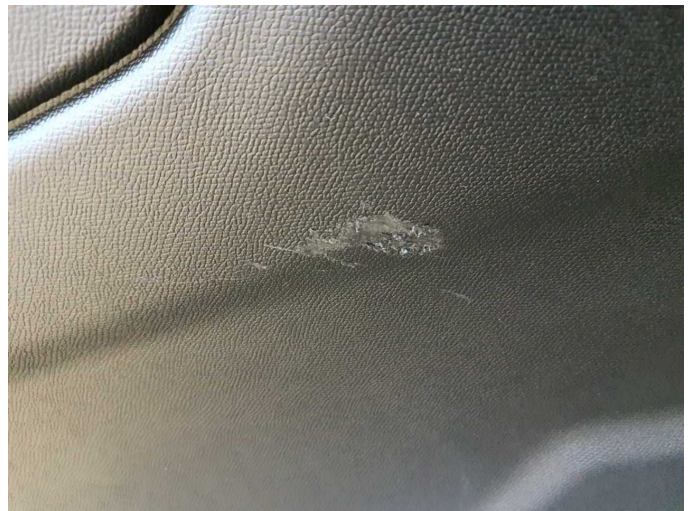
| No. | Component group | Description |
|---|---|---|
| 5 | Trim / covers | Boot lid - interior trim - Scratch(es) - Loss in value |

**Damage 5:** Trim / covers: Boot lid - interior trim - Scratch(es) - Loss in value

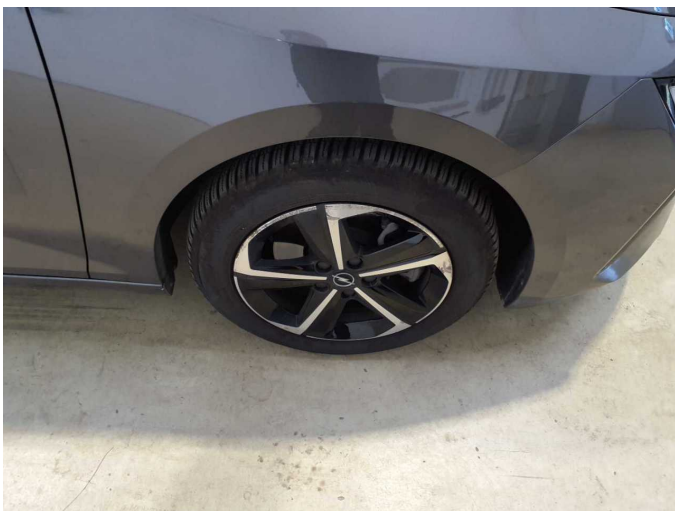
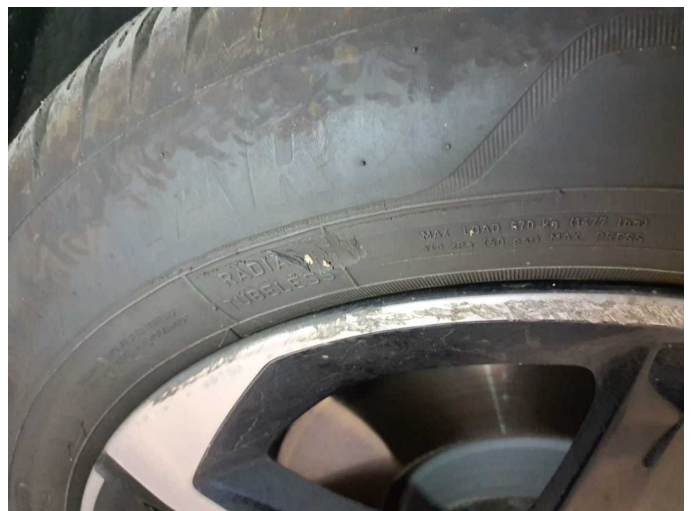
| No. | Component group | Description |
|---|---|---|
| 6 | Wheel / tyres | Tyre - front right side - Broken / torn - Replace |

**Damage 6:** Wheel / tyres: Tyre - front right side - Broken / torn - Replace

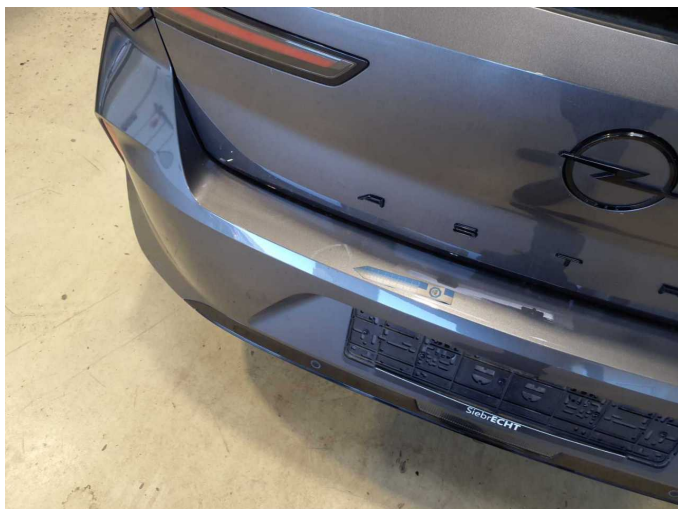
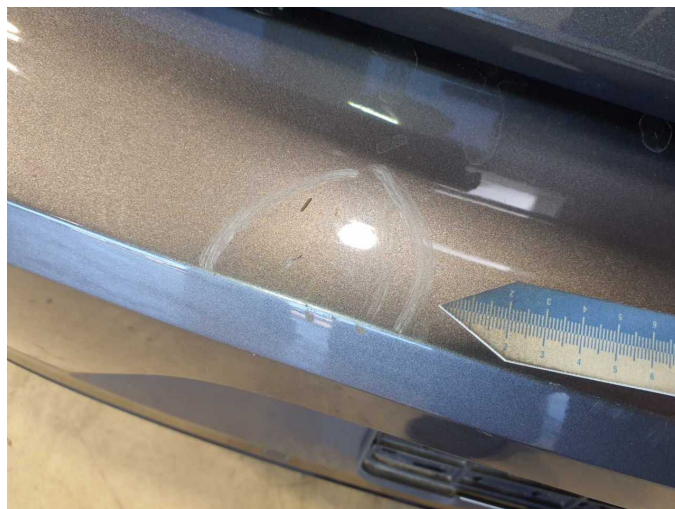
| No. | Component group | Description |
|---|---|---|
| 7 | Rear bumper | Rear bumper - Scratch(es) - Smart repair |

**Damage 7:** Rear bumper: Rear bumper - Scratch(es) - Smart repair

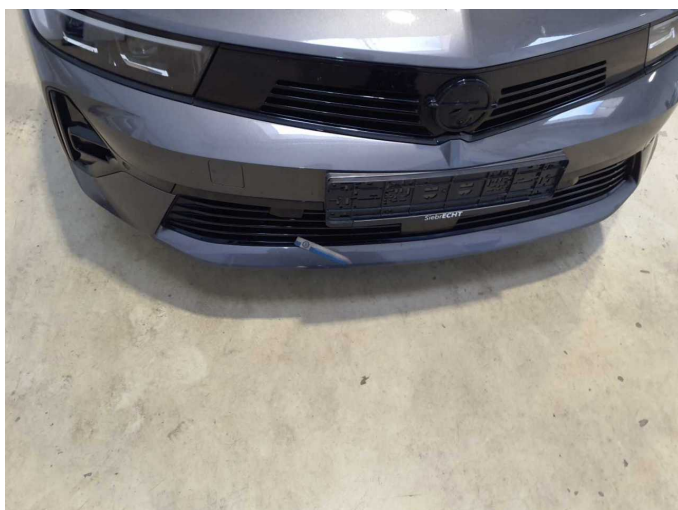
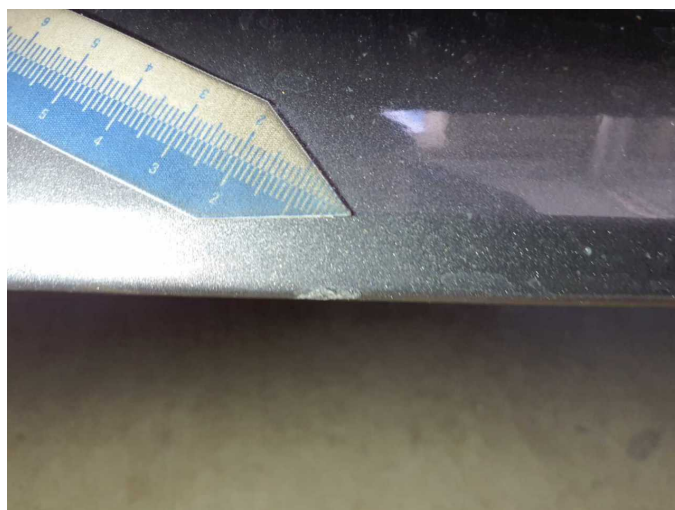
| No. | Component group | Description |
|---|---|---|
| 8 | Front bumper | Front bumper - Scratch(es) - Smart repair |

**Damage 8:** Front bumper: Front bumper - Scratch(es) - Smart repair

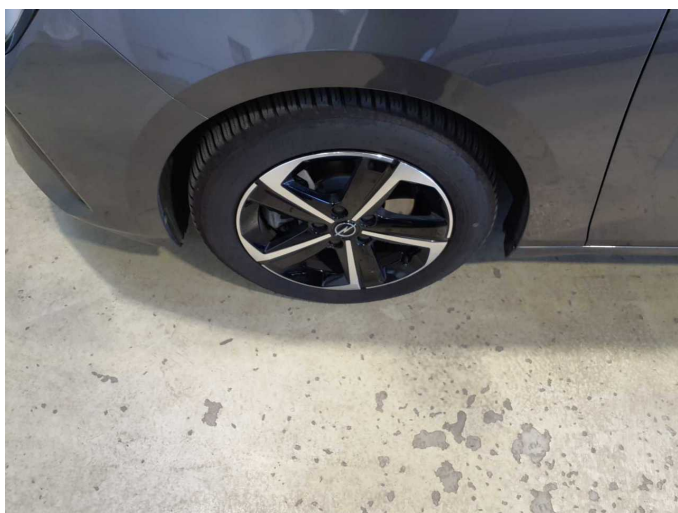
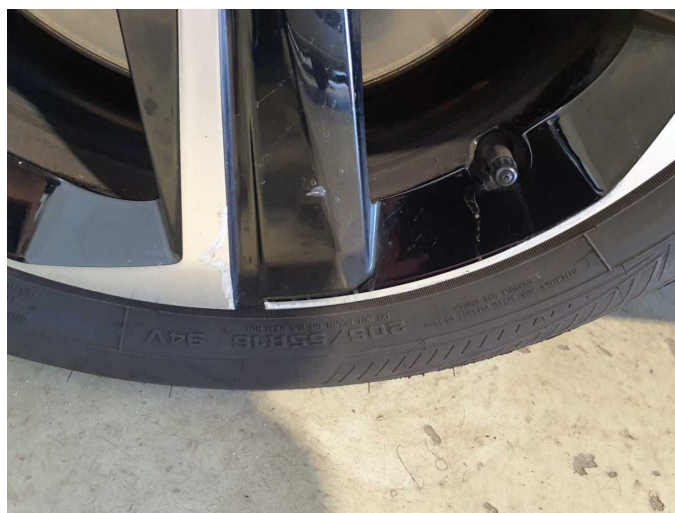
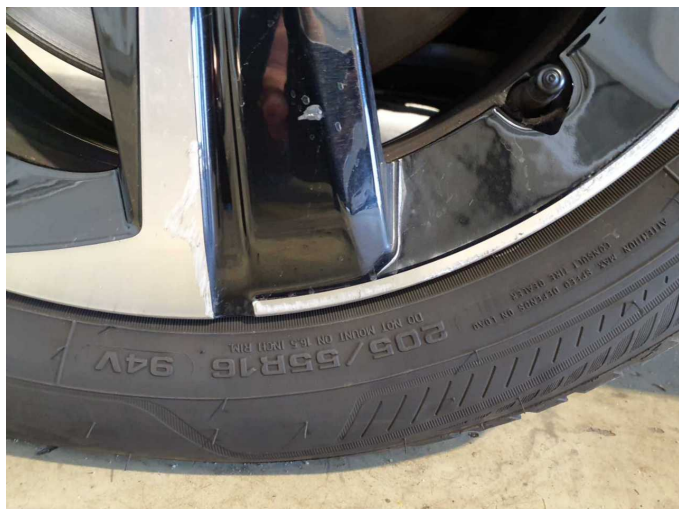
| No. | Component group | Description |
|---|---|---|
| 9 | Wheel / tyres | Alloy rim - front left side - Scratch(es) - Replace |

**Damage 9:** Wheel / tyres: Alloy rim - front left side - Scratch(es) - Replace

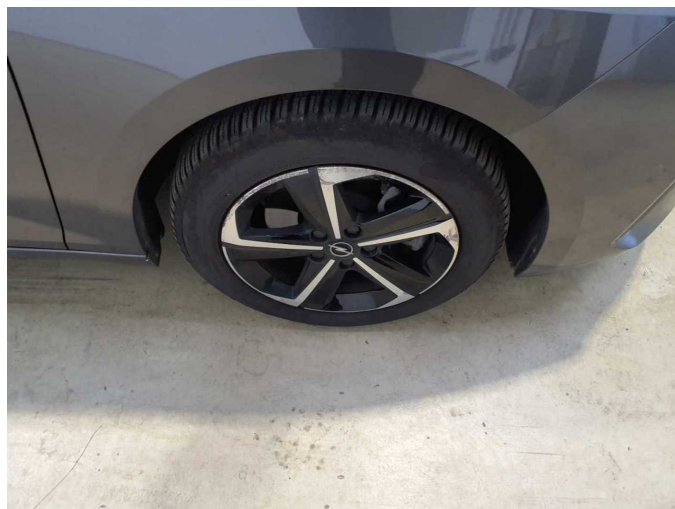
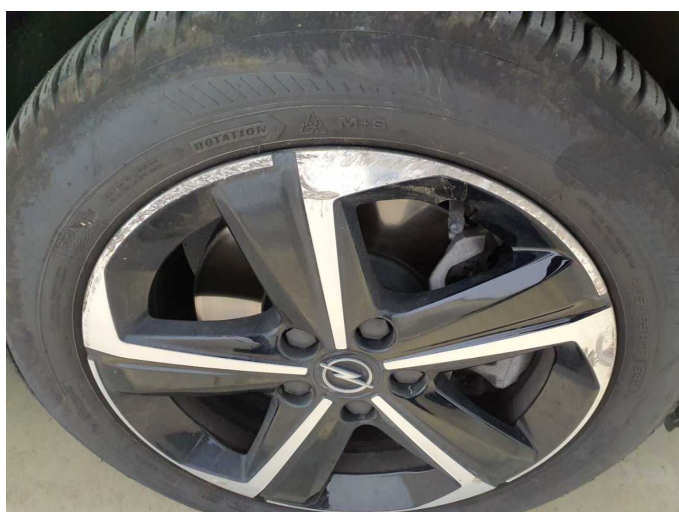
| No. | Component group | Description |
|---|---|---|
| 10 | Wheel / tyres | Alloy rim - front right side - Scratch(es) - Replace |

**Damage 10:** Wheel / tyres: Alloy rim - front right side - Scratch(es) - Replace

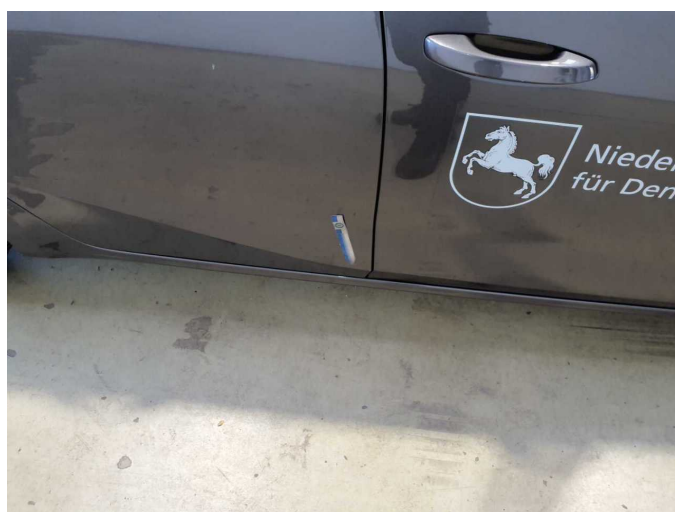
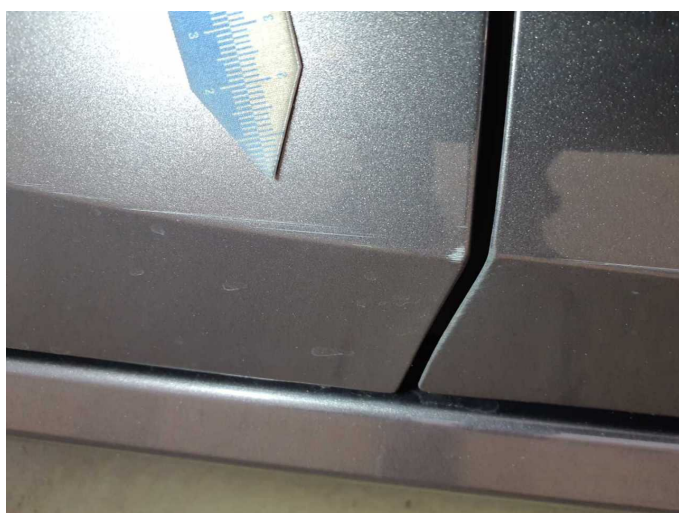
| No. | Component group | Description |
|---|---|---|
| 11 | Door - rear right side | Door - Scratch(es) - Paint |

**Damage 11:** Door - rear right side: Door - Scratch(es) - Paint

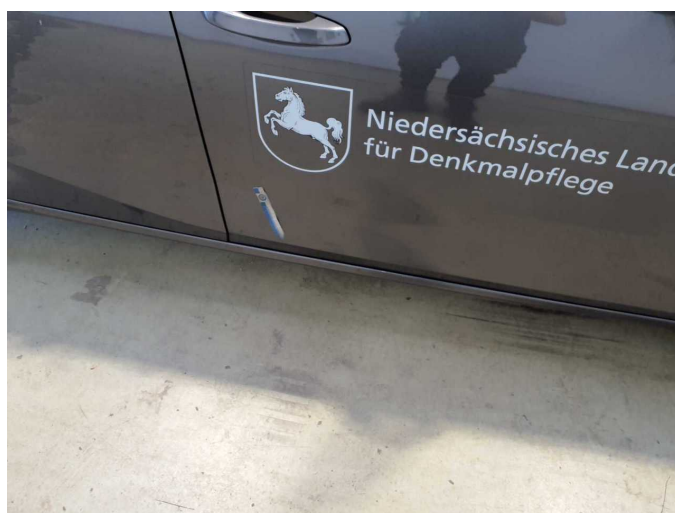
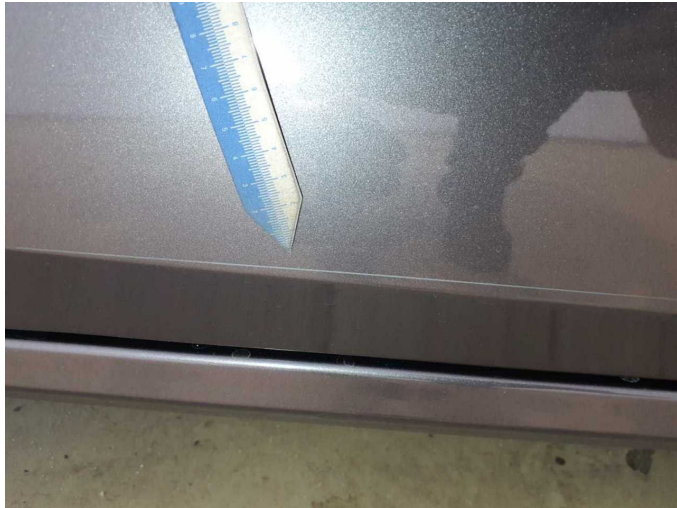
| No. | Component group | Description |
|---|---|---|
| 12 | Door - front right side | Door - Scratch(es) - Paint |

**Damage 12:** Door - front right side: Door - Scratch(es) - Paint

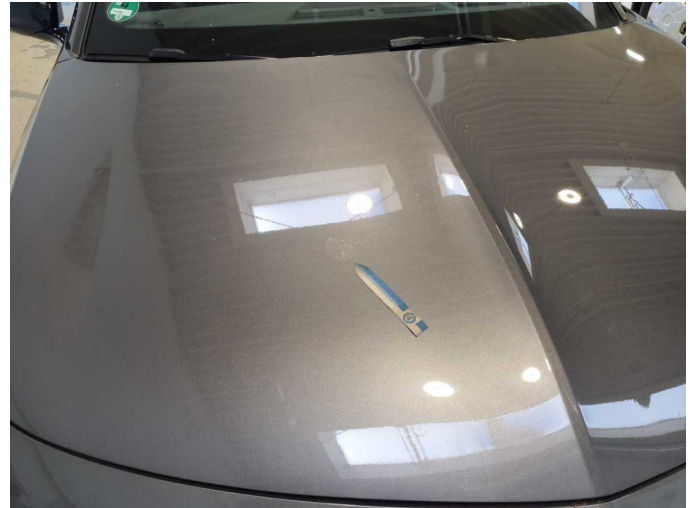
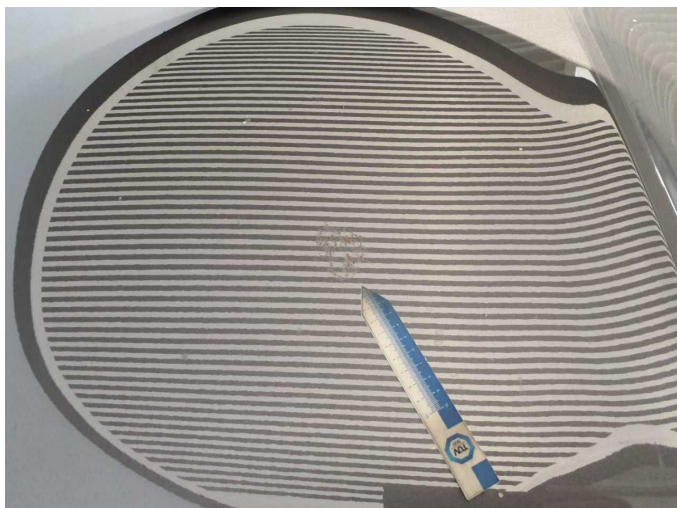
| No. | Component group | Description |
|---|---|---|
| 13 | Bonnet | Bonnet (Anätzung) - Paint defect - Repair and paint |

**Damage 13:** Bonnet: Bonnet (Anätzung) - Paint defect - Repair and paint

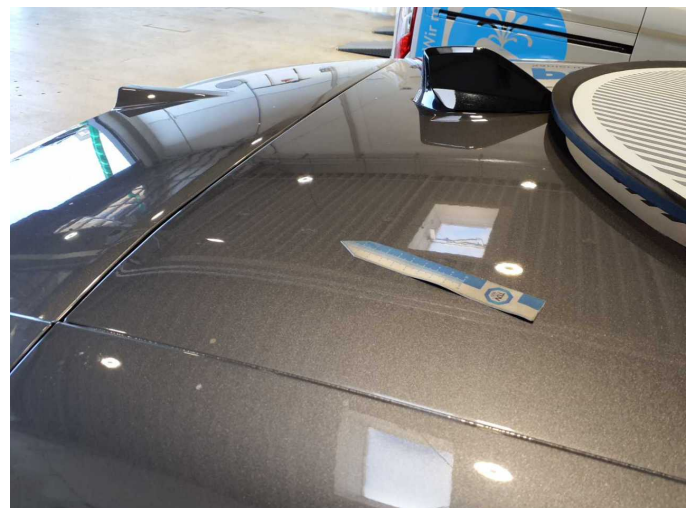
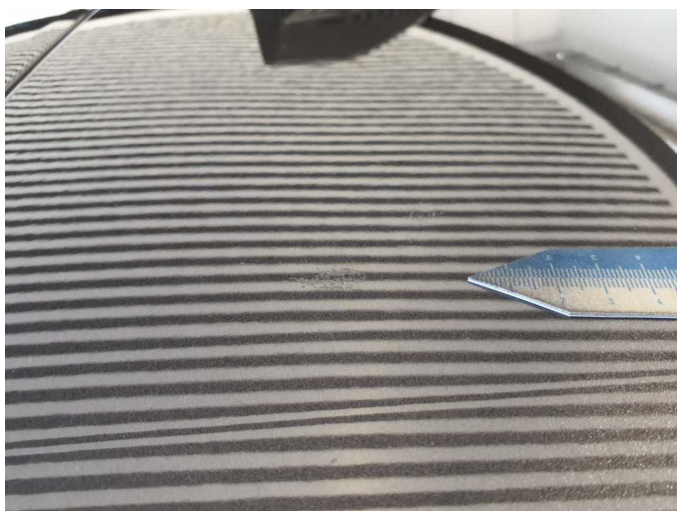
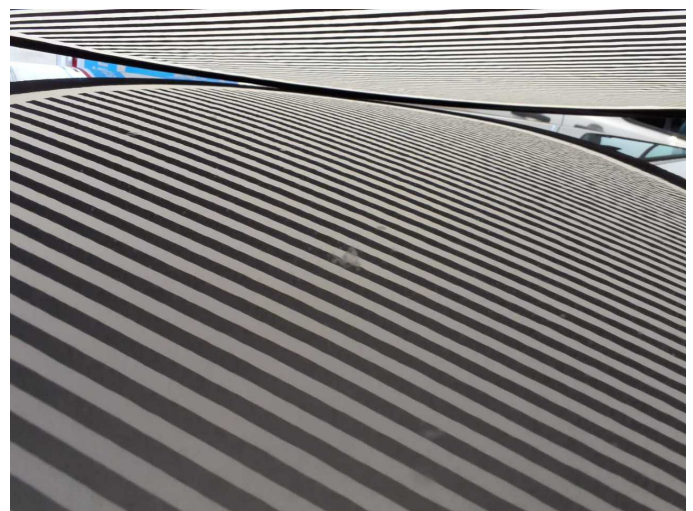
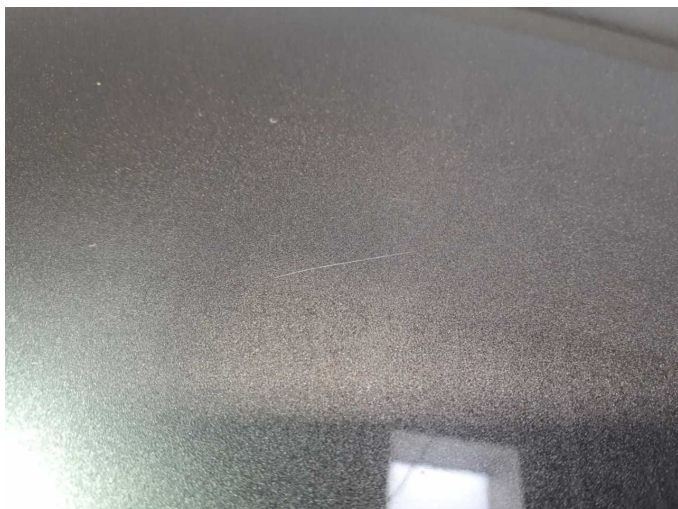
| No. | Component group | Description |
|---|---|---|
| 14 | Roof | Roof - Paint defect - Repair and paint |

**Damage 14:** Roof: Roof - Paint defect - Repair and paint
