Expertise

Protocol number: 46376166  
Order No. / Reference: 26653128  
Inspection date: 6 Jul 2026

Manufacturer: Citroën

Model: C5 Aircross Hybrid 136 ë-DSC6 MAX

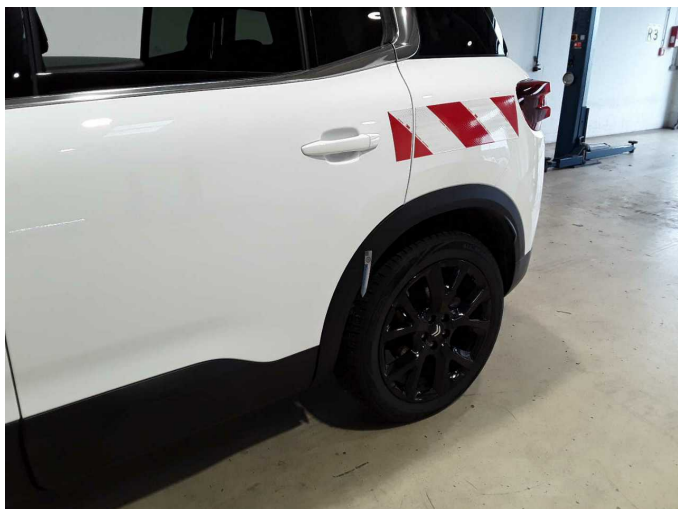
| No. | Component group | Description |
|---|---|---|
| 1 | Side panel - rear left side | Wheel well extension - Scratch(es) - Replace |

**Damage 1:** Side panel - rear left side: Wheel well extension - Scratch(es)  
- Replace

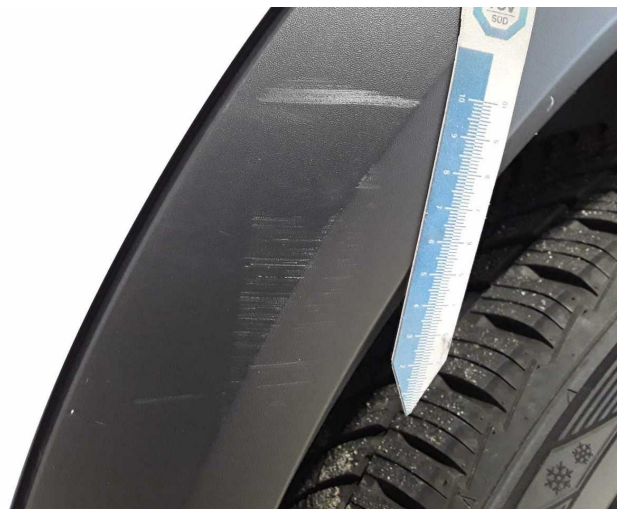
**Damage 1:** Side panel - rear left side: Wheel well extension - Scratch(es)  
- Replace

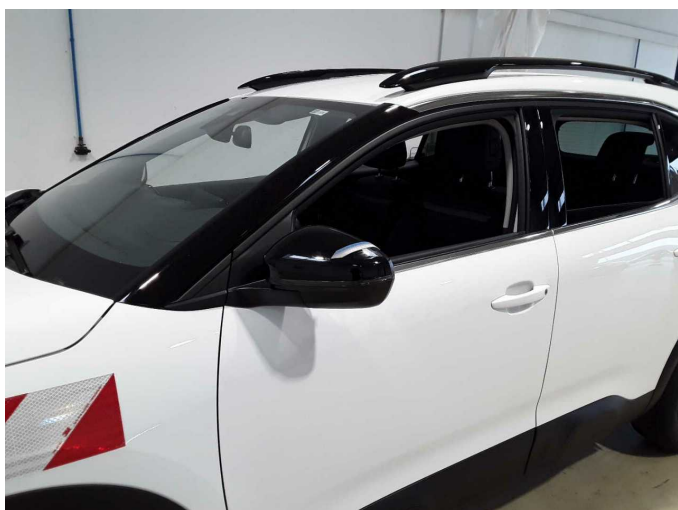
| No. | Component group | Description |
|---|---|---|
| 2 | Wing mirror - left side | Cap - Scratch(es) - Paint |

**Damage 2:** Wing mirror - left side: Cap - Scratch(es) - Paint

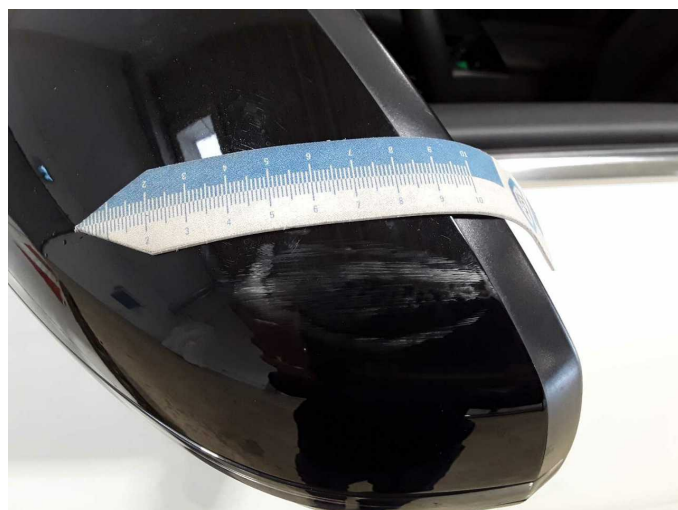
**Damage 2:** Wing mirror - left side: Cap - Scratch(es) - Paint

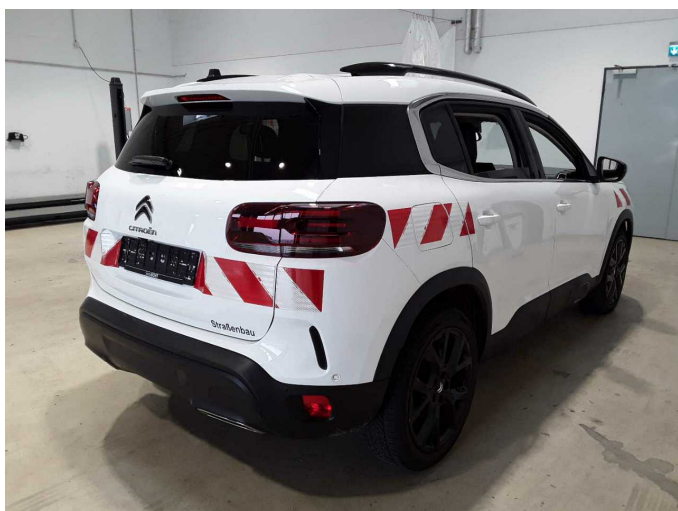
| No. | Component group | Description |
|---|---|---|
| 3 | Body | Body - Glued / labelled - De-glue / neutralise |

**Damage 3:** Body: Body - Glued / labelled - De-glue / neutralise

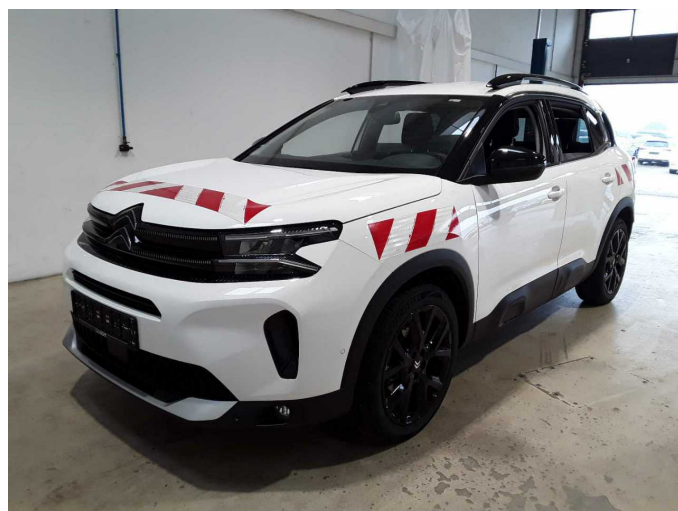
**Damage 3:** Body: Body - Glued / labelled - De-glue / neutralise

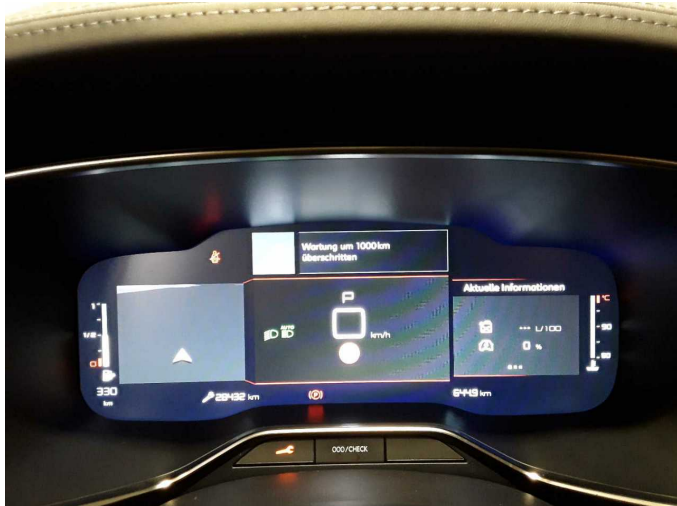
| No. | Component group | Description |
|---|---|---|
| 4 | Misc. | Inspection / maintenance - Due - Perform |

**Damage 4:** Misc.: Inspection / maintenance - Due - Perform

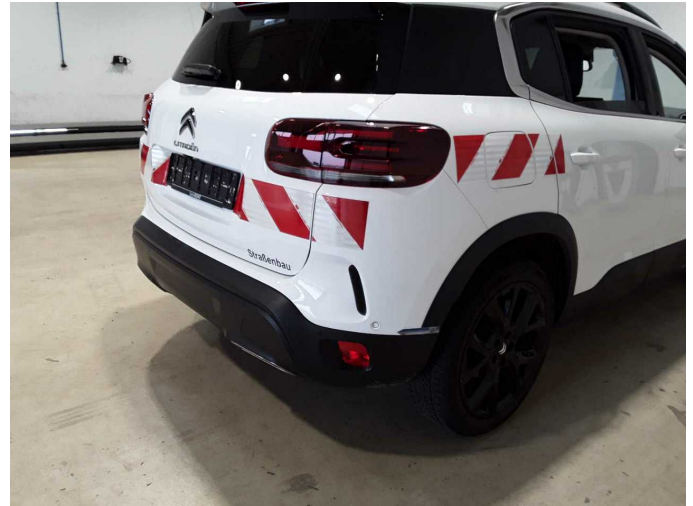
| No. | Component group | Description |
|---|---|---|
| 5 | Rear bumper | Spoiler - Scratch(es) - Replace |

**Damage 5:** Rear bumper: Spoiler - Scratch(es) - Replace

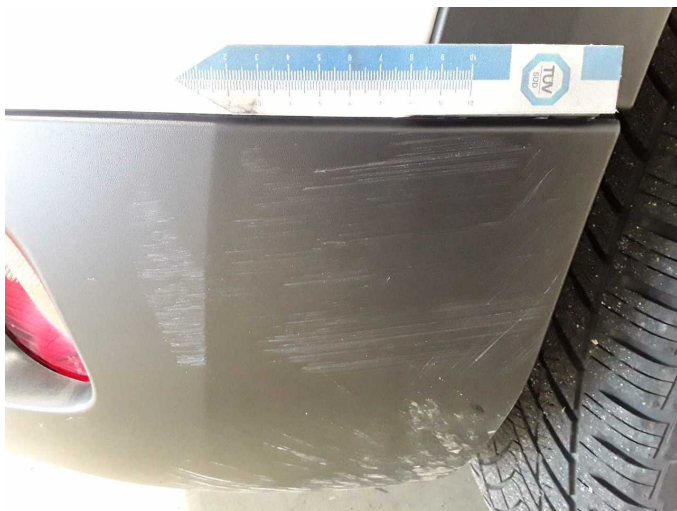
**Damage 5:** Rear bumper: Spoiler - Scratch(es) - Replace
