Expertise

Protocol number: 46334850  
Order No. / Reference: 26615109  
Inspection date: 1 Jul 2026

Manufacturer: Seat

Model: Ateca 1.6 TDI Style

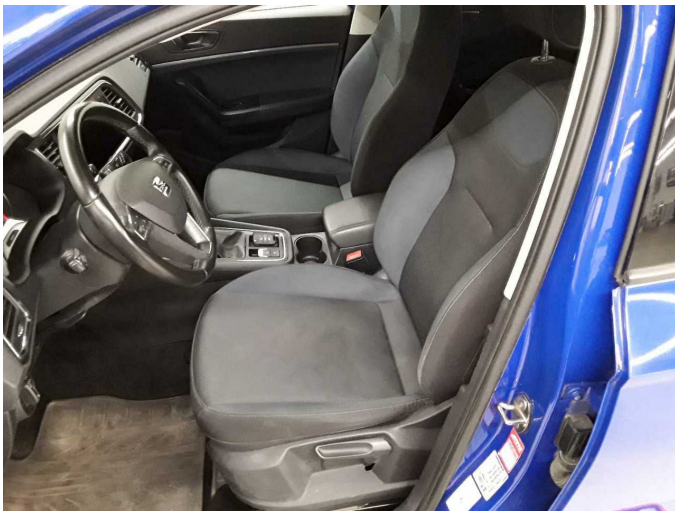
| No. | Component group | Description |
|---|---|---|
| 1 | Seat - front | Seat cover - left side (Sitze) - Soiled - Clean |

**Damage 1:** Seat - front: Seat cover - left side (Sitze) - Soiled - Clean

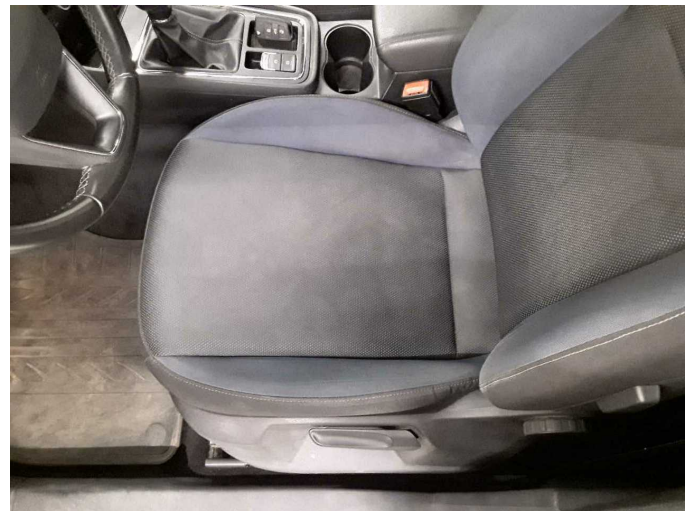
**Damage 1:** Seat - front: Seat cover - left side (Sitze) - Soiled - Clean

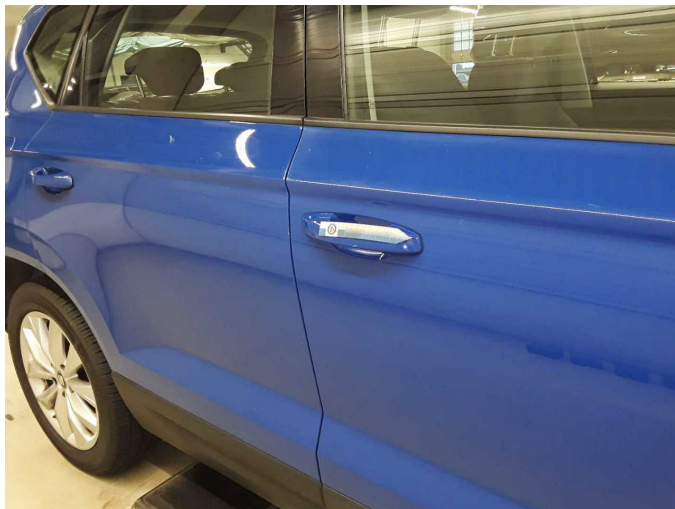
| No. | Component group | Description |
|---|---|---|
| 2 | Door - front right side | Door handle - outside - Scratch(es) - Smart repair |

**Damage 2:** Door - front right side: Door handle - outside - Scratch(es) - Smart repair

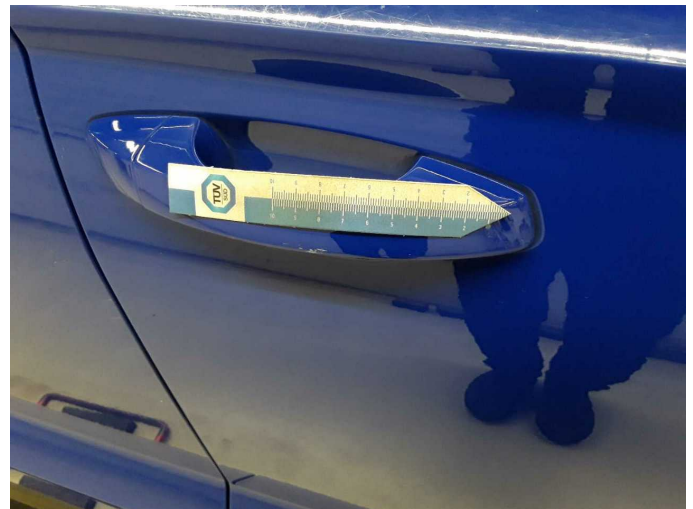
**Damage 2:** Door - front right side: Door handle - outside - Scratch(es) - Smart repair

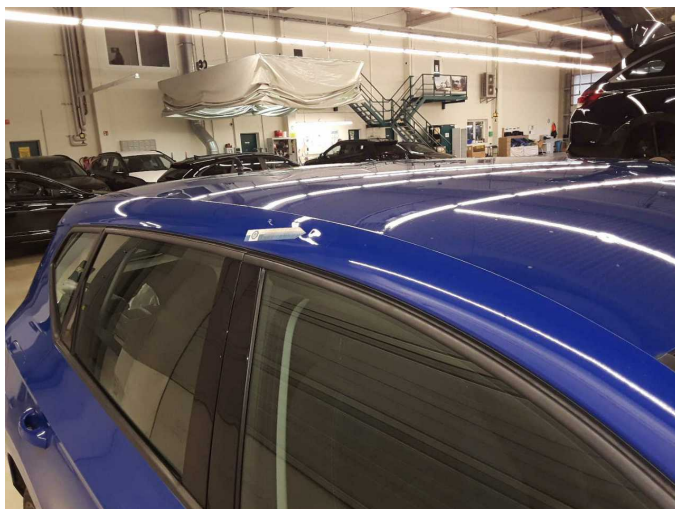
| No. | Component group | Description |
|---|---|---|
| 3 | Roof | Roof rail - right side - dent(s) - Smooth repair work |

**Damage 3:** Roof: Roof rail - right side - dent(s) - Smooth repair work

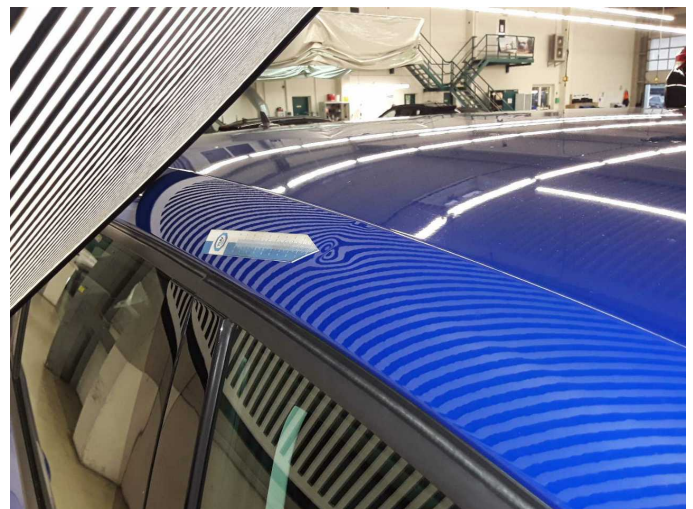
**Damage 3:** Roof: Roof rail - right side - dent(s) - Smooth repair work

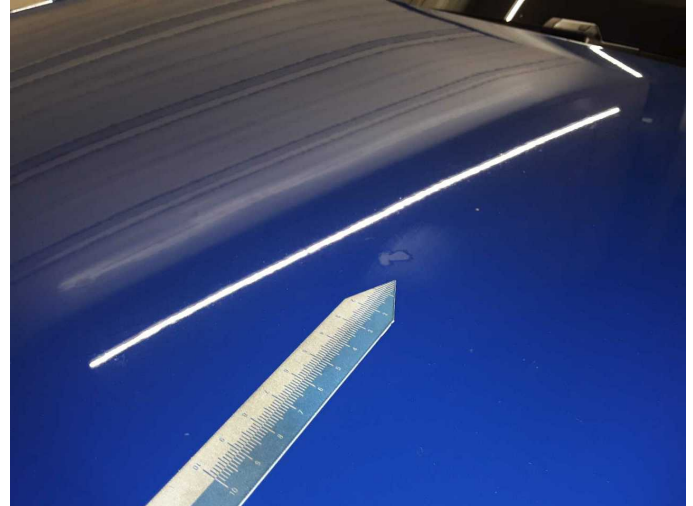
| No. | Component group | Description |
|---|---|---|
| 4 | Body | Body (Baumharz: Lackaufbereitung) - Soiled - Clean |

**Damage 4:** Body: Body (Baumharz: Lackaufbereitung) - Soiled - Clean

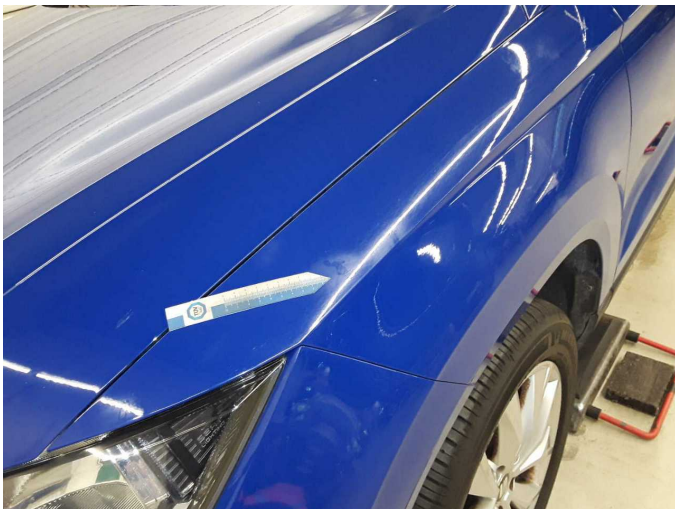
**Damage 4:** Body: Body (Baumharz: Lackaufbereitung) - Soiled - Clean

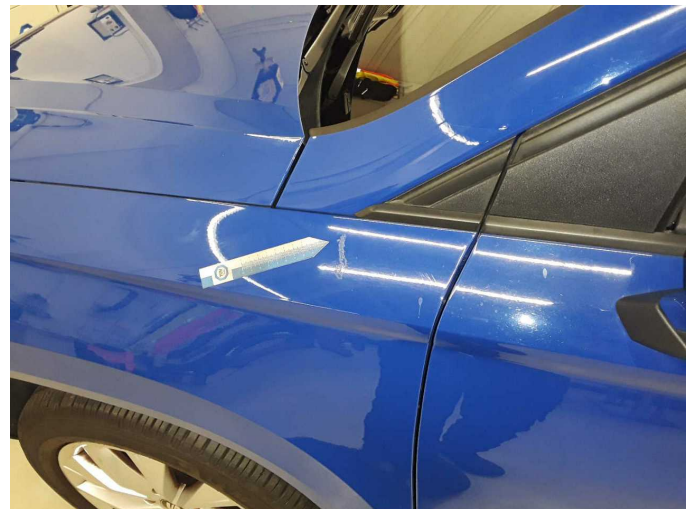
**Damage 4:** Body: Body (Baumharz: Lackaufbereitung) - Soiled - Clean

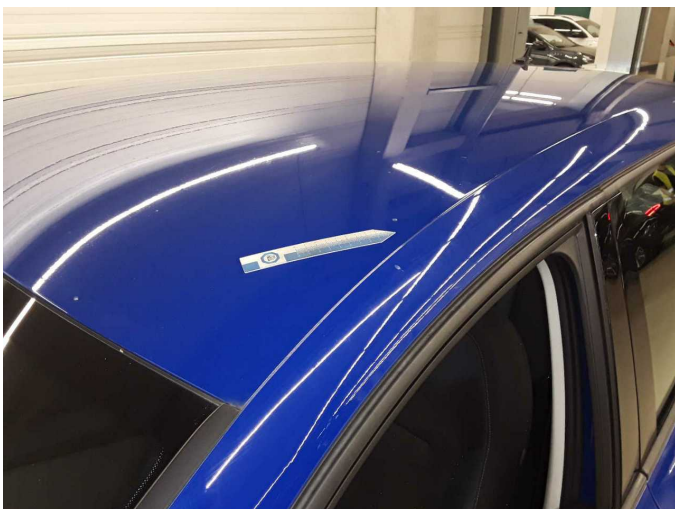
**Damage 4:** Body: Body (Baumharz: Lackaufbereitung) - Soiled - Clean

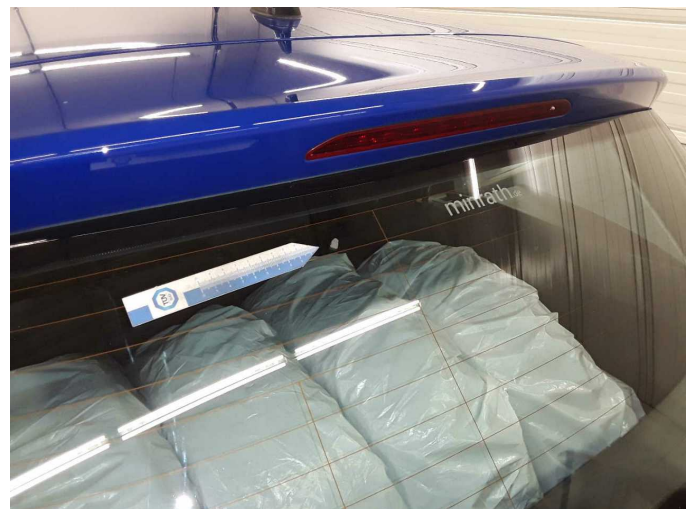
**Damage 4:** Body: Body (Baumharz: Lackaufbereitung) - Soiled - Clean

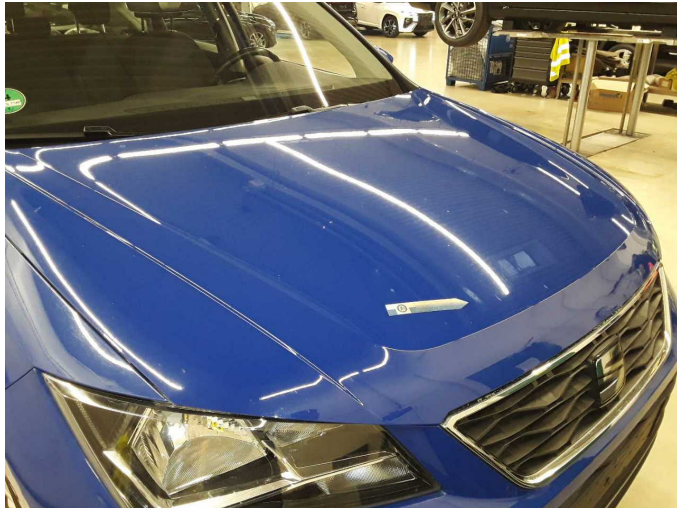
**Damage 4:** Body: Body (Baumharz: Lackaufbereitung) - Soiled - Clean

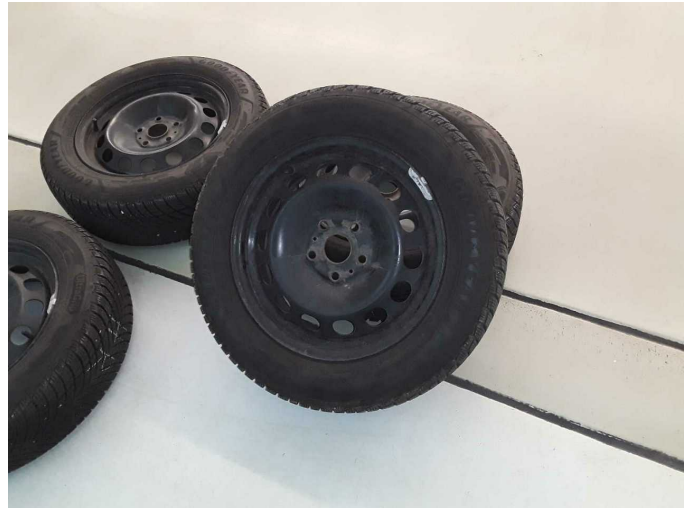
| No. | Component group | Description |
|---|---|---|
| 6 | 2nd wheel set | 1 tyre (Luftleer, keine Beschädigung erkennbar.) - Leaking - Replace |

**Damage 6:** 2nd wheel set: 1 tyre (Luftleer, keine Beschädigung erkennbar.) - Leaking - Replace

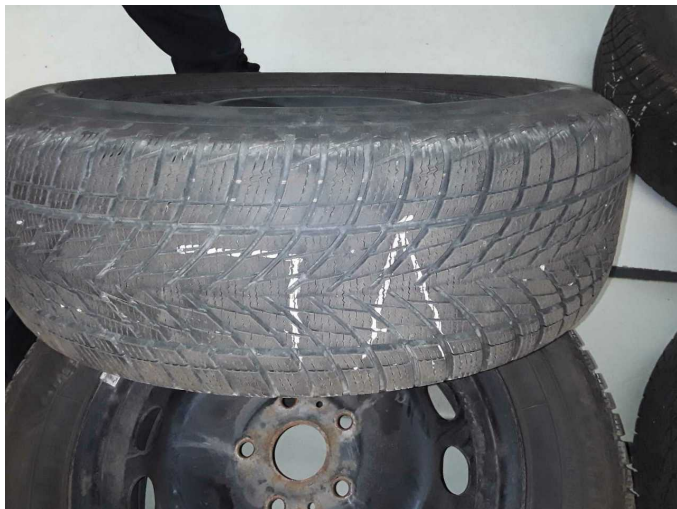
**Damage 6:** 2nd wheel set: 1 tyre (Luftleer, keine Beschädigung erkennbar.) - Leaking - Replace

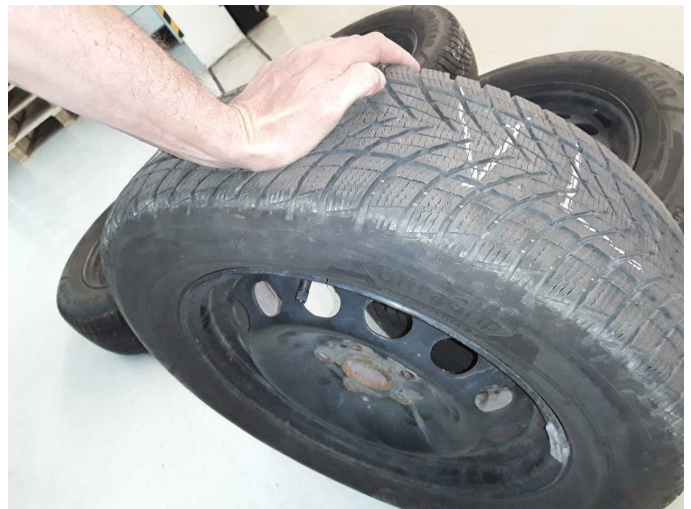
**Damage 6:** 2nd wheel set: 1 tyre (Luftleer, keine Beschädigung erkennbar.) - Leaking - Replace

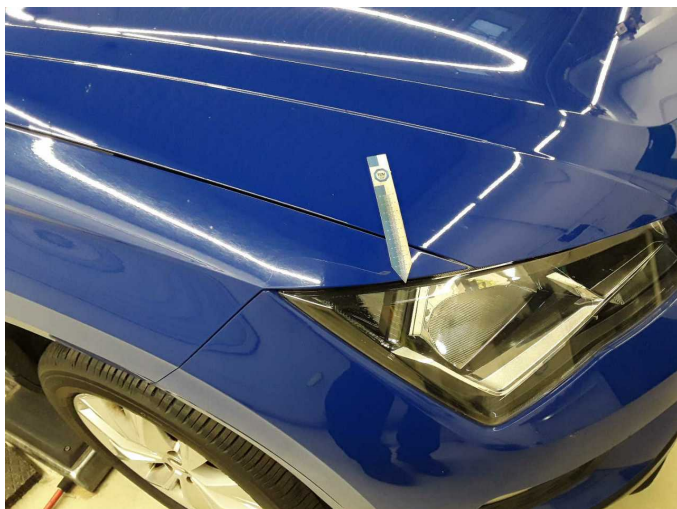
| No. | Component group | Description |
|---|---|---|
| 7 | Mudguard - right side | Mudguard - right side - Scratch(es) - Smart repair |

**Damage 7:** Mudguard - right side: Mudguard - right side - Scratch(es) - Smart repair

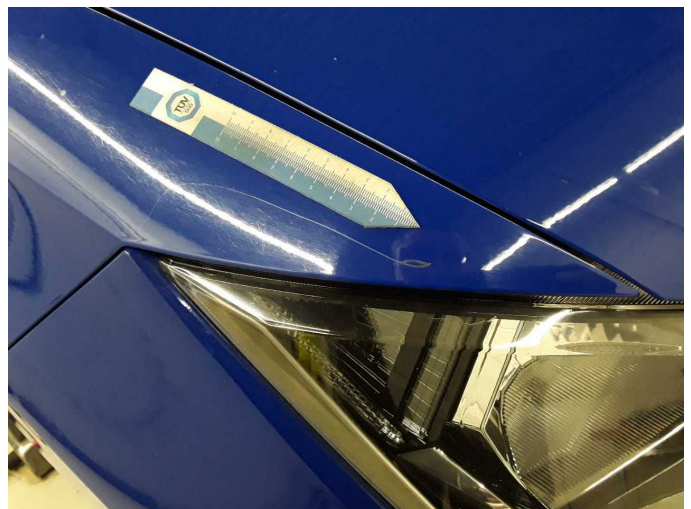
**Damage 7:** Mudguard - right side: Mudguard - right side - Scratch(es) - Smart repair

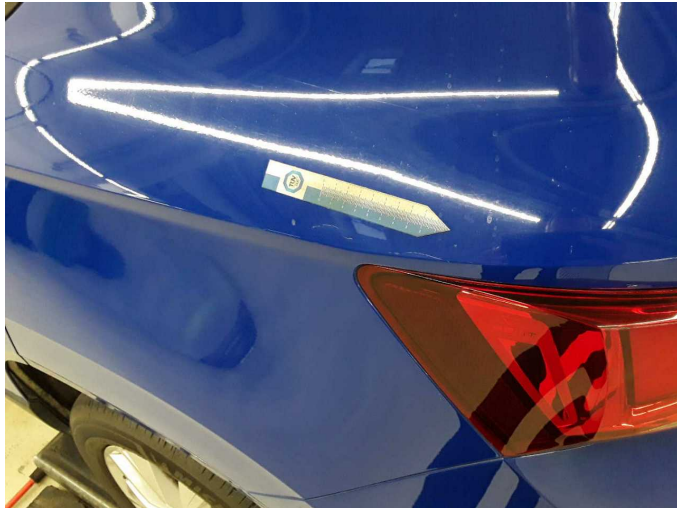
| No. | Component group | Description |
|---|---|---|
| 8 | Side panel - rear left side | Side panel - Scratch(es) - Smart repair |

**Damage 8:** Side panel - rear left side: Side panel - Scratch(es) - Smart repair

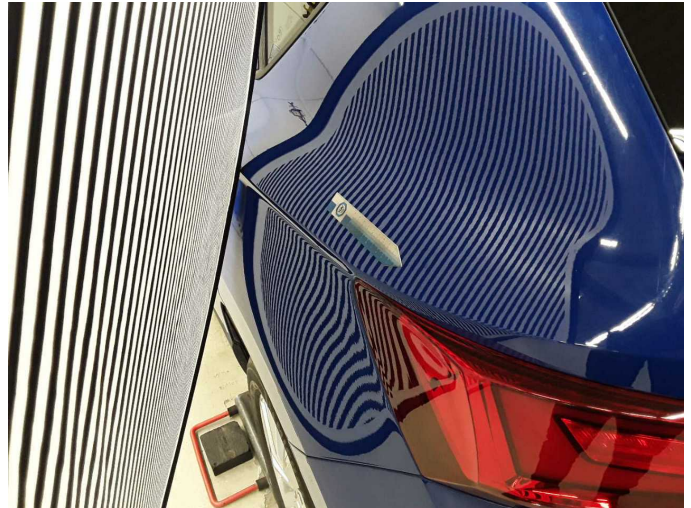
**Damage 8:** Side panel - rear left side: Side panel - Scratch(es) - Smart repair

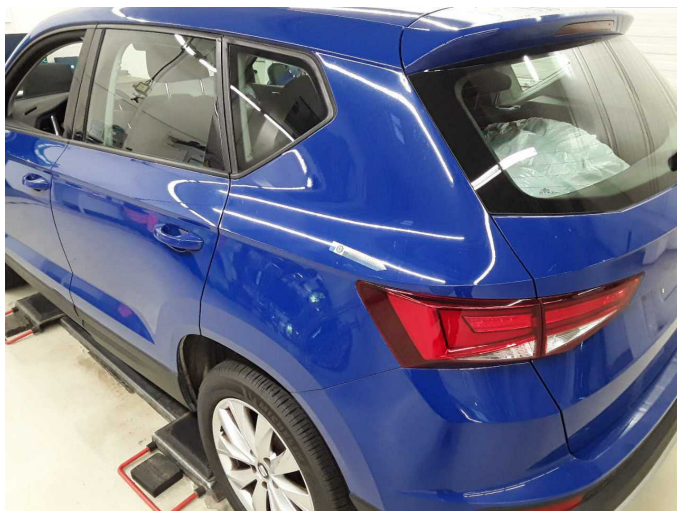
**Damage 8:** Side panel - rear left side: Side panel - Scratch(es) - Smart repair

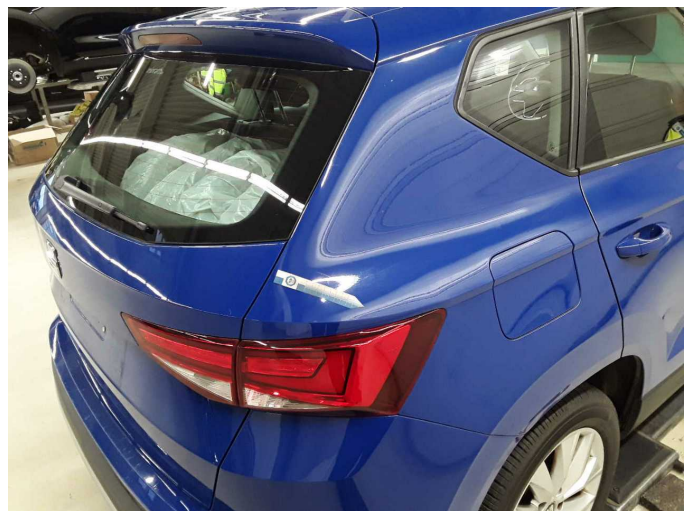
| No. | Component group | Description |
|---|---|---|
| 9 | Side panel - rear right side | Side panel (Oberflächliche) - Scratch(es) - Smart repair |

**Damage 9:** Side panel - rear right side: Side panel (Oberflächliche) - Scratch(es) - Smart repair

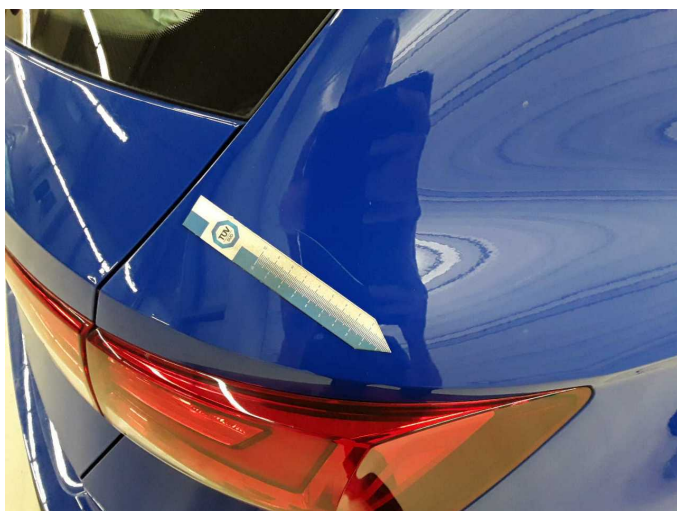
**Damage 9:** Side panel - rear right side: Side panel (Oberflächliche) - Scratch(es) - Smart repair

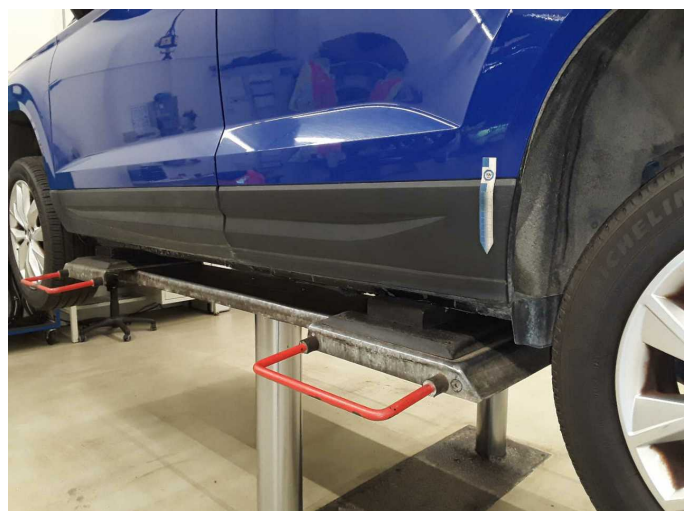
| No. | Component group | Description |
|---|---|---|
| 10 | Door - rear left side | Brightware - lower - Scratched - Replace |

**Damage 10:** Door - rear left side: Brightware - lower - Scratched - Replace

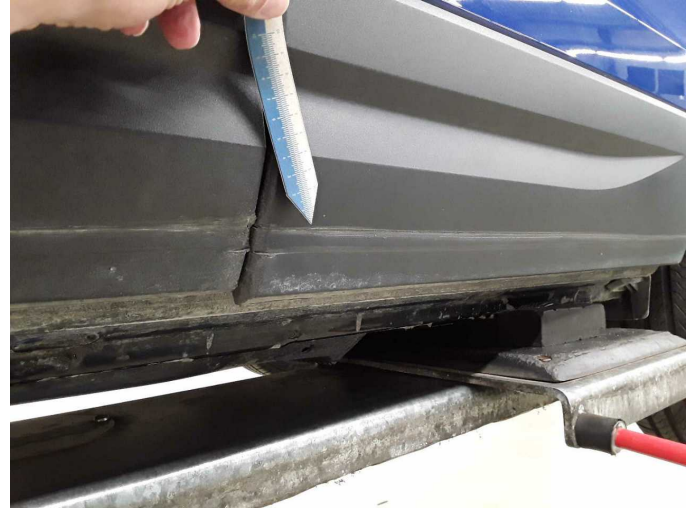
**Damage 10:** Door - rear left side: Brightware - lower - Scratched - Replace

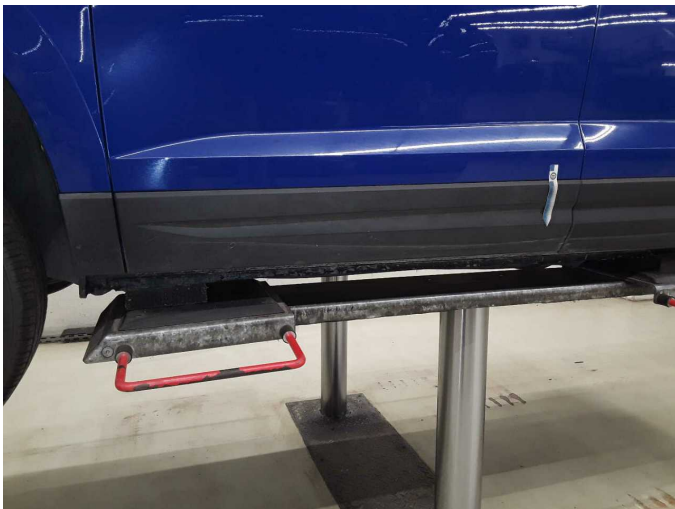
| No. | Component group | Description |
|---|---|---|
| 11 | Door - front left side | Brightware - lower - Scratched - Replace |

**Damage 11:** Door - front left side: Brightware - lower - Scratched - Replace

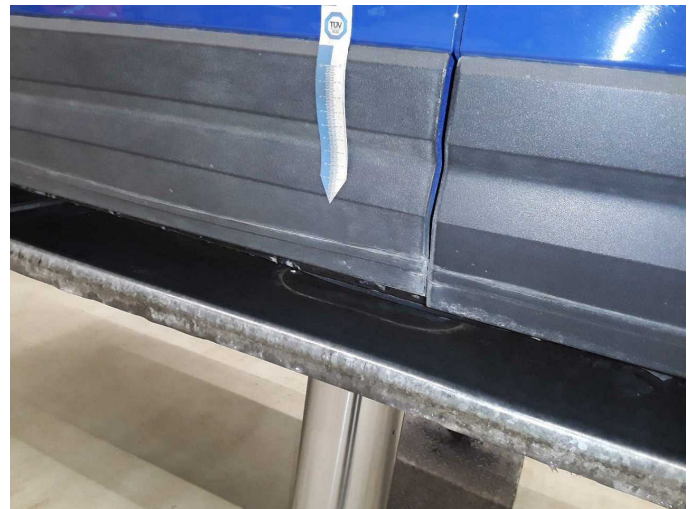
**Damage 11:** Door - front left side: Brightware - lower - Scratched - Replace

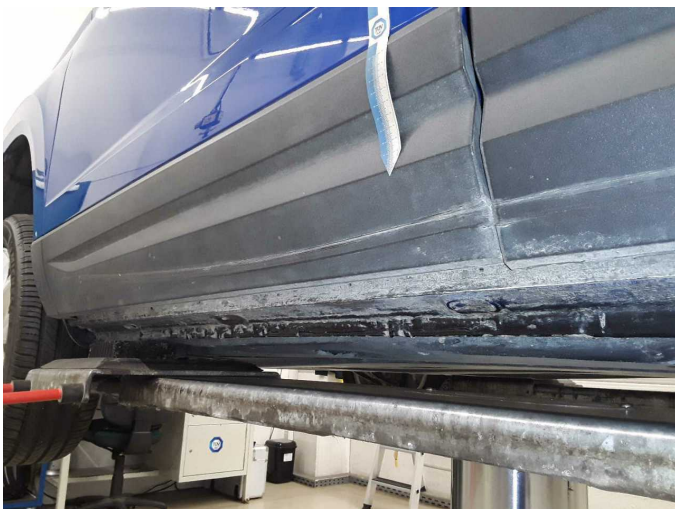
**Damage 11:** Door - front left side: Brightware - lower - Scratched - Replace

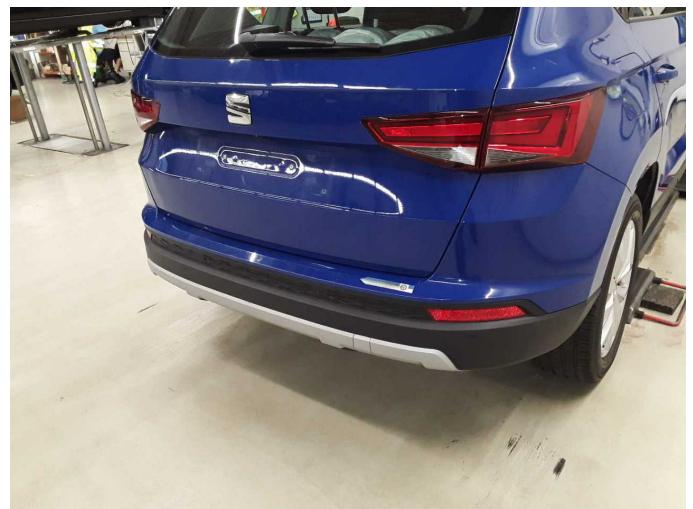
| No. | Component group | Description |
|---|---|---|
| 12 | Rear bumper | Rear bumper - Scratch(es) - Paint |

**Damage 12:** Rear bumper: Rear bumper - Scratch(es) - Paint

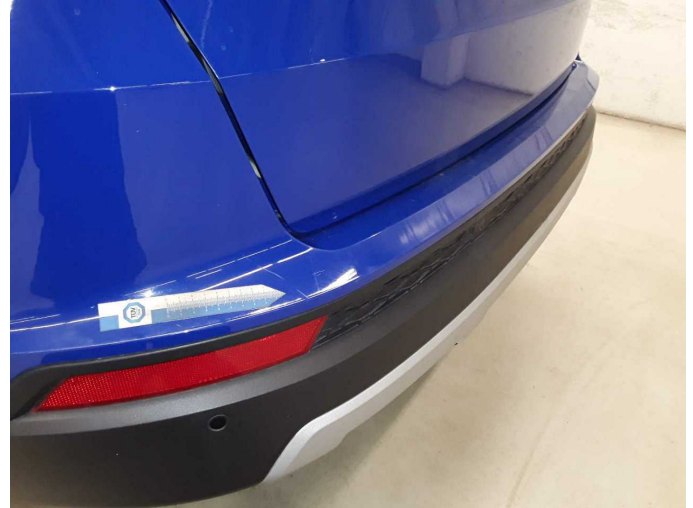
**Damage 12:** Rear bumper: Rear bumper - Scratch(es) - Paint

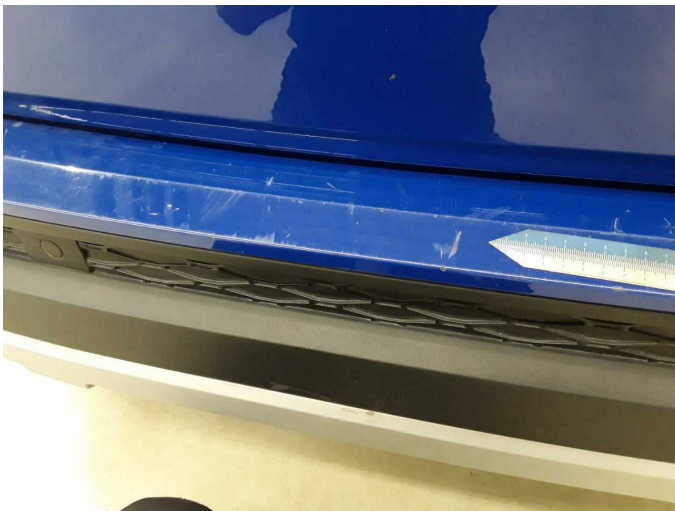
**Damage 12:** Rear bumper: Rear bumper - Scratch(es) - Paint

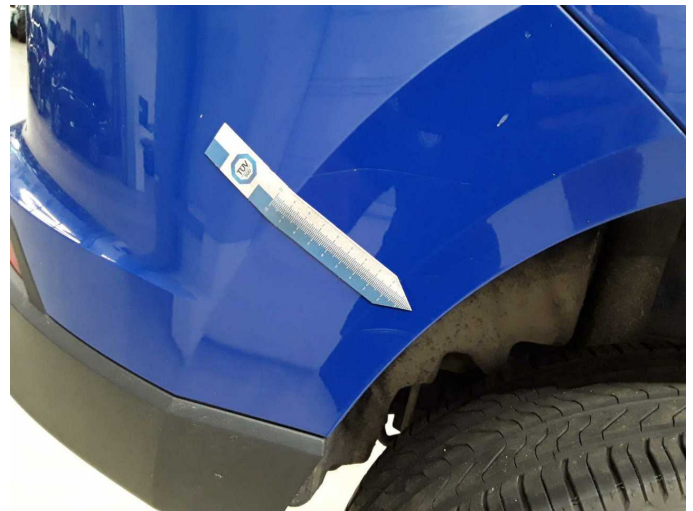
**Damage 12:** Rear bumper: Rear bumper - Scratch(es) - Paint

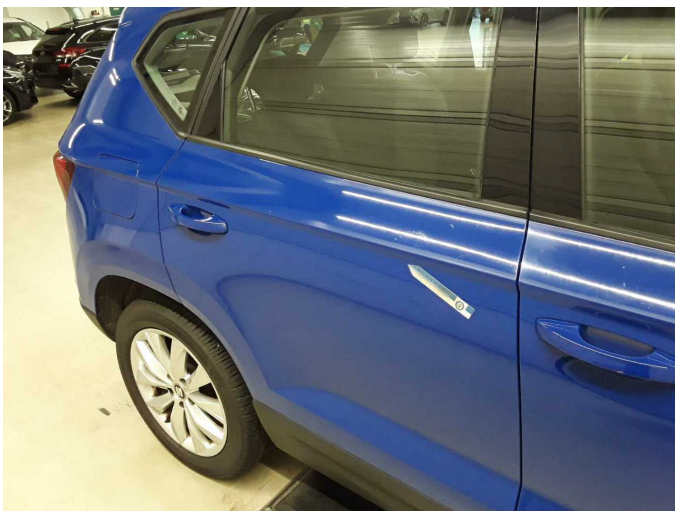
| No. | Component group | Description |
|---|---|---|
| 13 | Door - rear right side | Door - Scratch(es) - Paint |

**Damage 13:** Door - rear right side: Door - Scratch(es) - Paint

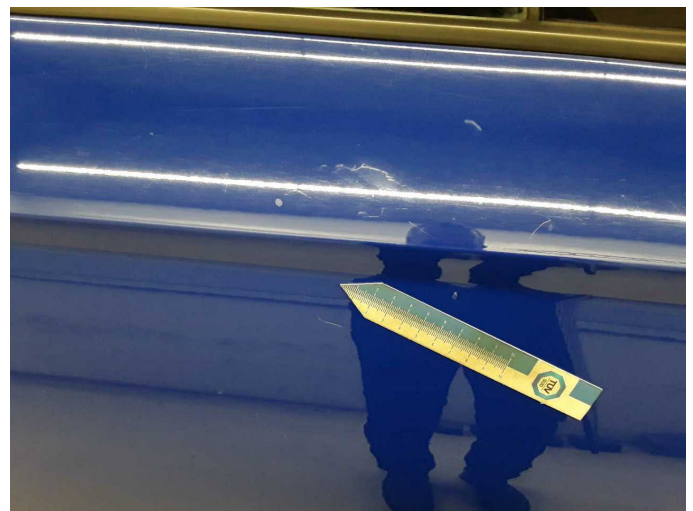
**Damage 13:** Door - rear right side: Door - Scratch(es) - Paint

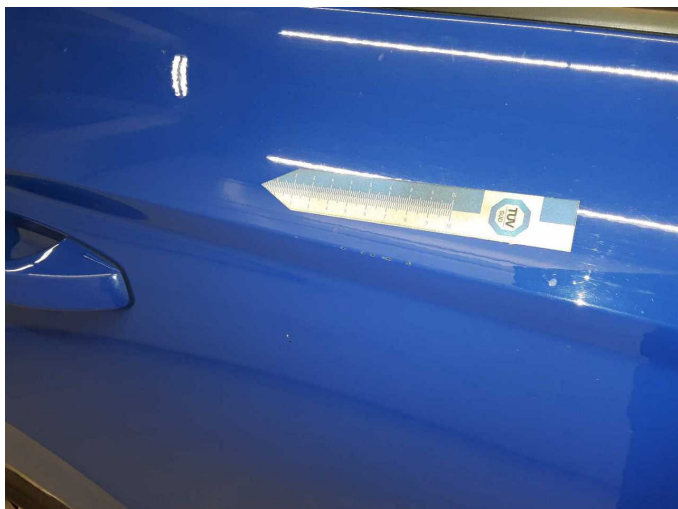
**Damage 13:** Door - rear right side: Door - Scratch(es) - Paint

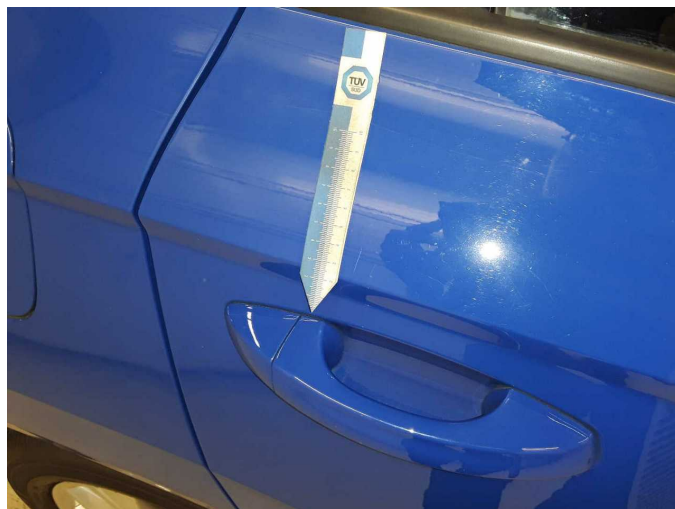
**Damage 13:** Door - rear right side: Door - Scratch(es) - Paint

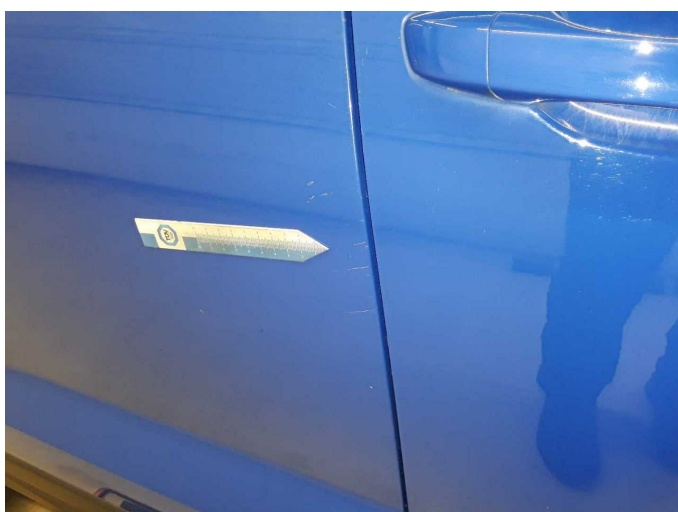
**Damage 13:** Door - rear right side: Door - Scratch(es) - Paint

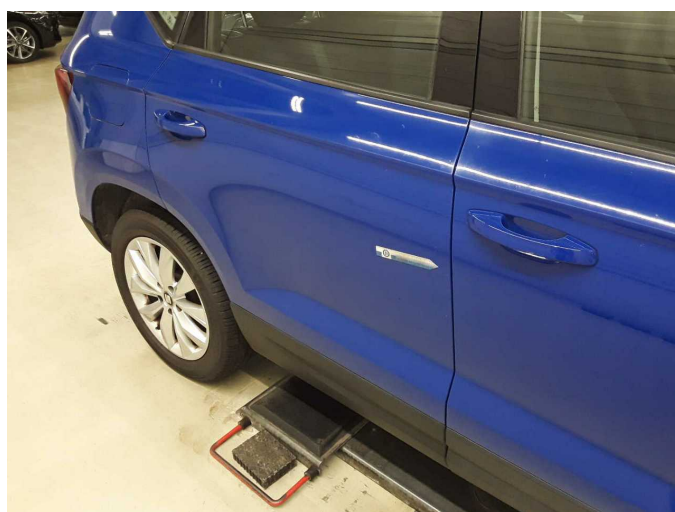
**Damage 13:** Door - rear right side: Door - Scratch(es) - Paint

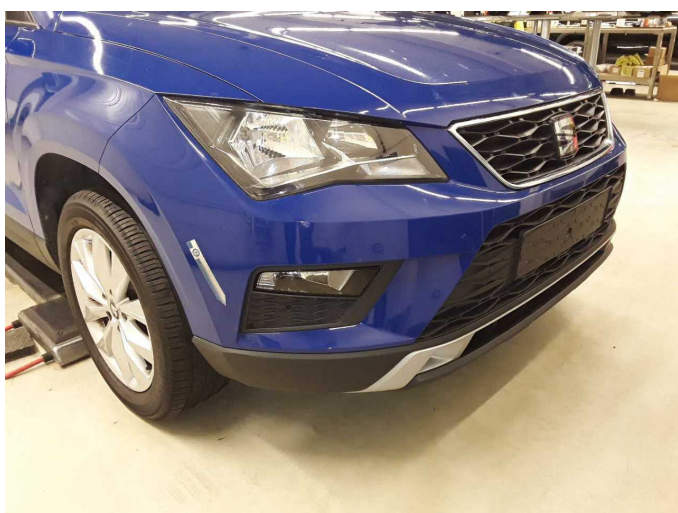
| No. | Component group | Description |
|---|---|---|
| 14 | Front bumper | Front bumper - Dent / paintcoat damage - Paint |

**Damage 14:** Front bumper: Front bumper - Dent / paintcoat damage - Paint

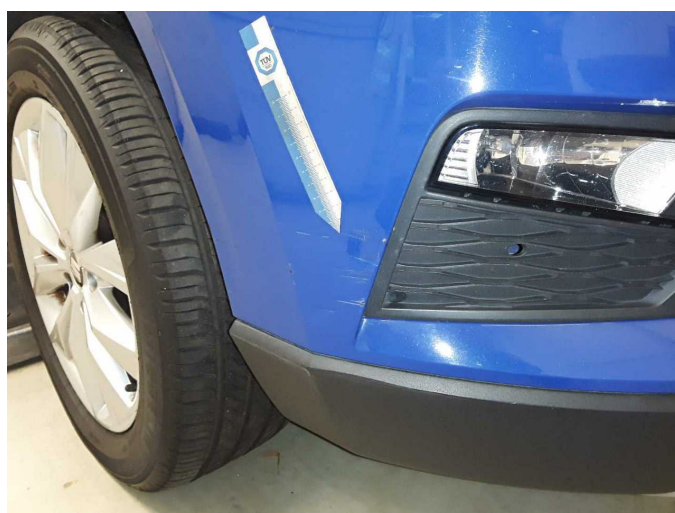
**Damage 14:** Front bumper: Front bumper - Dent / paintcoat damage - Paint

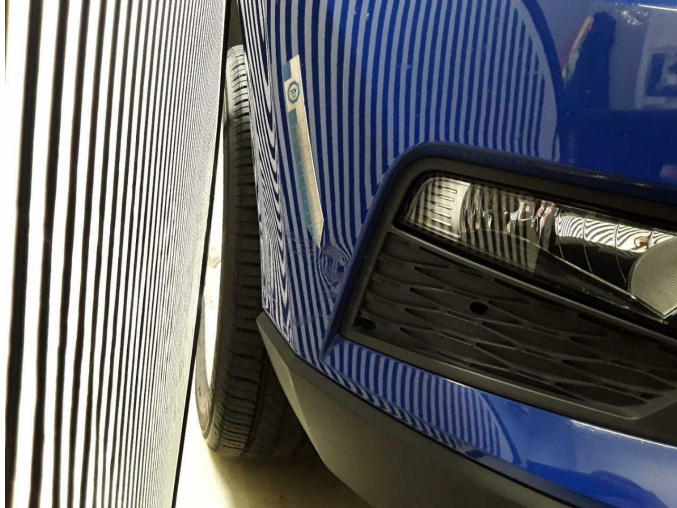
**Damage 14:** Front bumper: Front bumper - Dent / paintcoat damage - Paint

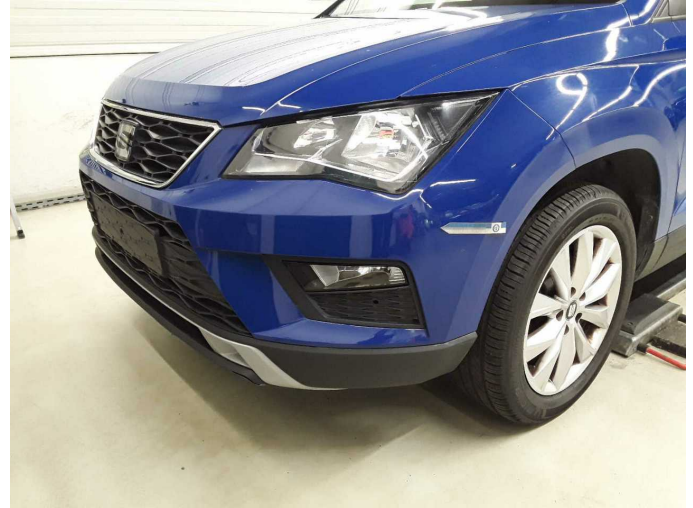
**Damage 14:** Front bumper: Front bumper - Dent / paintcoat damage - Paint

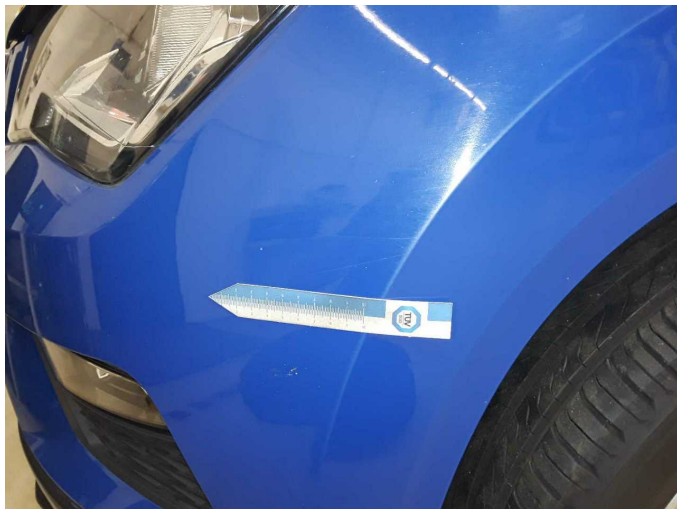
**Damage 14:** Front bumper: Front bumper - Dent / paintcoat damage - Paint

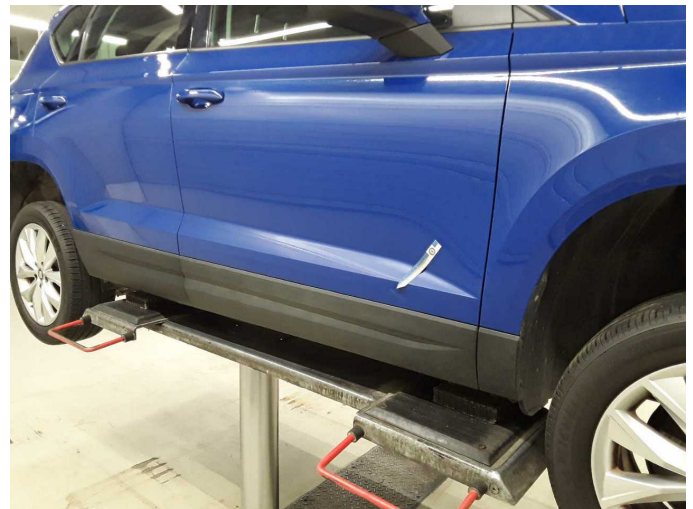
| No. | Component group | Description |
|---|---|---|
| 15 | Door - front right side | Door - Dent / paintcoat damage - Paint |

**Damage 15:** Door - front right side: Door - Dent / paintcoat damage - Paint

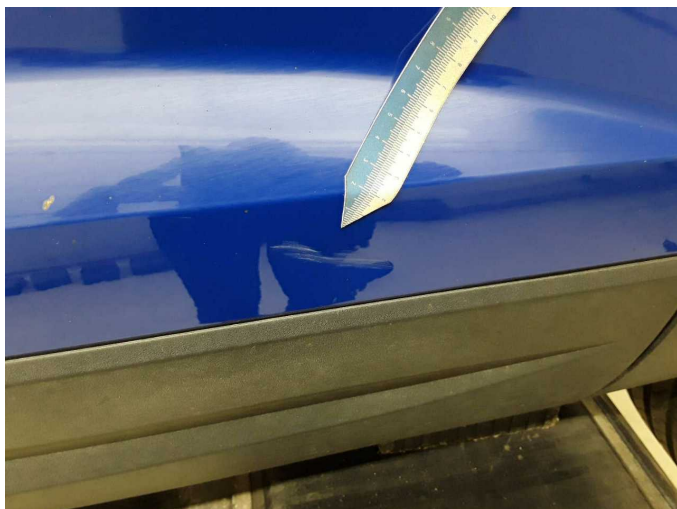
**Damage 15:** Door - front right side: Door - Dent / paintcoat damage - Paint

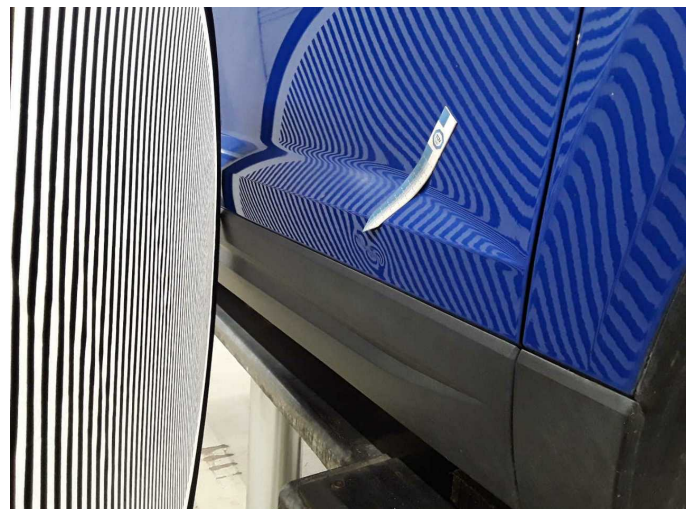
**Damage 15:** Door - front right side: Door - Dent / paintcoat damage - Paint

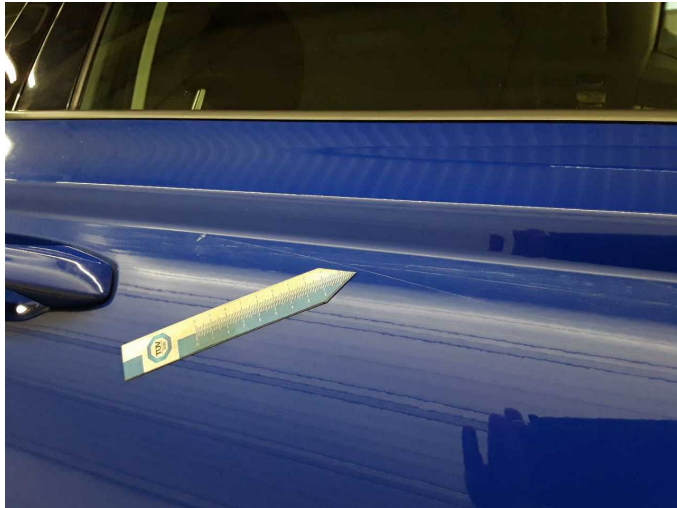
**Damage 15:** Door - front right side: Door - Dent / paintcoat damage - Paint

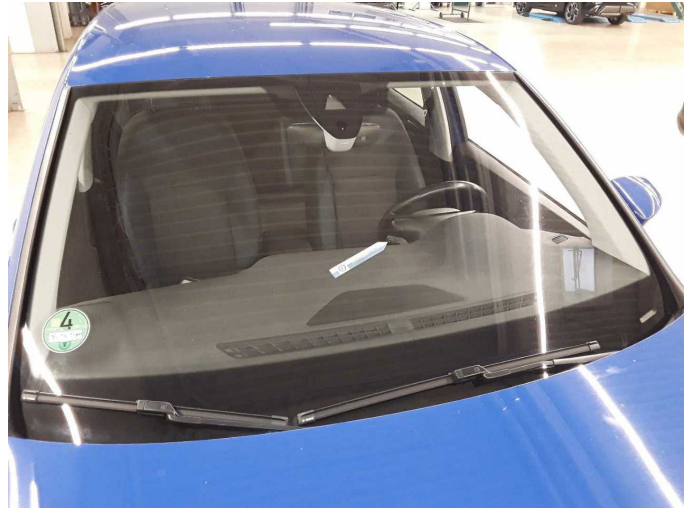
| No. | Component group | Description |
|---|---|---|
| 16 | Vehicle glazing | Windscreen - Stone chips - Replace |

**Damage 16:** Vehicle glazing: Windscreen - Stone chips - Replace

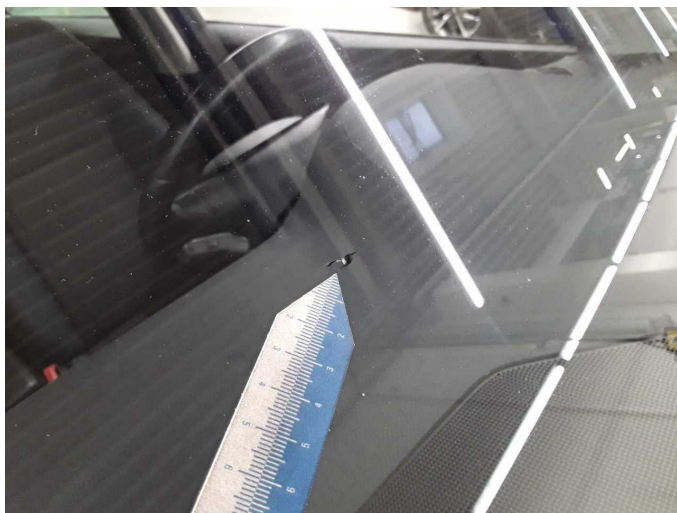
**Damage 16:** Vehicle glazing: Windscreen - Stone chips - Replace

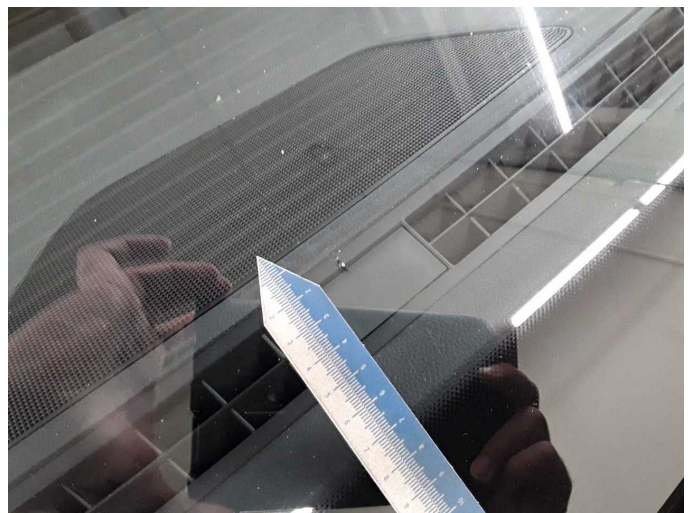
**Damage 16:** Vehicle glazing: Windscreen - Stone chips - Replace

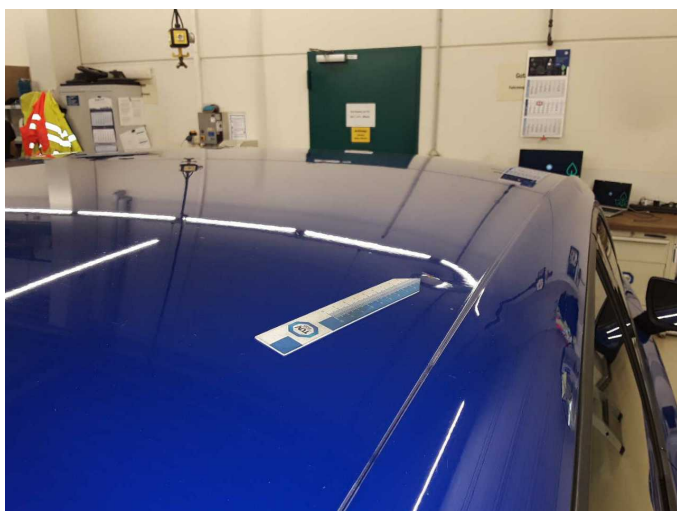
| No. | Component group | Description |
|---|---|---|
| 17 | Roof | Roof - Dent / paintcoat damage - Repair and paint |

**Damage 17:** Roof: Roof - Dent / paintcoat damage - Repair and paint

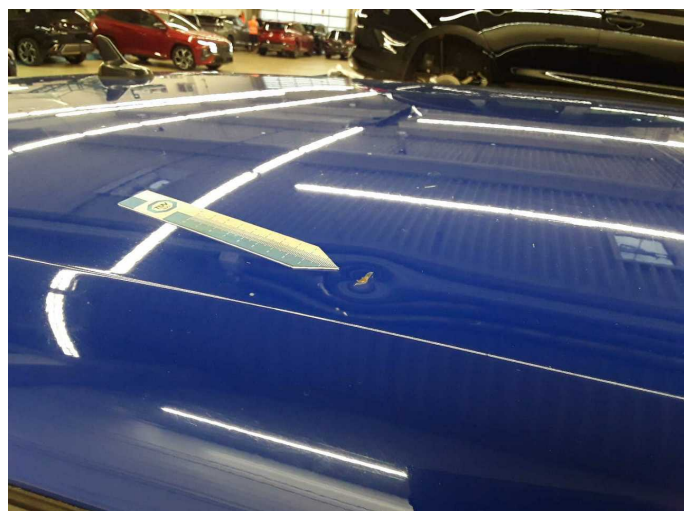
**Damage 17:** Roof: Roof - Dent / paintcoat damage - Repair and paint

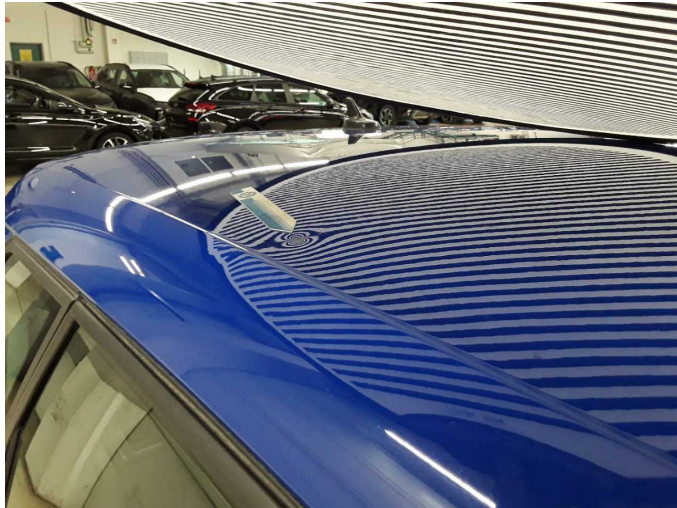
**Damage 17:** Roof: Roof - Dent / paintcoat damage - Repair and paint

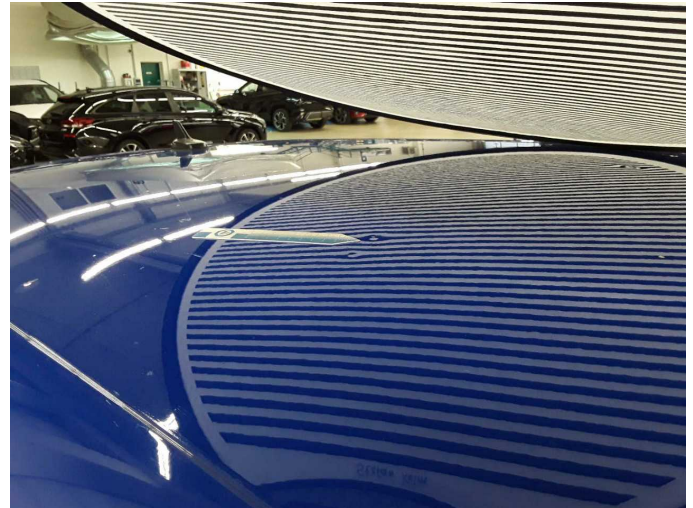
**Damage 17:** Roof: Roof - Dent / paintcoat damage - Repair and paint

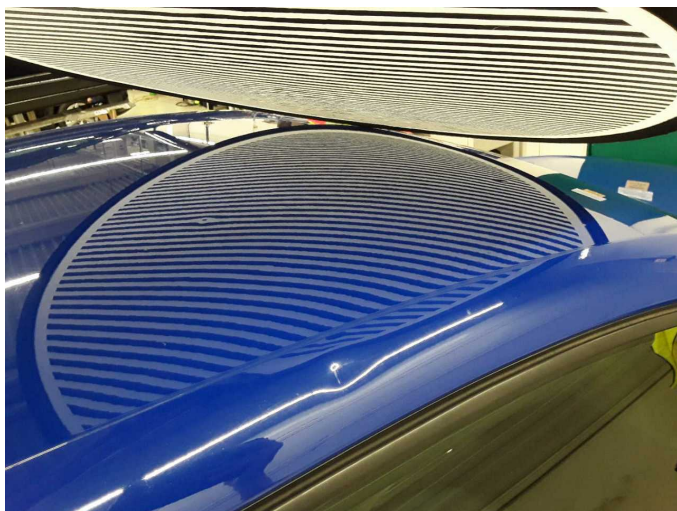
**Damage 17:** Roof: Roof - Dent / paintcoat damage - Repair and paint

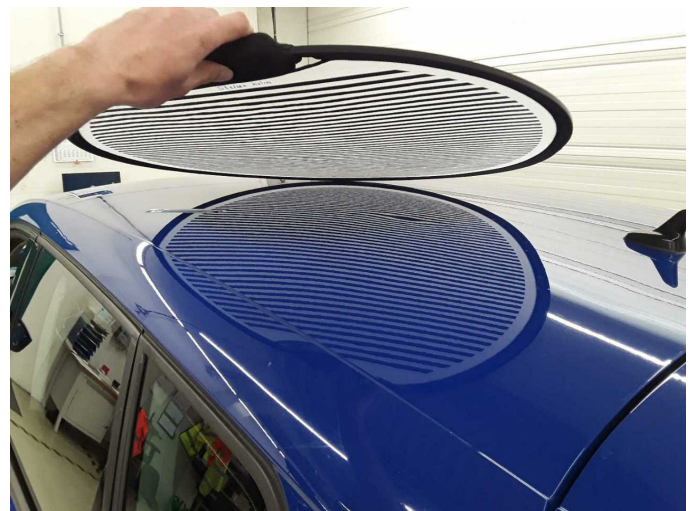
**Damage 17:** Roof: Roof - Dent / paintcoat damage - Repair and paint

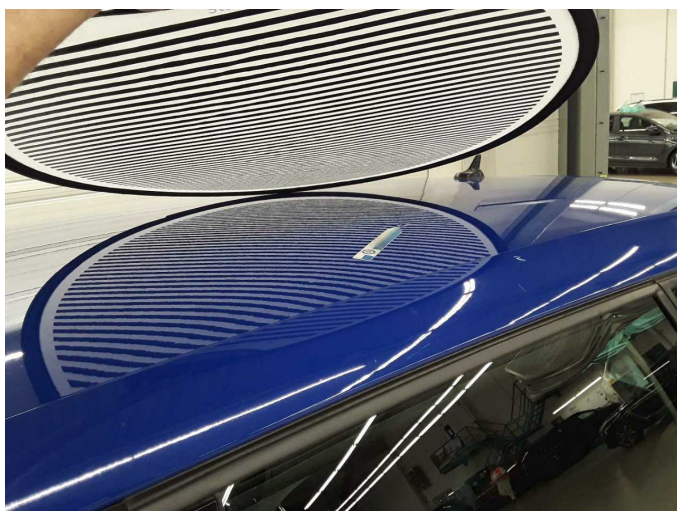
**Damage 17:** Roof: Roof - Dent / paintcoat damage - Repair and paint

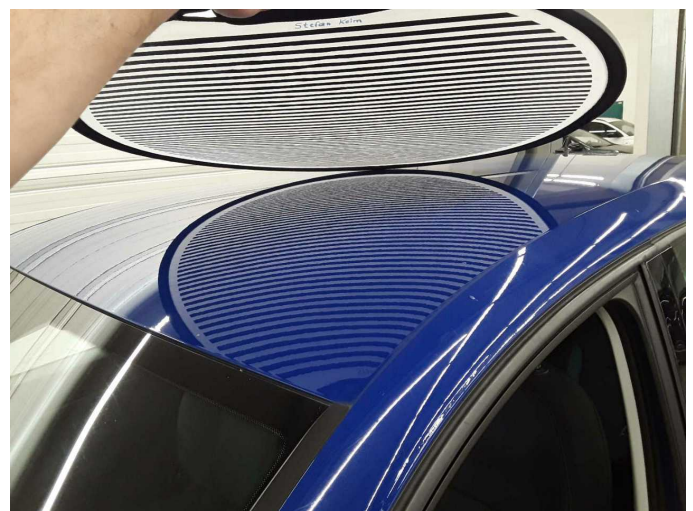
**Damage 17:** Roof: Roof - Dent / paintcoat damage - Repair and paint

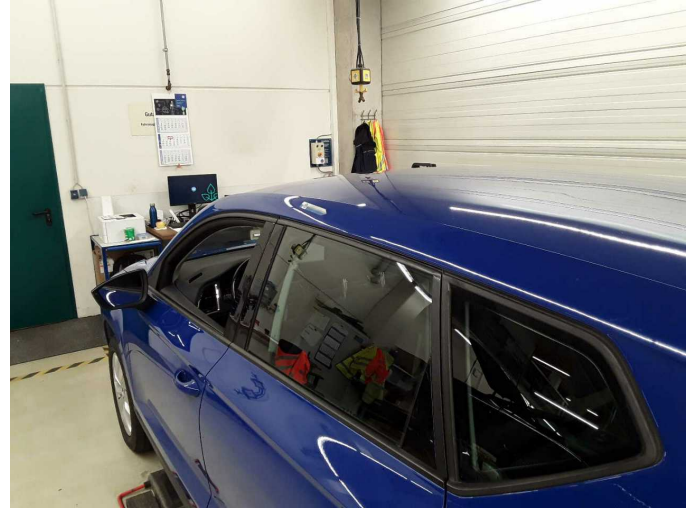
| No. | Component group | Description |
|---|---|---|
| 3 | Roof | Roof rail - left side - dent(s) - No deduction |

**Wear and tear 3:** Roof: Roof rail - left side - dent(s) - No deduction

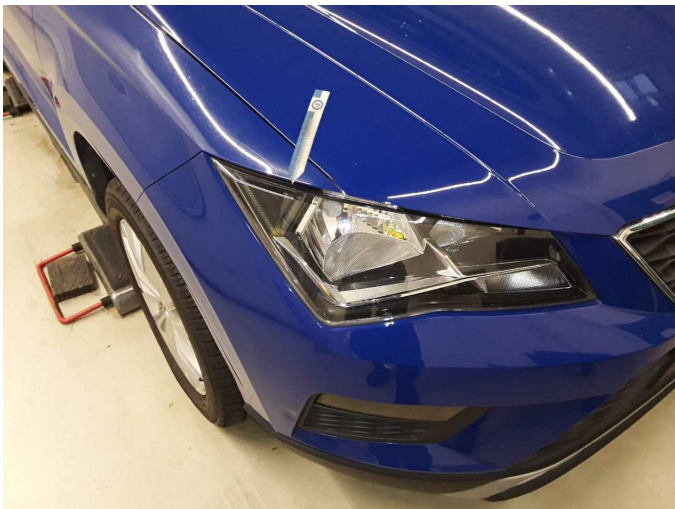
| No. | Component group | Description |
|---|---|---|
| 4 | Headlight | Headlight - right side - Scratch(es) - No deduction |

**Wear and tear 4:** Headlight: Headlight - right side - Scratch(es) - No deduction

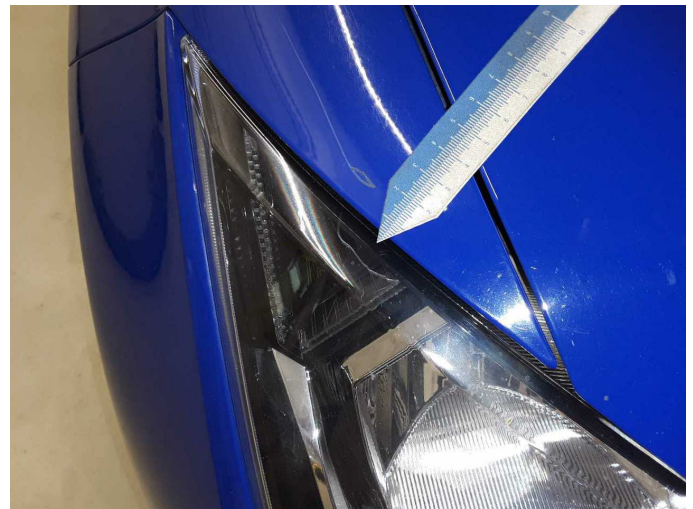
**Wear and tear 4:** Headlight: Headlight - right side - Scratch(es) - No deduction
