Expertise

Protocol number: 46334850  
Order No. / Reference: 26615109  
Inspection date: 1 Jul 2026

Manufacturer: Seat

Model: Ateca 1.6 TDI Style

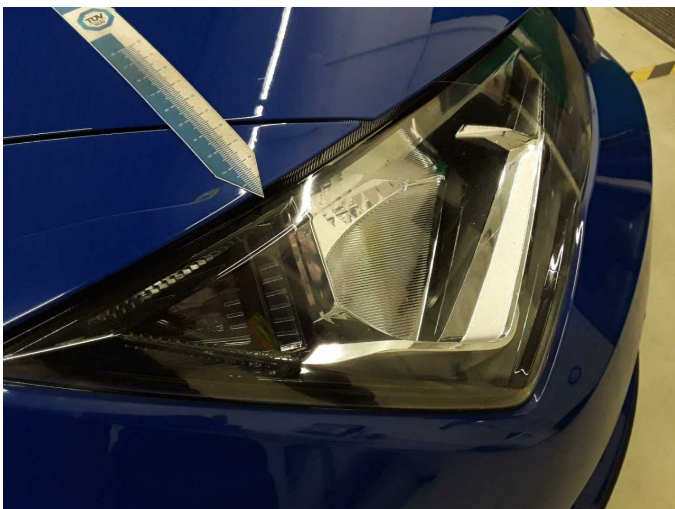
**Wear and tear 4:** Headlight: Headlight - right side - Scratch(es) - No deduction

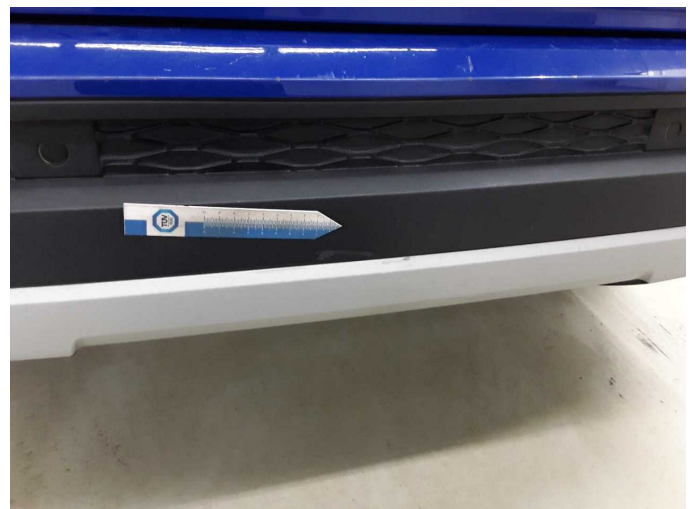
| No. | Component group | Description |
|---|---|---|
| 6 | Rear bumper | Spoiler - Scratch(es) - No deduction |

**Wear and tear 6:** Rear bumper: Spoiler - Scratch(es) - No deduction

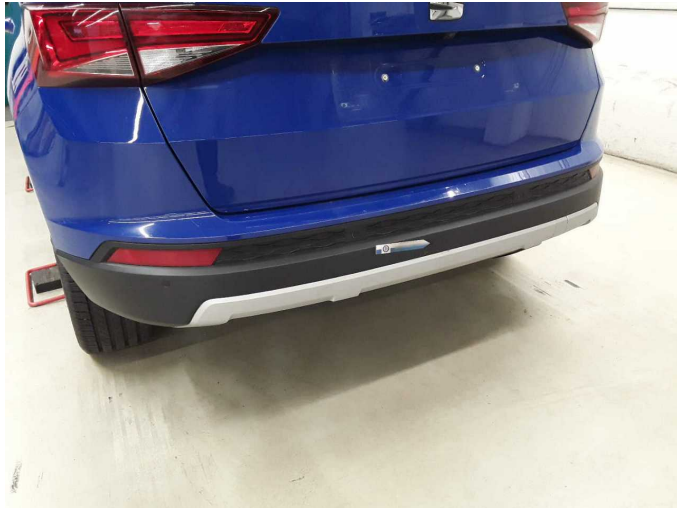
**Wear and tear 6:** Rear bumper: Spoiler - Scratch(es) - No deduction

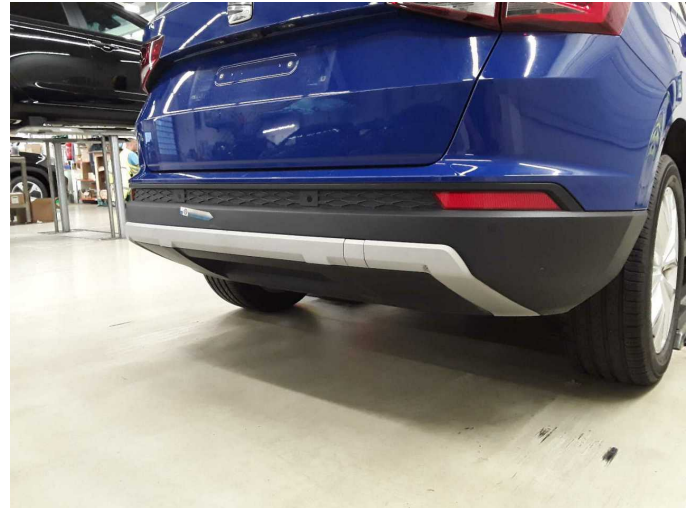
**Wear and tear 6:** Rear bumper: Spoiler - Scratch(es) - No deduction

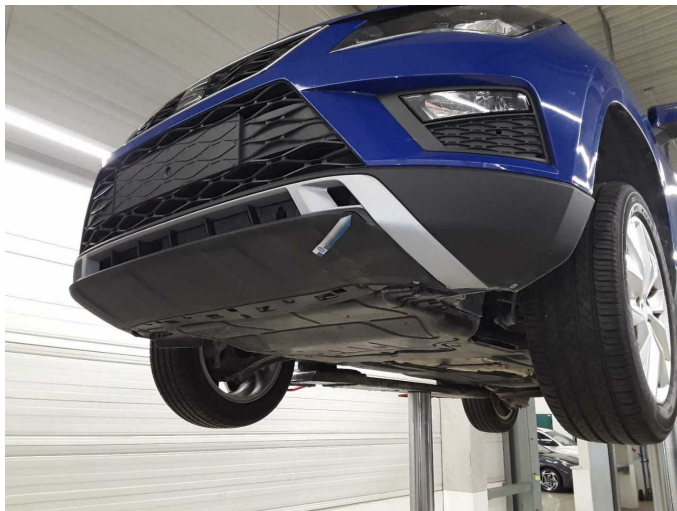
1 Front, Underbody

**Accident 1:** Front, Underbody
