Expertise

Protocol number: 46543964  
Order No. / Reference: 26603030  
Inspection date: 14 Jul 2026

Manufacturer: Peugeot

Model: 508 SW Hybrid 225 e-EAT8 Allure

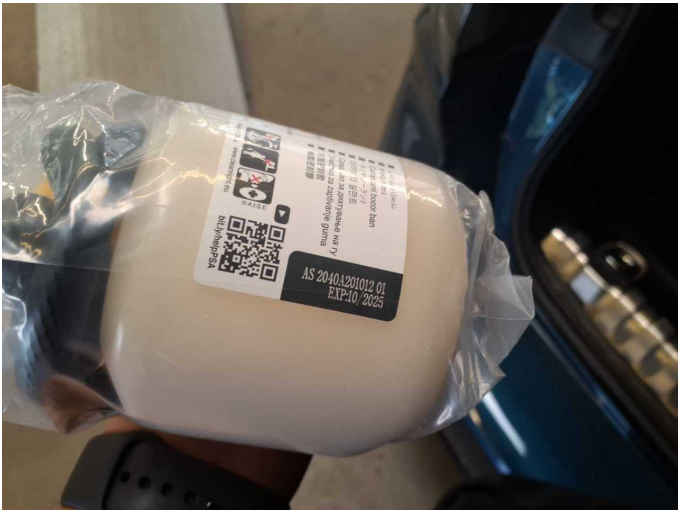
Damage 1: Equipment: Tirefit filler - Expired - Replace

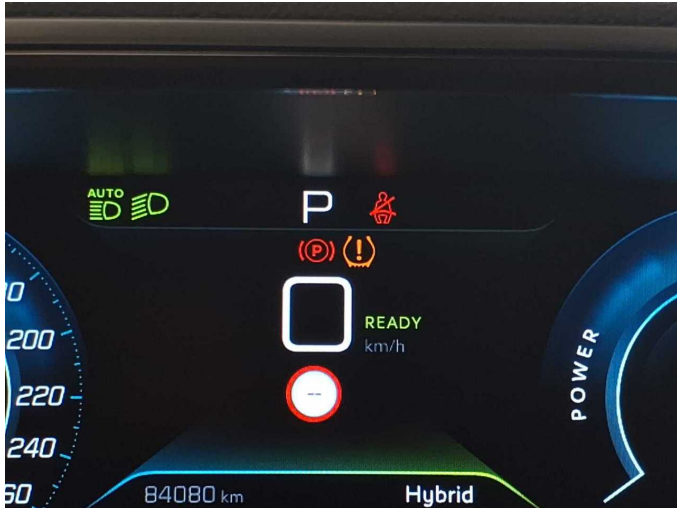
**Damage 2:** Instrument panel: Indicator light (Reifendruck) - on - Perform diagnosis

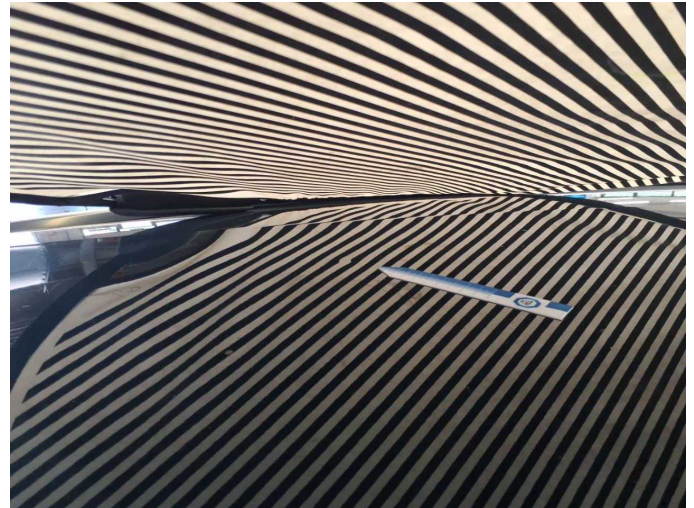
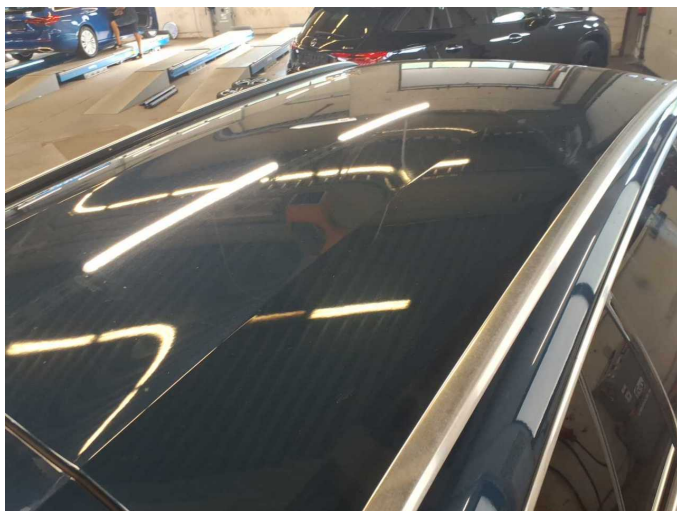
**Damage 3:** Roof: Roof - dent(s) - Smooth repair work

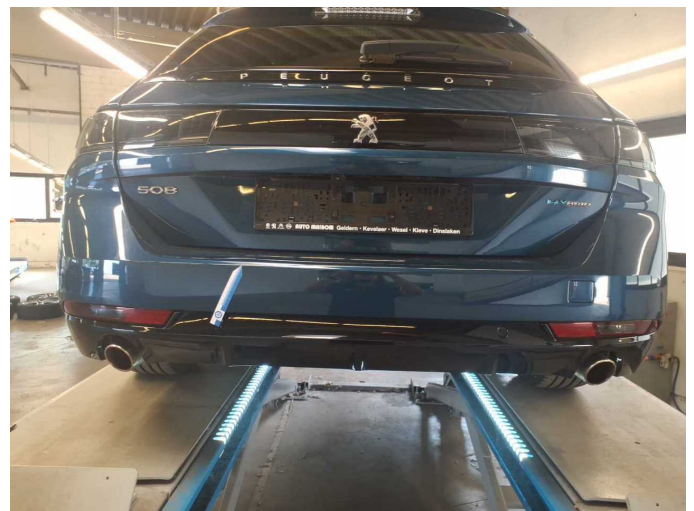
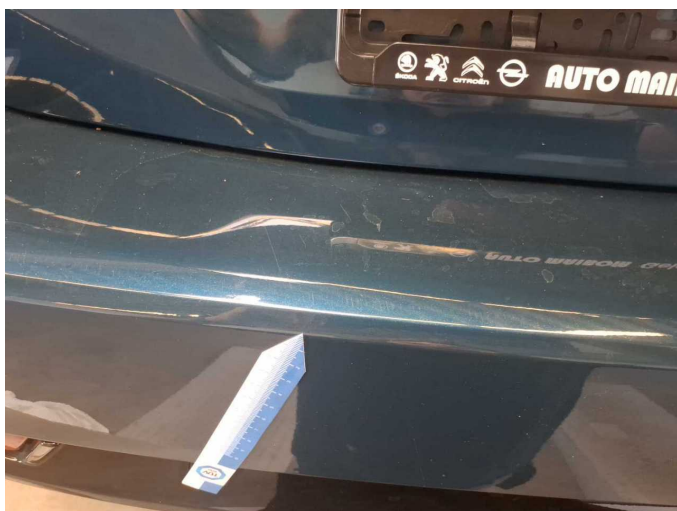
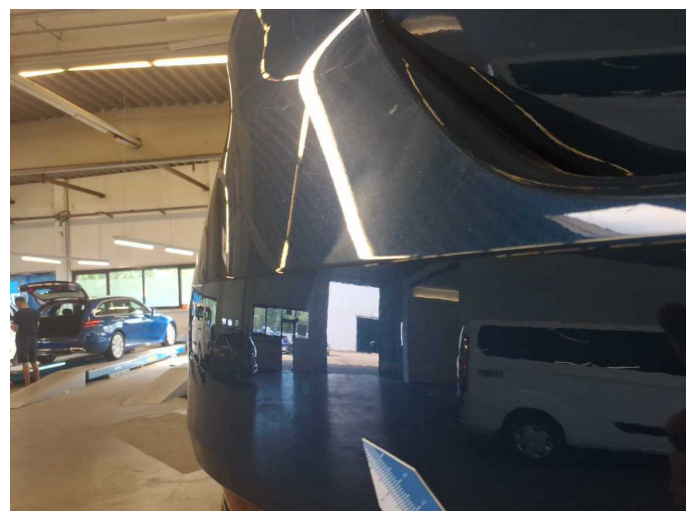
**Damage 4:** Rear bumper: Rear bumper (Lacknebel+kratzer) - Scratched - Smart repair

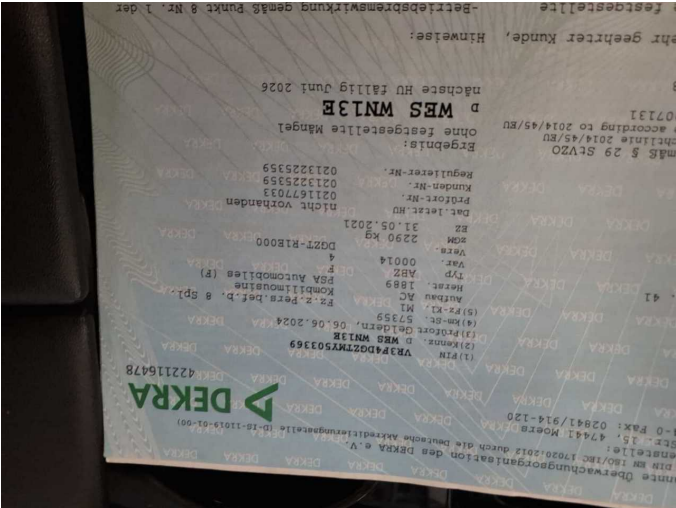
Damage 5: Misc.: Main inspection - Due - Perform

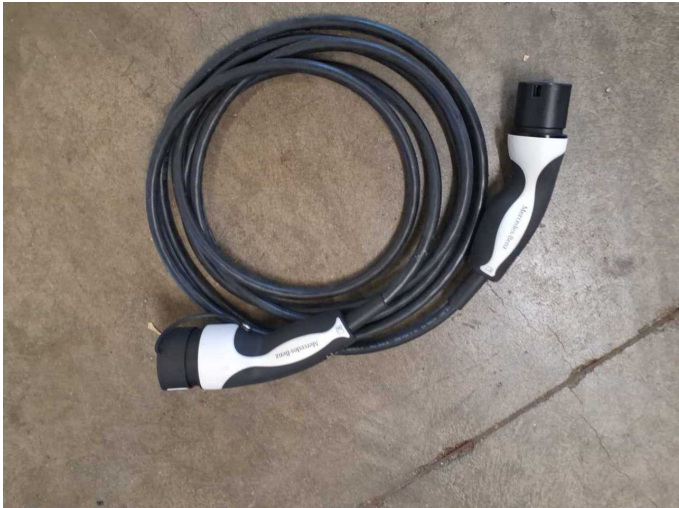
Damage 6: Equipment: charging cable (nicht für Haushaltssteckdosen (Schuko) geeignet) - Differs from the original configuration - Replace

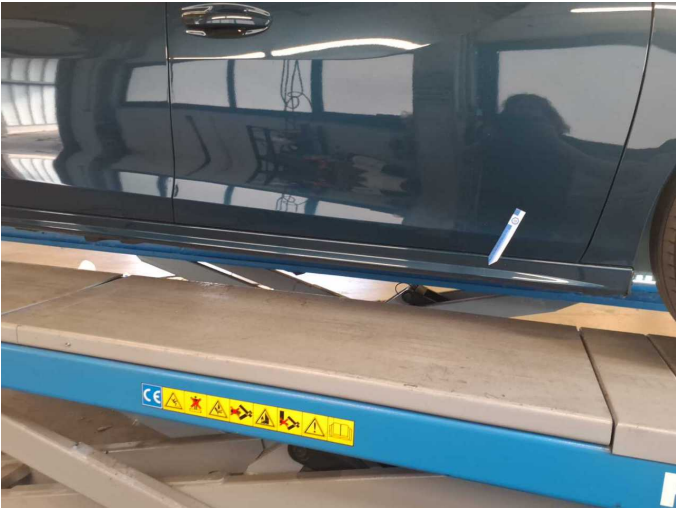
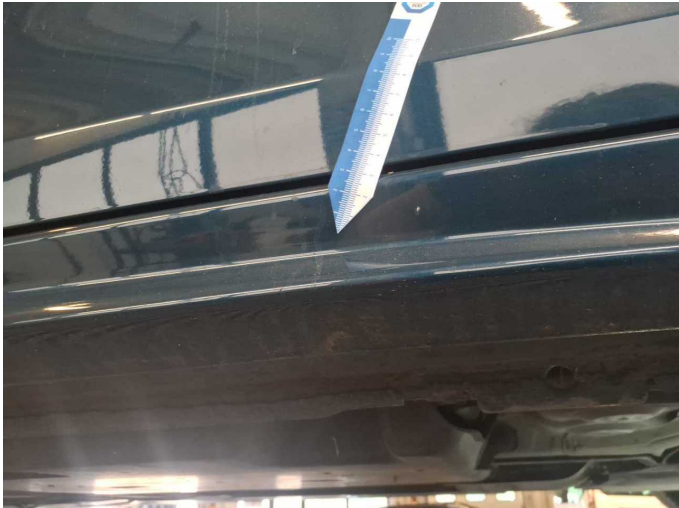
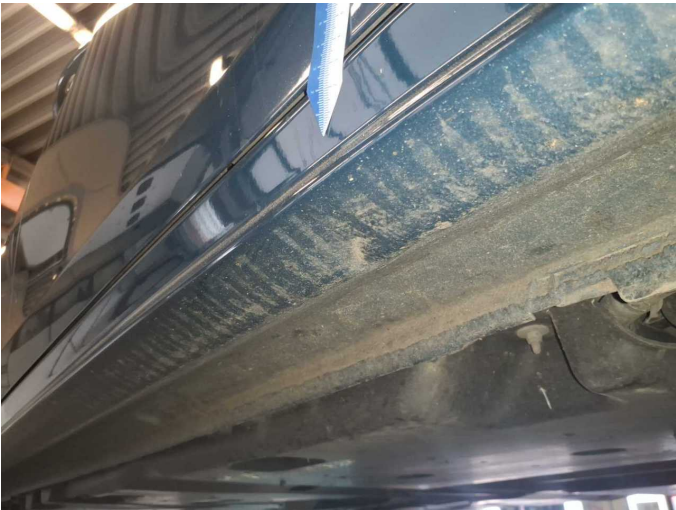
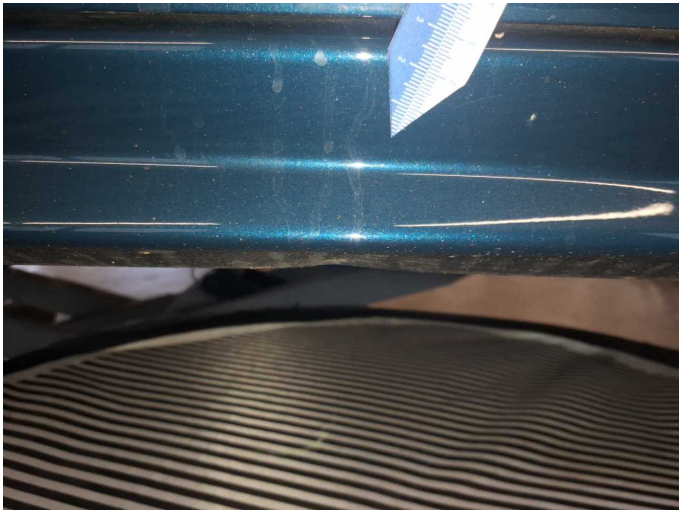
Damage 7: Sill - right side: Sill - Dent / paintcoat damage - Repair and paint

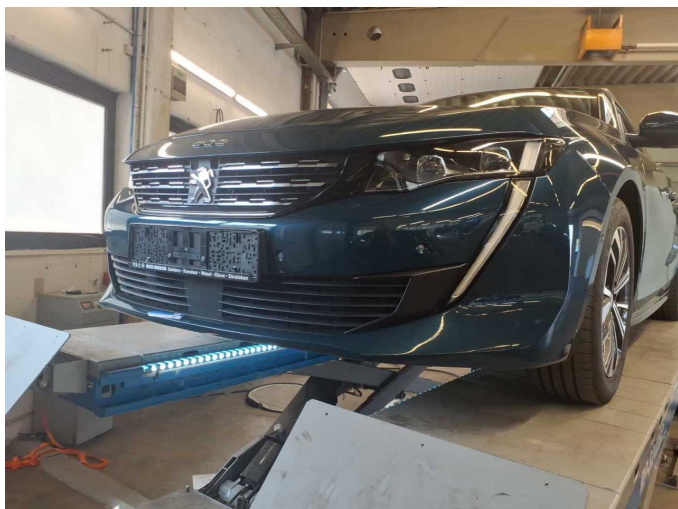
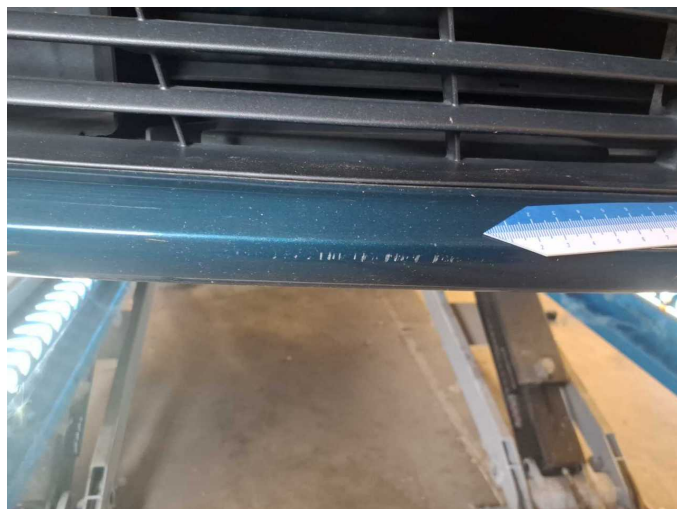
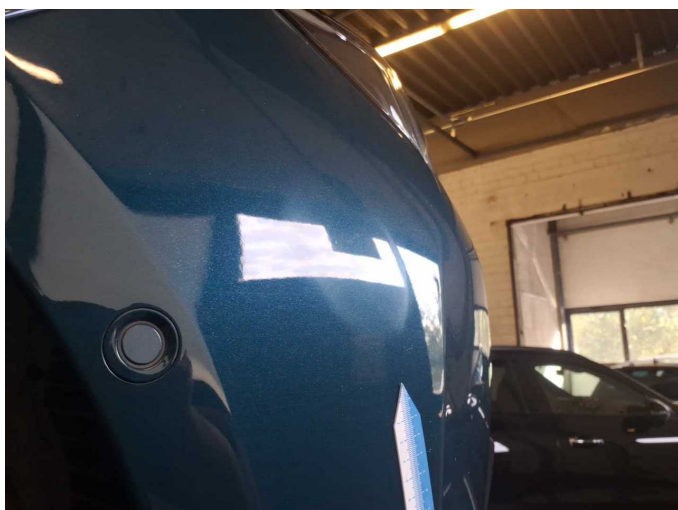
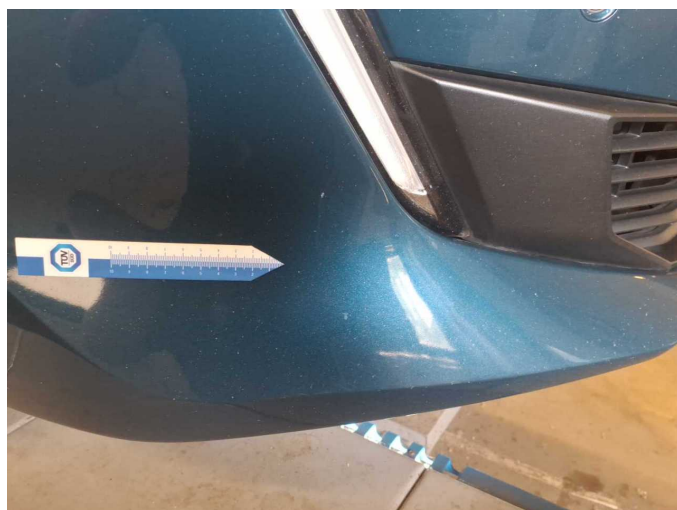
**Damage 8:** Front bumper: Front bumper - Scratched - Paint

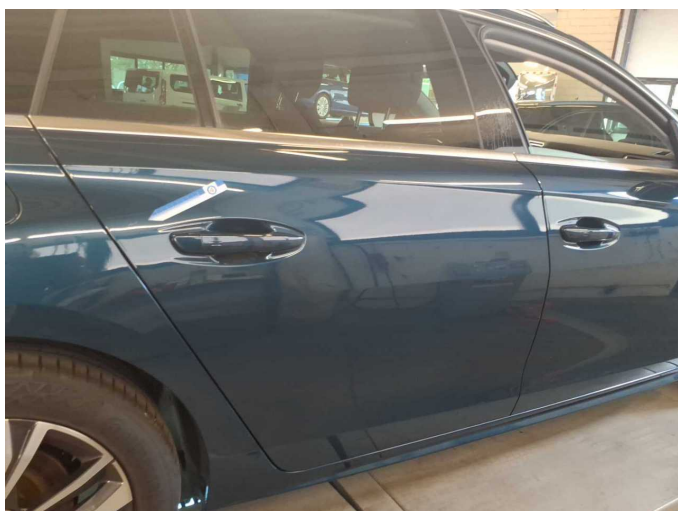
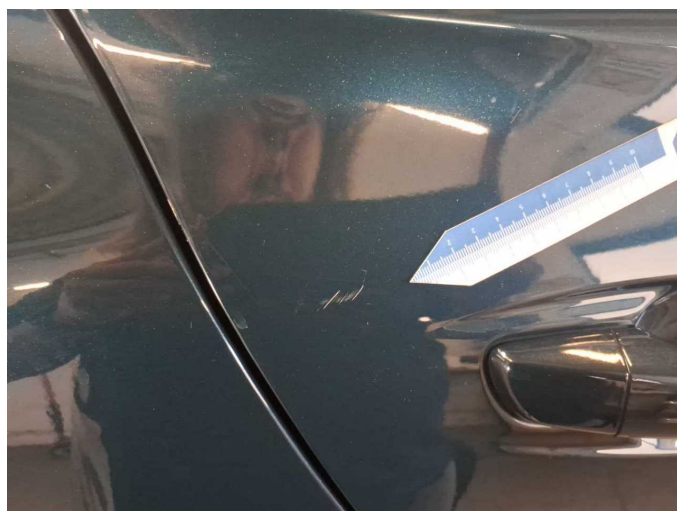
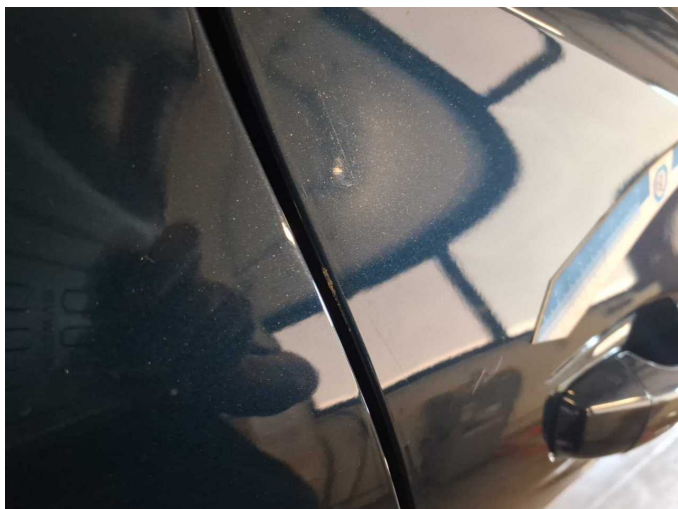
**Damage 9:** Door - rear right side: Door - Scratched - Paint

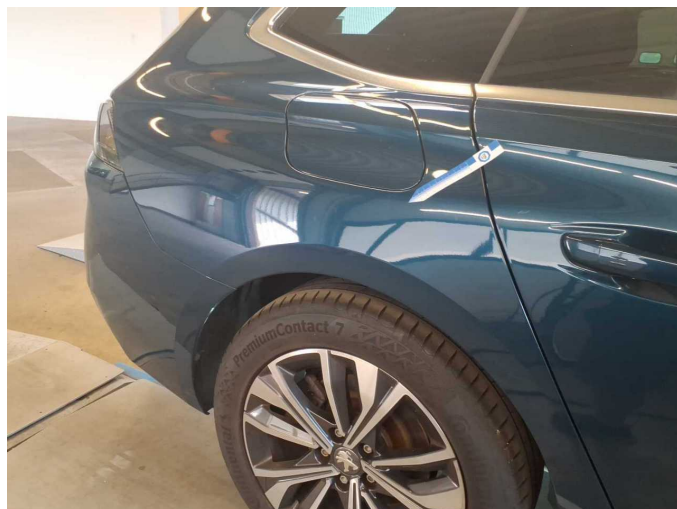
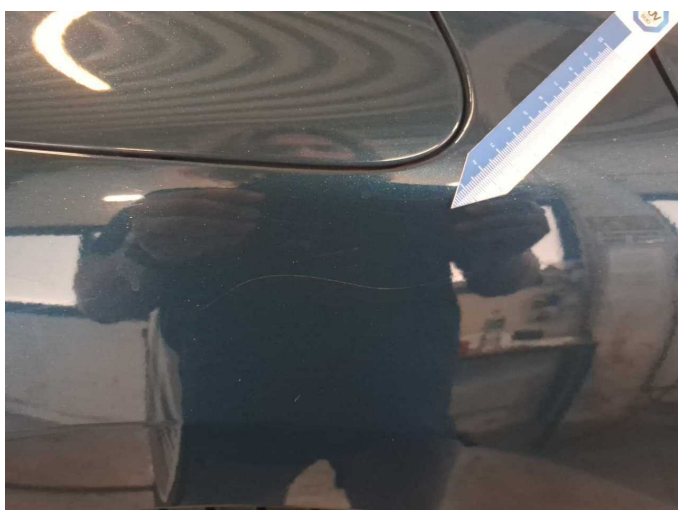
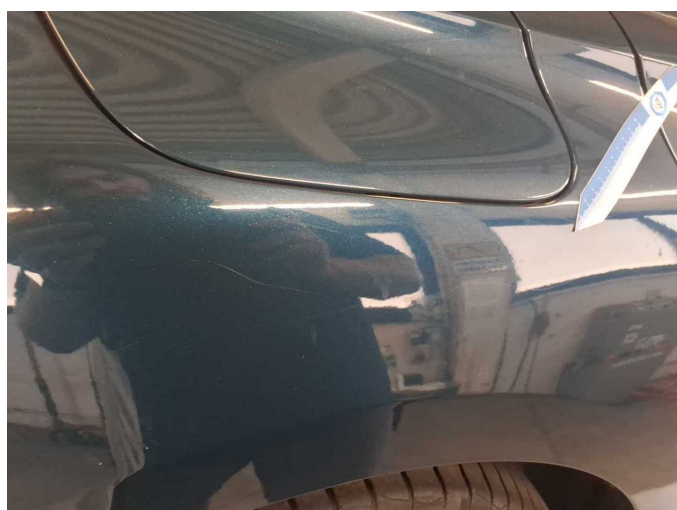
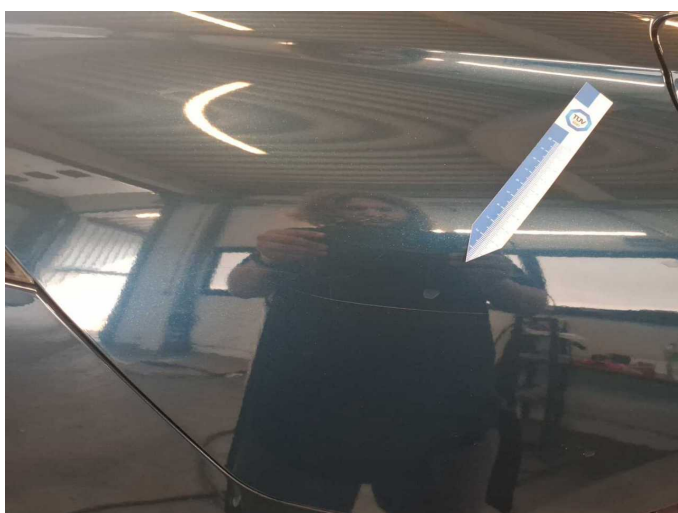
**Damage 10:** Side panel - rear right side: Side panel - Scratch(es) - Paint

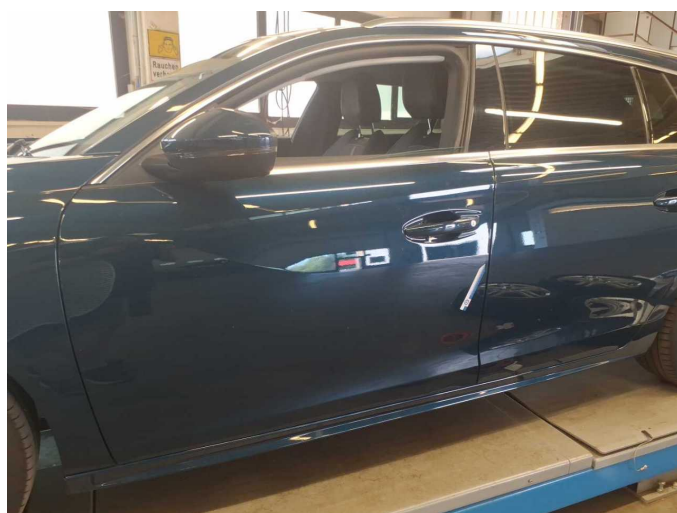
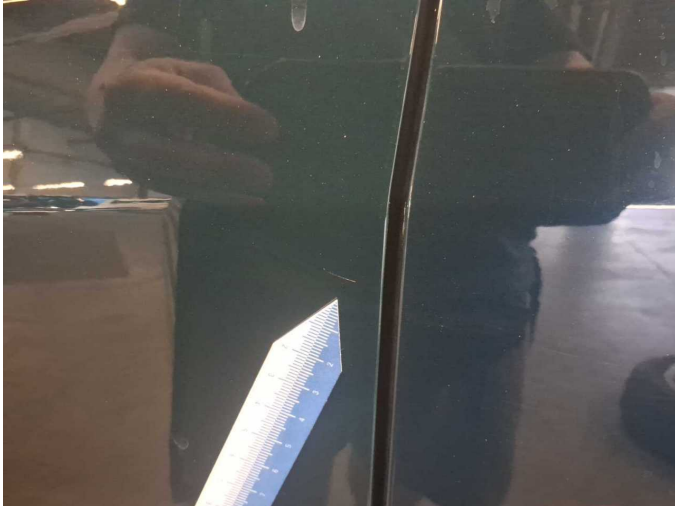
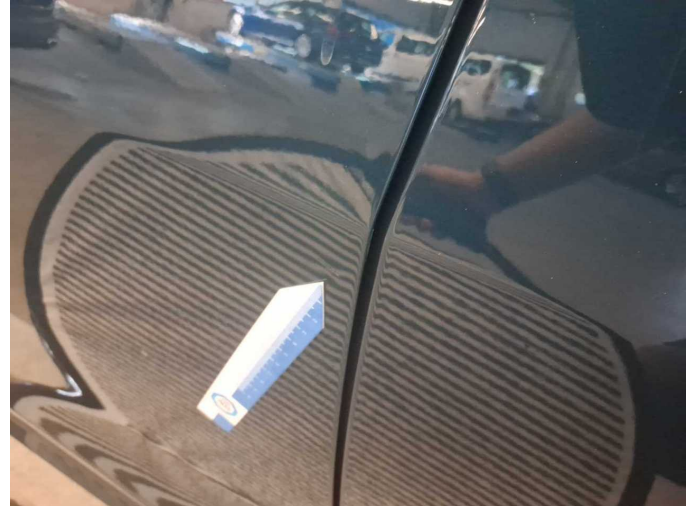
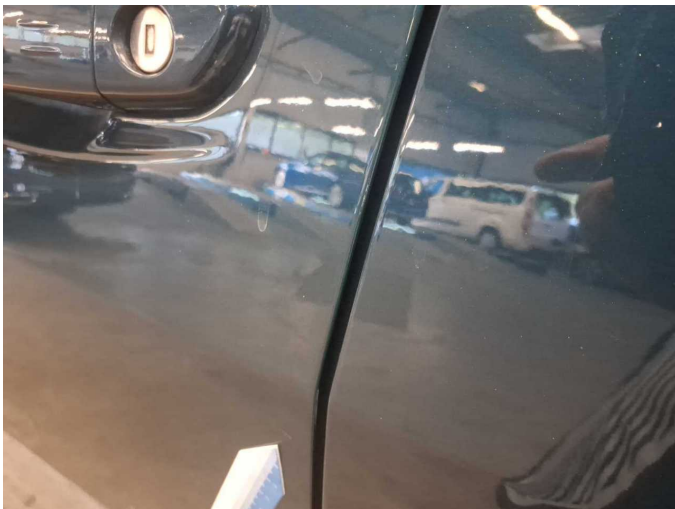
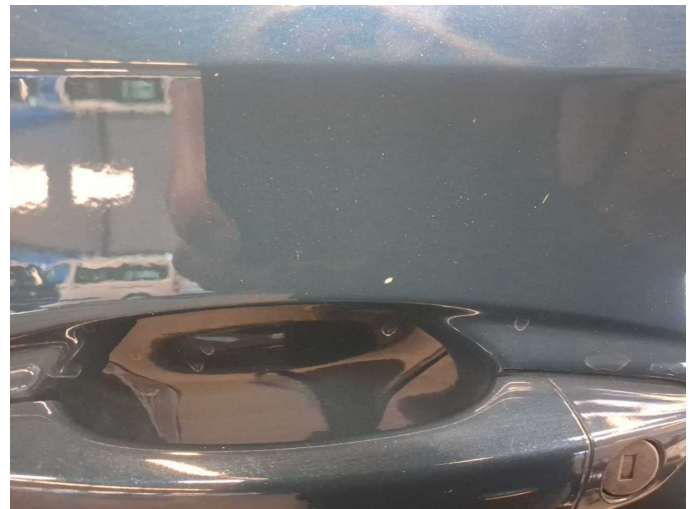
**Damage 11:** Door - front left side: Door - Dent / paintcoat damage - Repair and paint

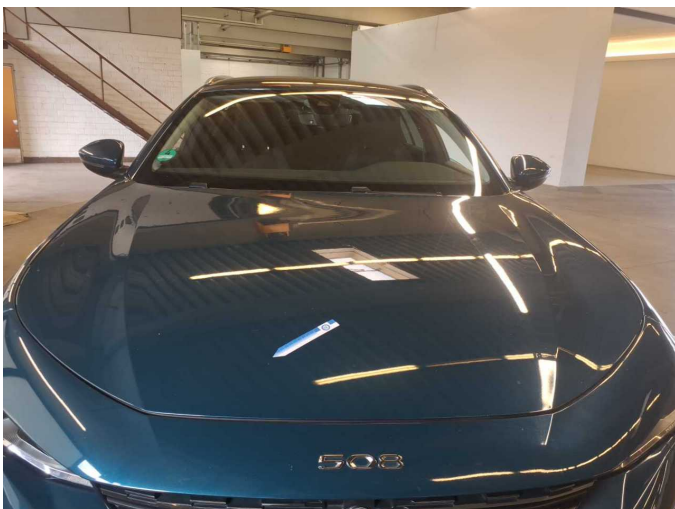
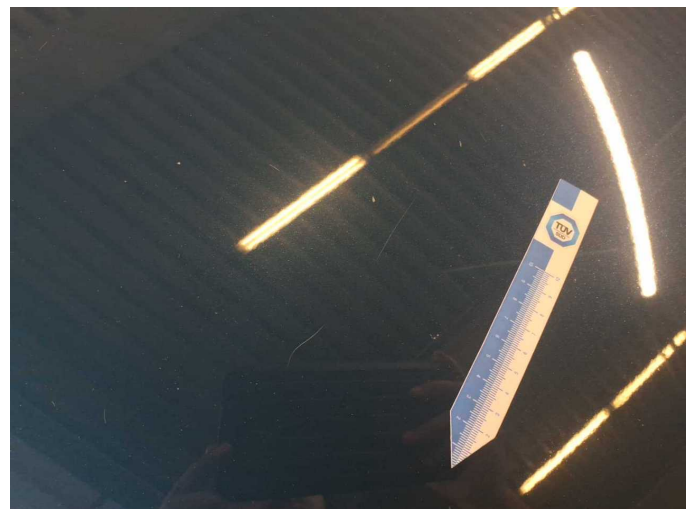
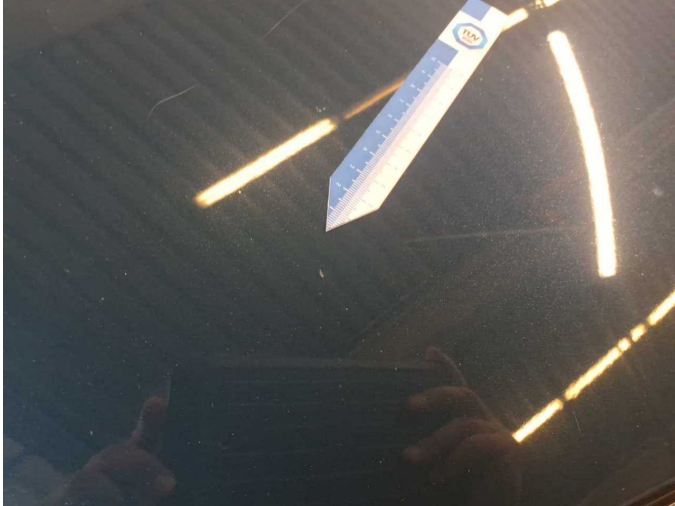
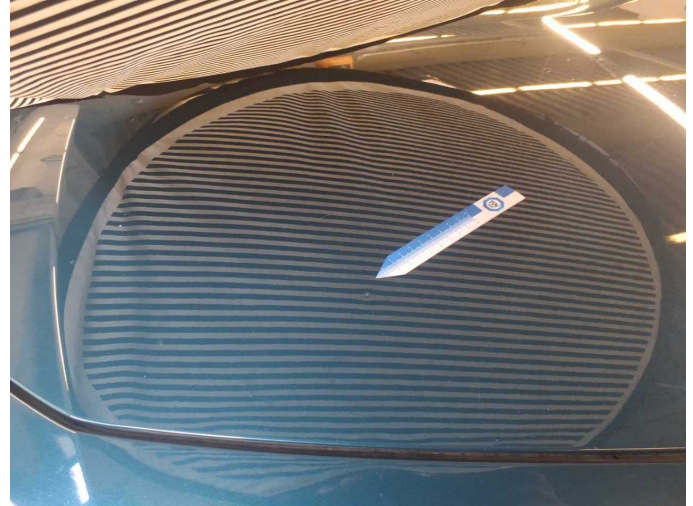
**Damage 12:** Bonnet: Bonnet - Dent / paintcoat damage - Repair and paint

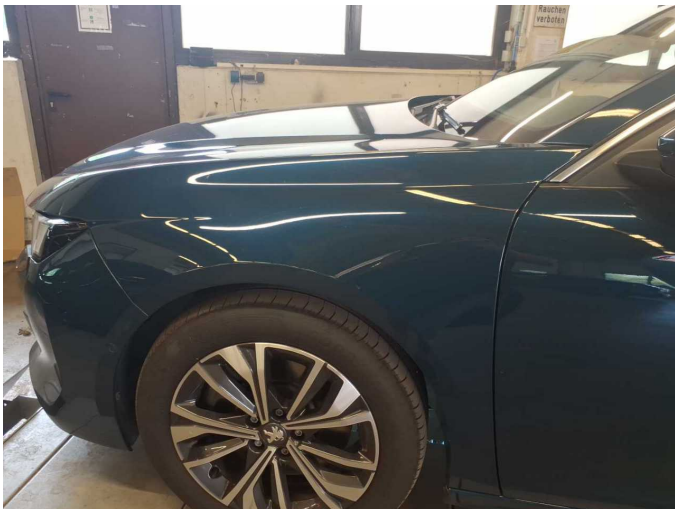
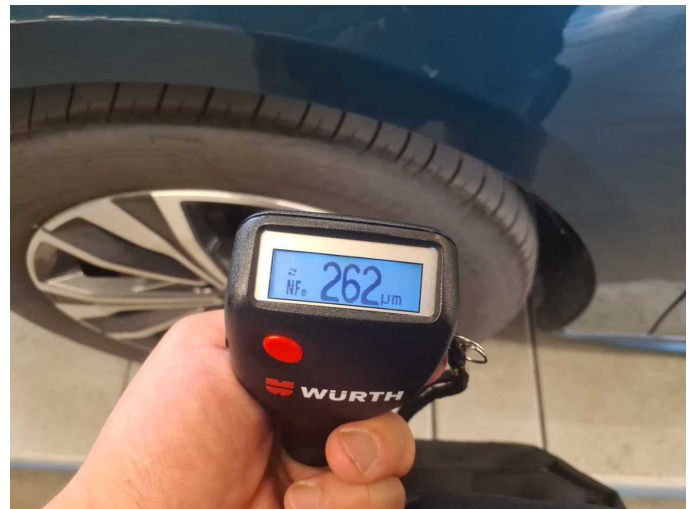
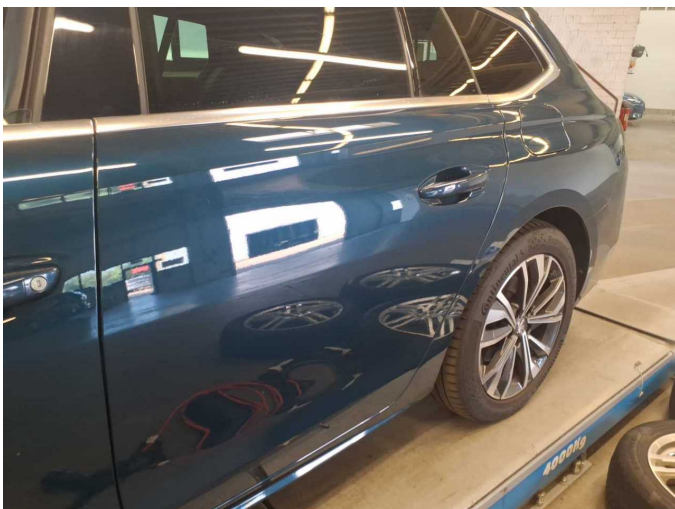
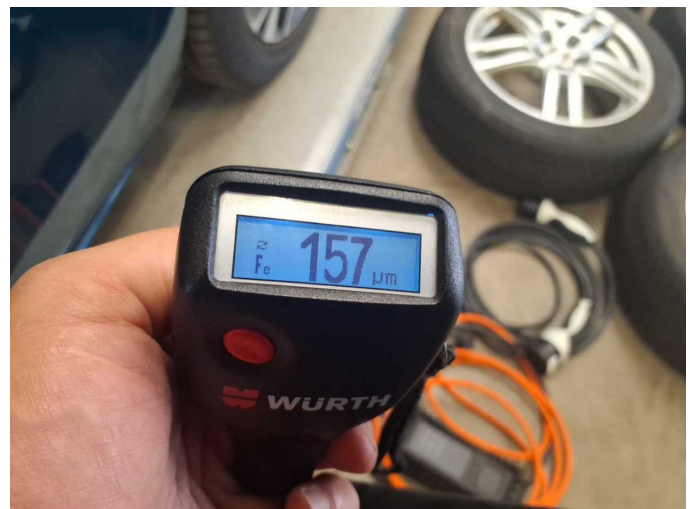
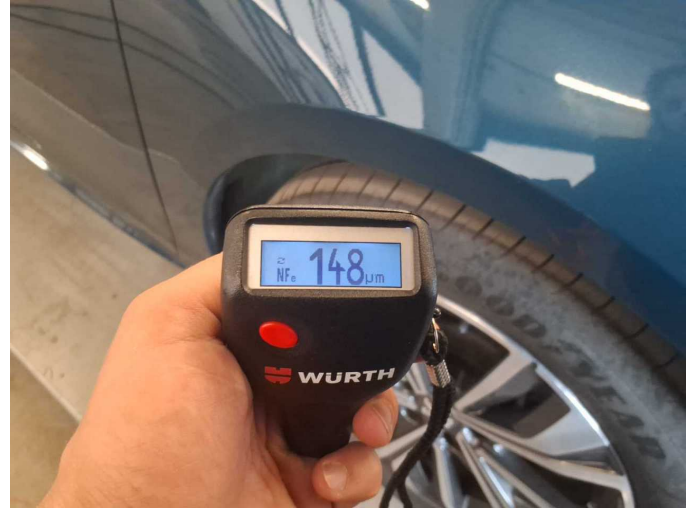
| Mudguard - left side | 264 µm | Mudguard - right side | 146 µm |
| Door - rear left side | 163 µm | | |

**Repainting 1:** Mudguard - left side, Mudguard - right side, Door - rear left side
