Expertise

Protocol number: 45931925
Order No. / Reference: 26463038
Inspection date: 11 Jun 2026

Manufacturer: Opel

Model: Combo-e Cargo XL (50-kWh) Edition

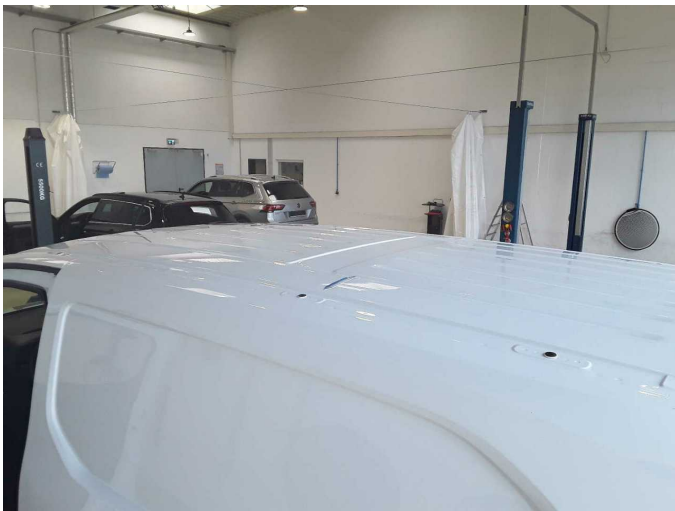
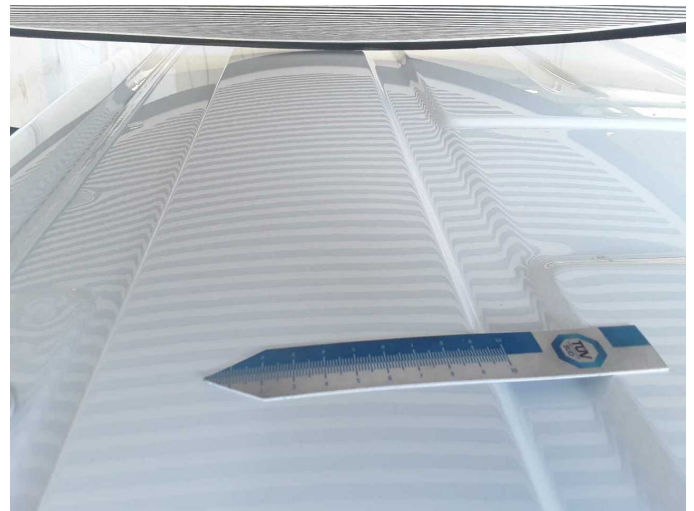
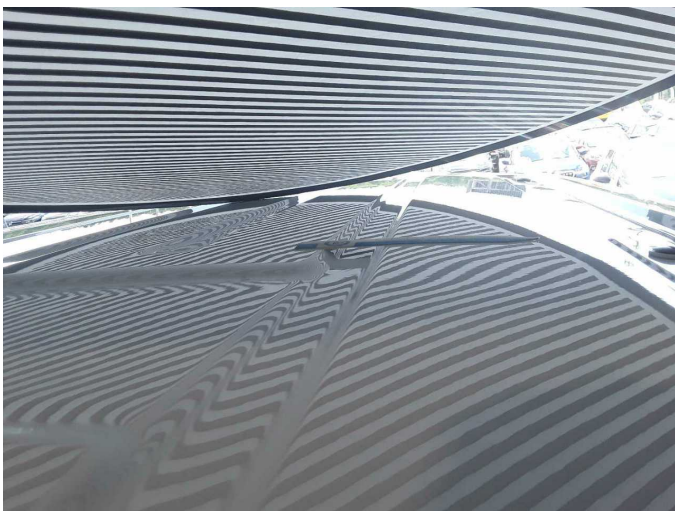
No.	Component group	Description
1	Misc.	Main inspection - No evidence - No deduction
2	Misc.	Inspection / maintenance - No evidence - No deduction
3	Roof	Roof - dent(s) - Smart repair
4	Front bumper	Spoiler - Scratched - Smart repair

Damage 3: Roof: Roof - dent(s) - Smart repair

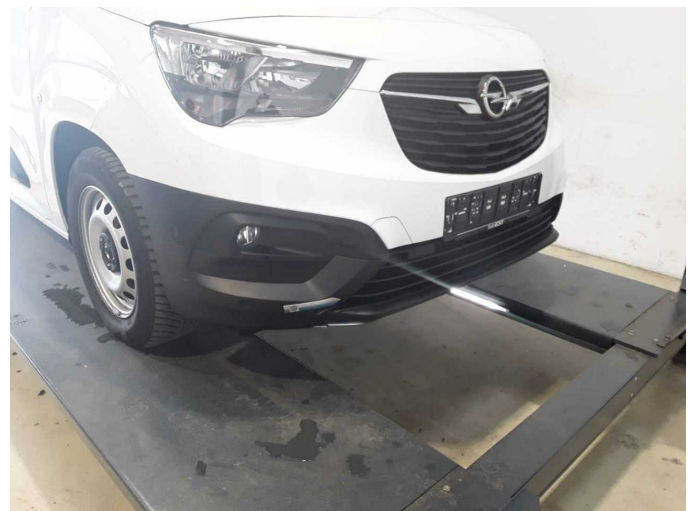
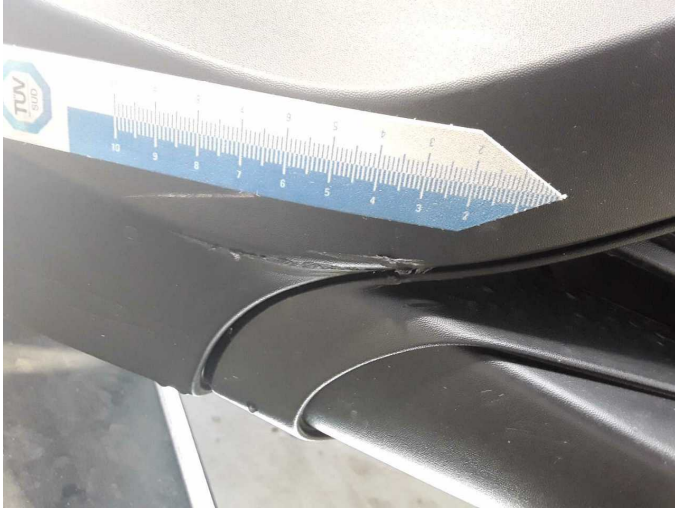
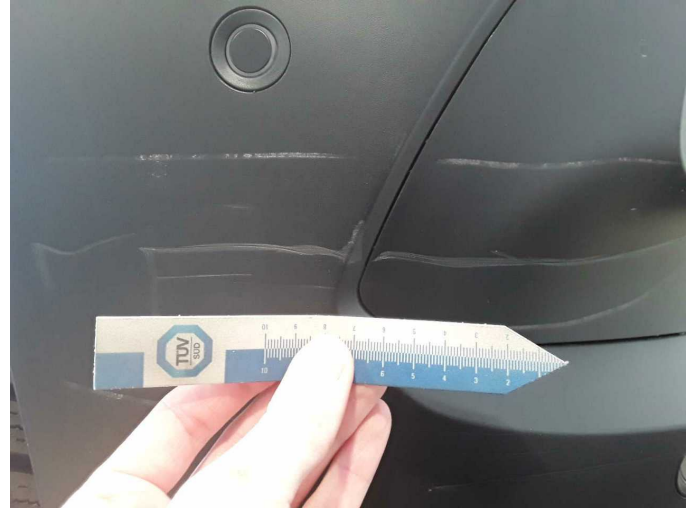
Damage 4: Front bumper: Spoiler - Scratched - Smart repair

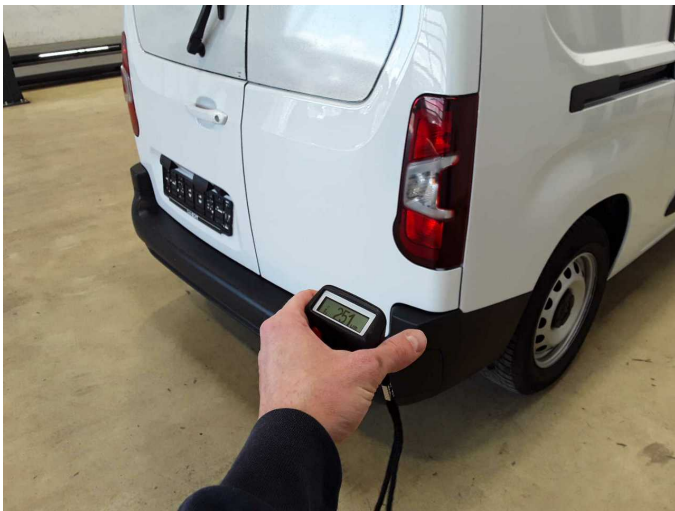
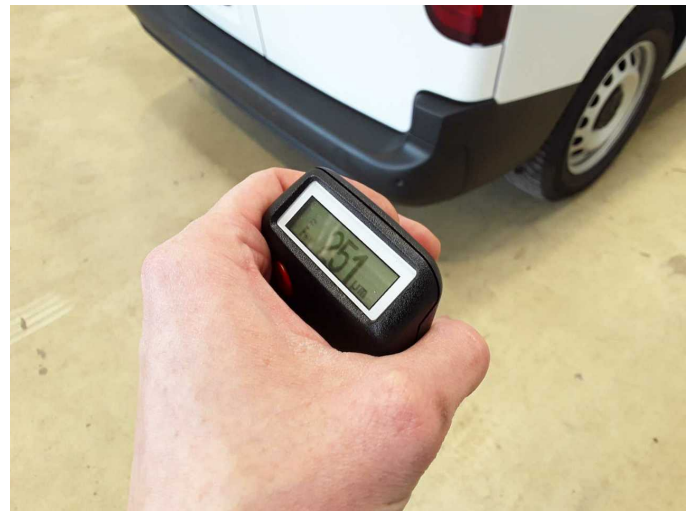
No.	Repainting
1	Boot lid / rear door, Professionally carried out, Invoice of repair done Non-existent

Boot lid / rear door	251 µm
----------------------	--------

Repainting 1: Boot lid / rear door
