## Expertise

Protocol number: 46031703  
Order No. / Reference: 26152432  
Inspection date: 17 Jun 2026

Manufacturer: Mercedes-Benz

Model: 317 CDI Sprinter Lang HA PRO

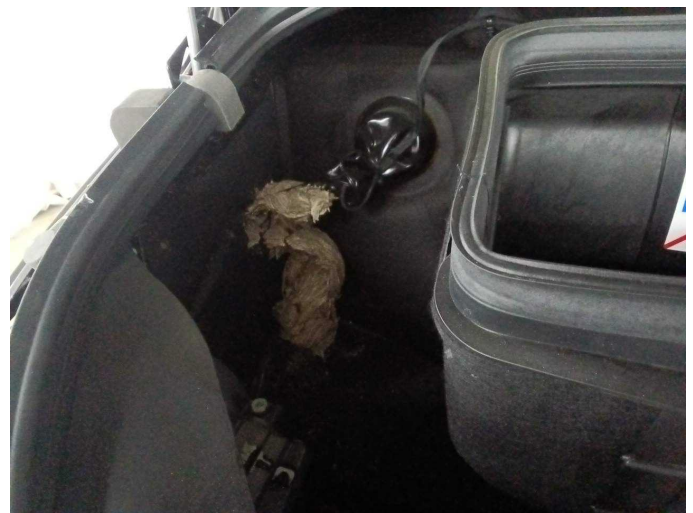
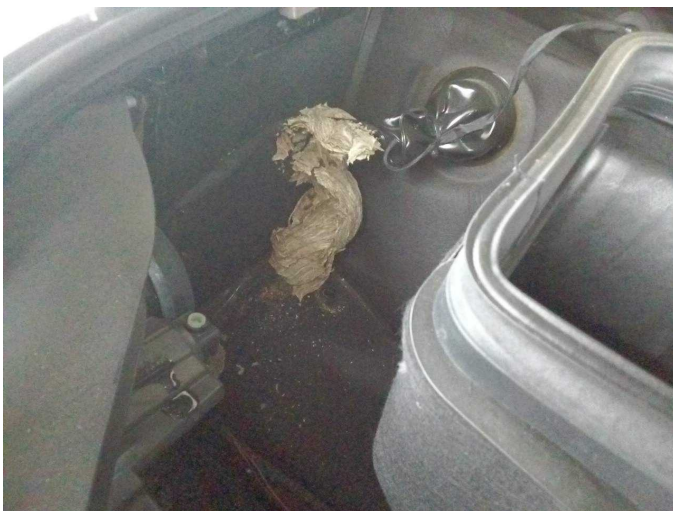
Damage 1: Engine: Engine (Bienennetz) - Not admissible - Remove

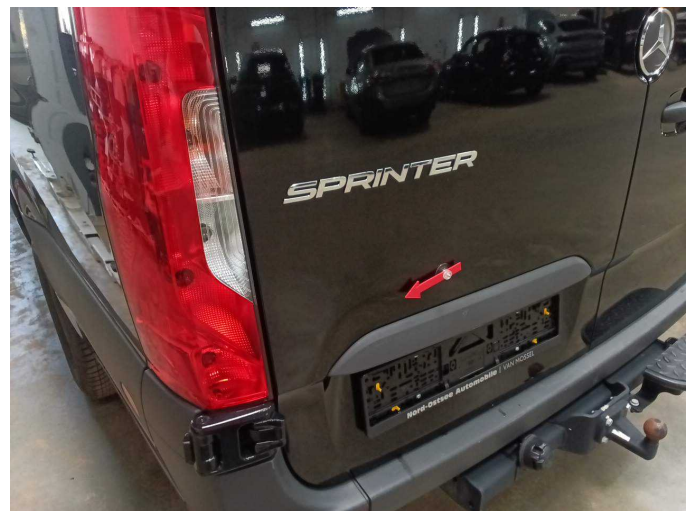
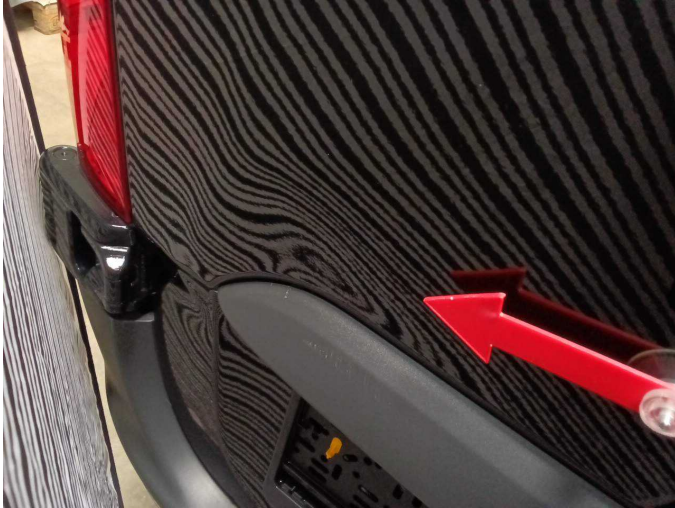
Damage 2: Boot lid / rear door: Rear door - left side - dent(s) - Smooth repair work

**Damage 2:** Boot lid / rear door: Rear door - left side - dent(s) - Smooth repair work

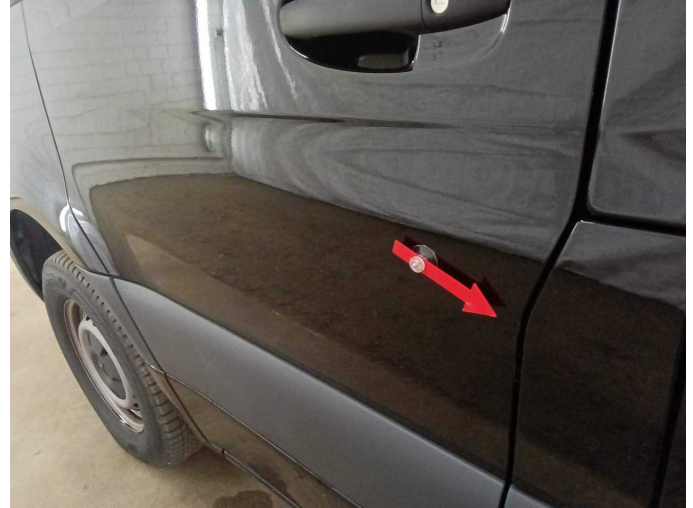
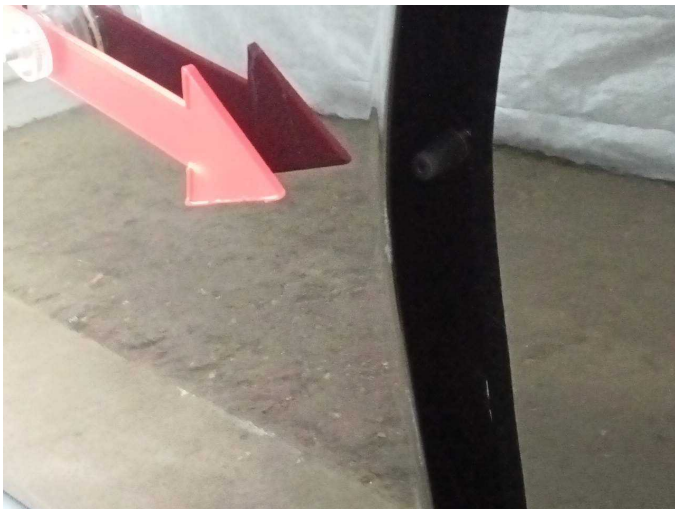
**Damage 3:** Door - front left side: Door edge - Scratch(es) - Smart repair

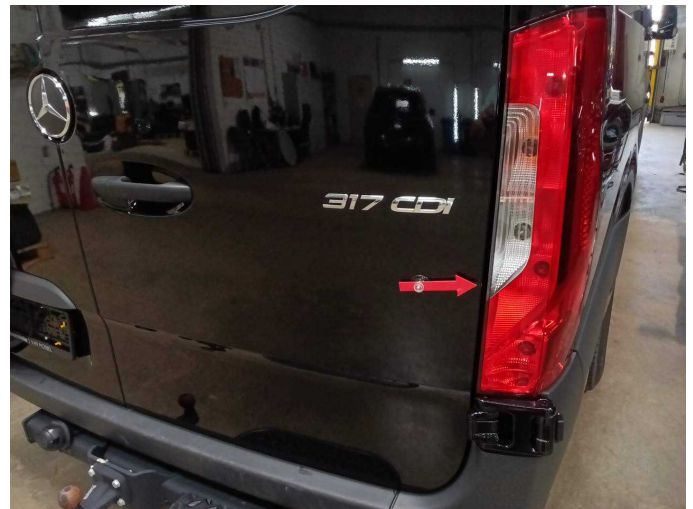
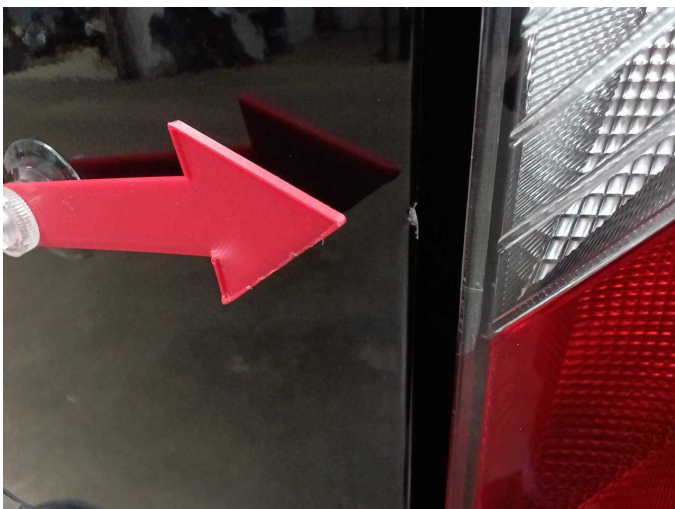
**Damage 4:** Boot lid / rear door: Rear door - right side - Scratch(es) - Smart repair

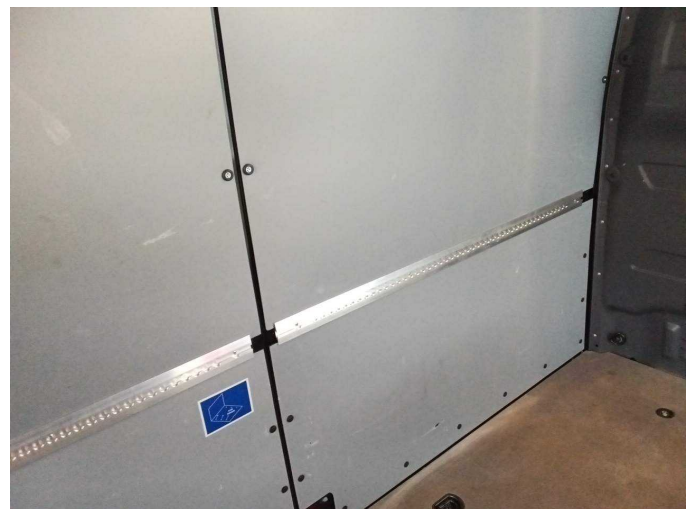
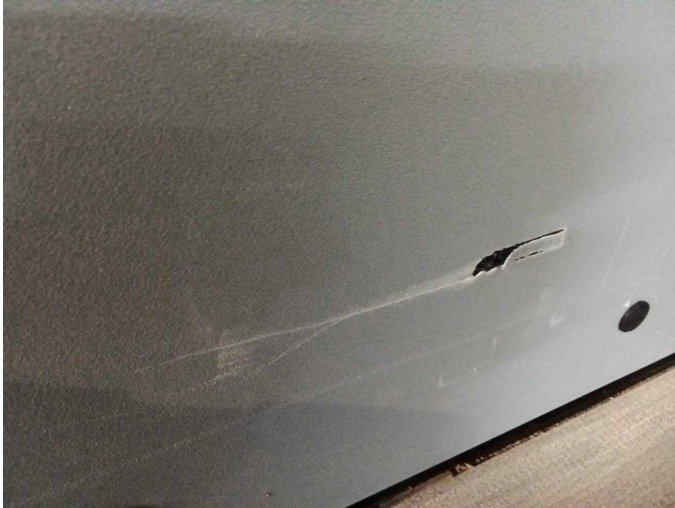
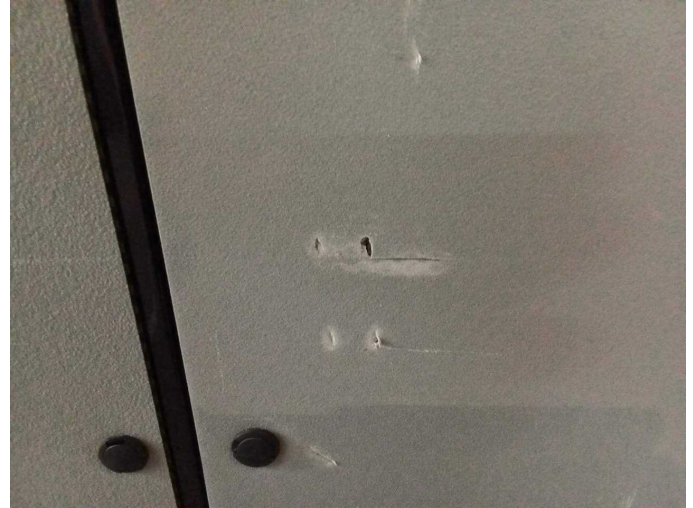
**Damage 5:** Side panel - rear left side: Interior trim - Holes - Replace

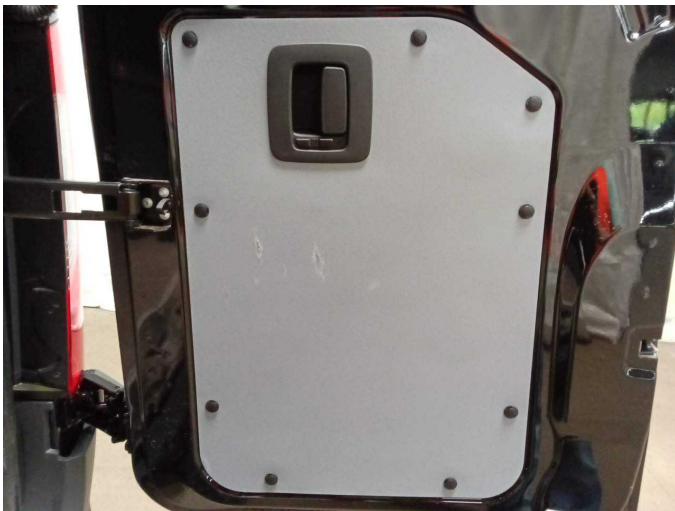
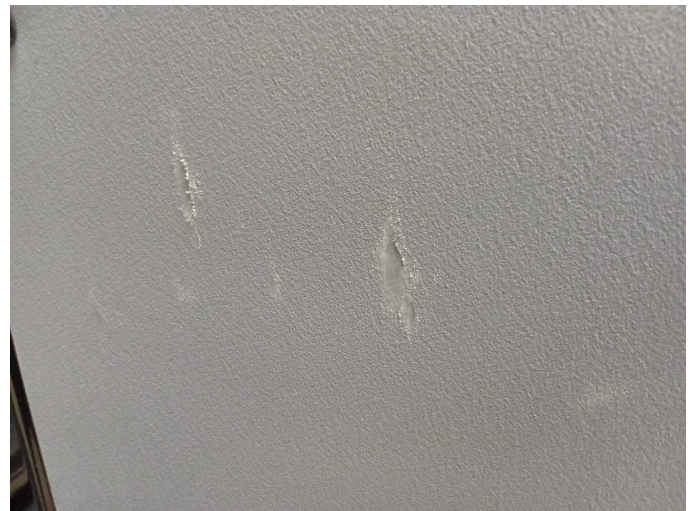
**Damage 6:** Trim / covers: Boot lid - interior trim - Scratched - Replace

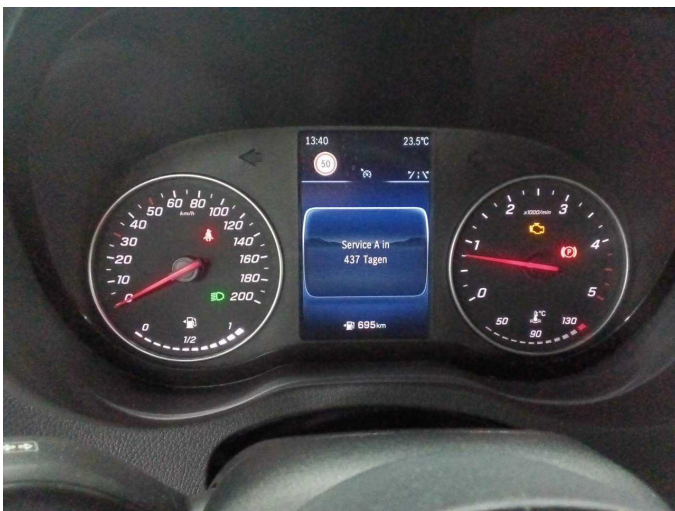
**Damage 7:** Instrument panel: Indicator light (Motorkontrollleuchte) - on - Perform diagnosis

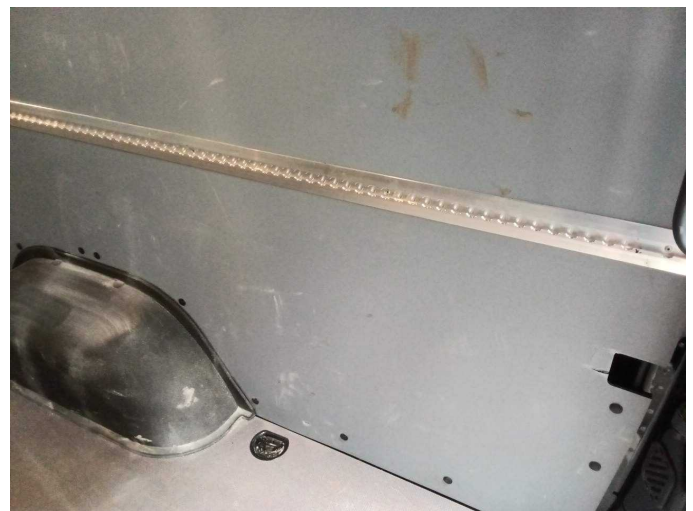
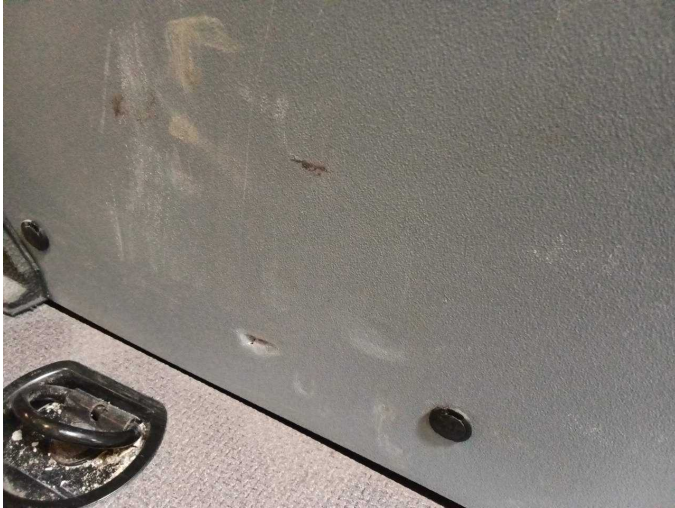
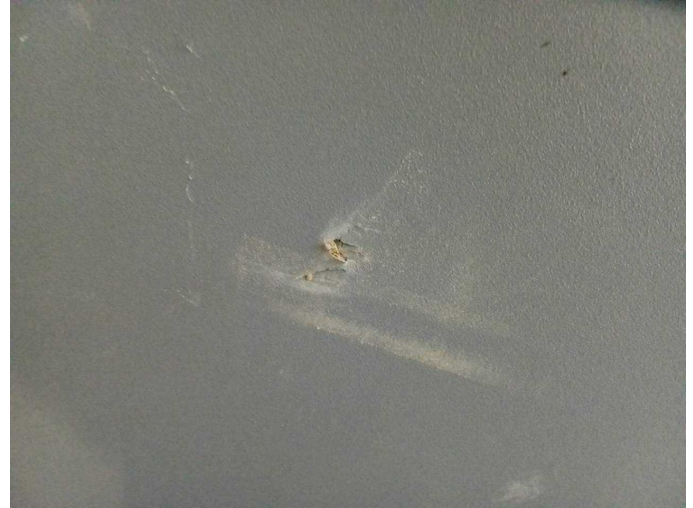
**Damage 8:** Side panel - rear right side: Interior trim - Holes - Replace

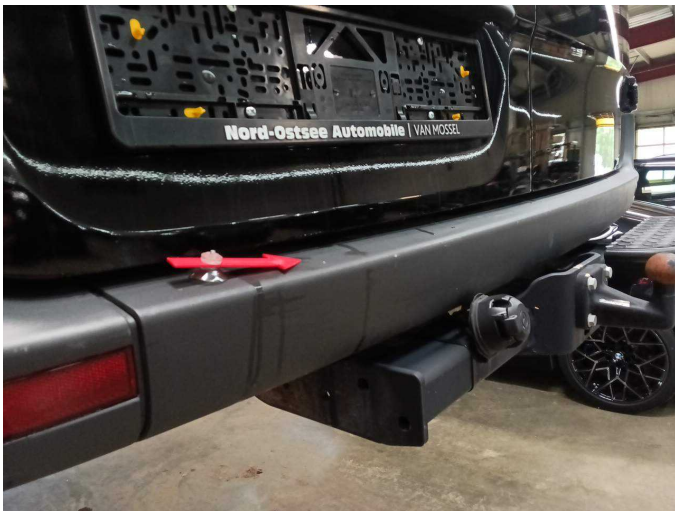
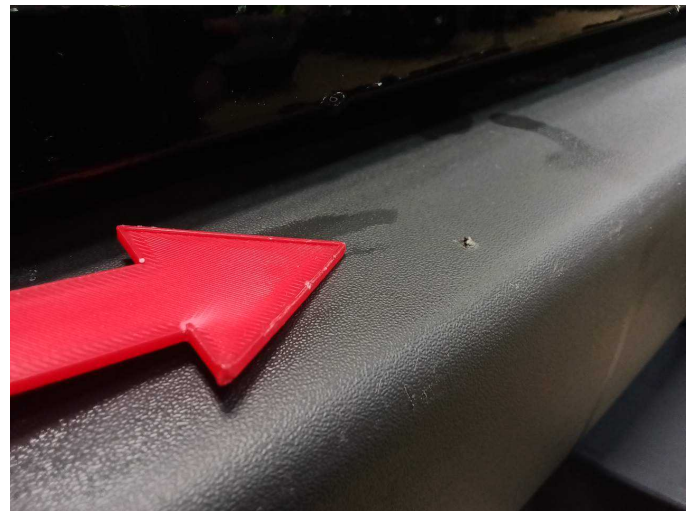
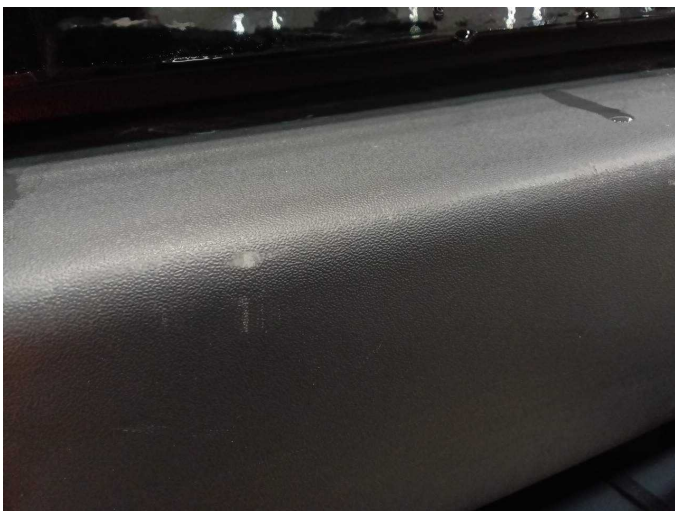
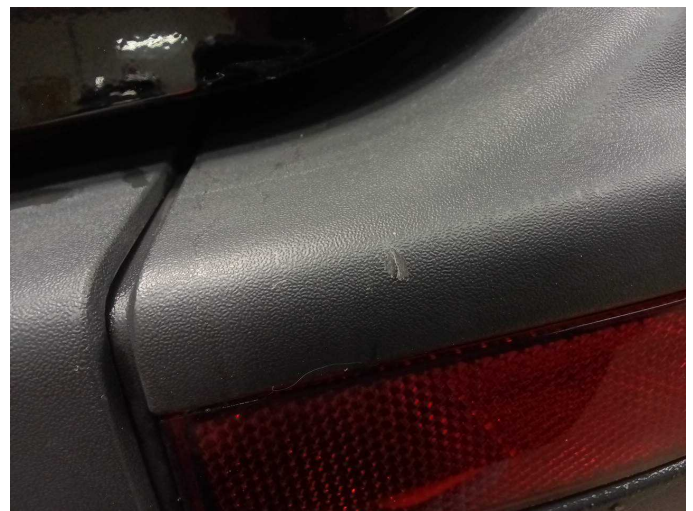
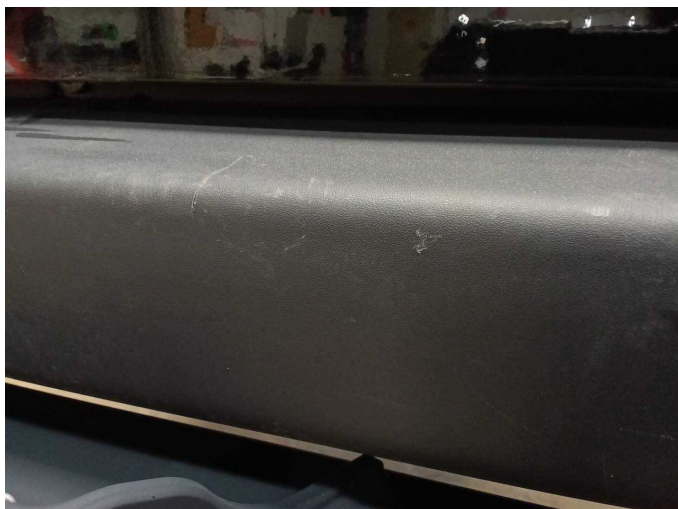
**Damage 9:** Rear bumper: Rear bumper - Scratch(es) - Replace
