Expertise

Protocol number: 46362133  
Order No. / Reference: 26201312  
Inspection date: 7 Jul 2026

Manufacturer: CUPRA

Model: Born 150kW/58kWh

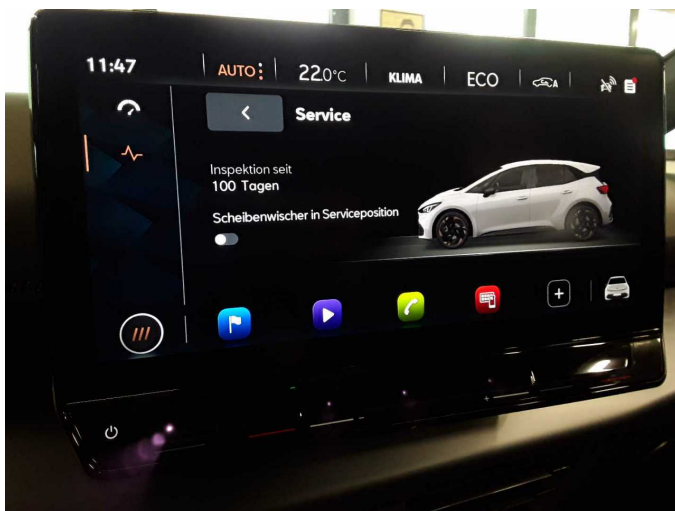
| No. | Component group | Description |
|---|---|---|
| 2 | Misc. | Inspection / maintenance - Due - Perform |

Damage 2: Misc.: Inspection / maintenance - Due - Perform

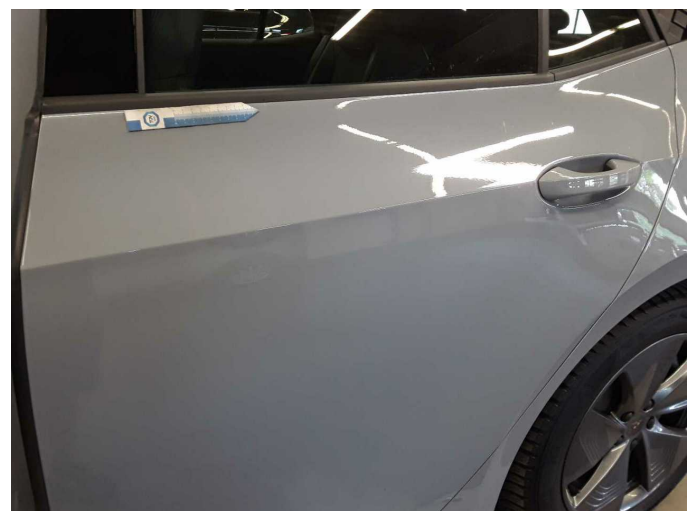
| No. | Component group | Description |
|---|---|---|
| 3 | Door - rear left side | Door - Scratch(es) - No deduction |

Wear and tear 3: Door - rear left side: Door - Scratch(es) - No deduction

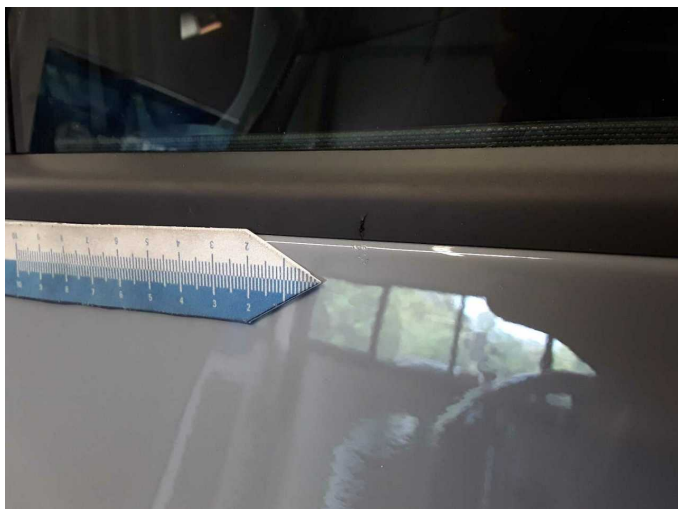
**Wear and tear 3:** Door - rear left side: Door - Scratch(es) - No deduction
