## Expertise

Protocol number: 46318528  
Order No. / Reference: 26542435  
Inspection date: 3 Jul 2026

Manufacturer: Opel

Model: Astra Sports Tourer 1.5 D Automatik GS Line

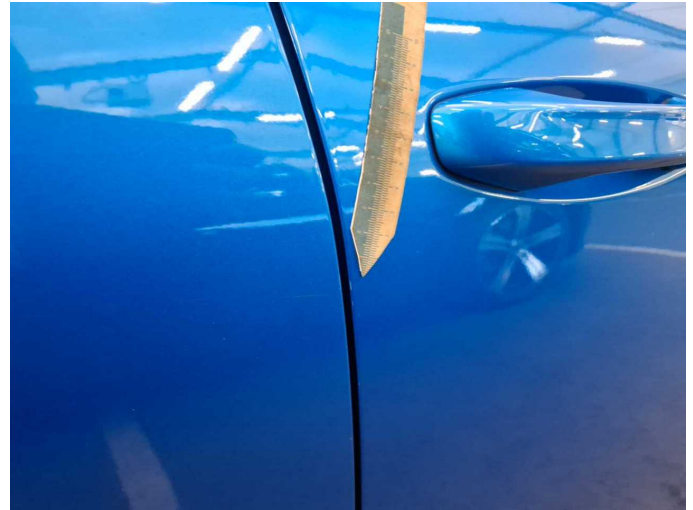
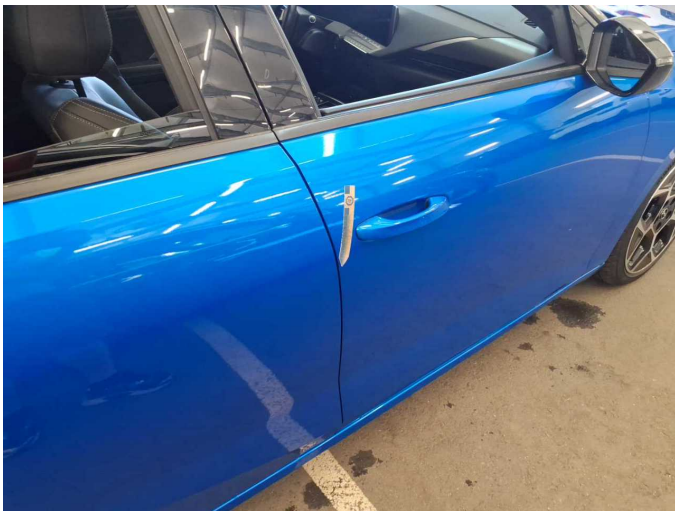
| No. | Component group | Description |
|---|---|---|
| 1 | Door - front right side | Door edge - Scratch(es) - Smart repair |

**Damage 1:** Door - front right side: Door edge - Scratch(es) - Smart repair

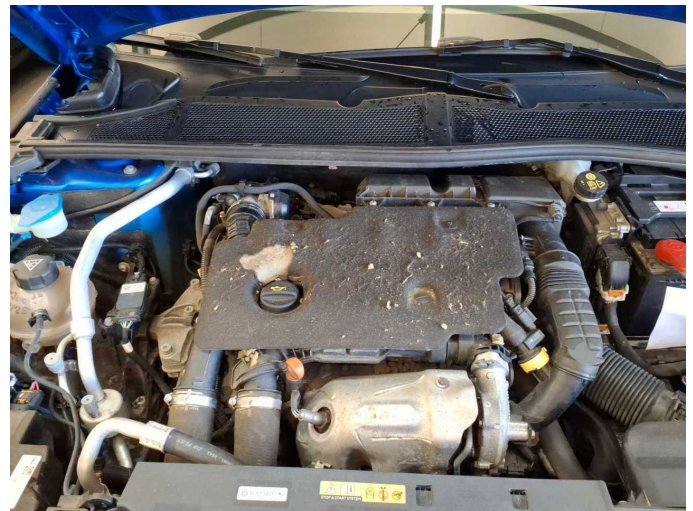
| No. | Component group | Description |
|---|---|---|
| 2 | Engine | Engine cover - Broken / torn - Replace |

**Damage 2:** Engine: Engine cover - Broken / torn - Replace

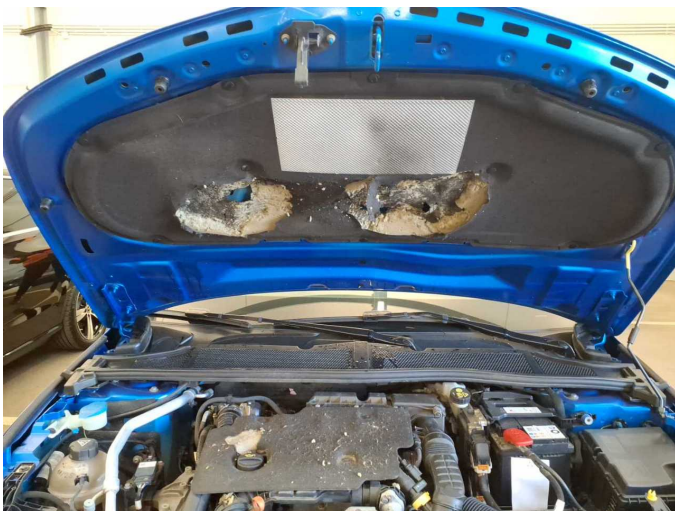
| No. | Component group | Description |
|---|---|---|
| 3 | Bonnet | Insulation lining - Broken / torn - Replace |

**Damage 3:** Bonnet: Insulation lining - Broken / torn - Replace

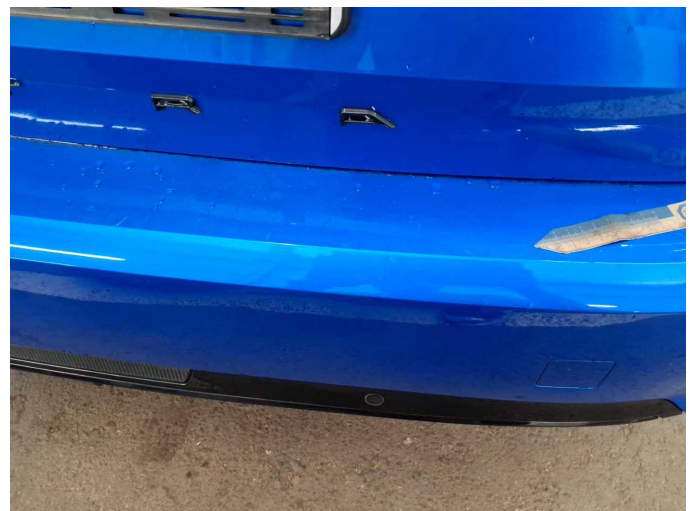
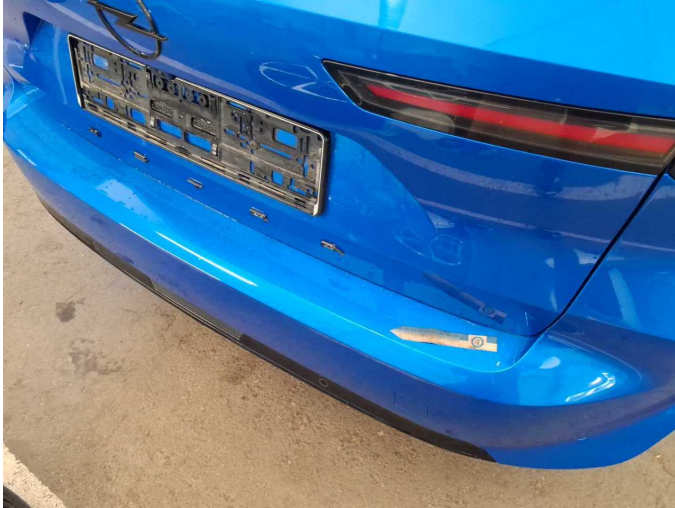
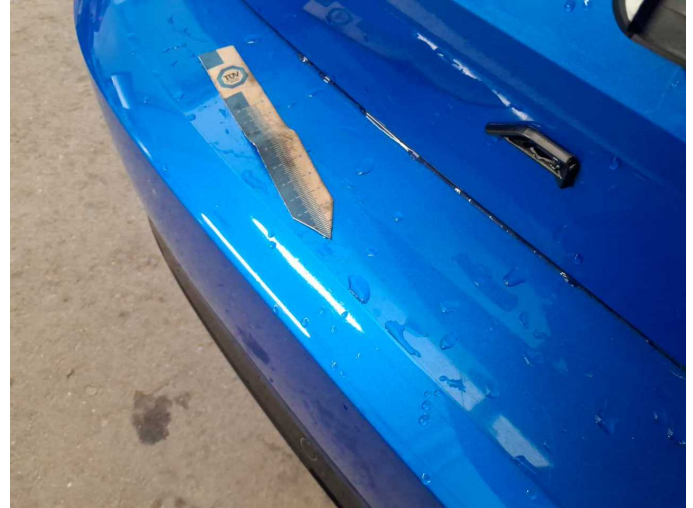
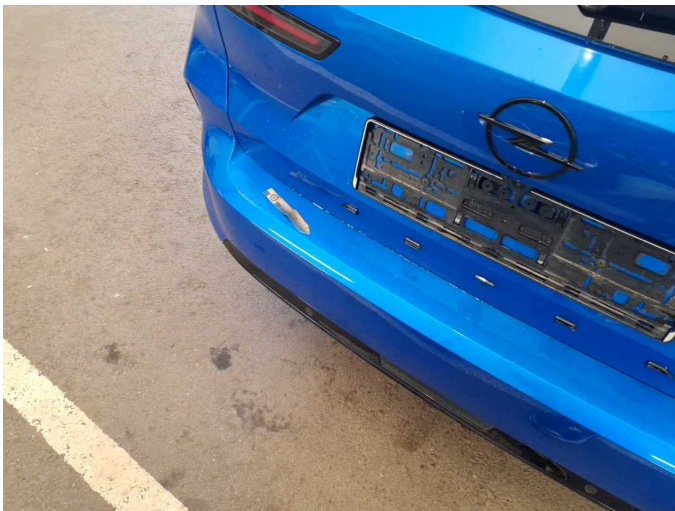
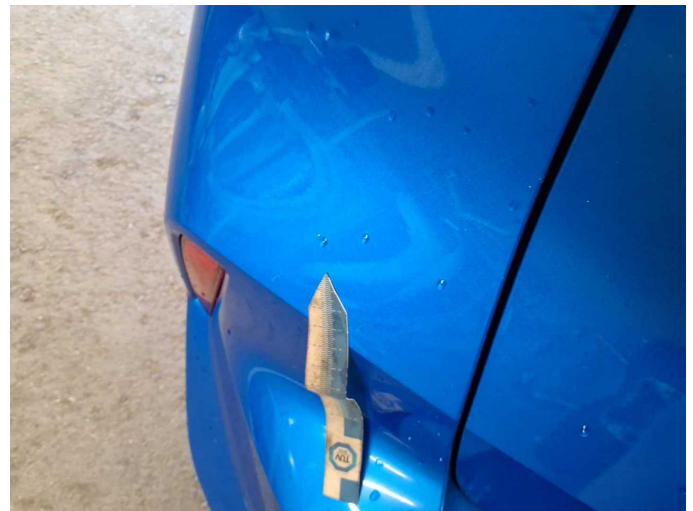
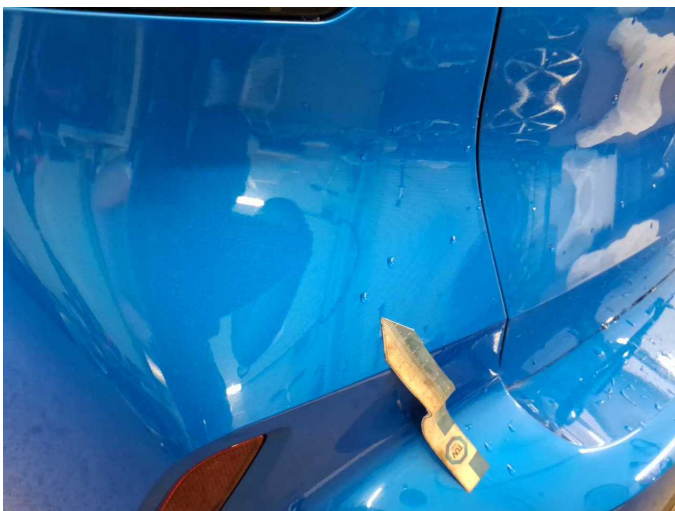
| No. | Component group | Description |
|---|---|---|
| 4 | Rear bumper | Rear bumper - Scratch(es) - Paint |

**Damage 4:** Rear bumper: Rear bumper - Scratch(es) - Paint

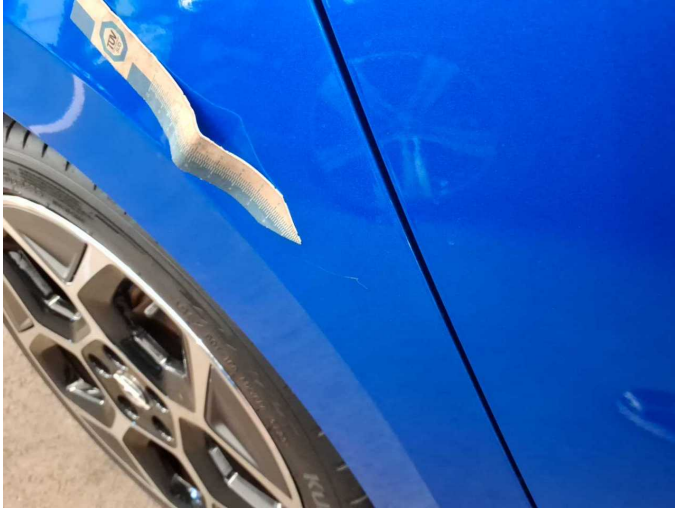
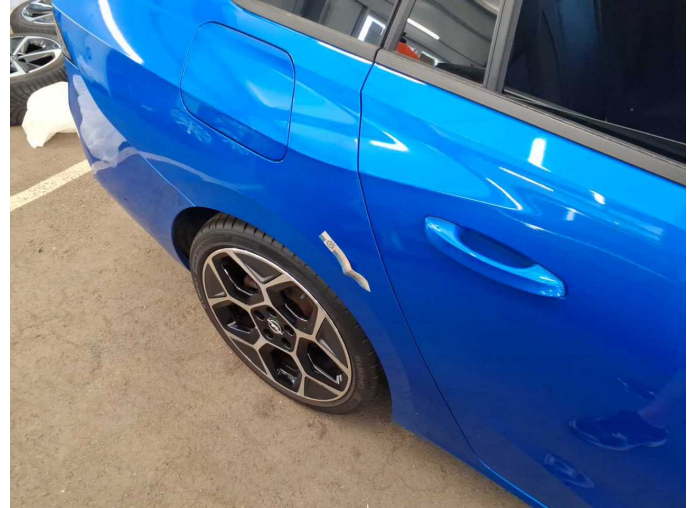
| No. | Component group | Description |
|---|---|---|
| 5 | Side panel - rear right side | Side panel - Scratch(es) - Paint |

**Damage 5:** Side panel - rear right side: Side panel - Scratch(es) - Paint

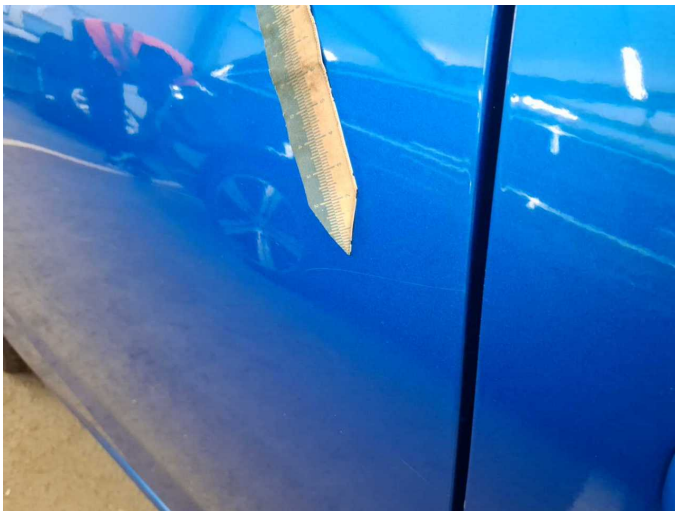
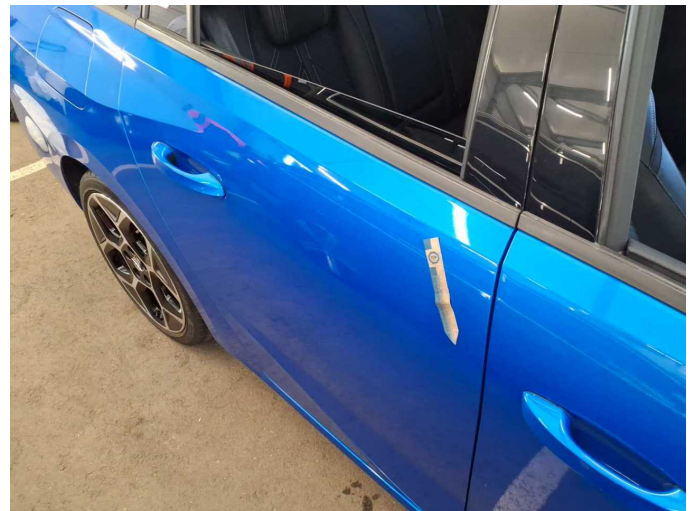
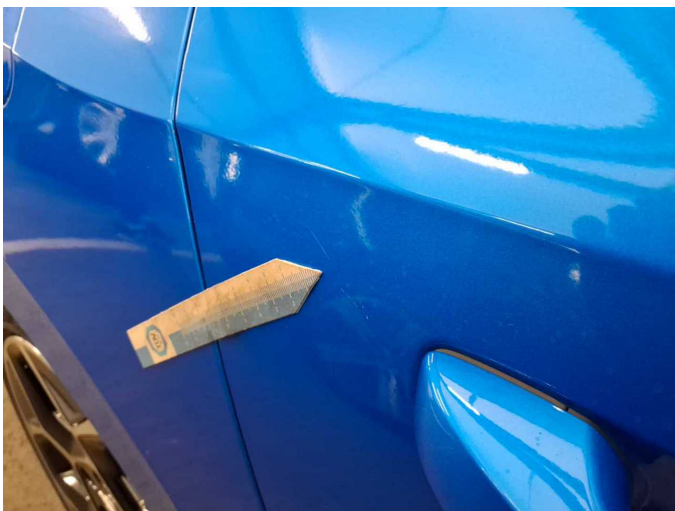
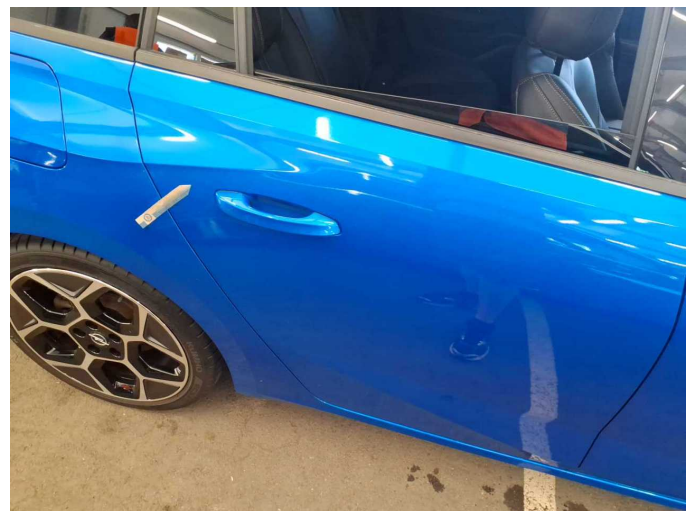
| No. | Component group | Description |
|---|---|---|
| 6 | Door - rear right side | Door - Scratch(es) - Paint |

**Damage 6:** Door - rear right side: Door - Scratch(es) - Paint

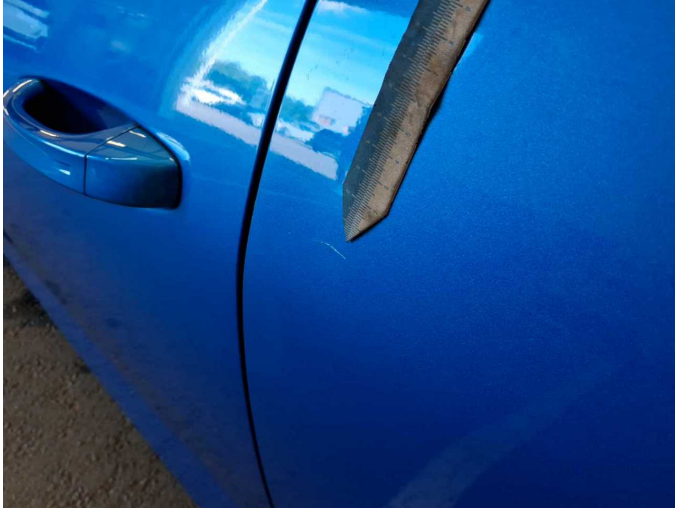
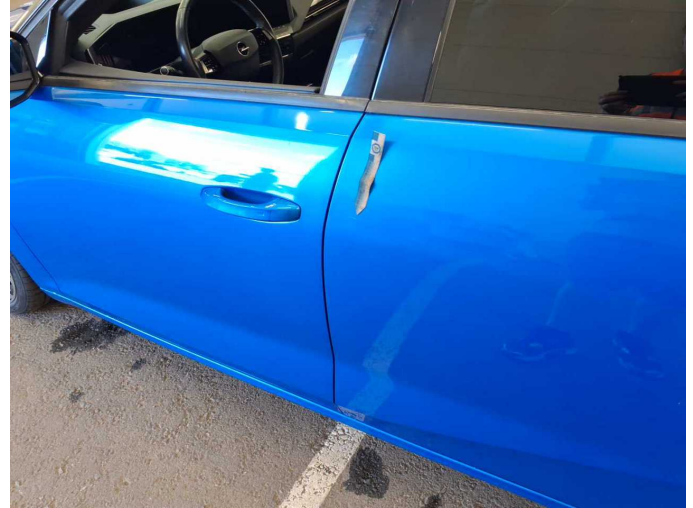
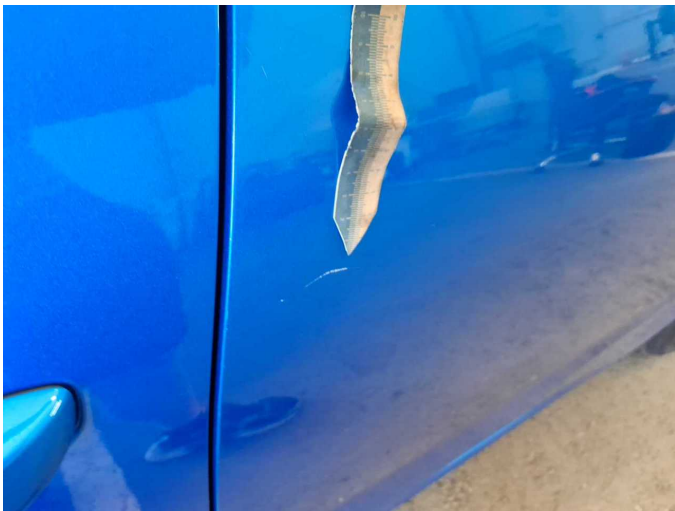
| No. | Component group | Description |
|---|---|---|
| 7 | Door - rear left side | Door - Scratch(es) - Paint |

**Damage 7:** Door - rear left side: Door - Scratch(es) - Paint

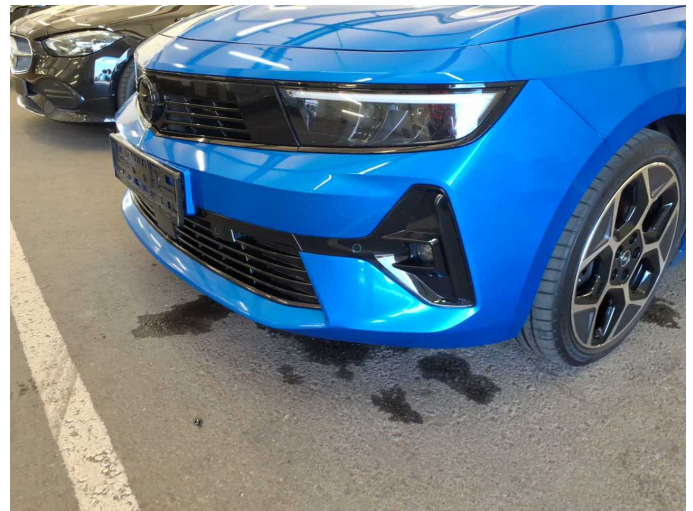
| No. | Component group | Description |
|---|---|---|
| 2 | Front bumper | Front bumper - Stone chips - No deduction |

**Wear and tear 2:** Front bumper: Front bumper - Stone chips - No deduction

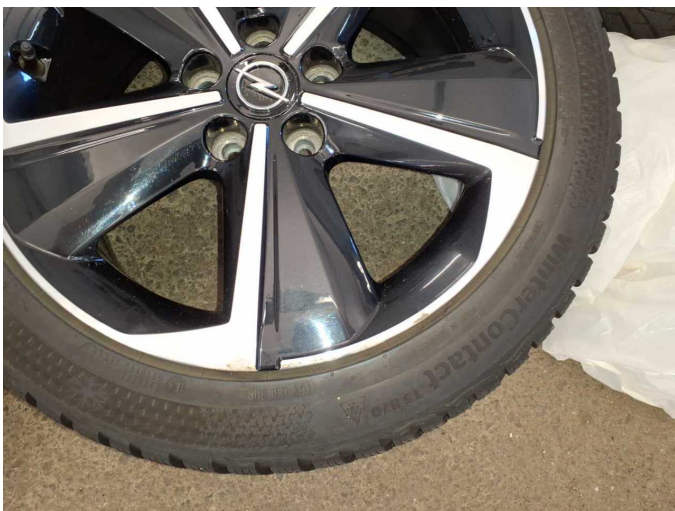
| No. | Component group | Description |
|---|---|---|
| 5 | 2nd wheel set | 1 alloy rim - Scratch(es) - No deduction |

**Wear and tear 5:** 2nd wheel set: 1 alloy rim - Scratch(es) - No deduction
