Expertise

Protocol number: 46277824  
Order No. / Reference: 26484015  
Inspection date: 25 Jun 2026

Manufacturer: Skoda  
VIN: TMBJJ7NS3P8026043

Model: Kodiahq 2.0 TDI DSG Ambition

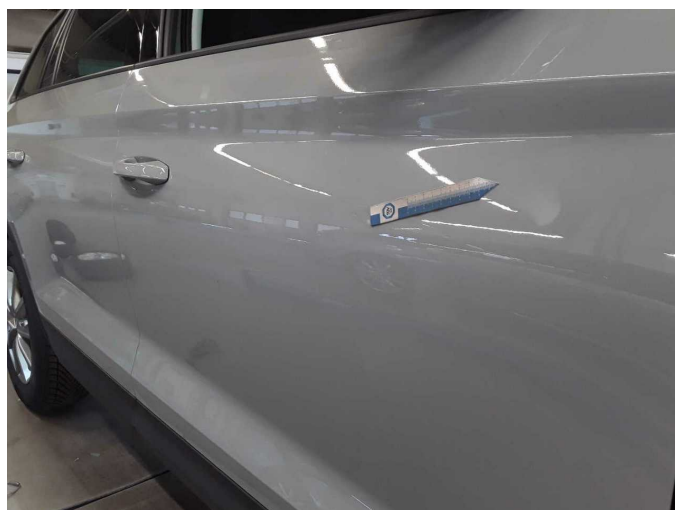
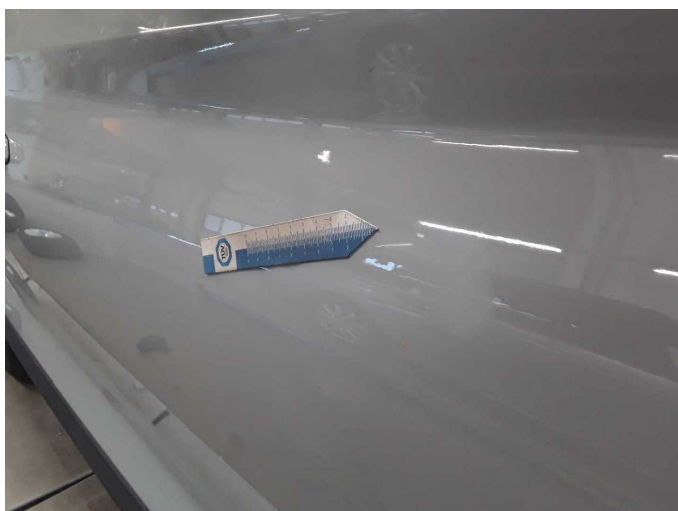
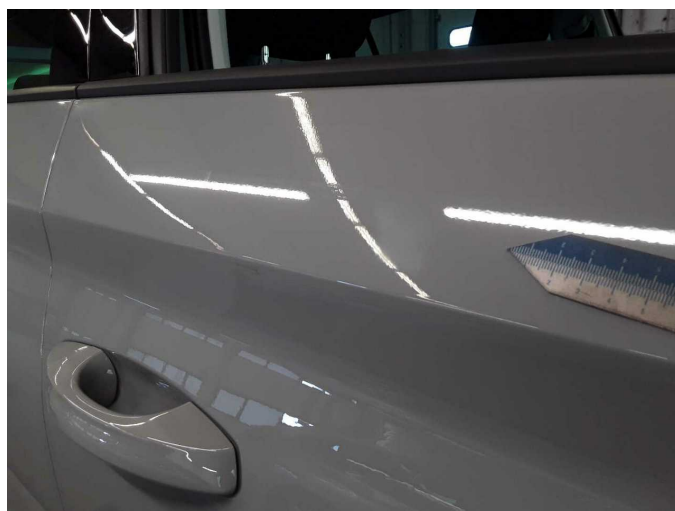
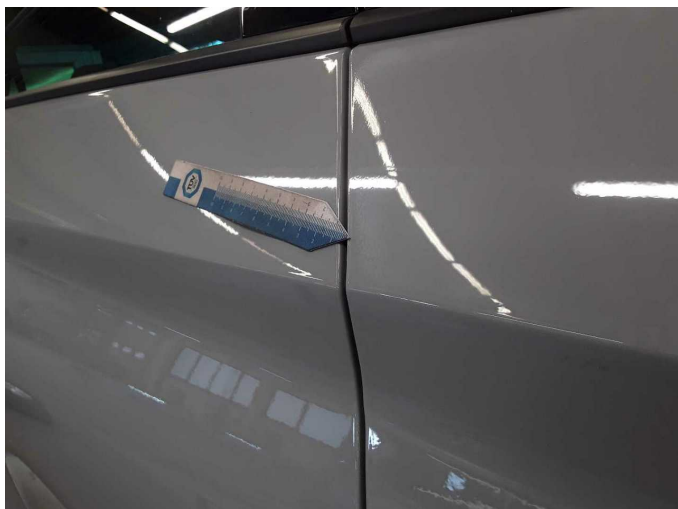
| No. | Component group | Description |
|---|---|---|
| 1 | Door - front right side | Door (Farbnebel, Mehrkosten sind möglich) - Unprofessionally repaired - Smart repair |

**Damage 1:** Door - front right side: Door (Farbnebel, Mehrkosten sind möglich) - Unprofessionally repaired - Smart repair

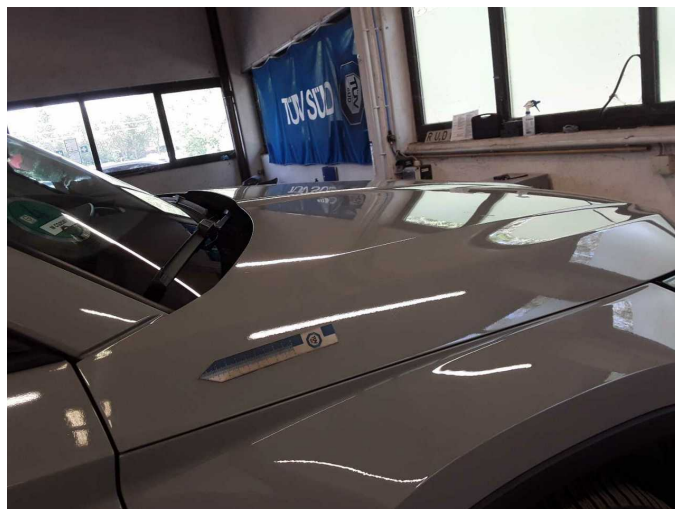
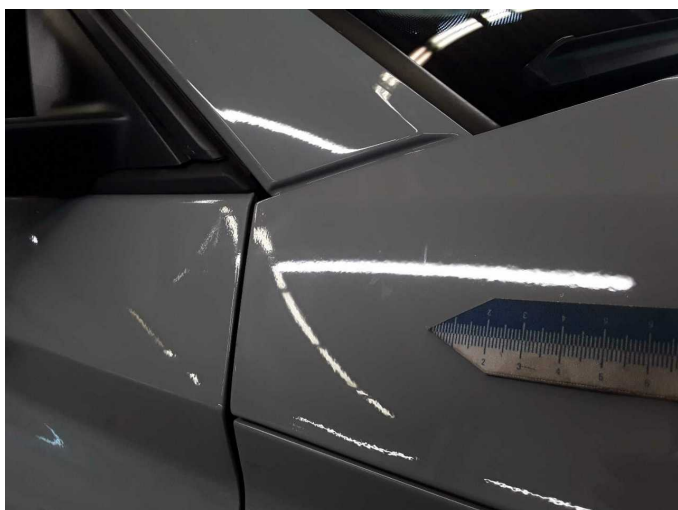
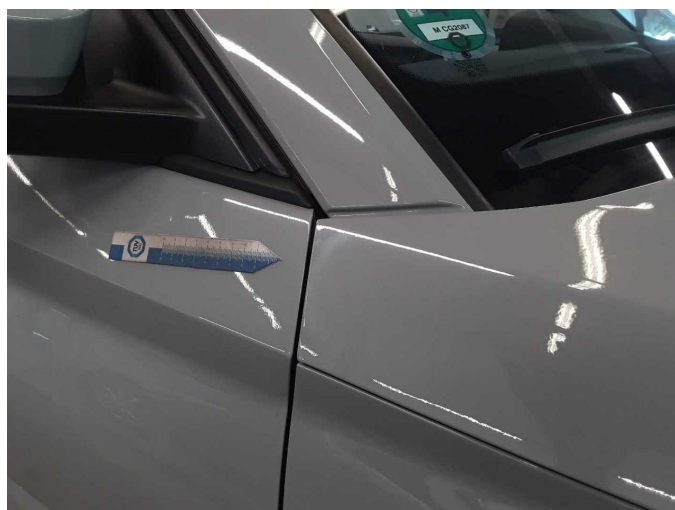
| No. | Component group | Description |
|---|---|---|
| 2 | Bonnet | Bonnet (Farbnebel, Mehrkosten sind möglich) - Unprofessionally repaired - Conditioning |

**Damage 2:** Bonnet: Bonnet (Farbnebel, Mehrkosten sind möglich) - Unprofessionally repaired - Conditioning

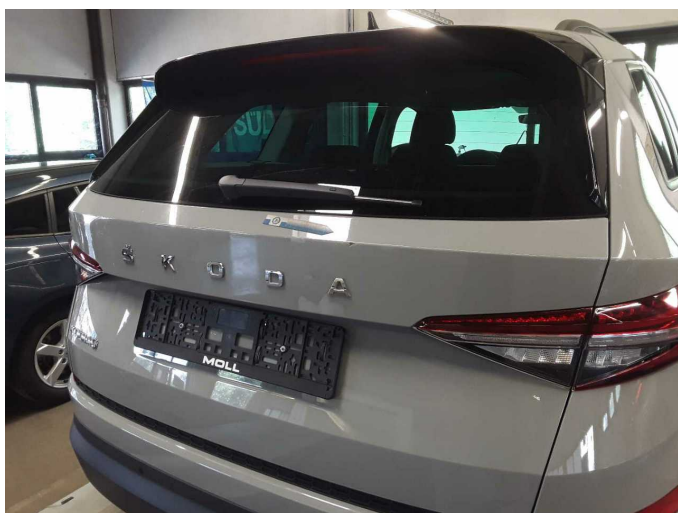
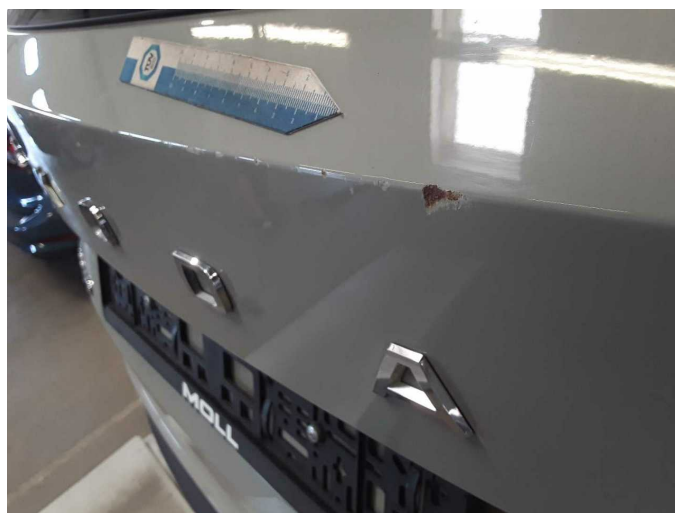
| No. | Component group | Description |
|---|---|---|
| 3 | Boot lid / rear door | Boot lid - Corrosion - Repair and paint |

**Damage 3:** Boot lid / rear door: Boot lid - Corrosion - Repair and paint

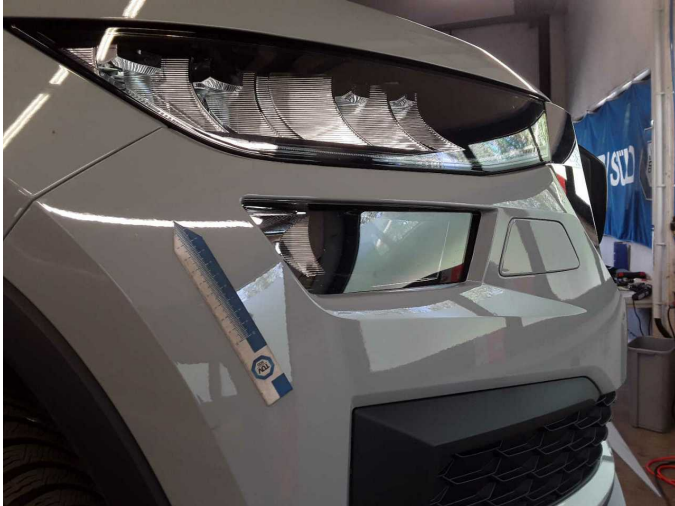
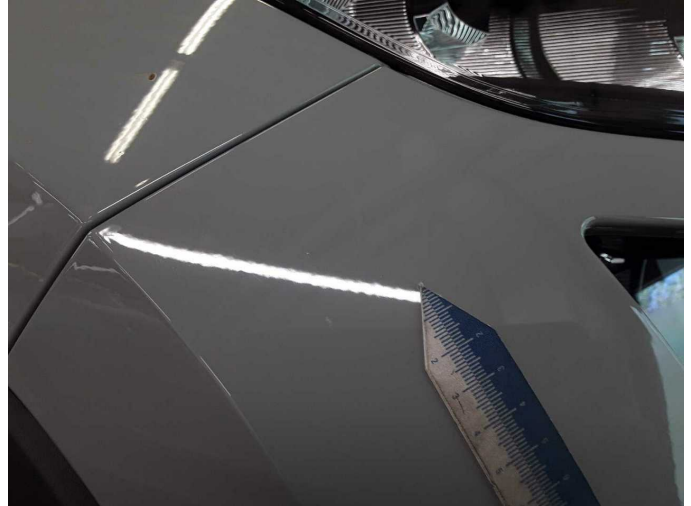
| No. | Component group | Description |
|---|---|---|
| 1 | Front bumper | Front bumper - Stone chips - No deduction |

**Wear and tear 1:** Front bumper: Front bumper - Stone chips - No deduction

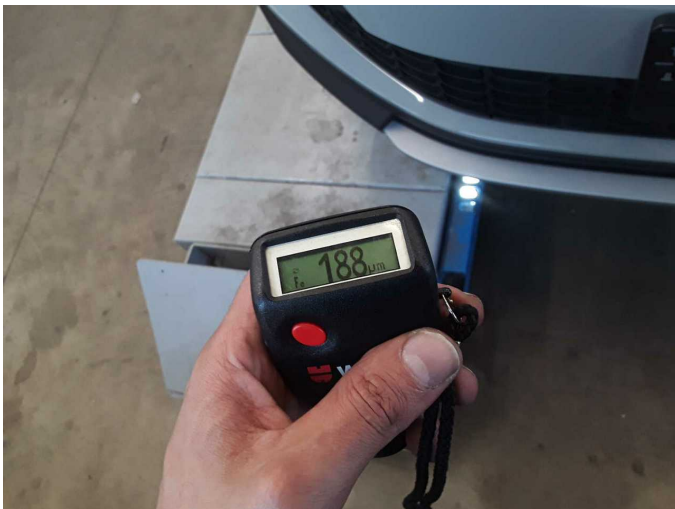
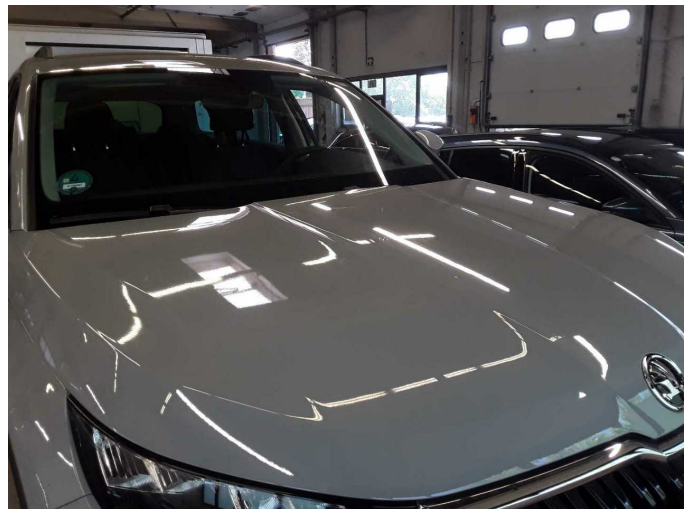
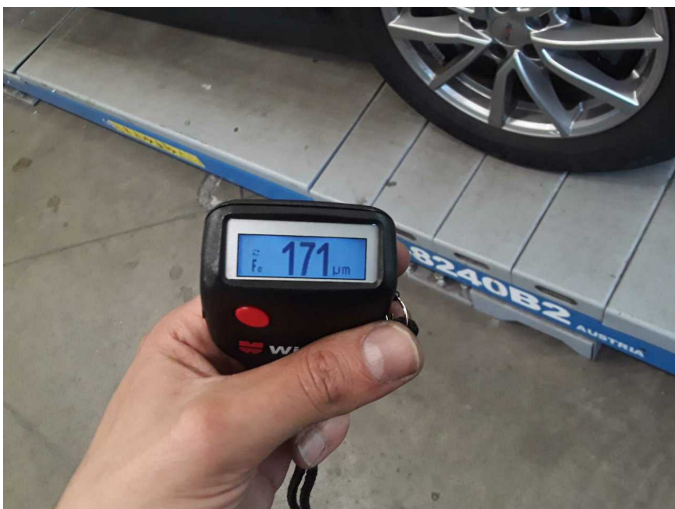
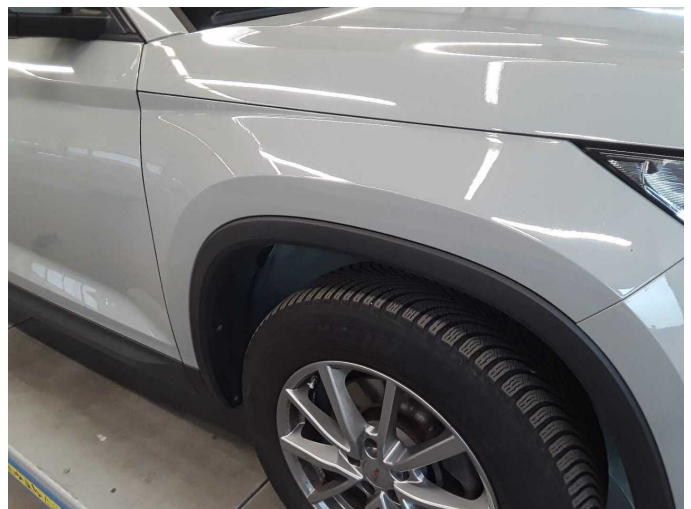
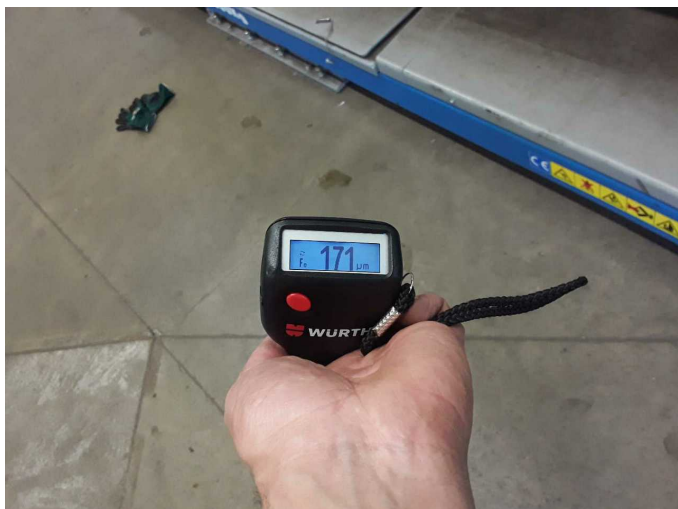
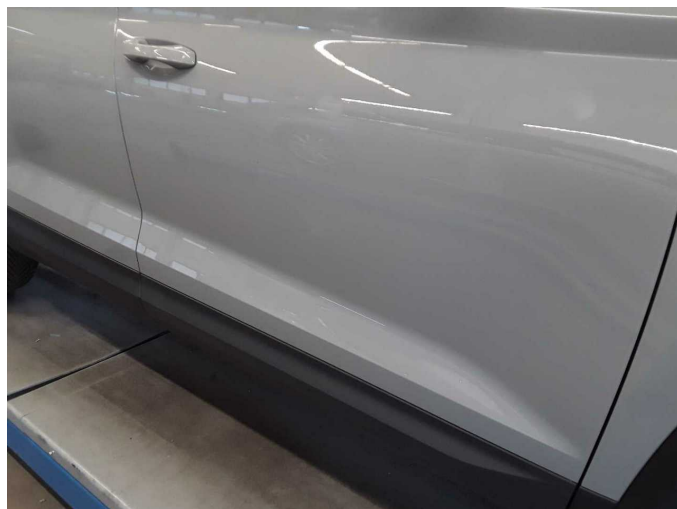
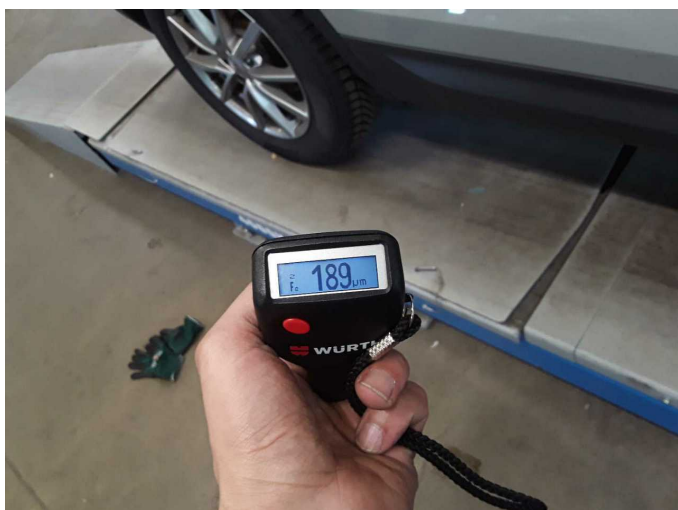
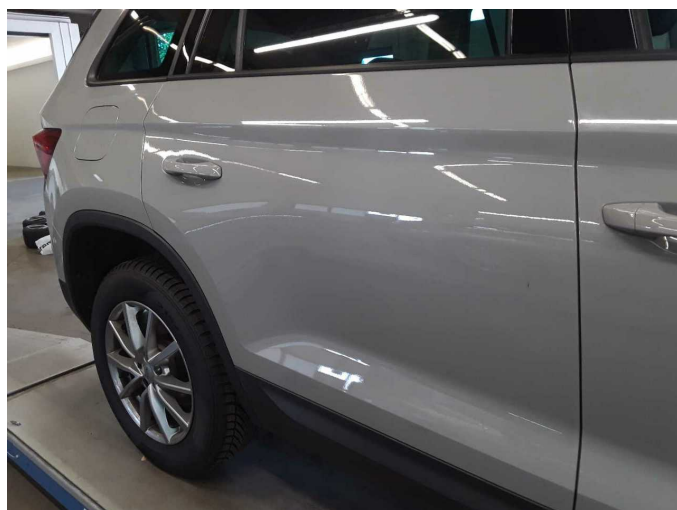
| No. | Repainting |
|---|---|
| 1 | Mudguard - right side, Bonnet, Door - rear right side, Door - front right side, Professionally carried out, Invoice of repair done Non-existent |

| Mudguard - right side | 171 µm | Bonnet | 188 µm |
| Door - rear right side | 189 µm | Door - front right side | 171 µm |

**Repainting 1:** Mudguard - right side, Bonnet, Door - rear right side, Door - front right side
