Expertise

Protocol number: 46410081  
Order No. / Reference: 26597100  
Inspection date: 9 Jul 2026

Model: Astra 1.5 D Start/Stop Sports Tourer Business Edition

VIN: W0VBD8EV0N8042053

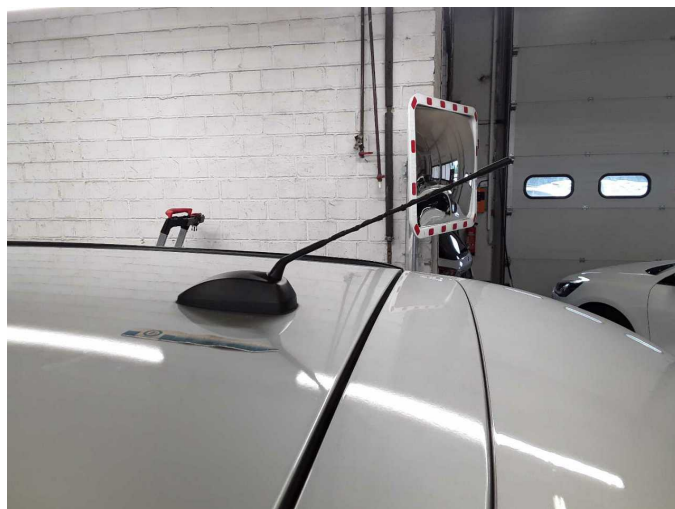
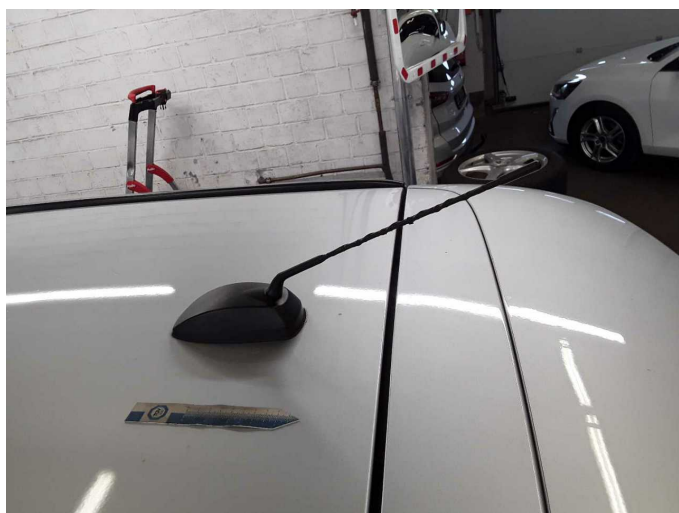
| No. | Component group | Description |
|---|---|---|
| 2 | Roof | Stub aerial - Damaged - Replace |

**Damage 2:** Roof: Stub aerial - Damaged - Replace

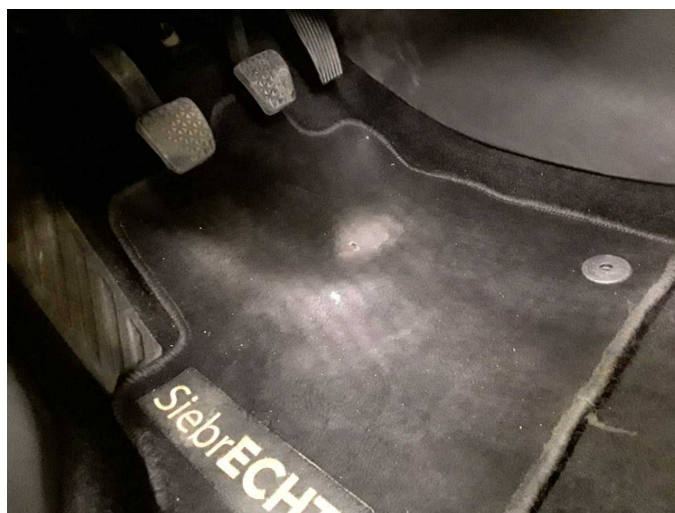
| No. | Component group | Description |
|---|---|---|
| 3 | Trim / covers | Floor mats - Holes - Replace |

**Damage 3:** Trim / covers: Floor mats - Holes - Replace

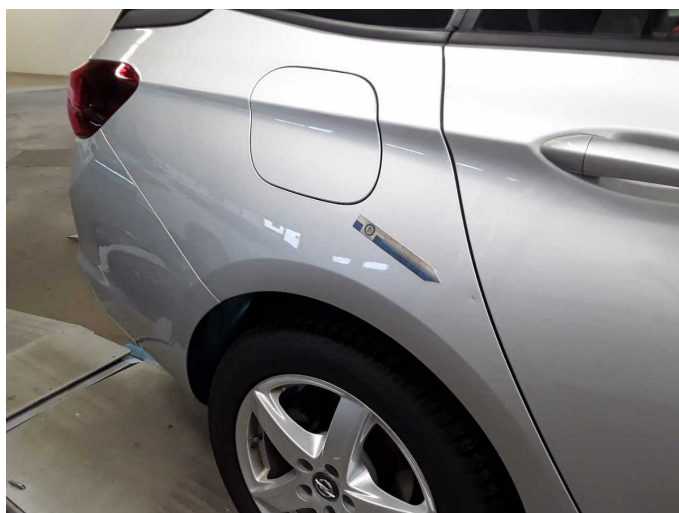
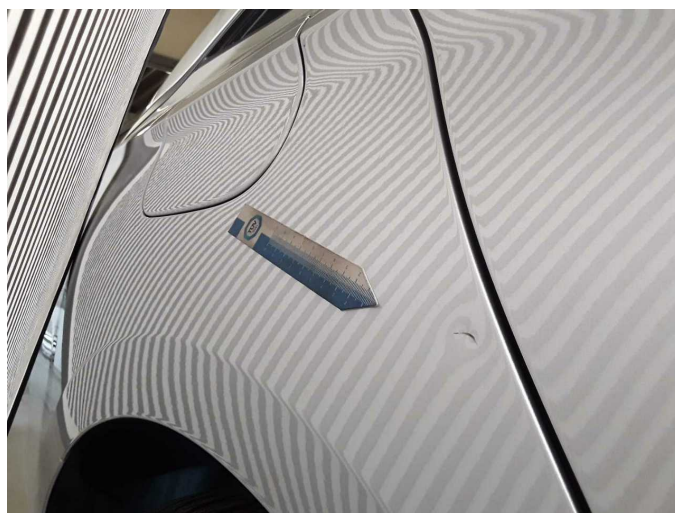
| No. | Component group | Description |
|---|---|---|
| 4 | Side panel - rear right side | Side panel - Dent / paintcoat damage - Smart repair |

**Damage 4:** Side panel - rear right side: Side panel - Dent / paintcoat damage - Smart repair

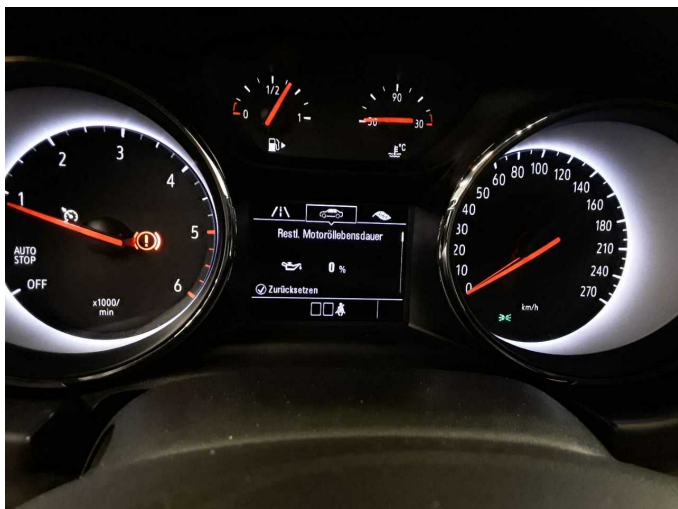
| No. | Component group | Description |
|---|---|---|
| 5 | Misc. | Inspection / maintenance - Due - Perform |

**Damage 5:** Misc.: Inspection / maintenance - Due - Perform

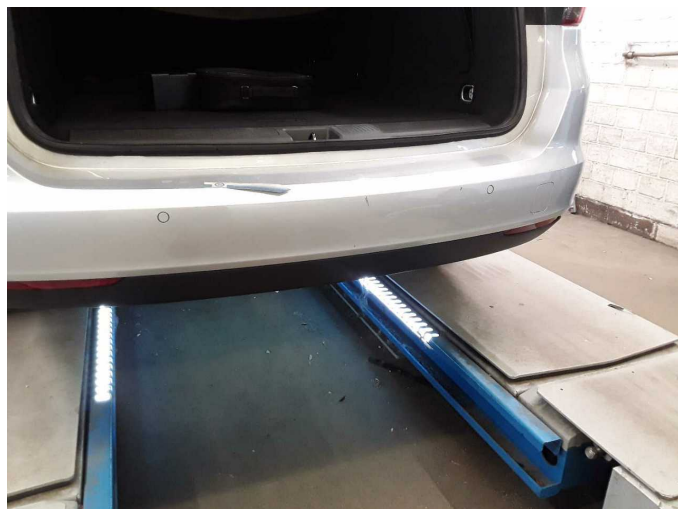
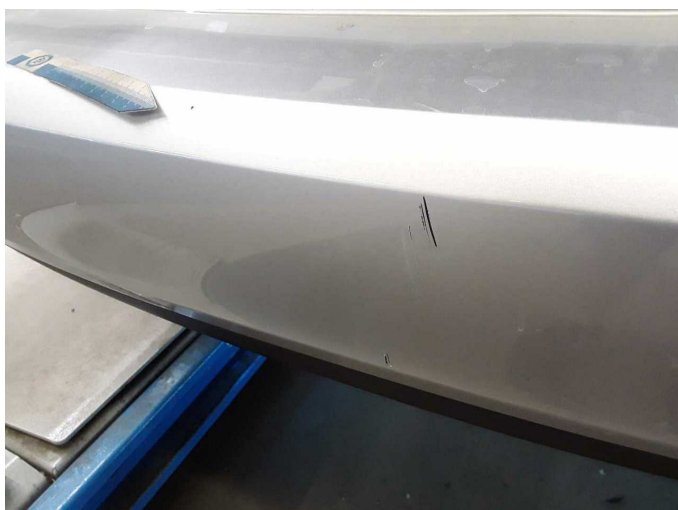
| No. | Component group | Description |
|---|---|---|
| 6 | Rear bumper | Rear bumper - Scratch(es) - Paint |

**Damage 6:** Rear bumper: Rear bumper - Scratch(es) - Paint

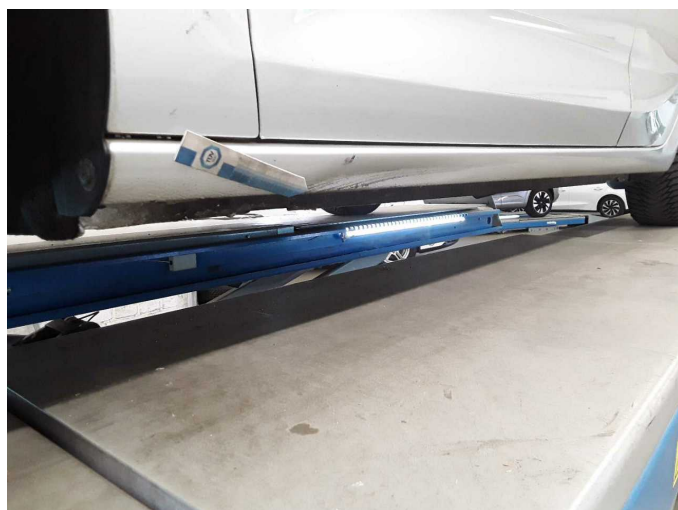
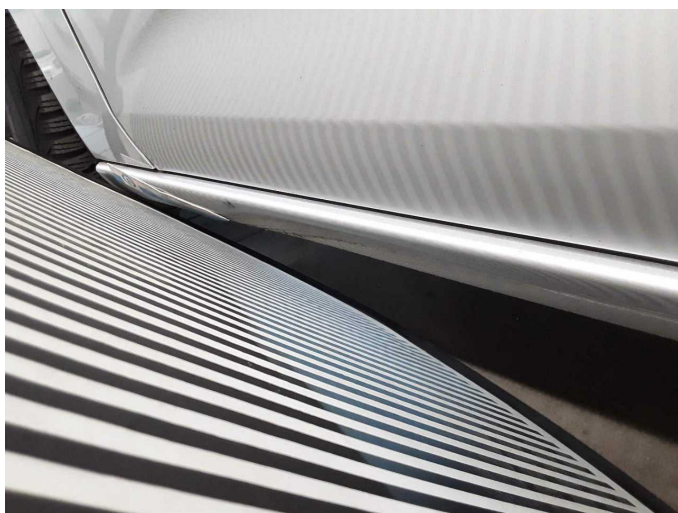
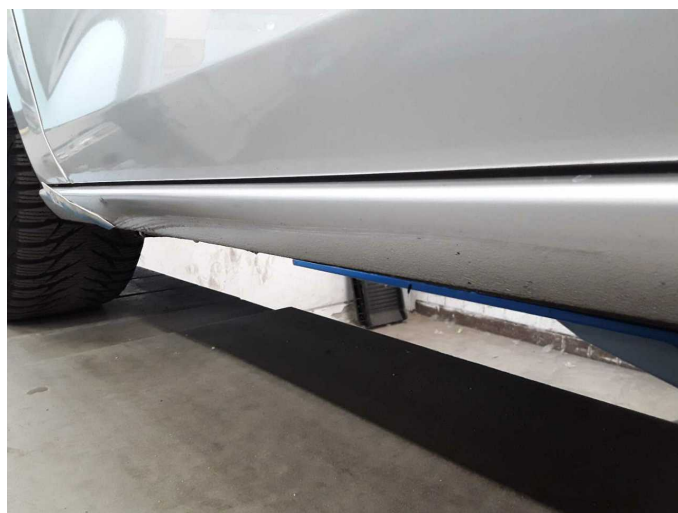
| No. | Component group | Description |
|---|---|---|
| 7 | Sill - left side | Sill - Damaged - Repair and paint |

**Damage 7:** Sill - left side: Sill - Damaged - Repair and paint

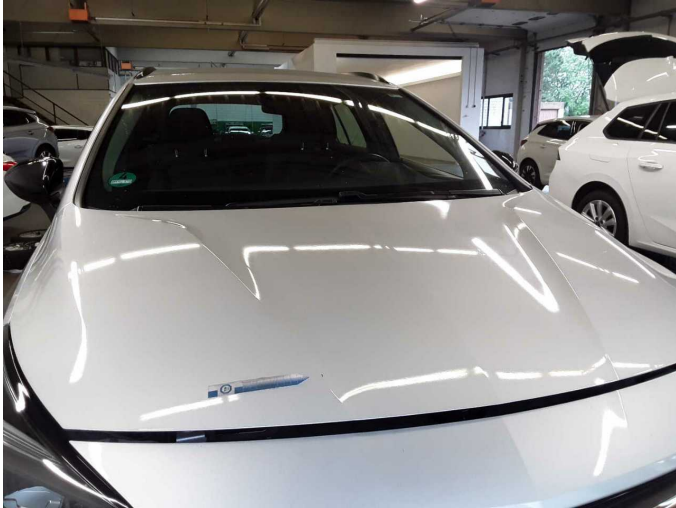
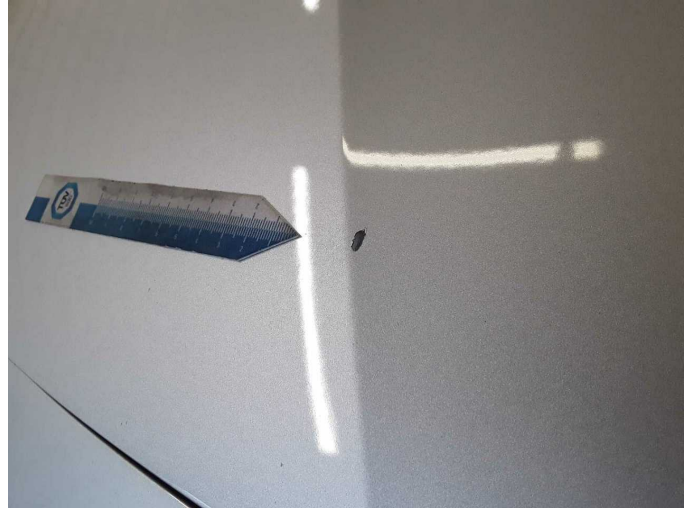
| No. | Component group | Description |
|---|---|---|
| 8 | Bonnet | Bonnet - Scratch(es) - Paint |

**Damage 8:** Bonnet: Bonnet - Scratch(es) - Paint

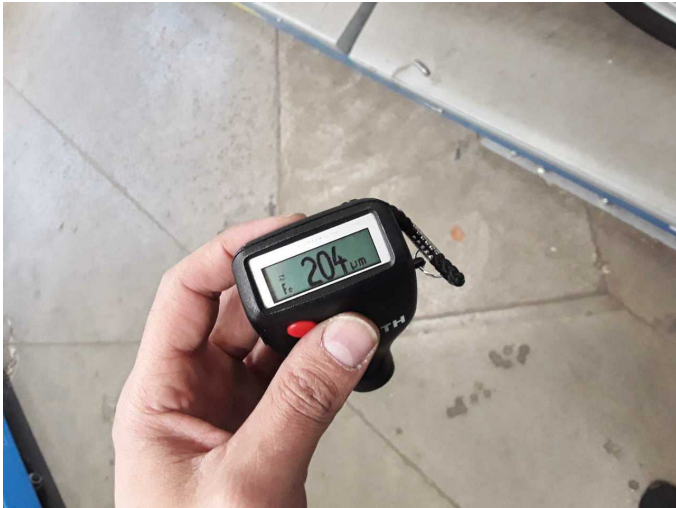
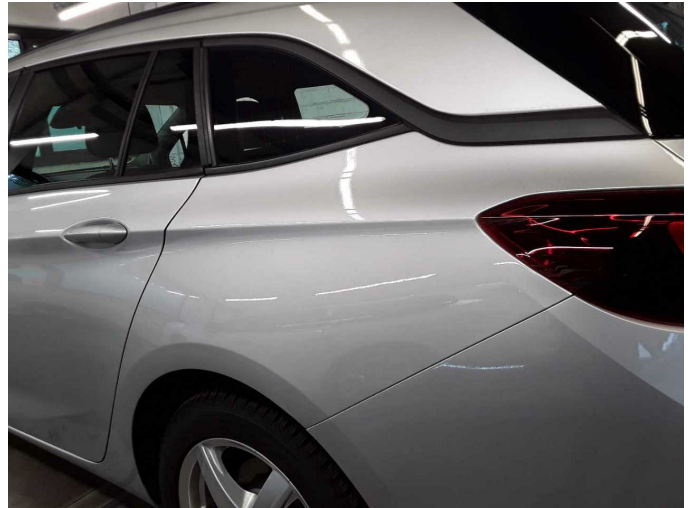
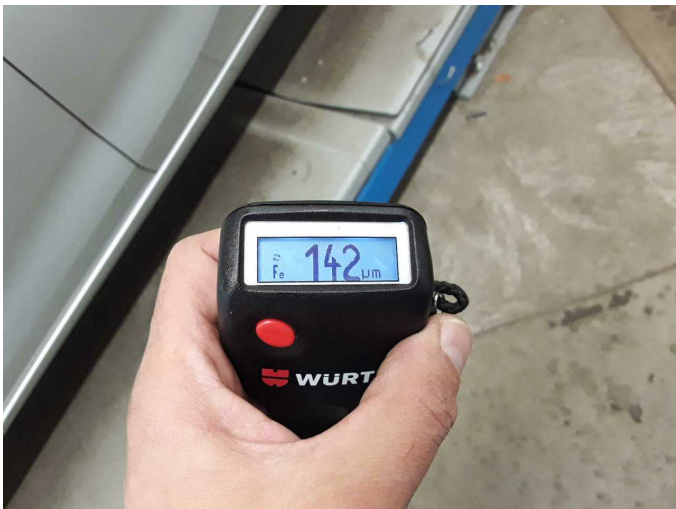
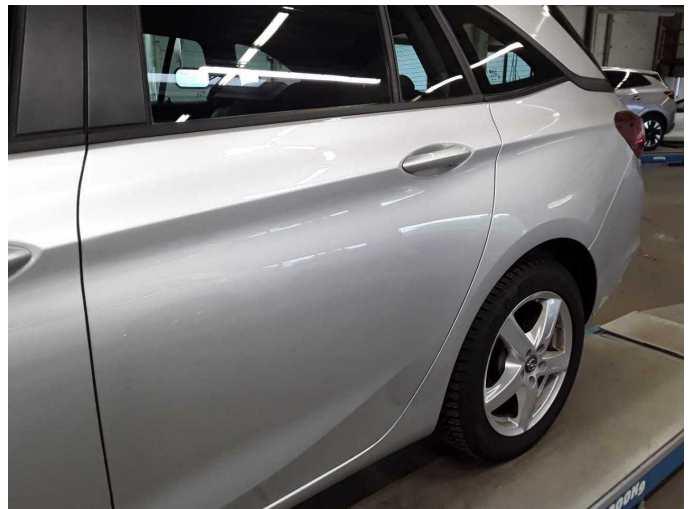
| No. | Repainting |
|---|---|
| 1 | Side panel - rear left side, Door - rear left side, Professionally carried out, Invoice of repair done Non-existent |

**Repainting 1:** Side panel - rear left side, Door - rear left side
