Expertise

Protocol number: 46053725  
Order No. / Reference: 26306601  
Inspection date: 16 Jun 2026

Manufacturer: Opel

Model: Astra Sports Tourer 1.2 Turbo Automatik GS

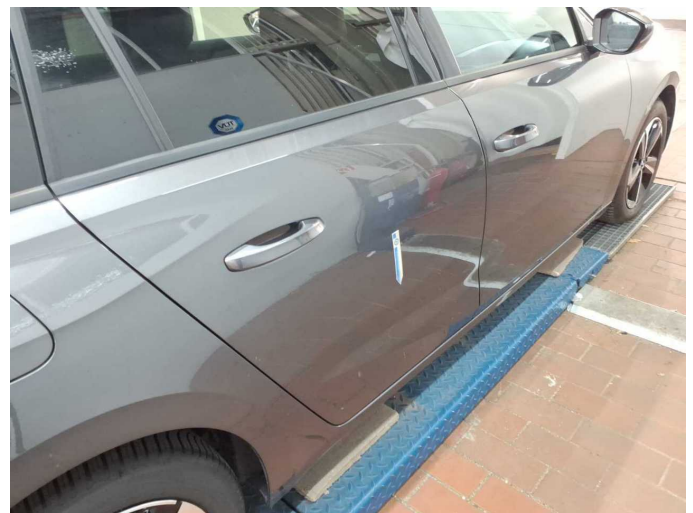
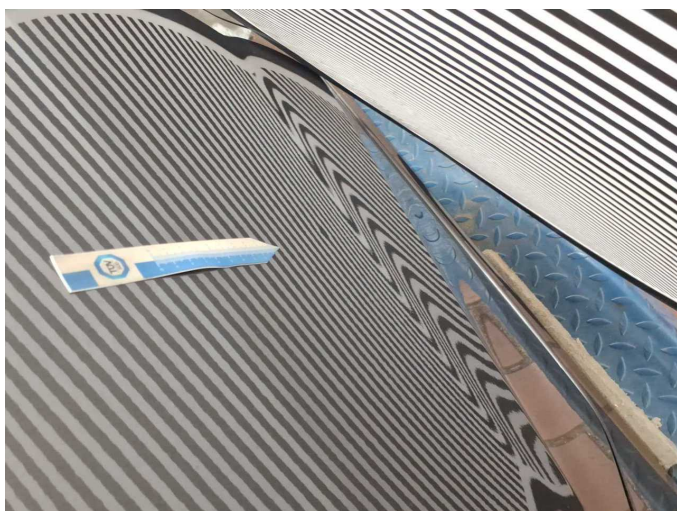
| No. | Component group | Description |
|---|---|---|
| 1 | Door - rear right side | Door - dent(s) - Smooth repair work |

**Damage 1:** Door - rear right side: Door - dent(s) - Smooth repair work

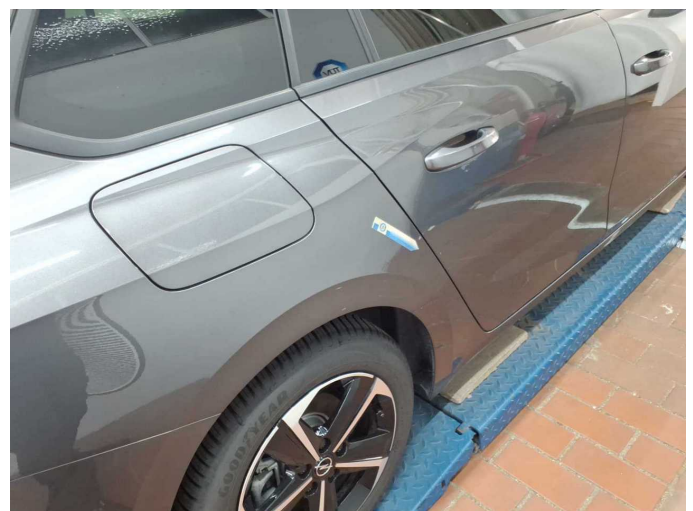
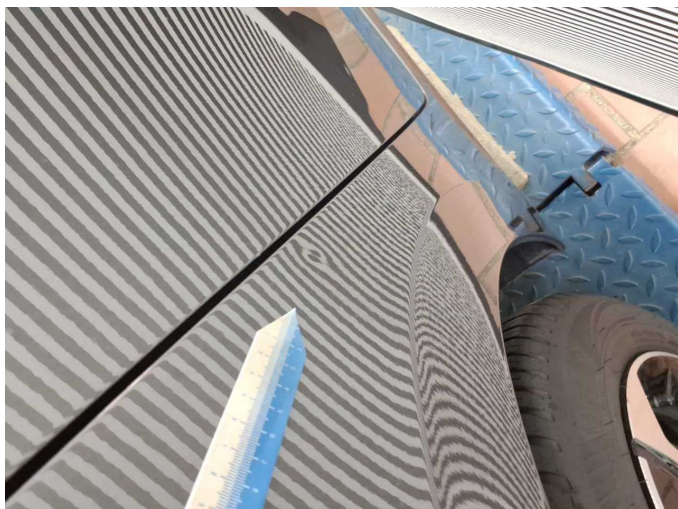
| No. | Component group | Description |
|---|---|---|
| 2 | Side panel - rear right side | Side panel - dent(s) - Smooth repair work |

**Damage 2:** Side panel - rear right side: Side panel - dent(s) - Smooth repair work

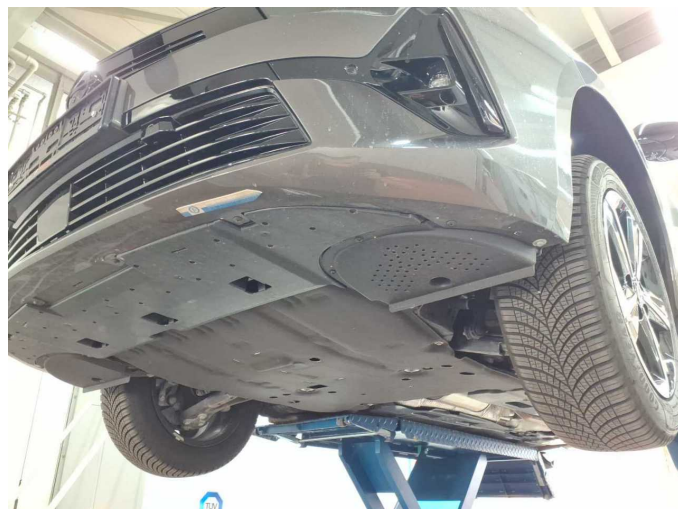
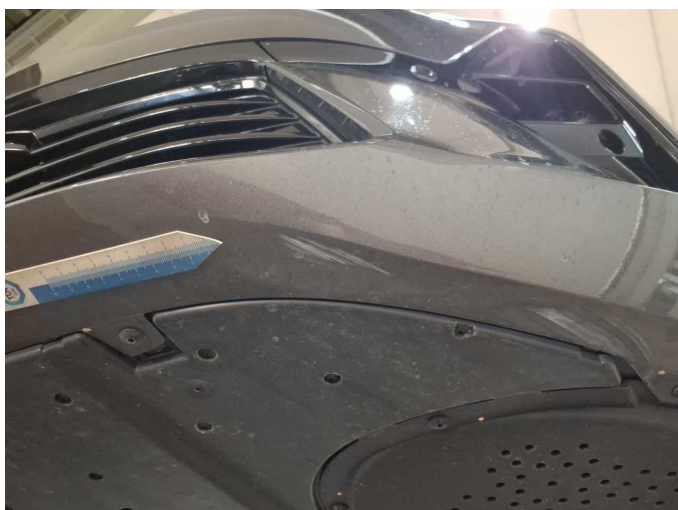
| No. | Component group | Description |
|---|---|---|
| 3 | Front bumper | Front bumper - Scratch(es) - Smart repair |

**Damage 3:** Front bumper: Front bumper - Scratch(es) - Smart repair

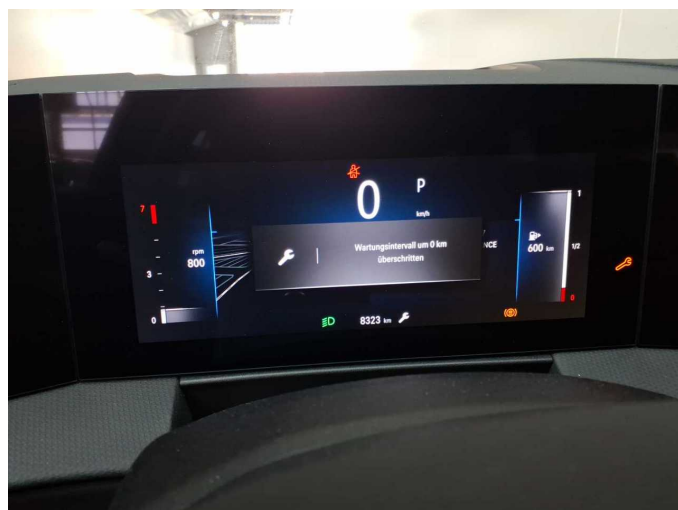
| No. | Component group | Description |
|---|---|---|
| 4 | Misc. | Inspection / maintenance - Due - Replace |

**Damage 4:** Misc.: Inspection / maintenance - Due - Replace

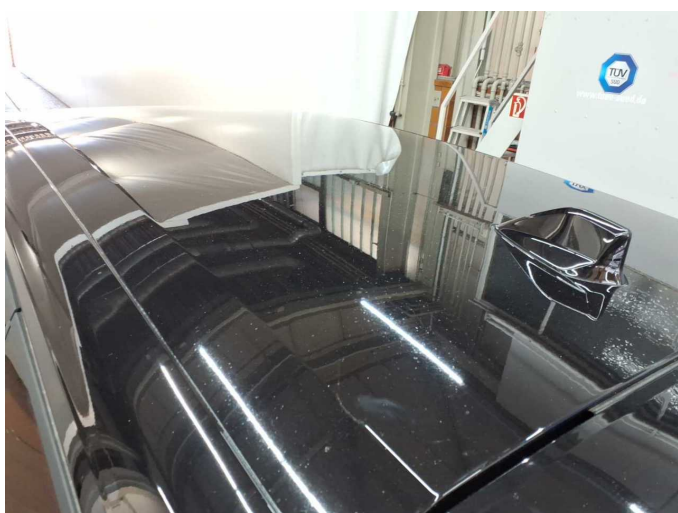
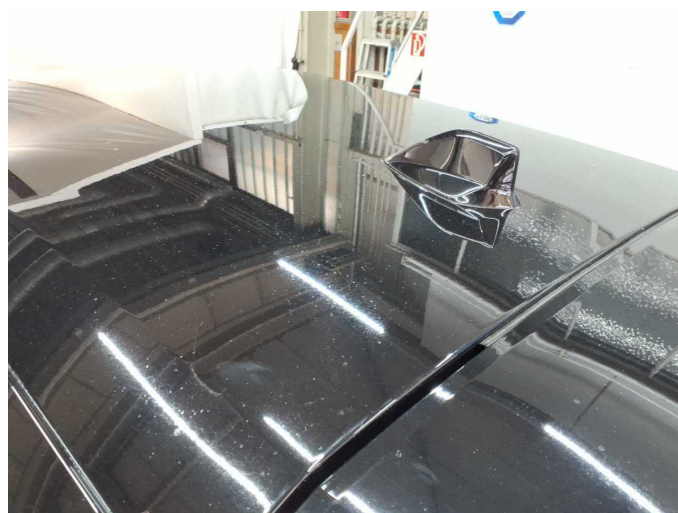
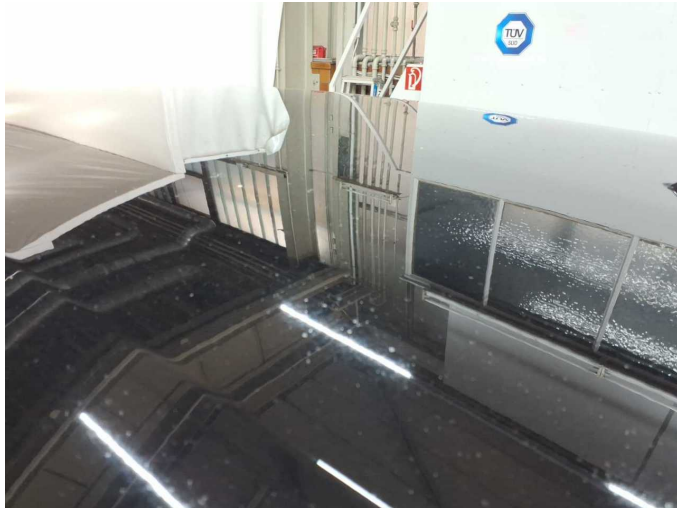
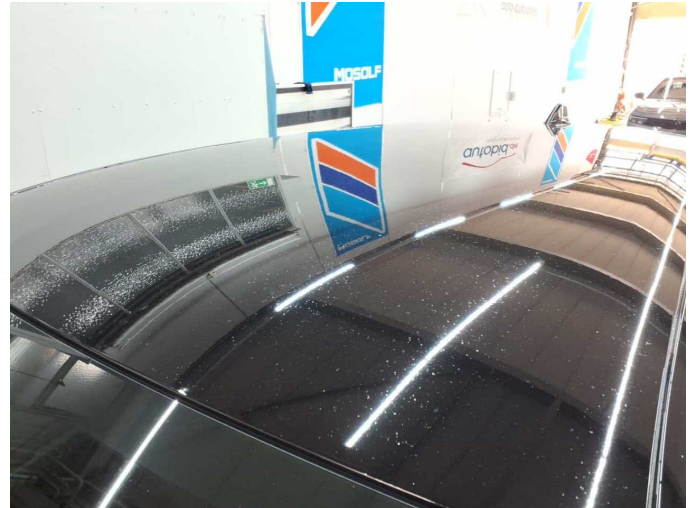
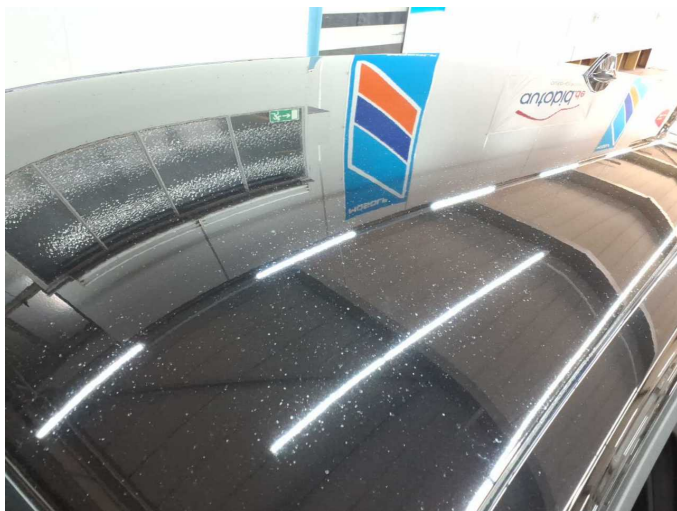
| No. | Component group | Description |
|---|---|---|
| 5 | Roof | Roof (Anhaftung hartz) - Paint defect - Paint |

**Damage 5:** Roof: Roof (Anhaftung hartz) - Paint defect - Paint
