Expertise

Protocol number: 46674065  
Order No. / Reference: 26656762  
Inspection date: 23 Jul 2026

| Manufacturer: Ford | Model: Transit Custom Kombi 300 L1H1 LKW VA Trend |

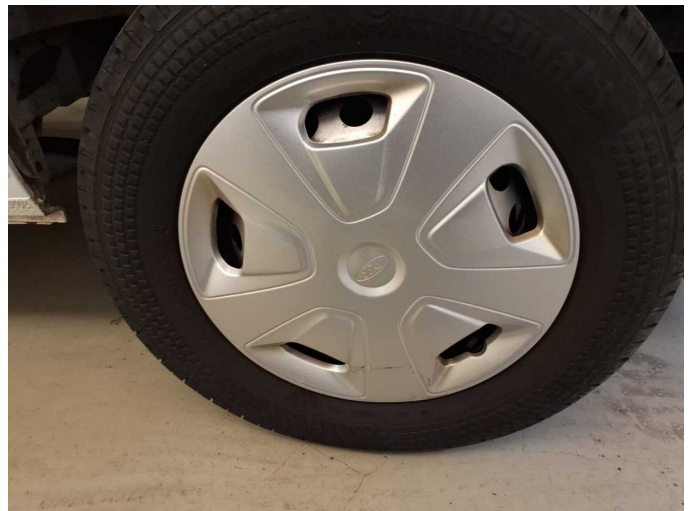
| No. | Component group | Description |
|---|---|---|
| 1 | Wheel / tyres | Wheel cover - rear left side - Scratch(es) - Replace |

Damage 1: Wheel / tyres: Wheel cover - rear left side - Scratch(es) - Replace

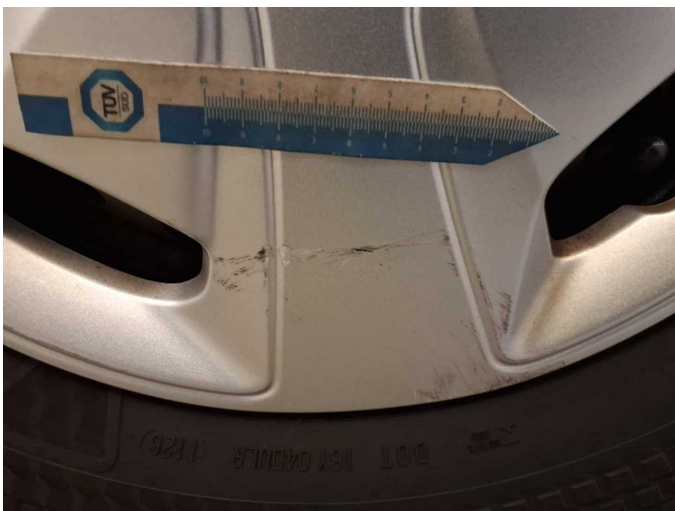
Damage 1: Wheel / tyres: Wheel cover - rear left side - Scratch(es) - Replace

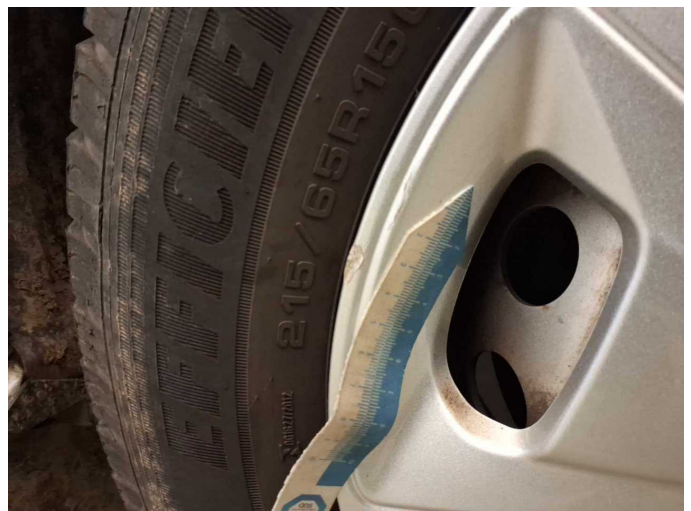
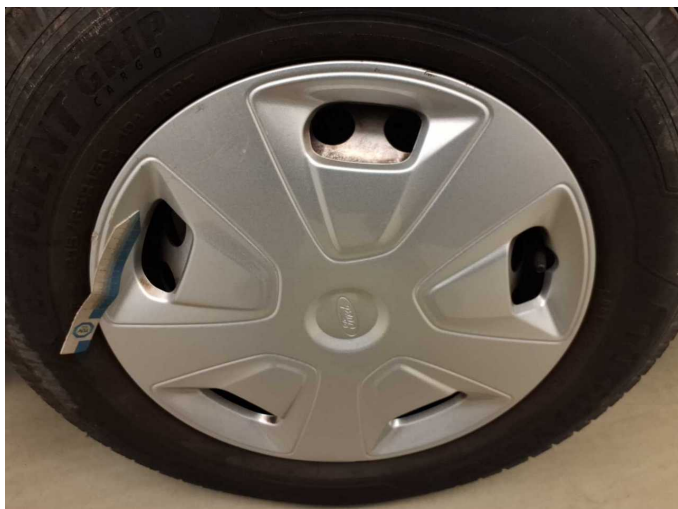
| No. | Component group | Description |
|---|---|---|
| 2 | Wheel / tyres | Wheel cover - front right side - Scratch(es) - Replace |

Damage 2: Wheel / tyres: Wheel cover - front right side - Scratch(es) - Replace

**Damage 2:** Wheel / tyres: Wheel cover - front right side - Scratch(es) - Replace

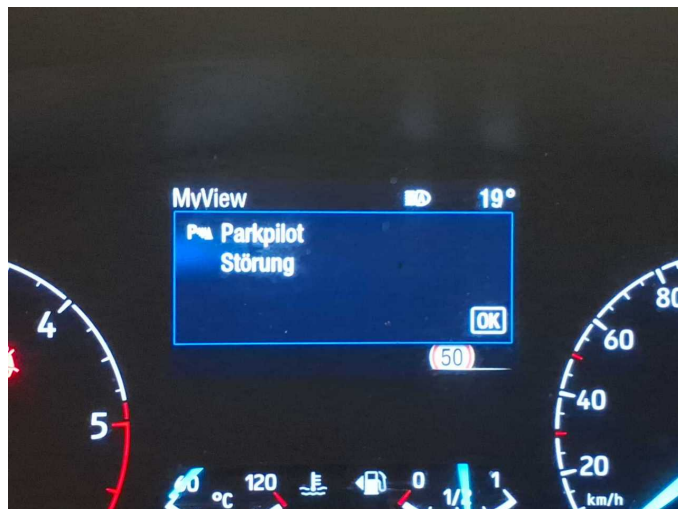
| No. | Component group | Description |
|---|---|---|
| 3 | Electronic systems | Parking assistance - on - Perform diagnosis |

**Damage 3:** Electronic systems: Parking assistance - on - Perform diagnosis

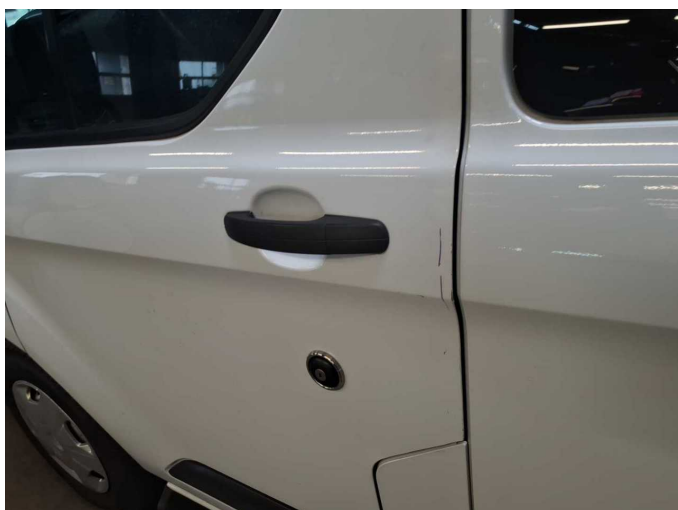
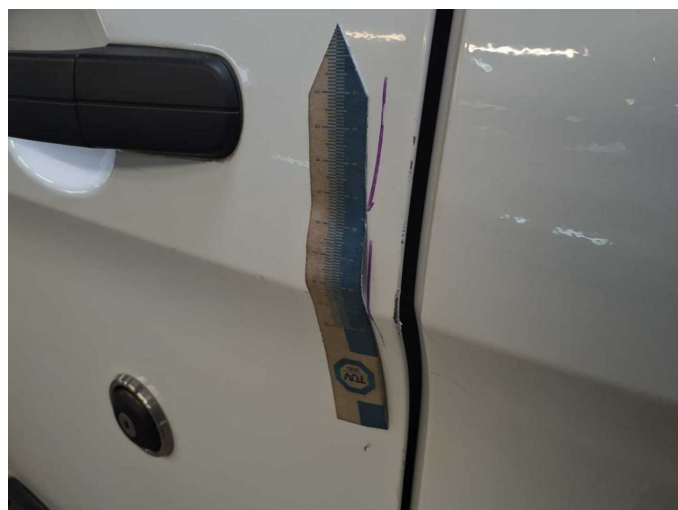
| No. | Component group | Description |
|---|---|---|
| 4 | Door - front left side | Door - Scratched - Smart repair |

**Damage 4:** Door - front left side: Door - Scratched - Smart repair

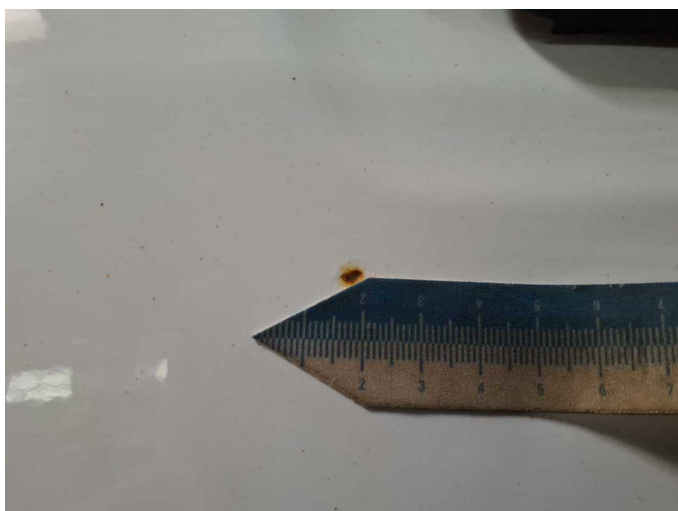
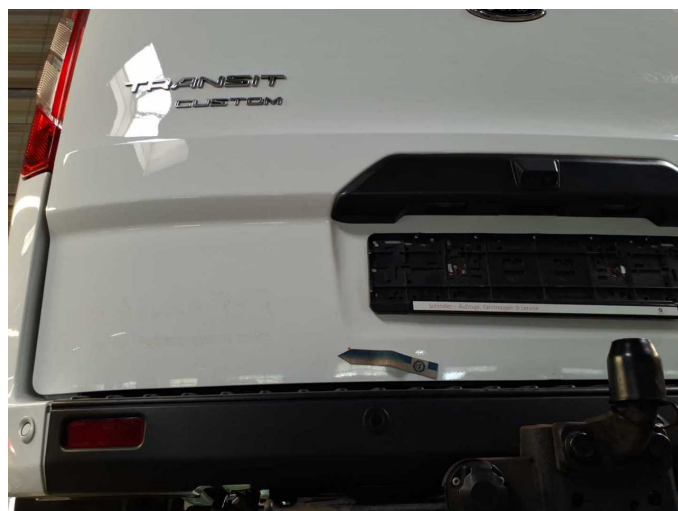
| No. | Component group | Description |
|---|---|---|
| 5 | Boot lid / rear door | Boot lid - Corrosion - Smart repair |

**Damage 5:** Boot lid / rear door: Boot lid - Corrosion - Smart repair

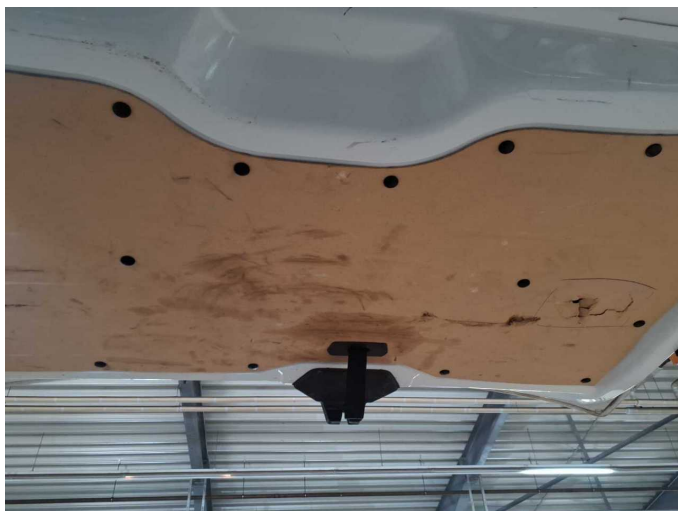
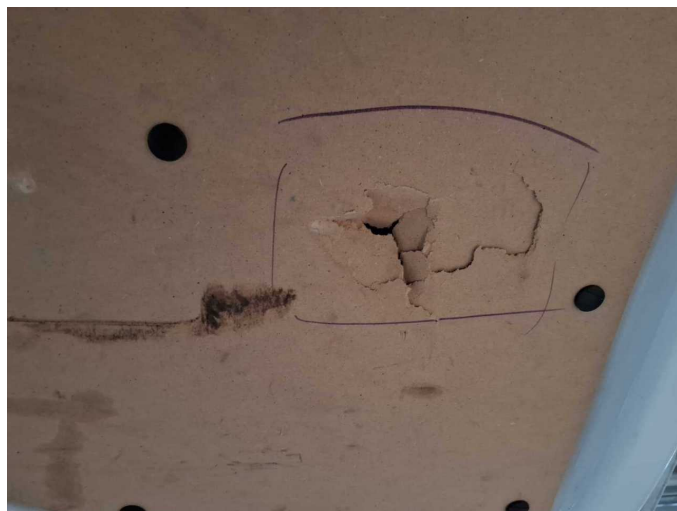
| No. | Component group | Description |
|---|---|---|
| 6 | Trim / covers | Boot lid - interior trim - Broken / torn - Replace |

**Damage 6:** Trim / covers: Boot lid - interior trim - Broken / torn - Replace

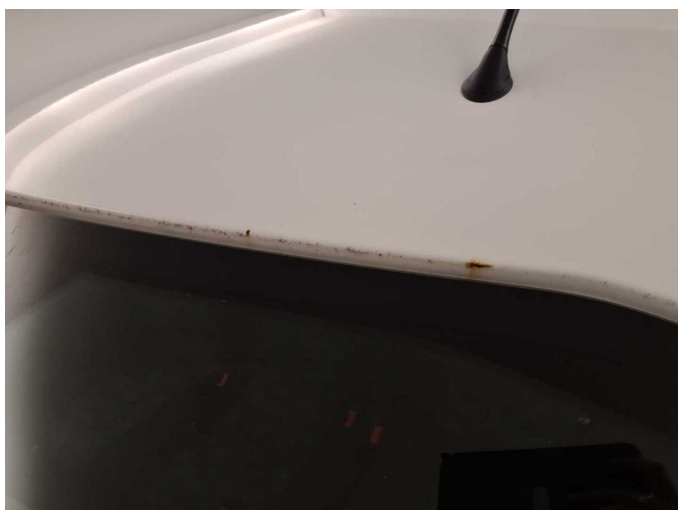
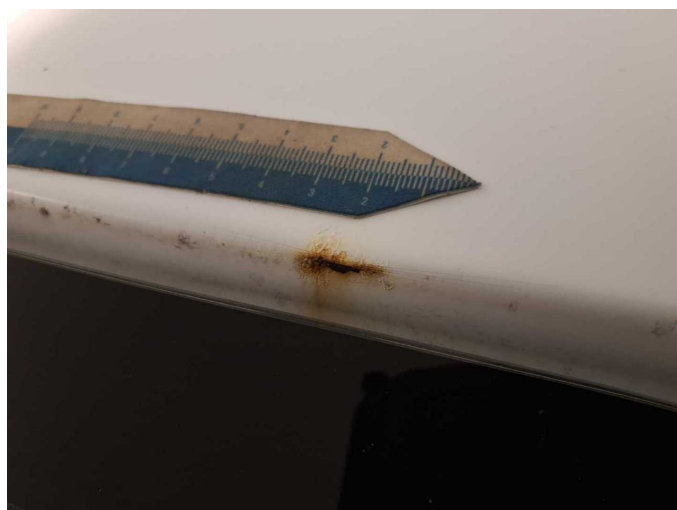
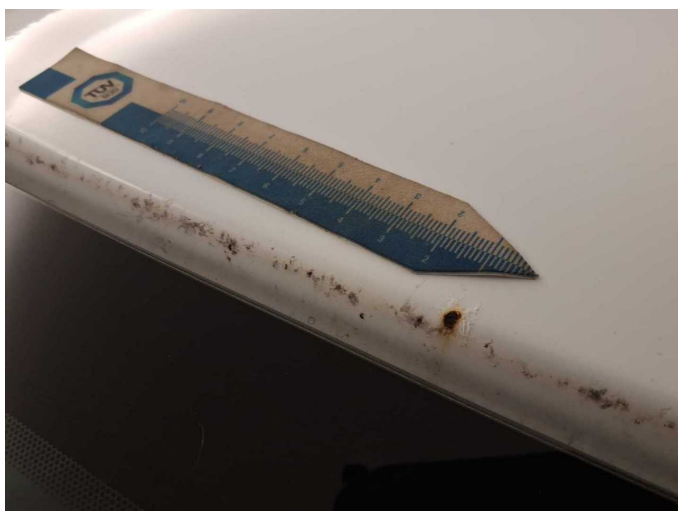
| No. | Component group | Description |
|---|---|---|
| 7 | Roof | Roof - Corrosion - Paint |

**Damage 7:** Roof: Roof - Corrosion - Paint

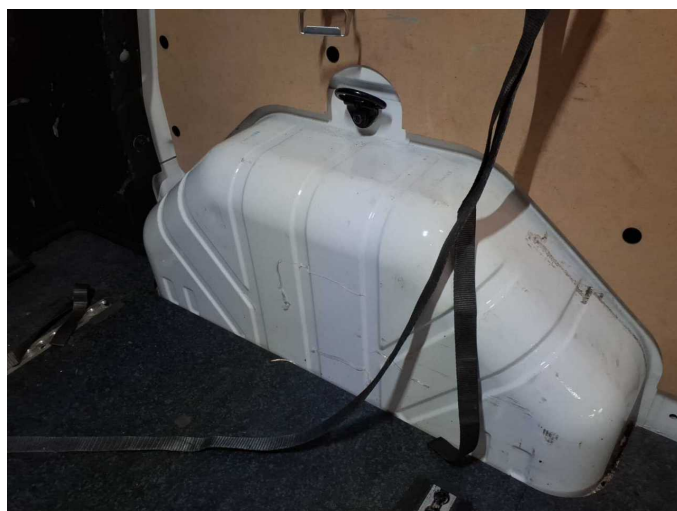
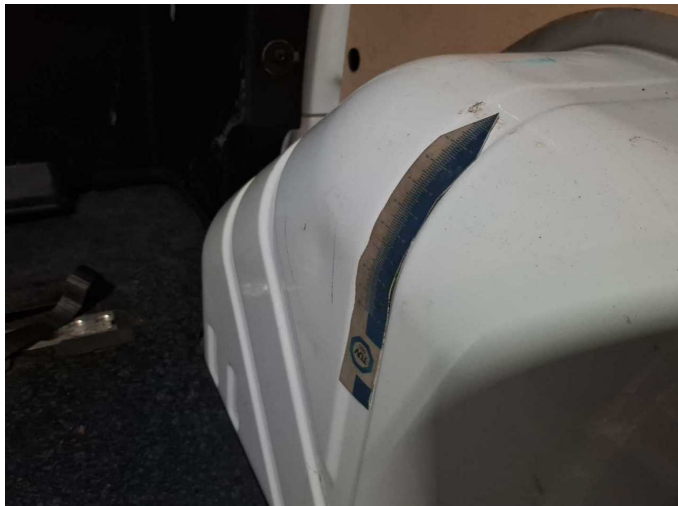
| No. | Component group | Description |
|---|---|---|
| 1 | Side panel - rear right side | Wheel arch - dent(s) - No deduction |

**Wear and tear 1:** Side panel - rear right side: Wheel arch - dent(s) - No deduction

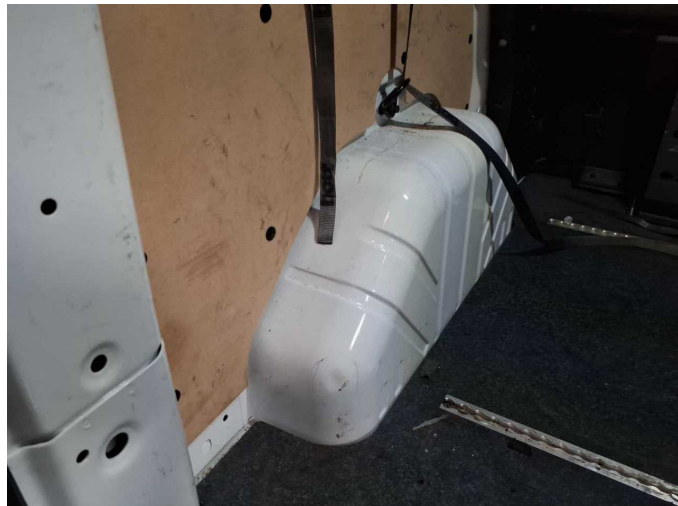
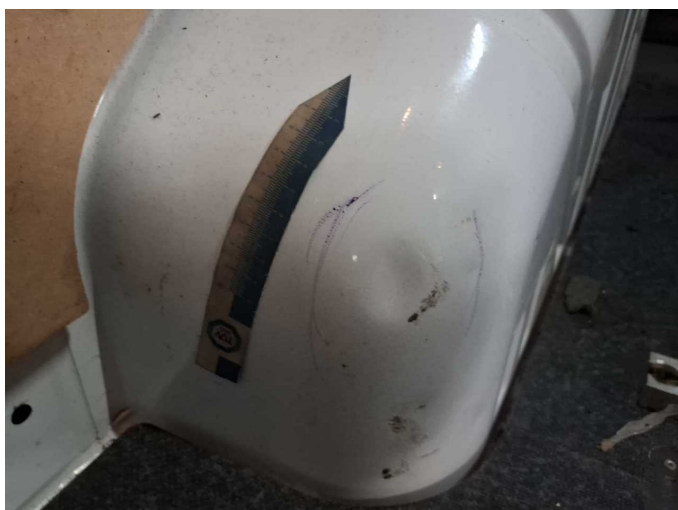
| No. | Component group | Description |
|---|---|---|
| 2 | Side panel - rear left side | Wheel arch - dent(s) - No deduction |

**Wear and tear 2:** Side panel - rear left side: Wheel arch - dent(s) - No deduction

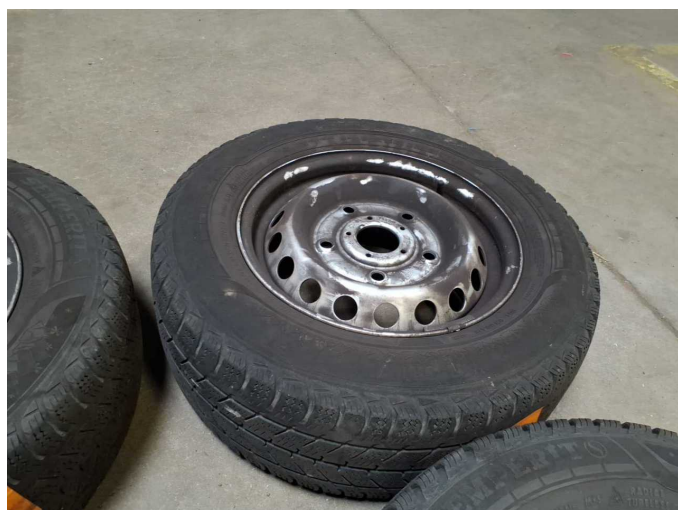
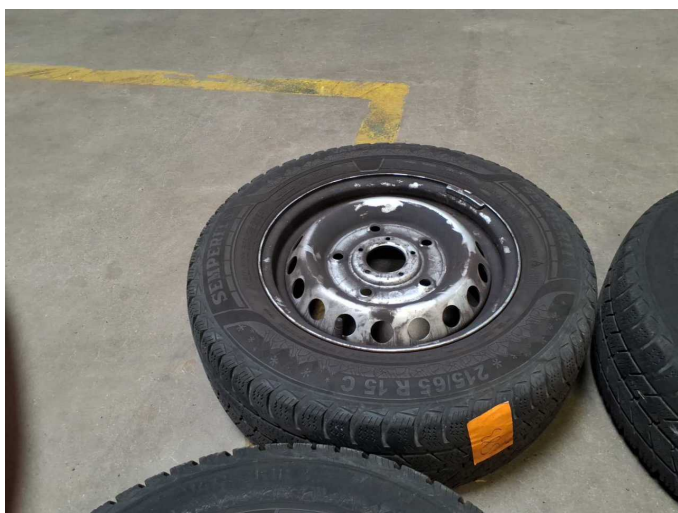
| No. | Component group | Description |
|---|---|---|
| 4 | 2nd wheel set | 2 tyres (WR) - Worn - No deduction |

**Wear and tear 4:** 2nd wheel set: 2 tyres (WR) - Worn - No deduction

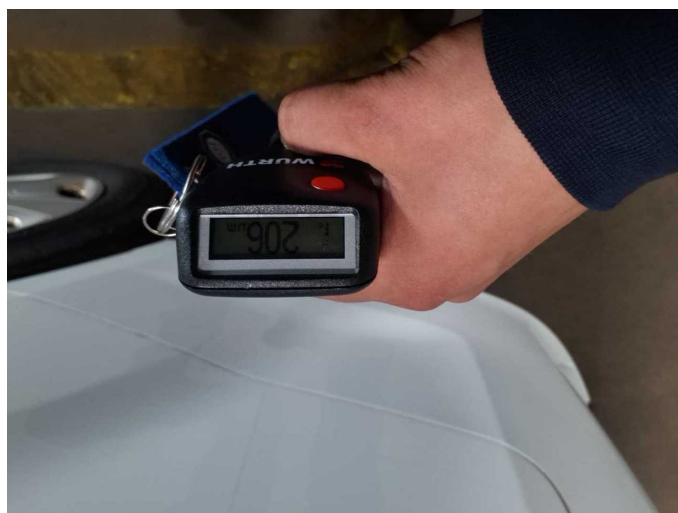
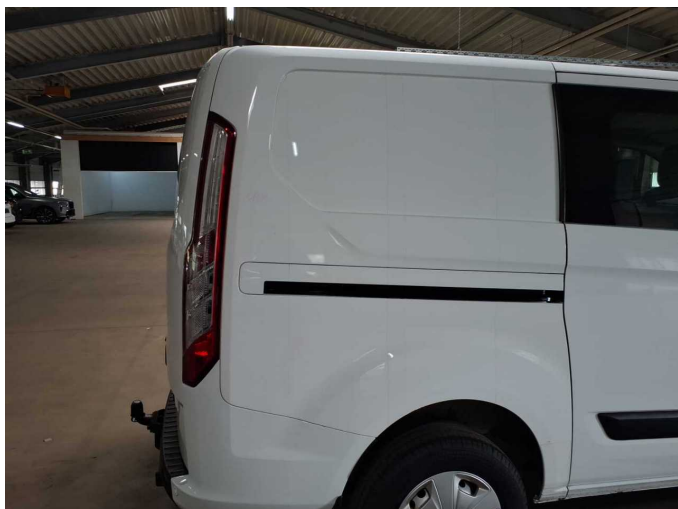
| No. | Repainting |
|---|---|
| 1 | Side panel - rear right side, Professionally carried out, Invoice of repair done Non-existent |

**Repainting 1:** Side panel - rear right side

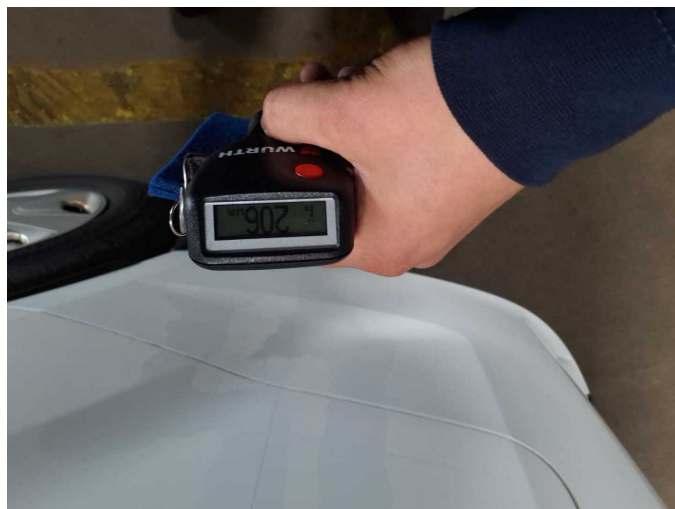
| Side panel - rear right side | 206 µm |

**Side panel - rear right side:** 206  $\mu\text{m}$
