Expertise

Protocol number: 45425301
Order No. / Reference: 26215774
Inspection date: 7 May 2026

Model: Trafic ENERGY dCi 120 L1H1 3,0t Komfort

VIN: VF1FL000666129284

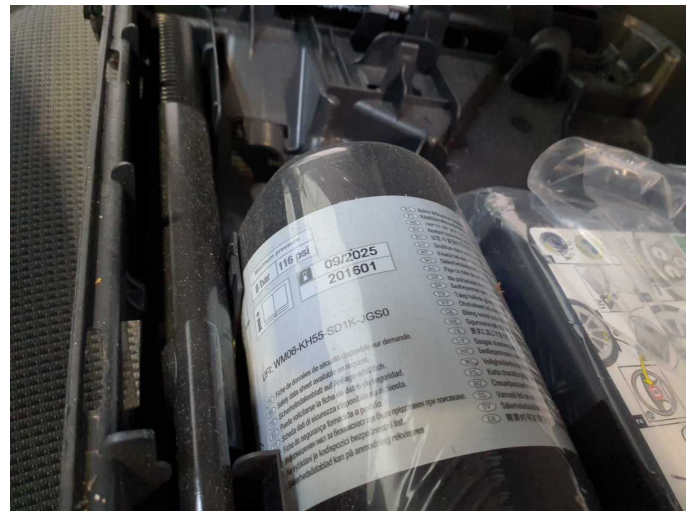
Damage 2: Equipment: Tirefit filler - Expired - Replace

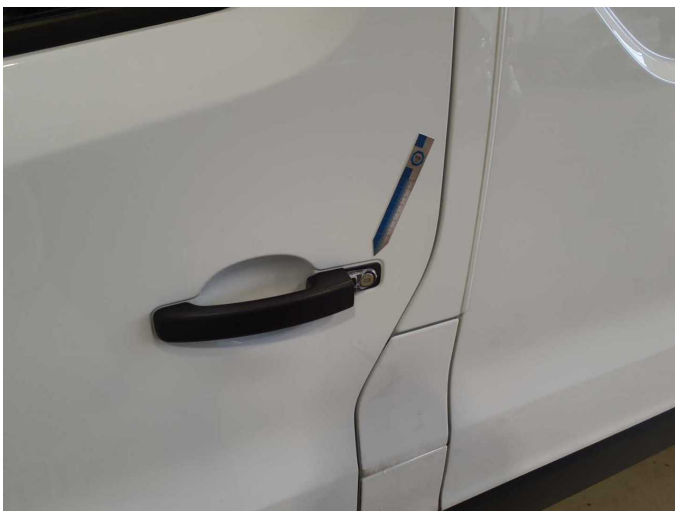
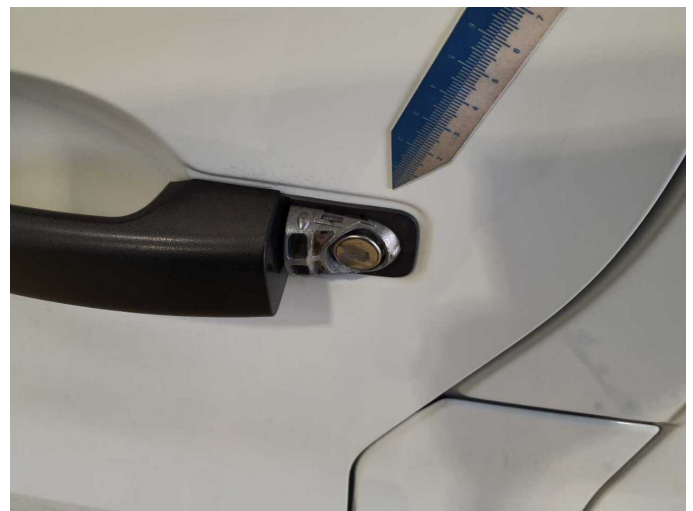
Damage 3: Door - front left side: Door handle - outside - Missing - Replace

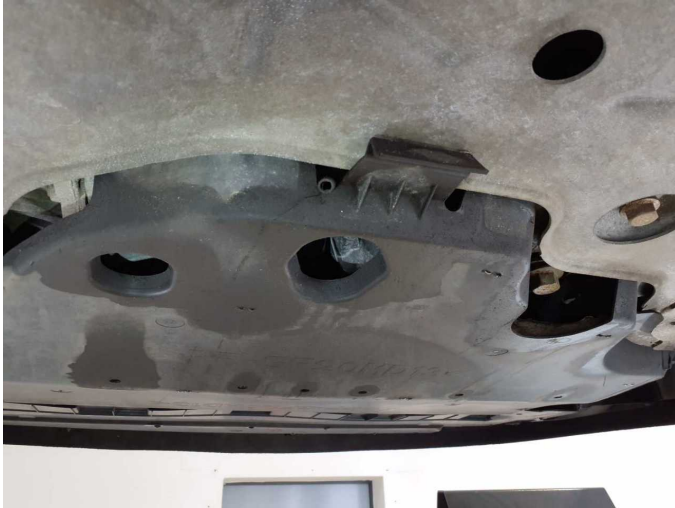
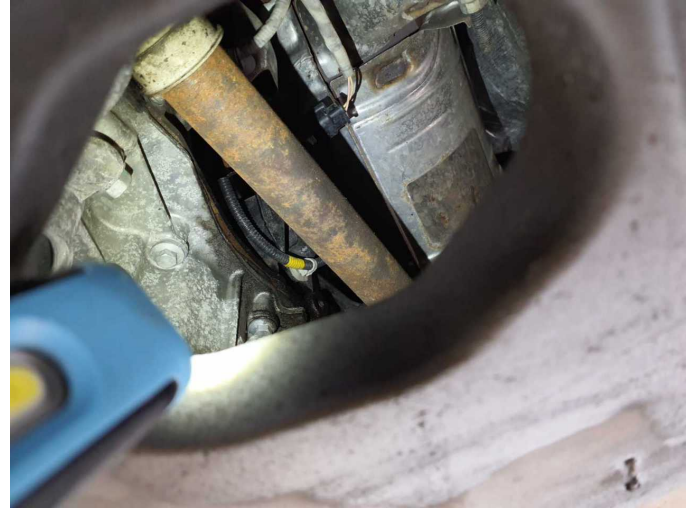
Damage 4: Engine: Engine - Leaking - Perform diagnosis

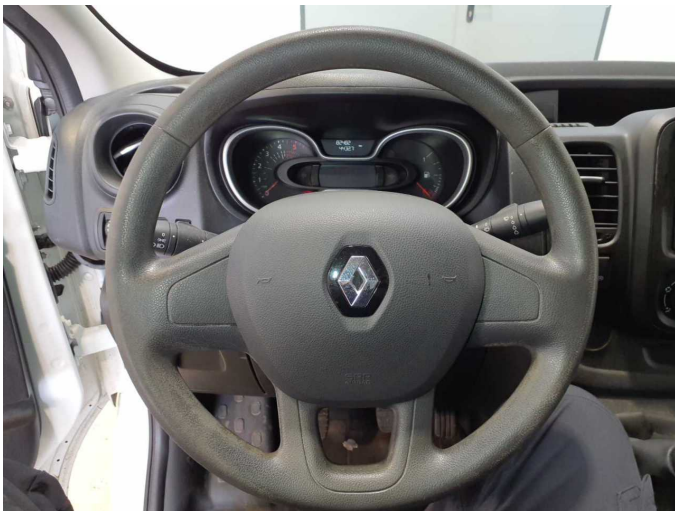
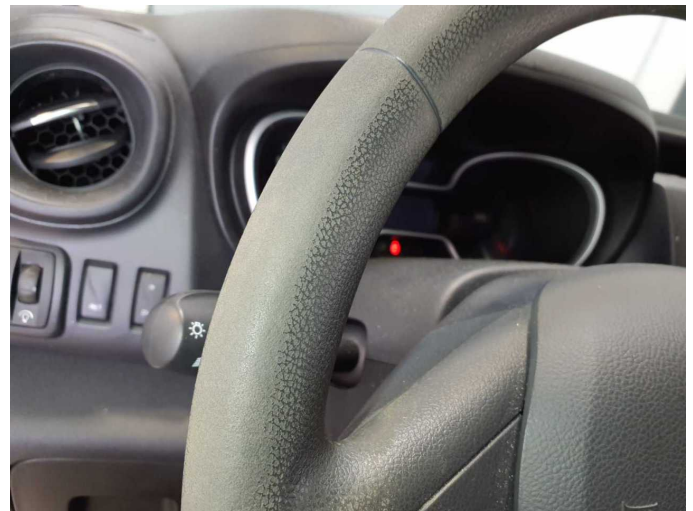
Damage 5: Steering system: Steering wheel - Scratch(es) - Loss in value

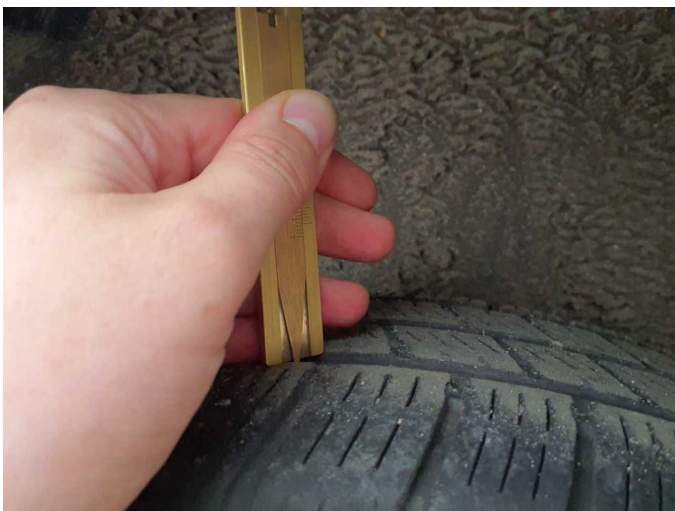
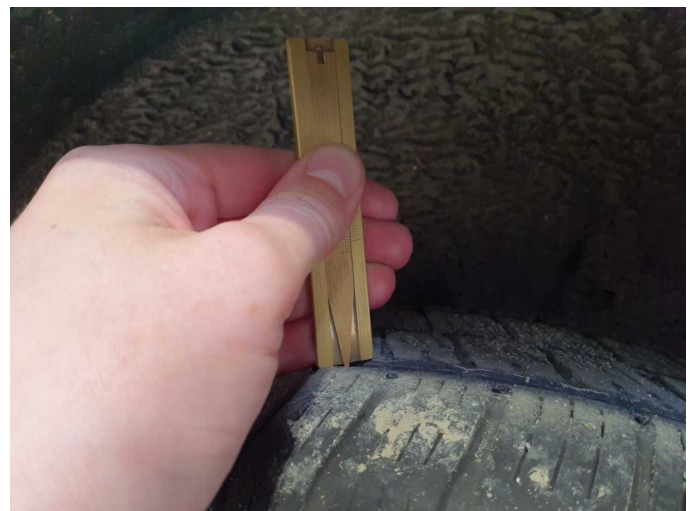
Damage 6: Wheel / tyres: Tyre - right - Worn - Replace

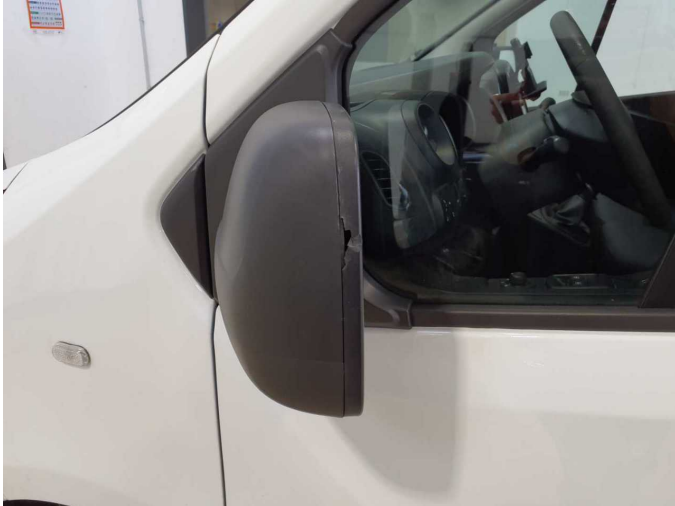
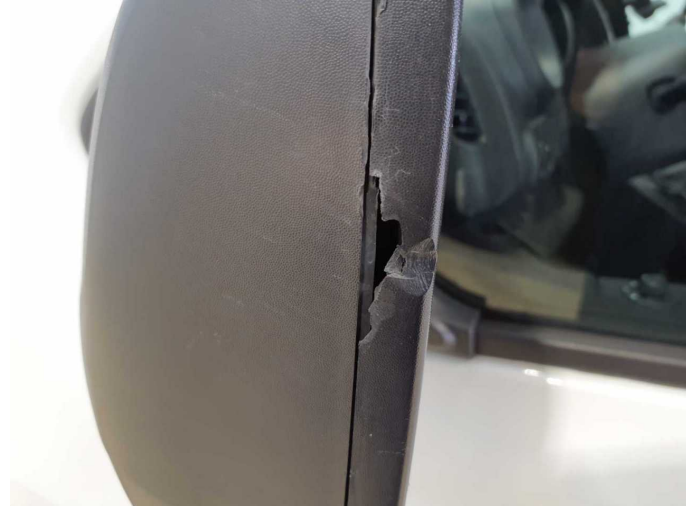
Damage 7: Wing mirror - left side: Chassis - Broken / torn - Replace

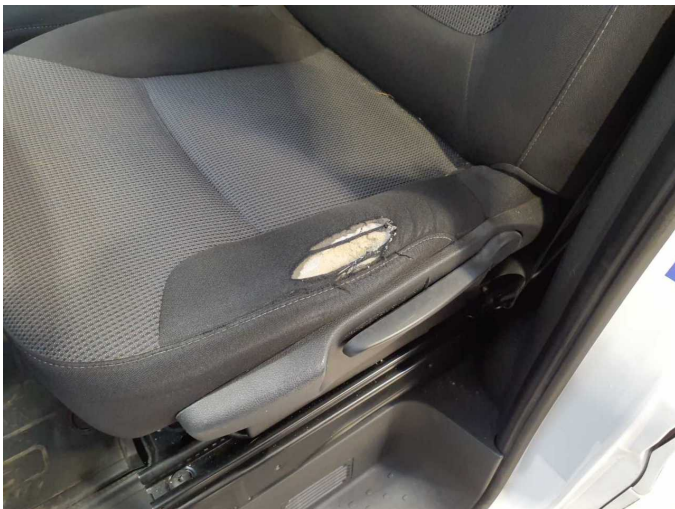
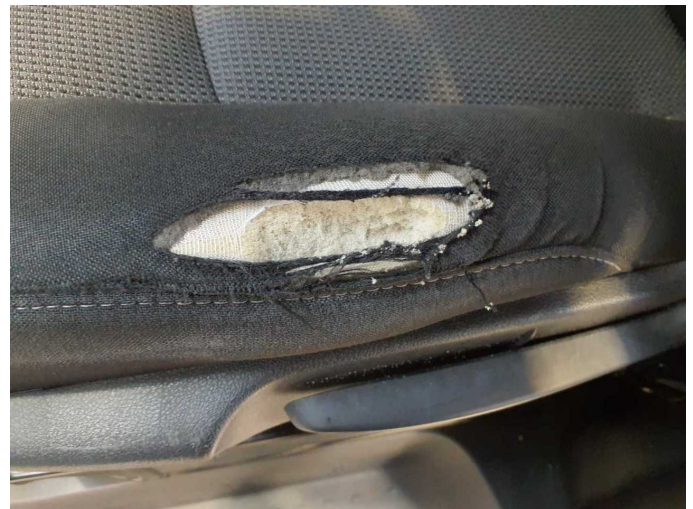
Damage 8: Seat - front: Seat cover - left side (Und polster) - Broken / torn - Replace

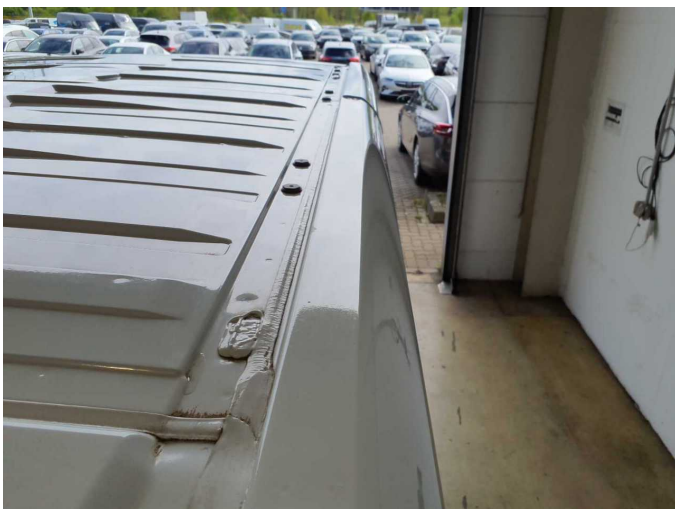
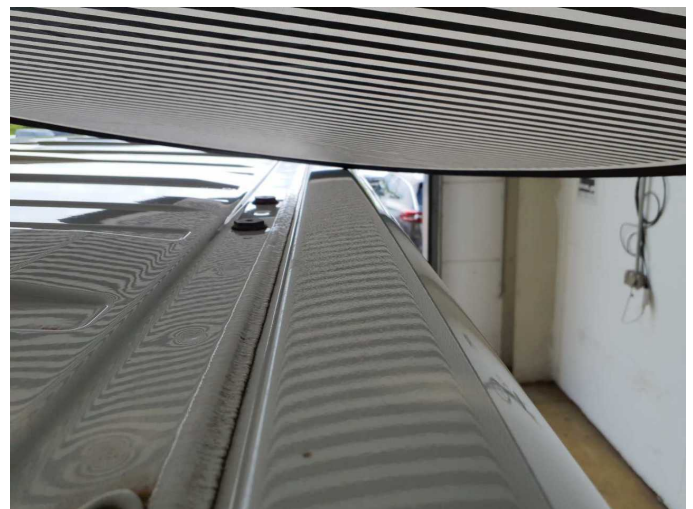
Damage 9: Roof: Roof rail - left side (Orangenhaut) - Unprofessionally repaired - Repair and paint

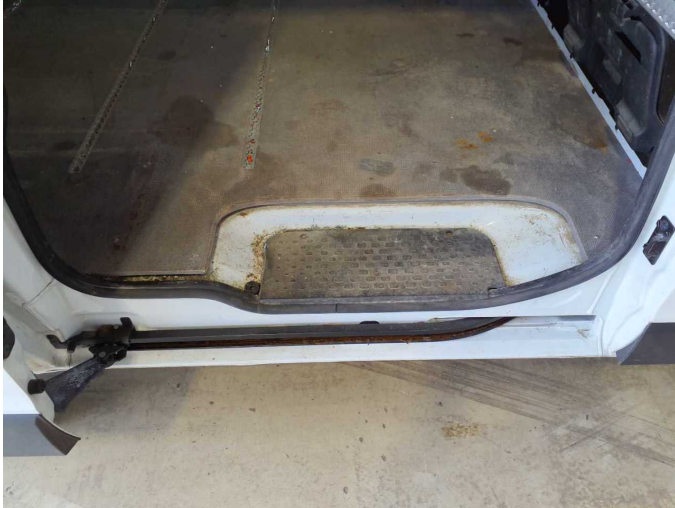
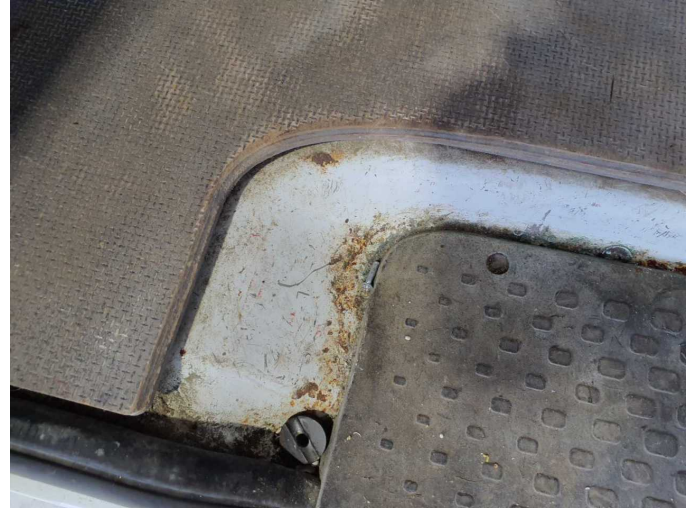
Damage 10: Side panel - rear right side: Sill - Corrosion - Repair and paint

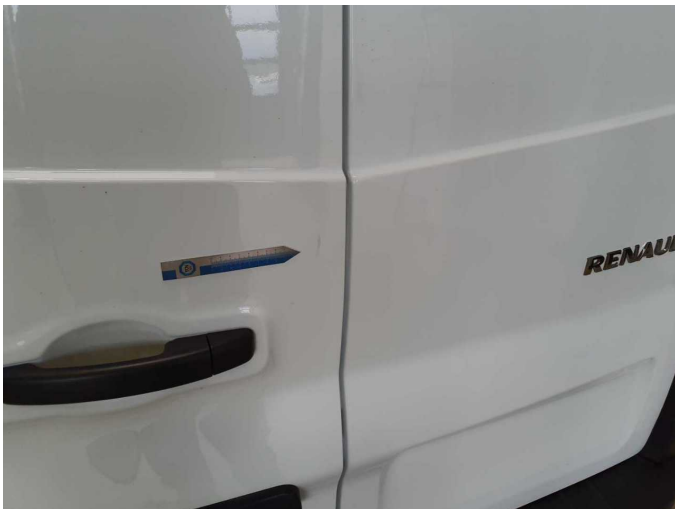
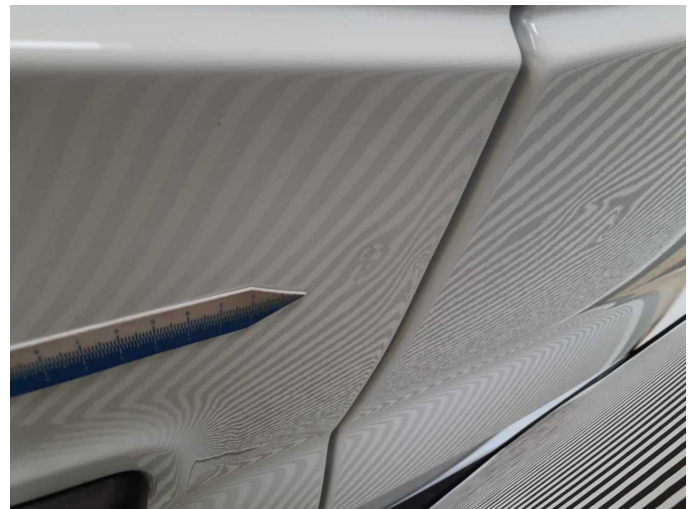
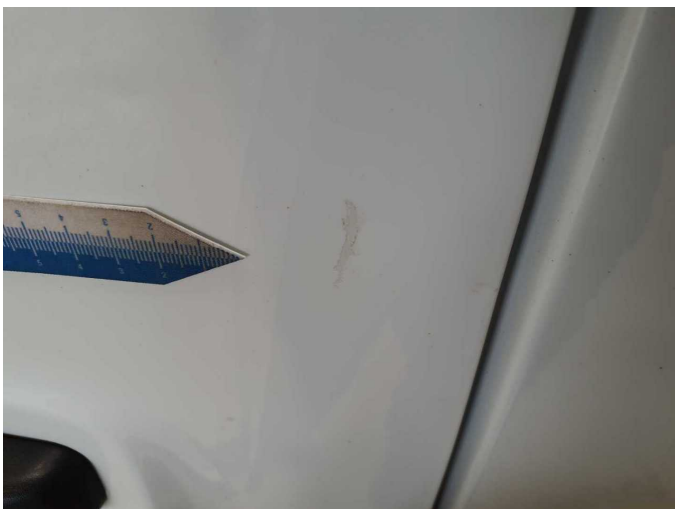
Damage 11: Boot lid / rear door: Rear door - left side - Dent / paintcoat damage - Repair and paint

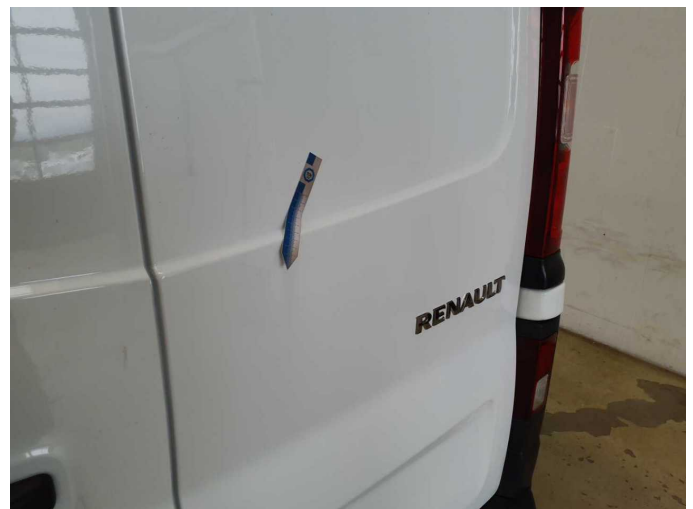
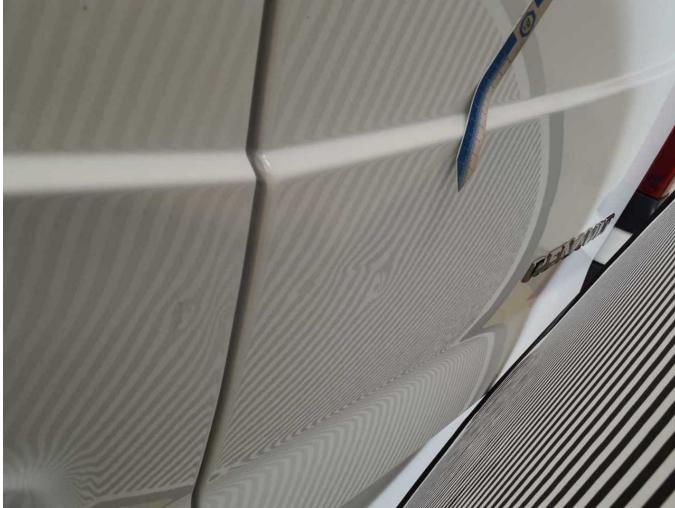
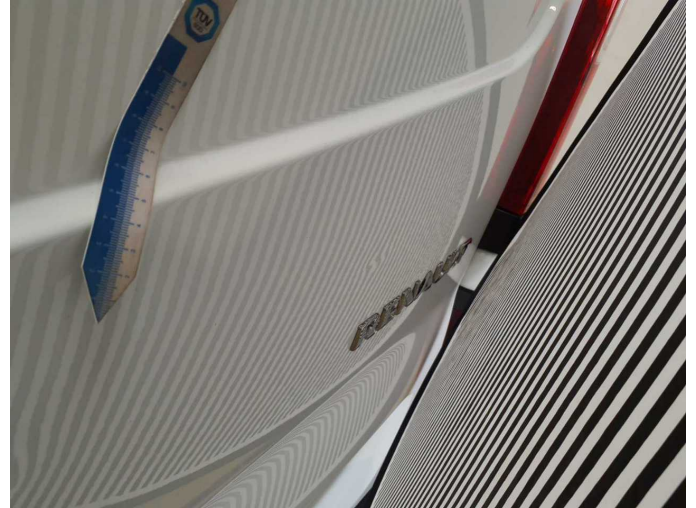
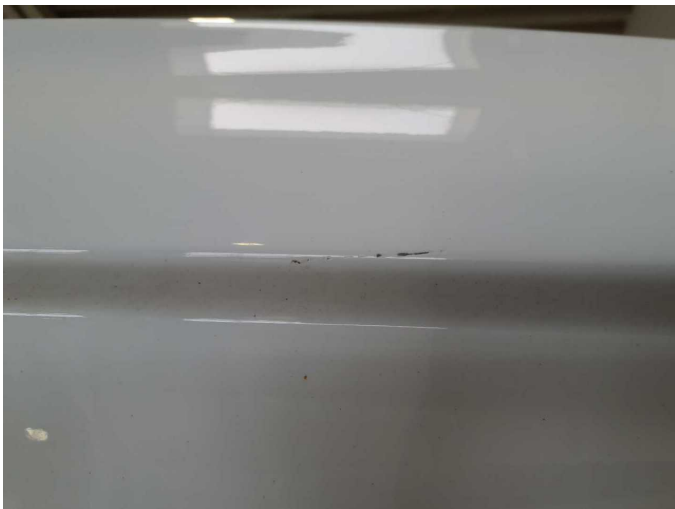
Damage 12: Boot lid / rear door: Rear door - right side - Dent / paintcoat damage - Repair and paint

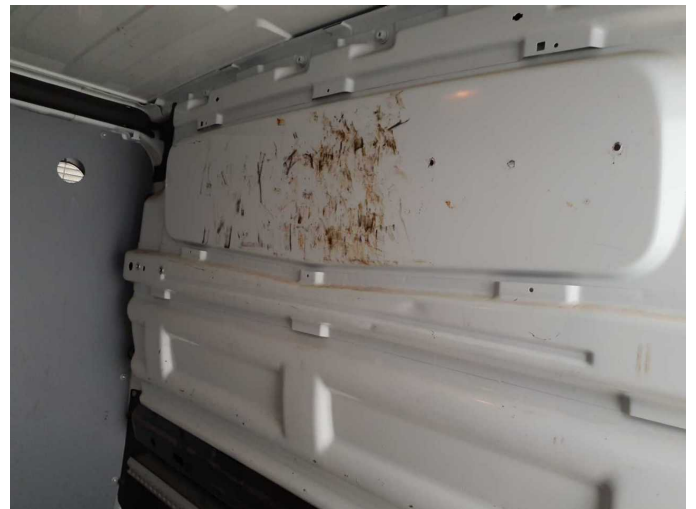
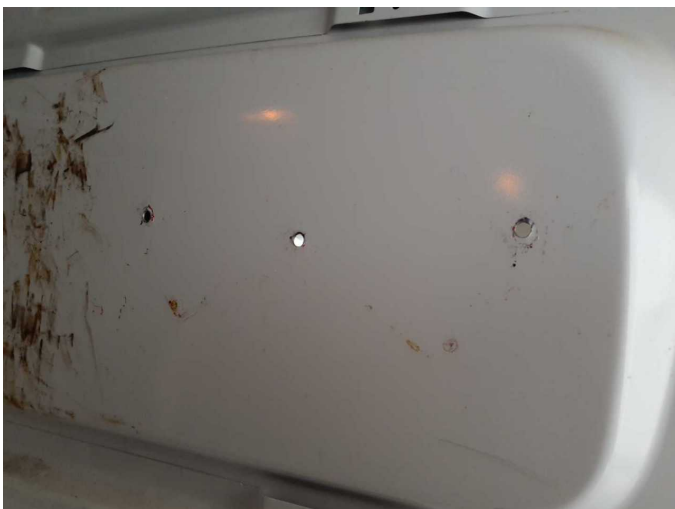
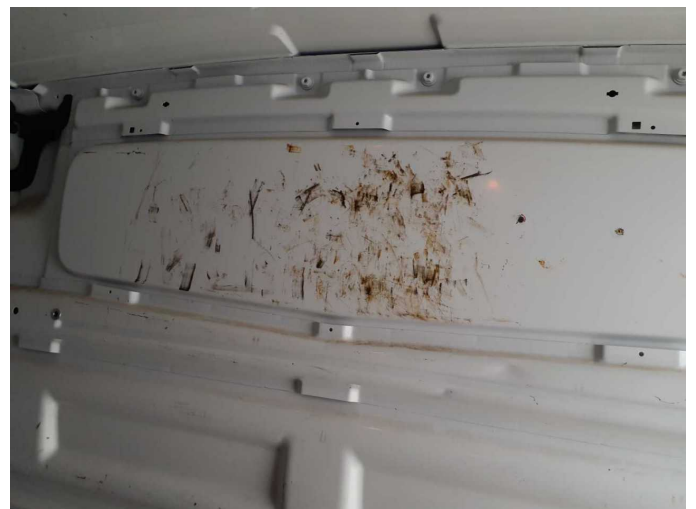
Damage 13: Body: Partition wall - Holes - Replace

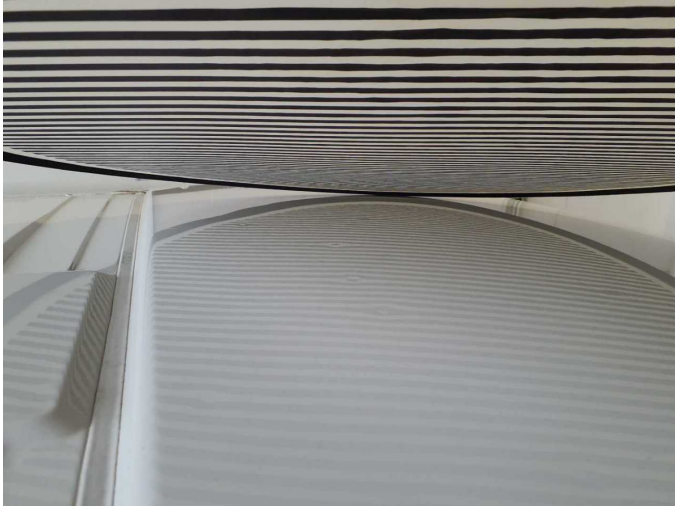
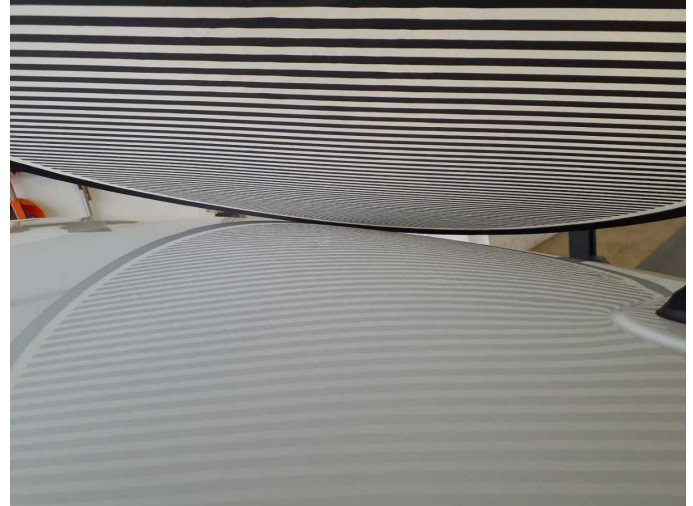
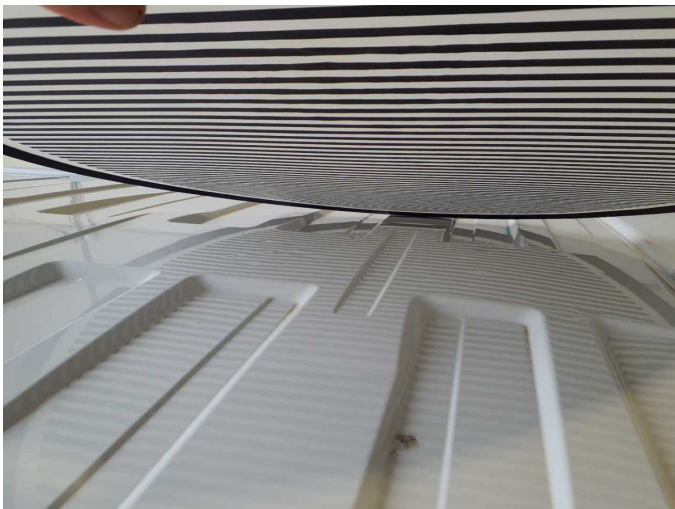
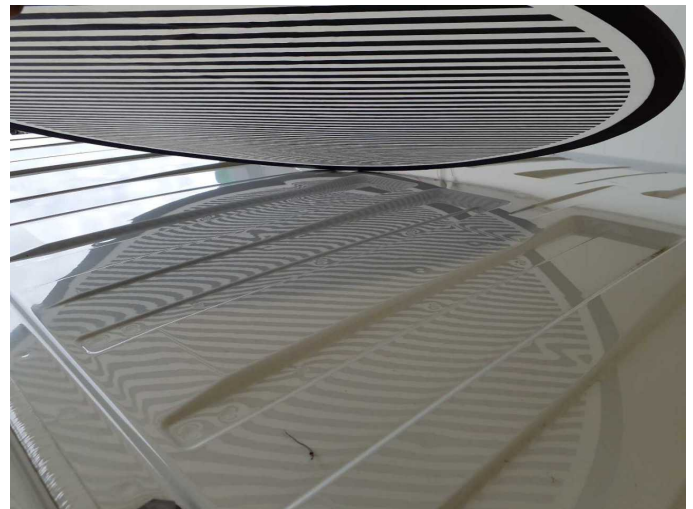
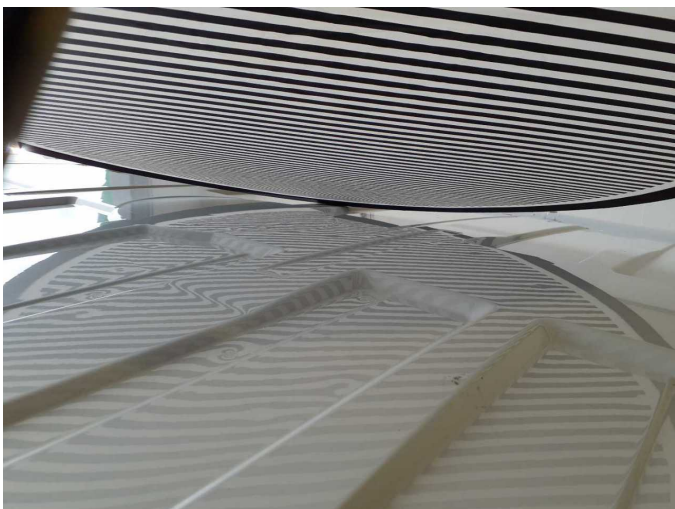
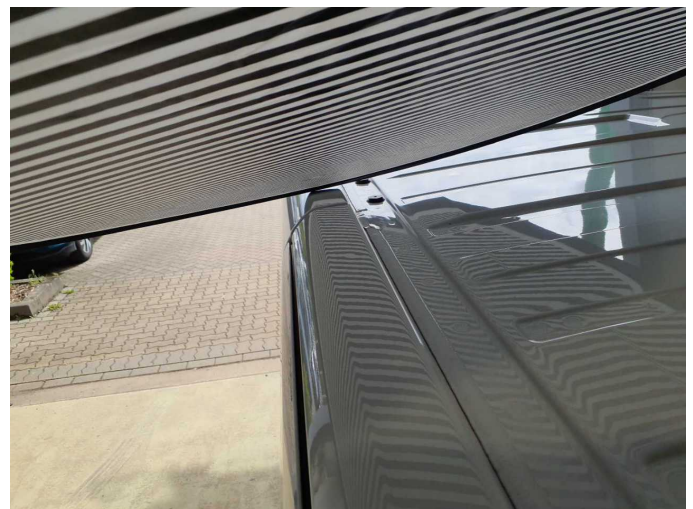
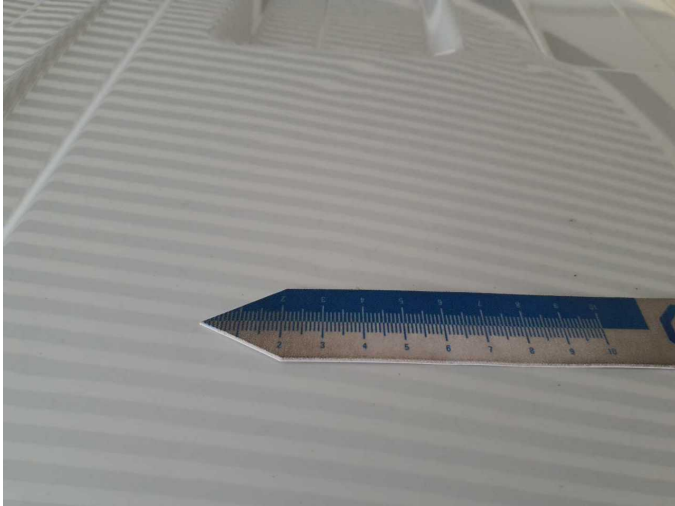
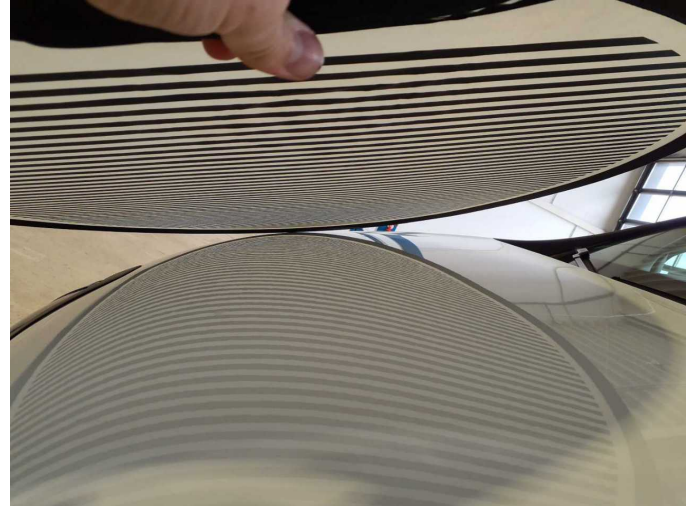
Der kalkulierte Hagelschaden wurde nach bestem Wissen und Gewissen unter eingeschränkter Besichtigungsbedingung im demontagefreien Zustand erstellt. Es können aufgrund verdeckter Beschädigung, Mehrkosten und somit Abweichung der für den Schaden ausgewiesenen Reparaturkosten nicht ausgeschlossen werden.

Damage 14: Body: Body - Damage by hail - repair according to calculation

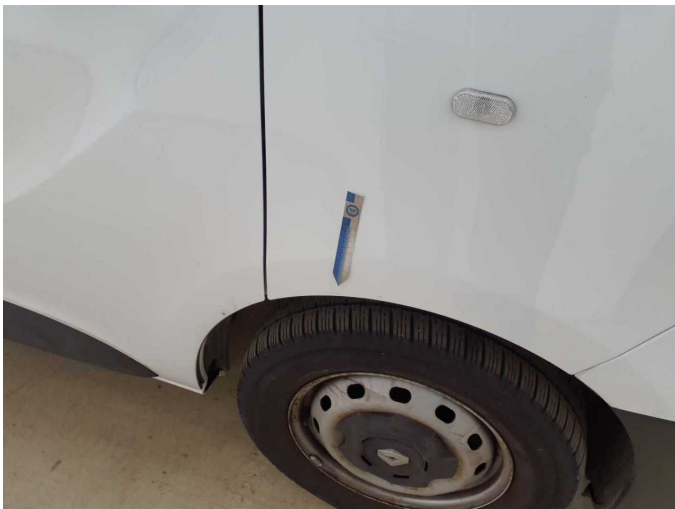
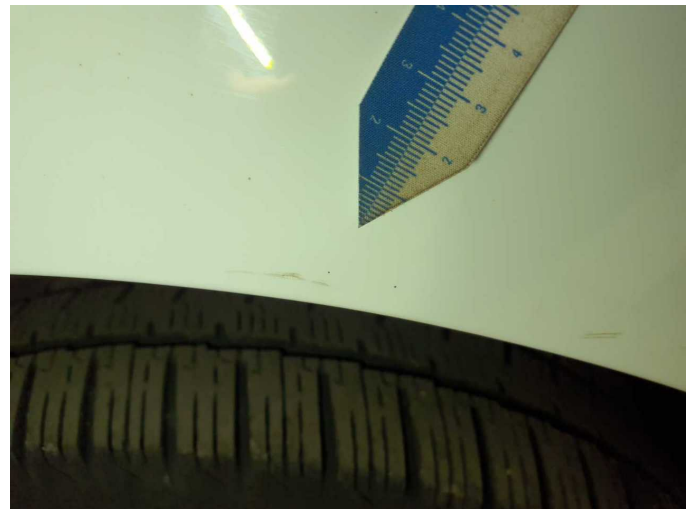
Wear and tear 3: Mudguard - right side: Mudguard - right side - Scratch(es) - No deduction

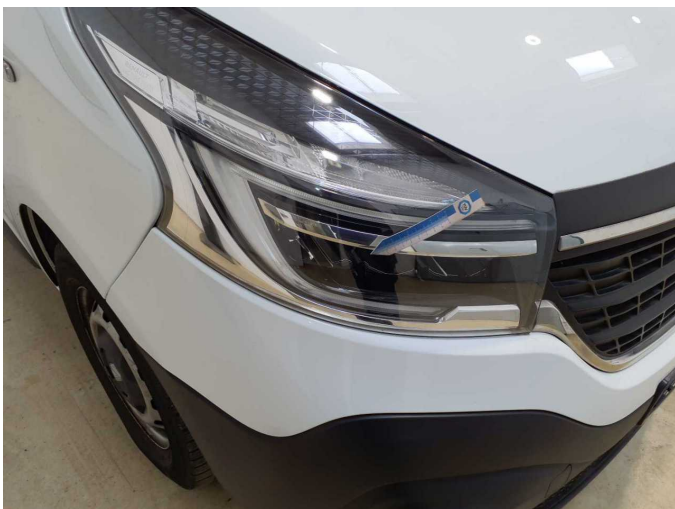
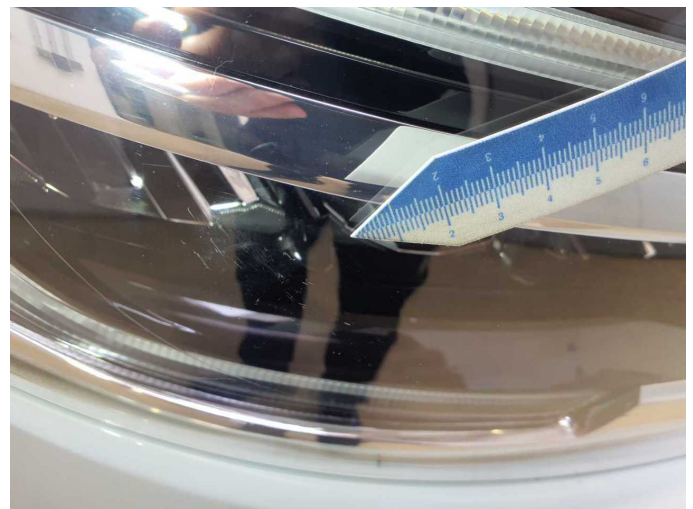
Wear and tear 4: Headlight: Headlight - right side - Scratch(es) - No deduction

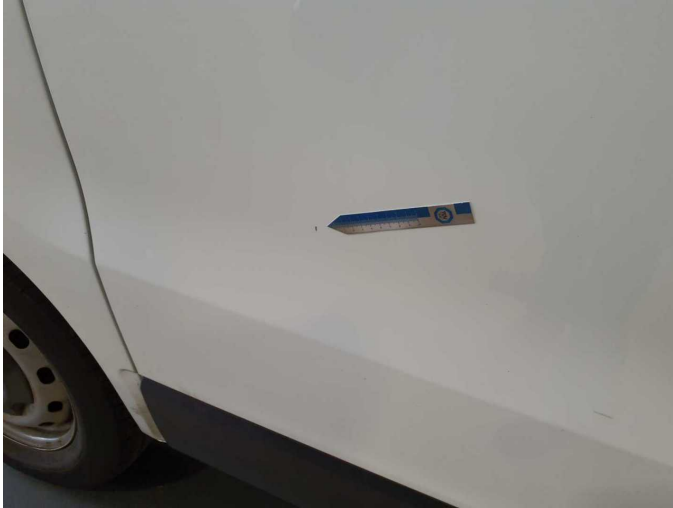
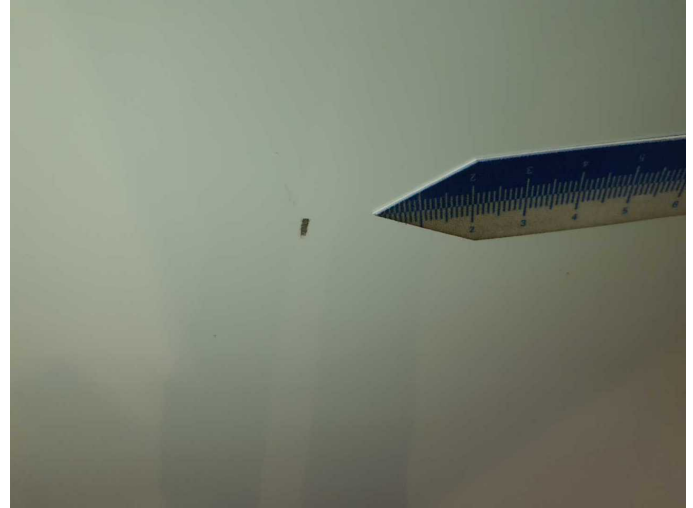
Wear and tear 5: Sliding door, right: Sliding door - Scratch(es) - No deduction

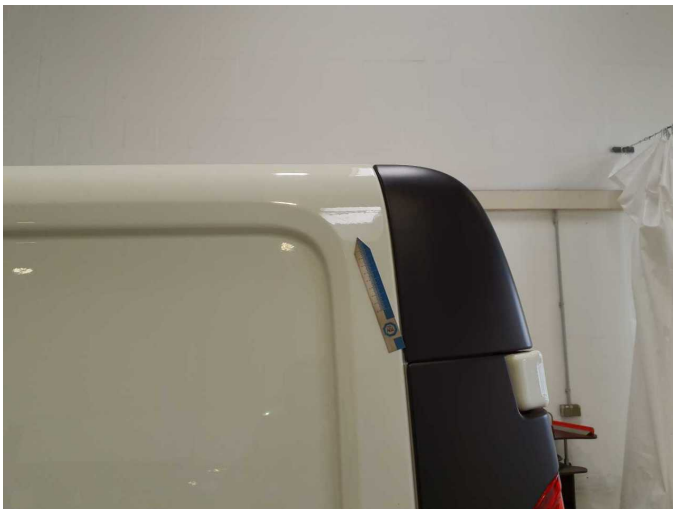
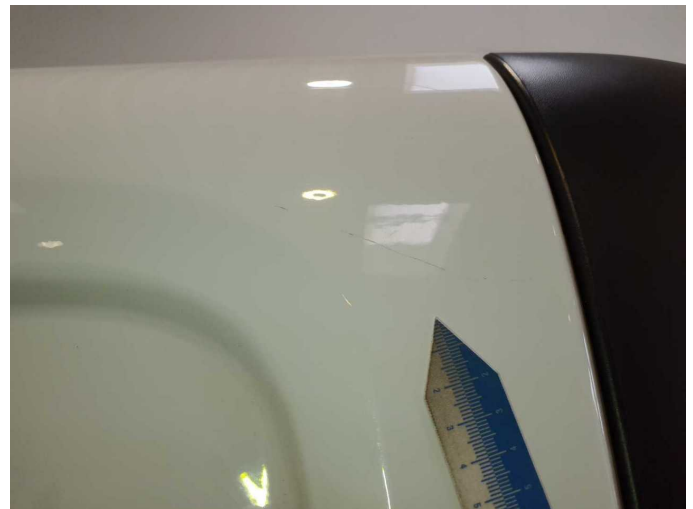
Wear and tear 6: Side panel - rear left side: Side panel - Scratch(es) - No deduction

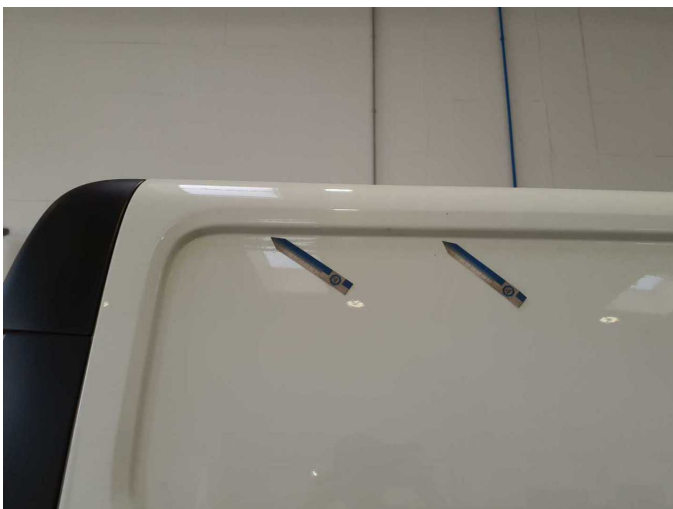
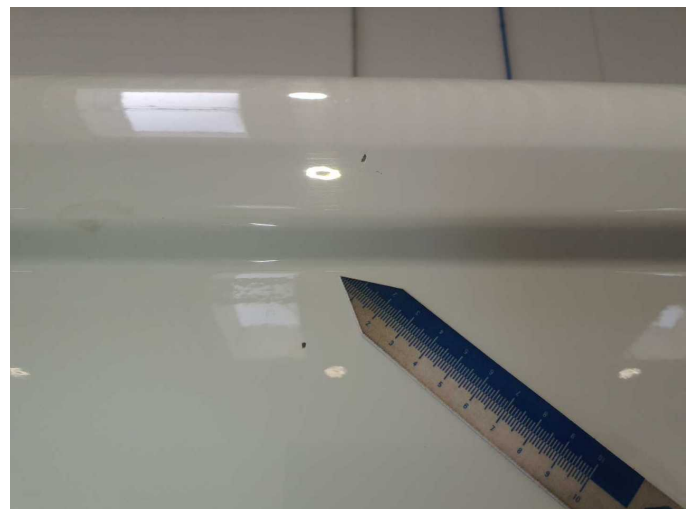
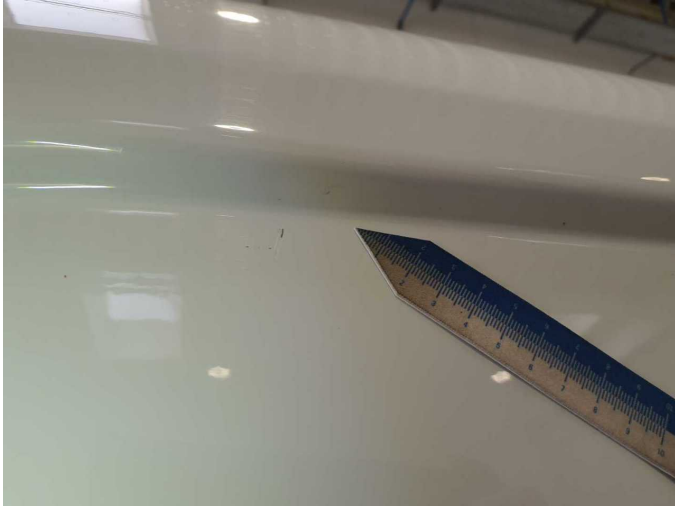
Wear and tear 7: Side panel - rear right side: Side panel - Scratch(es) - No deduction

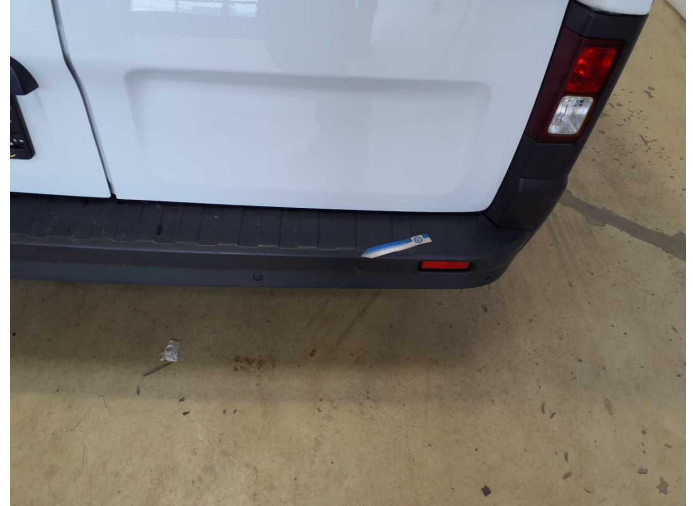
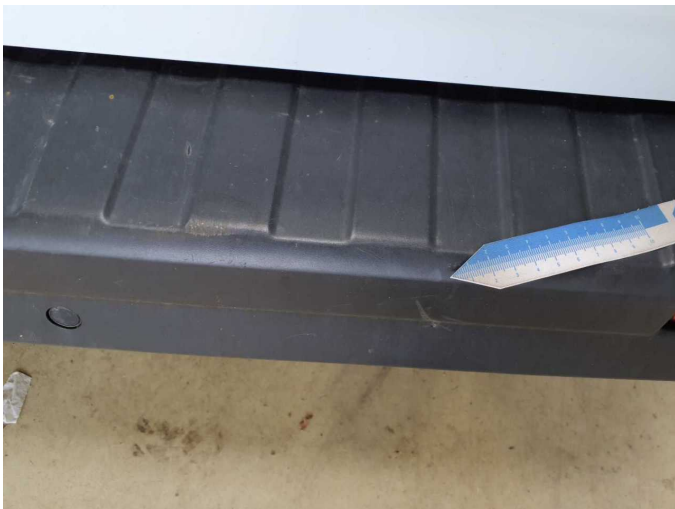
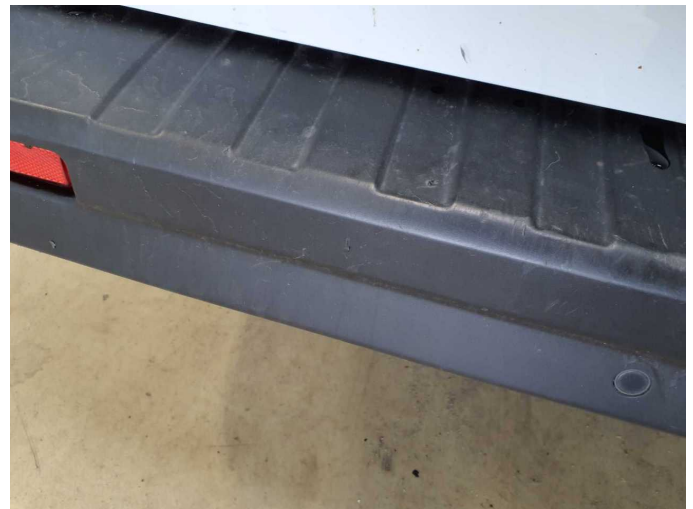
Wear and tear 8: Rear bumper: Rear bumper (unpainted) - Scratch(es) - No deduction

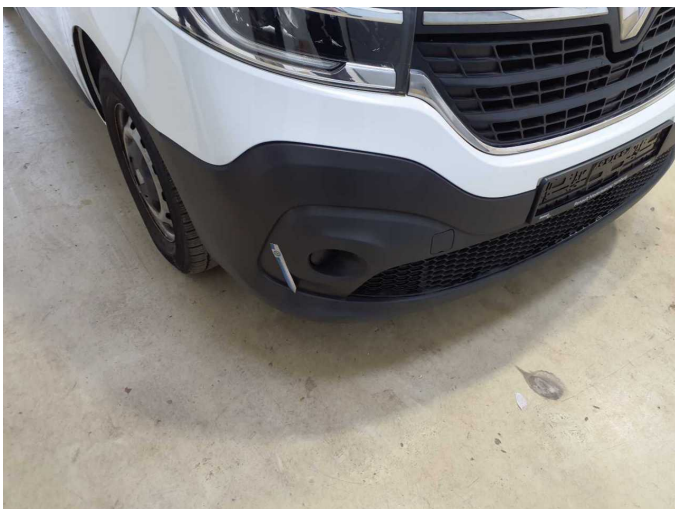
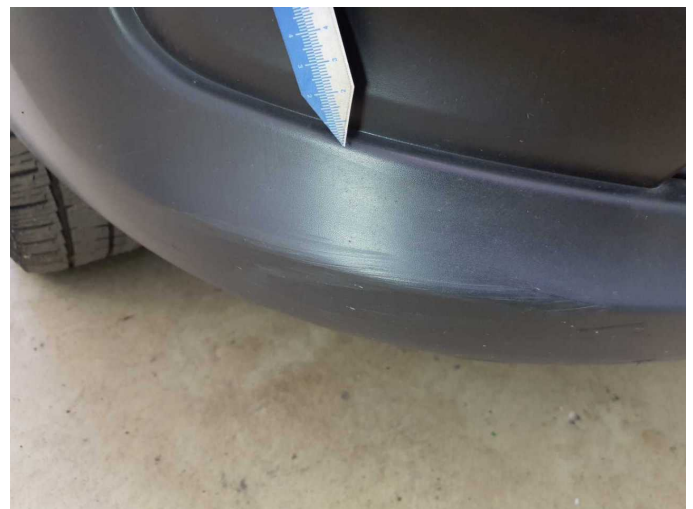
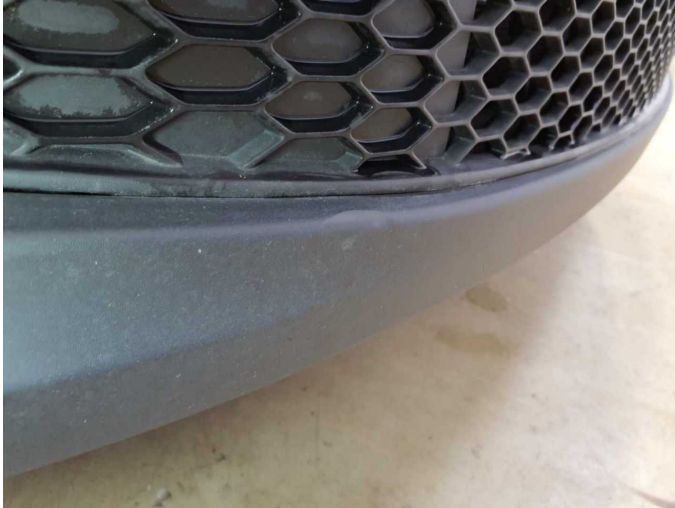
Wear and tear 9: Front bumper: Front bumper (unpainted) - Scratch(es) - No deduction

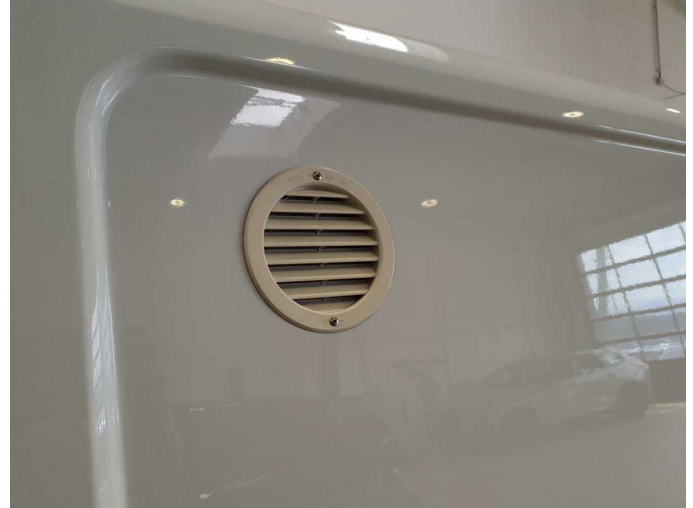
Wear and tear 10: Body: Body (Nachgerüstet) - Differs from the original configuration - No deduction

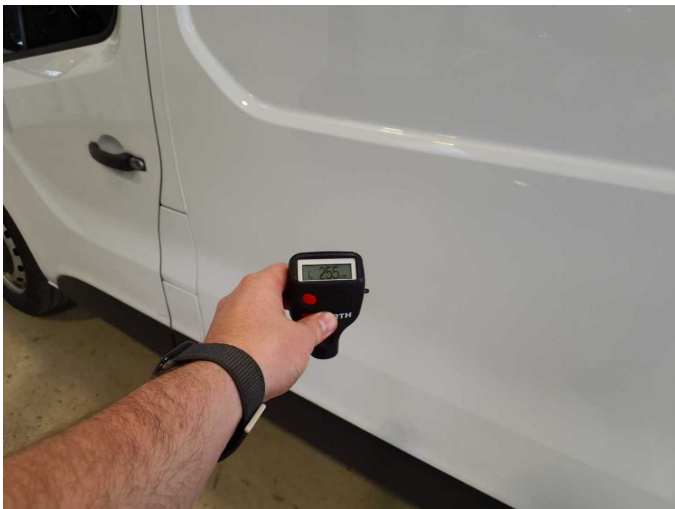
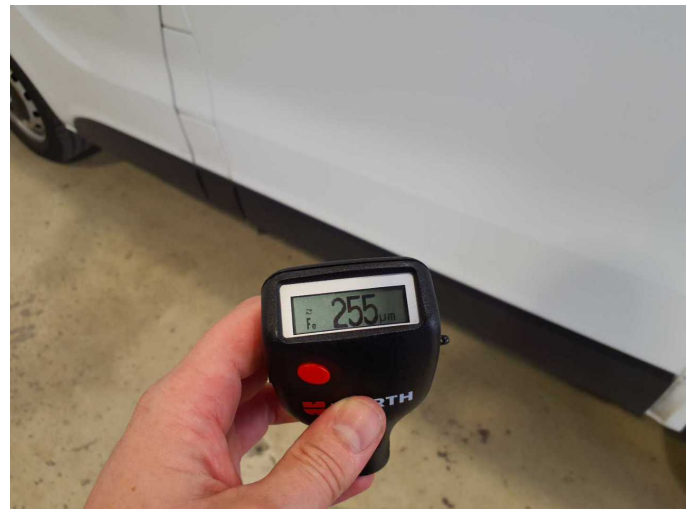
Side panel - rear left side	255 µm	Door - front left side	175 µm
-----------------------------	--------	------------------------	--------

Repainting 1: Side panel - rear left side

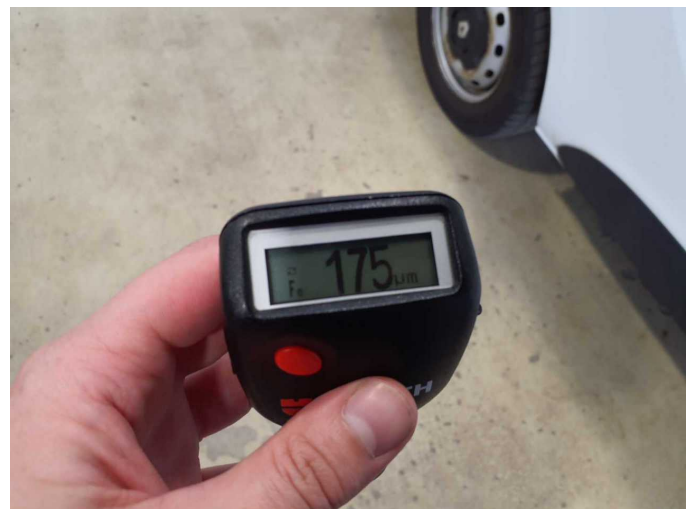
Repainting 2: Door - front left side
