Expertise

Protocol number: 46595320  
Order No. / Reference: 26546944  
Inspection date: 15 Jul 2026

Manufacturer: Ford

Model: e-Transit 350 L3H3 Lkw HA Basis

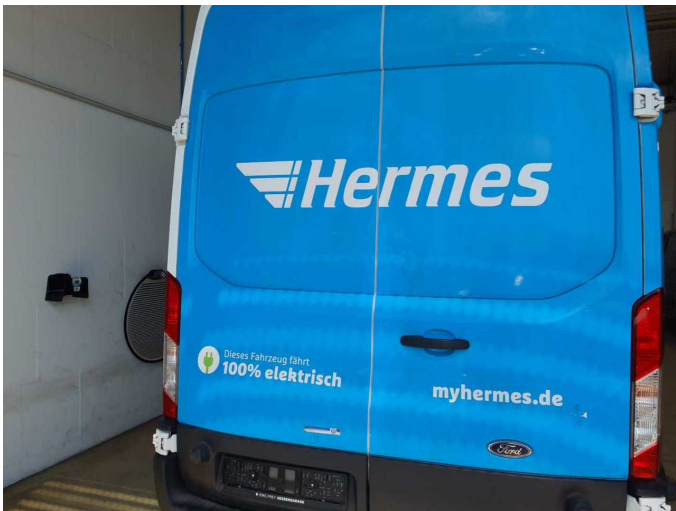
| No. | Component group | Description |
|---|---|---|
| 2 | Boot lid / rear door | Rear door - left side - dent(s) - Smooth repair work |

**Damage 2:** Boot lid / rear door: Rear door - left side - dent(s) - Smooth repair work

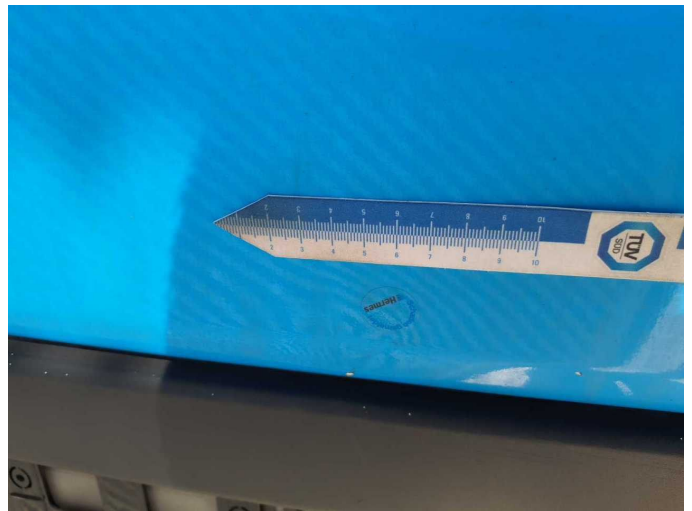
**Damage 2:** Boot lid / rear door: Rear door - left side - dent(s) - Smooth repair work

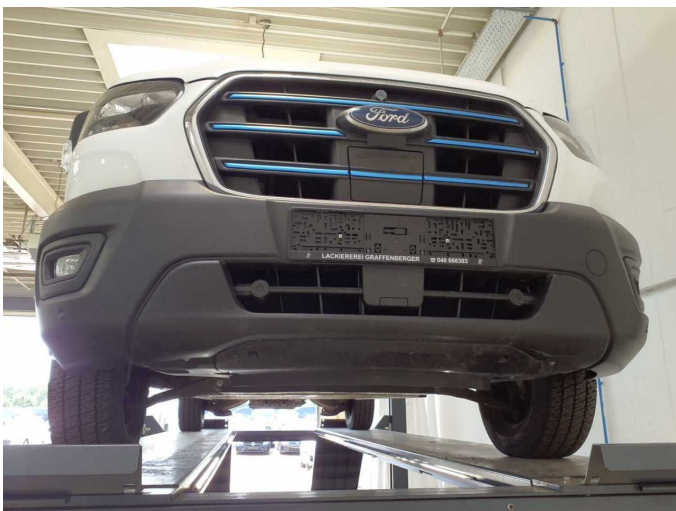
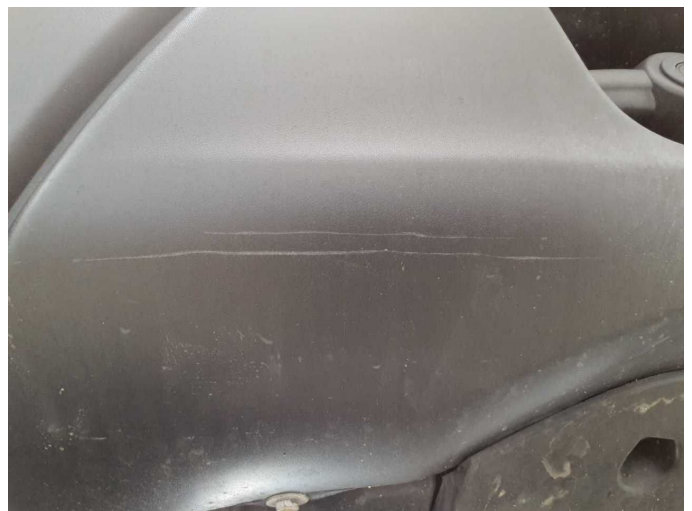
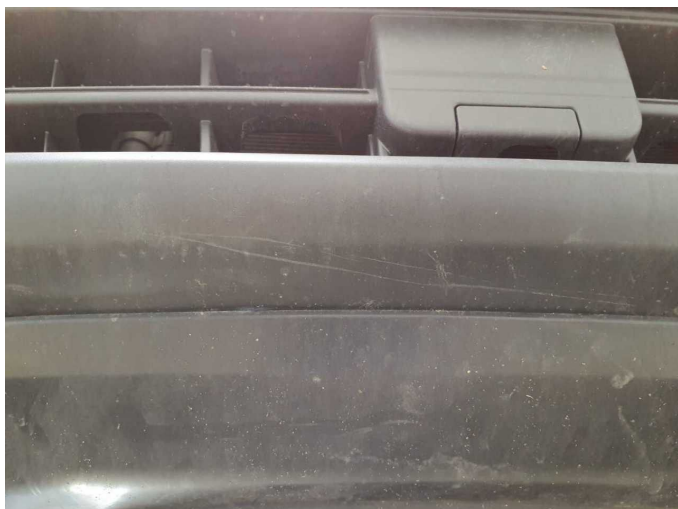
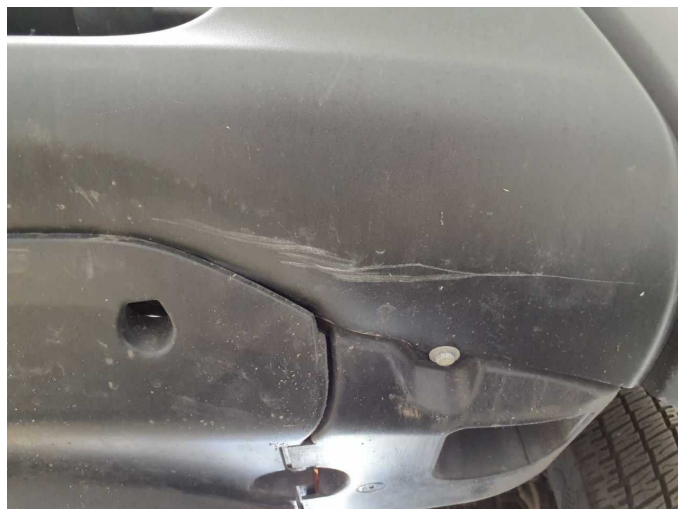
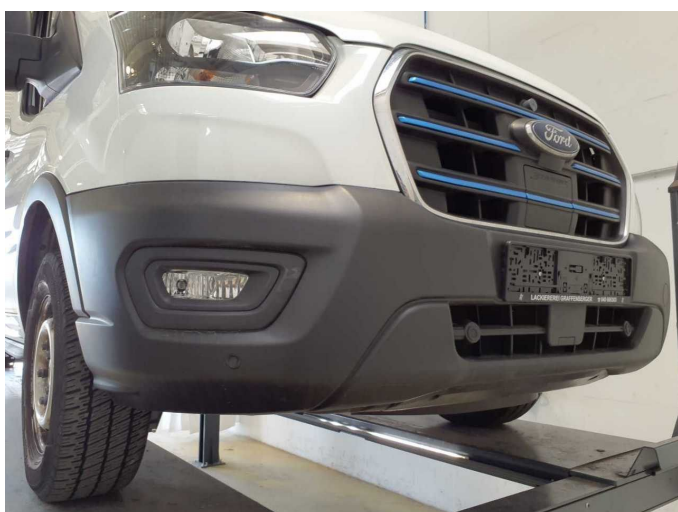
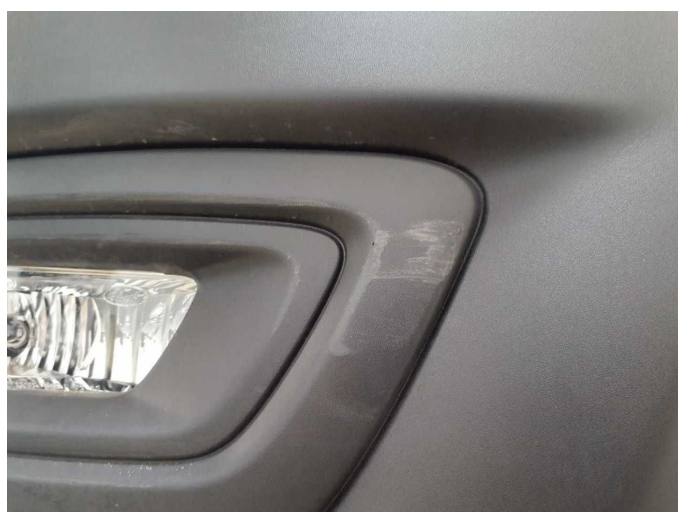
| No. | Component group | Description |
|---|---|---|
| 3 | Front bumper | Front bumper - Scratch(es) - Loss in value |

**Damage 3:** Front bumper: Front bumper - Scratch(es) - Loss in value

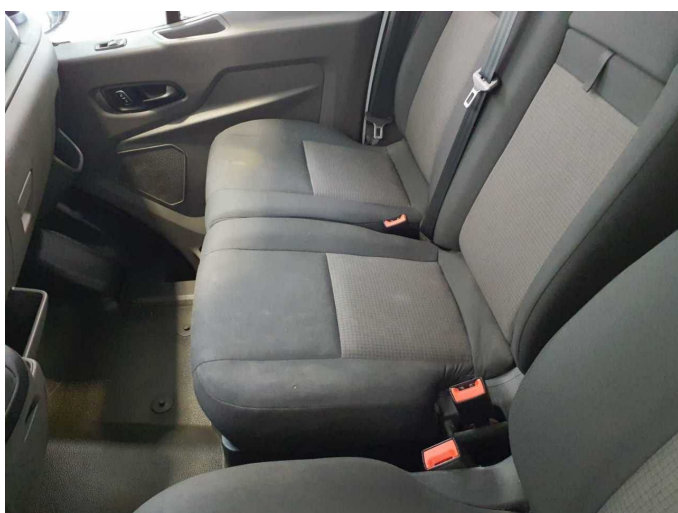
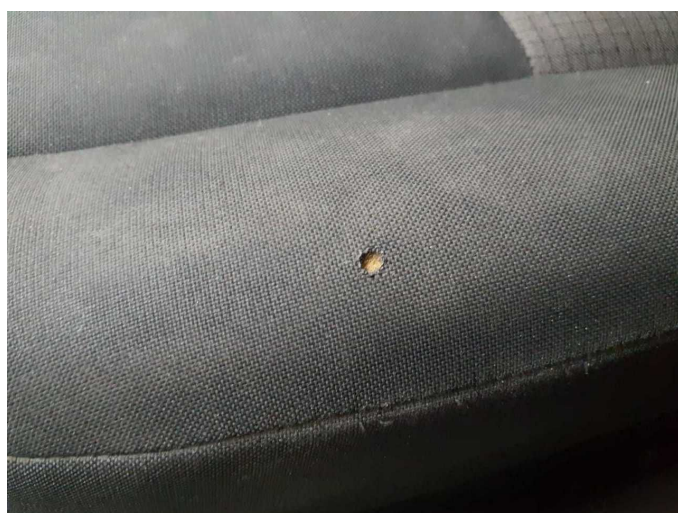
| No. | Component group | Description |
|---|---|---|
| 4 | Seat - front | Seat cover - right side - Holes - Smart repair |

**Damage 4:** Seat - front: Seat cover - right side - Holes - Smart repair

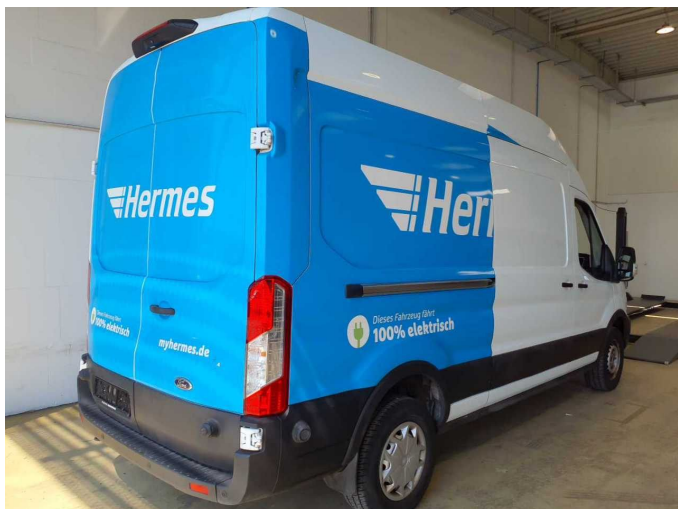
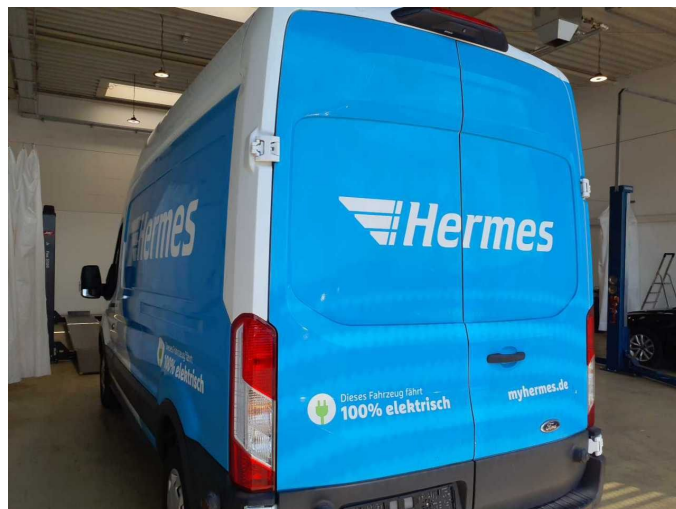
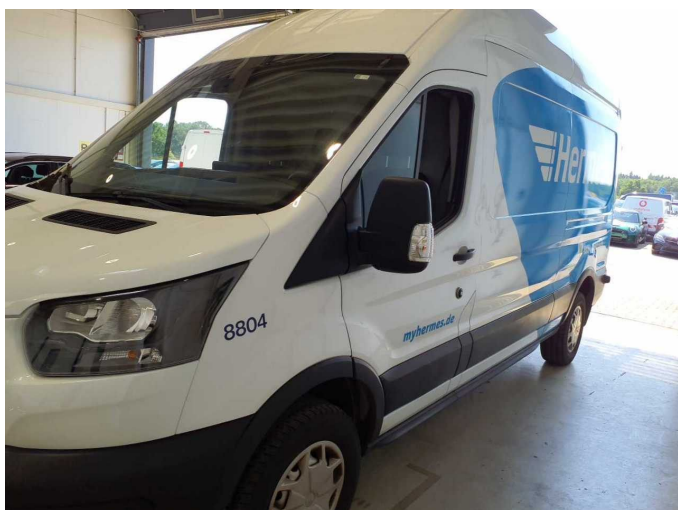
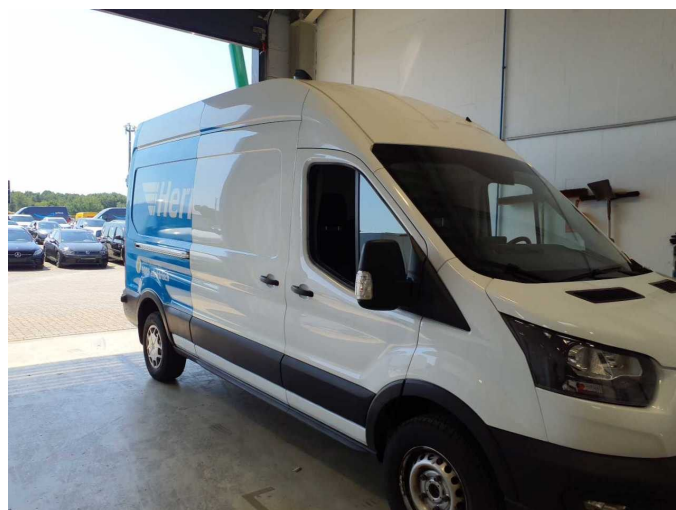
| No. | Component group | Description |
|---|---|---|
| 5 | Body | Body - Glued / labelled - De-glue / neutralise |

**Damage 5:** Body: Body - Glued / labelled - De-glue / neutralise

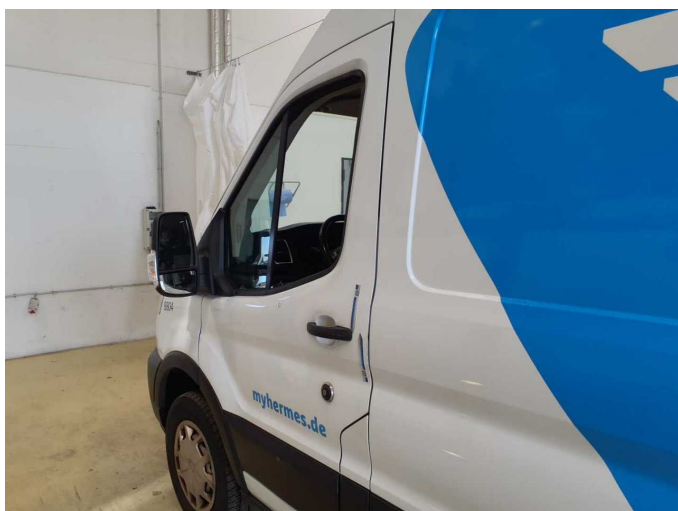
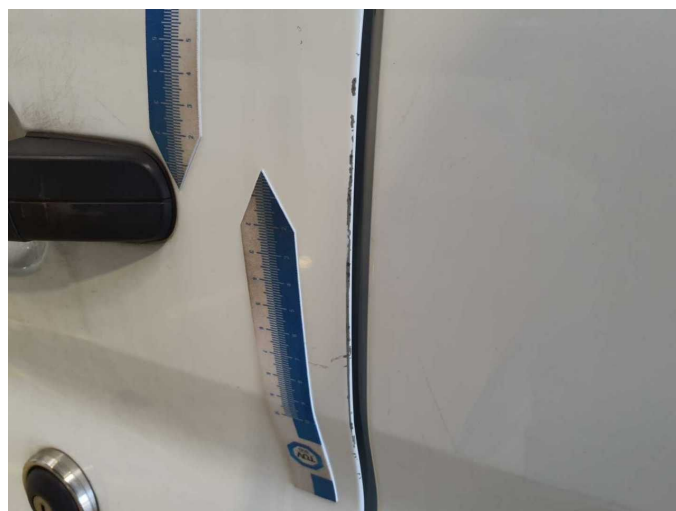
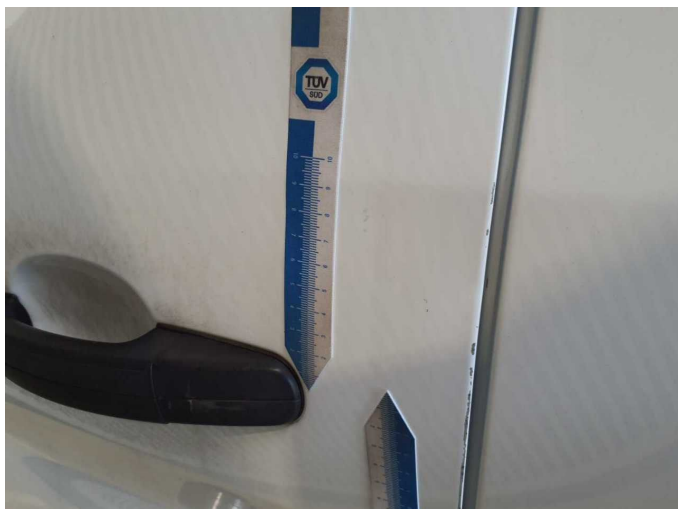
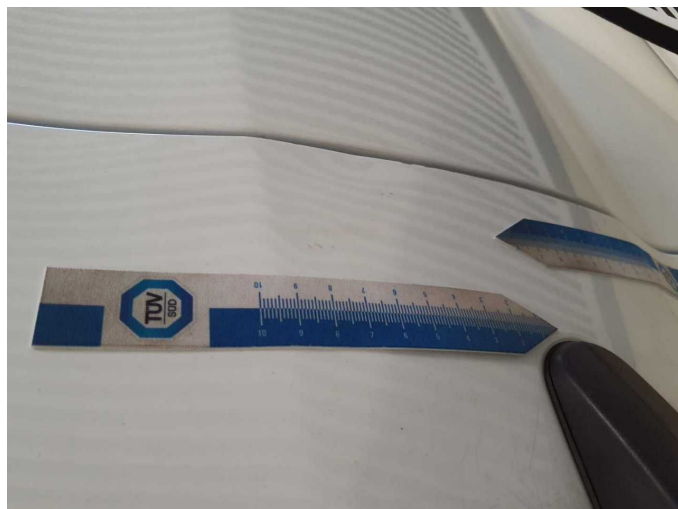
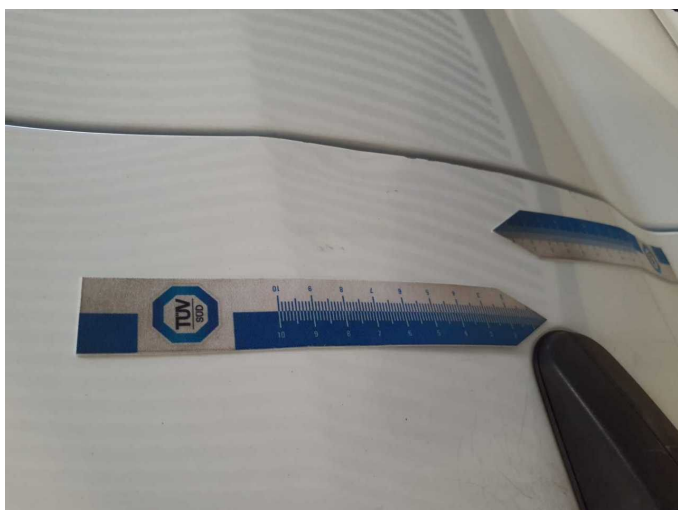
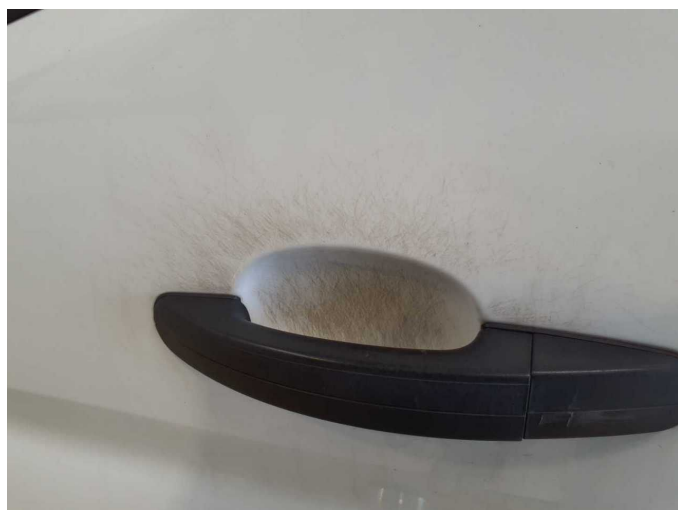
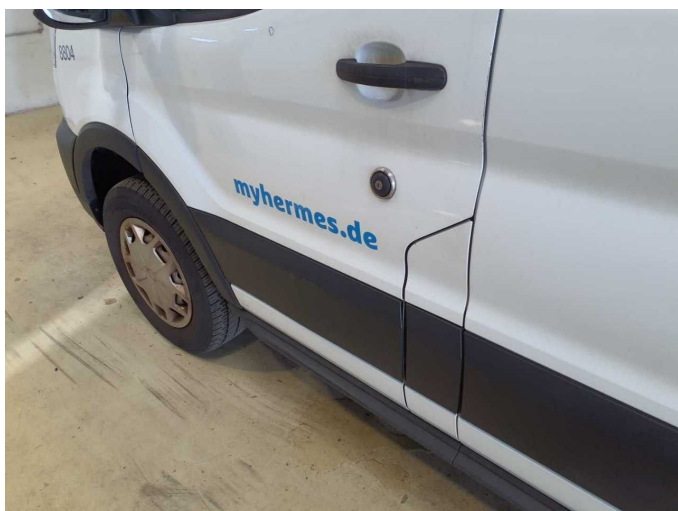
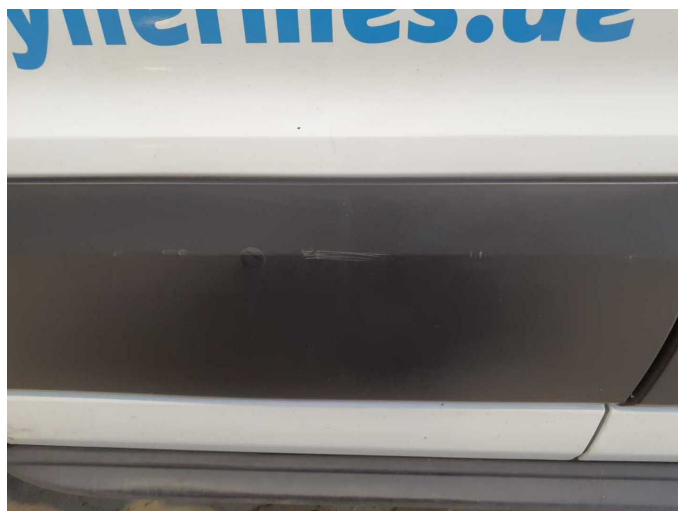
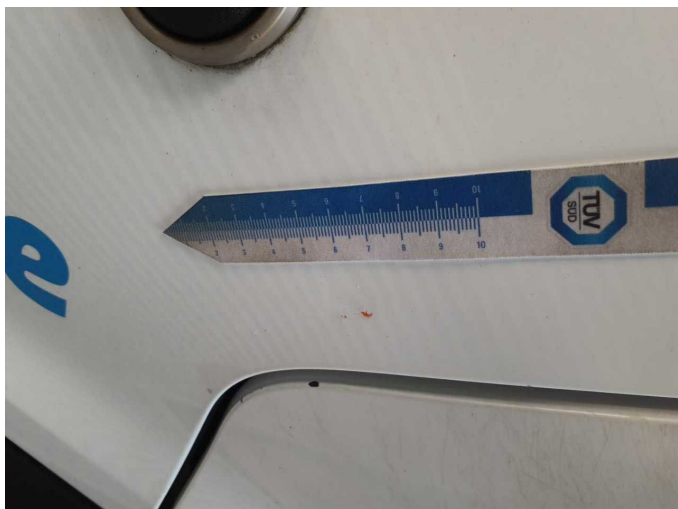
| No. | Component group | Description |
|---|---|---|
| 6 | Door - front left side | Door (Zusätzlich Blende Kratzer) - Dent / paintcoat damage - Repair and paint |

**Damage 6:** Door - front left side: Door (Zusätzlich Blende Kratzer) - Dent / paintcoat damage - Repair and paint

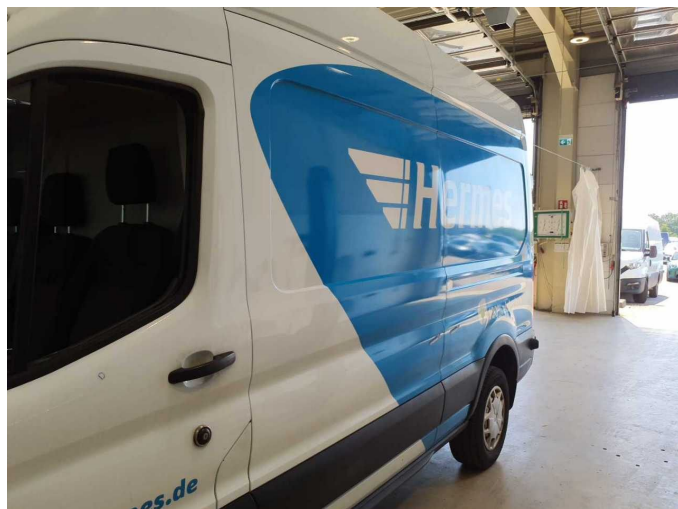
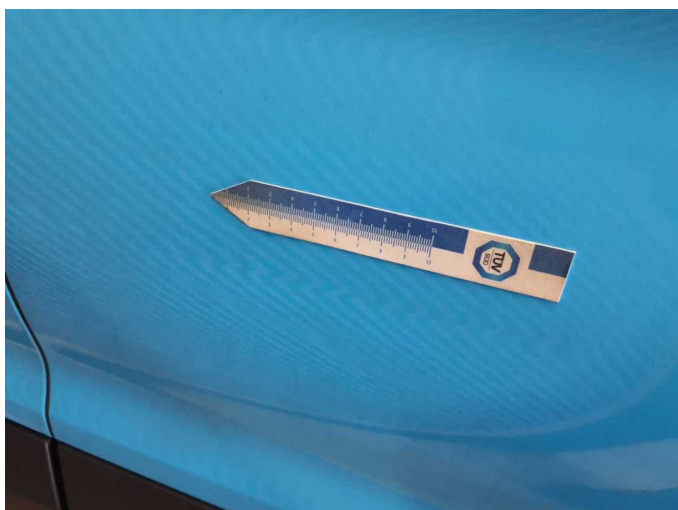
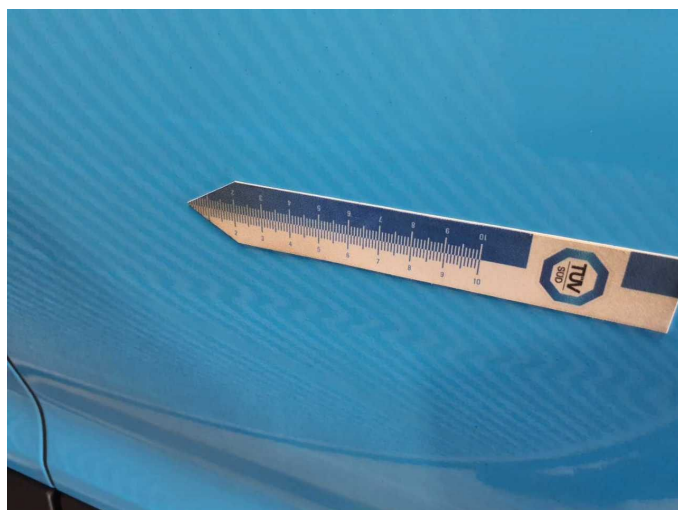
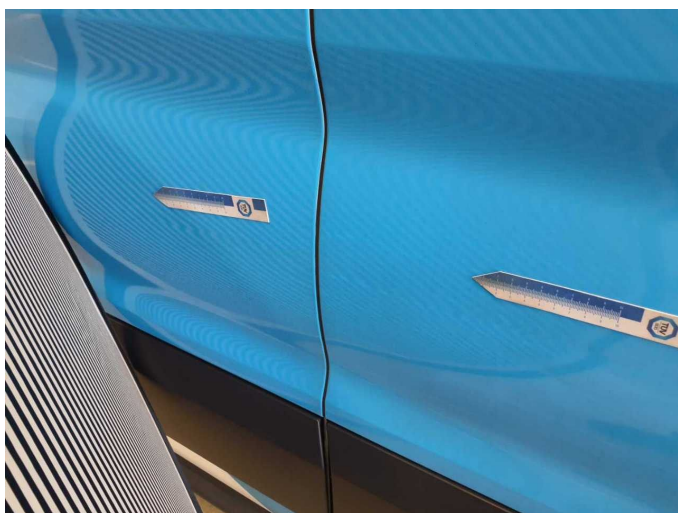
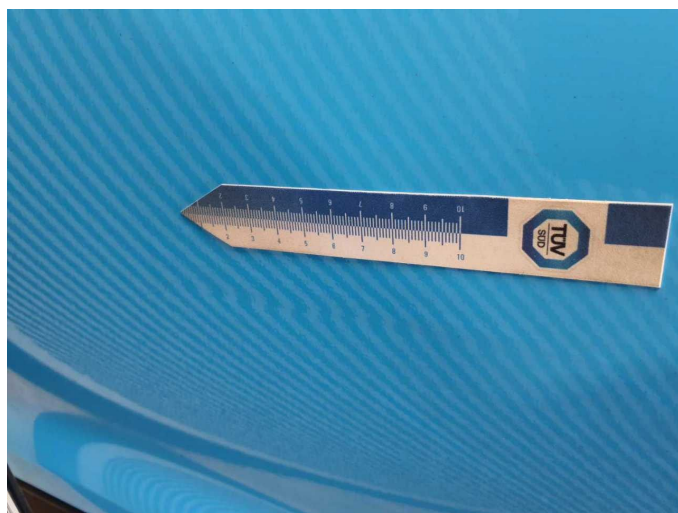
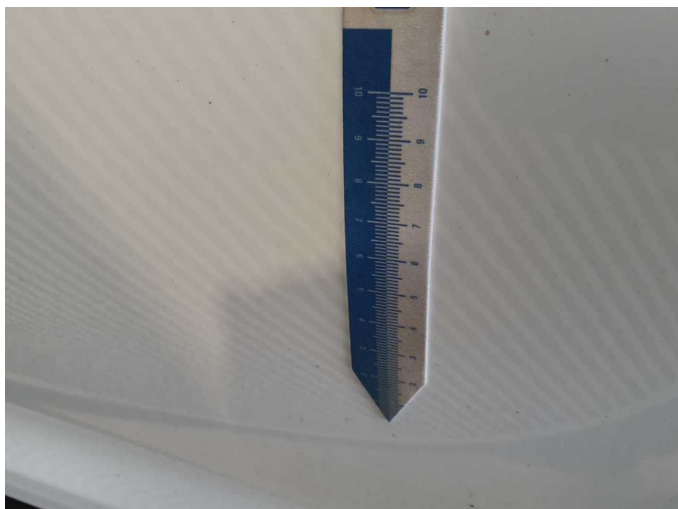
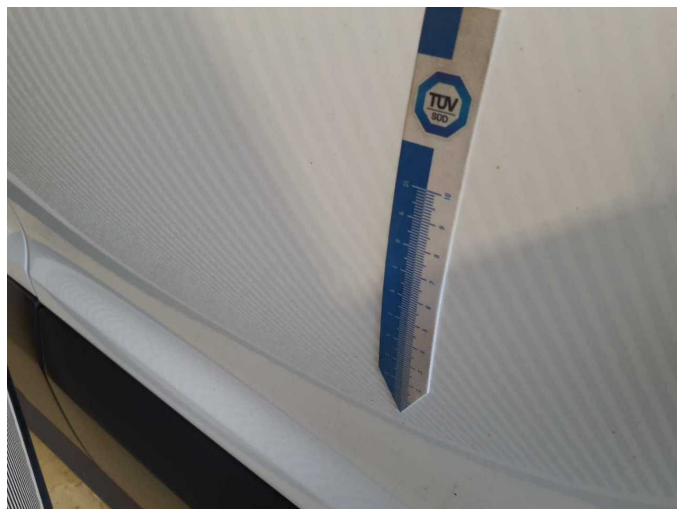
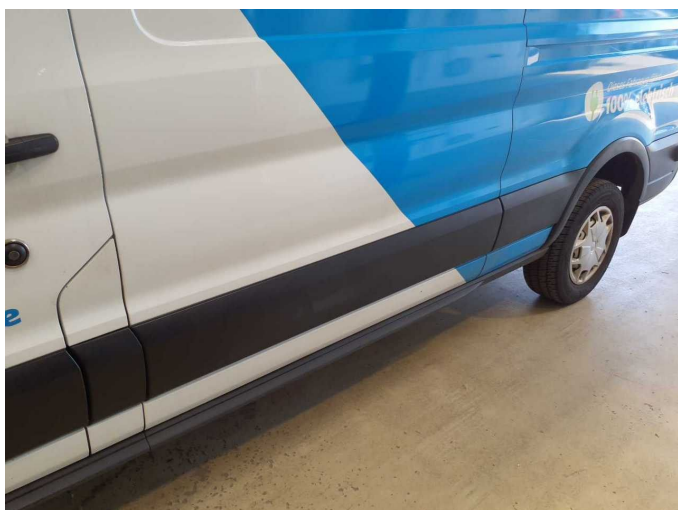
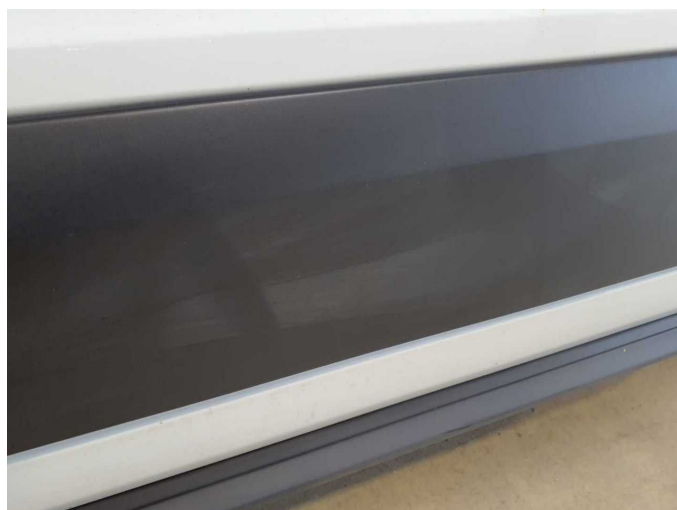
| No. | Component group | Description |
|---|---|---|
| 7 | Side panel - rear left side | Side panel (Zusätzlich Blende Kratzer) - Deformed - repair according to calculation |

**Damage 7:** Side panel - rear left side: Side panel (Zusätzlich Blende Kratzer) - Deformed - repair according to calculation

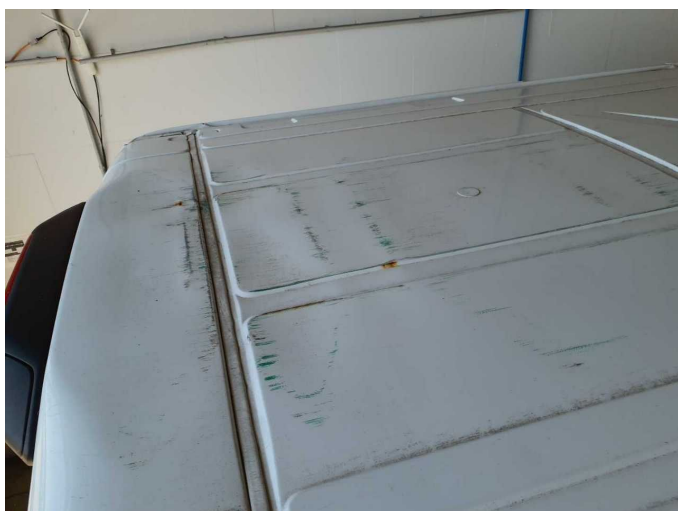
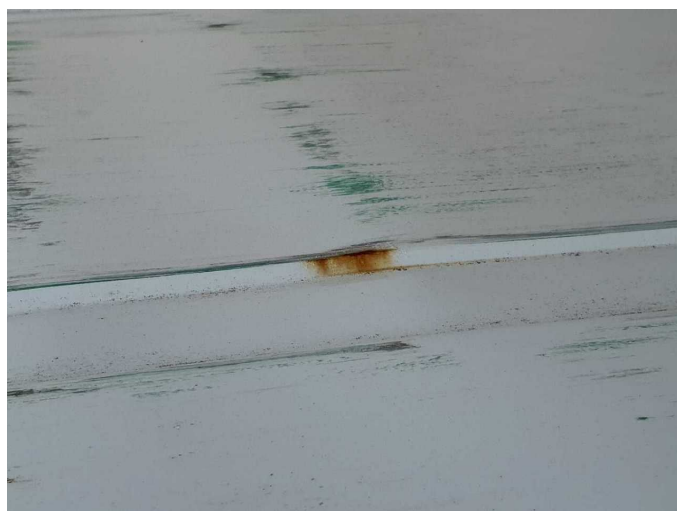
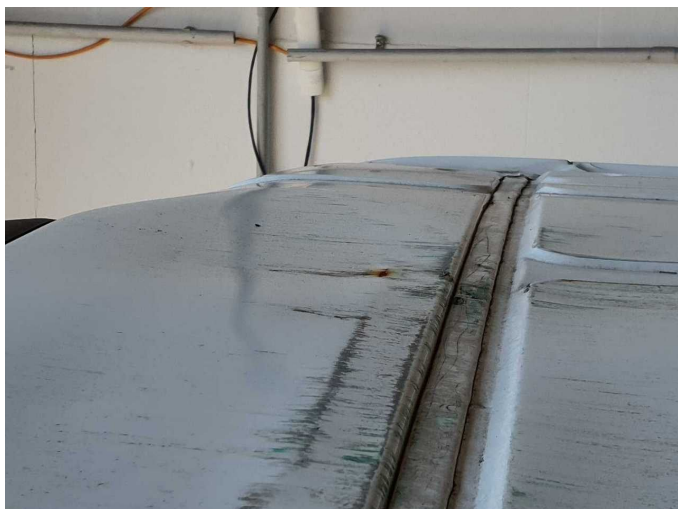
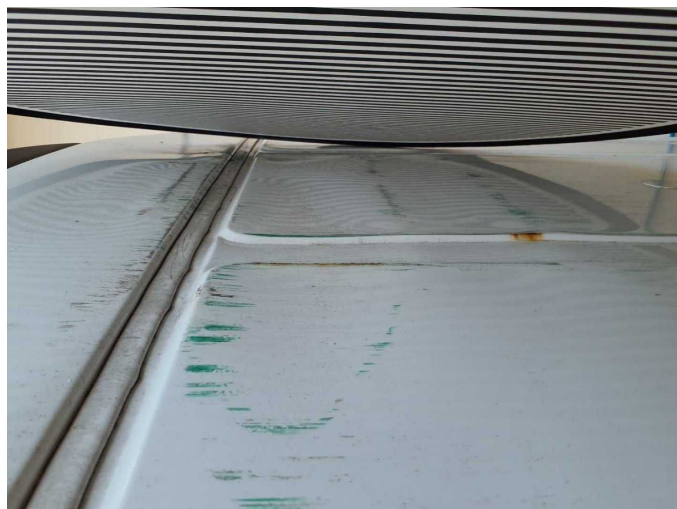
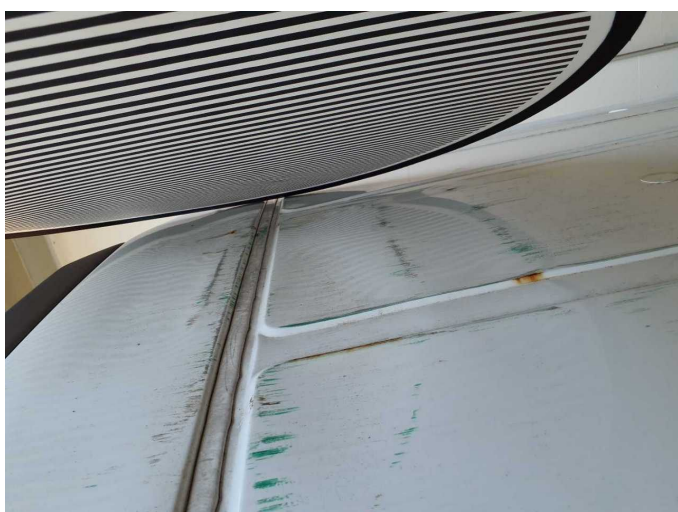
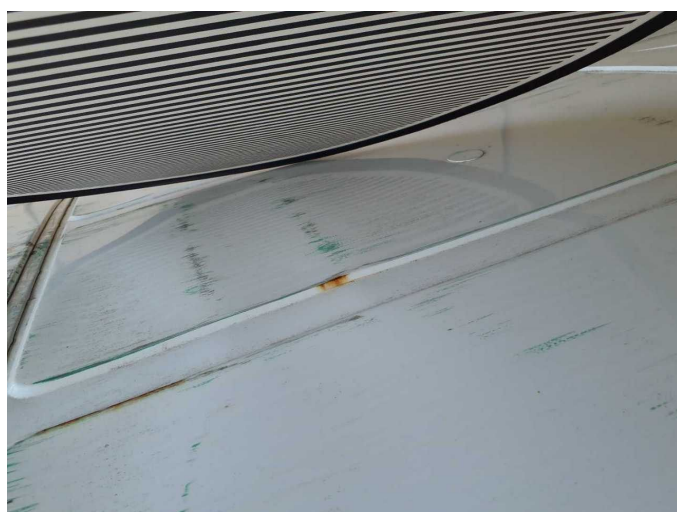
| No. | Component group | Description |
|---|---|---|
| 8 | Roof | Roof (beschädigt) - Corrosion - repair according to calculation |

**Damage 8:** Roof: Roof (beschädigt) - Corrosion - repair according to calculation

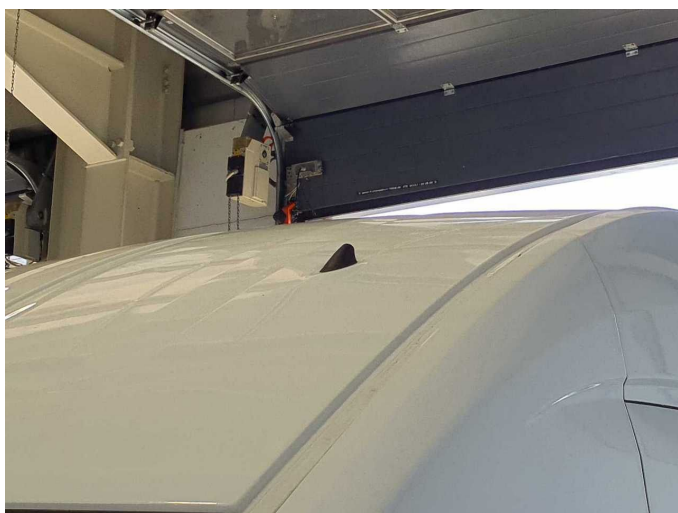
Roof - Stub aerial

**Missing part 1:** Roof: Stub aerial - Missing - Replace

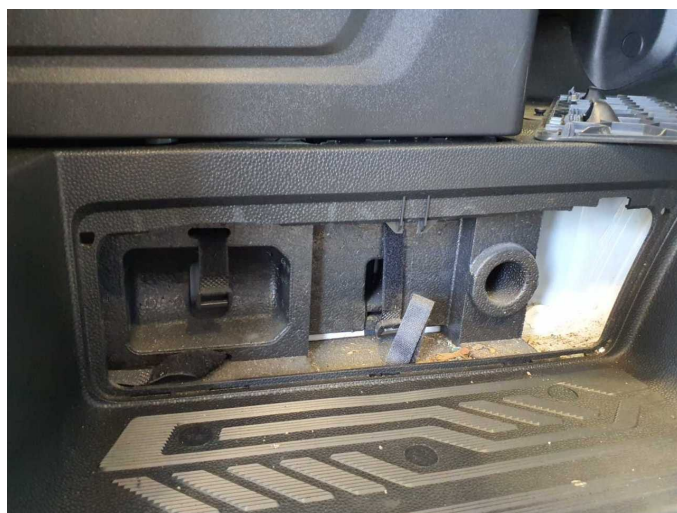
Equipment - Tirefit complete

**Missing part 2:** Equipment: Tirefit complete - Missing - Replace

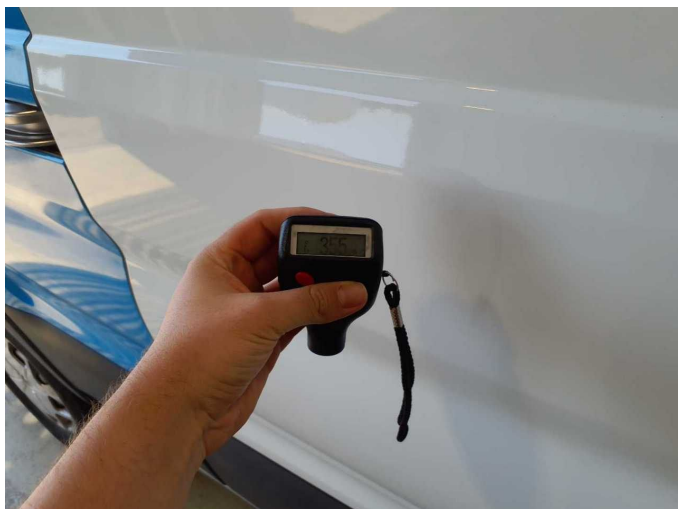
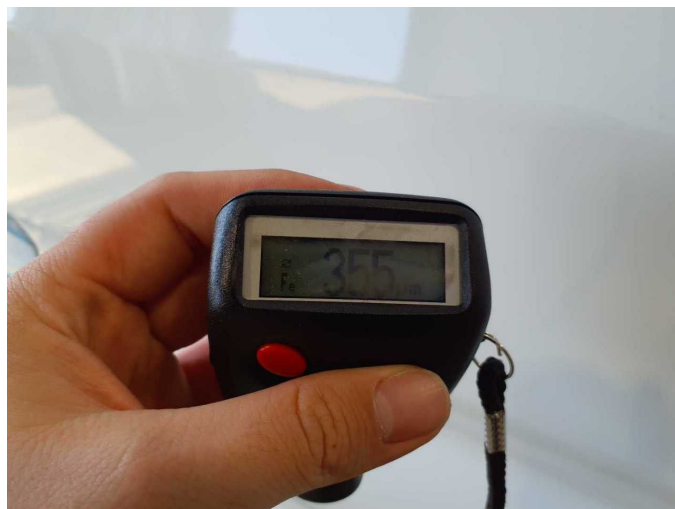
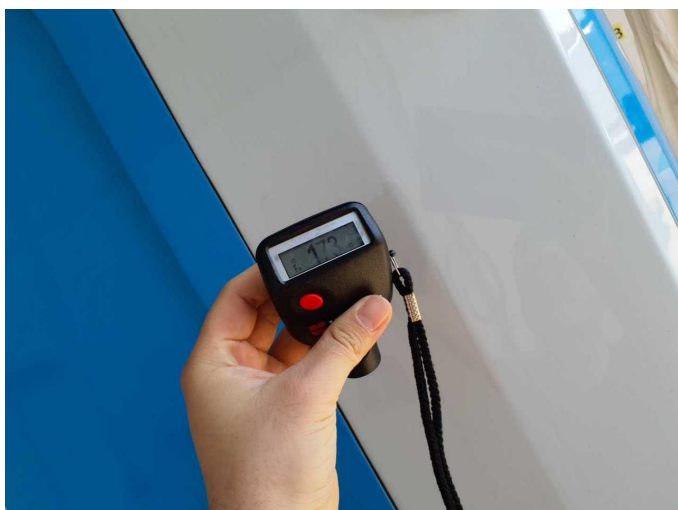
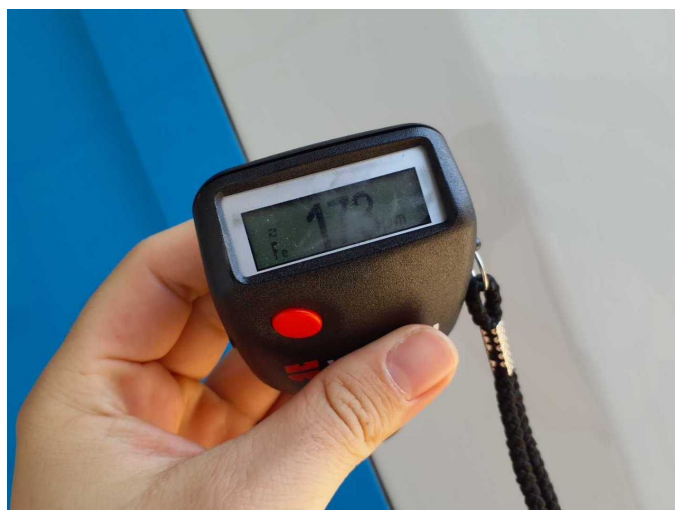
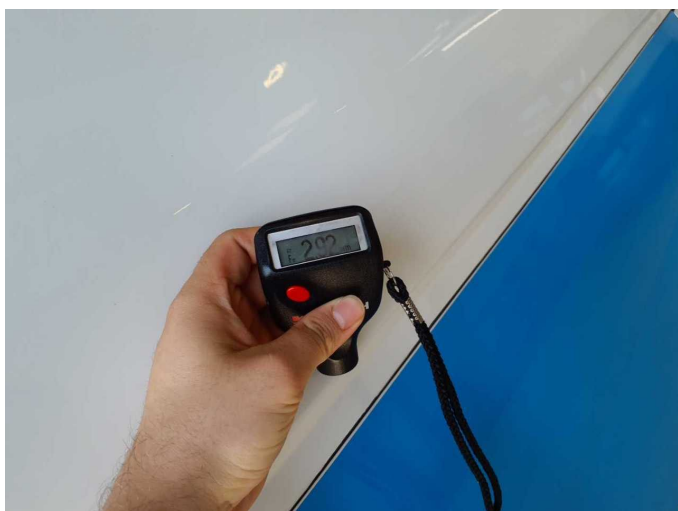
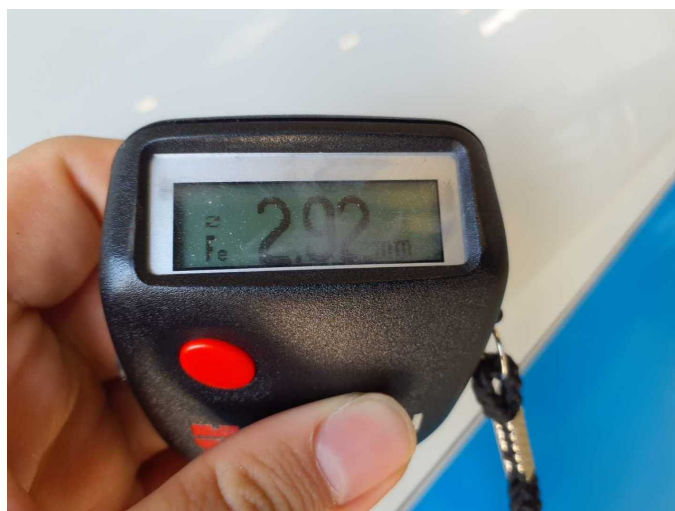
- Side panel - rear left side, Side panel - rear right side, Door - rear right side, Professionally carried out

| Side panel - rear left side | 173 µm | Side panel - rear right side | 2,920 µm |
| Door - rear right side | 355 µm | | |

**Repainting 1:** Side panel - rear left side, Side panel - rear right side,  
Door - rear right side
