Expertise

Protocol number: 45971223
Order No. / Reference: 26461597
Inspection date: 16 Jun 2026

Manufacturer: Volkswagen

Model: T-Roc 1.5 TSI ACT OPF Style

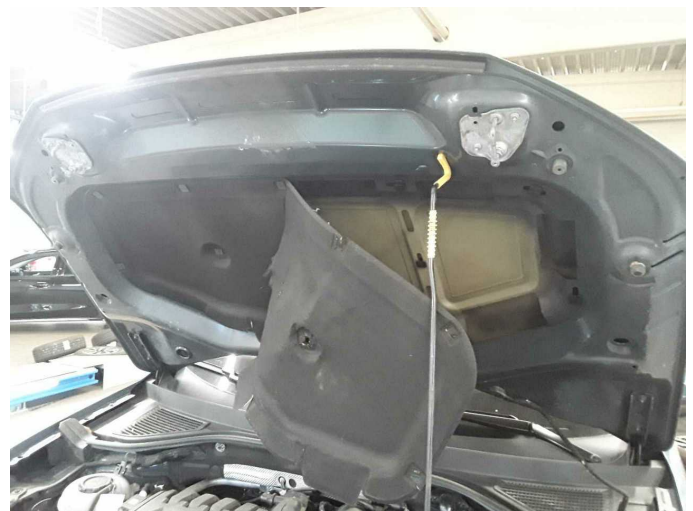
No.	Component group	Description
1	Bonnet	Insulation lining - Damaged - Replace
2	Side panel - rear left side	Sill - Scratch(es) - Smart repair

Damage 1: Bonnet: Insulation lining - Damaged - Replace

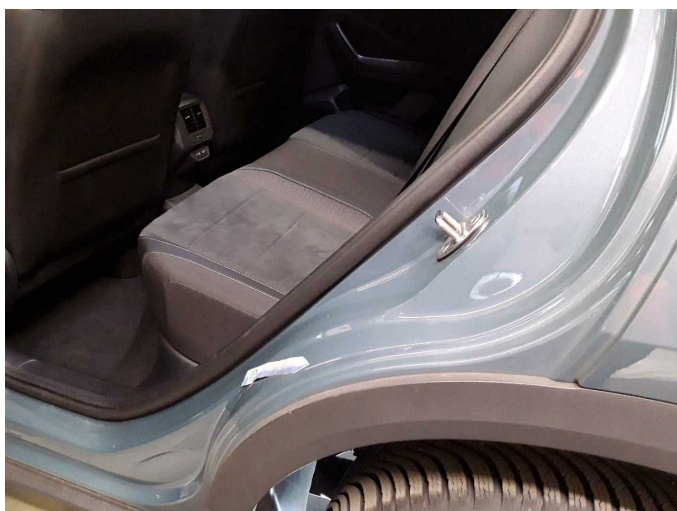
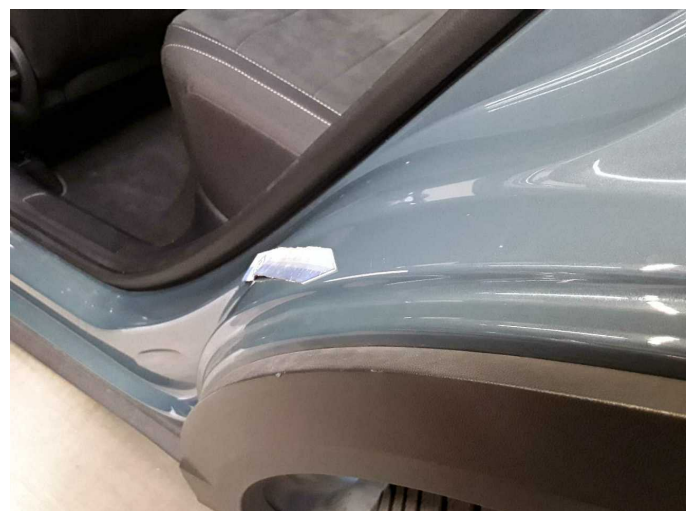
Damage 2: Side panel - rear left side: Sill - Scratch(es) - Smart repair

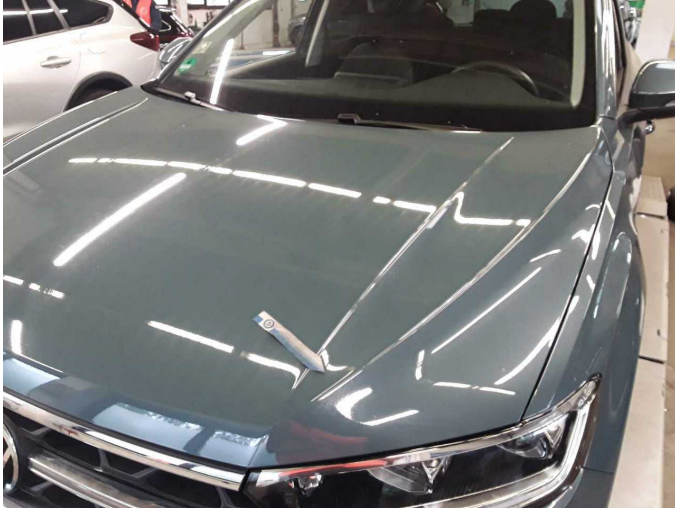
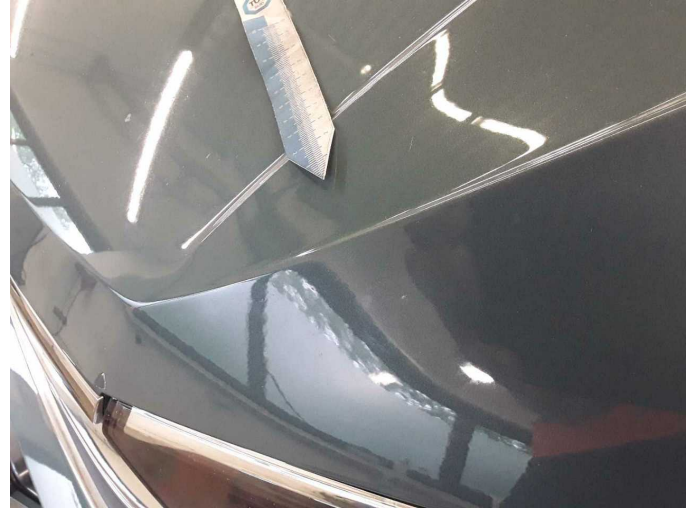
No.	Component group	Description
1	Bonnet	Bonnet - Stone chips - No deduction
2	Vehicle glazing	Windscreen - Stone chips - No deduction

Wear and tear 1: Bonnet: Bonnet - Stone chips - No deduction

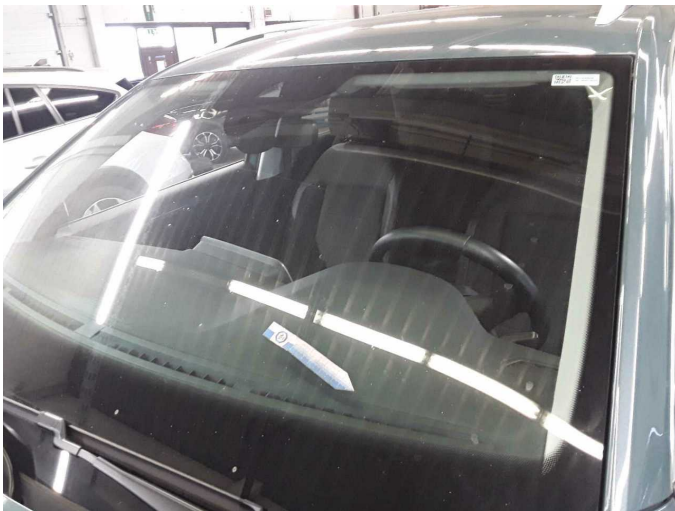
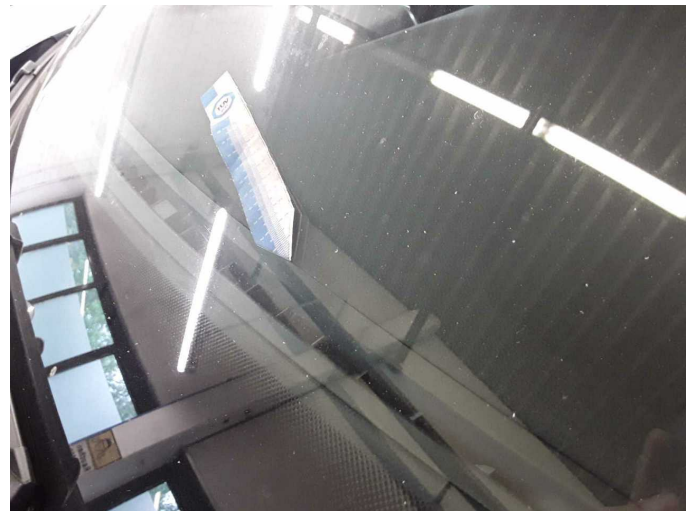
Wear and tear 2: Vehicle glazing: Windscreen - Stone chips - No deduction

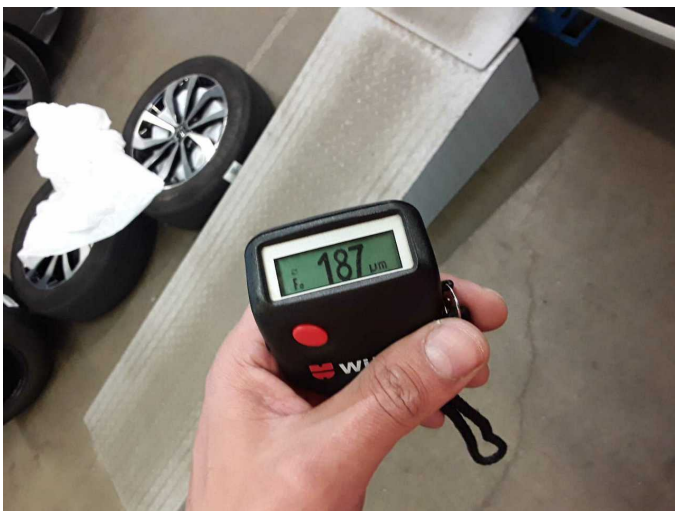
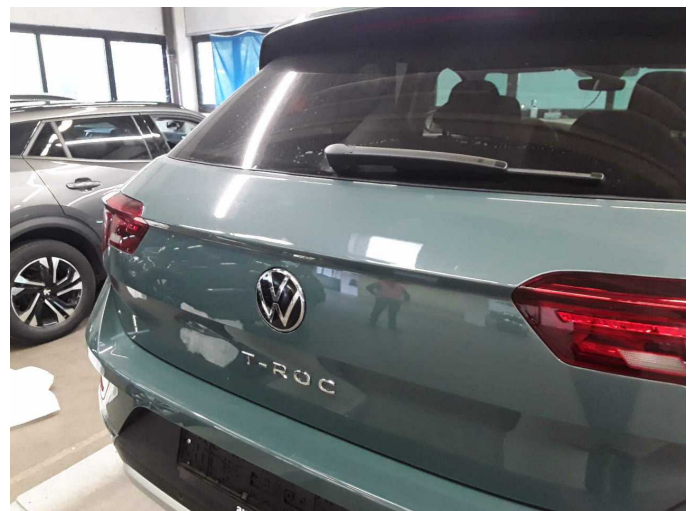
No.	Repainting
1	Boot lid / rear door, Professionally carried out, Invoice of repair done Non-existent

Repainting 1: Boot lid / rear door
