Expertise

Protocol number: 45570588
Order No. / Reference: 26352024
Inspection date: 18 May 2026

Manufacturer: Ford

Model: Focus Turnier 2.0 EcoBlue Start-Stopp-System Aut.
COOL&CONNECT

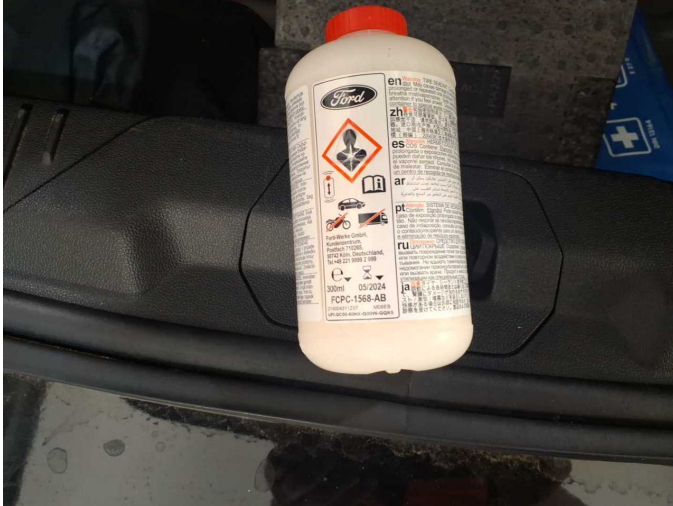
Damage 3: Equipment: Tirefit filler - Expired - Replace

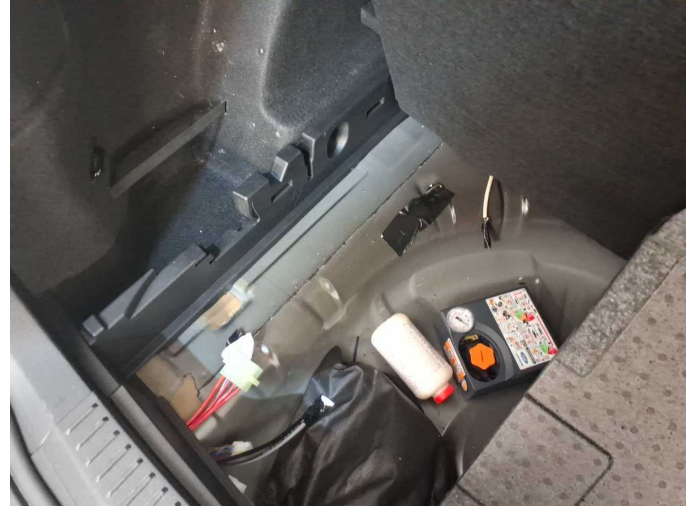
Damage 4: Electrical system: Cable strand (Kabelführung für Frontbereich im Laderaum) - Specify findings - Replace

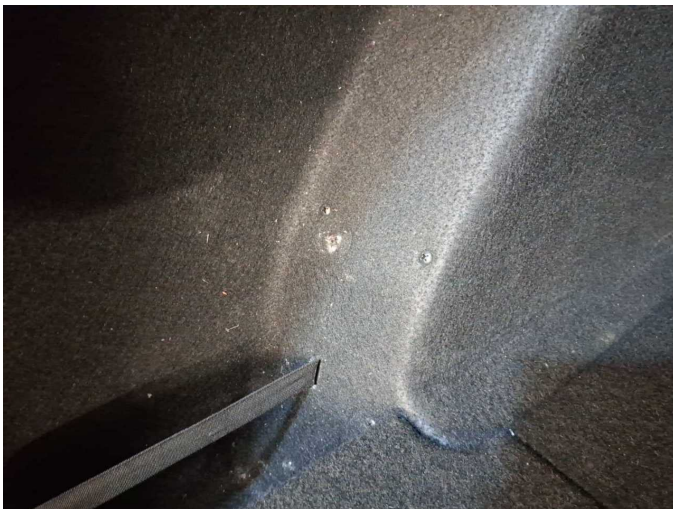
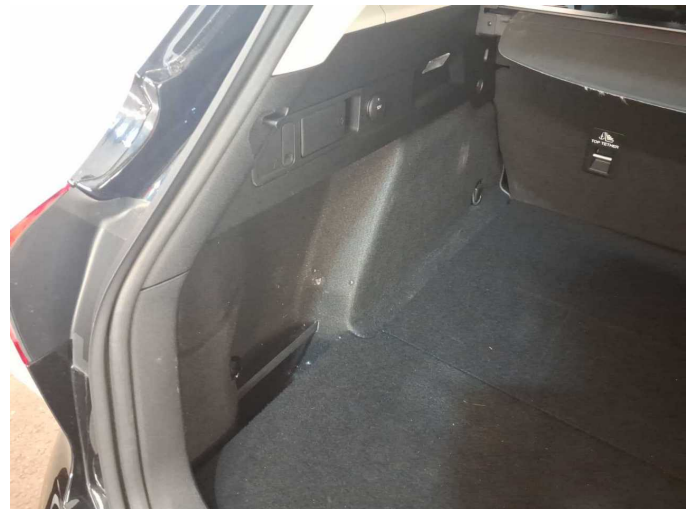
Damage 5: Side panel - rear left side: Interior trim - Damaged - Replace

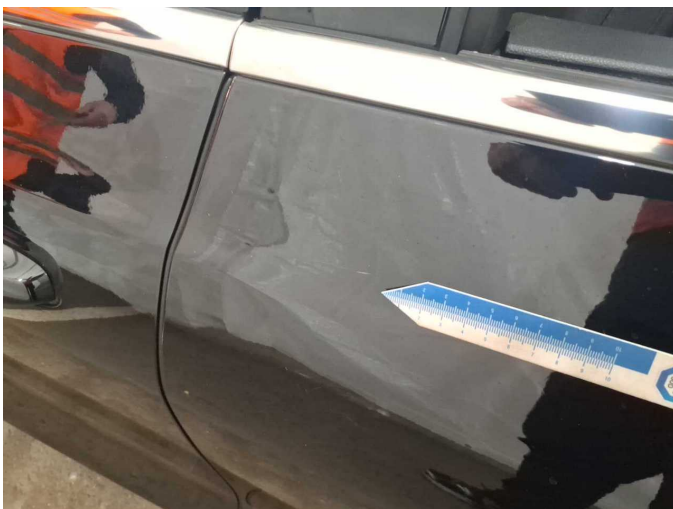
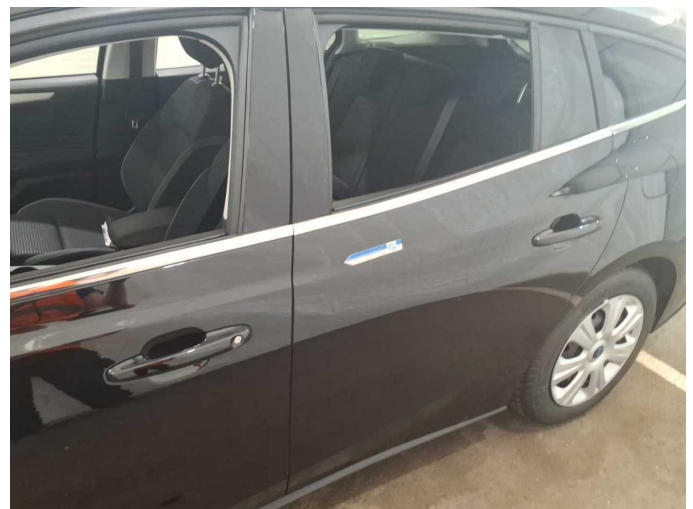
Damage 6: Door - rear left side: Door - Scratch(es) - Smart repair

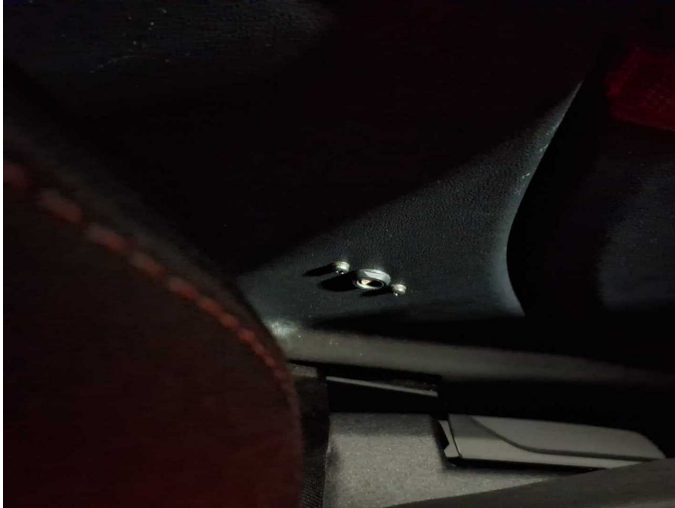
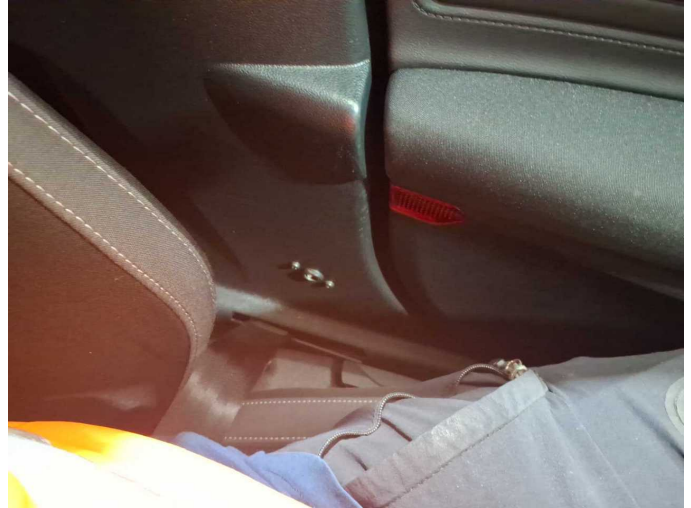
Damage 7: Trim / covers: B-pillar - trim - interior, left side - Damaged - Replace

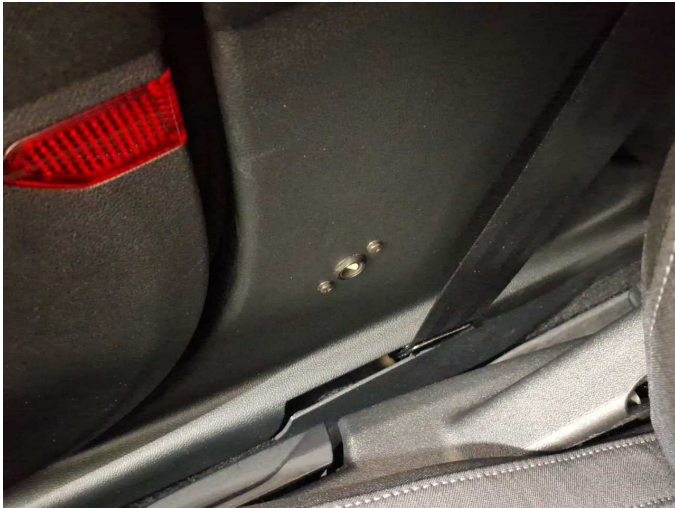
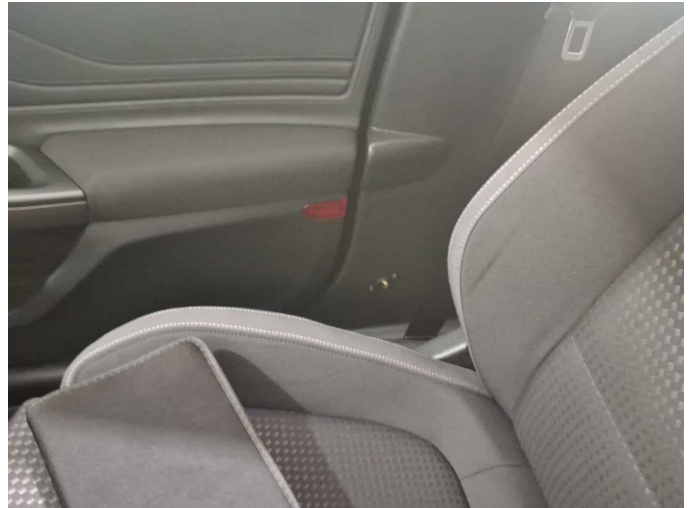
Damage 8: Trim / covers: B-pillar - trim - interior, right side - Damaged - Replace

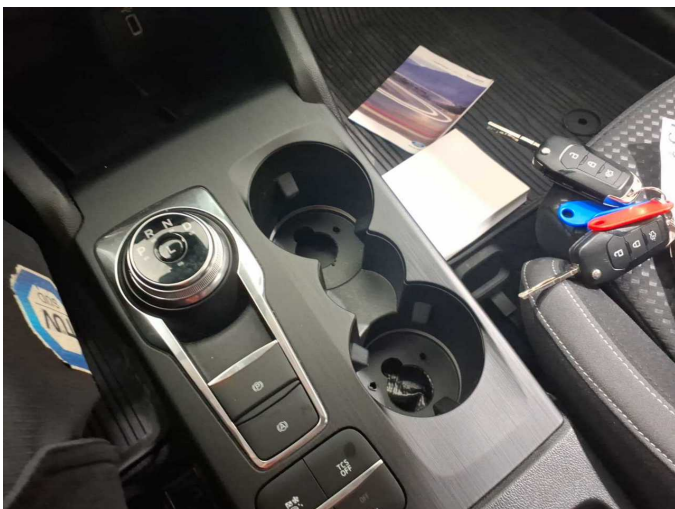
Damage 9: Instrument panel: Centre console - front - Damaged - Replace

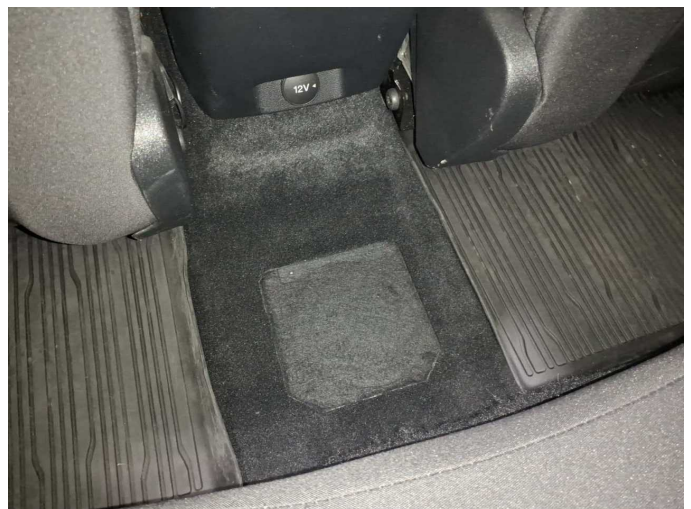
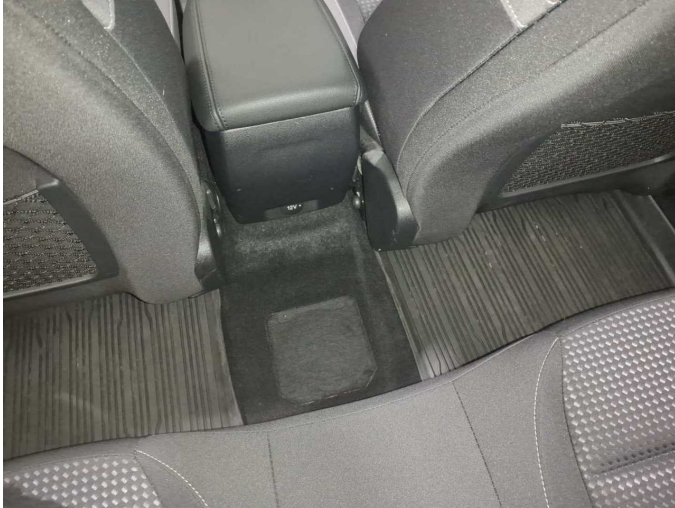
Damage 10: Trim / covers: Carpet - Damaged - Replace
