## 2-FHA-993

2-FHA-993 · ST Line 1.0i EcoBoost 125pk M6 · 6 August 2026 · Zaventem (BE)

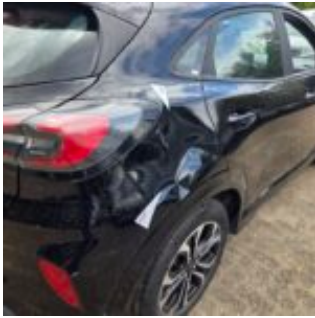
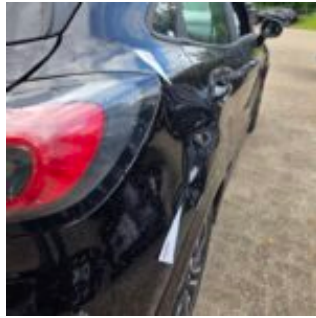
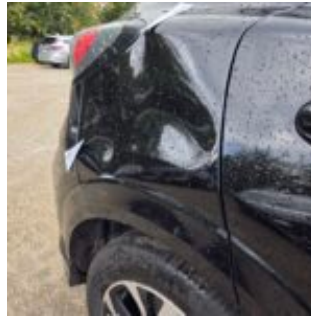
Damage Part  
Fender – Rear Right

Damage Type  
Dent(s)

Acceptable  
No

Repair Type  
Panelbeating & Spray

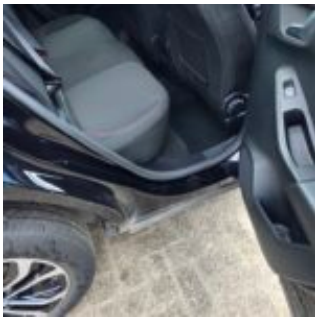
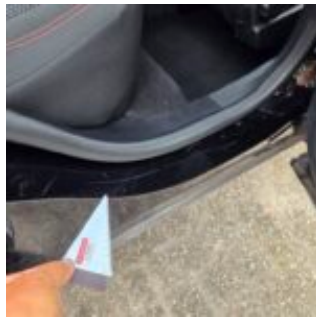
Damage Part  
Skirt – Right

Damage Type  
Scratch(es)

Acceptable  
No

Repair Type  
Spray

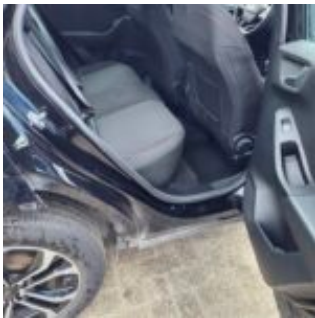
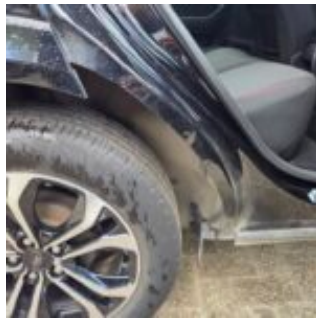
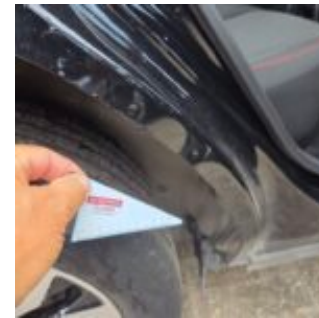
Damage Part  
Skirt – Right

Damage Type  
Missing

Notes  
Afdichtrubber

Acceptable  
No

Repair Type  
Replace

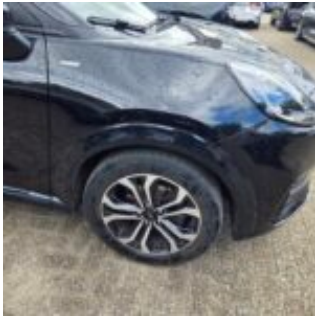
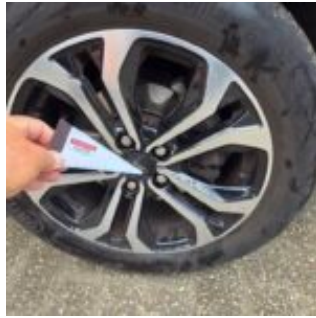
Damage Part  
Alloy – Right Front

Damage Type  
Damaged

Acceptable  
No

Repair Type  
Rim repair

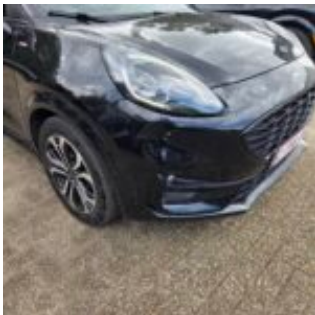
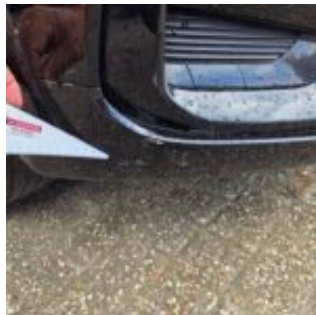
Damage Part  
spoiler FB

Damage Type  
Small scratch(es)

Acceptable  
No

Repair Type  
Spotrepair

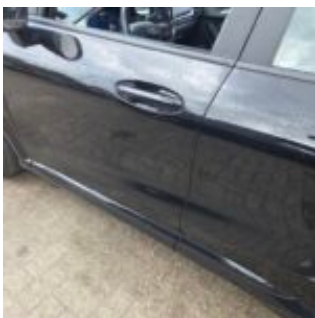
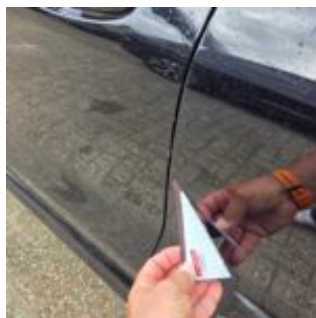
Damage Part  
Frontdoor – Left

Damage Type  
Door-edge chipped

Acceptable  
Yes

Repair Type  
Acceptable

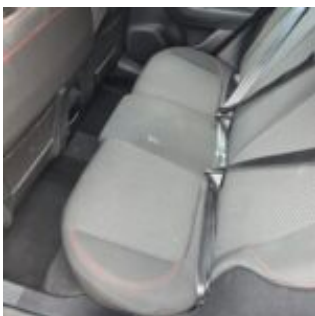
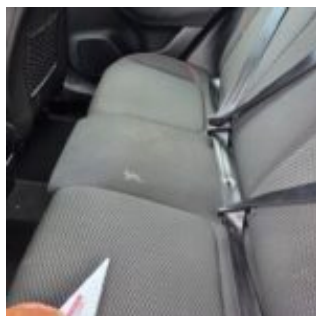
| Damage Part | Damage Type | Repair Type | Acceptable |
|---|---|---|---|
| Rear seat | Stains & dirt | Cleaning | No |

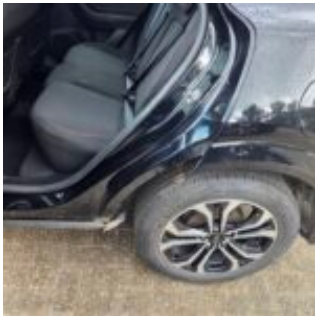
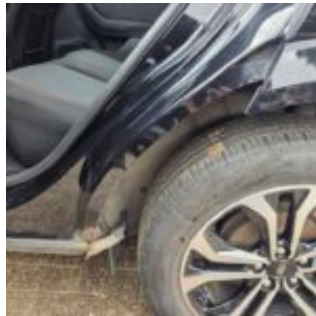
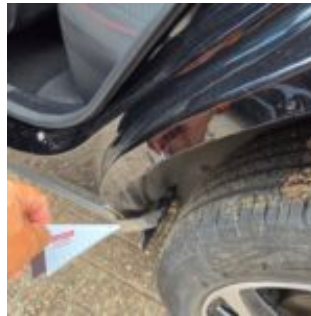
| Damage Part | Damage Type | Notes | Repair Type | Acceptable |
|---|---|---|---|---|
| Skirt - Left | Missing | Afdichtrubber | Replace | No |

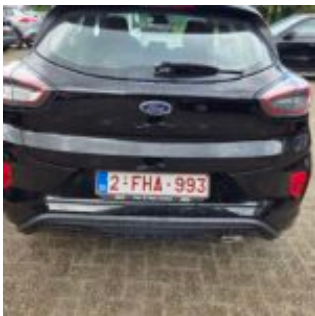
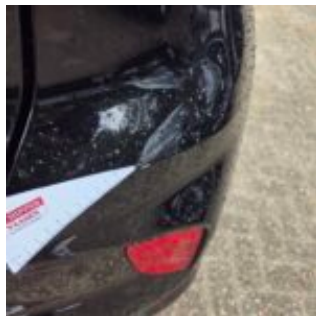
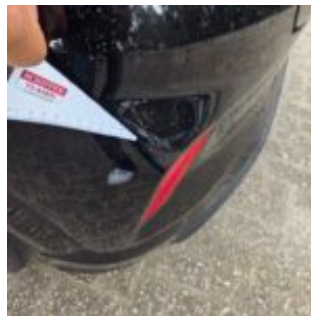
| Damage Part | Damage Type | Repair Type | Acceptable |
|---|---|---|---|
| Bumper - Rear | Scratch(es) | Spray | No |

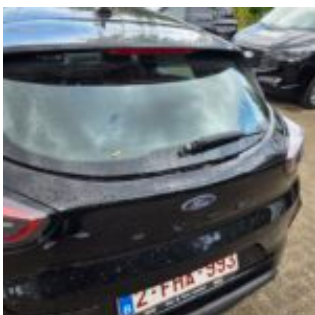
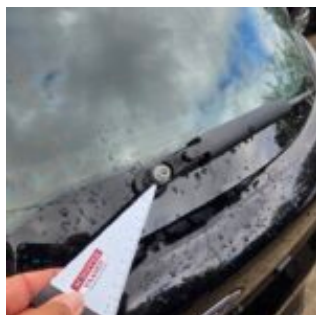
| Damage Part | Damage Type | Notes | Repair Type | Acceptable |
|---|---|---|---|---|
| Windscreen - Rear | Missing | Ruitenwisserkapje | Replace | No |
