Expertise

Protocol number: 46442658  
Order No. / Reference: 26580665  
Inspection date: 9 Jul 2026

Model: Transporter T6.1 DSG Kurz EcoProfi

VIN: WV1ZZZ7H5PX003531

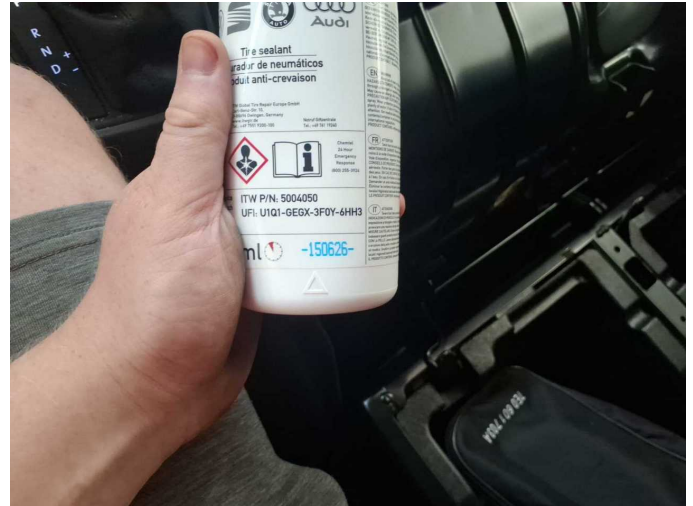
| No. | Component group | Description |
|---|---|---|
| 2 | Equipment | Tirefit filler - Expired - Replace |

**Damage 2:** Equipment: Tirefit filler - Expired - Replace

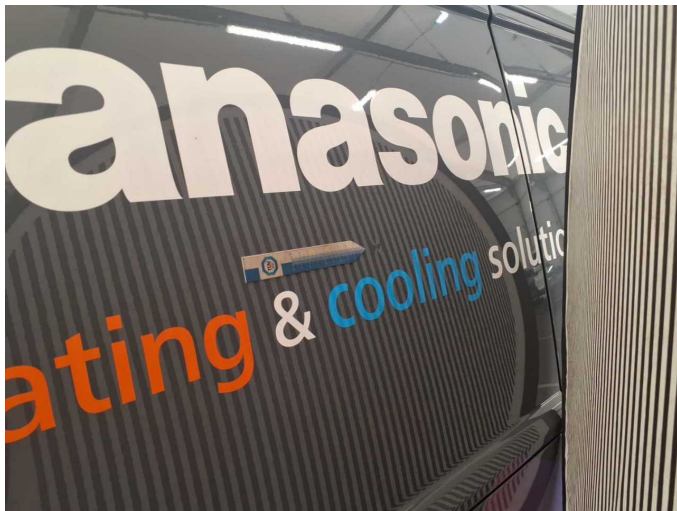
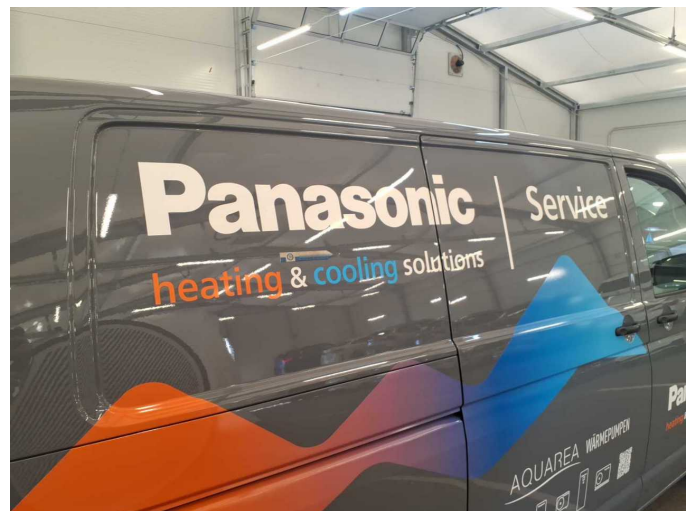
| No. | Component group | Description |
|---|---|---|
| 3 | Side panel - rear right side | Side panel - dent(s) - Smooth repair work |

**Damage 3:** Side panel - rear right side: Side panel - dent(s) - Smooth repair work

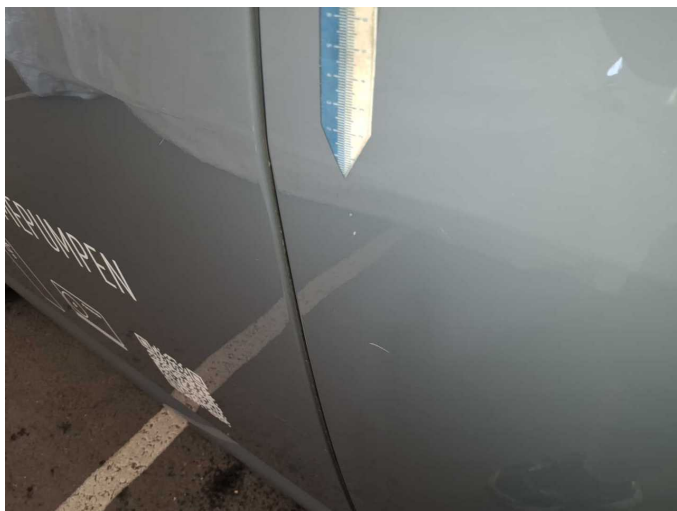
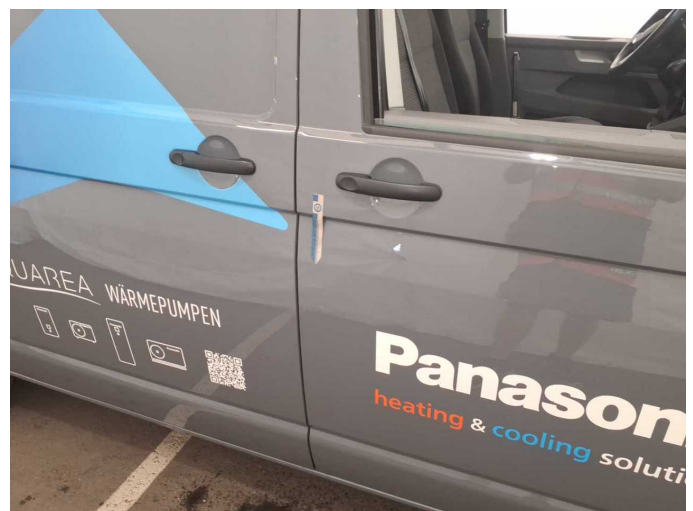
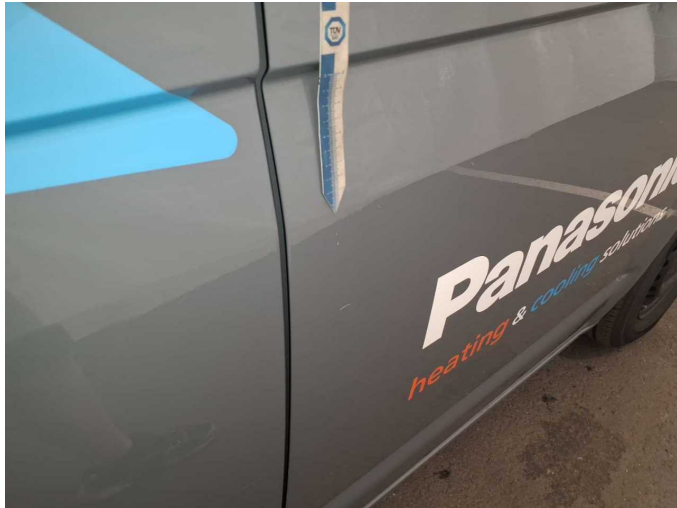
| No. | Component group | Description |
|---|---|---|
| 4 | Door - front right side | Door - Scratch(es) - Smart repair |

**Damage 4:** Door - front right side: Door - Scratch(es) - Smart repair

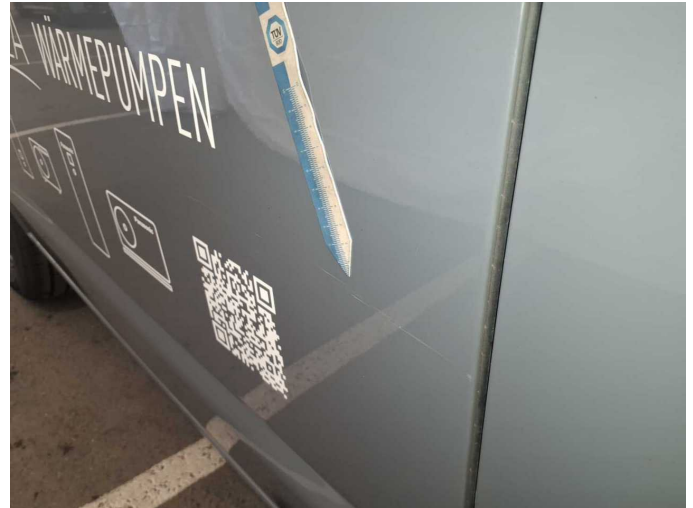
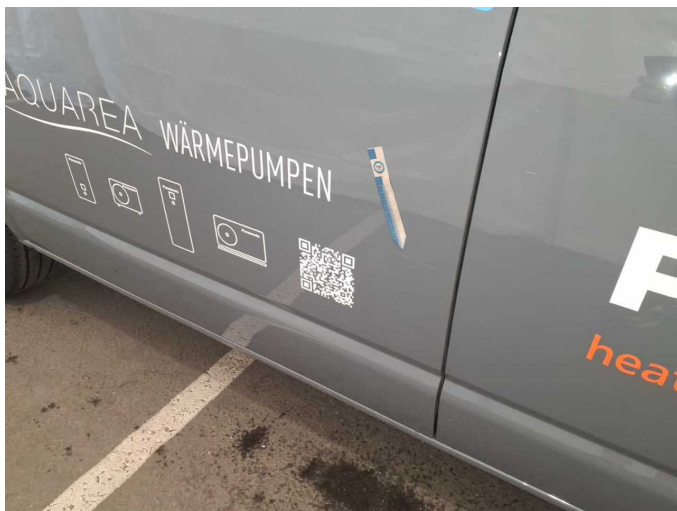
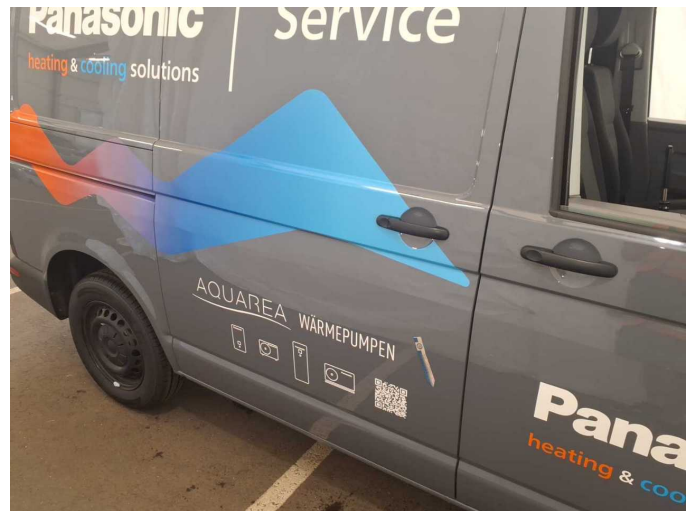
| No. | Component group | Description |
|---|---|---|
| 5 | Door - rear right side | Door - Scratch(es) - Smart repair |

**Damage 5:** Door - rear right side: Door - Scratch(es) - Smart repair

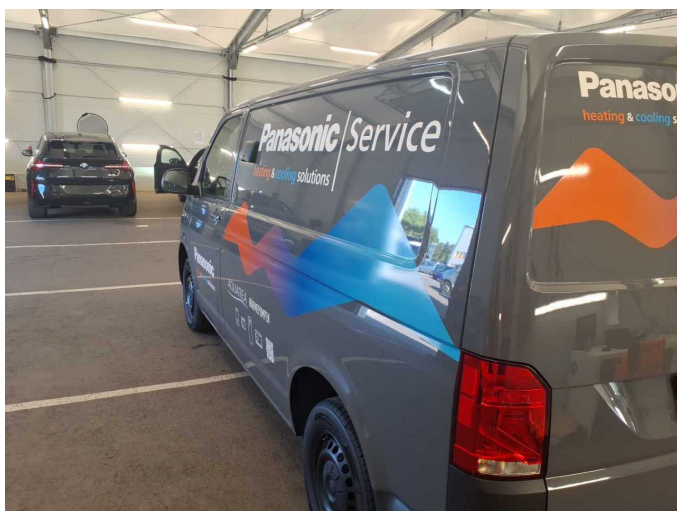
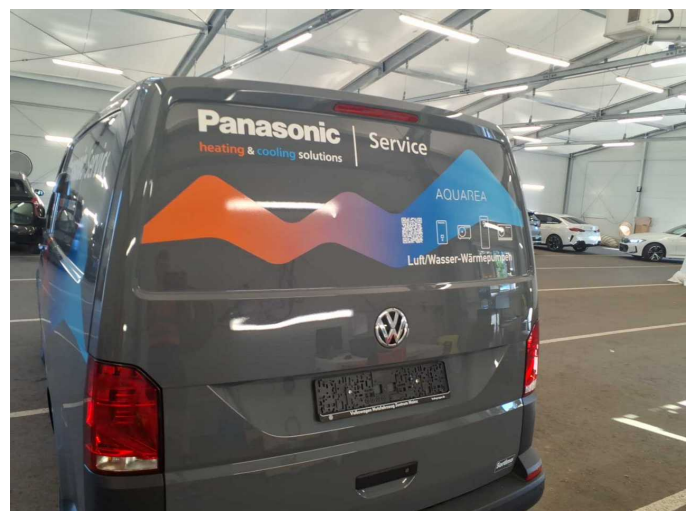
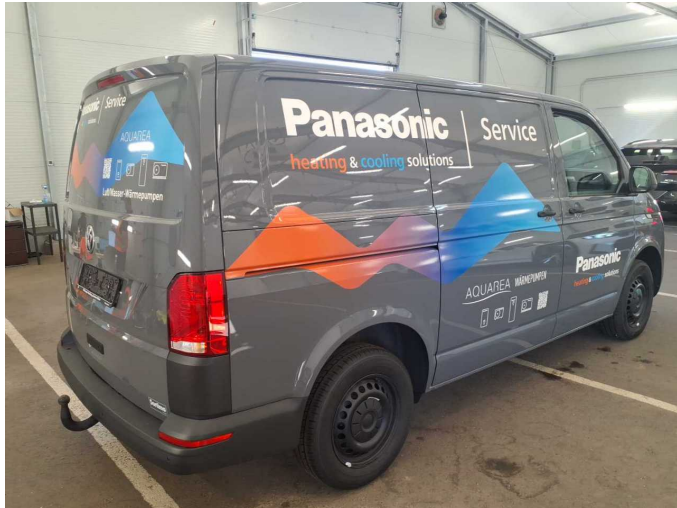
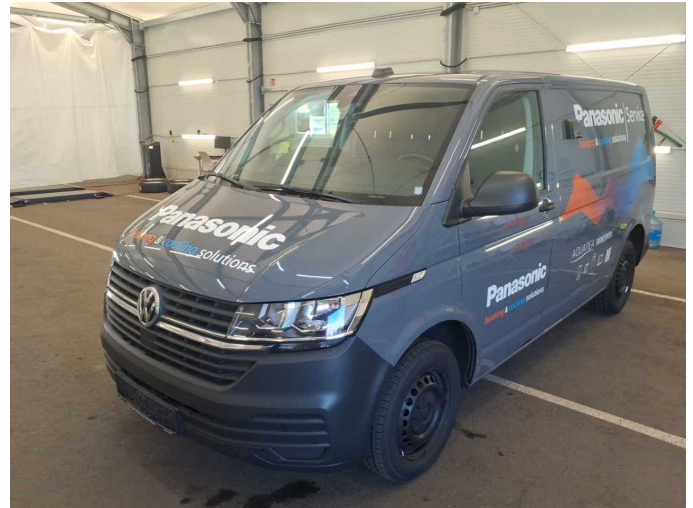
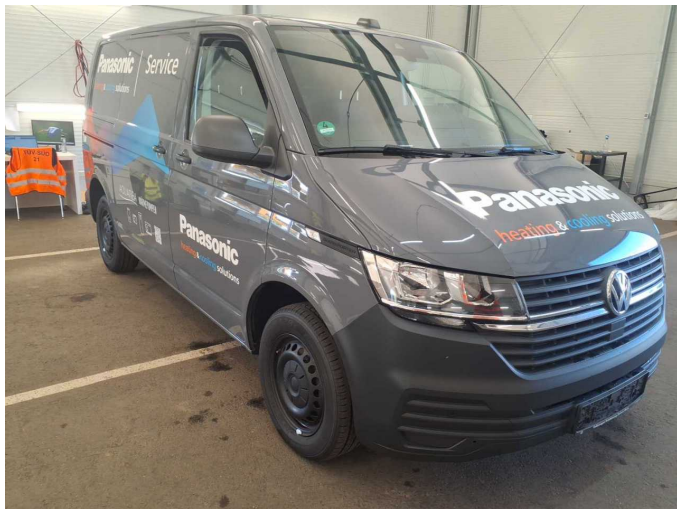
| No. | Component group | Description |
|---|---|---|
| 6 | Body | Body - Glued / labelled - De-glue / neutralise |

**Damage 6:** Body: Body - Glued / labelled - De-glue / neutralise

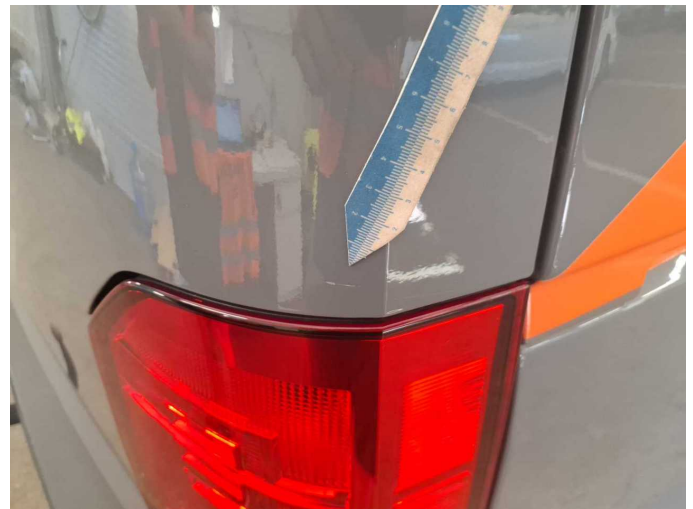
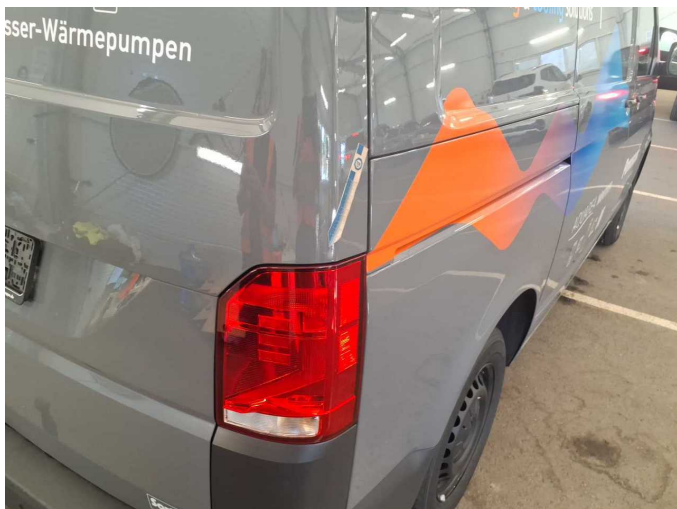
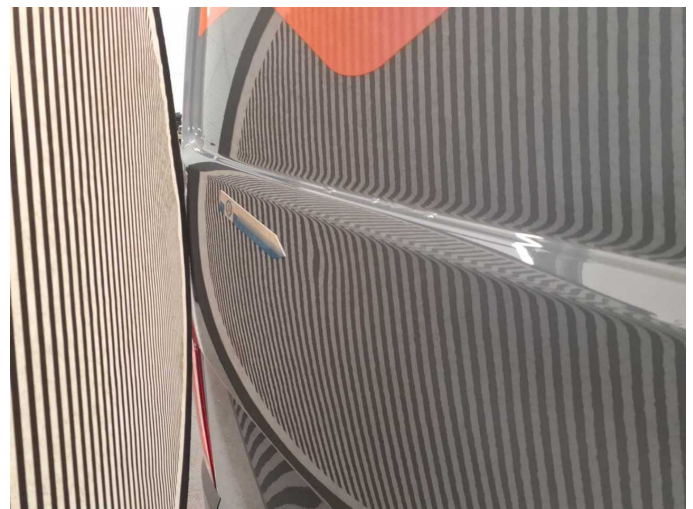
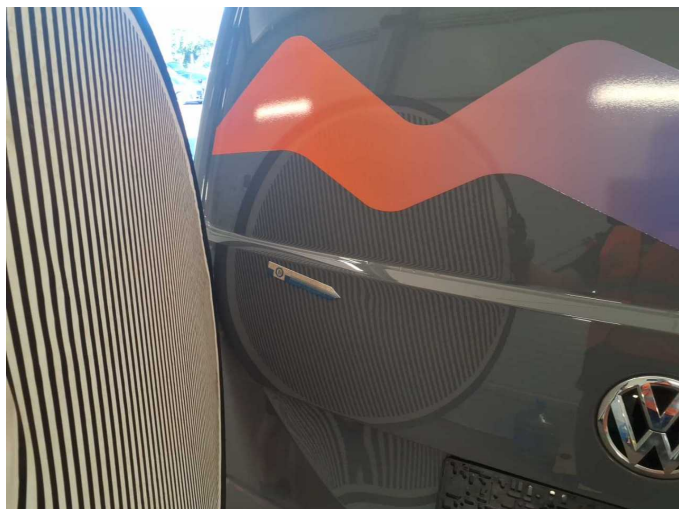
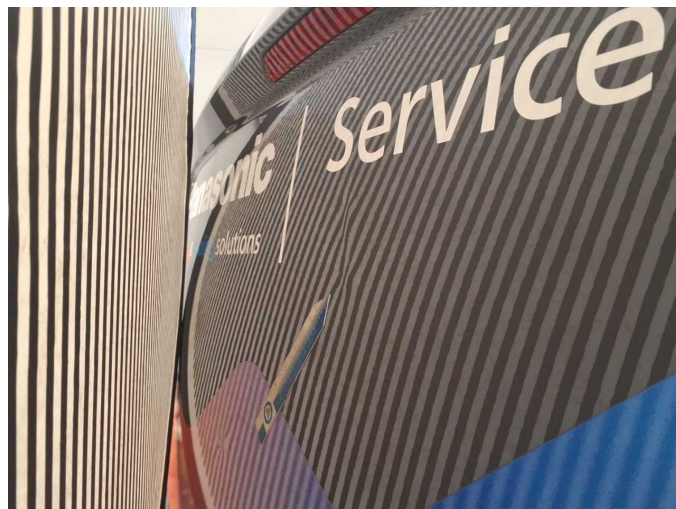
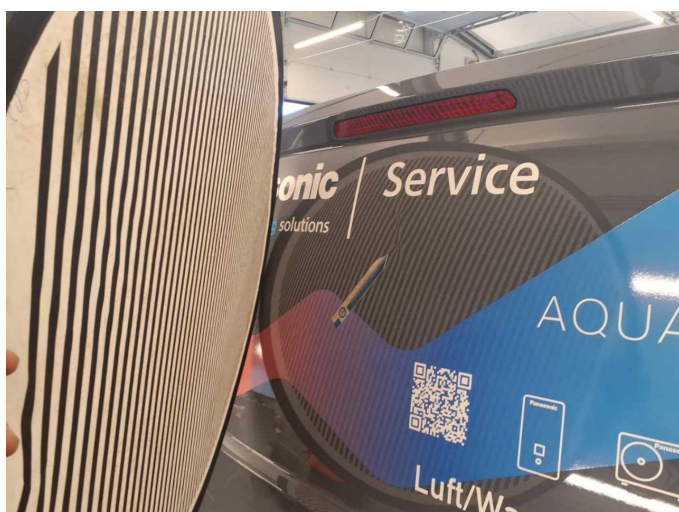
| No. | Component group | Description |
|---|---|---|
| 7 | Boot lid / rear door | Boot lid - Dent / paintcoat damage - Repair and paint |

**Damage 7:** Boot lid / rear door: Boot lid - Dent / paintcoat damage - Repair and paint

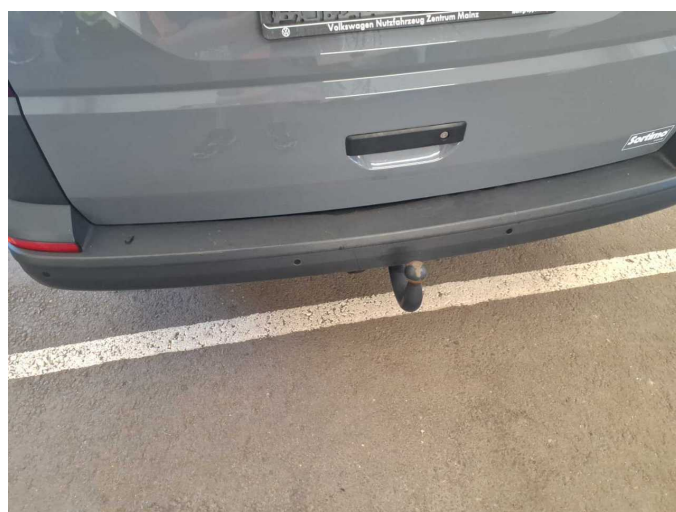
| No. | Component group | Description |
|---|---|---|
| 1 | Rear bumper | Rear bumper (unpainted) - Scratch(es) - No deduction |

**Wear and tear 1:** Rear bumper: Rear bumper (unpainted) - Scratch(es) - No deduction

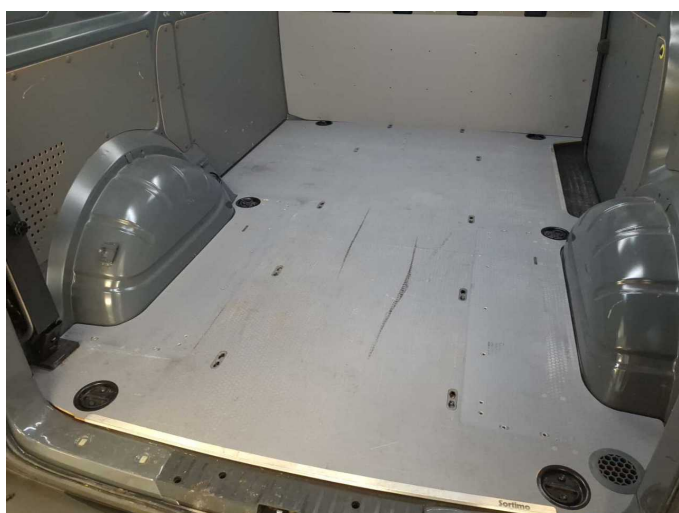
| No. | Component group | Description |
|---|---|---|
| 2 | Interior | Cargo area floor - Scratch(es) - No deduction |

**Wear and tear 2:** Interior: Cargo area floor - Scratch(es) - No deduction

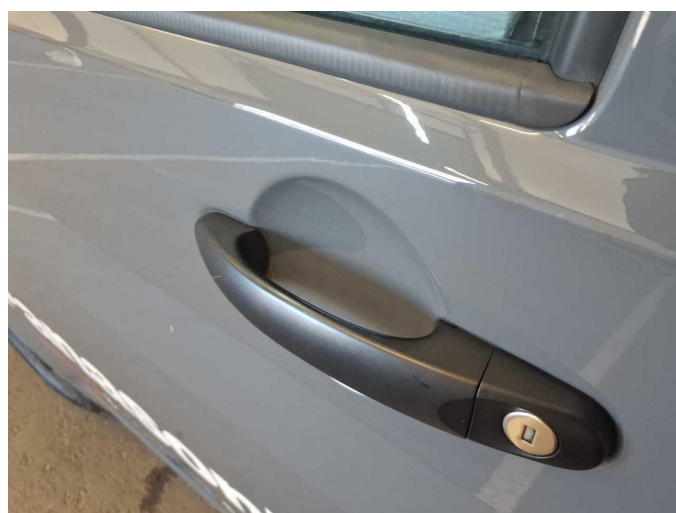
| No. | Component group | Description |
|---|---|---|
| 3 | Door - front left side | Door - Scratch(es) - No deduction |

**Wear and tear 3:** Door - front left side: Door - Scratch(es) - No deduction

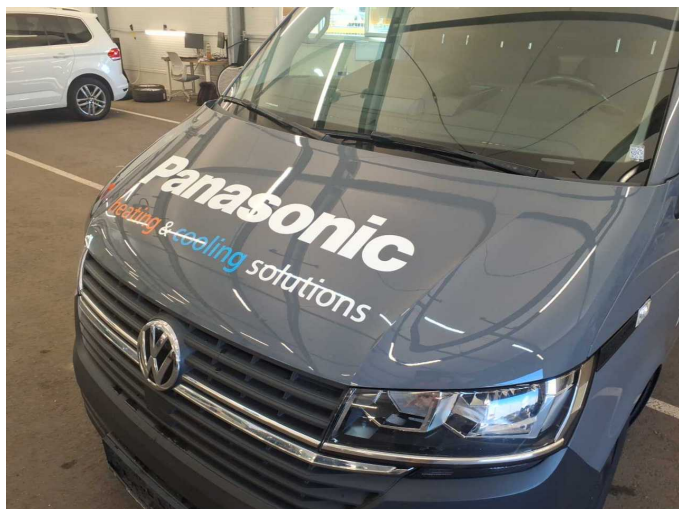
| No. | Component group | Description |
|---|---|---|
| 5 | Bonnet | Bonnet - Stone chips - No deduction |

**Wear and tear 5:** Bonnet: Bonnet - Stone chips - No deduction

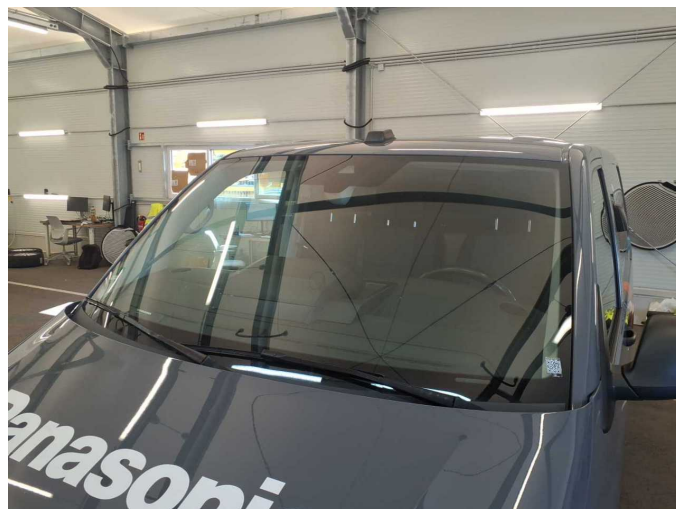
| No. | Component group | Description |
|---|---|---|
| 6 | Vehicle glazing | Windscreen - Stone chips - No deduction |

**Wear and tear 6:** Vehicle glazing: Windscreen - Stone chips - No deduction

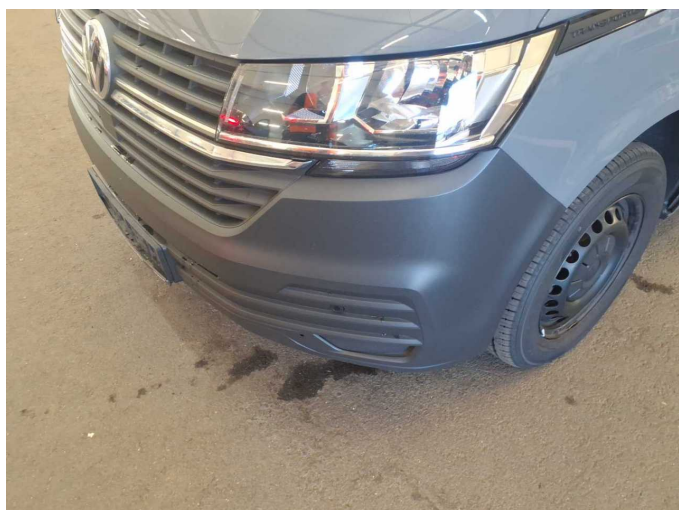
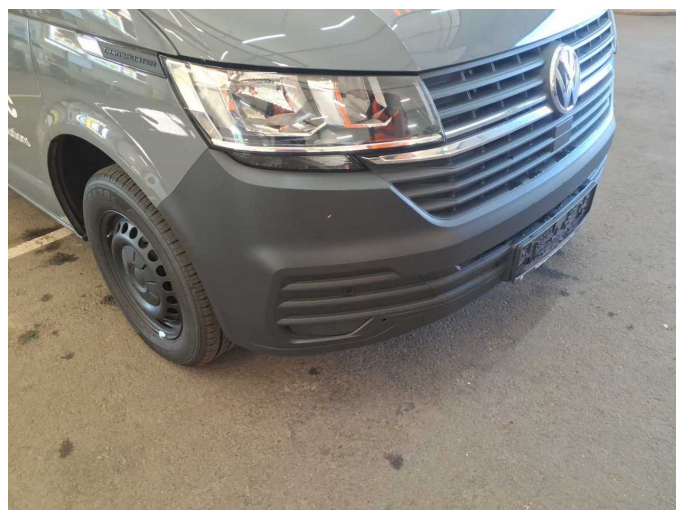
| No. | Component group | Description |
|---|---|---|
| 7 | Front bumper | Front bumper (unpainted) - Stone chips - No deduction |

**Wear and tear 7:** Front bumper: Front bumper (unpainted) - Stone chips - No deduction
