Expertise

Protocol number: 45332733
Order No. / Reference: 26292138
Inspection date: 4 May 2026

Model: 317 CDI Sprinter Standard HA 9G-TRONIC PRO

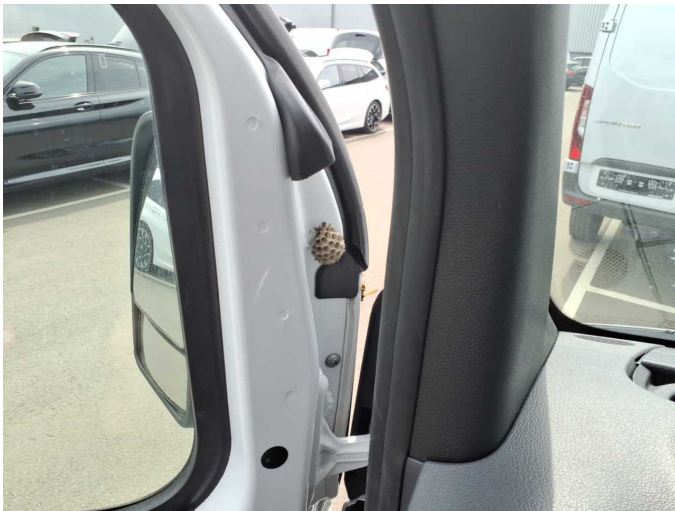
Wear and tear 8: Door - front left side: Door (Wespennest) - No deduction
