## Expertise

Protocol number: 46228089  
Order No. / Reference: 25933176  
Inspection date: 15 Jun 2026

Manufacturer: Mercedes-Benz

Model: Vito 116 CDI Lang HA Aut. PRO

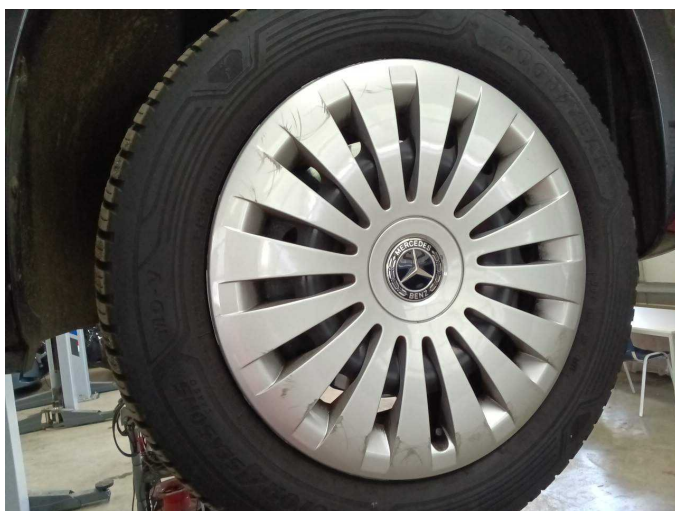
**Damage 1:** Wheel / tyres: Wheel cover - front right side - Scratch(es) - Replace

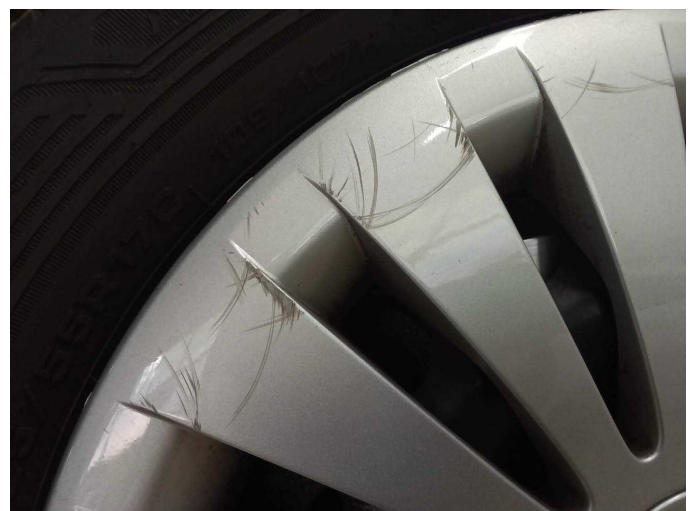
**Damage 1:** Wheel / tyres: Wheel cover - front right side - Scratch(es) - Replace

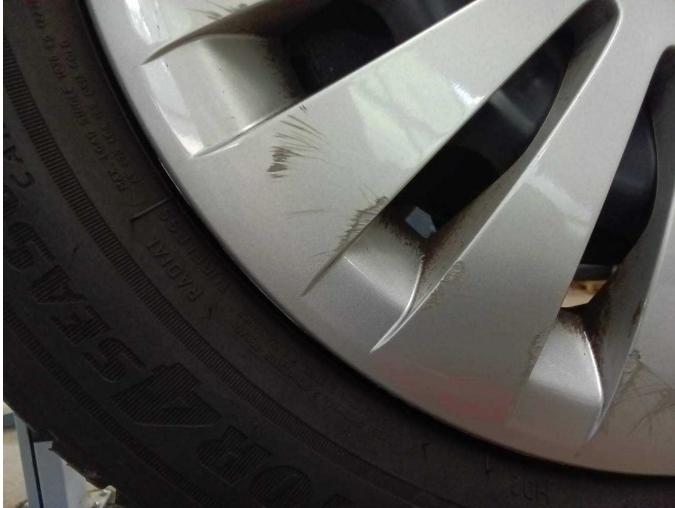
No.	Component group	Description
1	Wheel / tyres	Wheel cover - front right side - Scratch(es) - Replace
2	Sliding door, right	Sliding door - Scratch(es) - Smart repair
3	Door - front right side	Door - dent(s) - Smooth repair work
4	Bonnet	Bonnet - dent(s) - Smooth repair work
5	Rear bumper	Rear bumper - Dent / paintcoat damage - Repair and paint

**Damage 1:** Wheel / tyres: Wheel cover - front right side - Scratch(es) - Replace

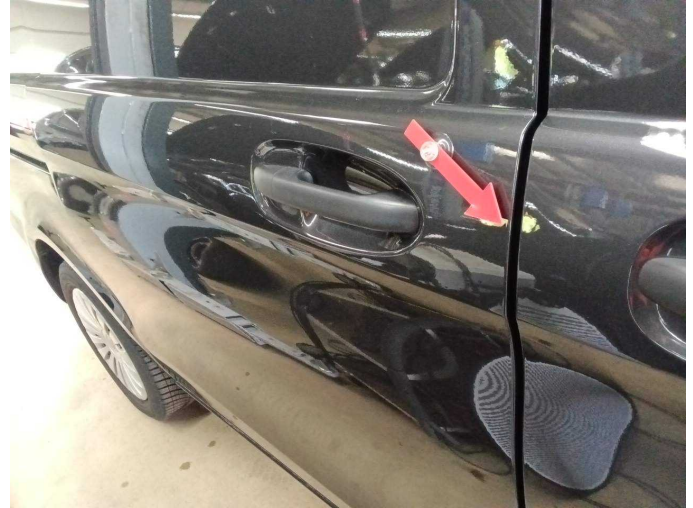
**Damage 2:** Sliding door, right: Sliding door - Scratch(es) - Smart repair

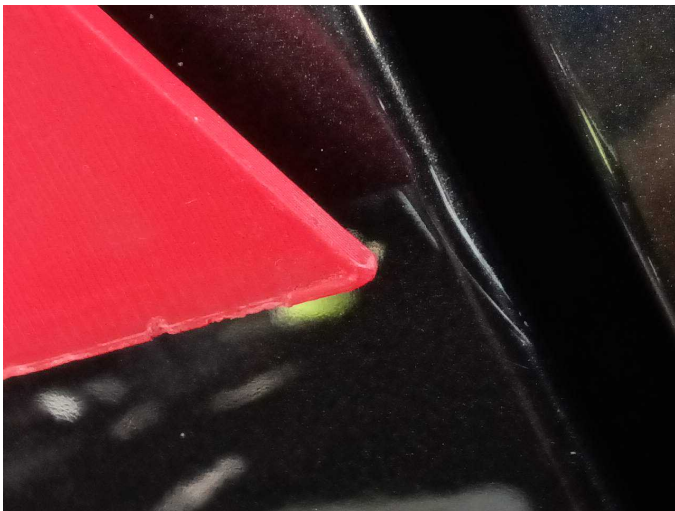
**Damage 2:** Sliding door, right: Sliding door - Scratch(es) - Smart repair

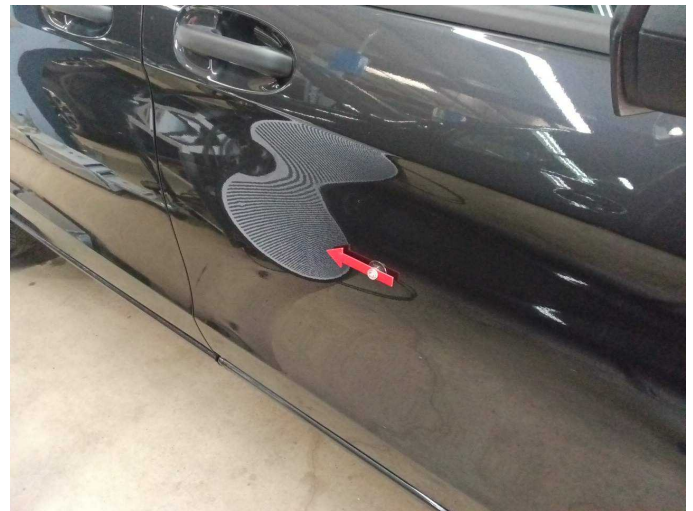
**Damage 3:** Door - front right side: Door - dent(s) - Smooth repair work

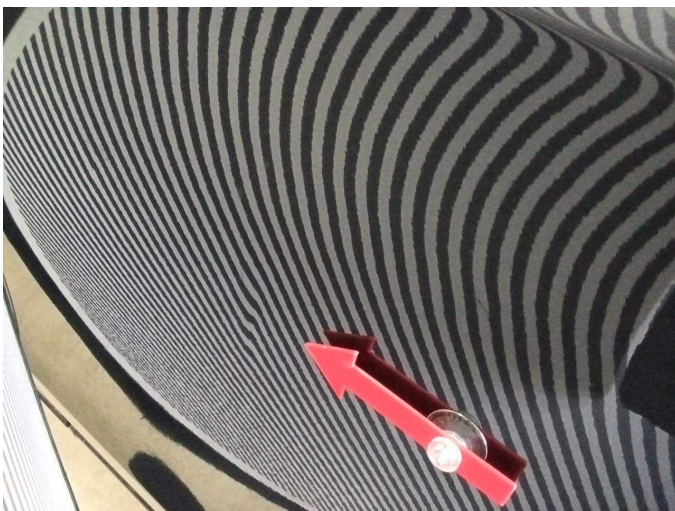
**Damage 3:** Door - front right side: Door - dent(s) - Smooth repair work

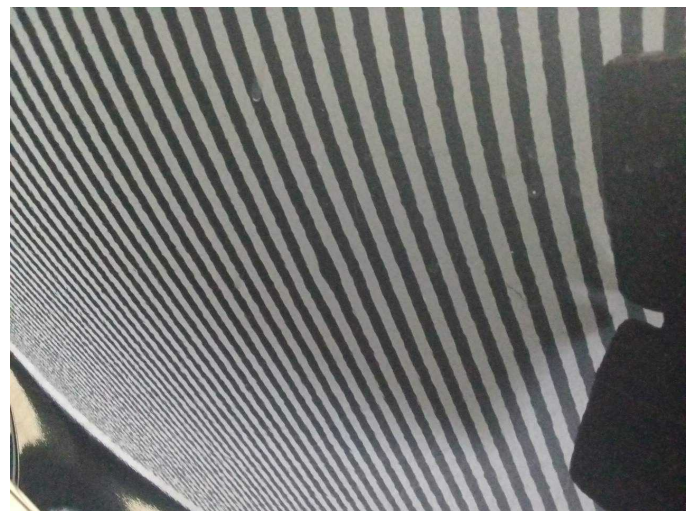
**Damage 3:** Door - front right side: Door - dent(s) - Smooth repair work

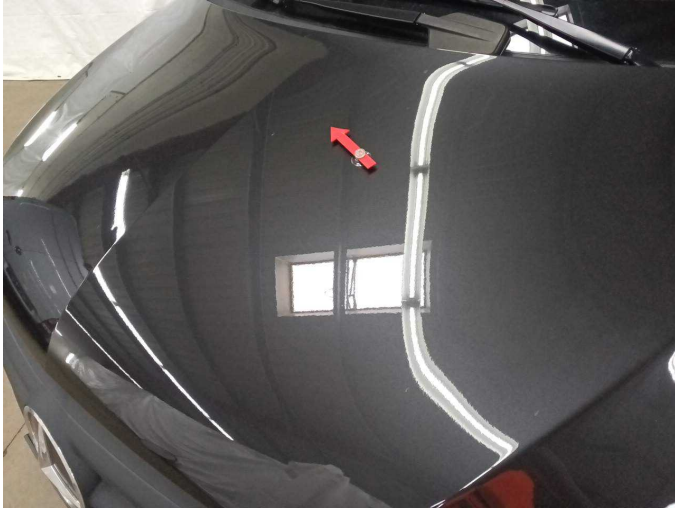
**Damage 4:** Bonnet: Bonnet - dent(s) - Smooth repair work

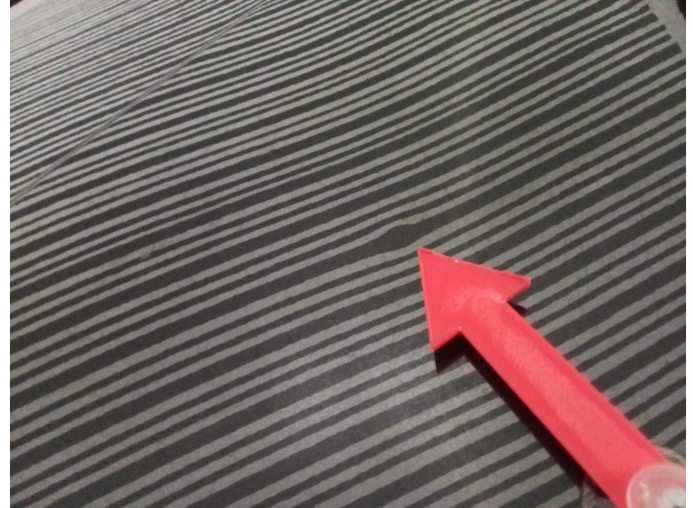
**Damage 4:** Bonnet: Bonnet - dent(s) - Smooth repair work

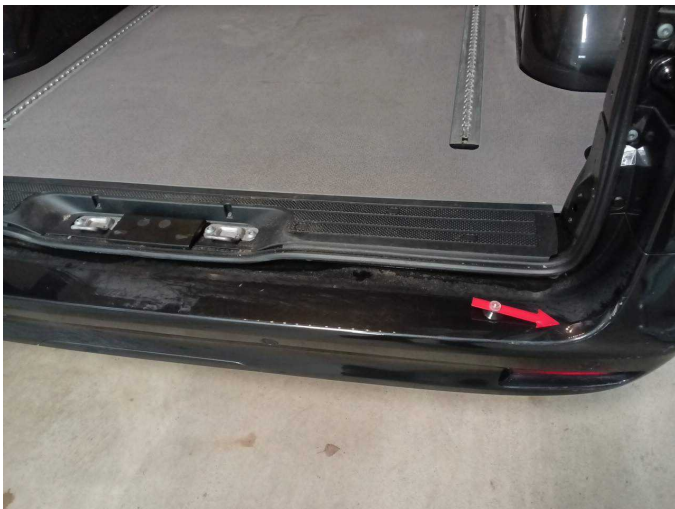
**Damage 5:** Rear bumper: Rear bumper - Dent / paintcoat damage - Repair and paint

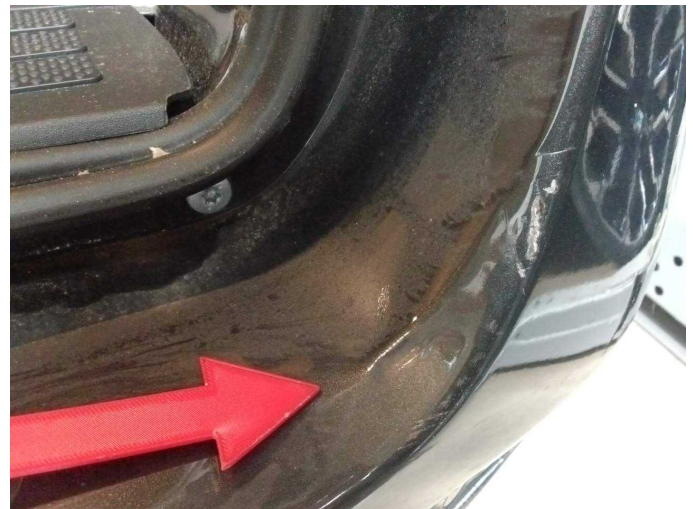
**Damage 5:** Rear bumper: Rear bumper - Dent / paintcoat damage - Repair and paint

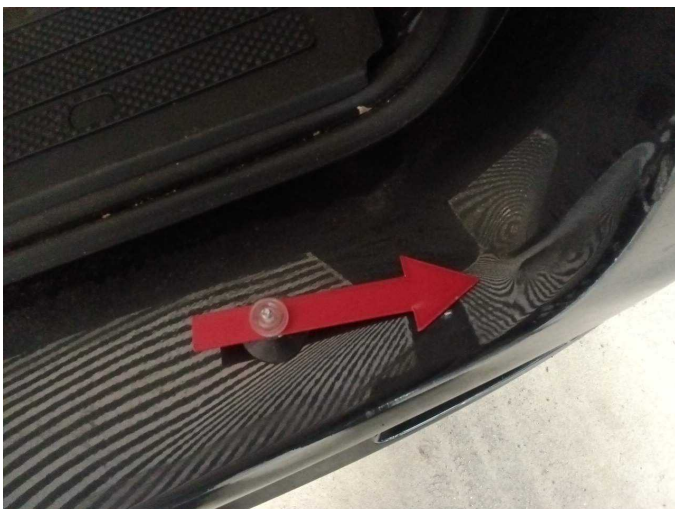
**Damage 5:** Rear bumper: Rear bumper - Dent / paintcoat damage - Repair and paint

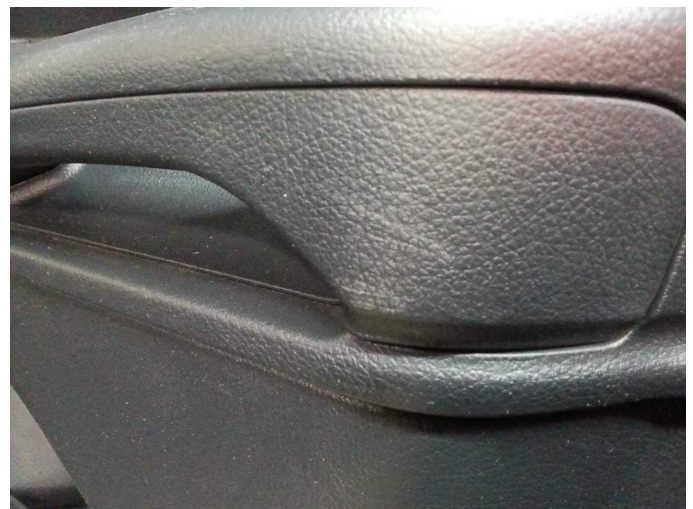
No.	Component group	Description
1	Vehicle glazing	Windscreen - Stone chips - No deduction
2	Trim / covers	Door trim - front right side - Scratch(es) - No deduction
3	Door - front left side	Door edge - Scratch(es) - No deduction

**Wear and tear 2:** Trim / covers: Door trim - front right side - Scratch(es) - No deduction
